Re: Disturbed Area Boundary and Legal Description Change, Fossil Rock Resources, LLC, Permit Number C/015/0009, Task ID# 5161

APPLICATION FOR COAL PERMIT PROCESSING

Title: Disturbed Area Boundary and Legal Description Text and Plate Changes, Task ID#5161

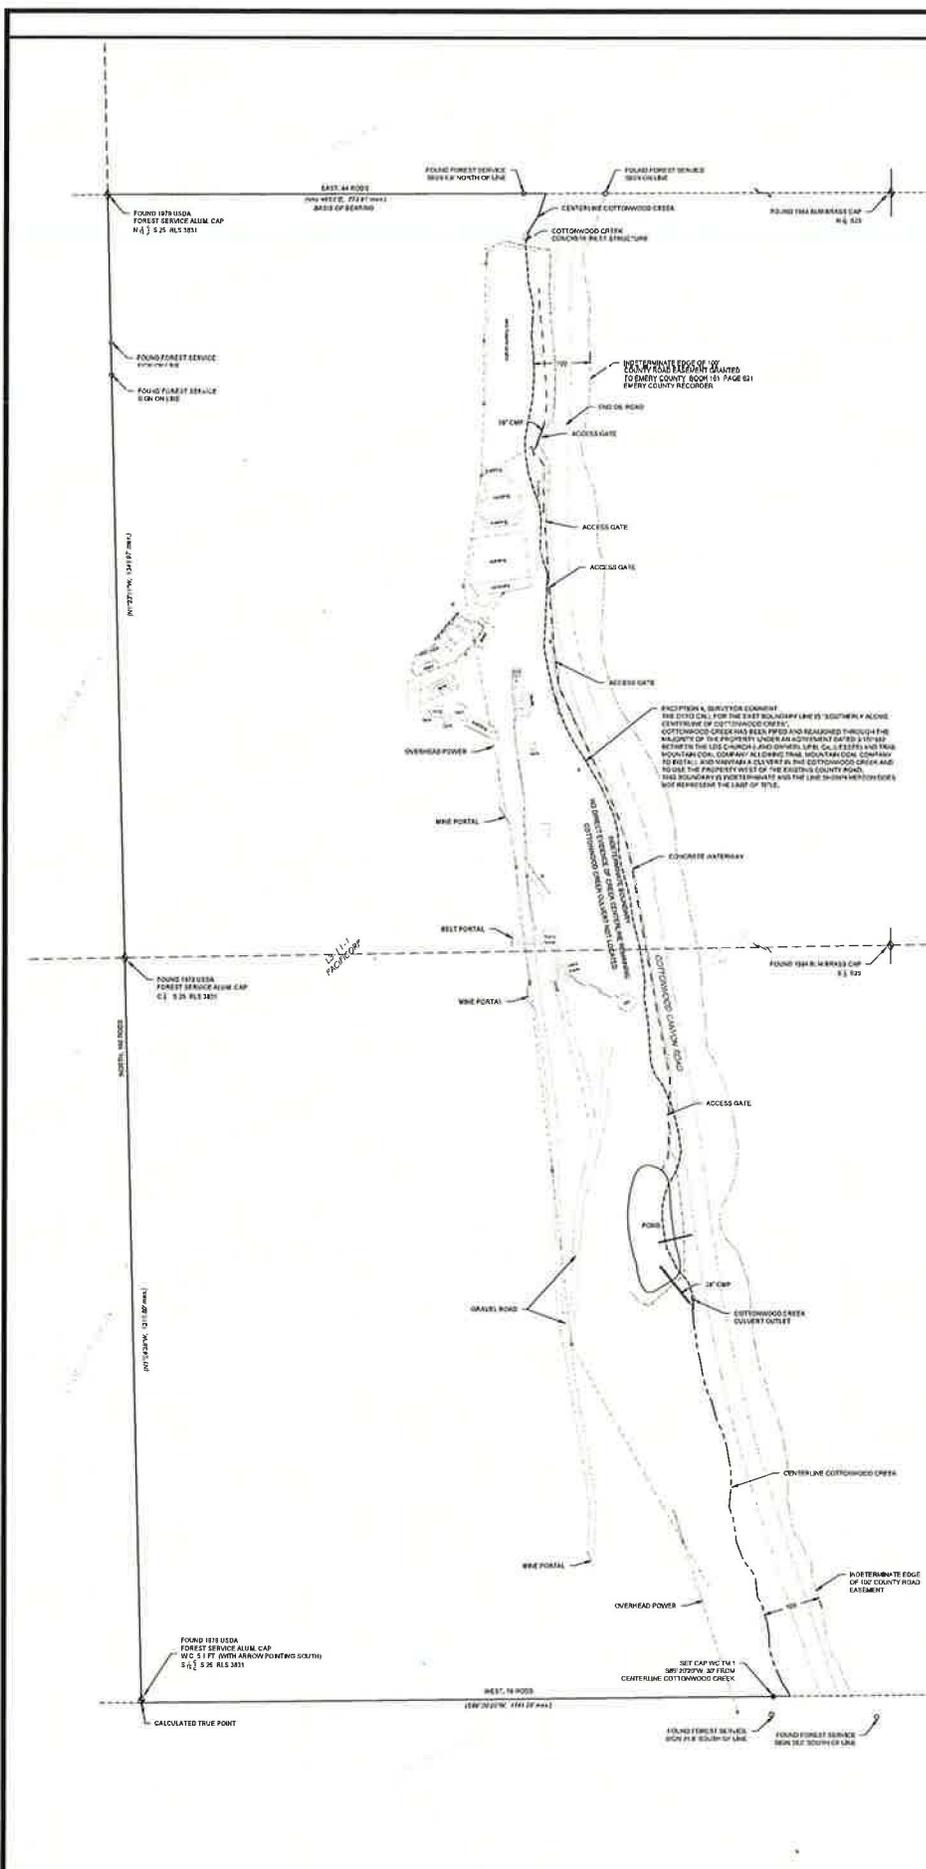
ALTA/ACSM LAND TITLE SURVEY
PACIFICCORP TRAIL MT. MINE

- Exception 5, 6, 7, 8, 9, 10, 11 Not applicable to survey.
- Exception 12 Any rights associated with the County Road or Cottonwood Canyon Road as disclosed on an aerial photo and in the Acknowledgment of Right-of-Way by the USA, as recorded on May 7, 2008 as entry No. 380382.

- Surveyor Comment: Document does not apply to private property.
- Exception 14 Not applicable to survey.

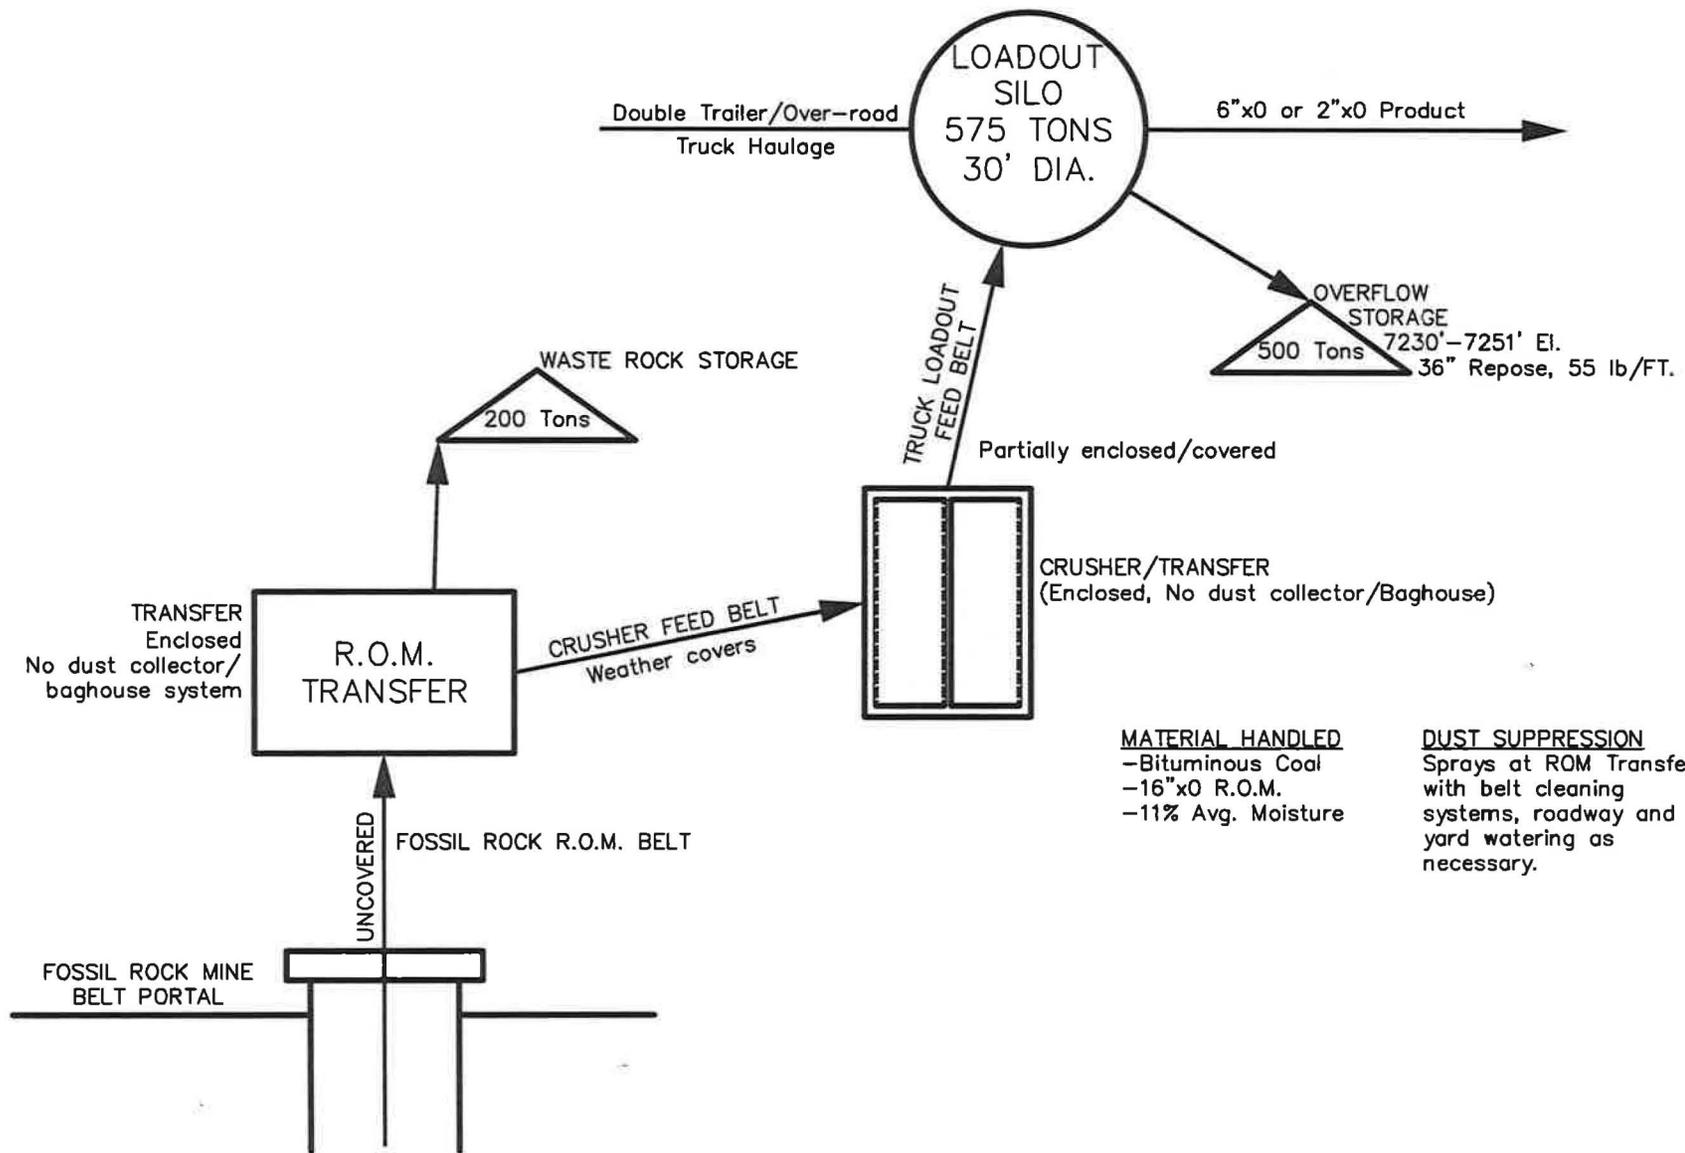
MATERIAL HANDLED
 -Bituminous Coal
 -16"x0 R.O.M.
 -11% Avg. Moisture

DUST SUPPRESSION
 Sprays at ROM Transfer,
 with belt cleaning
 systems, roadway and
 yard watering as
 necessary.

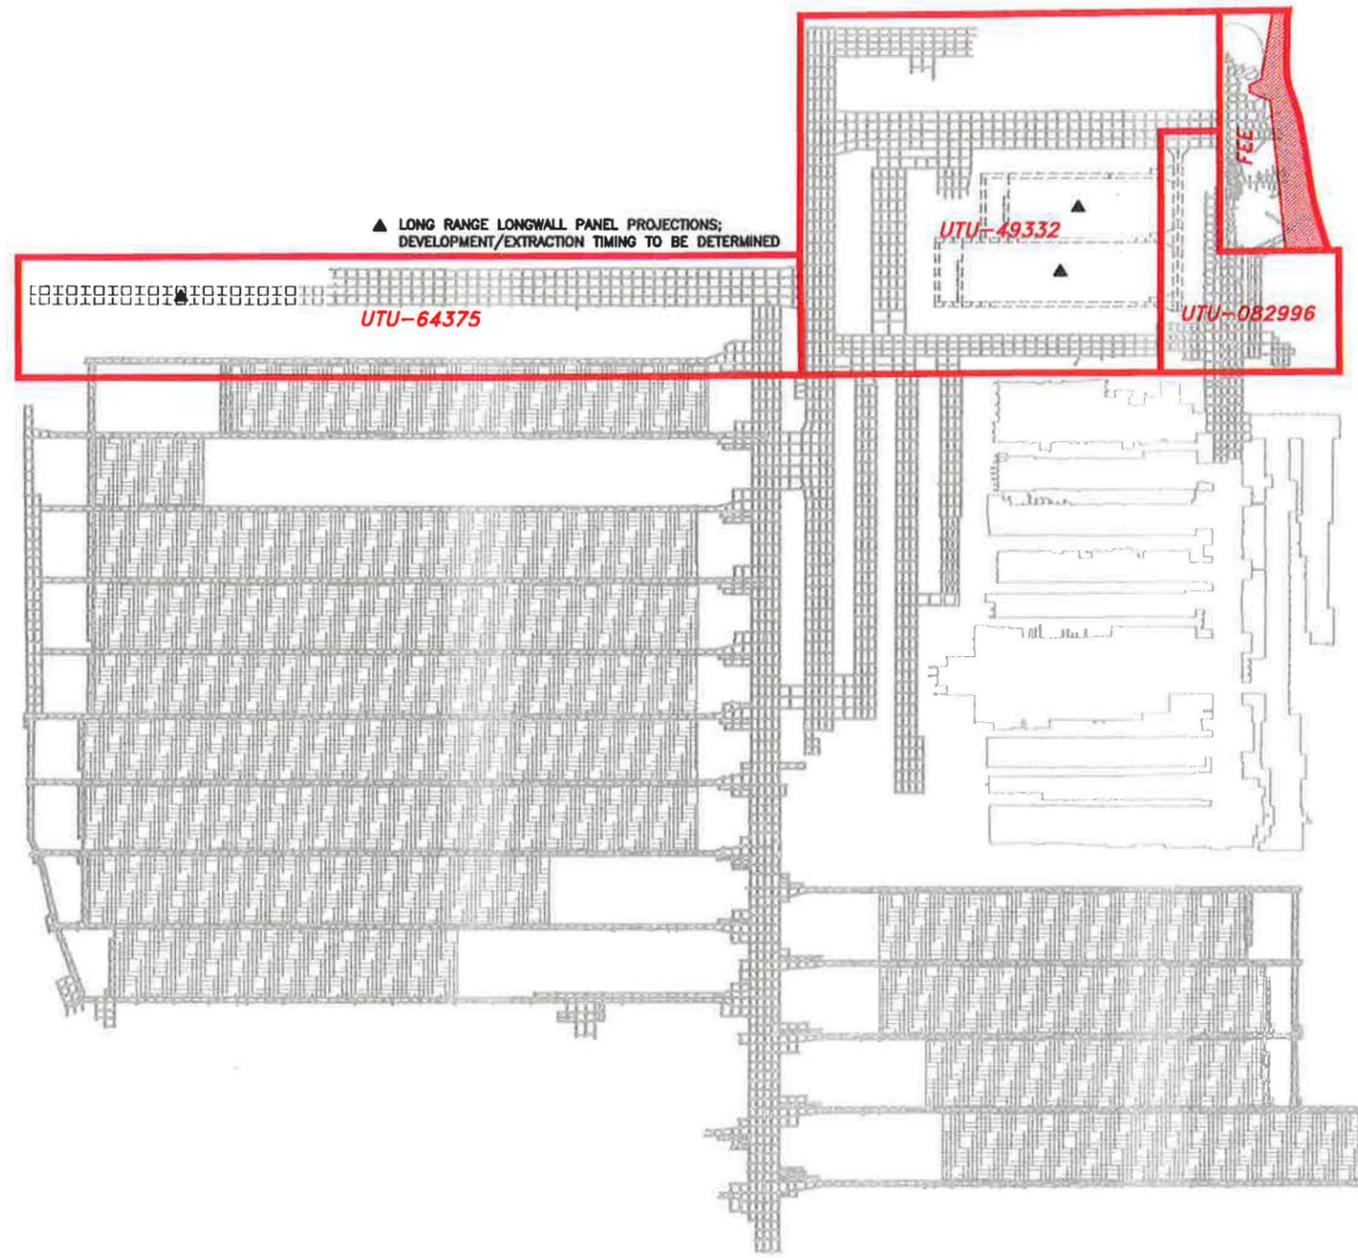
SHEET NO.
PLATE 3-2

▲ LONG RANGE LONGWALL PANEL PROJECTIONS;
DEVELOPMENT/EXTRACTION TIMING TO BE DETERMINED

MINING PLAN

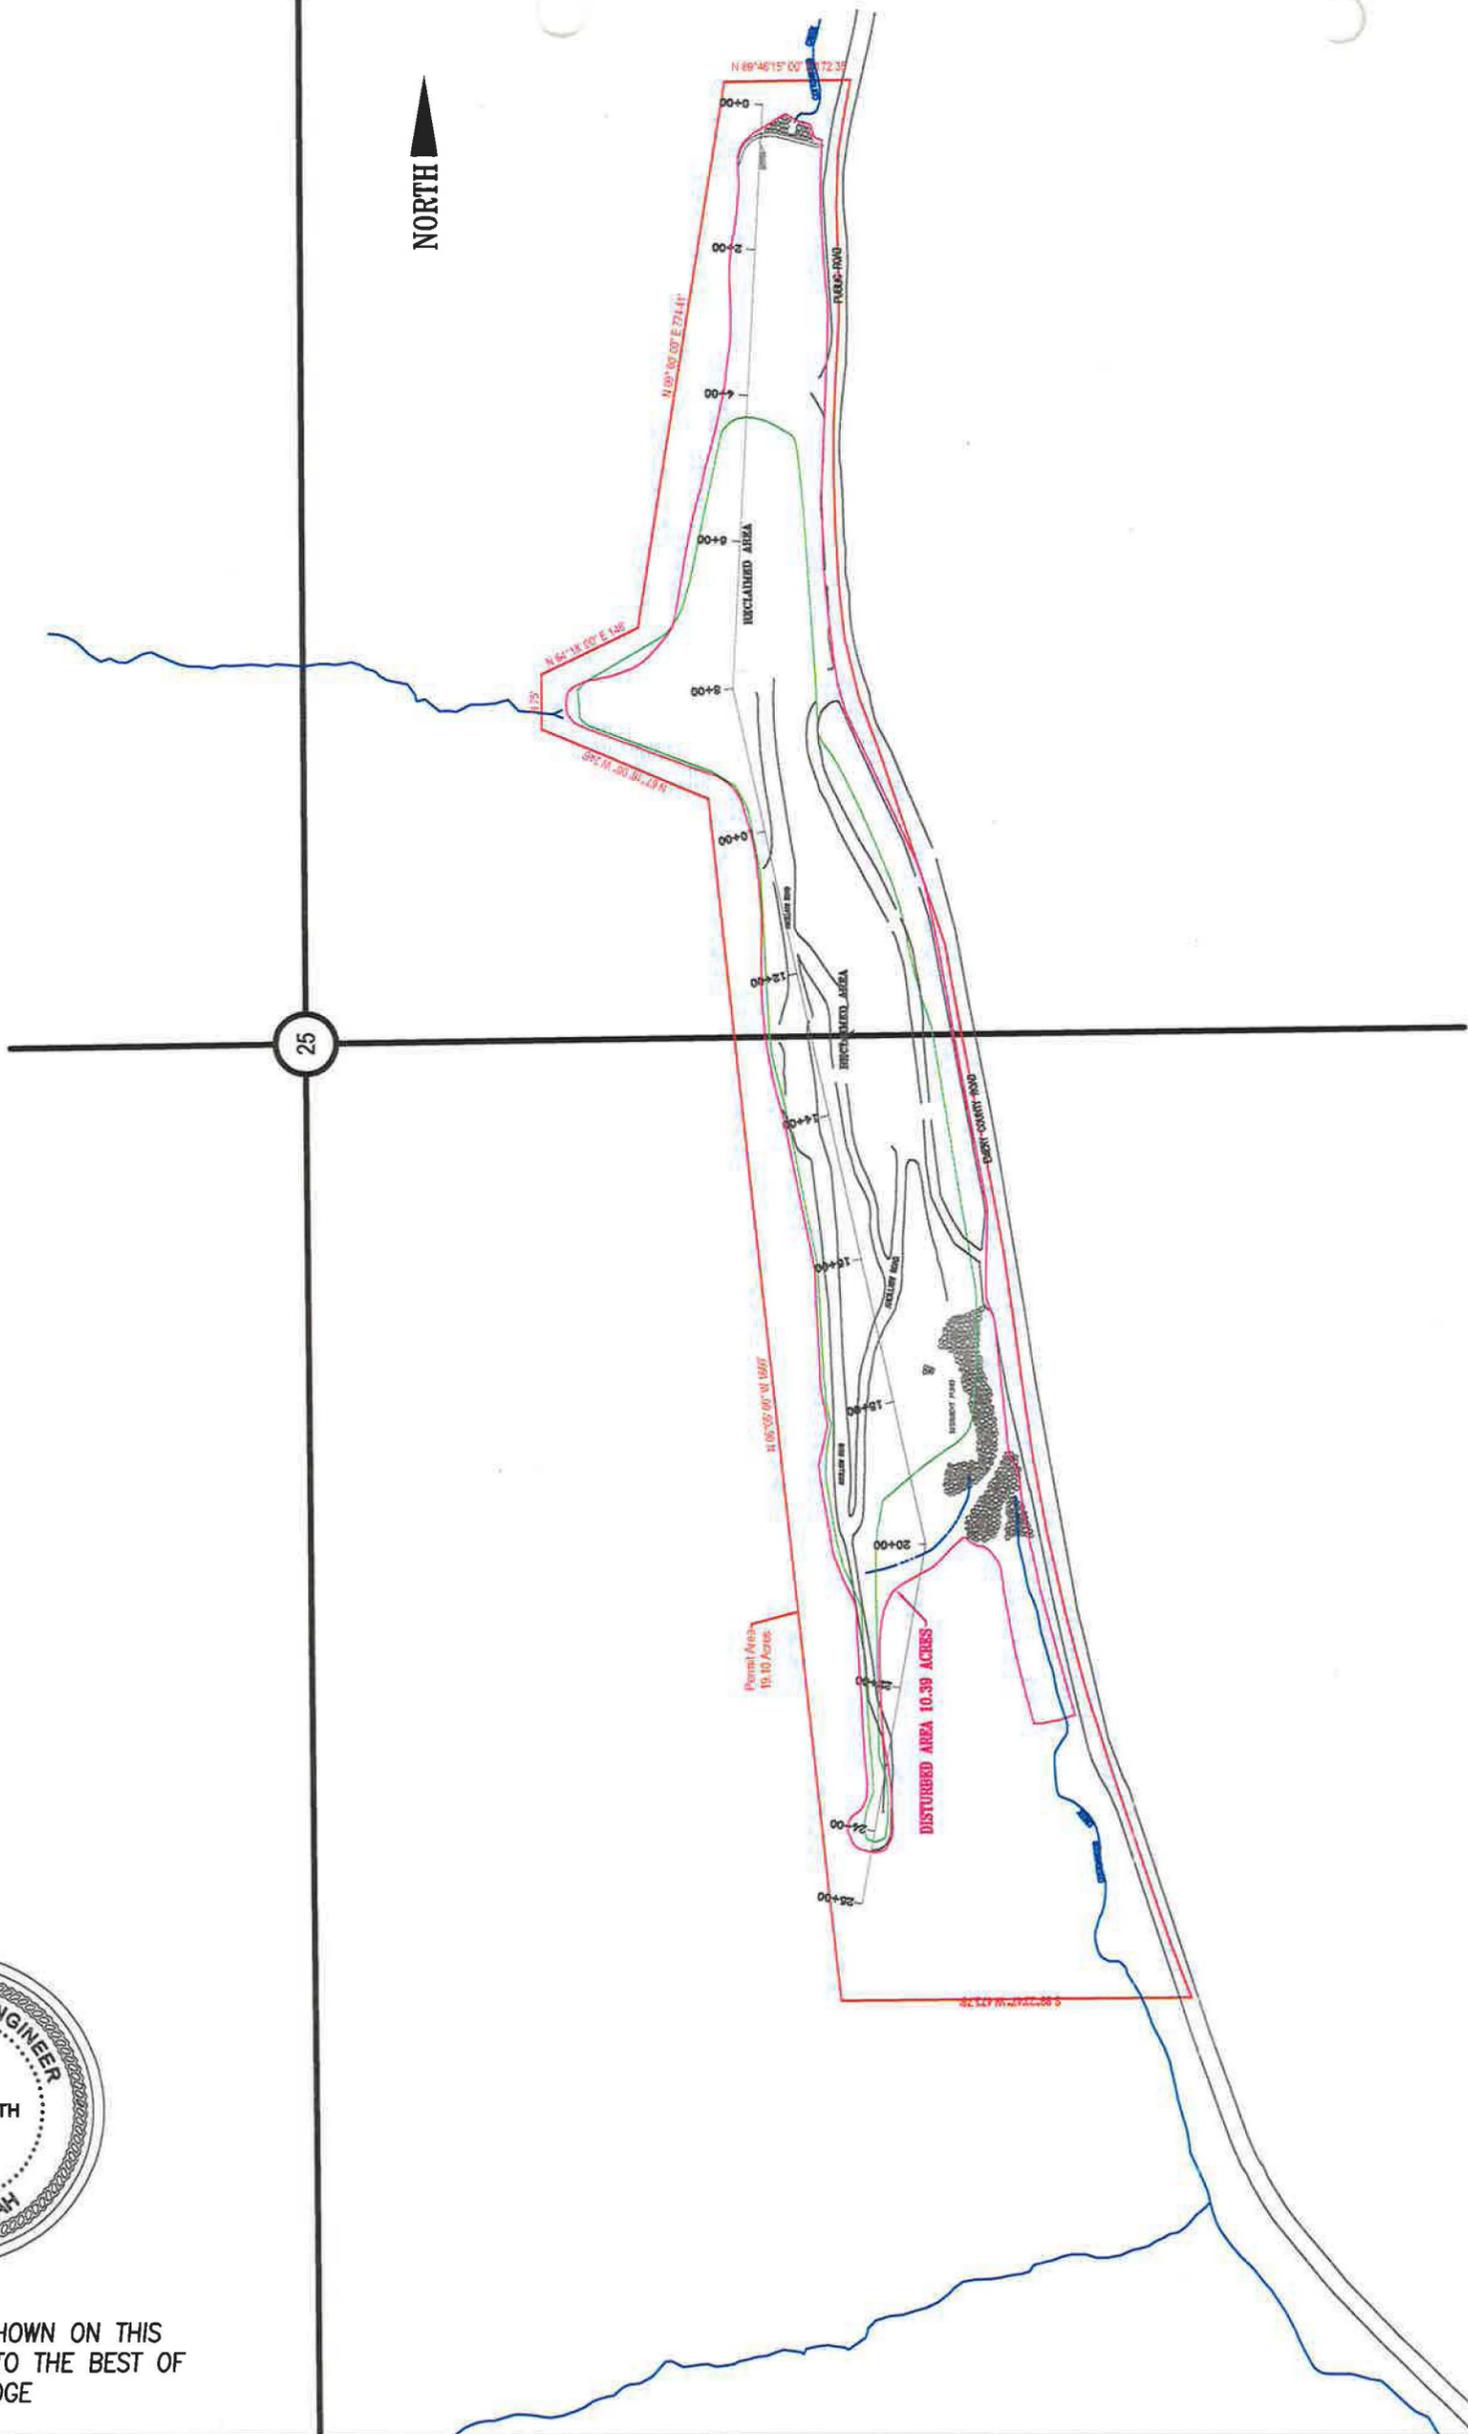
SHEET NO.
Plate 3-5

Fossil Rock Mine		
Post Mining Contour Map Reclamation Phase 1		
SCALE: 1" = 250'	DATE: 9/13/2016	DRAWN BY: BR
ENGINEER: JS	CHECKED BY: VM	PROJ:
FILE NAME: H:\DRAWINGS\Trail Mountain\Permit and Drawings August 2015\Permit Maps\Plate 3-5.dwg

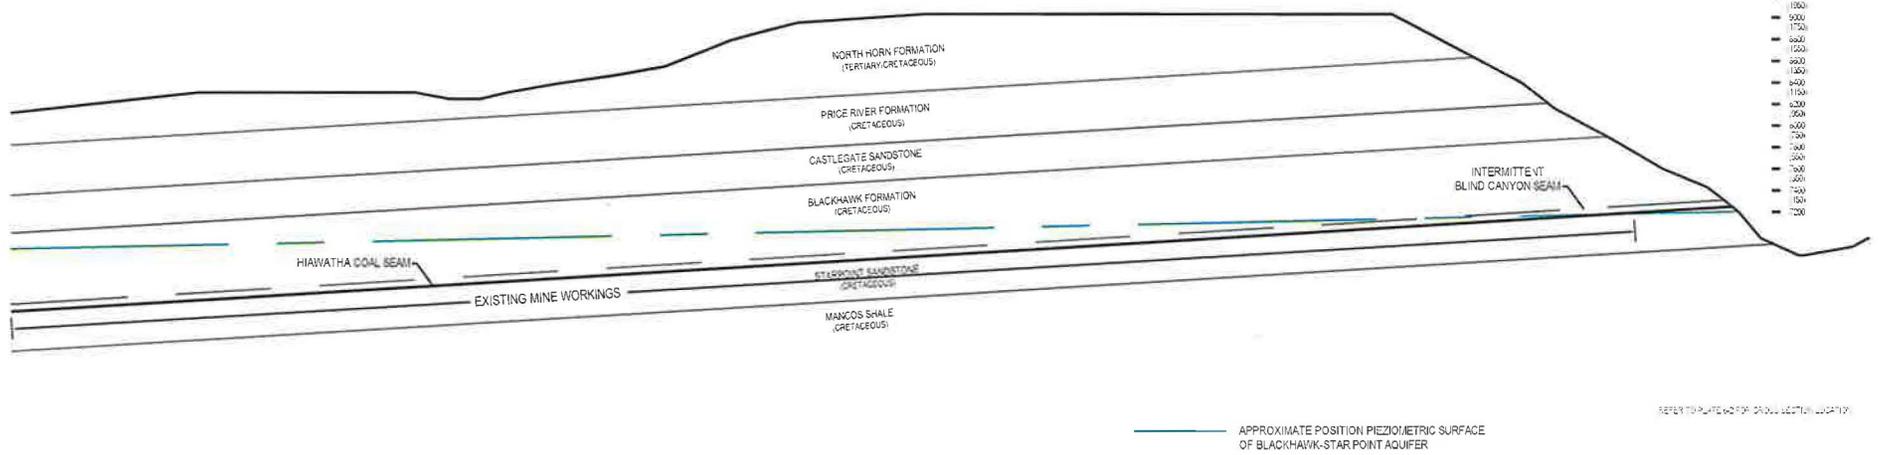
SHEET NO.
Plate 6-1

Fossil Rock Mine
Cross Section A-A'

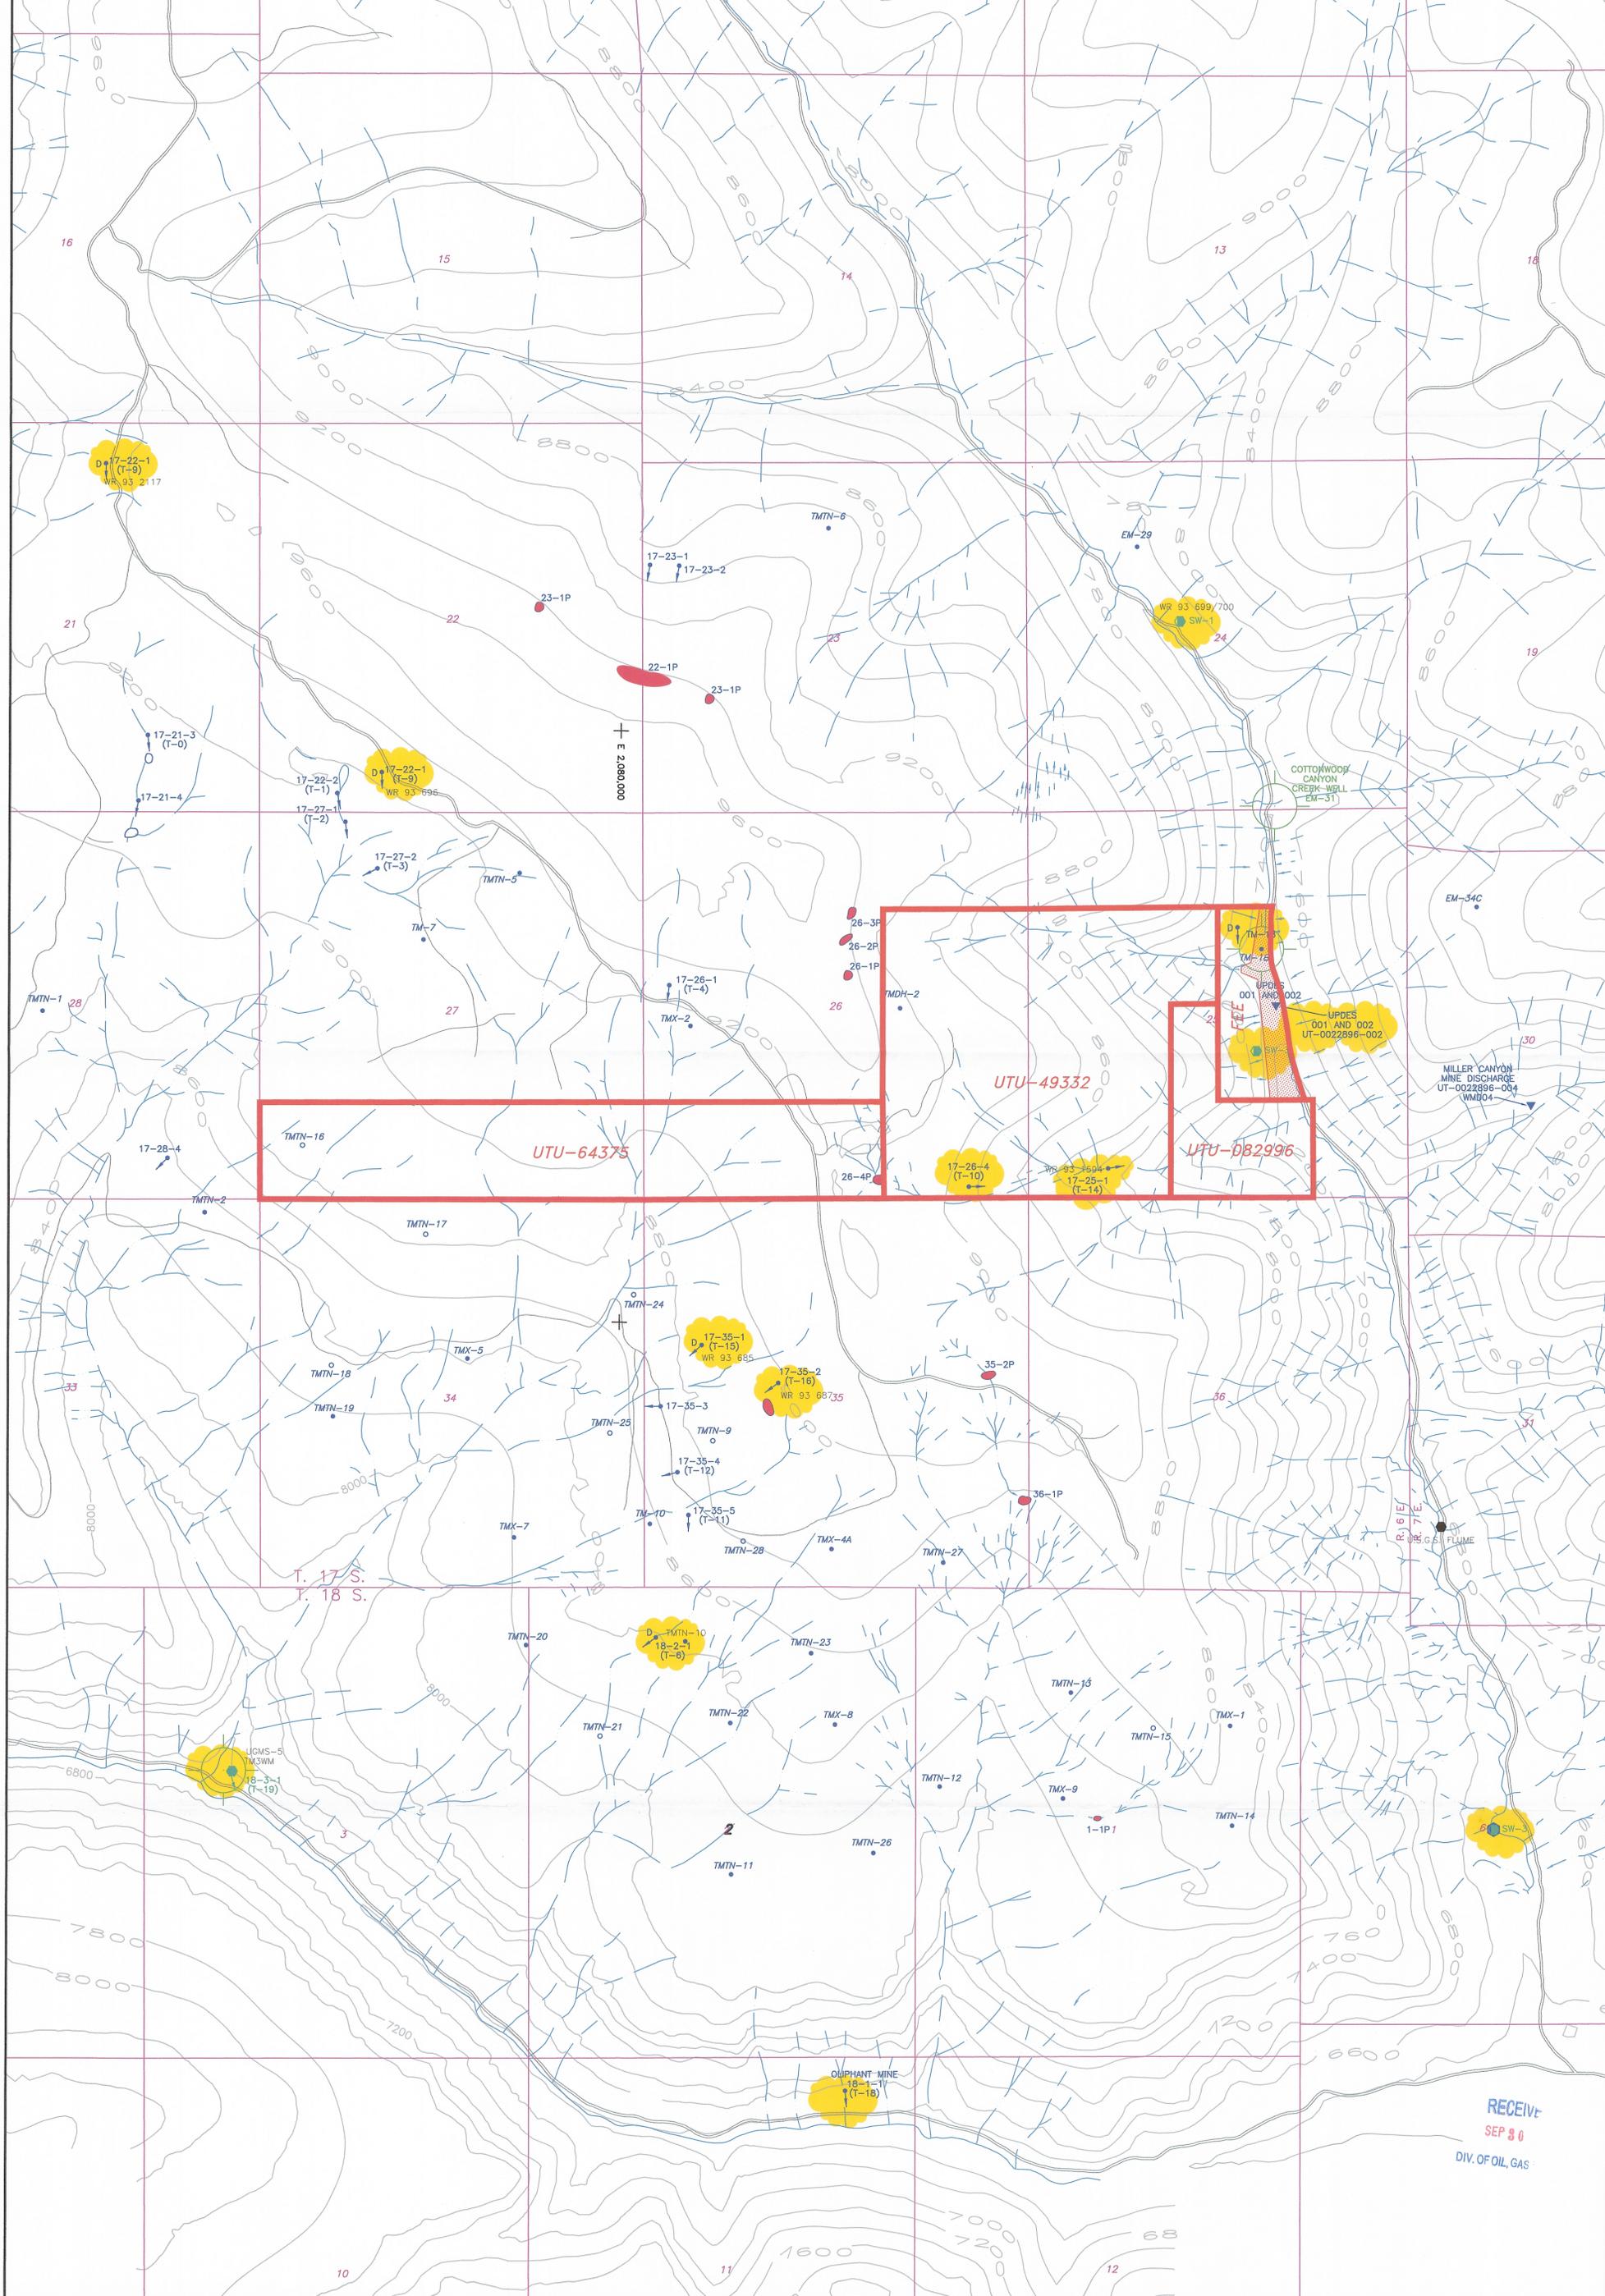
PEN TBL:	SCALE: 1" = 1000'	DATE: 9/21/2016	DRAWN BY: BR	ENGINEER: JS	CHECKED BY: VM	SHEET NO.
SHT SET:	PROJECT NUMBER: TMS1450C	FILE NAME: H:\DRAWINGS\Trail Mountain\Permit and Drawings August 2015\Permit Maps\Plate 7-2.dwg	Plate 7-2

LEASE BOUNDARY	MONITORING WELL
DEVELOPED SPRING (WITH STOCK WATERING TROUGH)	WATER WELL
POND BLENDOFF FED	SPRING (REQUIRES MONITORING)
POND SPRING FED - CONSIDERED DEVELOPED BY THE USFS	PERMIT AREA
SPRING TOWNSHIP SECTION-SPRING NO. (MTN COAL L.D.)	EAST MOUNTAIN DRILL HOLE NO. 12 (C-CORED)
WATER RIGHTS NO.	TRAIL MOUNTAIN DRILL HOLE NO. 10
WATER MONITORING STATION WITH FLUME	DRILL HOLE
WATER MONITORING STATION WITH FLUME	
UPDES DISCHARGE LOCATION

Surface Water Quality - Three surface water sites (referred to as SW-1, SW-2 and SW-3 in Plate 7-2) have been sampled since 1979. Table 7-3 contains a list of the water quality parameters analyzed along with the results of the chemical analyses of surface water samples collected at these three sites. As illustrated in Plate 7-2, SW-1 is located approximately one mile above the mine, SW-2 is located immediately below all mine surface facilities, and SW-3 is located approximately 2 miles below the mine near the confluence of Cottonwood Canyon Creek and Straight Canyon. Additional water quality data have been collected by the USGS at a gaging station on the Cottonwood Canyon Creek located in the SE1/4NE1/4, Section 36, T17S, R6E. This data is compiled and reported in Table 7-4. This station was discontinued in 1981; however, an additional monitoring station, SW-3, was added by the applicant to monitor Cottonwood Creek below the permit area. Results from all the monitoring stations are summarized in the Annual Report (pre-2015).

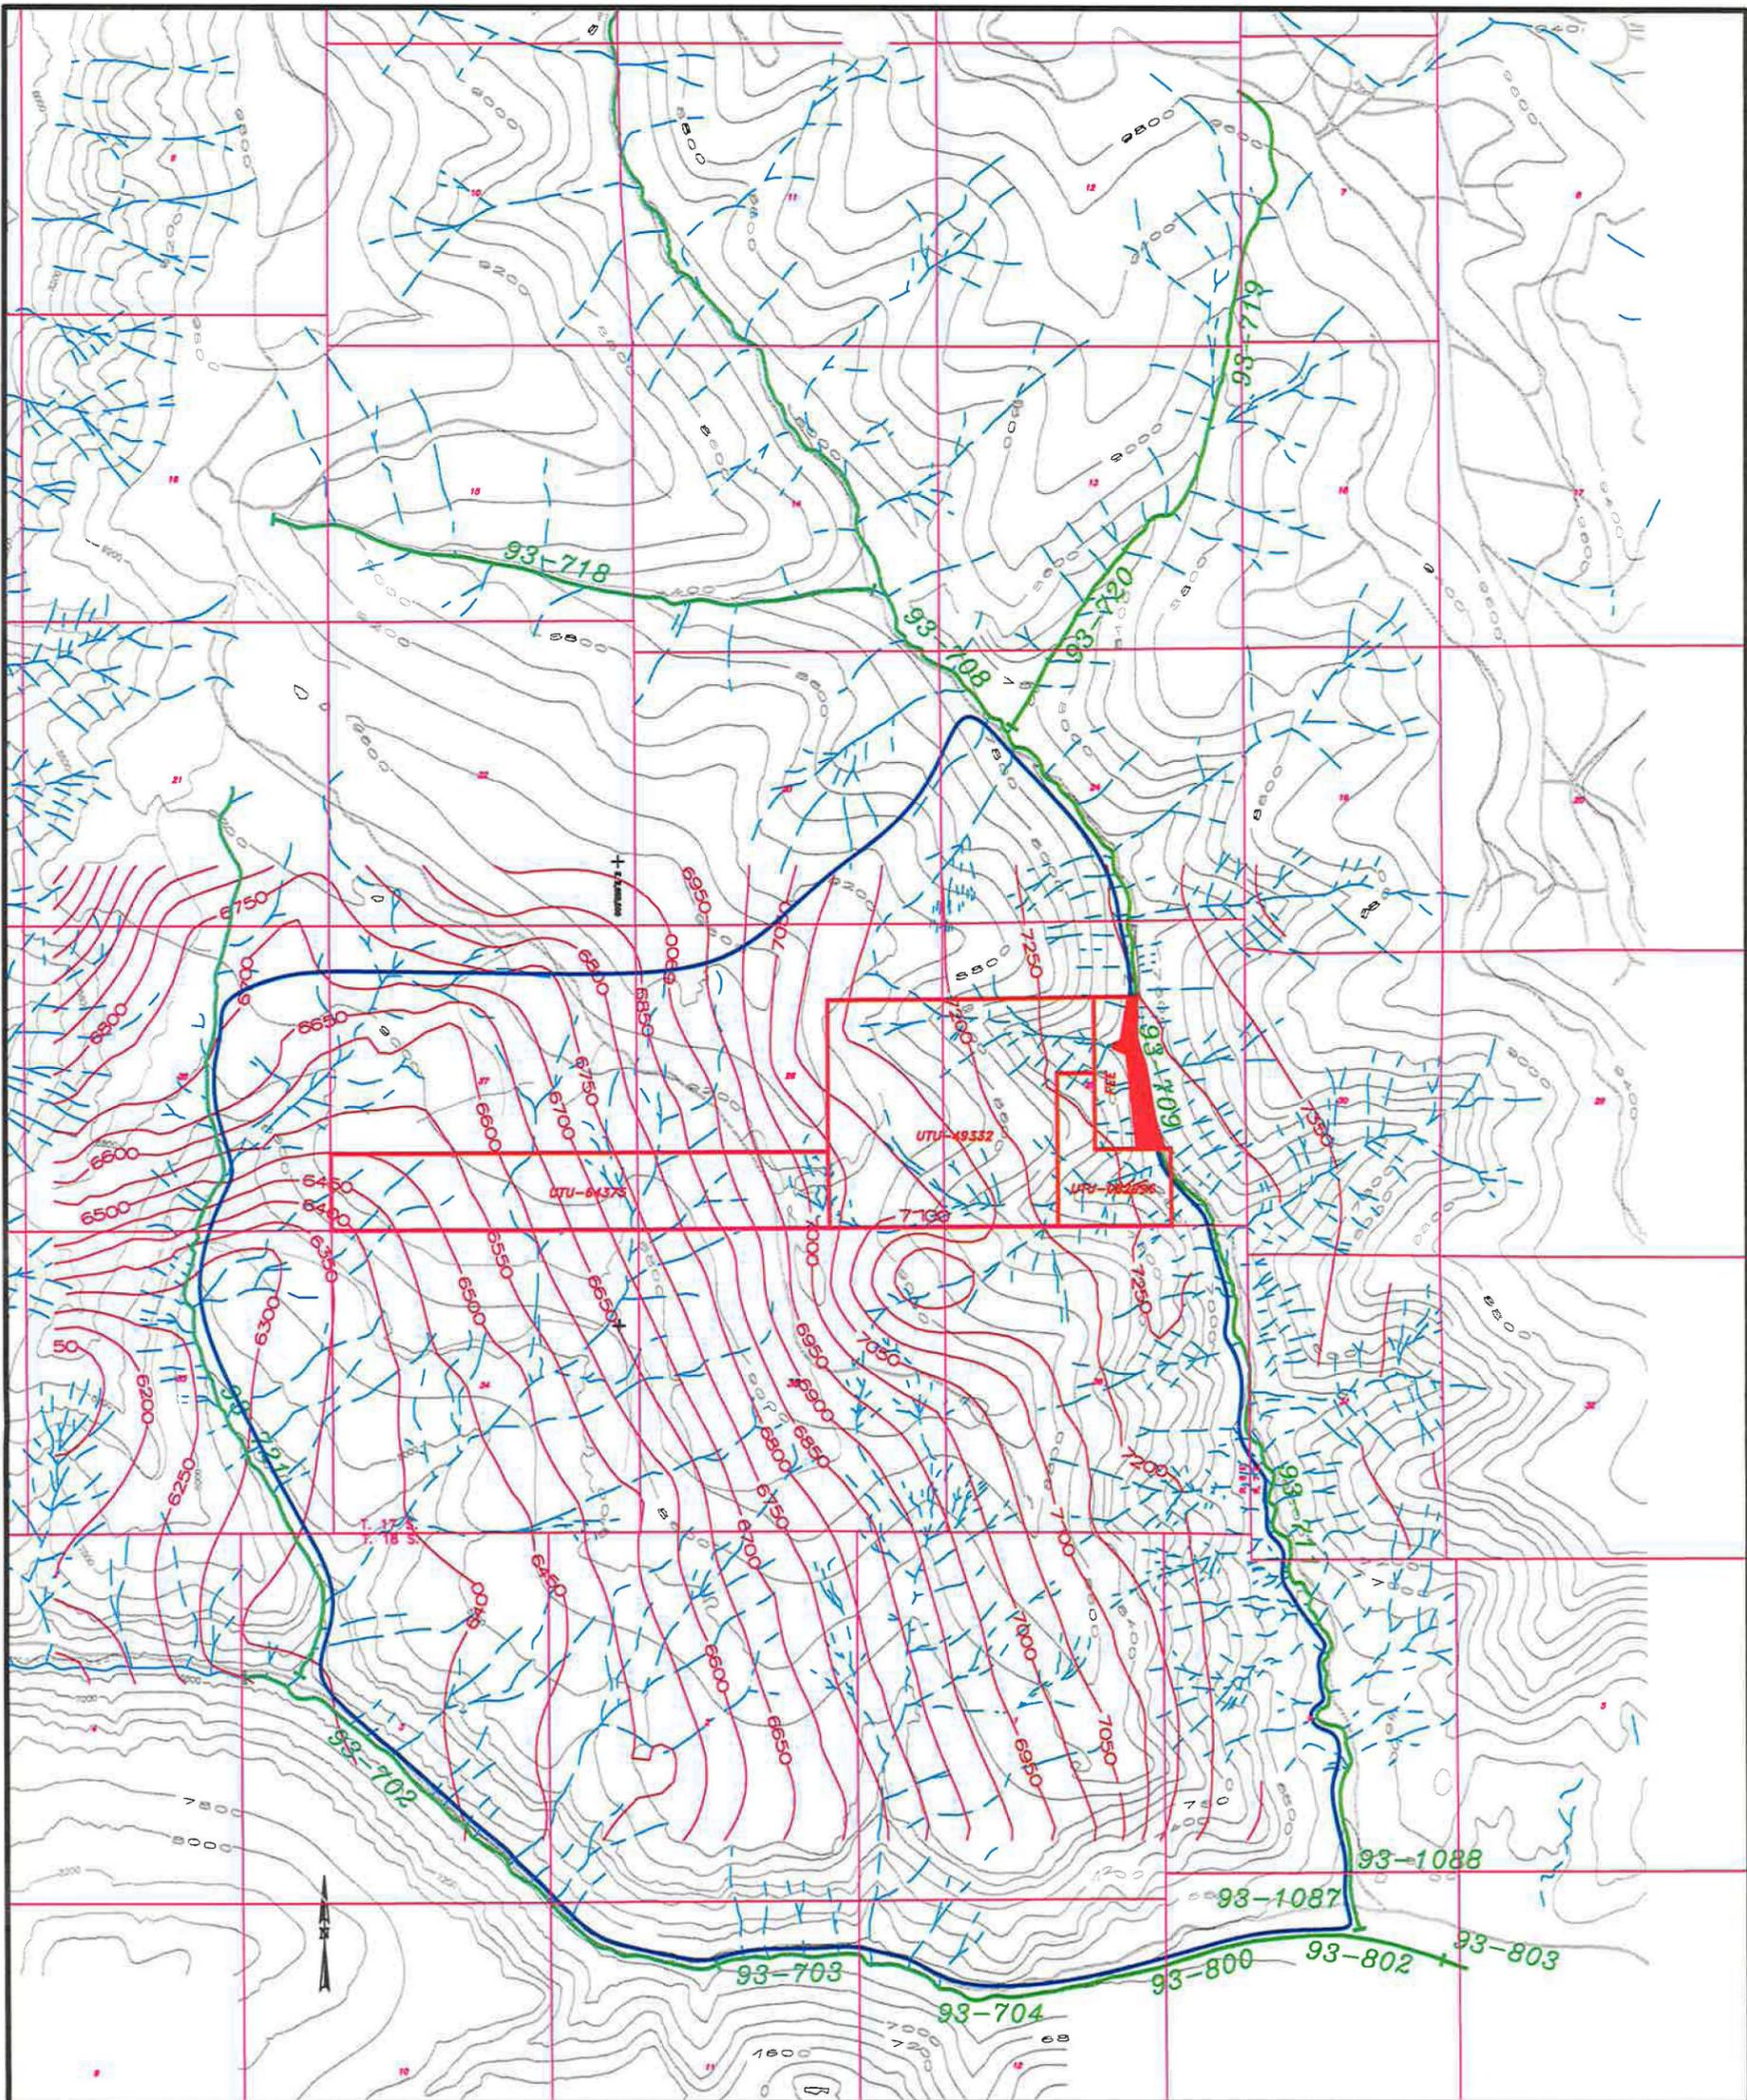
- LEGEND**
- 93-1088 WATER USE CLAIM NUMBER
 - STREAM SEGMENT
 - POTENTIAL HYDROLOGIC IMPACT AREA
 - PERMIT AREA
 - LEASE BOUNDARY

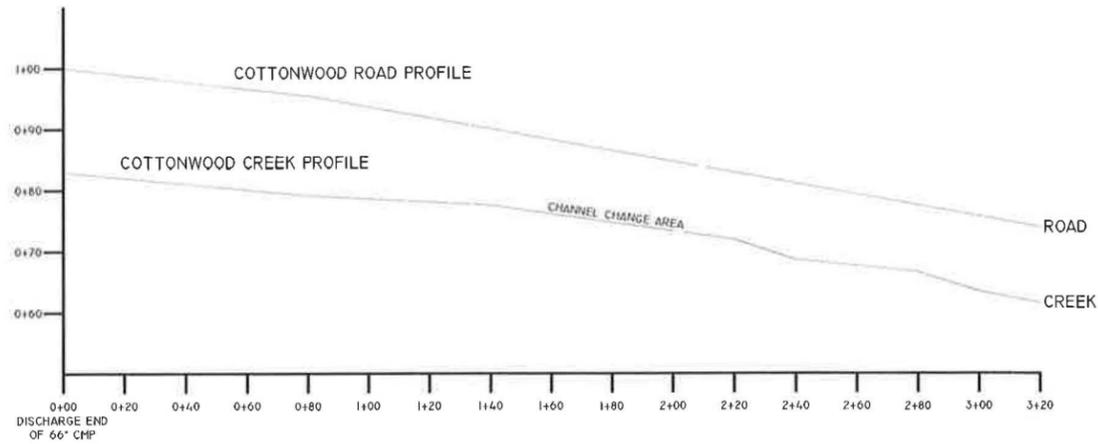
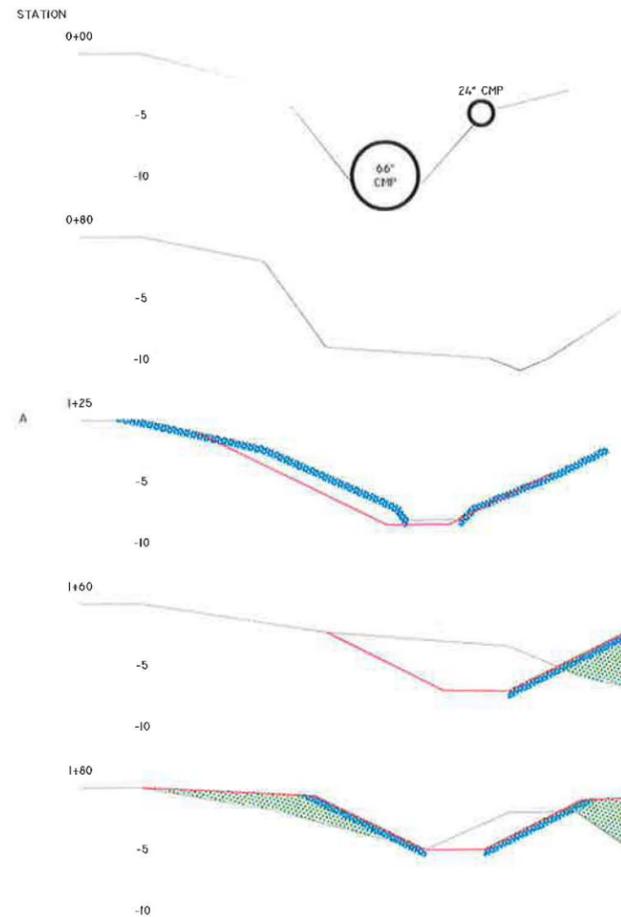
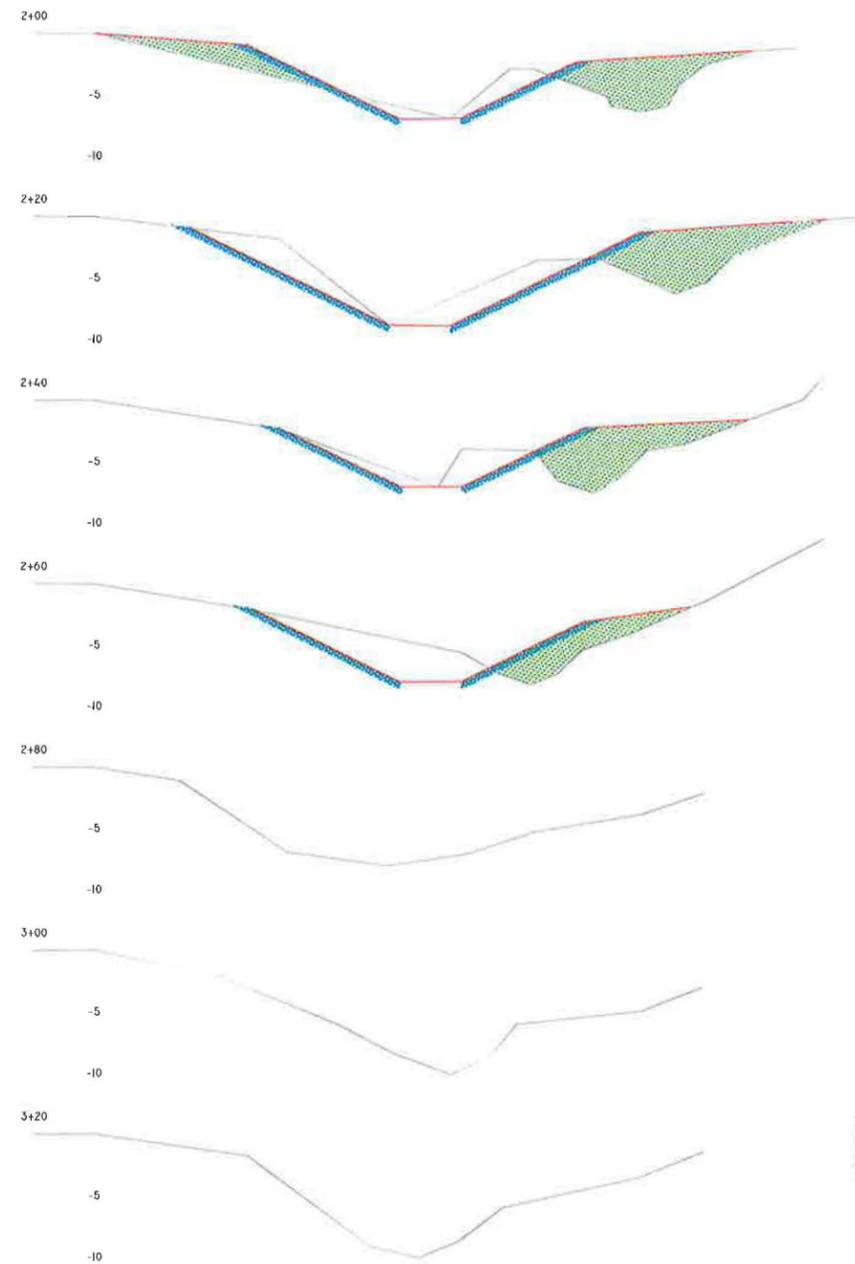
SHEET NO.
Plate 7-10

NOTES
 SIDE SLOPES - 2:1
 BOTTOM WIDTH - MINIMUM OF 5.0'
 SLOPE - NATURAL .07'
 CHANNEL DEPTH - MINIMUM OF 4.0'
 DISCHARGE - MINIMUM OF 535 CFS

RIPRAP
 6" OF 2" ROAD BASE ON SLOPES (D₅₀) -1.4 FEET.
 (MEDIUM DIAMETER) FOR METHODOLOGY SEE APPENDIX
 7-25 AND 7-27 (4-5) OF THE TRAIL MOUNTAIN TRACT I
 MPR.

THE BANKS WILL BE CONTOURED TO APPROXIMATELY 2:1
 SLOPE AND WILL BE COMPACTED WITH A BACKHOE PRIOR
 TO PLACING RIPRAP. RIPRAP WILL BE DISTRIBUTED ALONG
 THE CHANNEL BANKS. RIPRAP WILL BE PLACED 4.5 FEET
 HIGH ALONG THE BANKS.

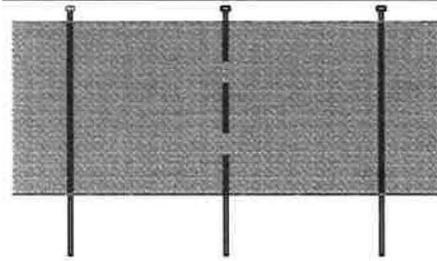
SILT FENCE
 (SEDIMENT CONTROL/RUNOFF CONTROL
 WIDTH AND HEIGHT VARIES)
 BOTTOM KEYED IN TO PREVENT BYPASS
 SIDES KEYED IN WHEN NECESSARY

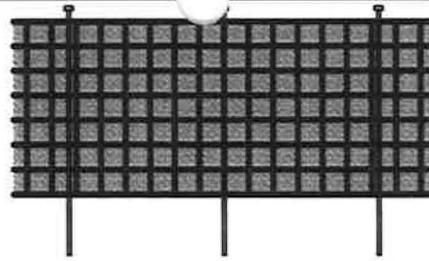
SILT FENCE & MESH
 (SEDIMENT CONTROL/RUNOFF CONTROL
 WIDTH AND HEIGHT VARIES)
 BOTTOM KEYED IN TO PREVENT BYPASS
 SIDES KEYED IN WHEN NECESSARY

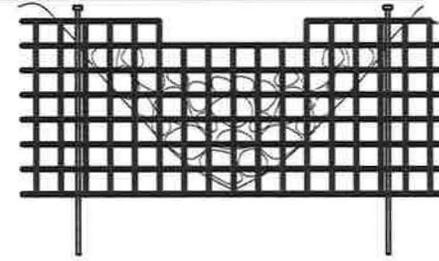
ROCK GABION
 (SEDIMENT CONTROL/ENERGY DISSIPATER
 WIDTH AND HEIGHT VARIES)

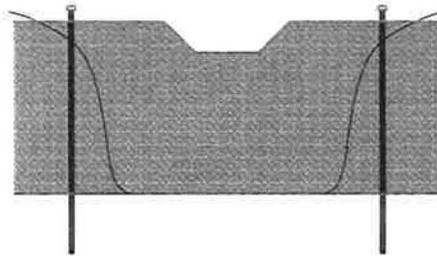
**SILT FENCE OR OTHER FLOW
 CONTROLLING DEVICE WITH NOTCH**
 (SEDIMENT CONTROL/RUNOFF CONTROL
 WIDTH AND HEIGHT VARIES)
 SIDES AND BOTTOM KEYED IN
 TO PREVENT BYPASS

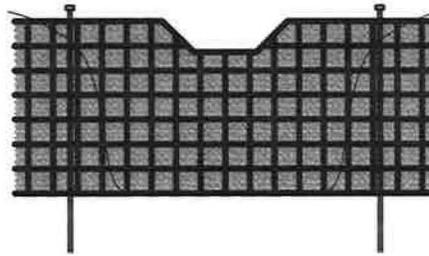
SILT FENCE & MESH WITH NOTCH
 (SEDIMENT CONTROL/RUNOFF CONTROL
 WIDTH AND HEIGHT VARIES)
 SIDES AND BOTTOM KEYED IN
 TO PREVENT BYPASS

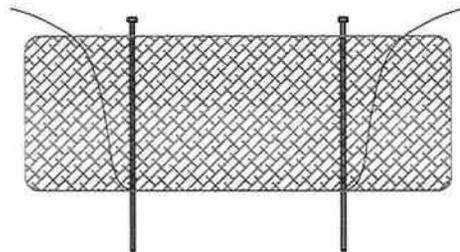
STRAW BALE INSTALLATION
 (SEDIMENT CONTROL/RUNOFF CONTROL
 WIDTH AND HEIGHT VARIES)
 SIDES AND BOTTOM KEYED IN
 TO PREVENT BYPASS
