Inspection Report

Permit Number:	C0150009
Inspection Type:	PARTIAL
Inspection Date:	Friday, February 24, 2017
Start Date/Time:	2/24/2017 12:00:00 PM
End Date/Time:	2/24/2017 12:30:00 PM
Last Inspection:

Permittee: **FOSSIL ROCK RESOURCES, LLC**
 Operator: **FOSSIL ROCK RESOURCES, LLC**
 Site: **FOSSIL ROCK MINE**
 Address: **225 North 5th Street, 9th Floor, CO 81501**
 County: **EMERY**
 Permit Type: **PERMANENT COAL PROGRAM**
 Permit Status: **ACTIVE**

ATTACHMENT A – Photos February 24, 2017 site visit

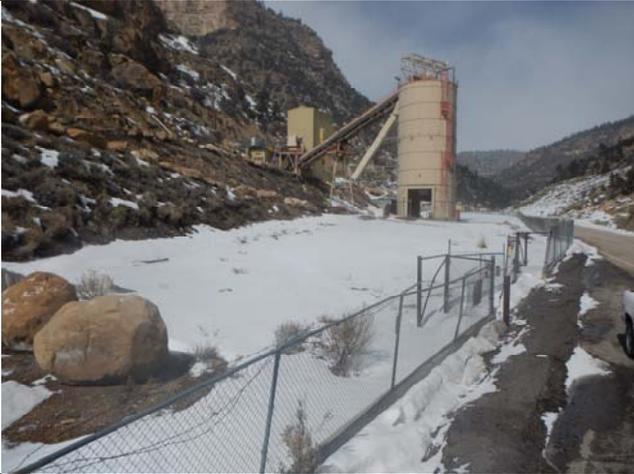
PHOTO 1

The berm on the east side of the mine will contain the snow melt runoff and direct it to the sediment pond once it warms up.

Berm on eastern edge of mine properly functioning.
February 24, 2017

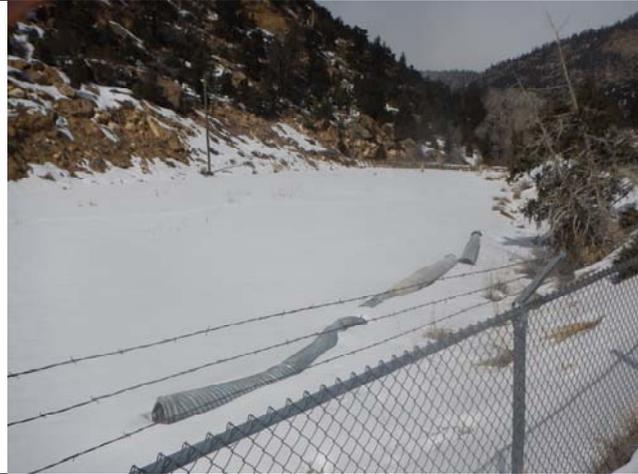
PHOTO 2

Berm on eastern edge of mine properly functioning.
February 24, 2017

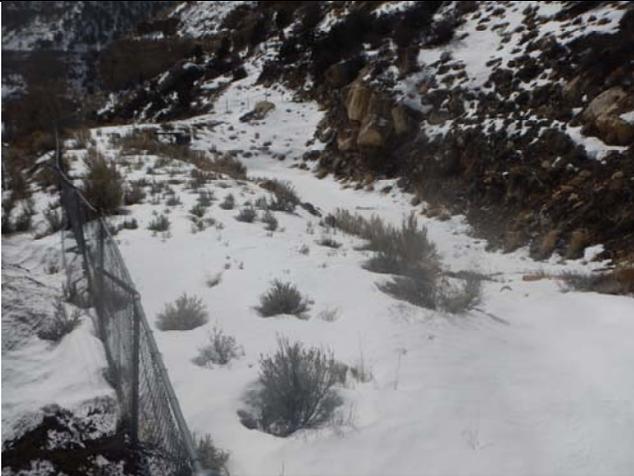
PHOTO 3

The sediment pond was properly functioning. It contained a couple feet of snow fall.

The sediment pond held a foot of snow in the bottom.
February 24, 2017

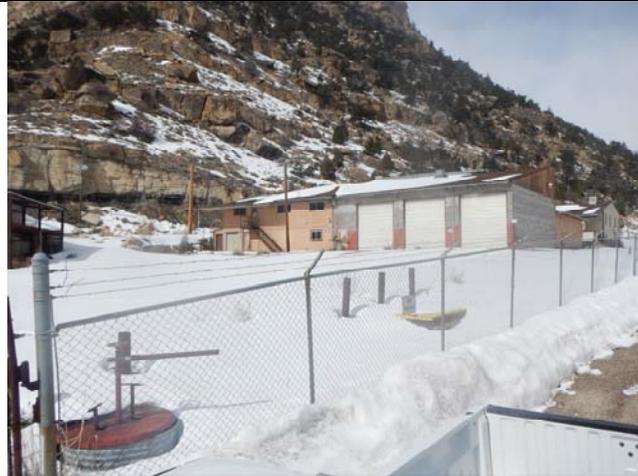
PHOTO 4

I conducted a partial inspection at the main mine site of the Fossil Rock mine. The gate was locked but I was able to see the site from the county road. The main mine is idle and has no activity occurring at the site.

No activity has occurred in a while.
February 24, 2017
