Re: Emery Mine
Electromagnetic Gradiometer Detection of Coal Mine Voids
Stolar/MSHA/Consol research project

STOLAR/MSHA
ELECTROMAGNETIC GRADIOMETER
DETECTION OF COAL MINE VOIDS

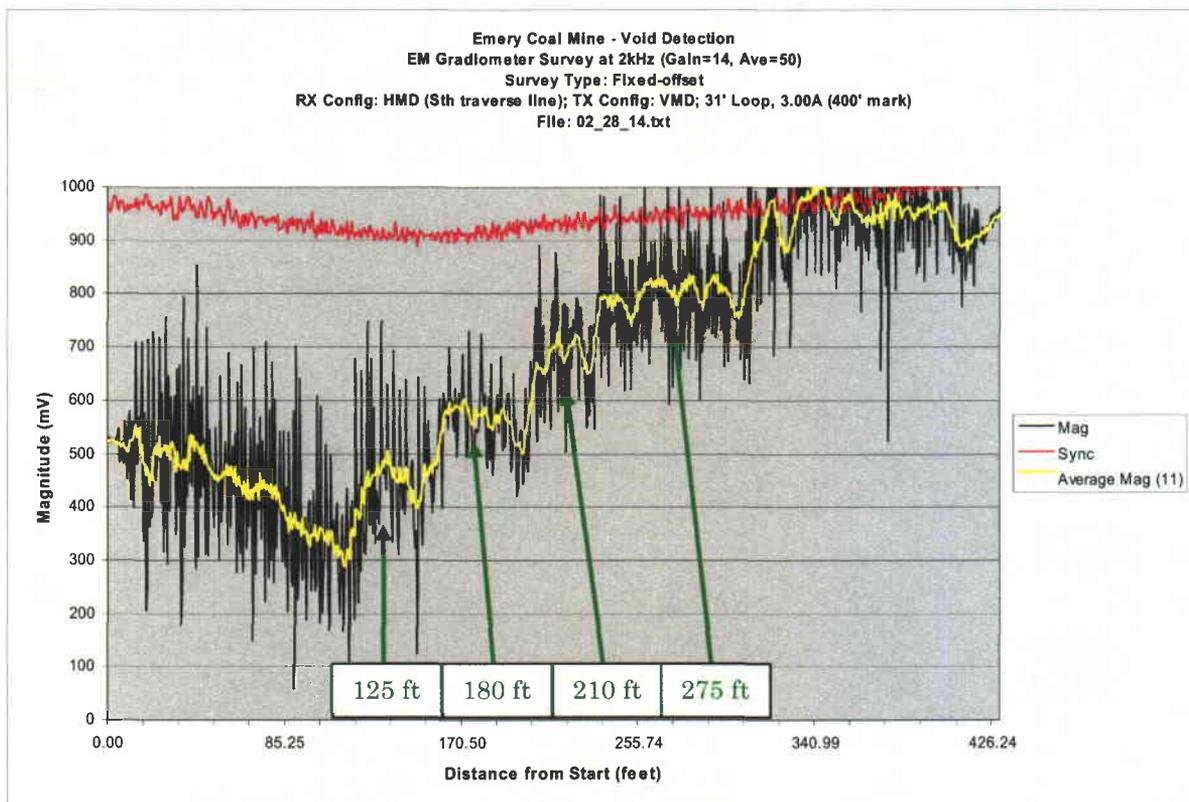
Figure 2. Gradiometer response plot 1

The traverse response plots are shown in Figures 2 and 3. Both plots were along the same survey line and both operated at the 2-kHz frequency. However, two different transmit antennas were utilized. The first plot was with the 31-foot diameter loop antenna operating at 3.0 amps of loop current and located 400 feet away. The second plot was with the 30-inch diameter loop antenna operating at 2.5 amps of loop current and located 300 feet away.

The plots display signal magnitude (Mag), and the receiver synchronization automatic gain control (Sync AGC). The sync AGC signal is from the primary wave of the local source transmitter. The sync AGC signal is inversely proportional to signal strength and should be fairly constant. The Average Mag (11) signal has been added for smoothing.

The resulting plots show the locations at which the gradiometer response peaked and nulled. The detection can be characterized by peaking in the profile. The peaks indicate the approximate location of the underground anomaly surface projection on the traverse line. The Mag signal peaking has been identified and labeled in the green text boxes as distance from the start. The starting point for both plots is the SW Marker shown in Figure 4.

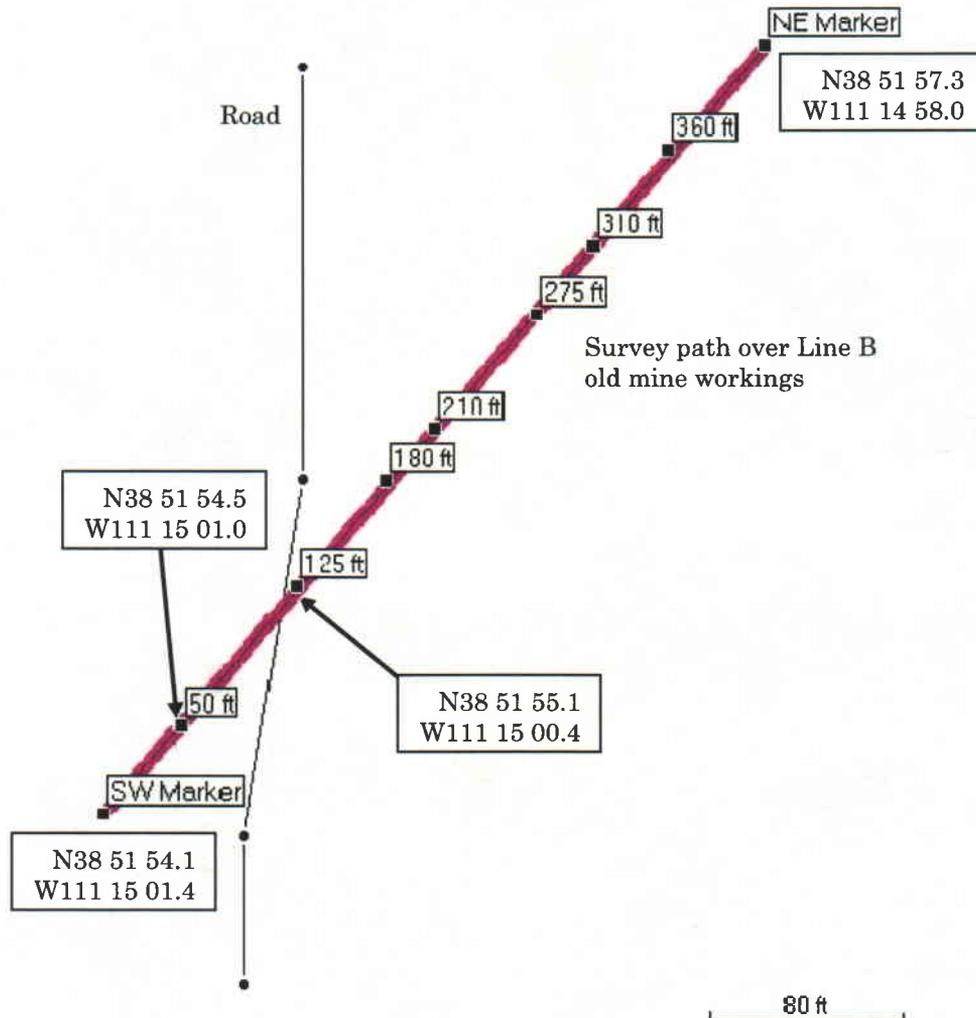
Figure 4. GPS scaled plan view with identified void locations (distance away from SW Marker)

Figure 4 is the scaled GPS plan view of the gradiometer survey path over Line B of the old mine workings test site area. GPS spatial data points were taken by the DeltaEM gradiometer in degrees-minutes-seconds as geodetic latitude and longitude in the WGS 1984 datum. All of the identified voids from the plots of Figures 2 and 3 have been placed on the survey path. **The 50-foot and 125-foot locations have been initially selected as locations for confirmation drilling.**

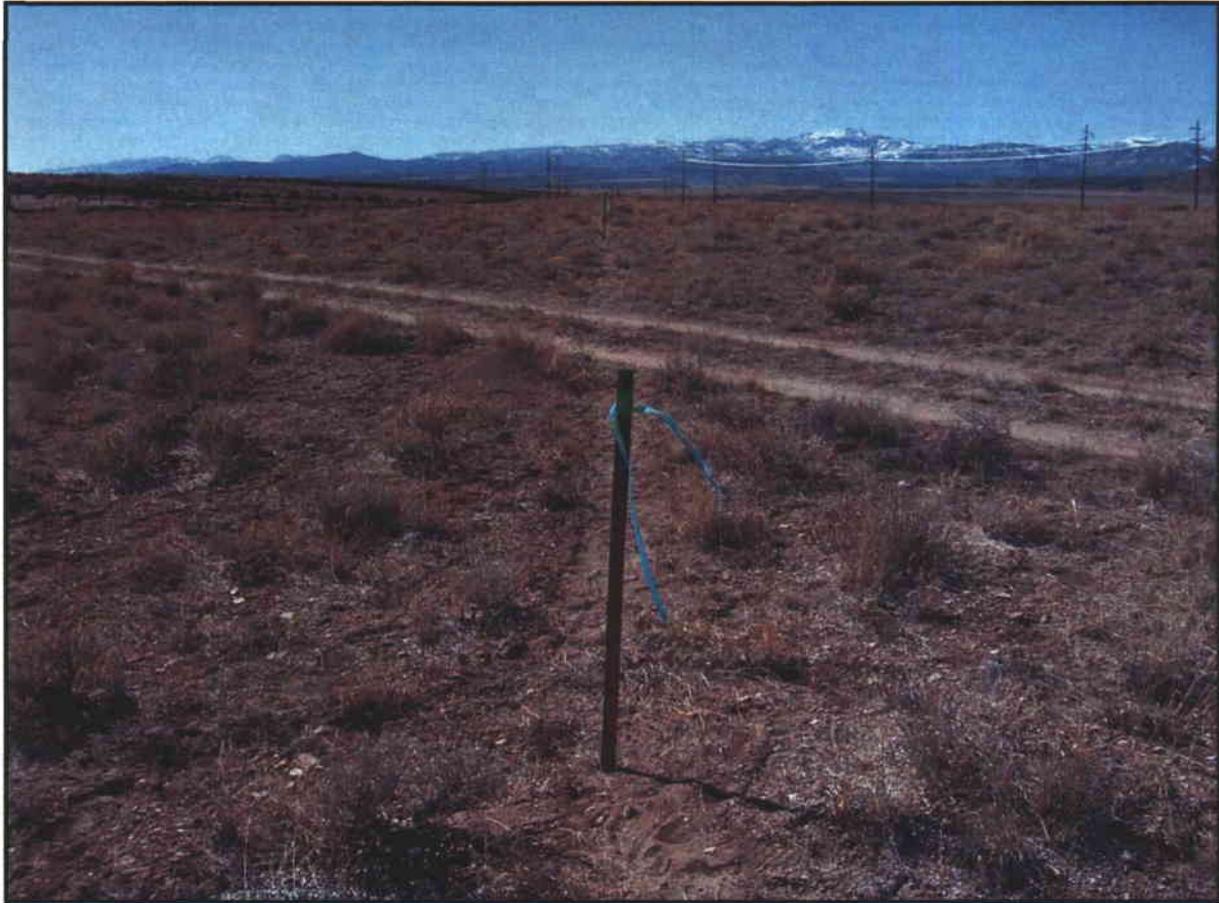
Figure 5. Test site surface location over the Emery Coal mine

Figure 5 shows the test site surface location and the survey path line.

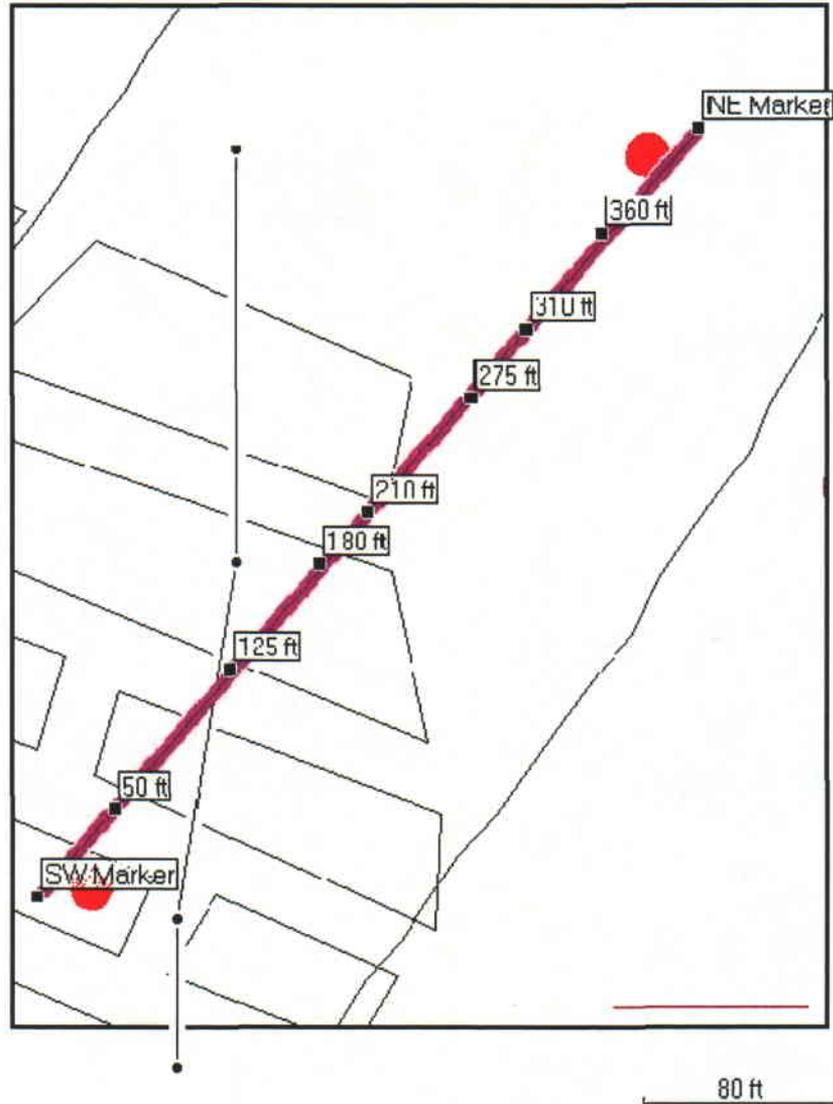
Figure 6. Overlay of survey path with void locations on mine workings

The survey path line with identified void locations of Figure 4 has been roughly overlaid on the coal mine workings and is shown in Figure 6.
