# Inspection Report

| Permit Number: | C0150015 |
| Inspection Date: | Wednesday, April 11, 2007 |

Permitee: **CONSOLIDATION COAL CO**  
 Operator: **CONSOLIDATION COAL CO SESSER OPERATIONS**  
 Site: **EMERY DEEP MINE**  
 Address: **PO BOX 566, SESSER IL 62884**  
 County: **EMERY**  
 Permit Type: **PERMANENT COAL PROGRAM**  
 Permit Status: **ACTIVE**

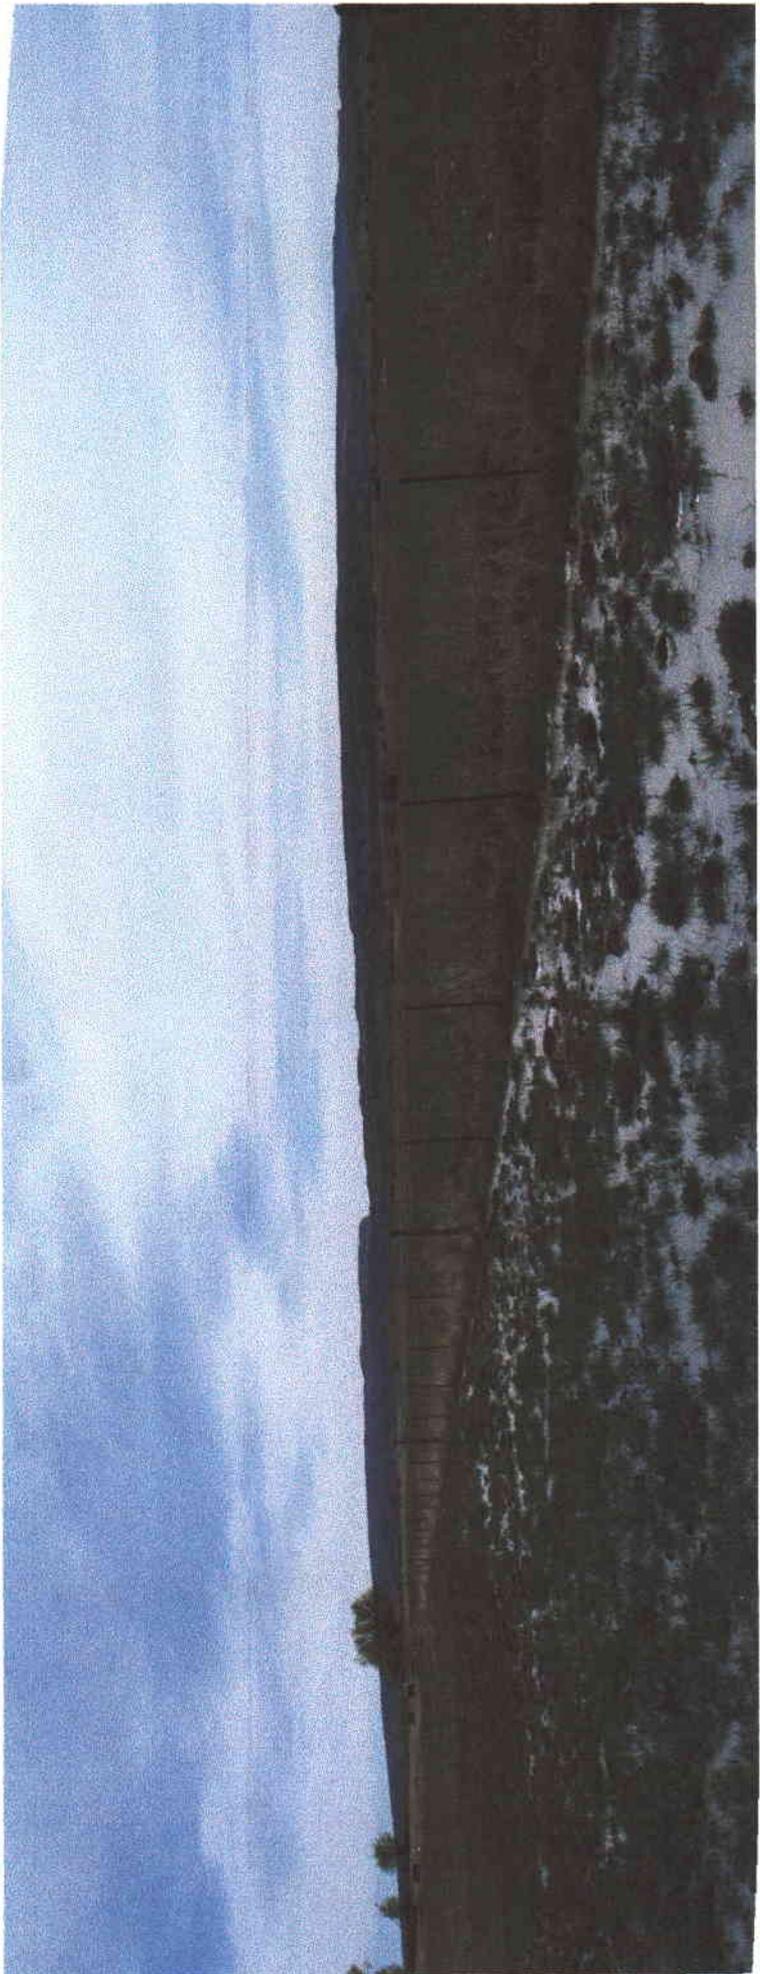
The panels are located in T 22 S, R 6 E in Section 29. The surface in the north half of the north half of Section 29 is among the most productive irrigated pasture land within the permit area. It is identified as prime farmland by the NRCS (Utah Agricultural Experiment Station Research Report No. 76). The vegetation and land use map Plate VIII-1 erroneously shows irrigated pasture land only within the 15th west panel, but the irrigated pasture land extends all along the plateau north of the county road. The Division did not field check this map, but irrigation ditches and irrigated pasture above the 14th and 15th west were photographed and are attached to this report as 04112007A.jpg. The location and direction of the image is noted on a second attachment, 0411207A2.pdf.

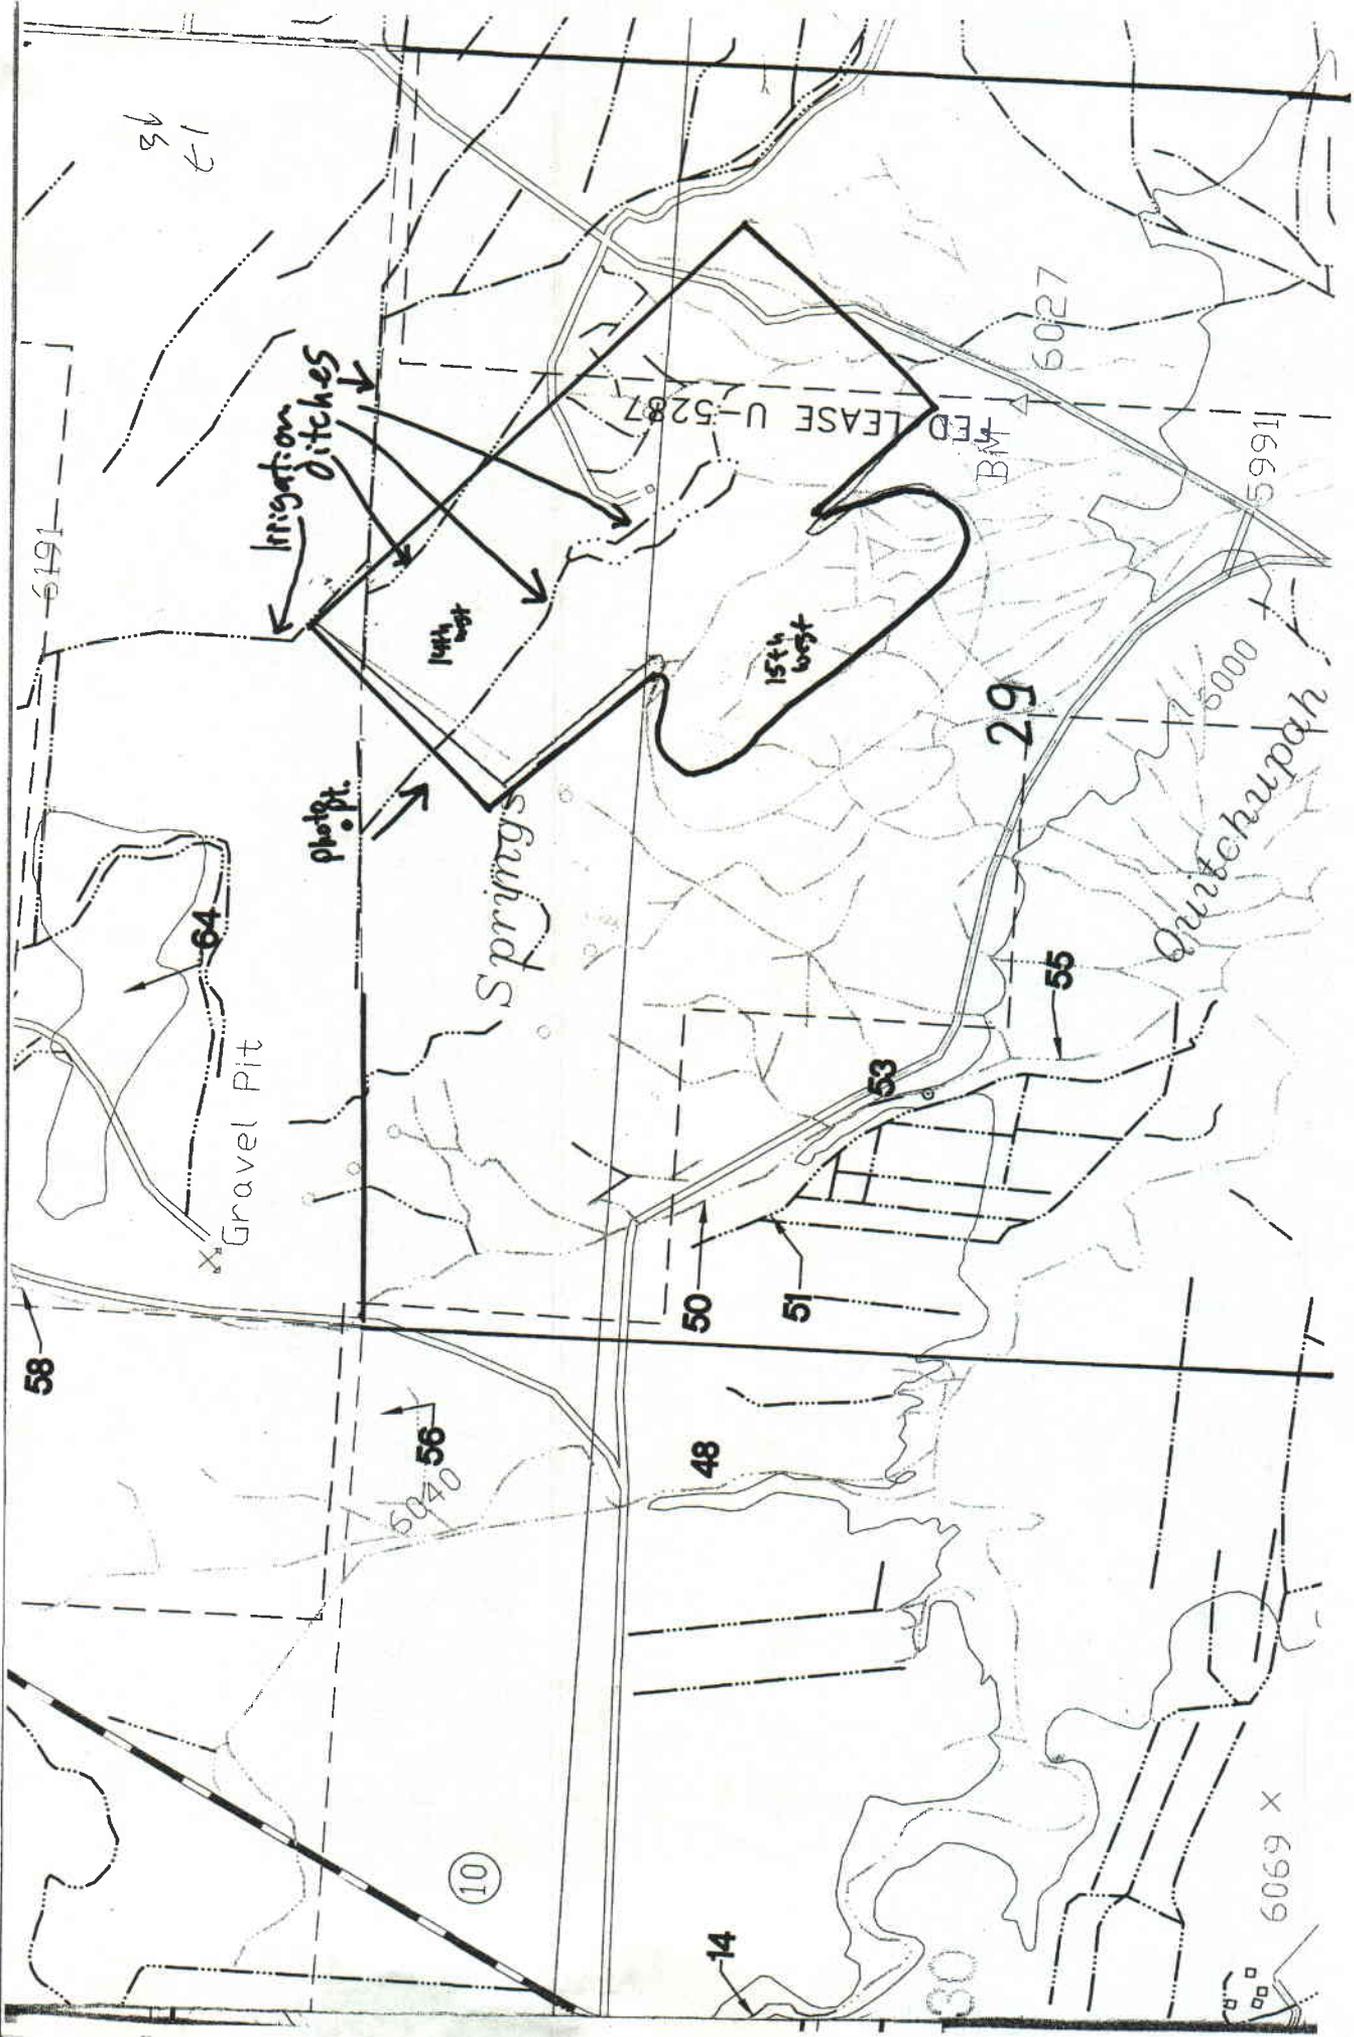
Irrigation ditches shown on the surface in the October 2006 Plate V-3 Pre-Subsidence Survey Hydrology map extend into the 15 west panel. The approximate boundaries of the 14th and 15th West panels as shown on the April 3, 2007 copy of Plate V-5 were outlined onto Plate V-3 and are included with this report as file 04112007A2.pdf. It appears from this information that the subsidence shown for panels 14 and 15 West on the April 3, 2007 version of Plate V-5 Subsidence Monitoring Points and Buffer Zones will intercept the irrigation ditches. The Permittee was reminded of the permit requirements in Chapter V.B.1 Items 1a, 2a, 11, 12, and 13 requiring evaluation of the irrigation ditch gradients and monitoring of the ditches prior to and after full extraction and to provide this survey to the water conservancy district, landowner, and the Division. Consol is currently negotiating the details of subsidence mitigation with Osbrun Bret Carter and Russell H. Odle and Morgan Robertson, landowners of the surface above the 14th and 15th west panels and the 8th North Main Entry.
