# Inspection Report

Permit Number:	C0150015
Inspection Type:	COMPLETE
Inspection Date:	Wednesday, February 15, 2017
Start Date/Time:	2/15/2017 9:00:00 AM
End Date/Time:	2/15/2017 12:00:00 PM
Last Inspection:	Wednesday, January 18, 2017

Permittee: **BRONCO UTAH OPERATIONS, LLC**  
 Operator: **BRONCO UTAH OPERATIONS, LLC**  
 Site: **EMERY DEEP MINE**  
 Address: **PO BOX 527, EMERY UT 84522**  
 County: **EMERY**  
 Permit Type: **PERMANENT COAL PROGRAM**  
 Permit Status: **ACTIVE**

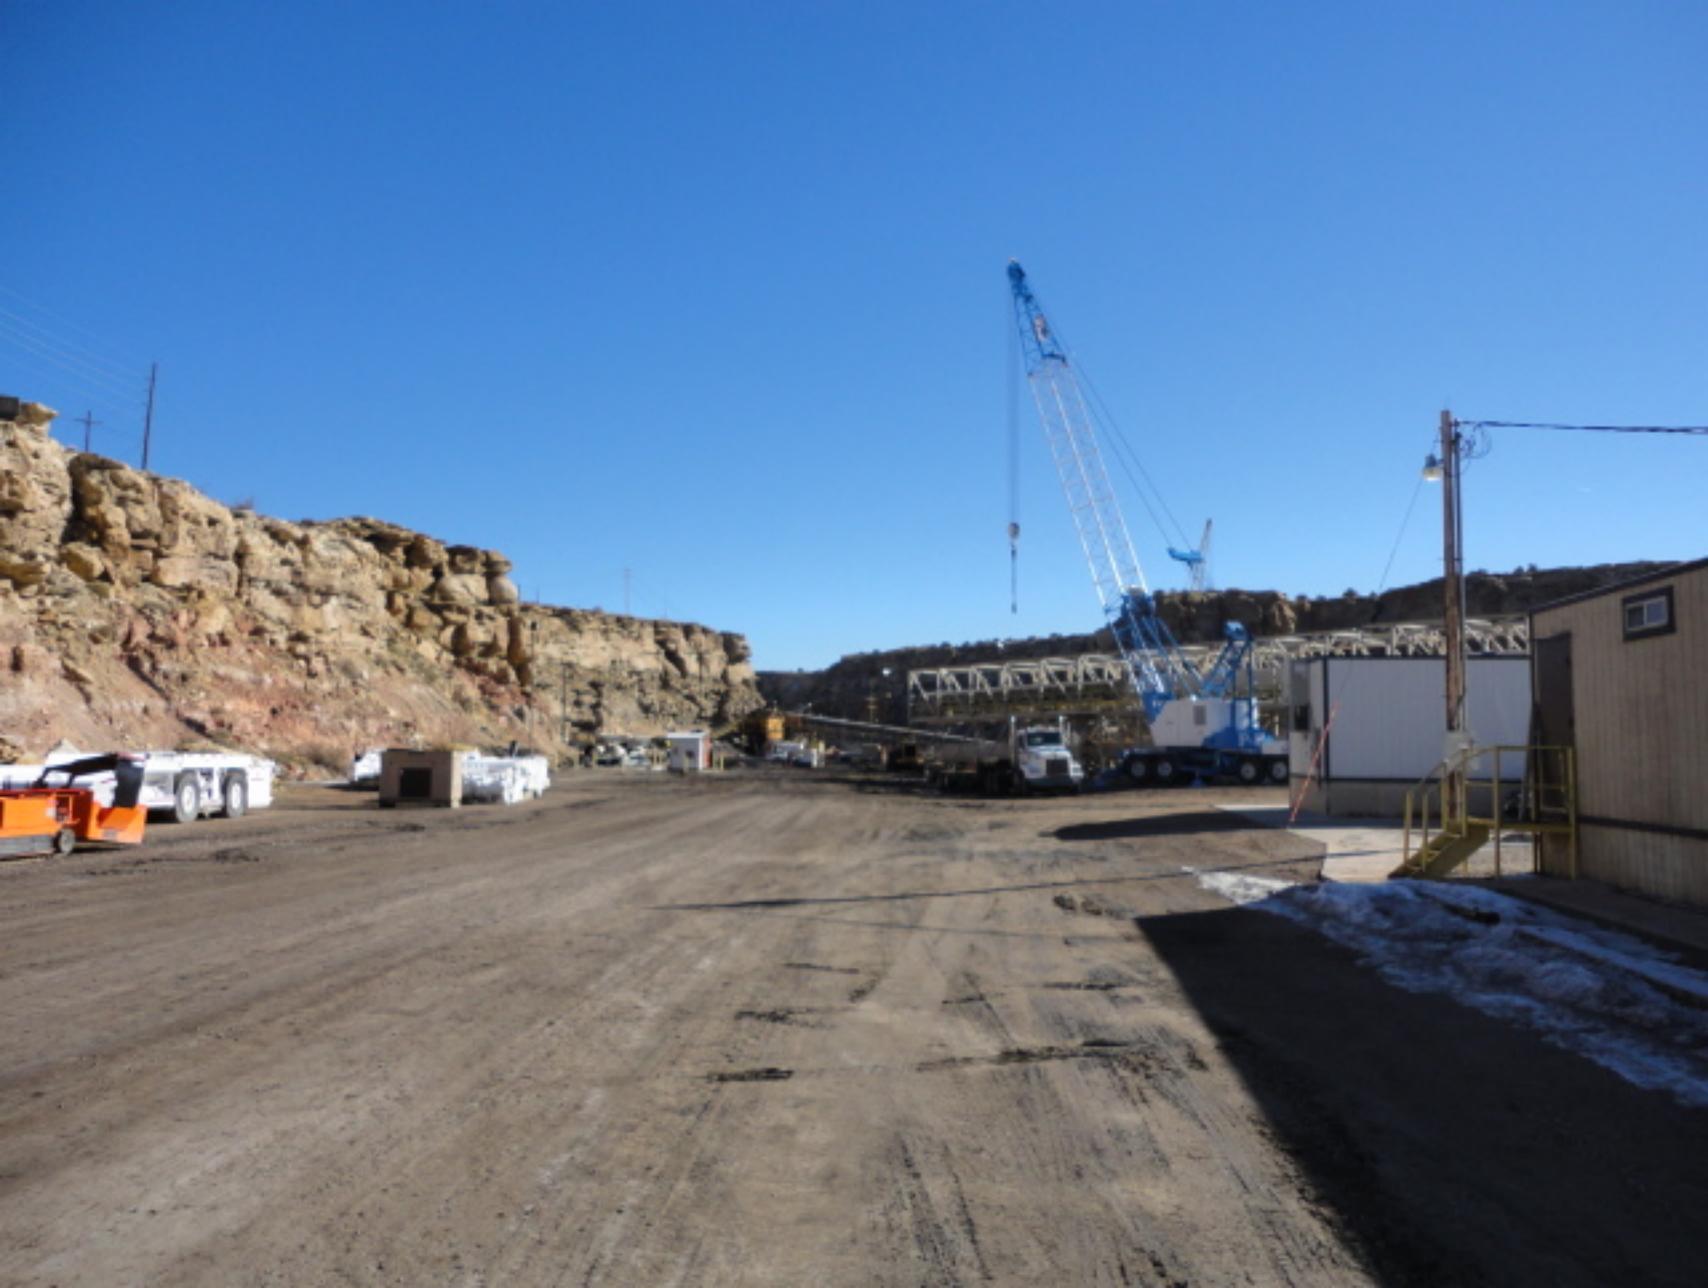
Some of diversions culverts were open and functioning as design. See Photo. There were of diversions still snow covered.

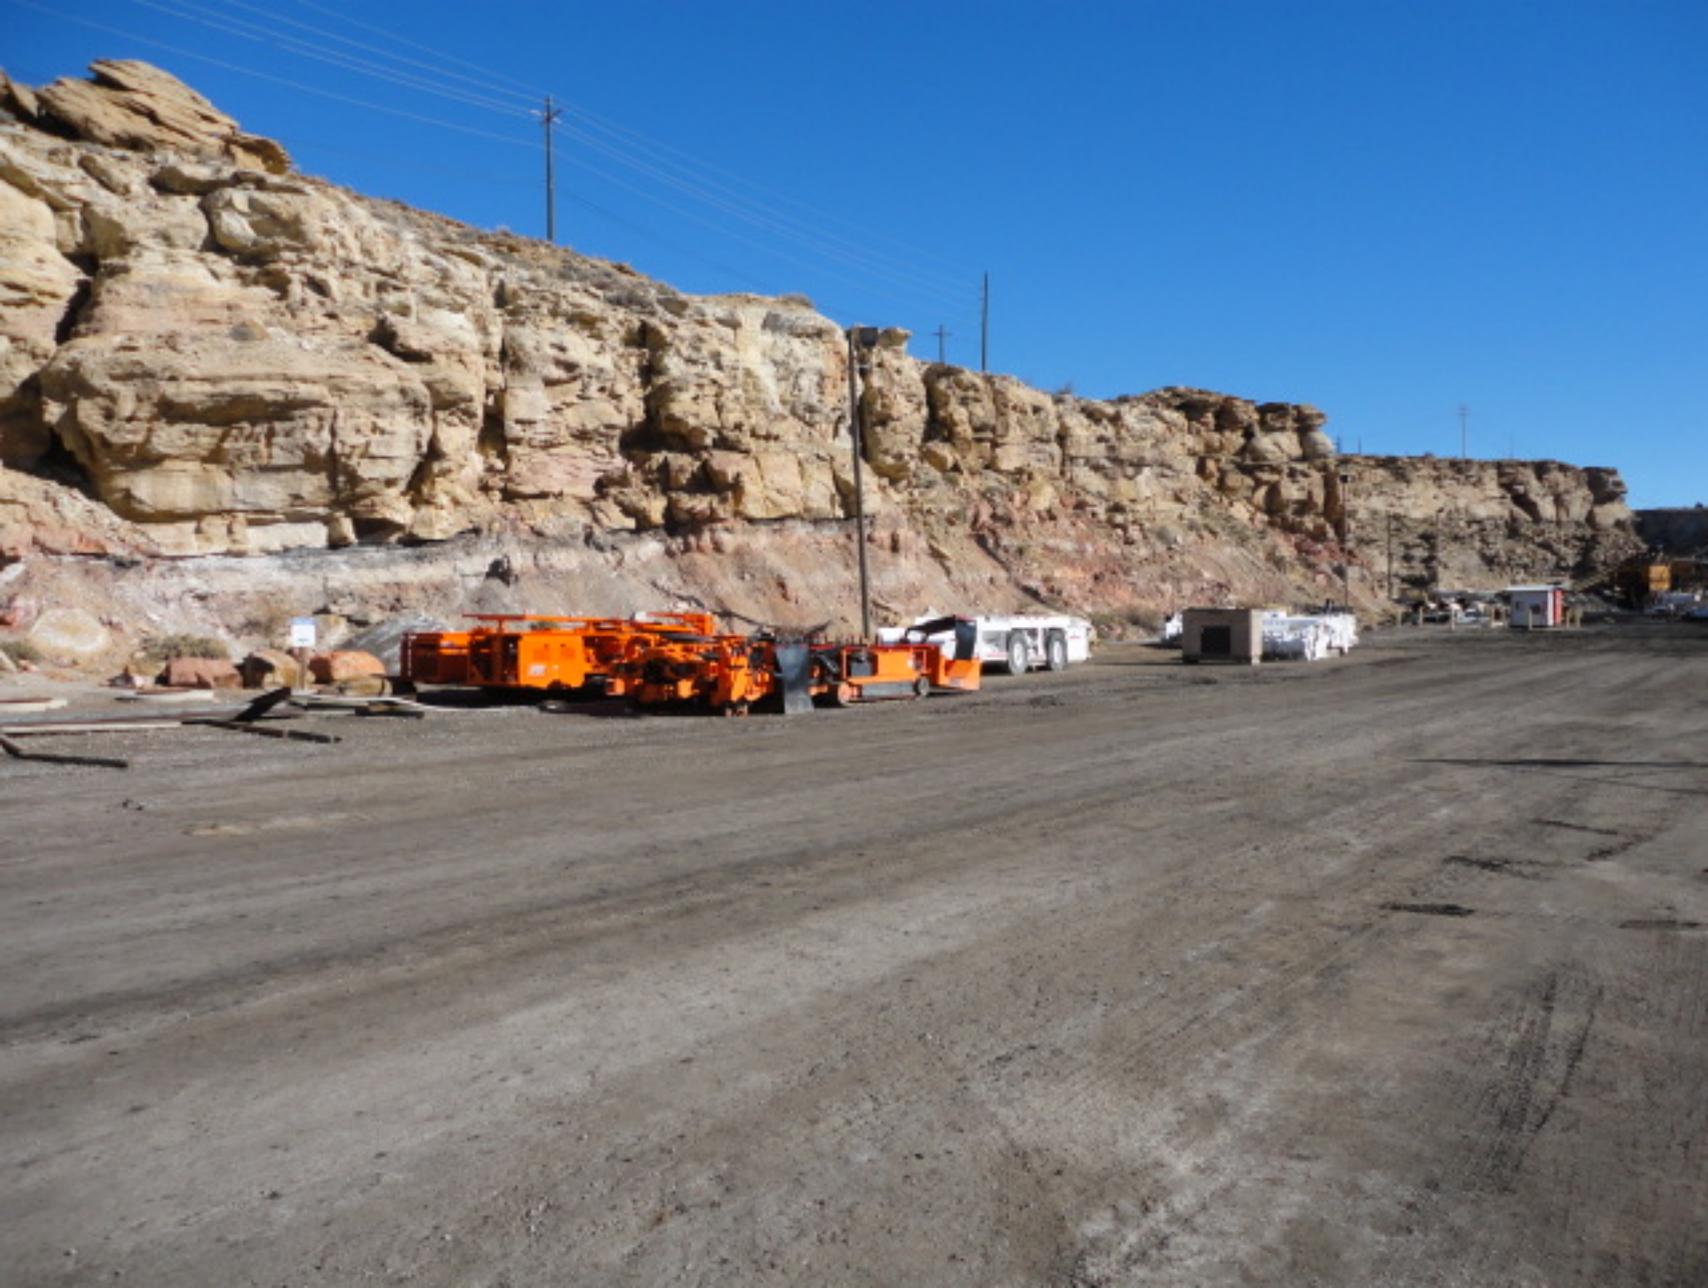
The permittee has started to build a road to the new area were fan and water tank is located. A track hoe was located of the side hill. The area has no topsoil. This area was a cut slope and disturb in the past. See Photo

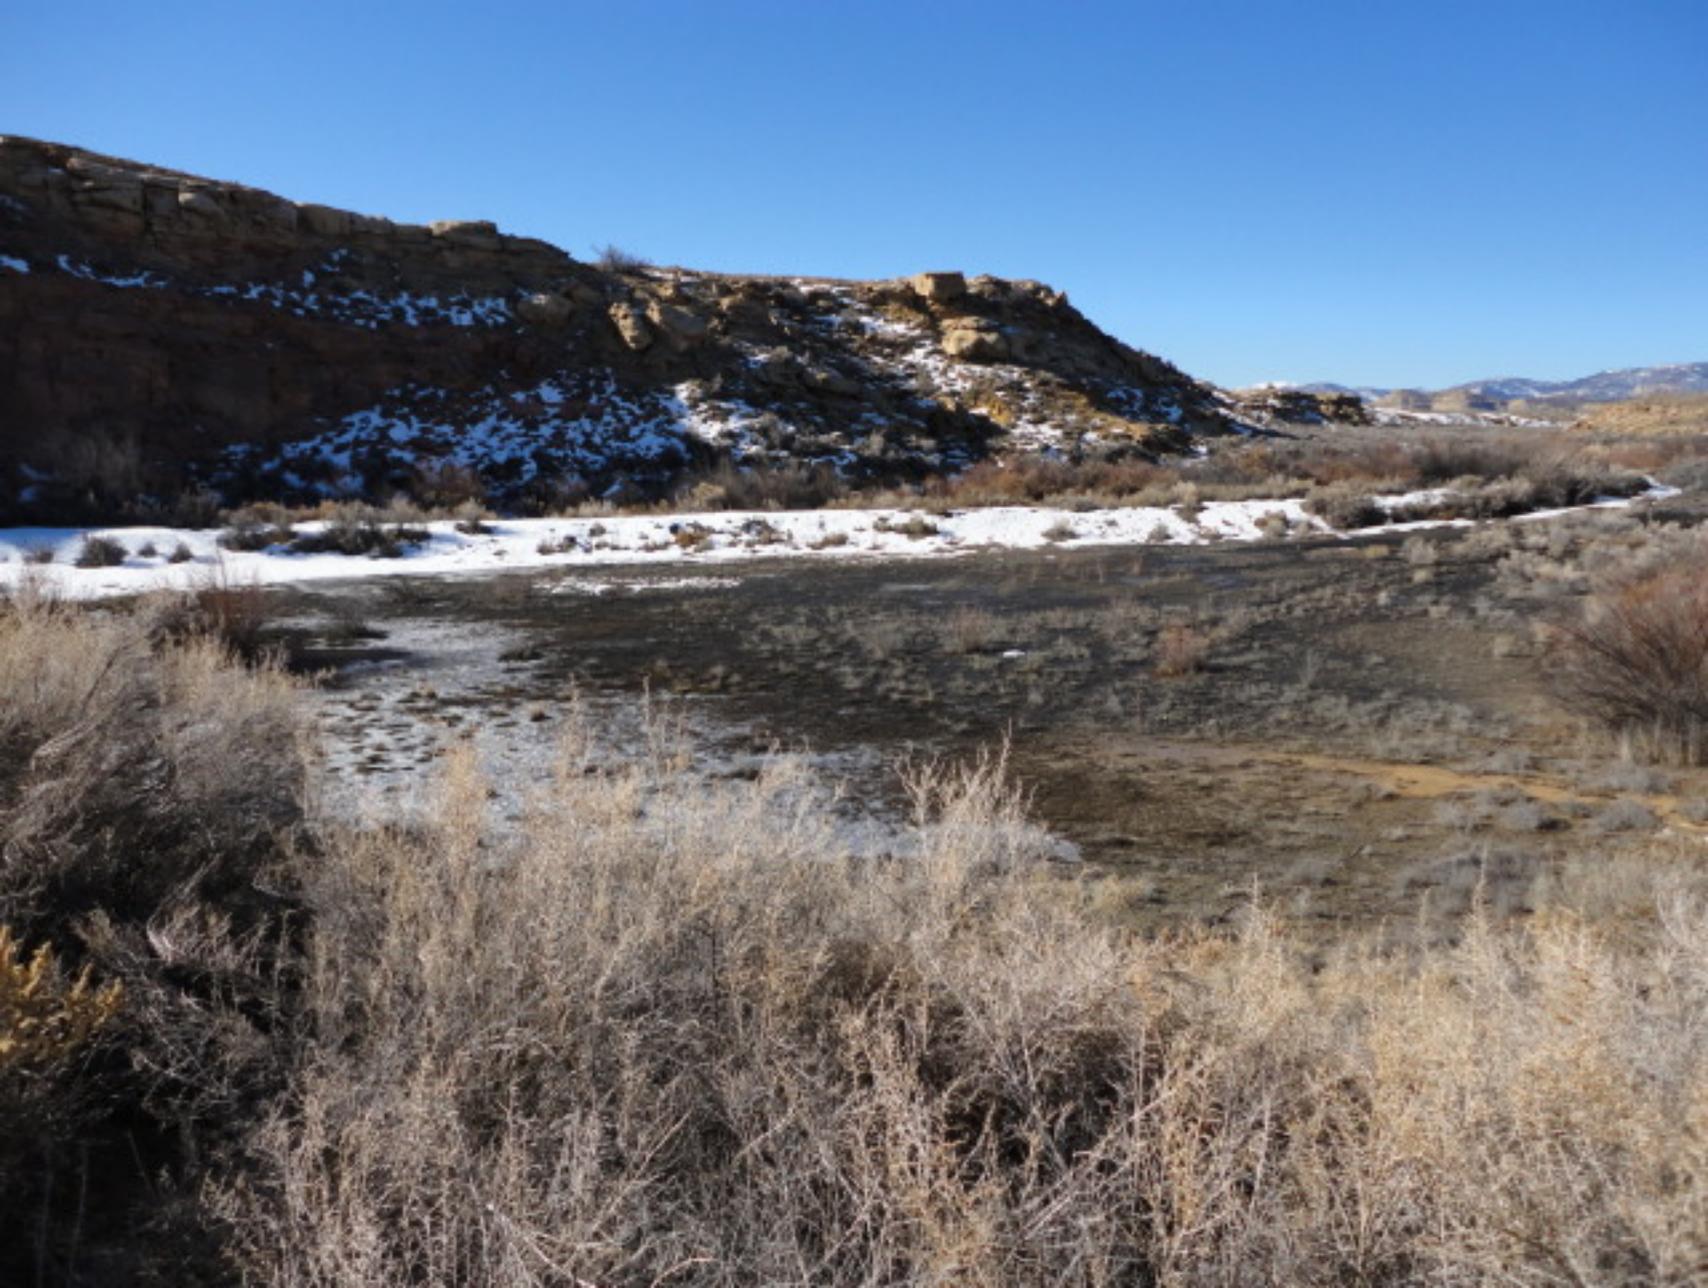
Some of the diversions and culverts were open and functioning as designed. See Photo
