## Inspection Report

Permit Number:	<b>C0150015</b>
Inspection Type:	COMPLETE
Inspection Date:	Thursday, August 27, 2020
Start Date/Time:	8/27/2020 10:00:00 AM
End Date/Time:	8/27/2020 4:00:00 PM
Last Inspection:	Wednesday, July 29, 2020

Site: **EMERY DEEP MINE**

**ATTACHMENT A – Emery**

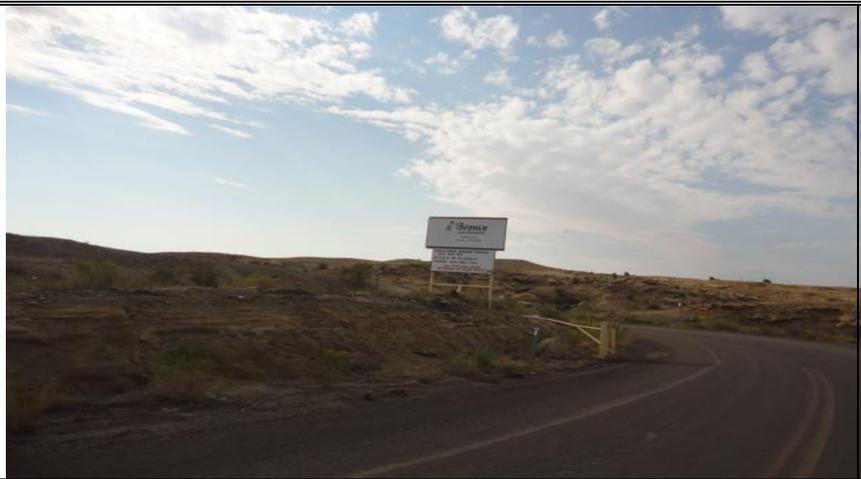
The identification sign was inspected and it meets the requirements of the R645 Coal Rules. See Photo

**PHOTO 1**  
Identification Sign

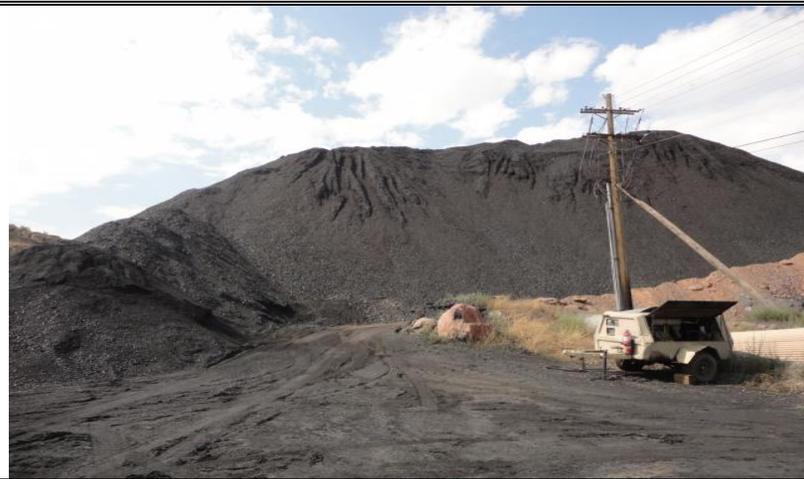
It was good news for Bronco by receiving a coal contract from the Rocky Mountain Power (Hunter Power Plant). The mine was operating and shipping coal. Coal piles are large. See photos

**PHOTO 2**  
Coal yard

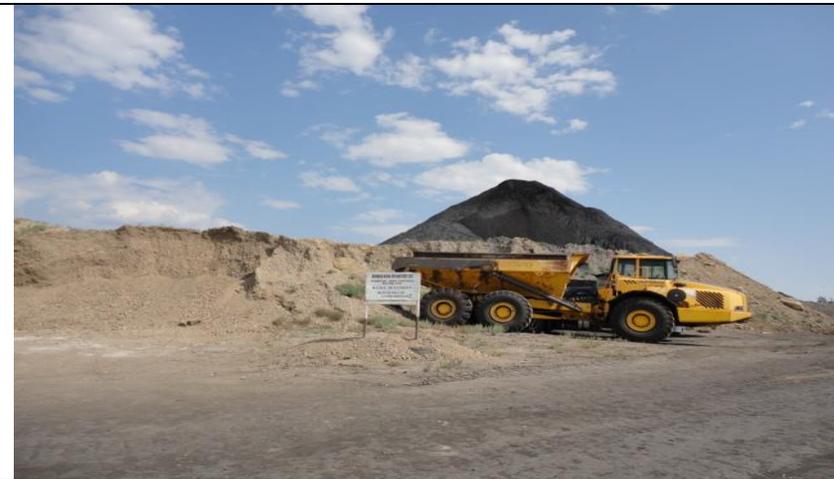
I inspected the refuse pile and it appears to be stable. I did not notice any hazardous conditions to the embankments. The refuse pile is inactive. The permittee conducted a second quarter refuse pile inspection May 26, 2020. This document is P.E. certified. No hazardous conditions were reported. See Photos

**PHOTO 3**  
Refuse Pile

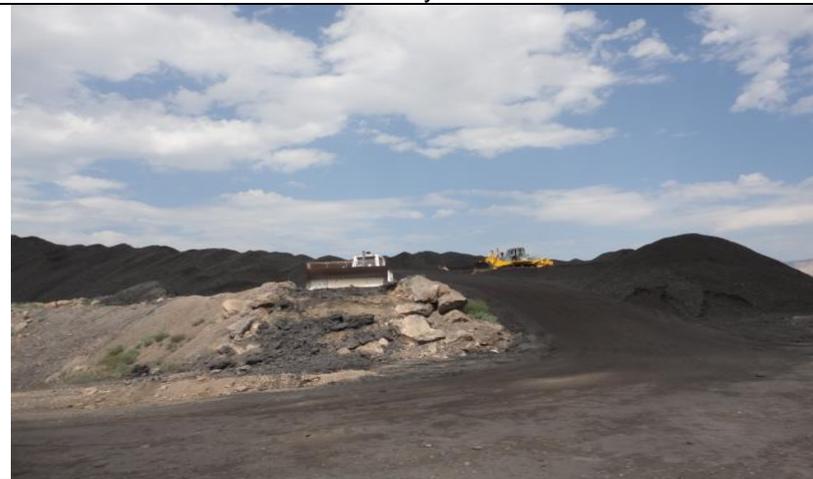
**PHOTO 4**  
Refuse Pile

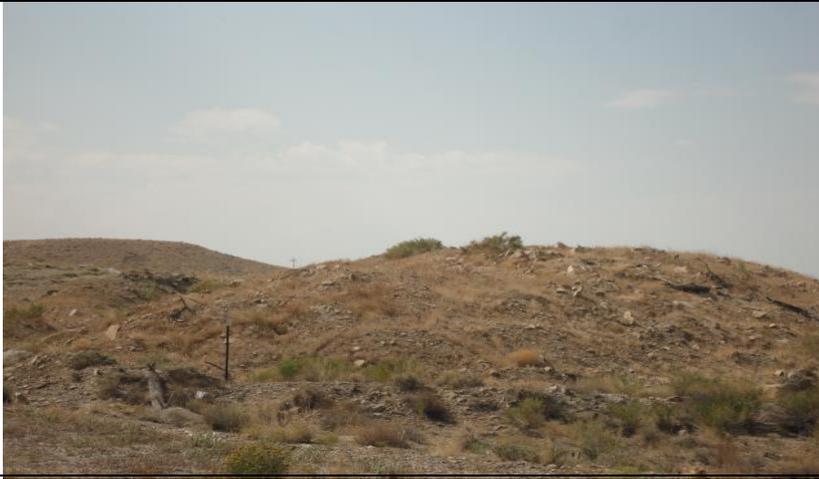
I inspected the topsoil piles throughout the property. Some piles have a small amount of vegetation with the 4th East portals having the most. The piles have not received any major amount of water since May. There were no signs of erosion. The piles are protected by berms.

**PHOTO 5**  
Refuse Topsoil Pile

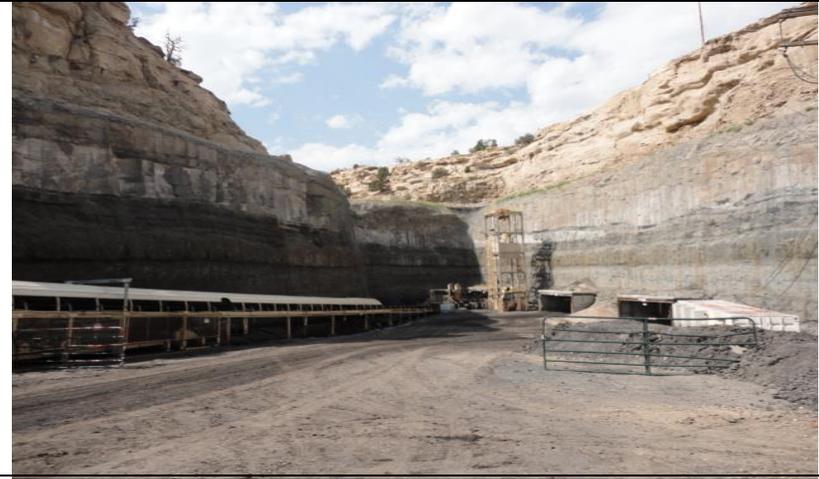
**PHOTO 6**  
.New Portals

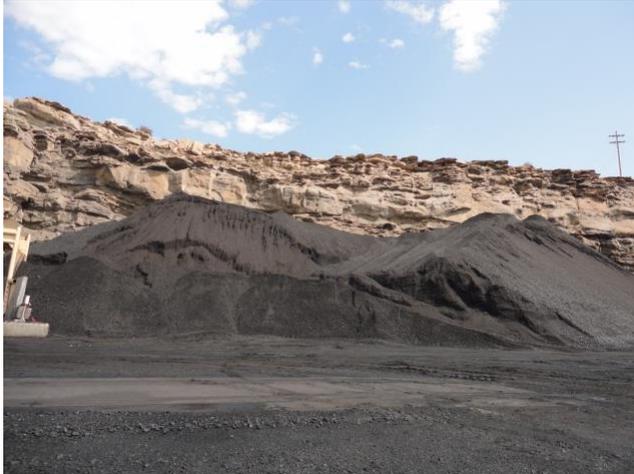
**PHOTO 7**  
Second Coal Storage Area

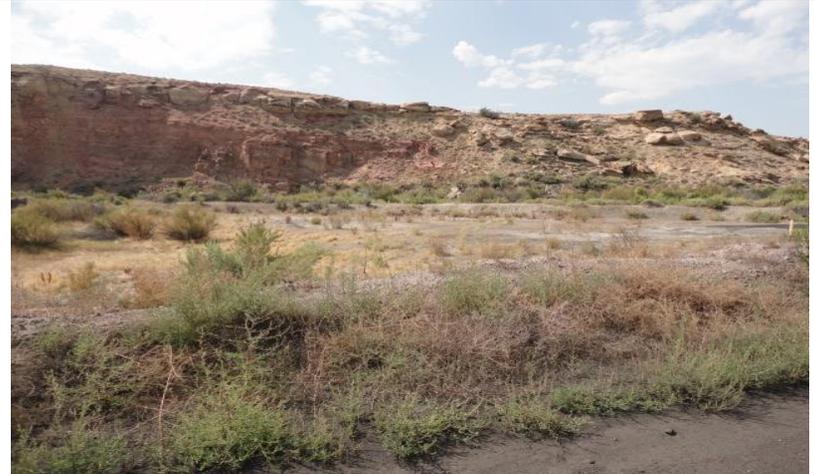
I inspected the sediment ponds throughout the property. The ponds contained were dry. It is unlikely these structures will discharge in the near future. The embankments appear to be stable. Inlets and outlets would function as design. I did not see any hazardous conditions to these structures. The permittee conducted a second quarter sediment pond inspection on May 26, 2020. There is no report of a hazardous condition.

**PHOTO 8**  
Sediment Pond #6
