Inspection Report

Permit Number:	C0150018
Inspection Type:	PARTIAL
Inspection Date:	Thursday, July 11, 2019
Start Date/Time:	7/11/2019 8:30:00 AM
End Date/Time:	7/11/2019 11:30:00 AM
Last Inspection:	Thursday, June 20, 2019

Permitee: **PACIFICORP**
 Operator: **INTERWEST MINING CO**
 Site: **DEER CREEK MINE**
 Address: **PO BOX 310, HUNTINGTON UT 84528**
 County: **EMERY**
 Permit Type: **PERMANENT COAL PROGRAM**
 Permit Status: **ACTIVE**

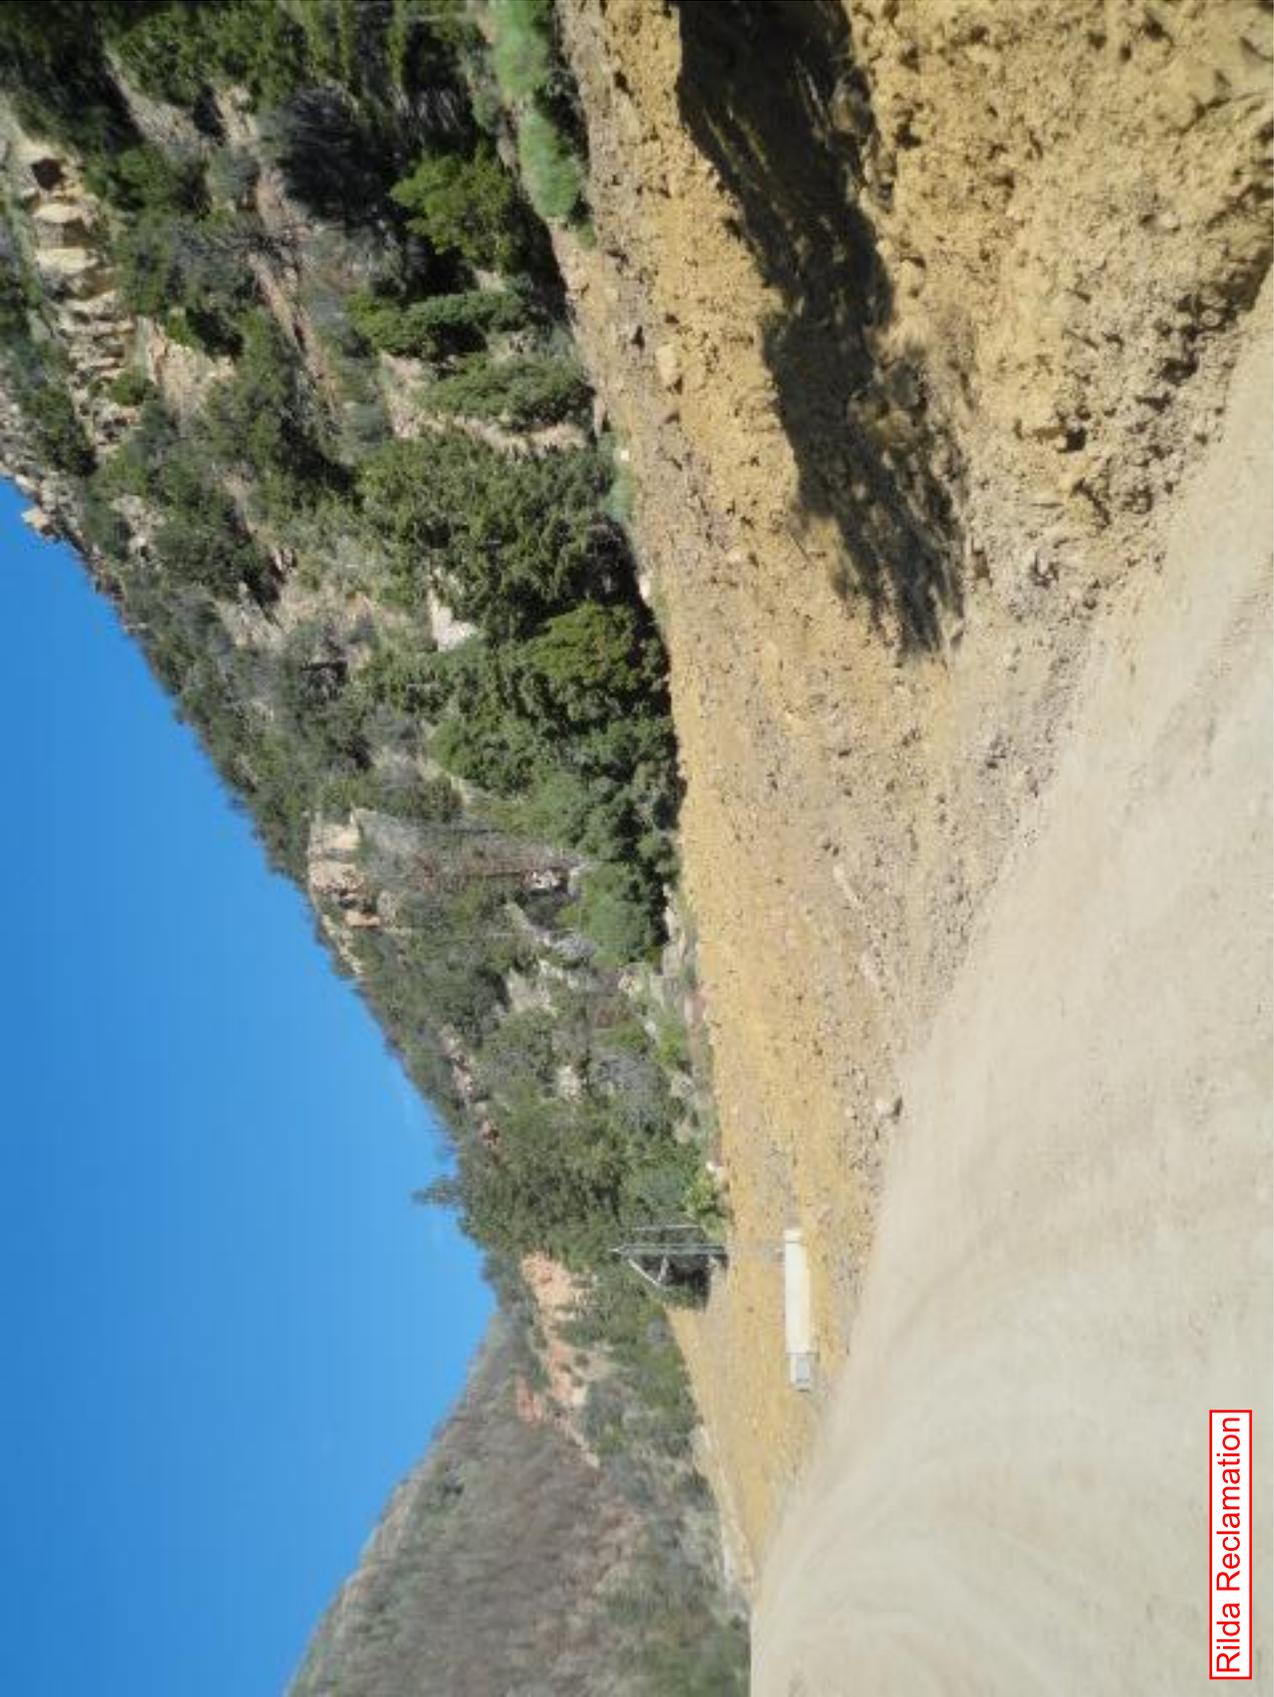
Rilda Reclamation

AML was on site at the Rilda area working to put out hot spot areas near to and adjacent to where the topsoil pile was located. All topsoil has been removed through the reclamation project. Reclamation work in rilda is now completed.

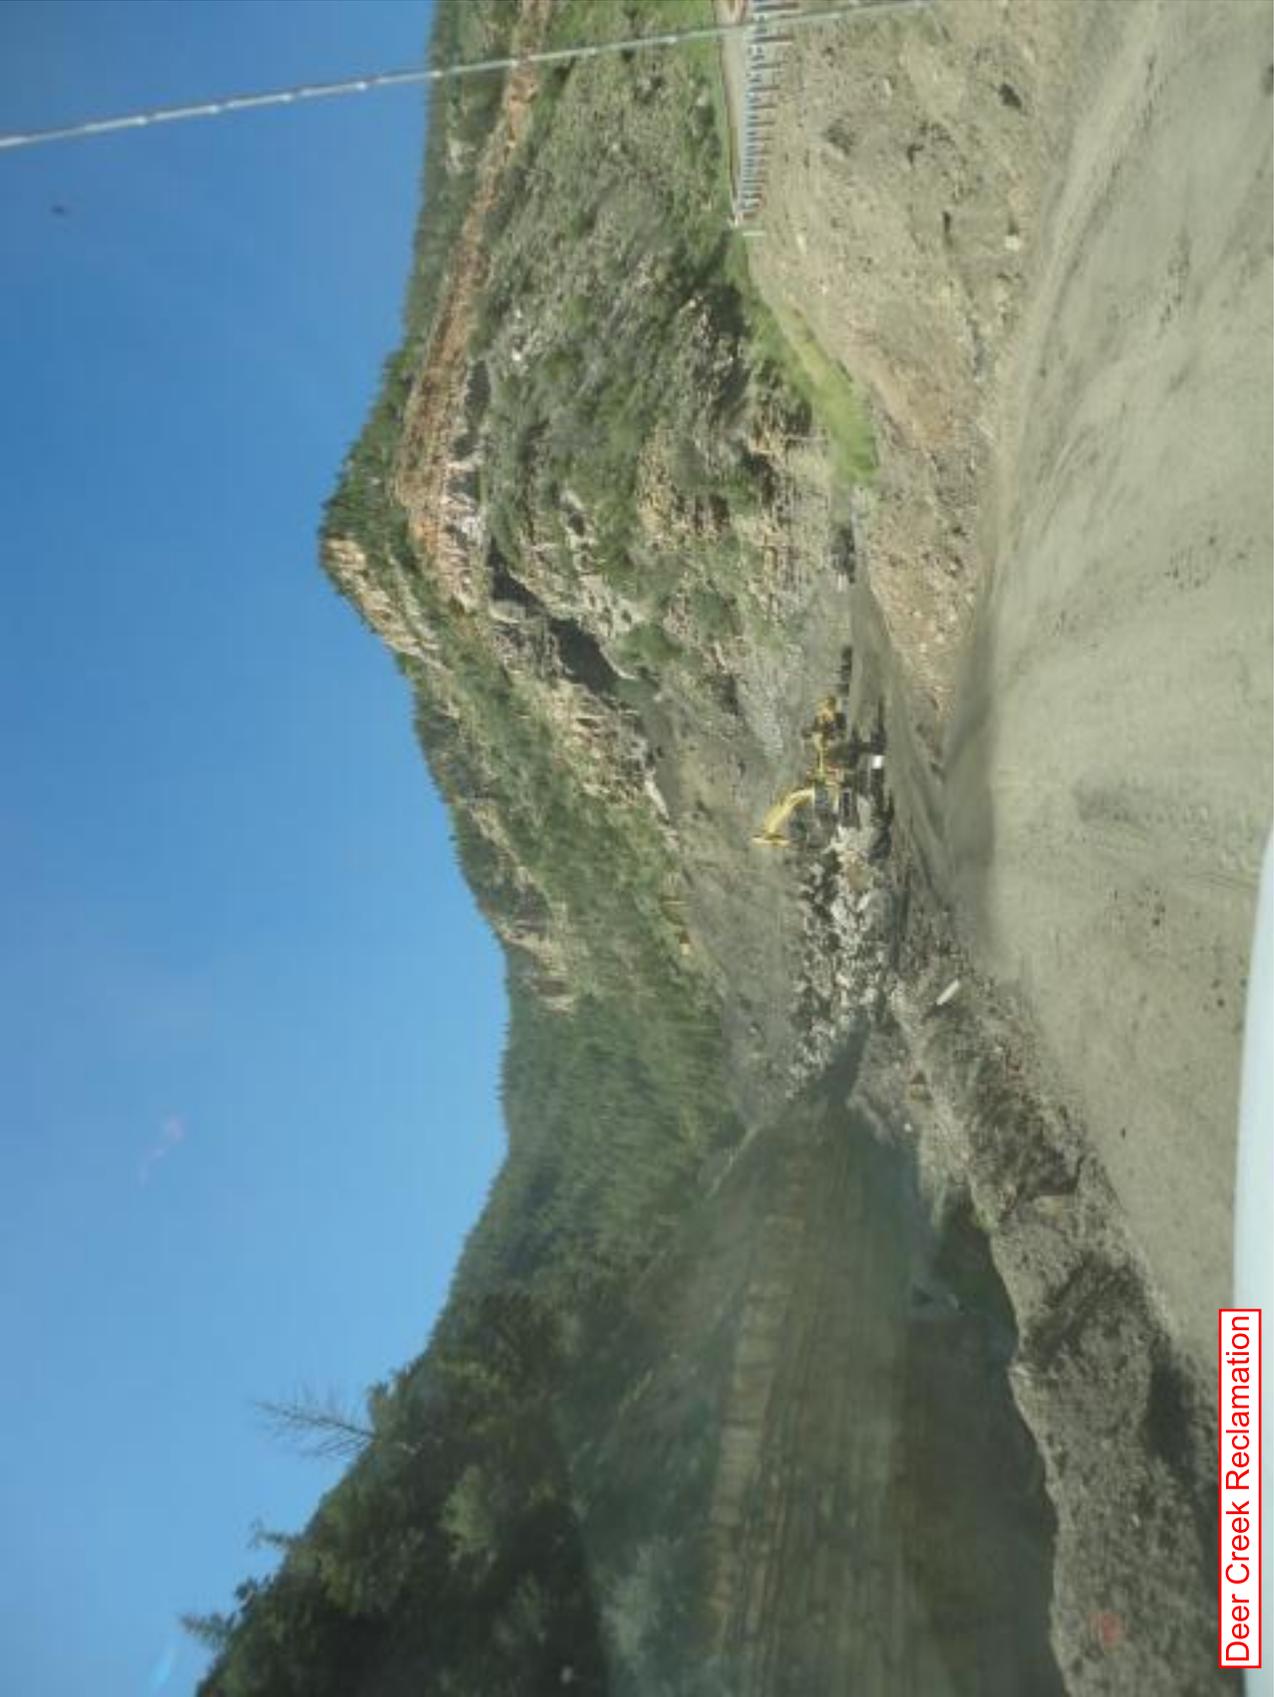
Deer Creek Reclamation

Reclamation of the Deer Canyon area is completed down to where the fuel storage area was located.
