# Inspection Report

Permit Number:	C0150019
Inspection Type:	PARTIAL
Inspection Date:	Wednesday, October 26, 2016
Start Date/Time:	10/26/2016
End Date/Time:	10/26/2016
Last Inspection:

Permitee: **PACIFICORP**  
 Operator: **INTERWEST MINING CO**  
 Site: **COTTONWOOD/ WILBERG**  
 Address: **PO BOX 310, HUNTINGTON UT 84528**  
 County: **EMERY**  
 Permit Type: **PERMANENT COAL PROGRAM**  
 Permit Status: **ACTIVE**

ATTACHMENT A – Photos October 26, 2016 site visit

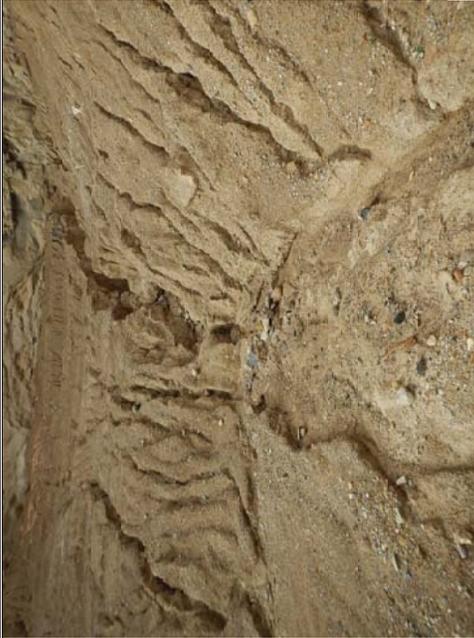
The mine site has experienced one or multiple large storm events over the last couple months. Considering the severity of the storms the diversions have largely remained intact. The Permittee must focus on repairing two areas diverting runoff that have been damaged by recent storms. The first area is the road base temporarily placed at the edge of the upper road pad in the left fork. This road base has been relatively stable over the summer, however undisturbed runoff flowing over the material has formed a large gully through the fill (Photo 1). I spoke with Dennis Oakley of Pacificorp over the phone and he informed me they are working to restabilize the fill. The second area in need of maintenance is a drop culvert. The drop culvert is located along the inner bend of the access road as it passes the lower pad in the right fork of Grimes wash. Runoff is designed to drop into the culvert inlet and conveyed to the sediment ponds. Instead, it appears the berm acting as a backstop behind the drop culvert has failed (Photo 2). Runoff now flows past/over the drop culvert and is scouring a large gully on the hillslope down below the culvert. The culvert must be repaired to properly convey water the gully on the hillslope must be stabilized.

<p><b>PHOTO 1</b> Runoff has gullied the road base from recent events. October 26, 2016</p>

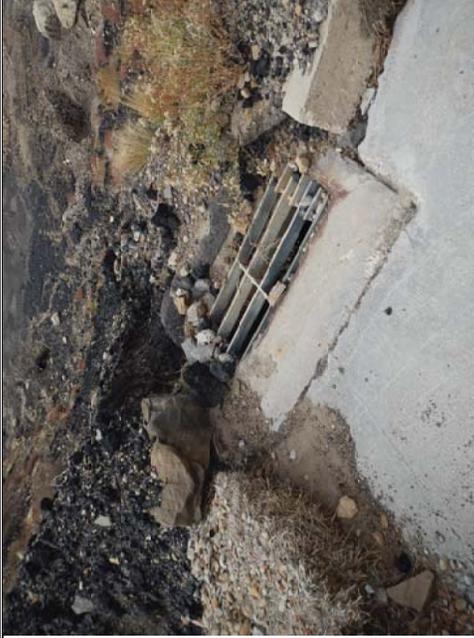
<p><b>PHOTO 2</b> Failed drop culvert and gullied hillslope down below. October 26, 2016</p>

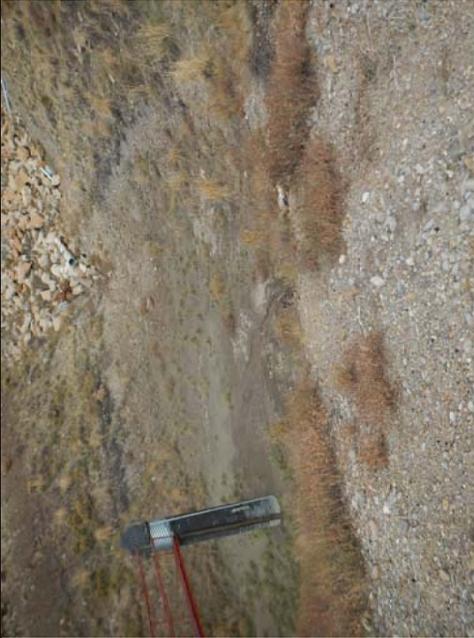
The south pond was dry and the north pond contained a couple feet of standing water (Photos 3 and 4).

<p><b>PHOTO 3</b> South pond was dry. October 26, 2016</p>

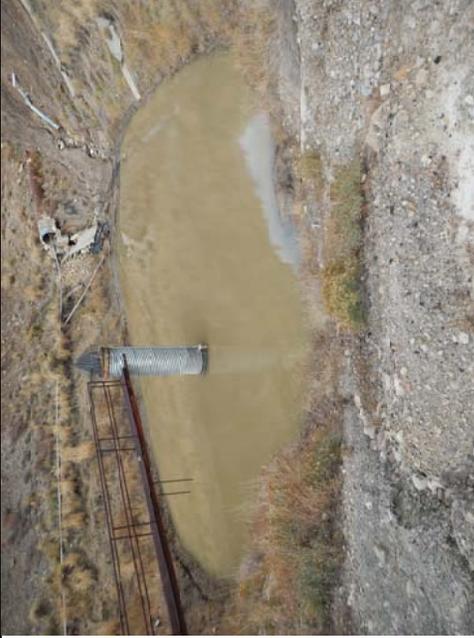
<p><b>PHOTO 4</b> North pond contained a couple feet of water. October 26, 2016</p>

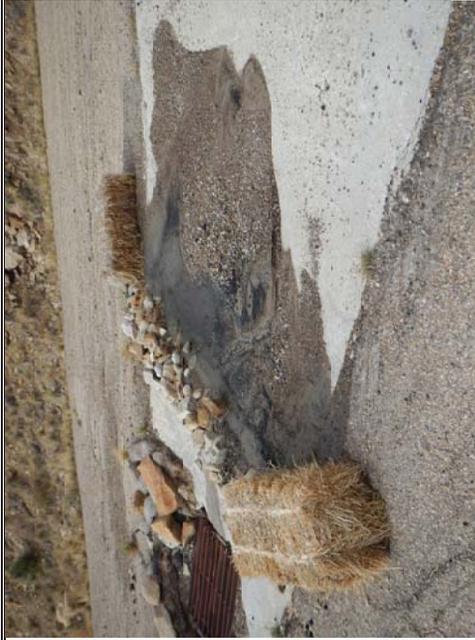
The rock/straw bale check dam directly below the south pond must be cleaned out (Photo 5). The check dam is full and is no longer able to capture sediment prior to leaving the mine site. The check dam/silt fence to the east of the entrance gate is in need of maintenance as well (Photo 6). This sediment control structure is about half full and appears to need additional settling time before runoff is allowed to exit the permit area.

**PHOTO 5**  
Check dam below ponds is full. Must be cleaned out.  
October 26, 2016

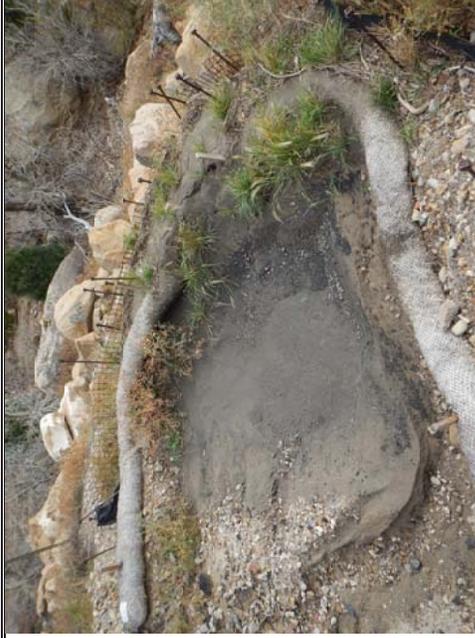
**PHOTO 6**  
Check dam to the east of the entrance gate in need of maintenance.  
October 26, 2016

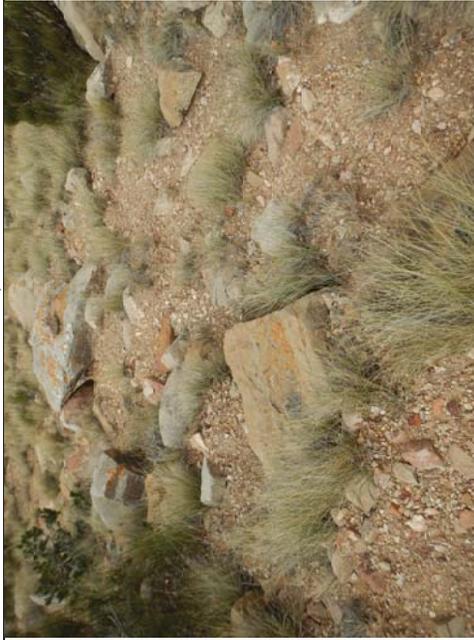
The undisturbed hillslope to the east of the sediment ponds was walked. The vegetation appeared to be stable and dense enough to prevent the formation of rills across the entire hillslope. Instead, it appears runoff is limited to sheet flow (Photos 7 – 10).

**PHOTO 7**  
Rocks, grasses, and woody vegetation limit the concentration of runoff on undisturbed hillslopes above the mine site.  
October 26, 2016

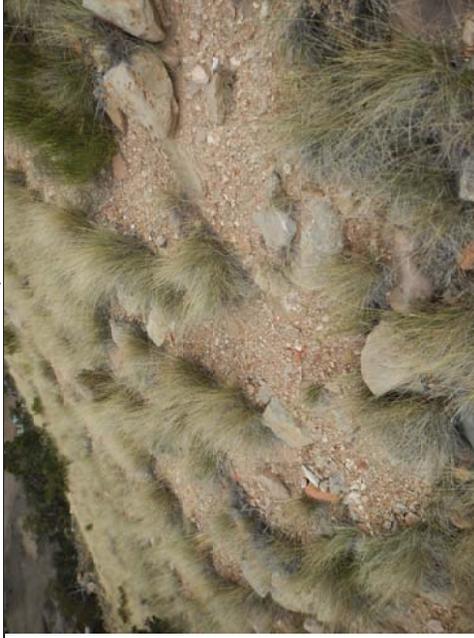
**PHOTO 8**  
Rocks, grasses, and woody vegetation limit the concentration of runoff on undisturbed hillslopes above the mine site.  
October 26, 2016

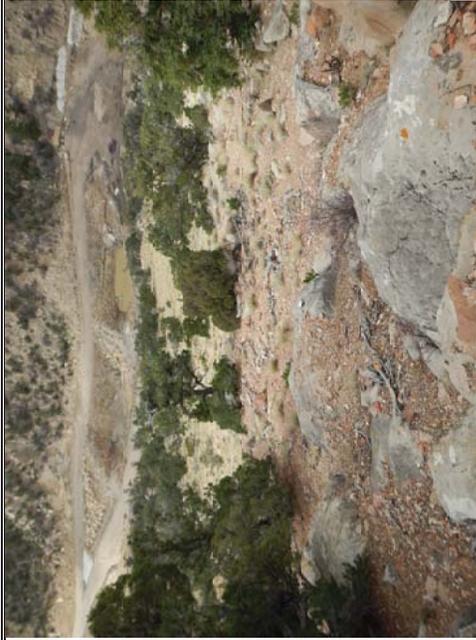
**PHOTO 9**

Rocks, grasses, and woody vegetation limit the concentration of runoff on undisturbed hillslopes above the mine site.  
October 26, 2016

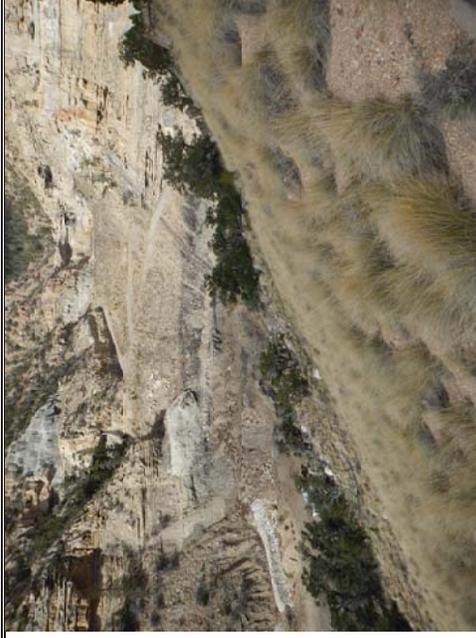
**PHOTO 10**

Rocks, grasses, and woody vegetation limit the concentration of runoff on undisturbed hillslopes above the mine site.  
October 26, 2016
