Division of Oil, Gas and Mining

## Inspection Report

Permitee: **PACIFICORP**  
 Operator: **INTERWEST MINING CO**  
 Site: **COTTONWOOD/ WILBERG**  
 Address: **PO BOX 310, HUNTINGTON UT 84528**  
 County: **EMERY**  
 Permit Type: **PERMANENT COAL PROGRAM**  
 Permit Status: **ACTIVE**

The Division conducted an inspection at the Cottonwood-Wilberg mine on August 30, 2018. Reclamation permit conditions for hillslopes, diversions, and vegetation were inspected. The site remains stable since the last inspection.

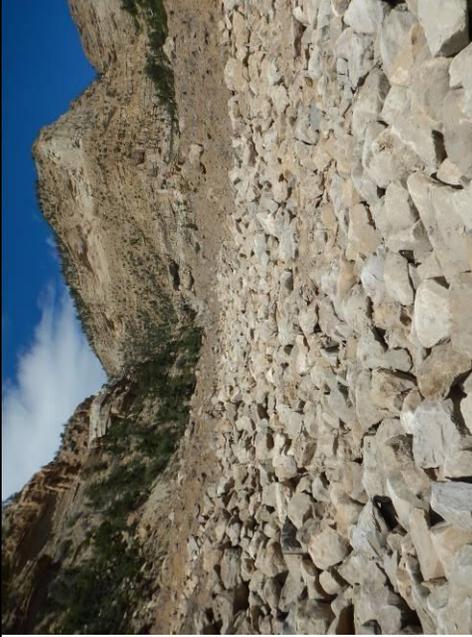
The reclaimed channel was walked up to the junction of the left and right forks of Grimes wash. The channel appears to be functioning as designed.

<p><b>PHOTO 1</b> Reclaimed channel looking up canyon. August 30, 2018</p>	<p><b>PHOTO 2</b> Vegetative growth in bottom of pock. August 30, 2018</p>

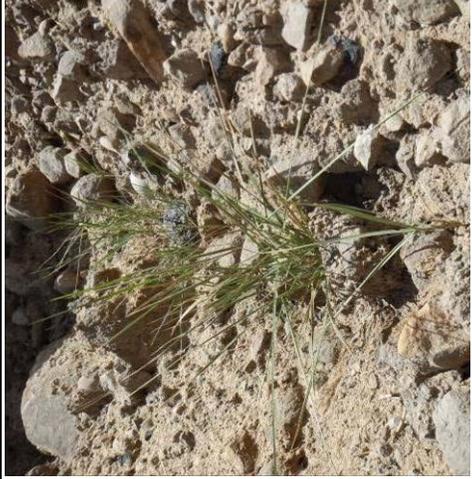
There has been very little rainfall since the seed was applied to the reclaimed hillslopes. Vegetation is sparse but it is beginning to be established in the bottom of the pocks. It is anticipated winter moisture will help vegetation become established across the site.

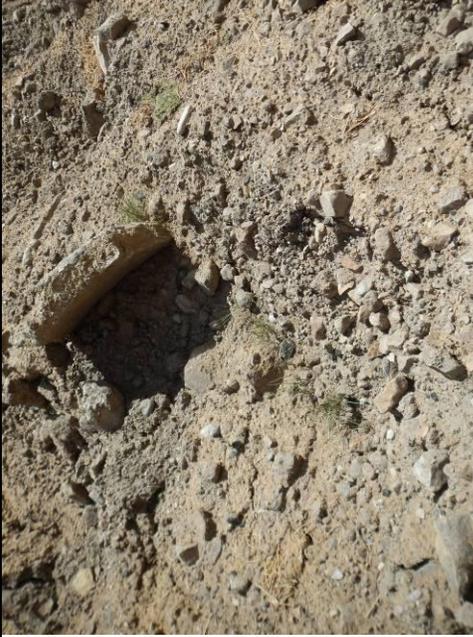
<p><b>PHOTO 3</b> Vegetative growth in bottom of pock. August 30, 2018</p>	<p><b>PHOTO 4</b> Vegetative growth in bottom of pock. August 30, 2018</p>
