Subject: Amendment to Update the MRP at the Completion of Final Reclamation, PacifiCorp, Cottonwood/Wilberg Mine C/015/0019, Emery County, Utah

Amendment to Update Permit to Include As-Built Conditions Post Final Reclamation Activities

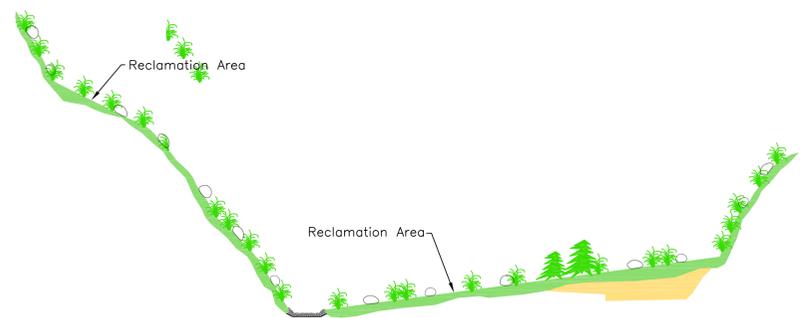
STEP 5

CONDITION AT 10 YEAR RESPONSIBILITY PERIOD

- a) Reclaimed areas meet Performance Standards
