# Inspection Report

Permit Number:	<b>C0150019</b>
Inspection Type:	COMPLETE
Inspection Date:	Tuesday, November 12, 2019
Start Date/Time:	11/12/2019 9:00:00 AM
End Date/Time:	11/12/2019 12:00:00 PM
Last Inspection:	Tuesday, October 15, 2019

Permitee: **PACIFICORP**  
 Operator: **INTERWEST MINING CO**  
 Site: **COTTONWOOD/ WILBERG**  
 Address: **PO BOX 310, HUNTINGTON UT 84528**  
 County: **EMERY**  
 Permit Type: **PERMANENT COAL PROGRAM**  
 Permit Status: **ACTIVE**

The reclamation is complete. An inspection was made on the Trail Mountain side of Cottonwood Mine.

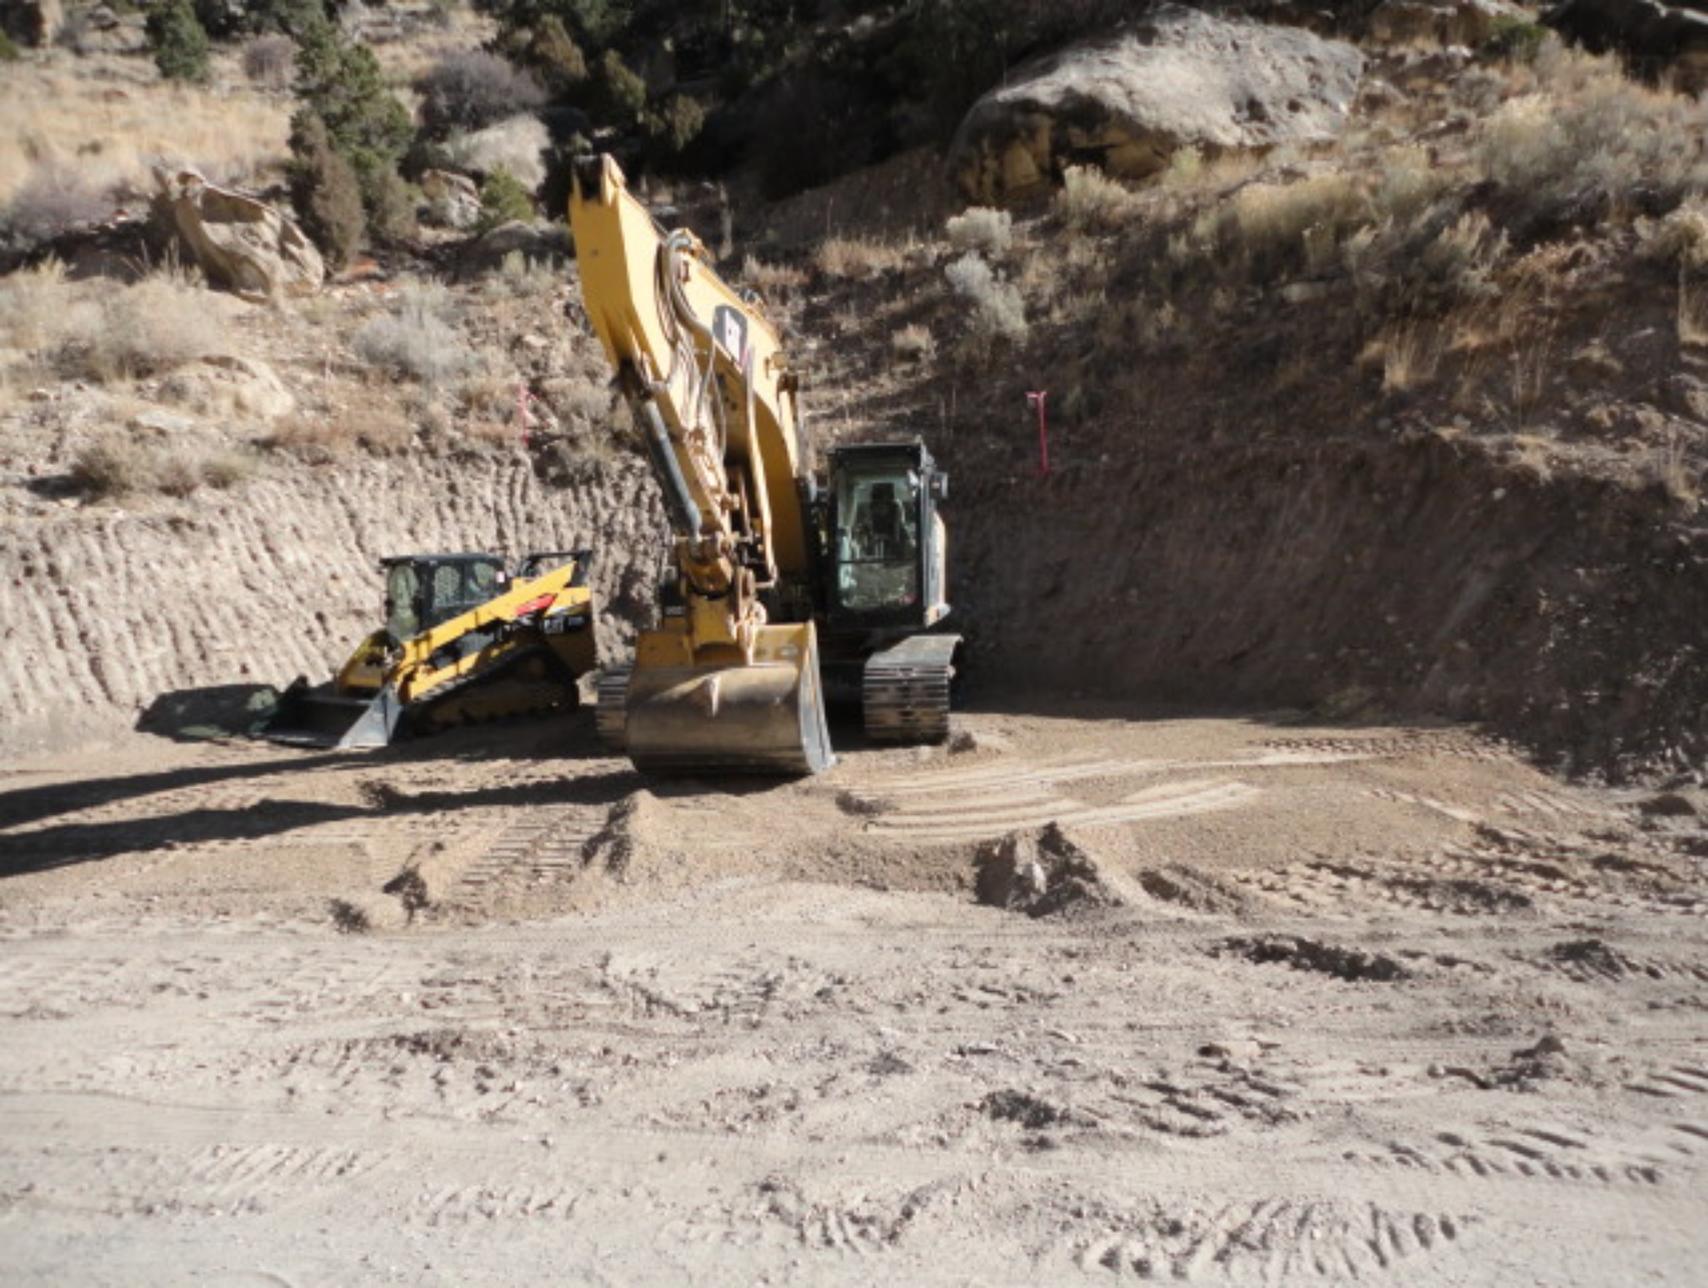
**Cottonwood Mine  
TMA Area**

Owner: Nevada Energy  
Operator: Cottonwood Mining Company  
Huntington Office  
Address: P.O. Box 20  
Huntington, W.V. 25642  
Phone: 420-971-8611
