EXISTING STRUCTURES

Table 5A-1 Existing Structures
Construction Dates

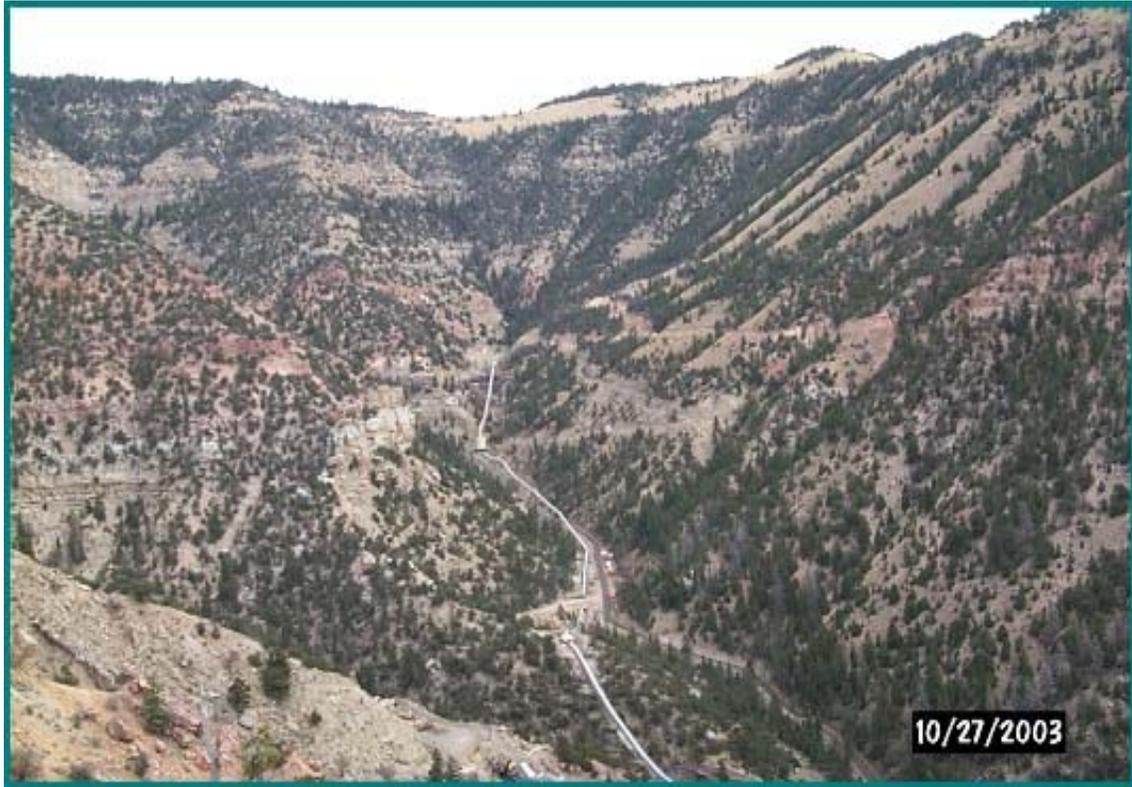
Photo #9 Cross Wild Horse Ridge Conveyor Belt

Cross Conveyor. This belt conveys the coal from the Blind Canyon Seam to the coal storage bin. See [Photo #9.12](#).

~~21~~²³. Wild Horse Ridge Conveyor Belt. This structure transports coal from the Bear Canyon No. 3 Mine to the tipple facilities.

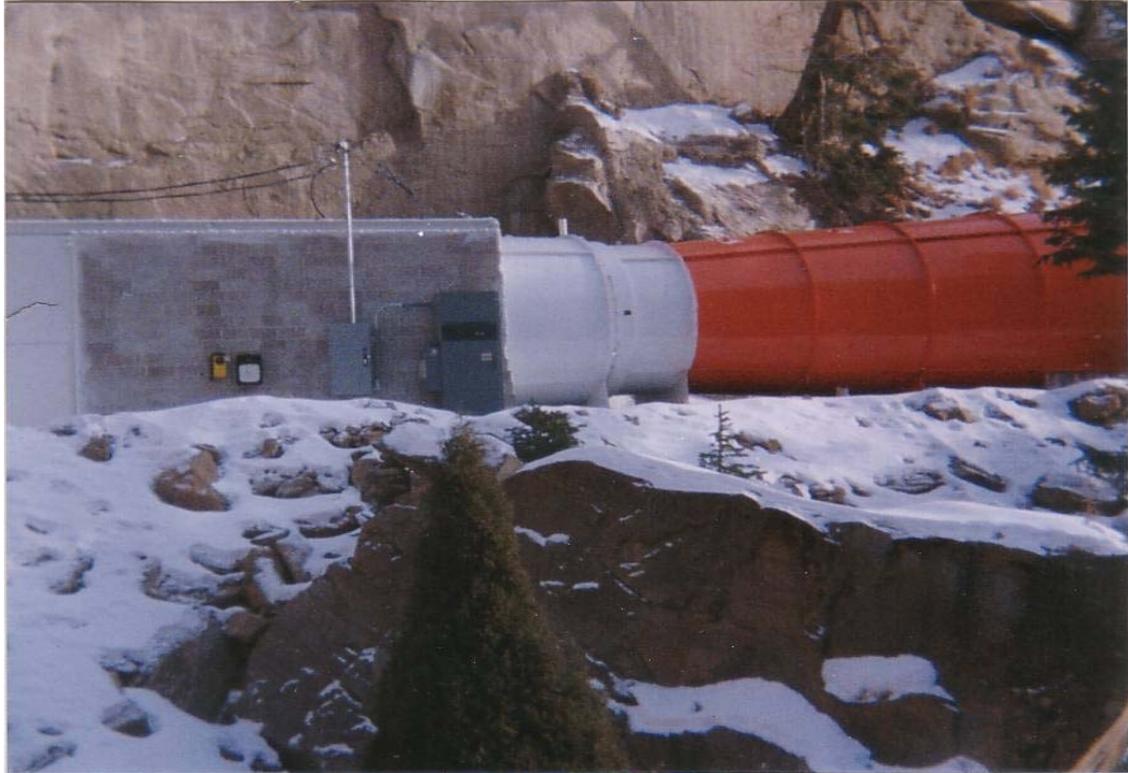
Photo #10 WHR Tank Seam Fan

1213. WHR Tank Seam Fan. The Wild Horse Ridge Tank Seam Fan (Shown in [Photo #10](#)) was the old Blind Canyon Fan and is MSHA approved. All safety guards are maintained and in place.

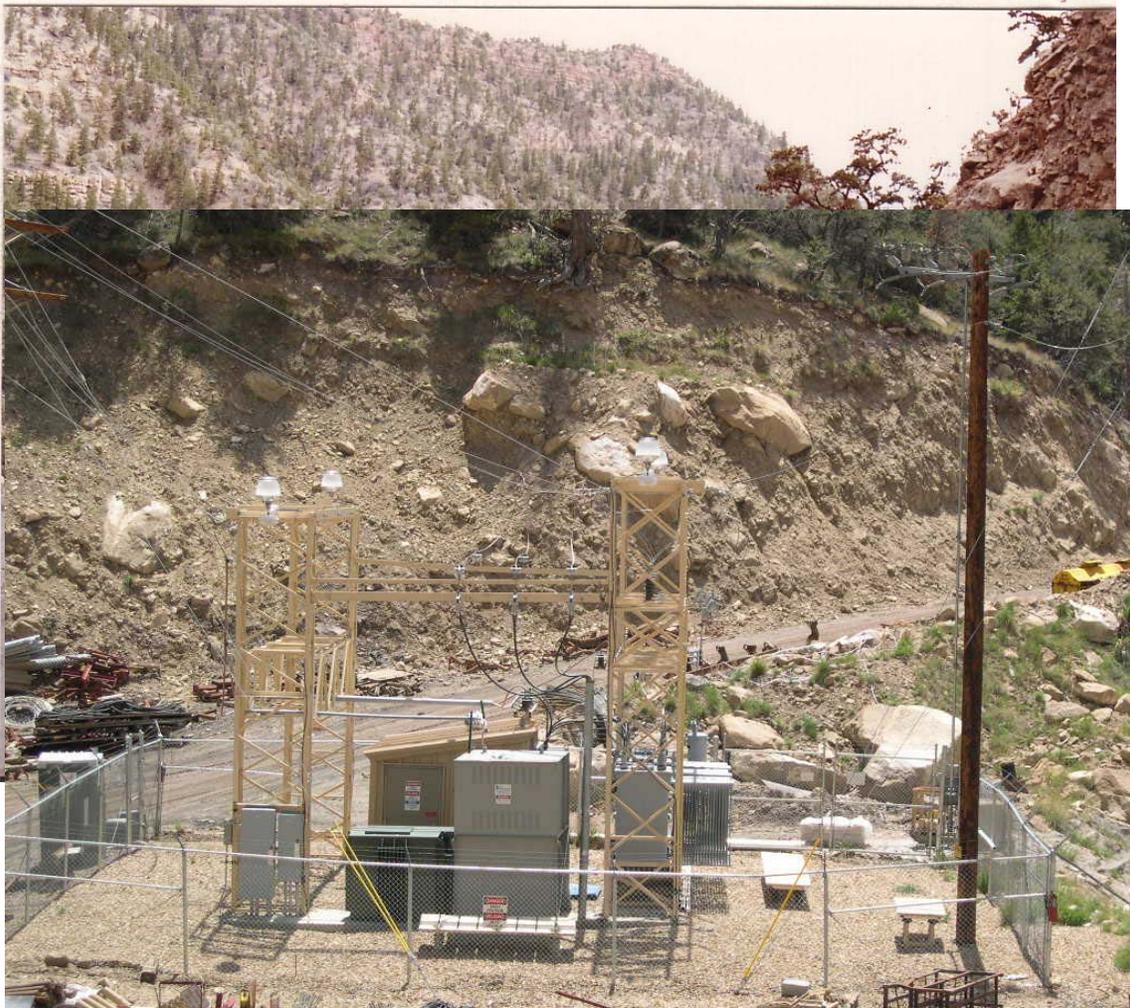
Photo #12 WHR Substation

~~22~~²⁴. WHR Substation. This facility supplies electrical power to the surface and underground facilities operating in Wild Horse Ridge.

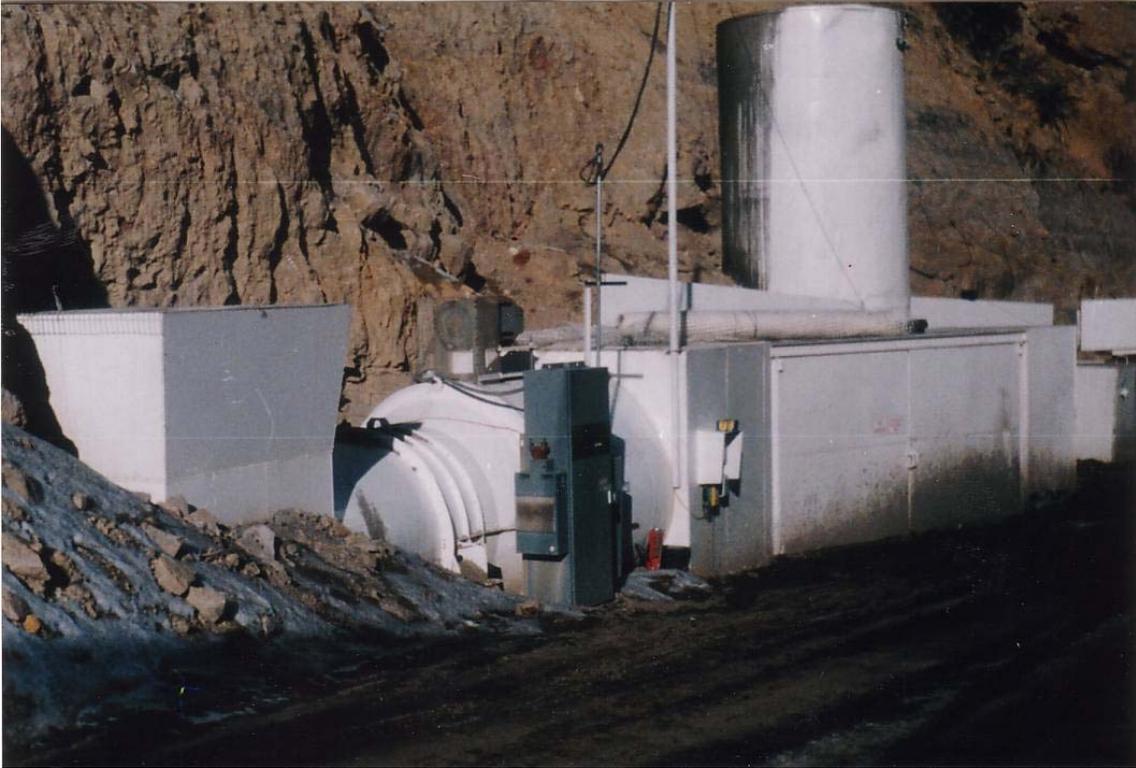
Photo #19 WHR Blind Canyon Seam Fan

~~20~~²². WHR Blind Canyon Seam Fan. The WHR Blind Canyon Seam Ventilation Fan came from the old Tank Seam mine and is MSHA approved, and all safety guards are maintained in place. See [photo #19](#).

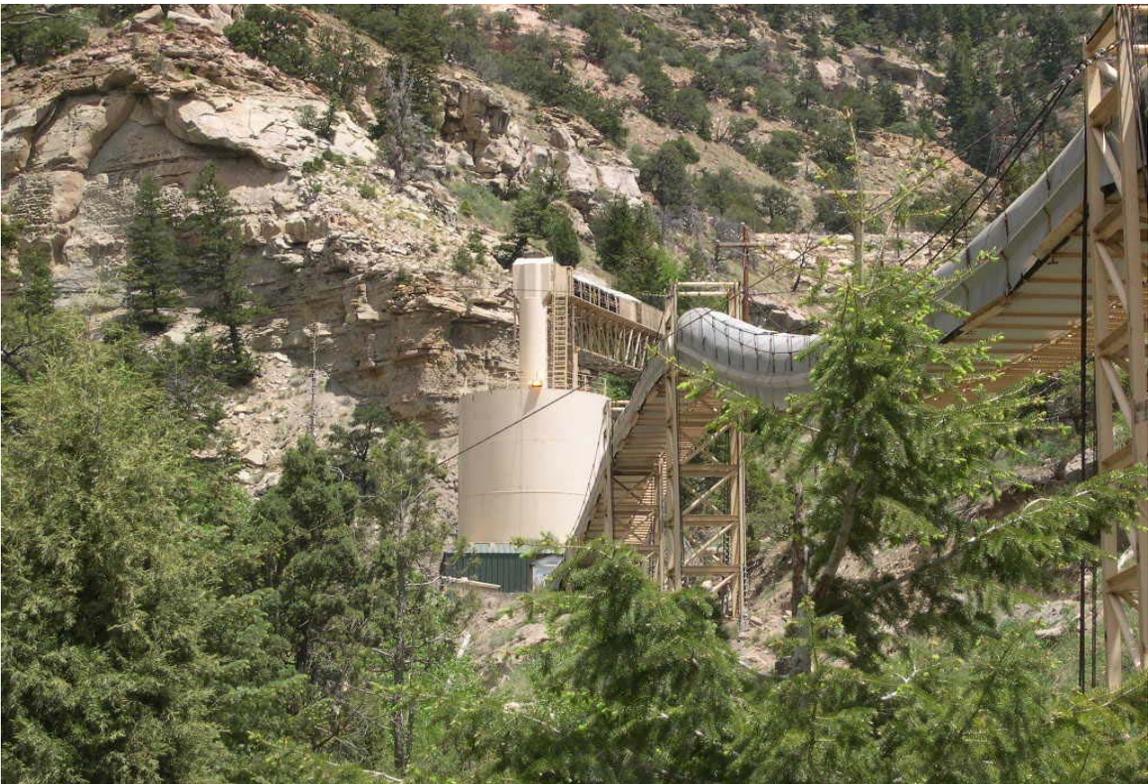
Photo #20 WHR Coal Storage Bin Tank Seam Borehole Structure

~~24~~²⁷. WHR Coal Storage Bin. This structure is used for coal surge capacity from the Bear Canyon No. 3 and 4 Mines. It consists of a metal storage silo approximately 30' diameter.
