# Inspection Report

Permit Number:	<b>C0150025</b>
Inspection Type:	COMPLETE
Inspection Date:	Wednesday, May 13, 2020
Start Date/Time:	5/13/2020 9:30:00 AM
End Date/Time:	5/13/2020 2:00:00 PM
Last Inspection:	Wednesday, March 11, 2020

Permittee: **CASTLE VALLEY MINING LLC**  
 Operator: **CASTLE VALLEY MINING LLC**  
 Site: **BEAR CANYON MINE**  
 Address: **5550 W. BEAR CANYON ROAD, P.O. BOX 475 HUNTINGTON UT 84528**  
 County: **EMERY**  
 Permit Type: **PERMANENT COAL PROGRAM**  
 Permit Status: **ACTIVE**

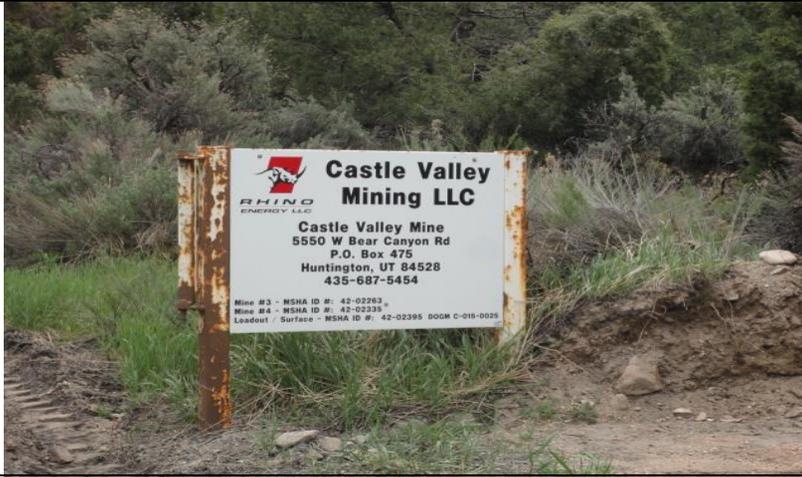
**PHOTO 1**  
Identification Sign

The identification sign was inspected and it meets the requirements of the R645 Coal Rules. See Photo

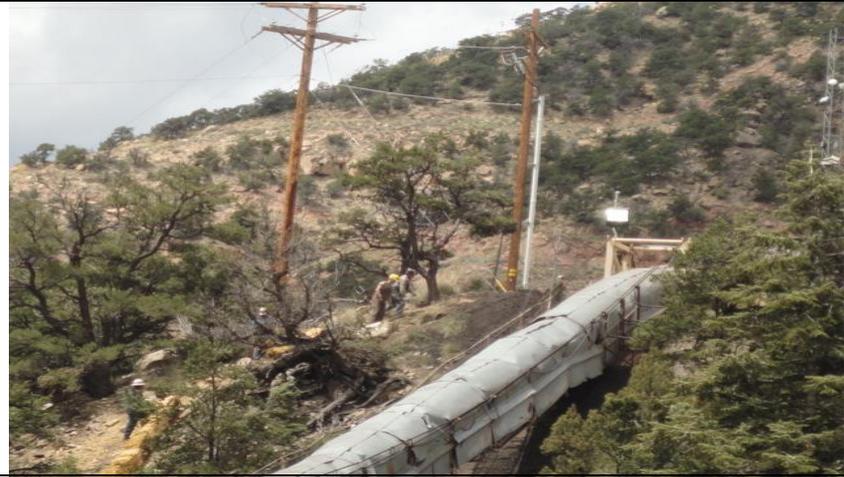
**PHOTO 2**  
Installing Straw Bales under beltline

The permittee was installing straw bales under the belt conveyor to treat the area affected by the coal fines from off the belt line. This treatment was approved by an amendment that was submitted to the Division. See Photo

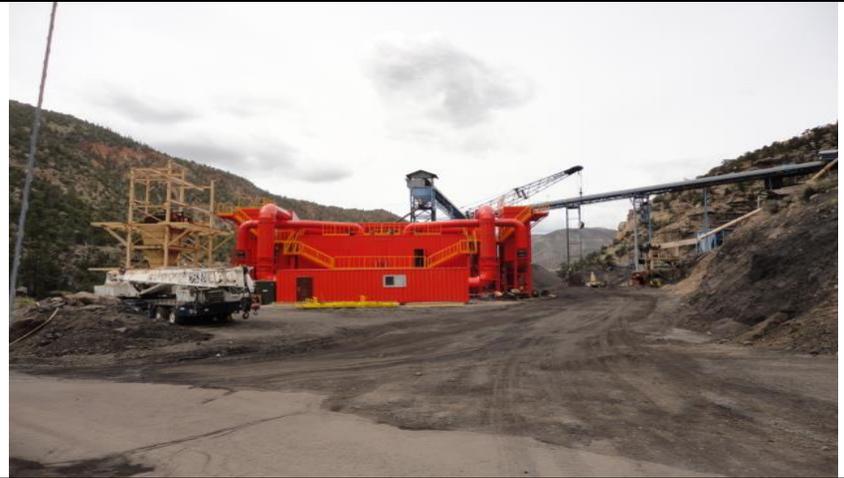
**PHOTO 4**  
Air Jig and Conveyor Belt

The permittee was still installing the conveyor to the Air Jig. The mine was in full operation.
