# Inspection Report

Permit Number:	<b>C0150025</b>
Inspection Type:	PARTIAL
Inspection Date:	Tuesday, June 16, 2020
Start Date/Time:	6/16/2020 9:00:00 AM
End Date/Time:	6/16/2020 2:30:00 PM
Last Inspection:	Wednesday, May 13, 2020

Permittee: **CASTLE VALLEY MINING LLC**  
 Operator: **CASTLE VALLEY MINING LLC**  
 Site: **BEAR CANYON MINE**  
 Address: **5550 W. BEAR CANYON ROAD, P.O. BOX 475 HUNTINGTON UT 84528**  
 County: **EMERY**  
 Permit Type: **PERMANENT COAL PROGRAM**  
 Permit Status: **ACTIVE**

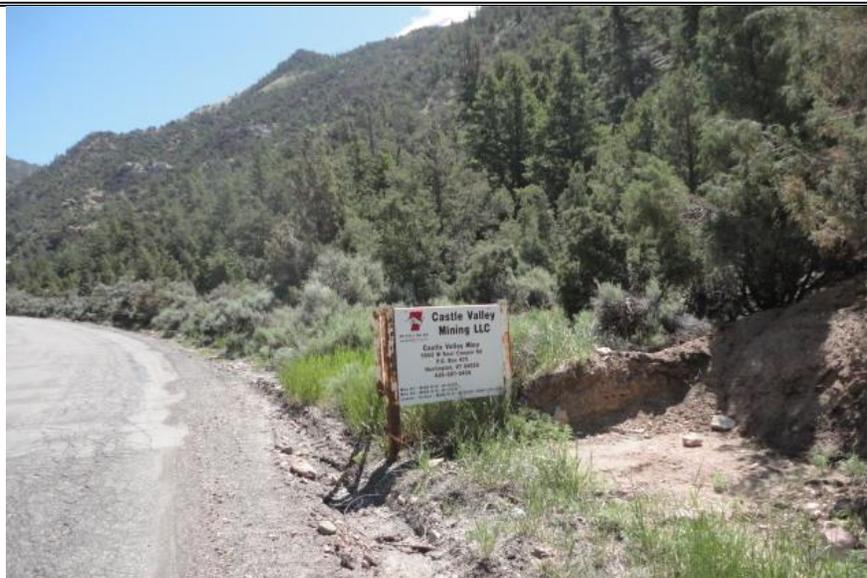
**PHOTO 1**  
Identification Sign

The identification sign was inspected and it meets the requirements of the R645 Coal Rules. See Photo

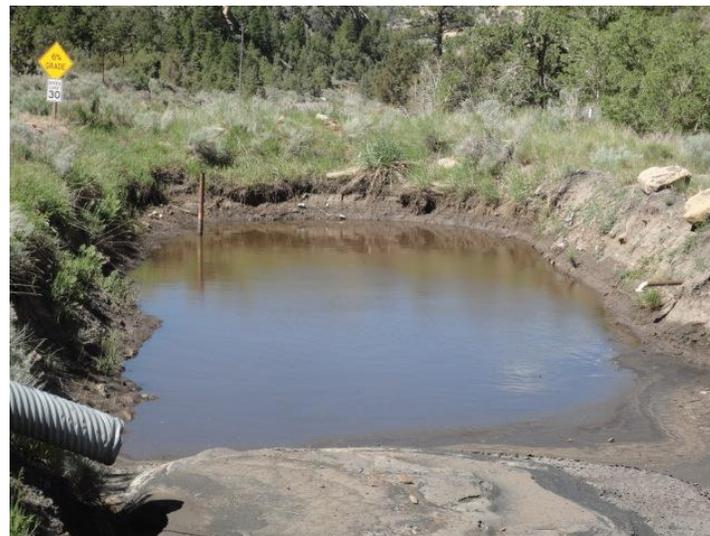
**PHOTO 2**  
Pond B

I inspected the sediment ponds during the inspection. They were mostly dry and none of the sediment ponds were discharging. No hazardous conditions were noticed. The embankments appear to be stable. The inlets and outlets were open.
