# GENWAL MINE 015/032

## MINING AND RECLAMATION PLAN

ADDENDUM TO THE RECLAMATION PLAN  
FOR THE

EAST MOUNTAIN EMERGENCY  
DRILLPADS  
TASK # 2893

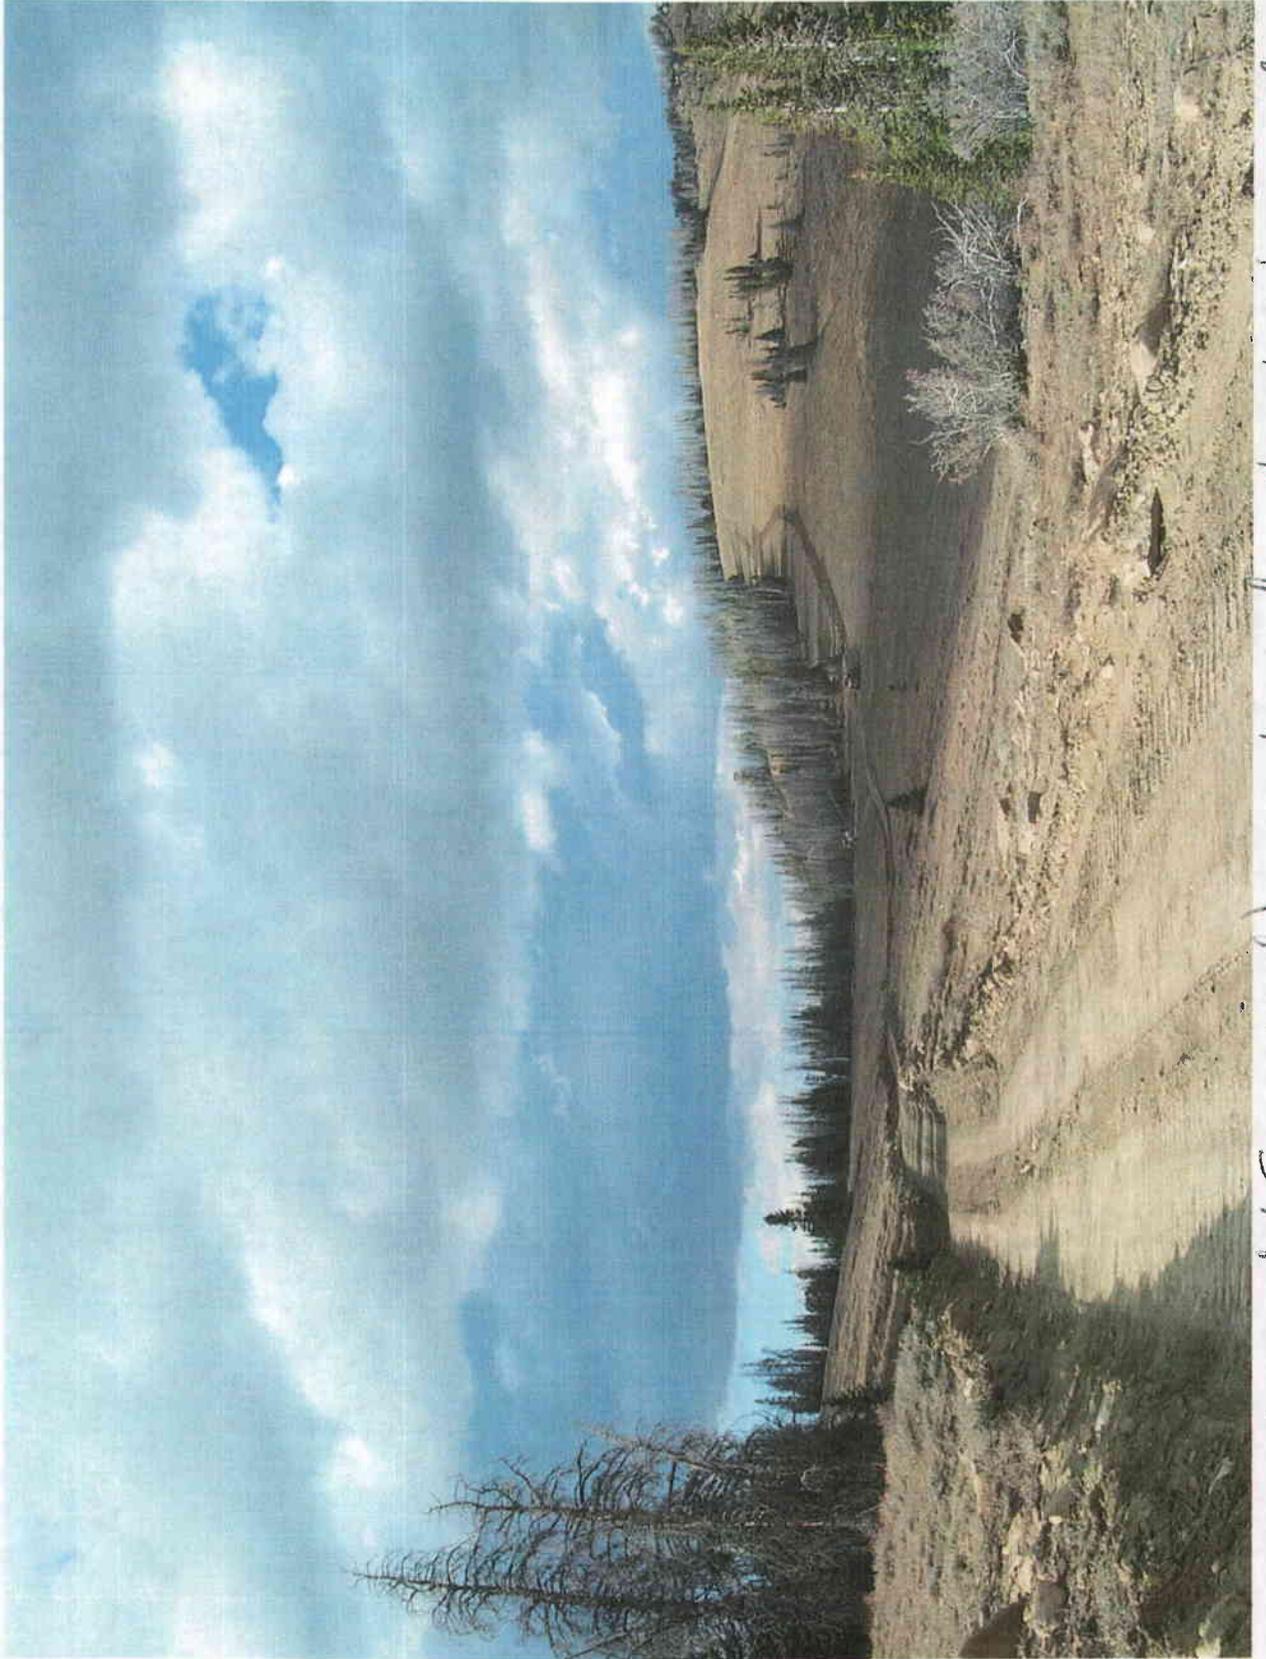
SITUA road (foreground), reclaimed water truck road (background)

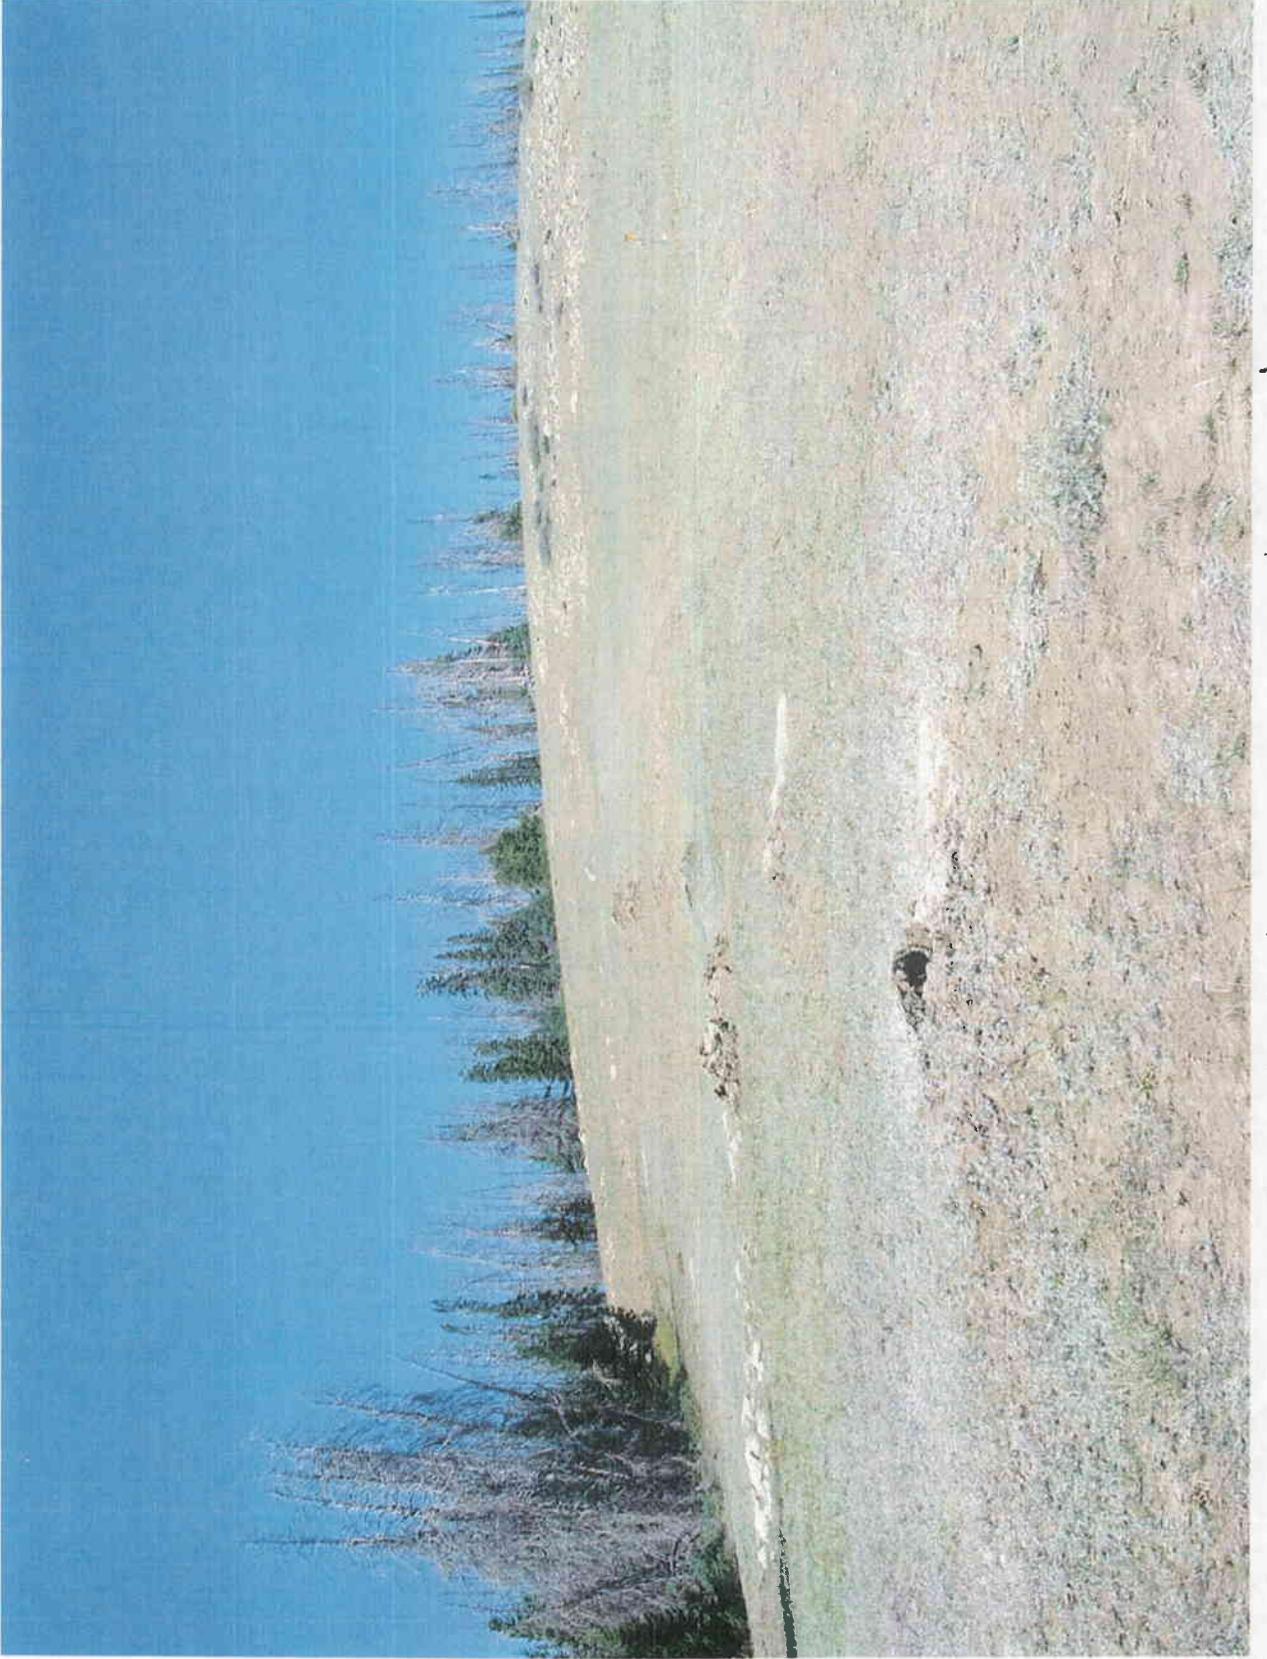
Shot holes, pre reclamation

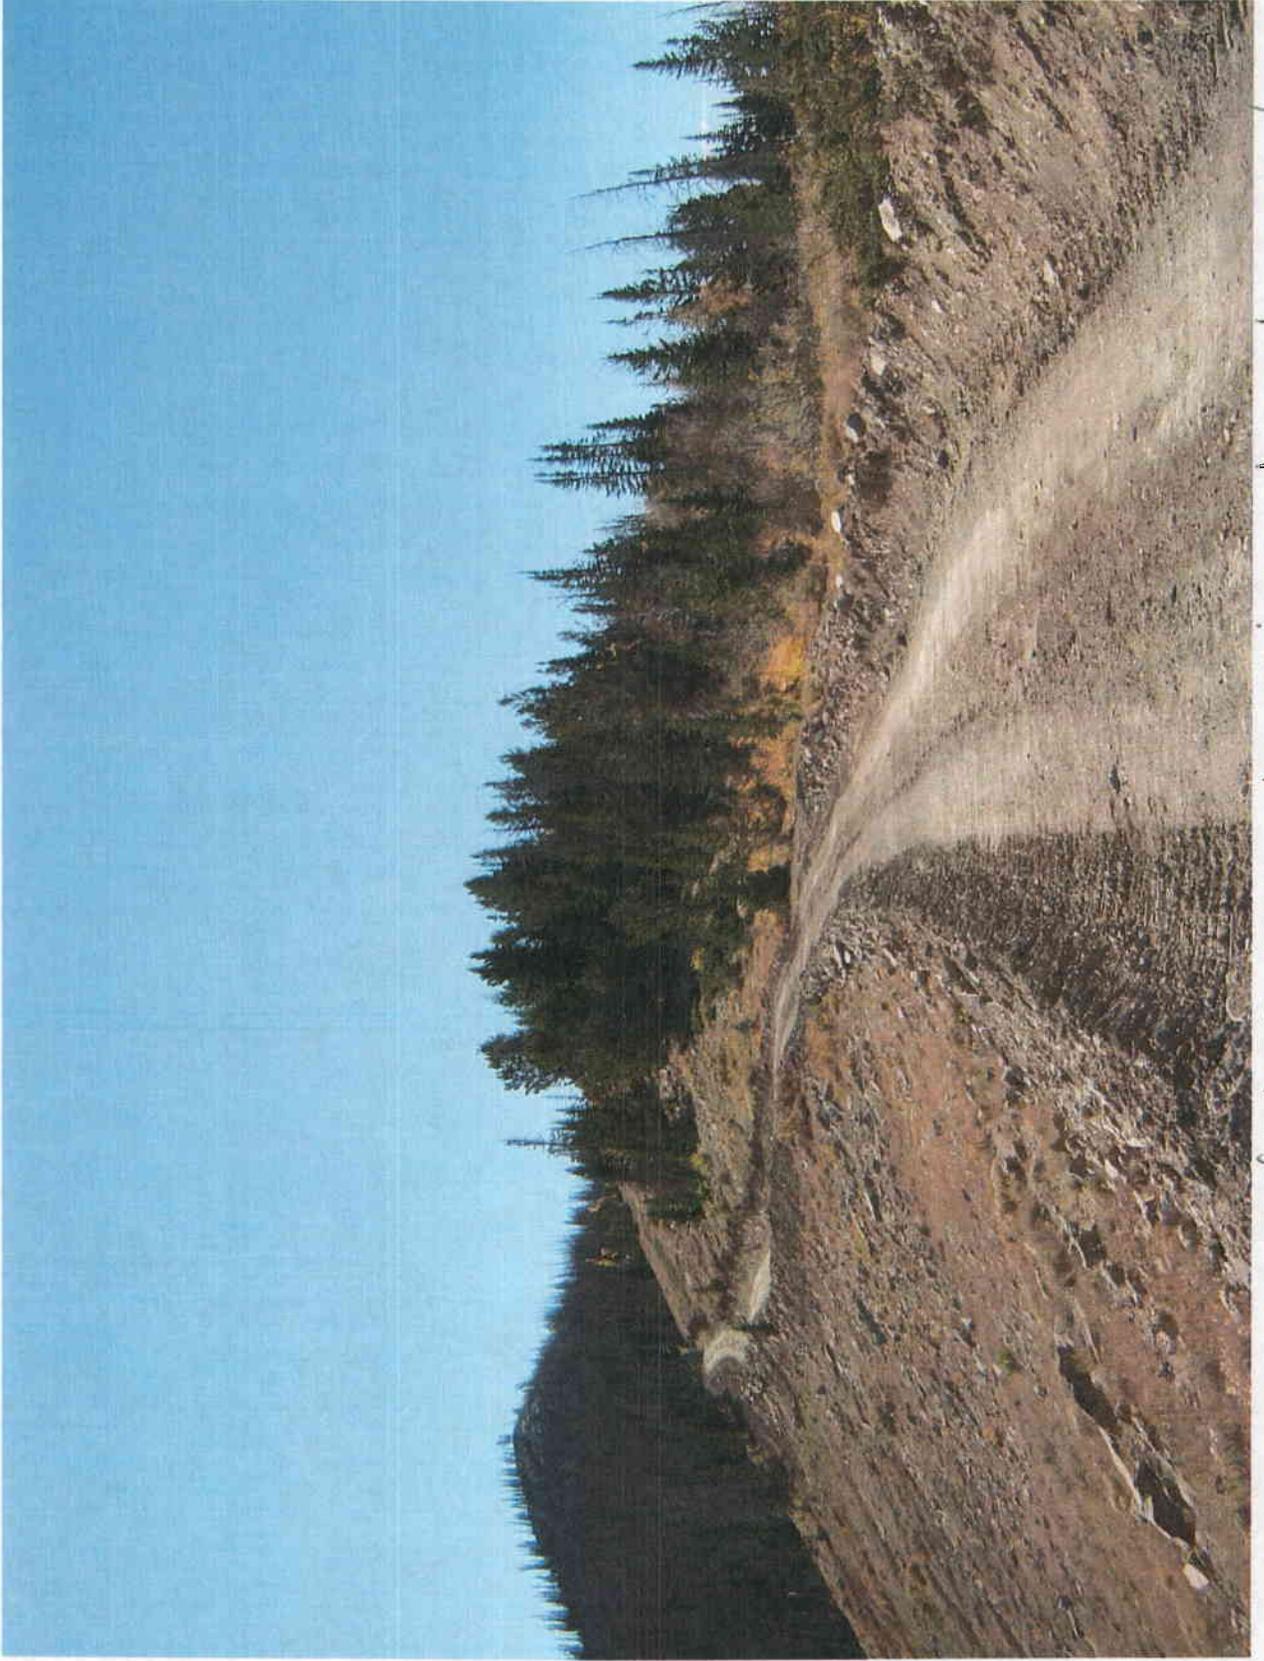
SITLA road before reclamation and realignment

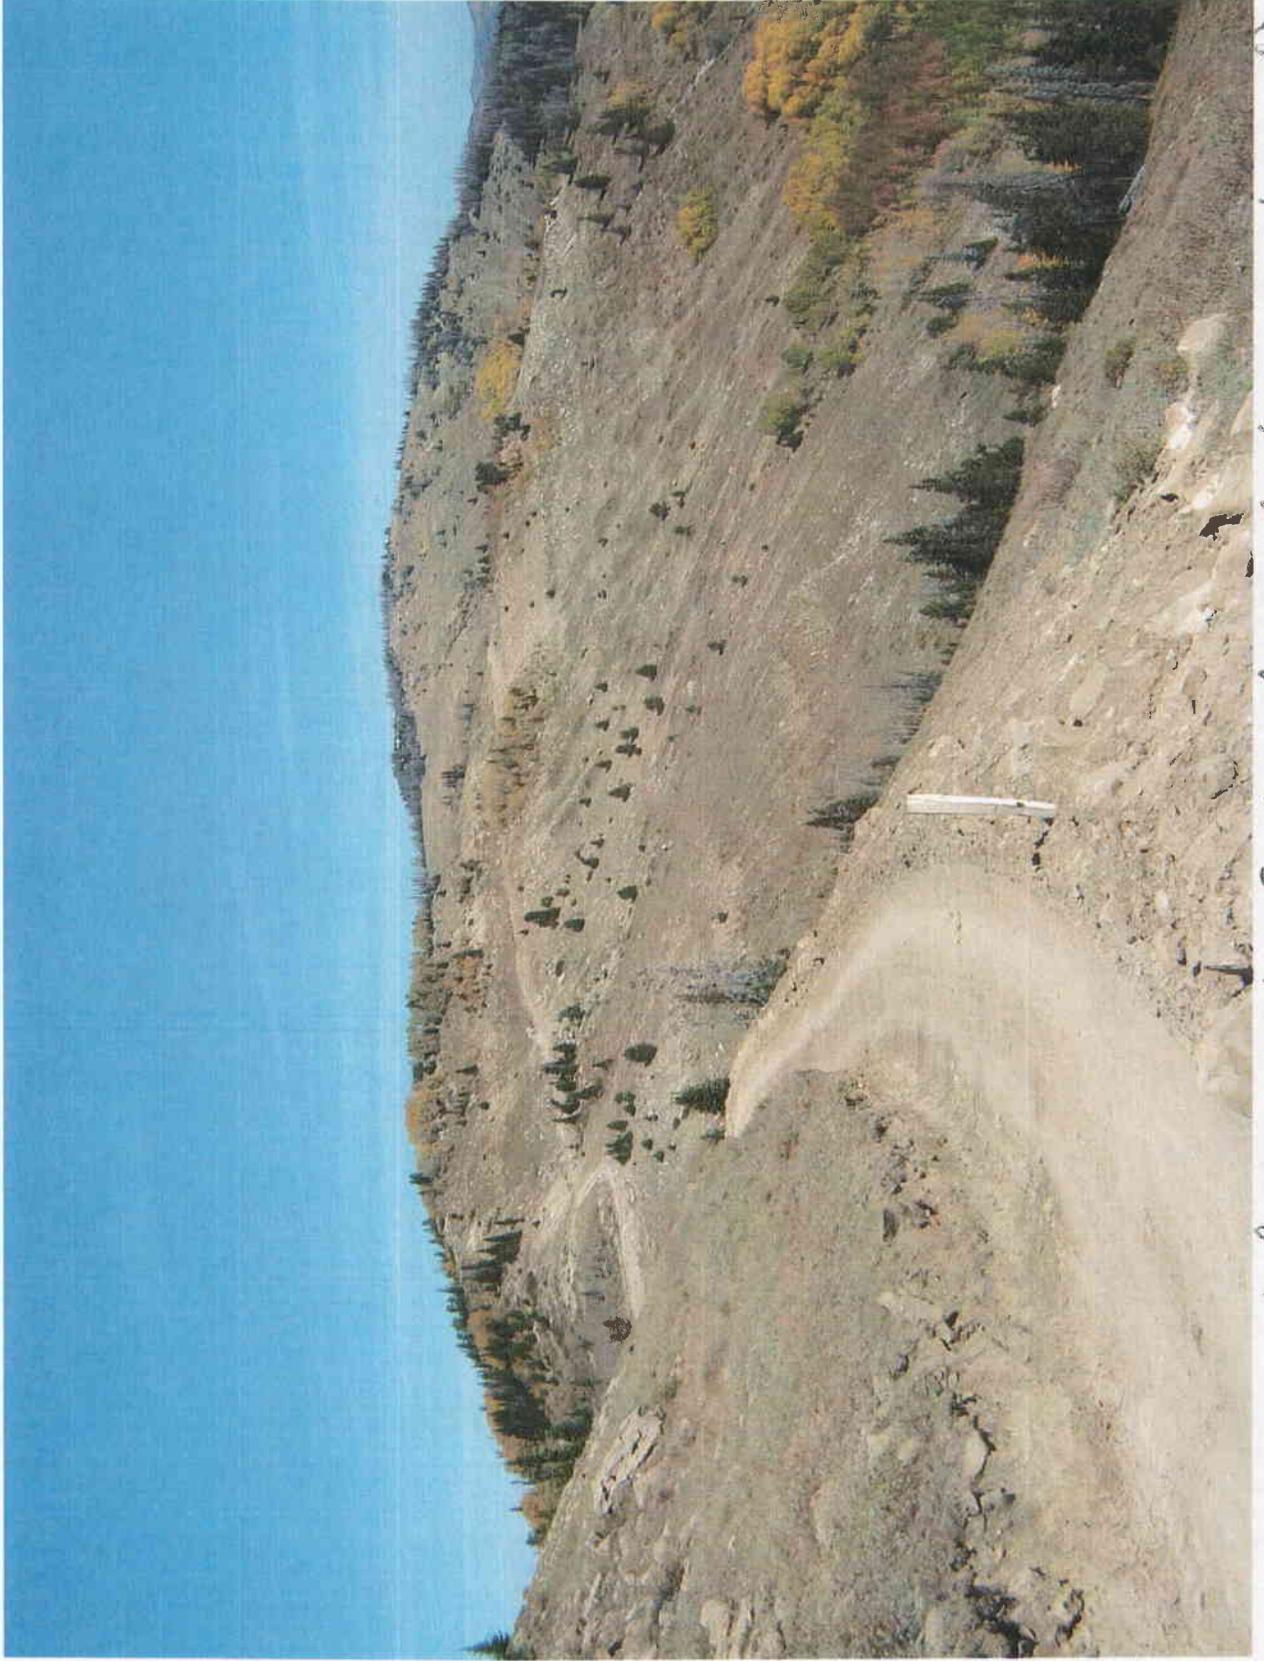
Unreclaimed segment of SITLA road (now reclaimed)

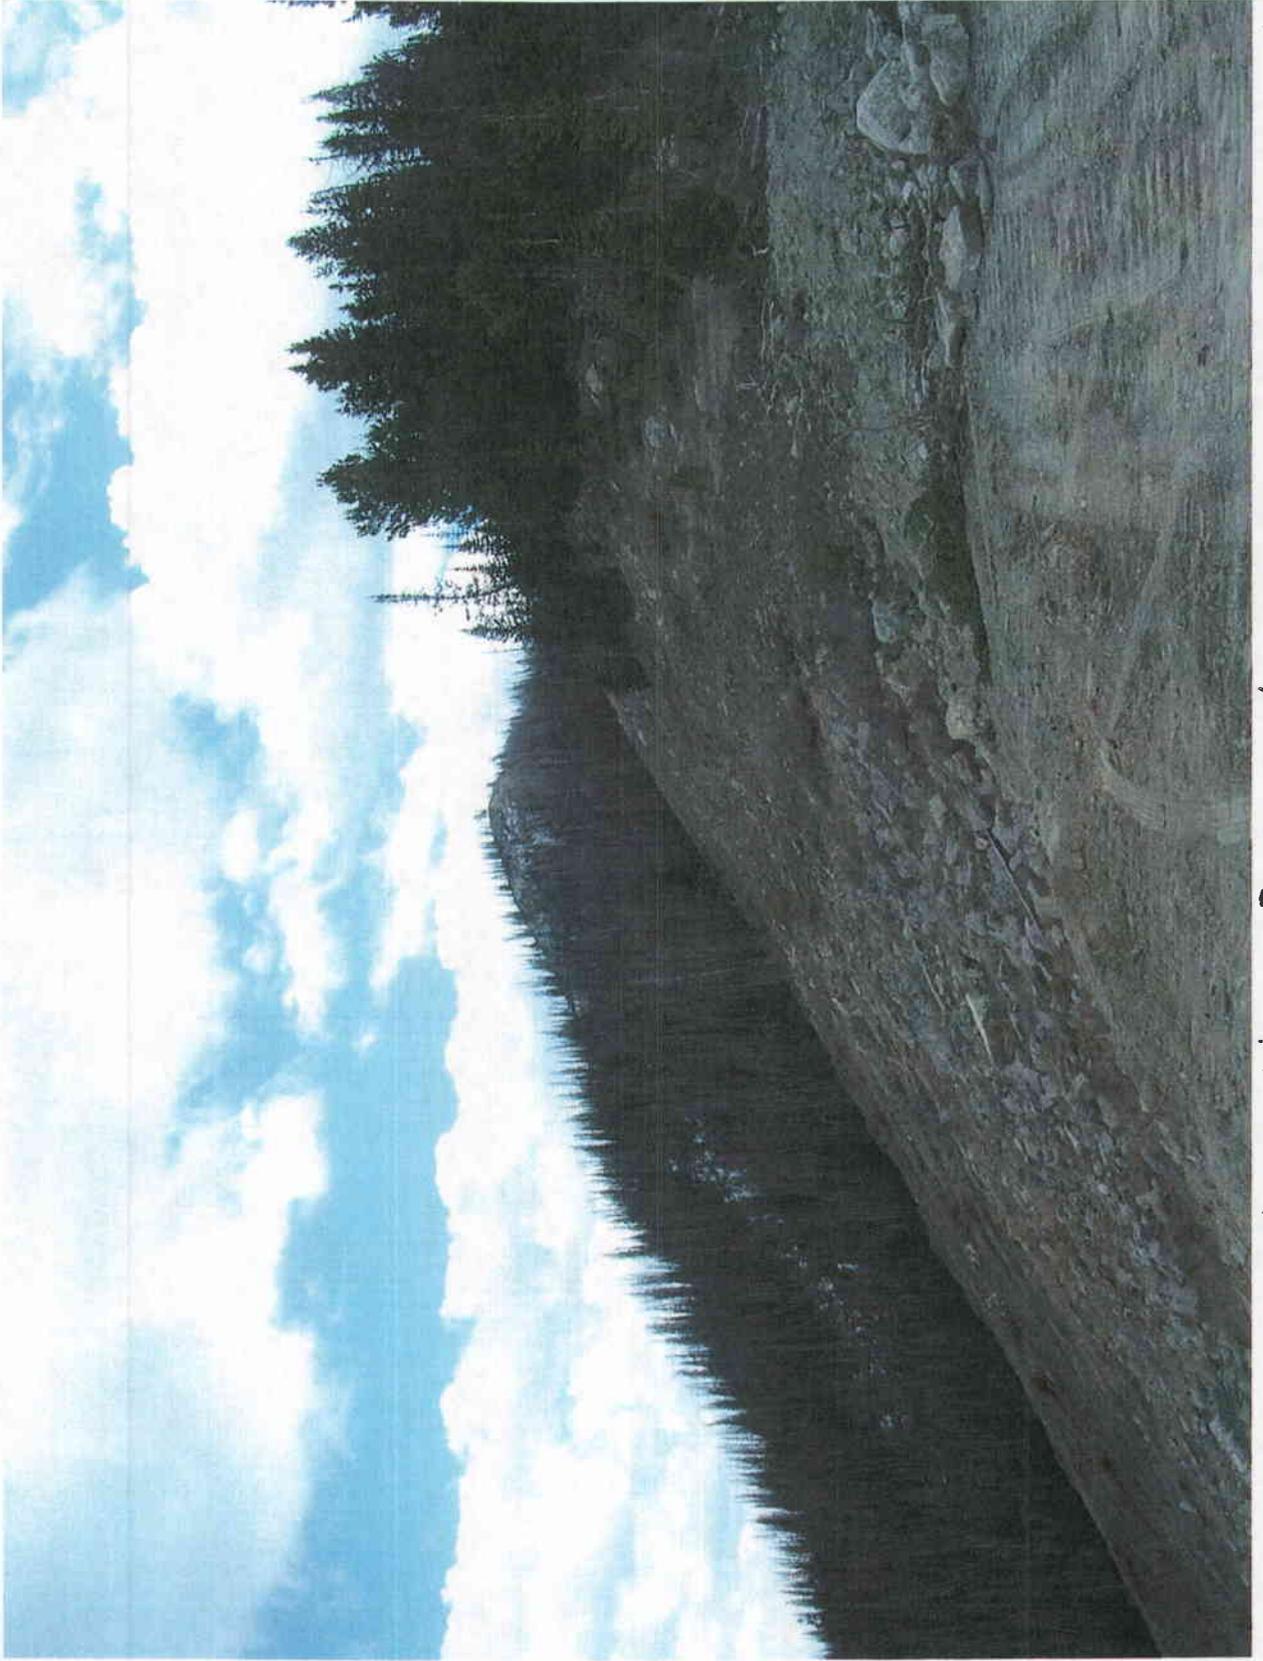
Reclaimed section of SITLA road

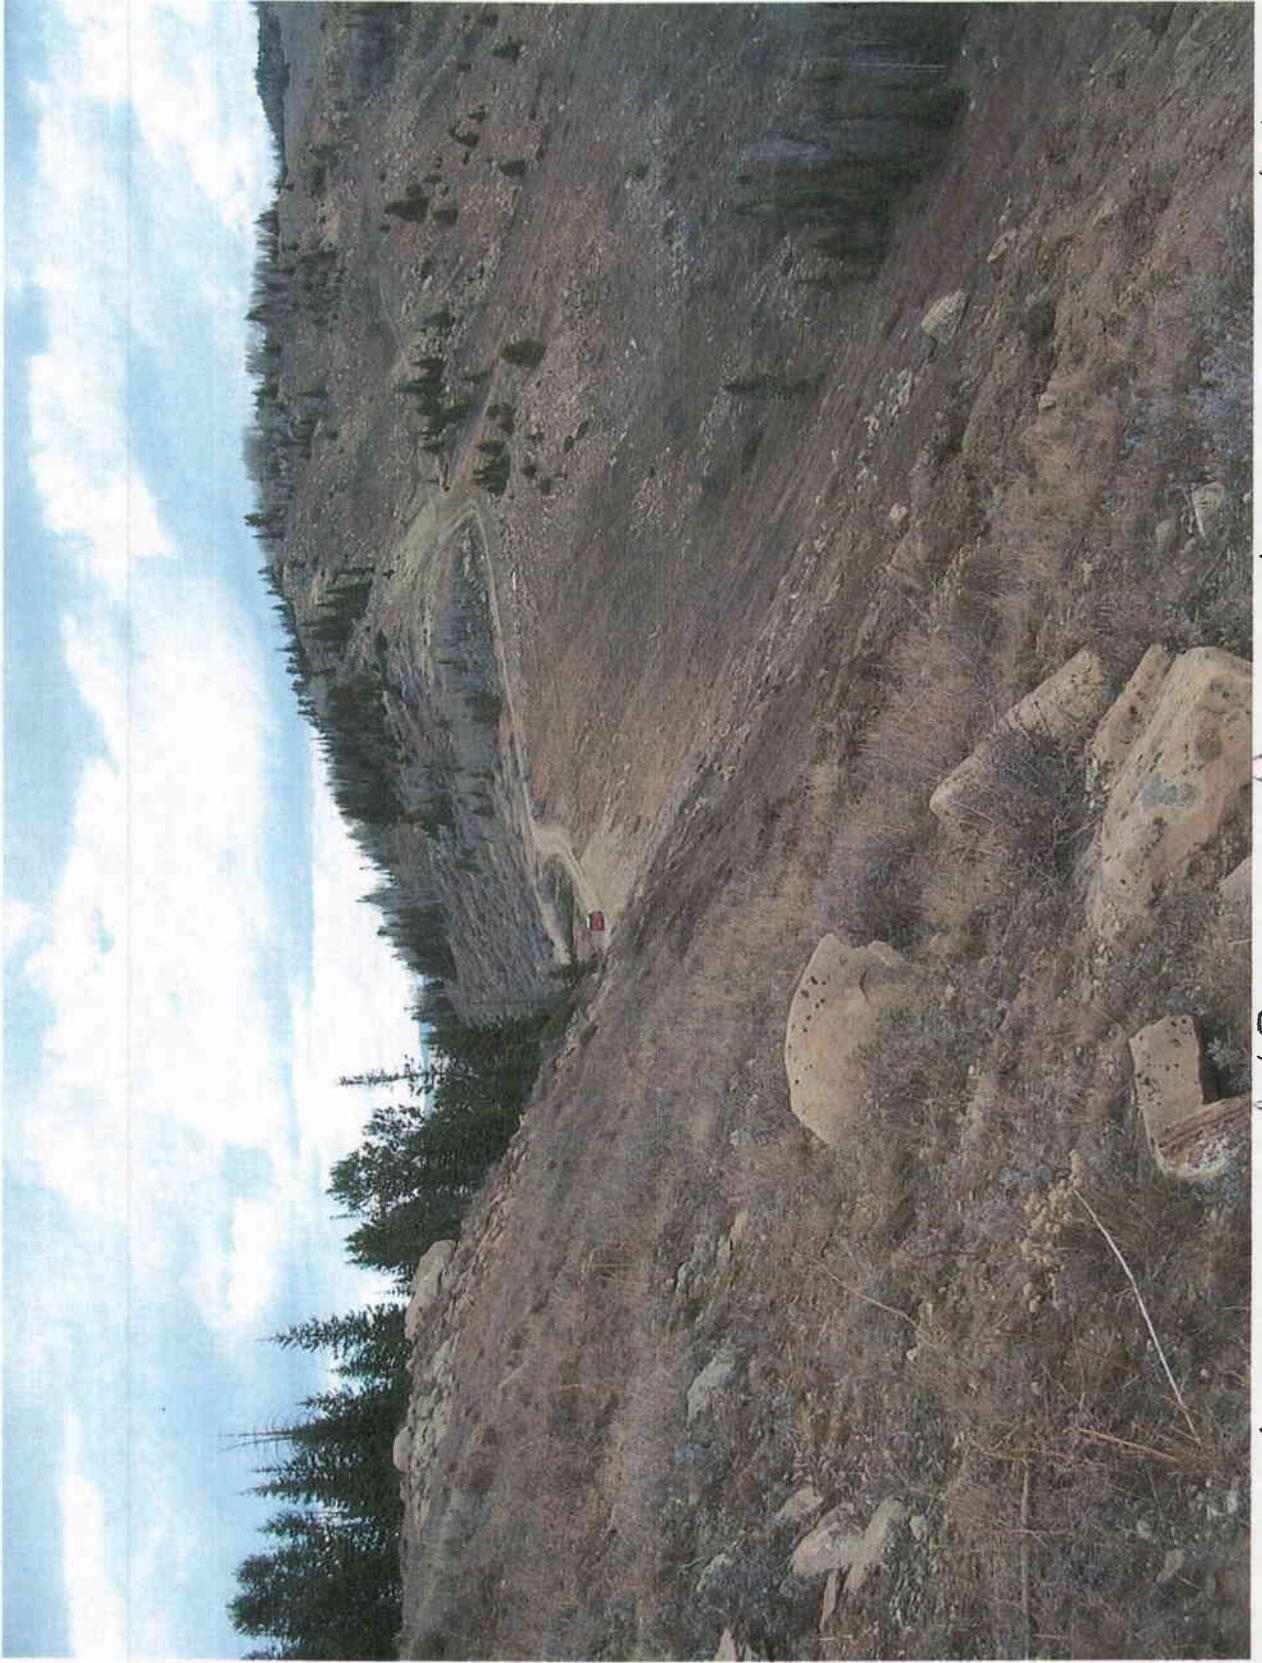
Reclaimed SITLA road (foreground), existing SITLA road (background)

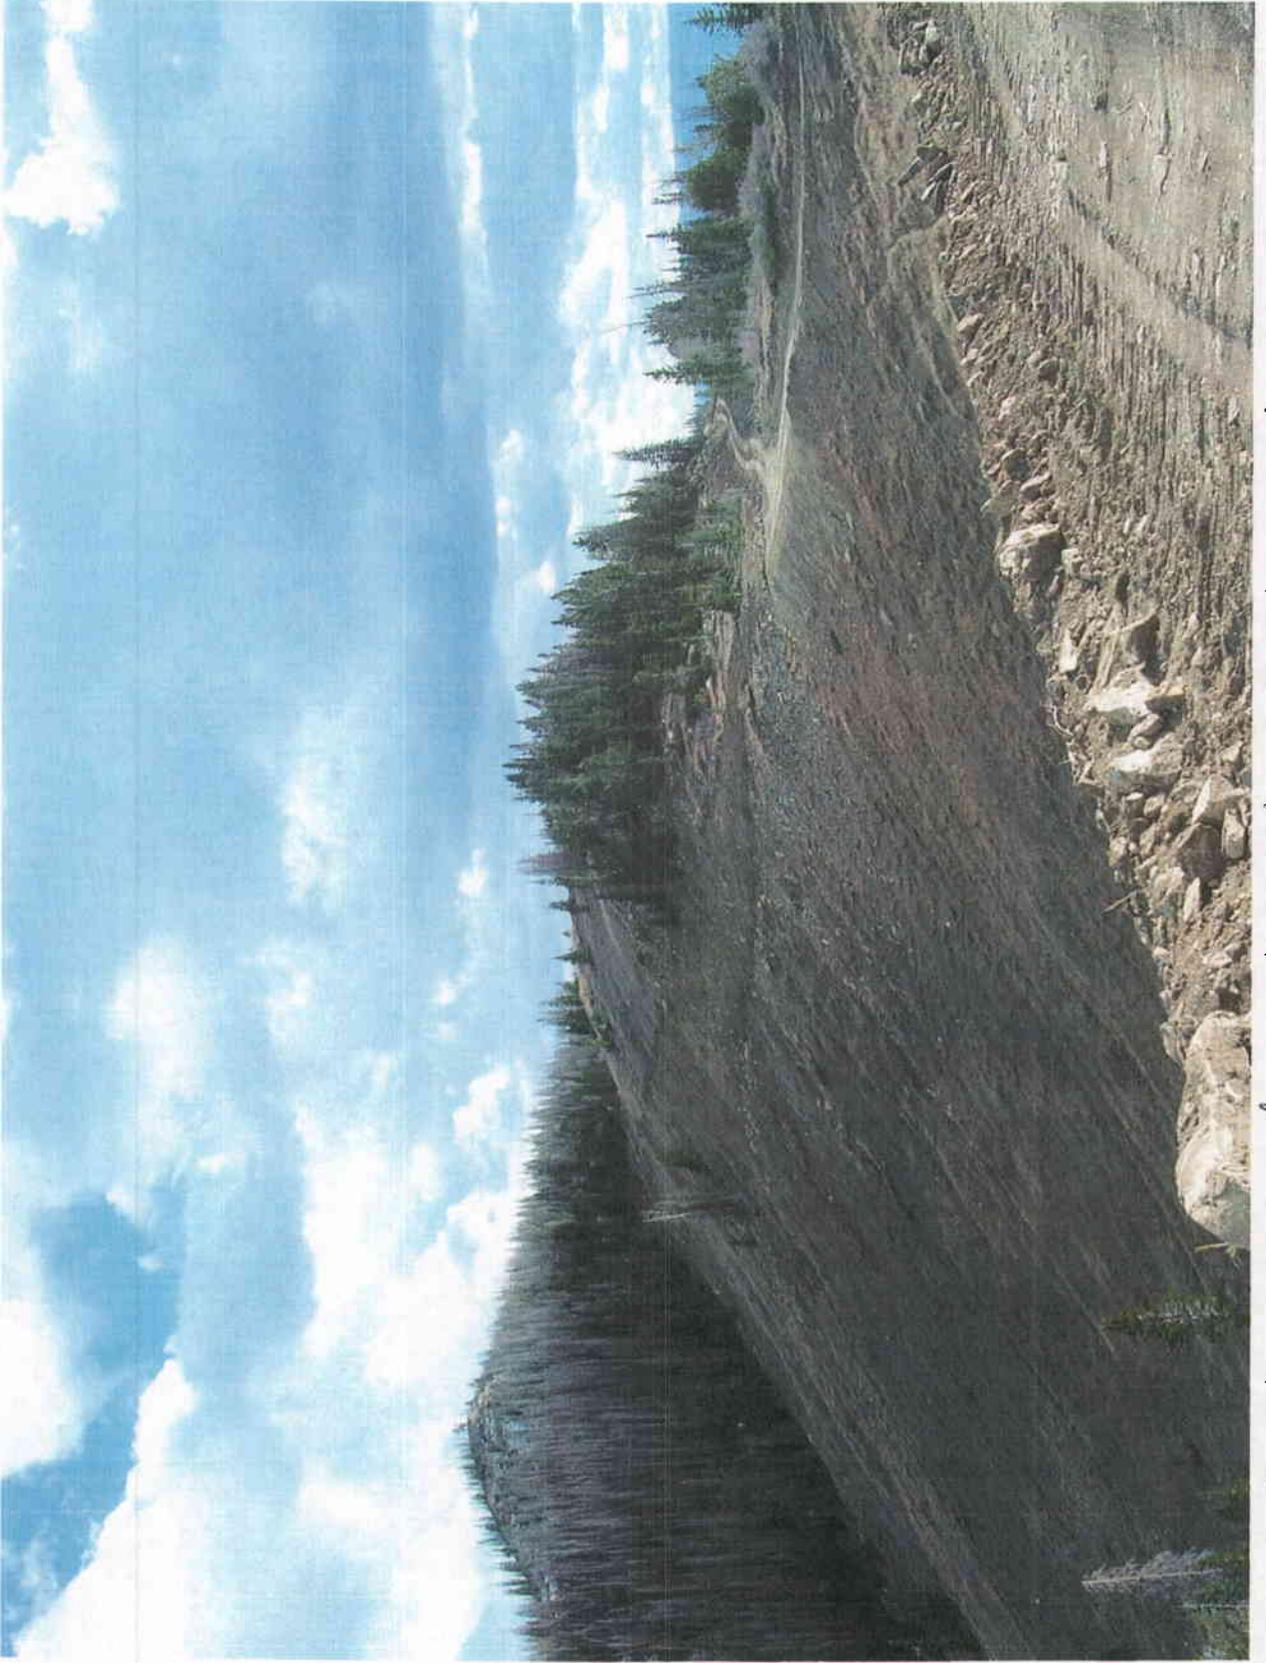
Reclaimed and realigned S/TLA road

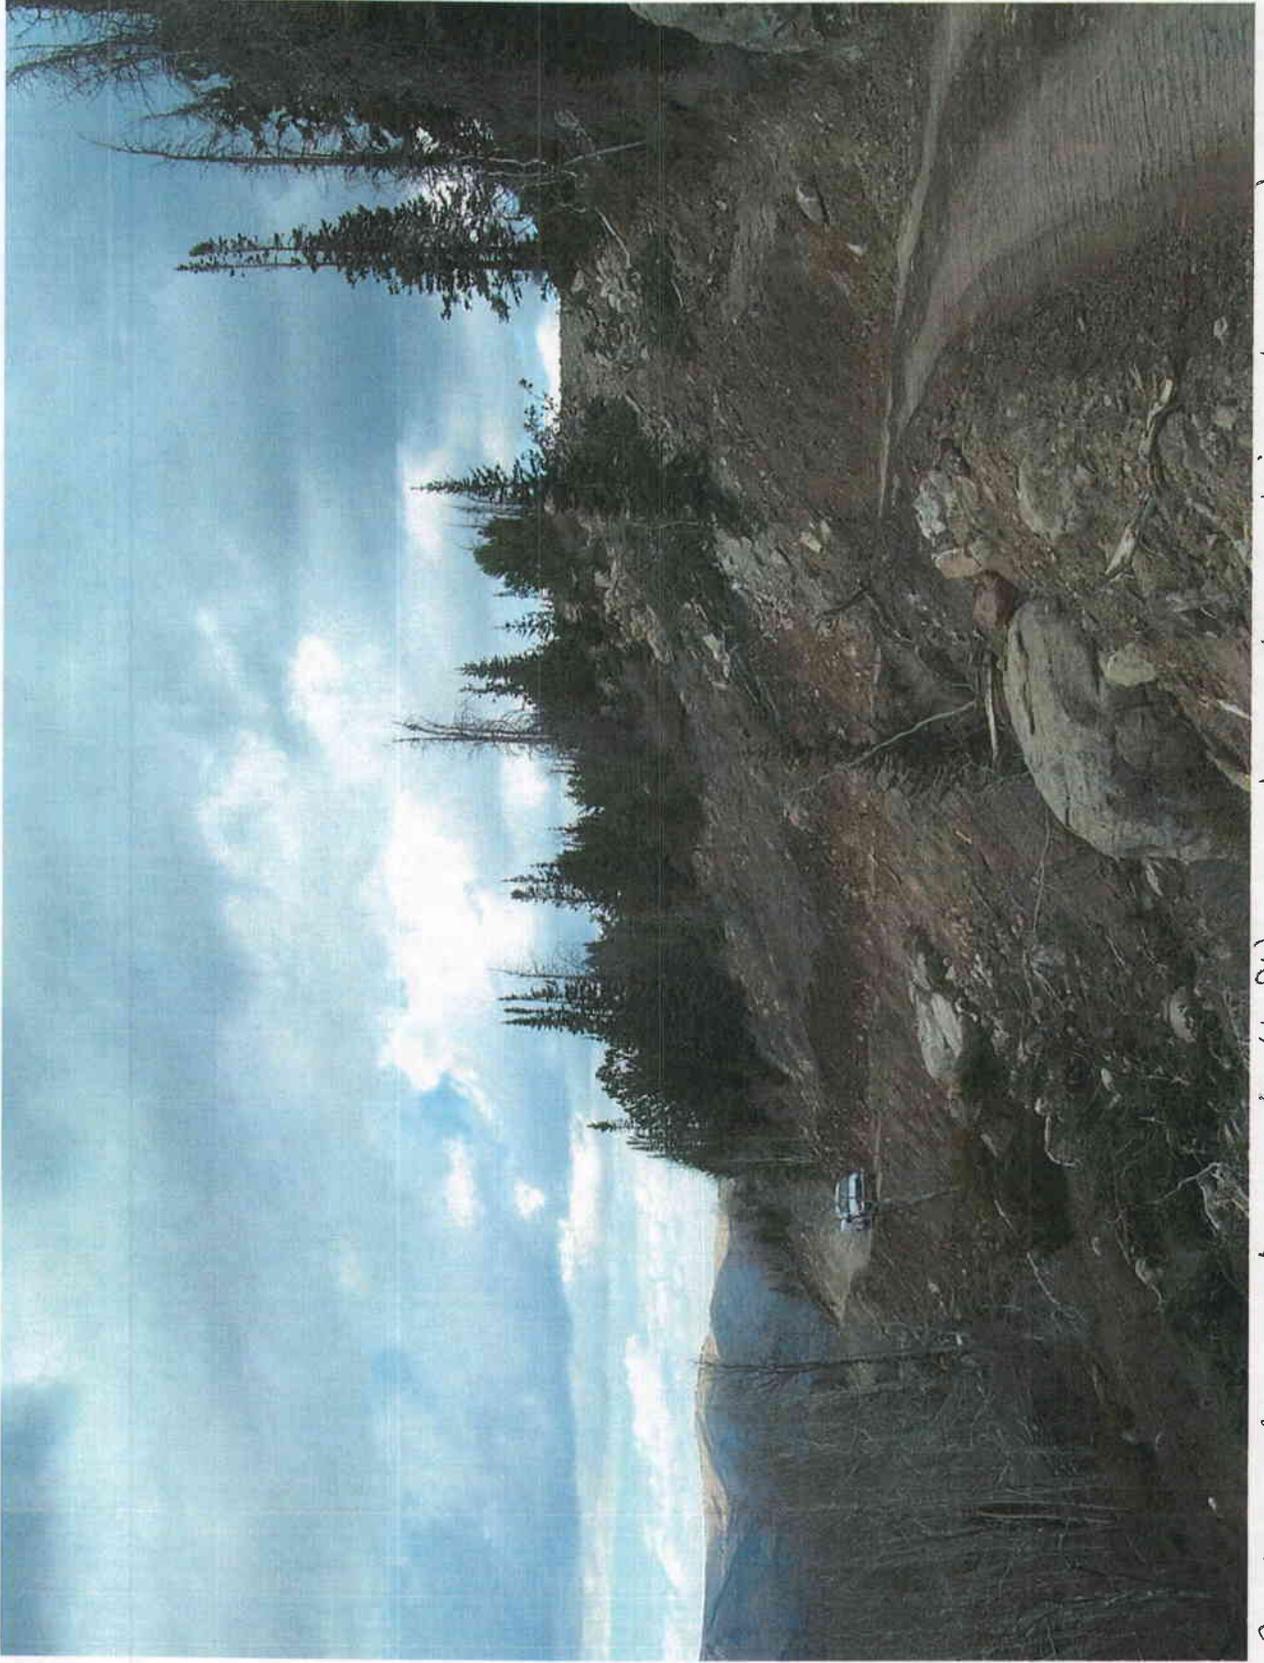
Realigned SITLA road (left), reclaimed section (right)

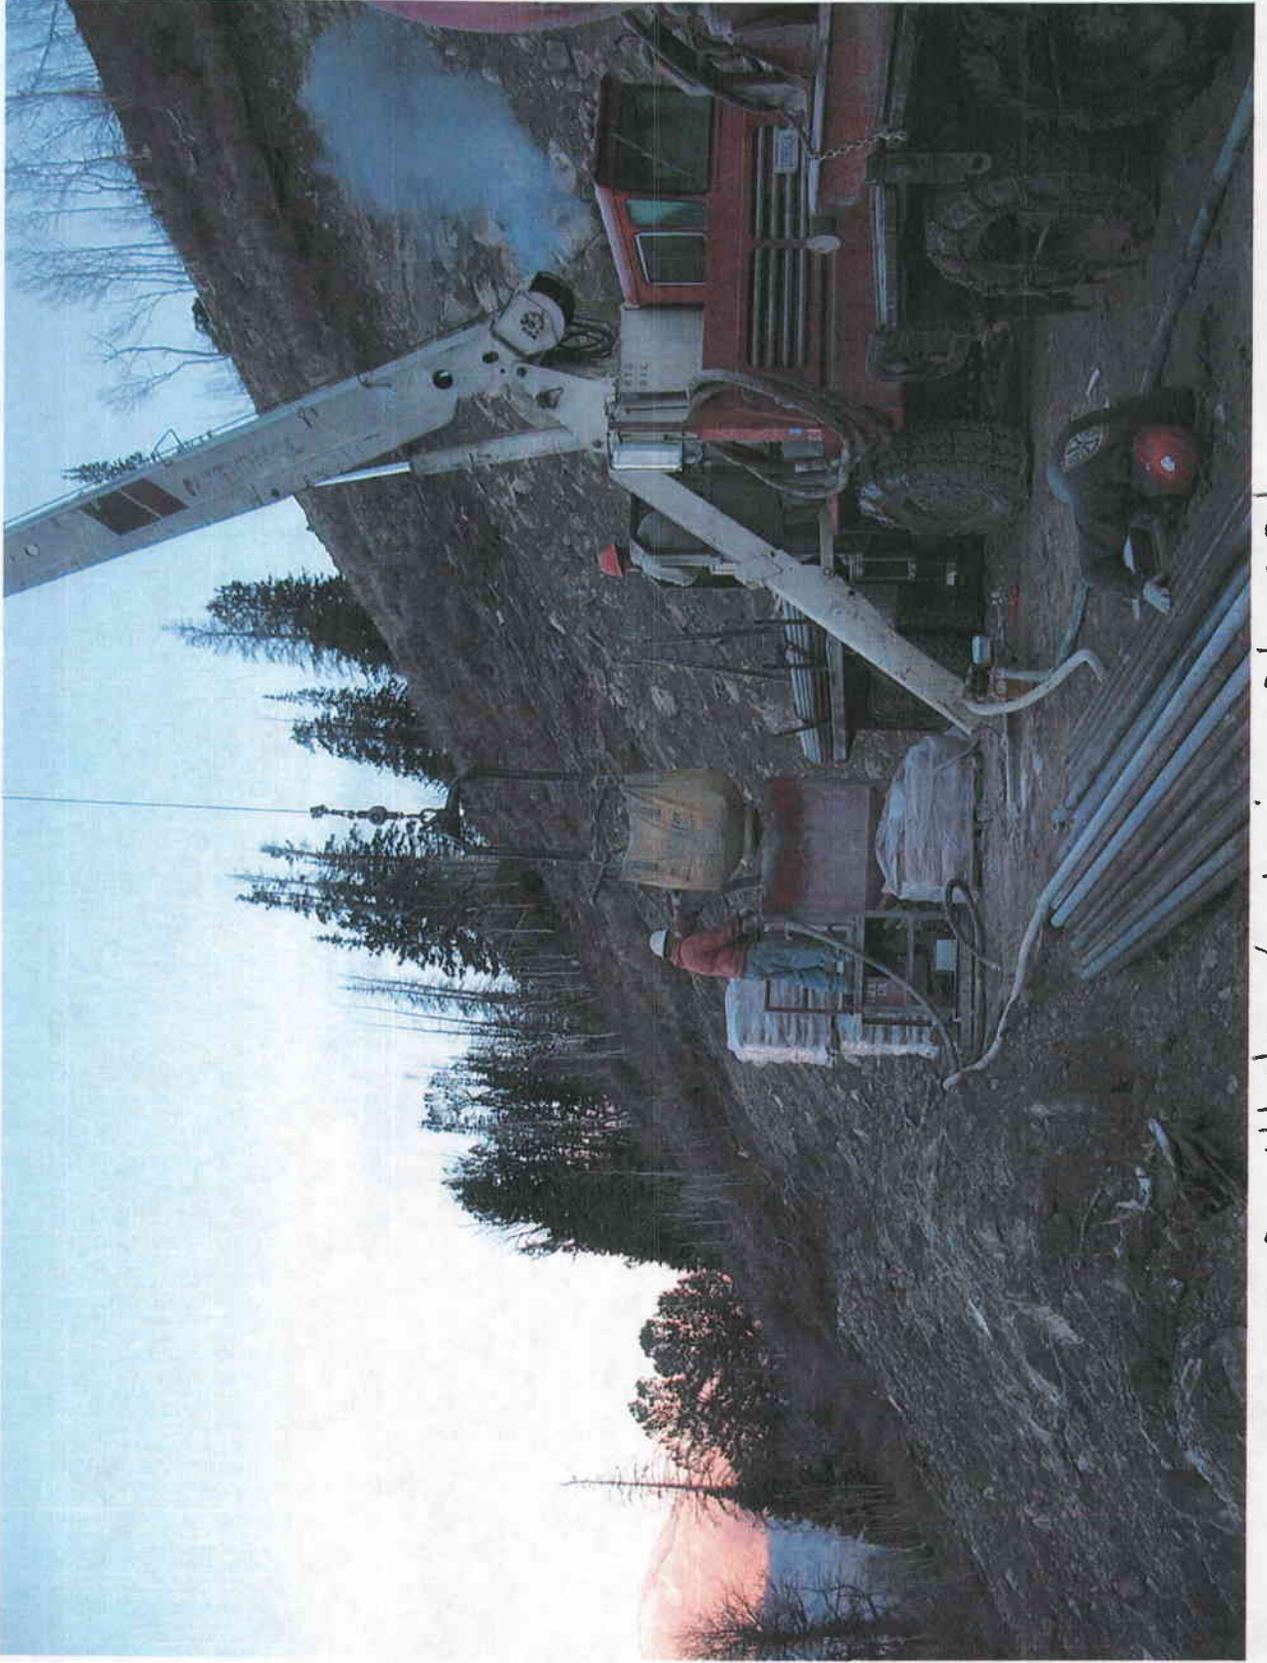
Drill hole to being plugged

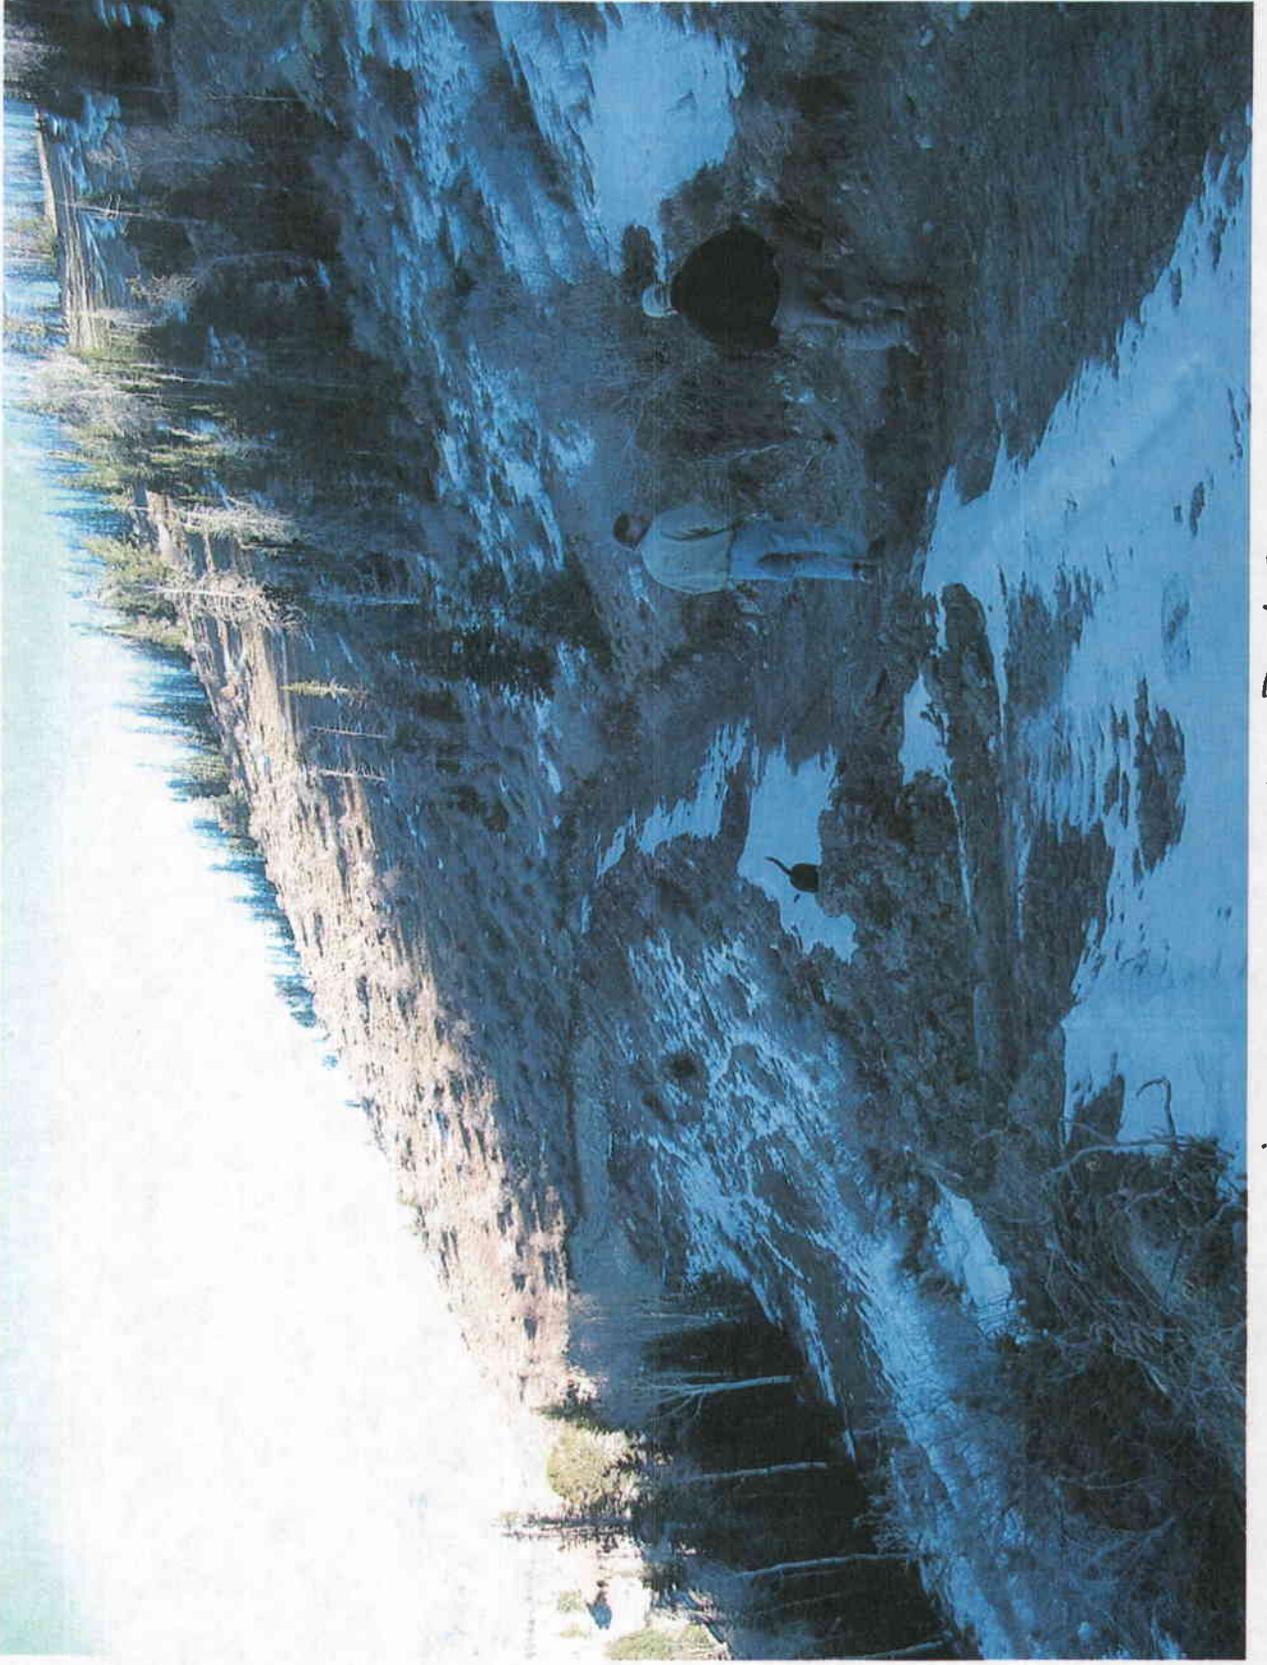
Unreclaimed road into Pad 2

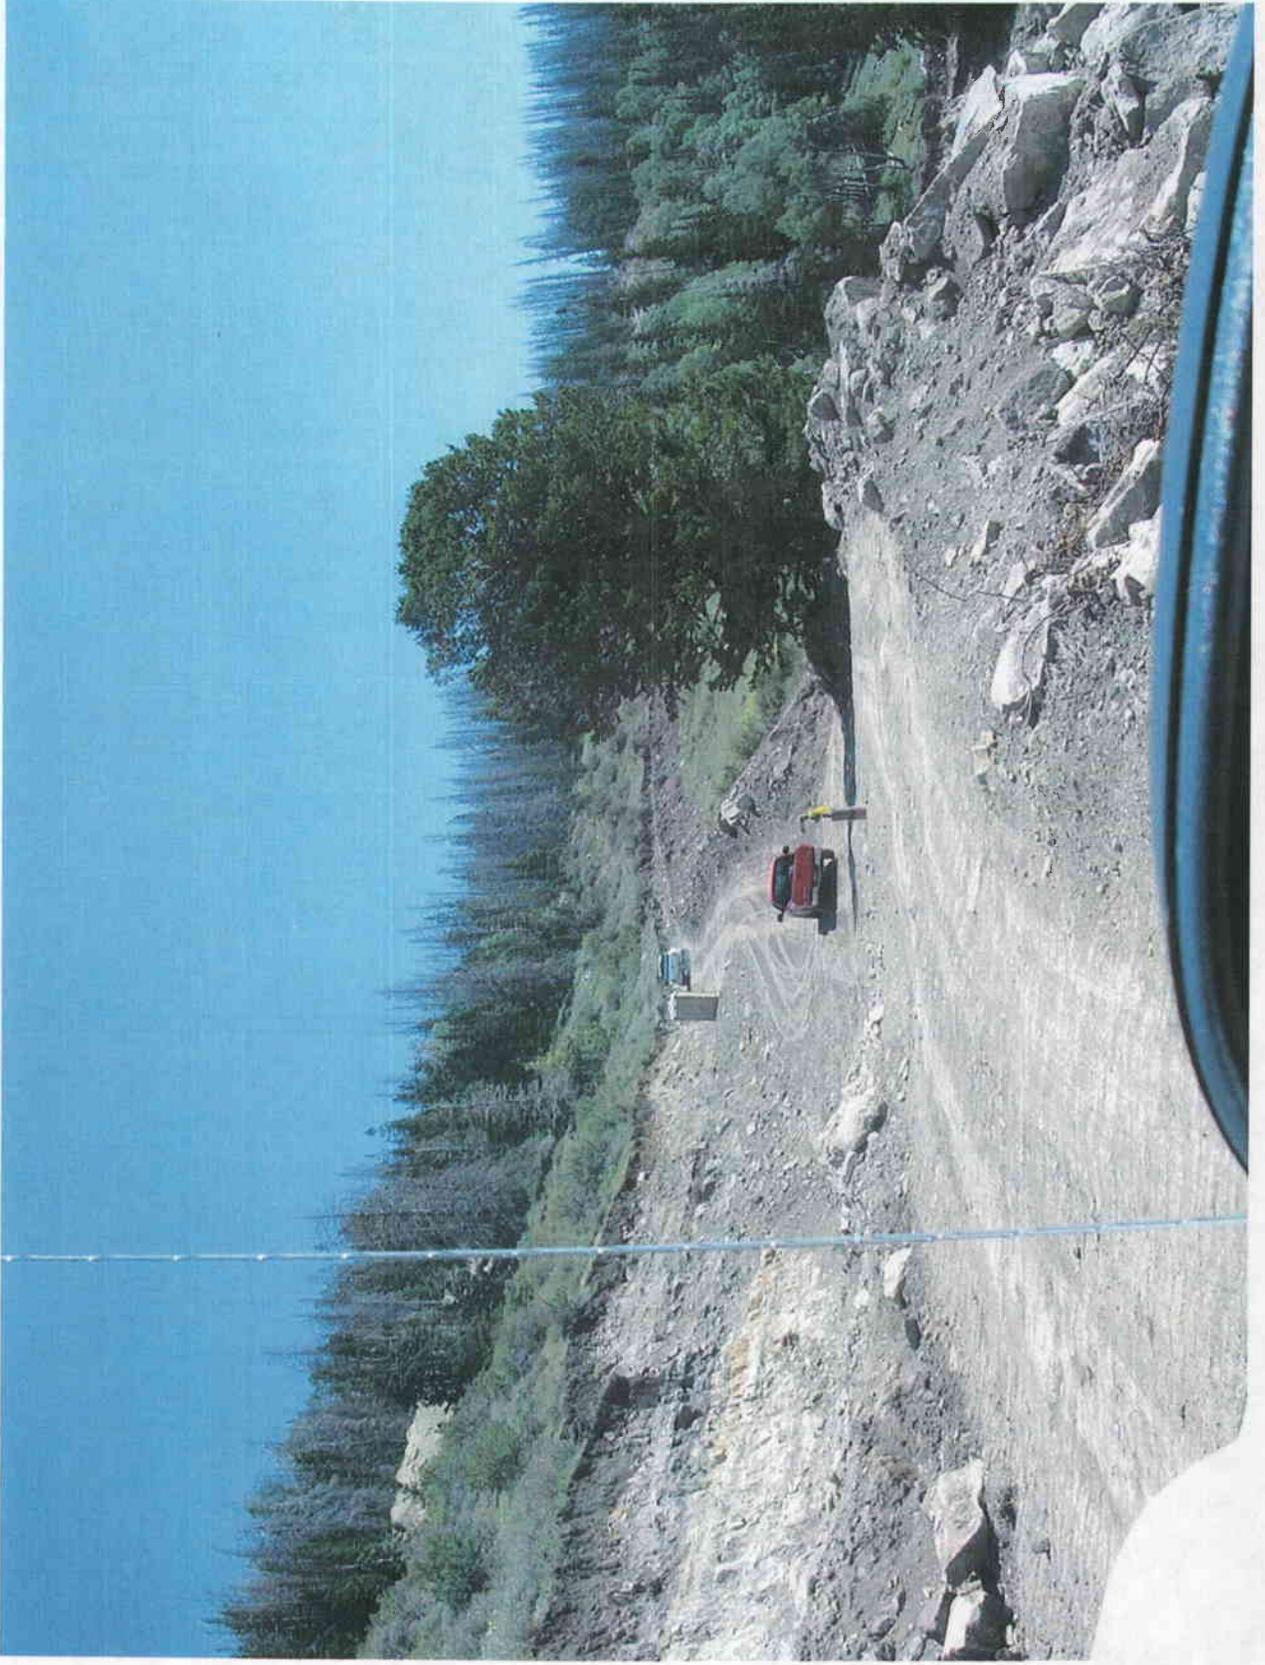
Pad 2 pre-reclamation
