# GENWAL MINE 015/032

## MINING AND RECLAMATION PLAN

ADDENDUM TO THE RECLAMATION PLAN  
FOR THE

EAST MOUNTAIN EMERGENCY  
DRILLPADS  
TASK # 2893

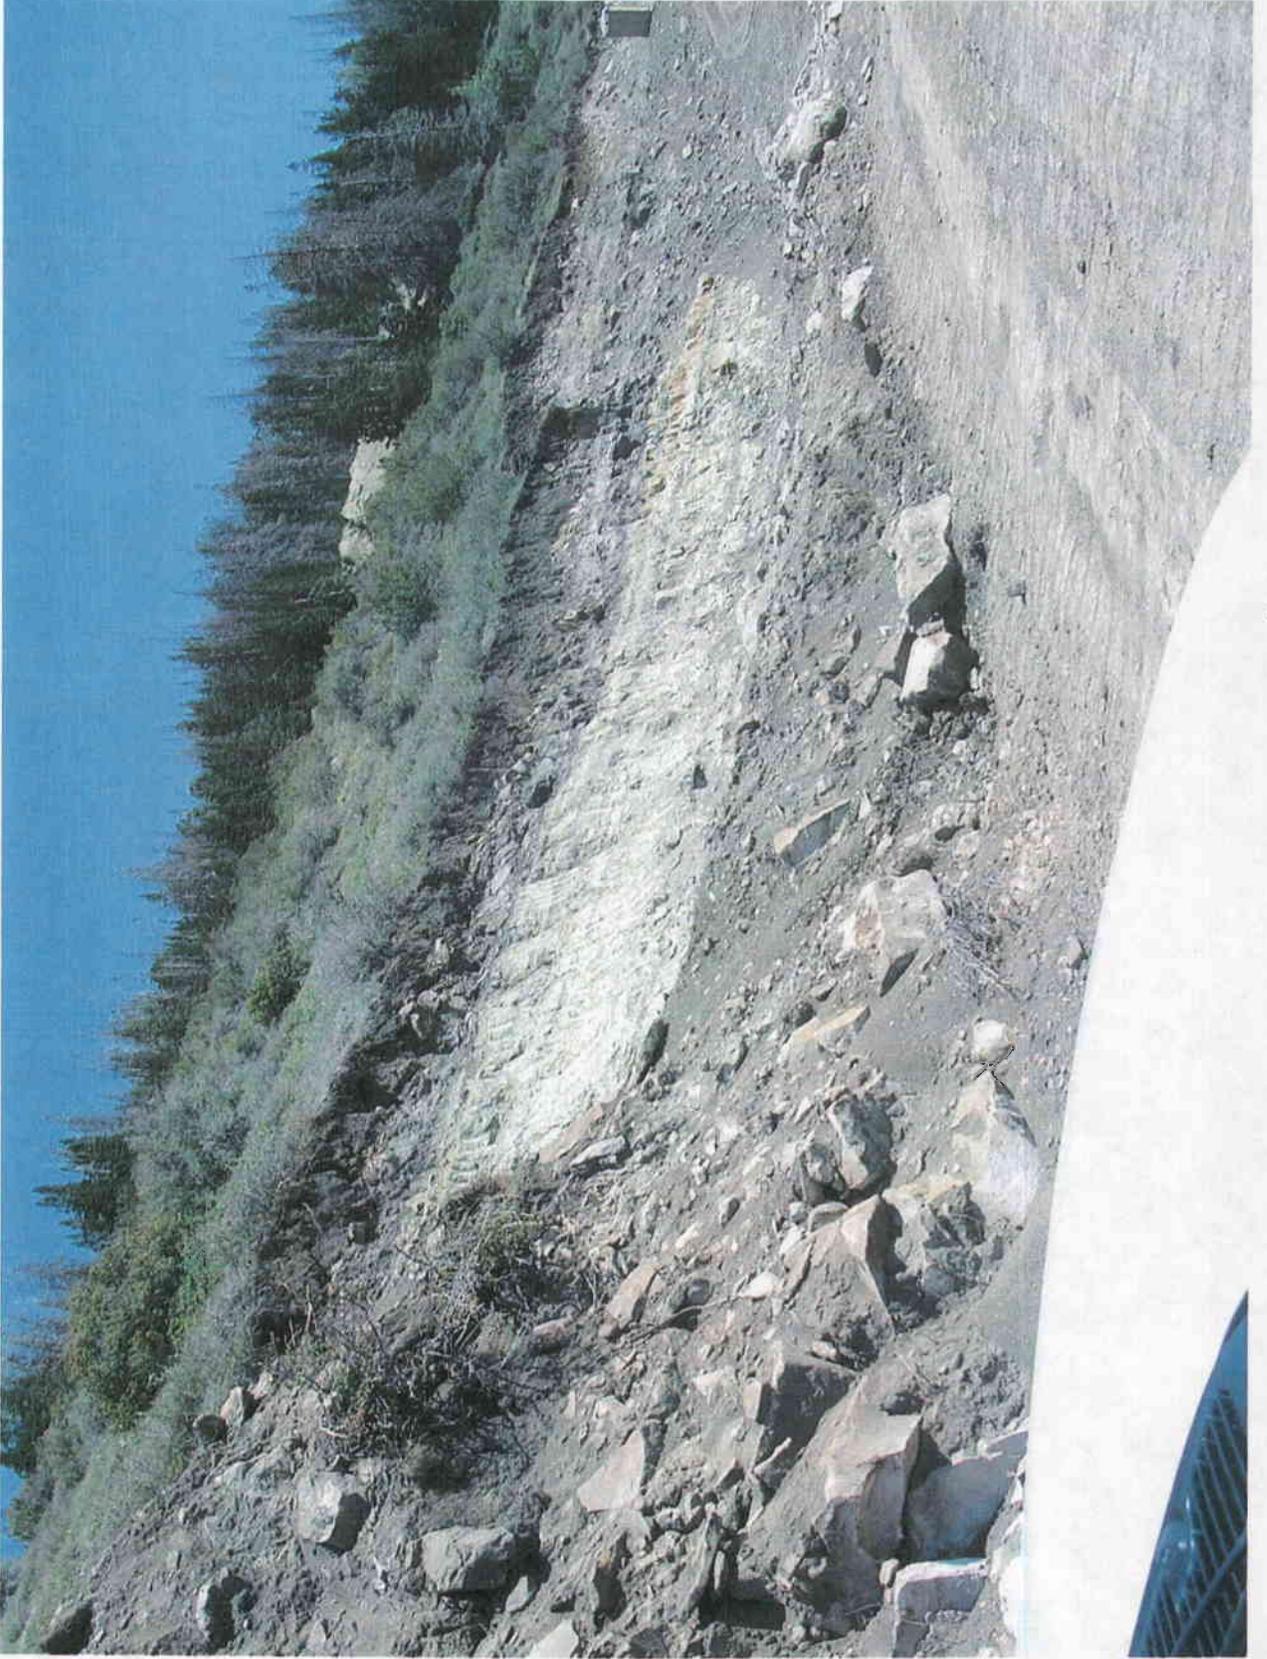
Pad 2, pre-reclamation

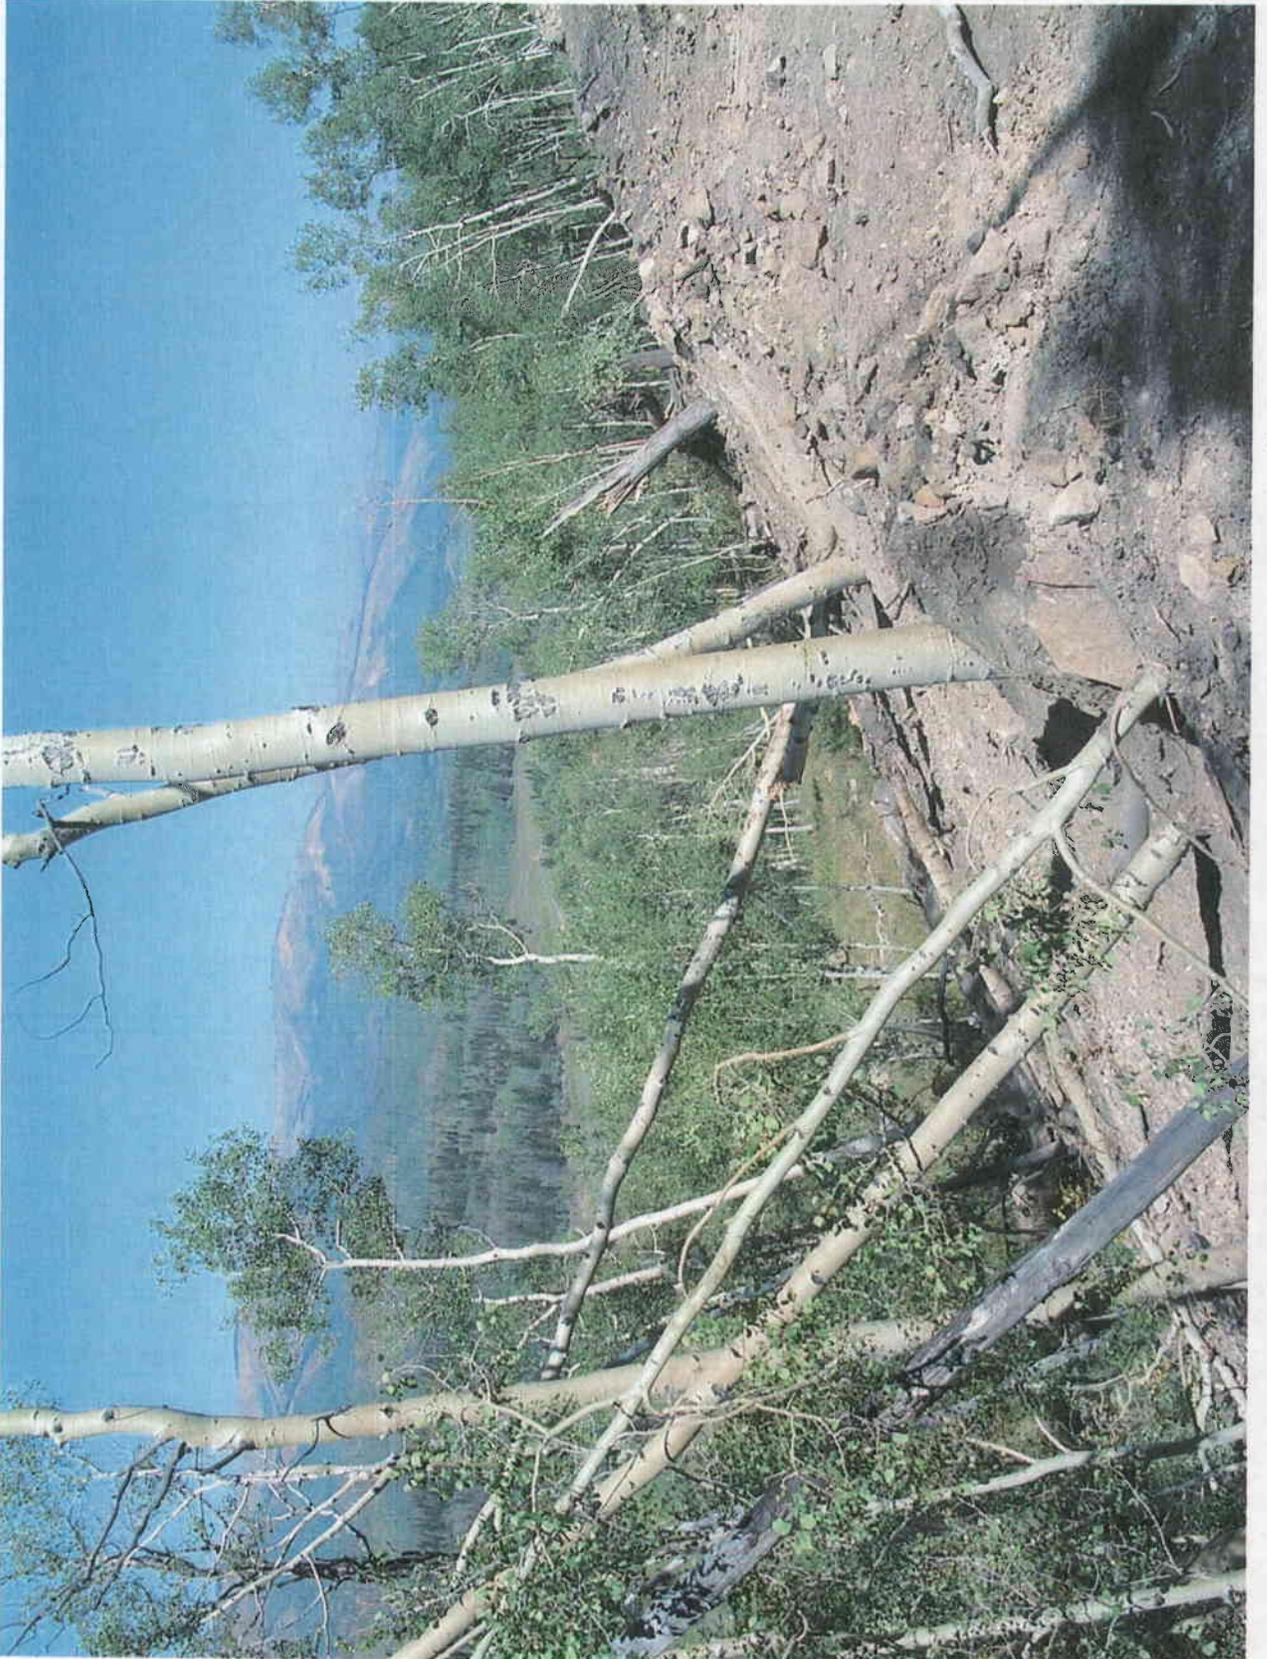
Pod 3 outslope, pre-reclamation

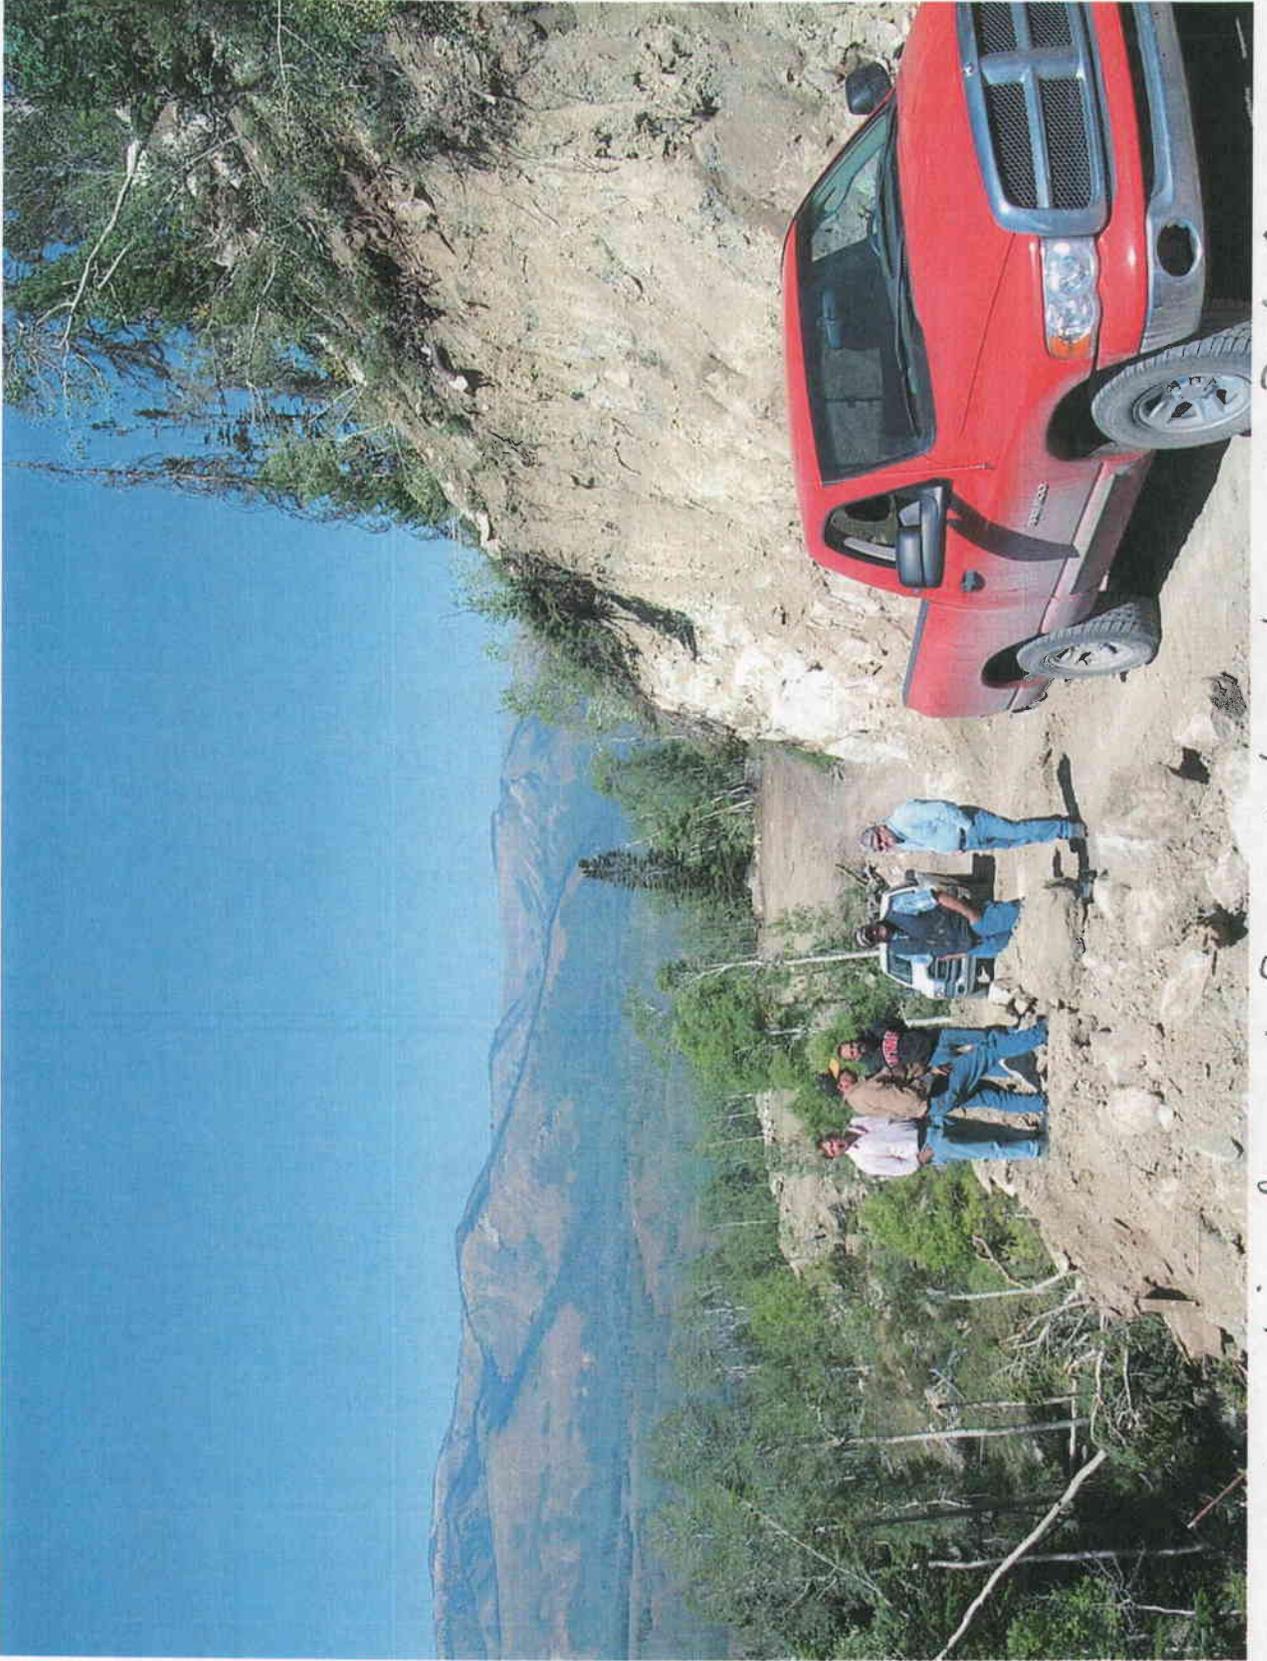
Unreclaimed road from ledge down to Pad 4

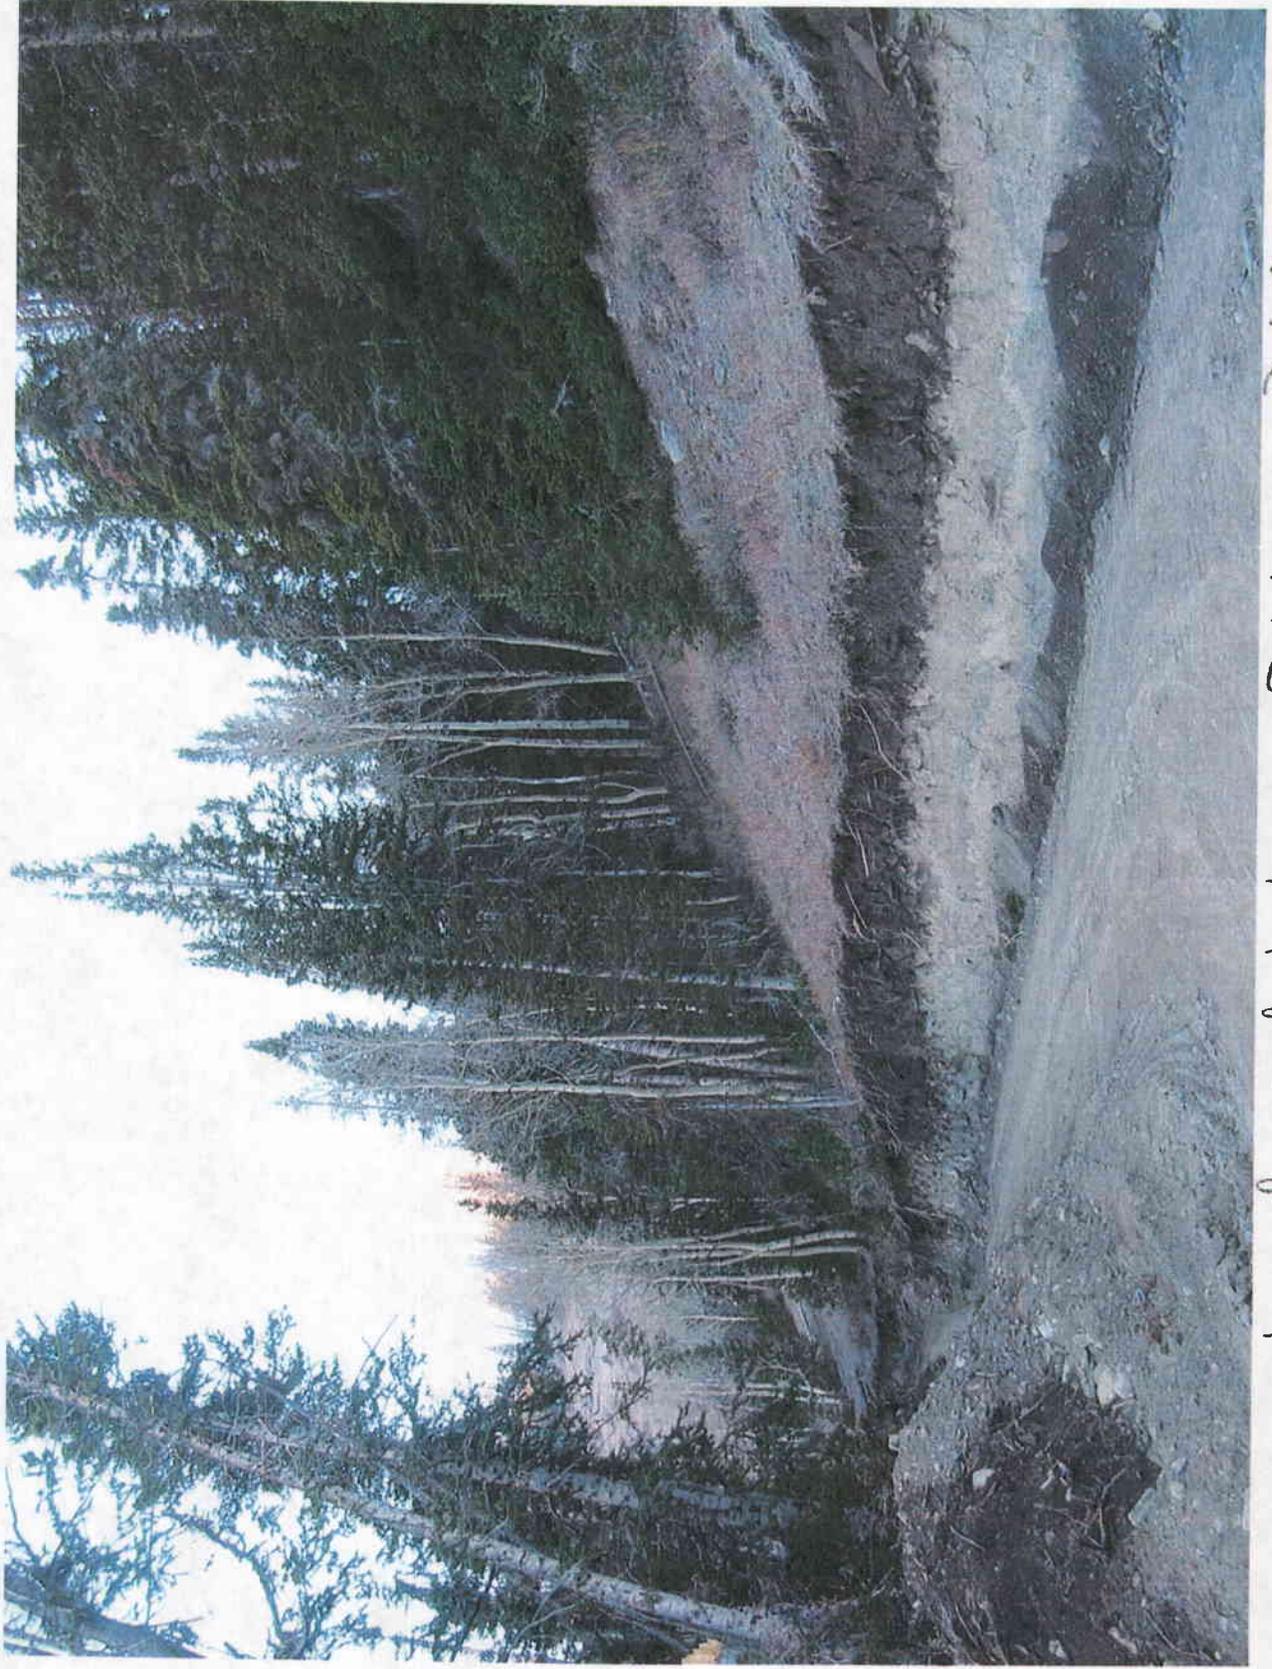
Unreclaimed road between Pad 6 and Pad 4

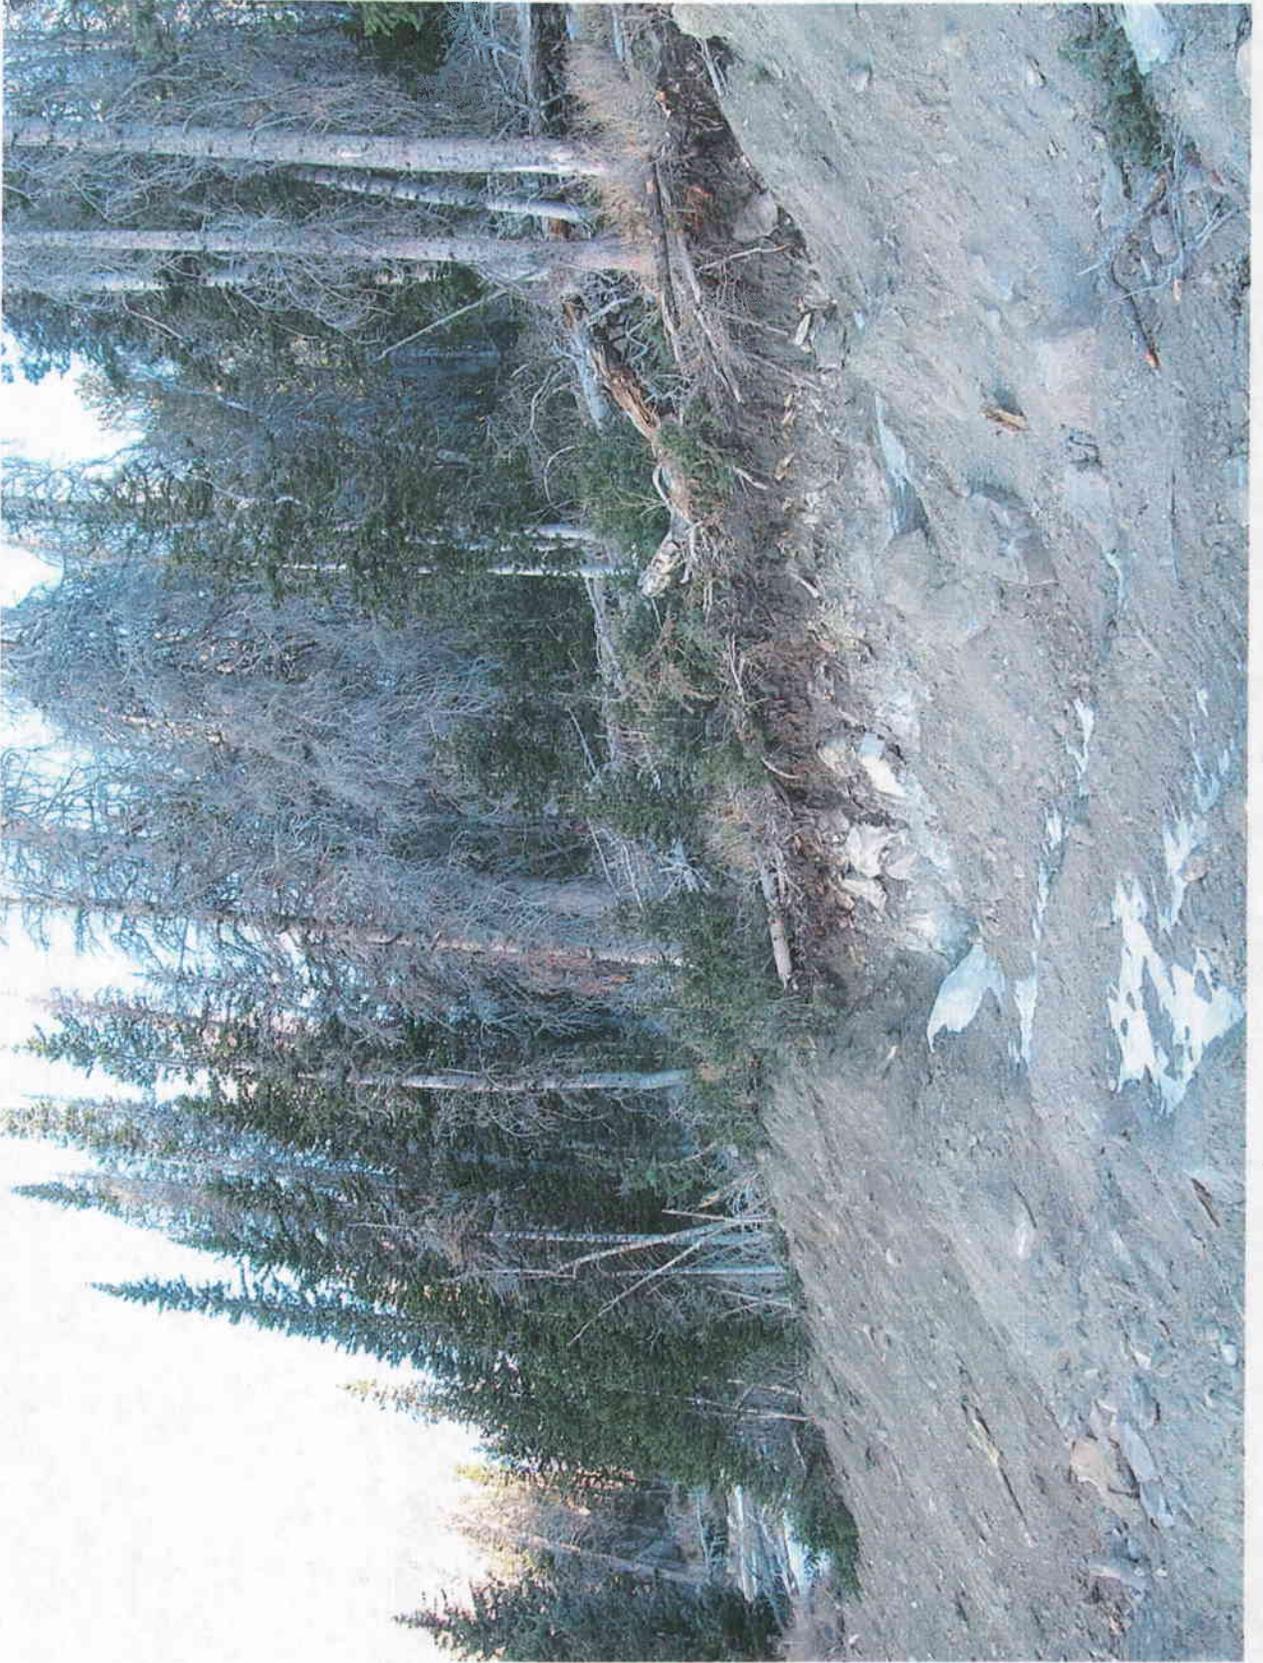
Partially reclaimed Pad 5

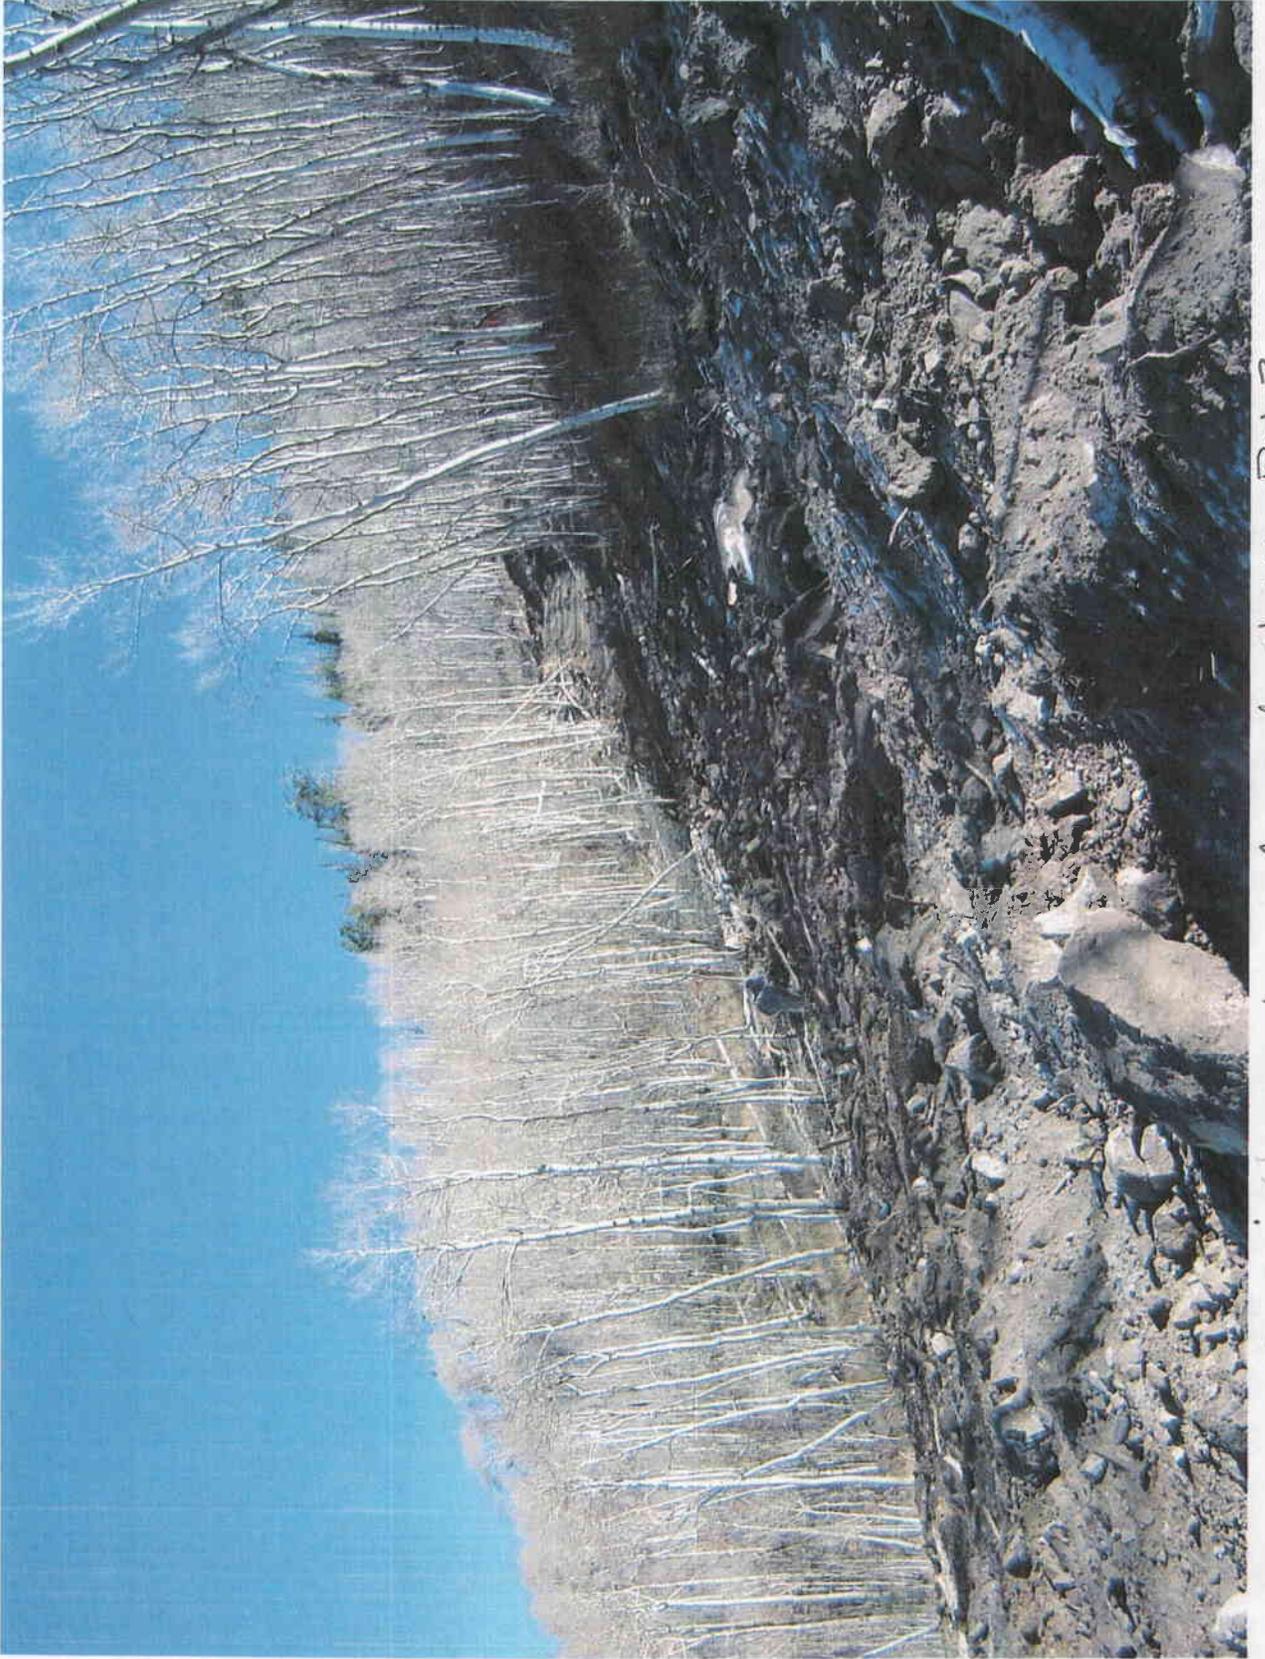
Partially reclaimed road above Pad 3

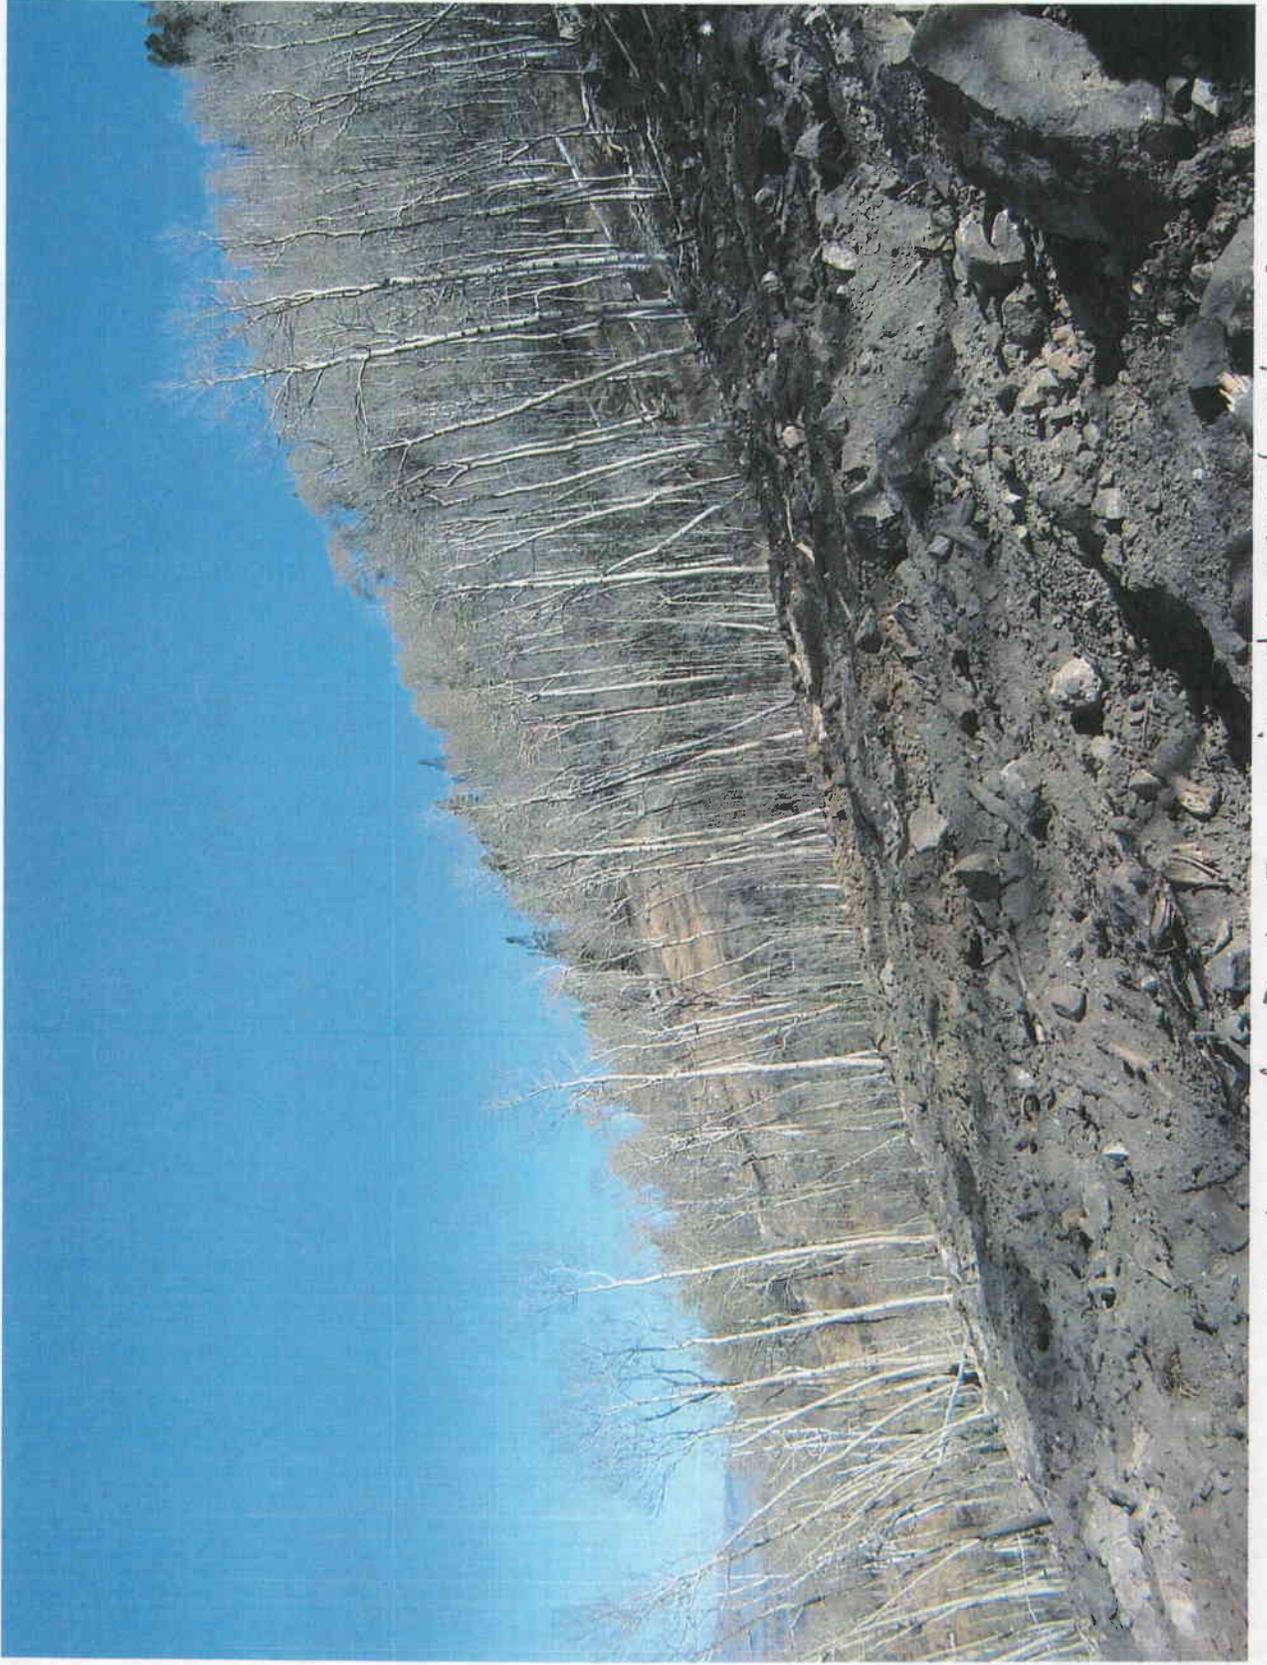
Reclaimed Pad 3 prior to wood straw

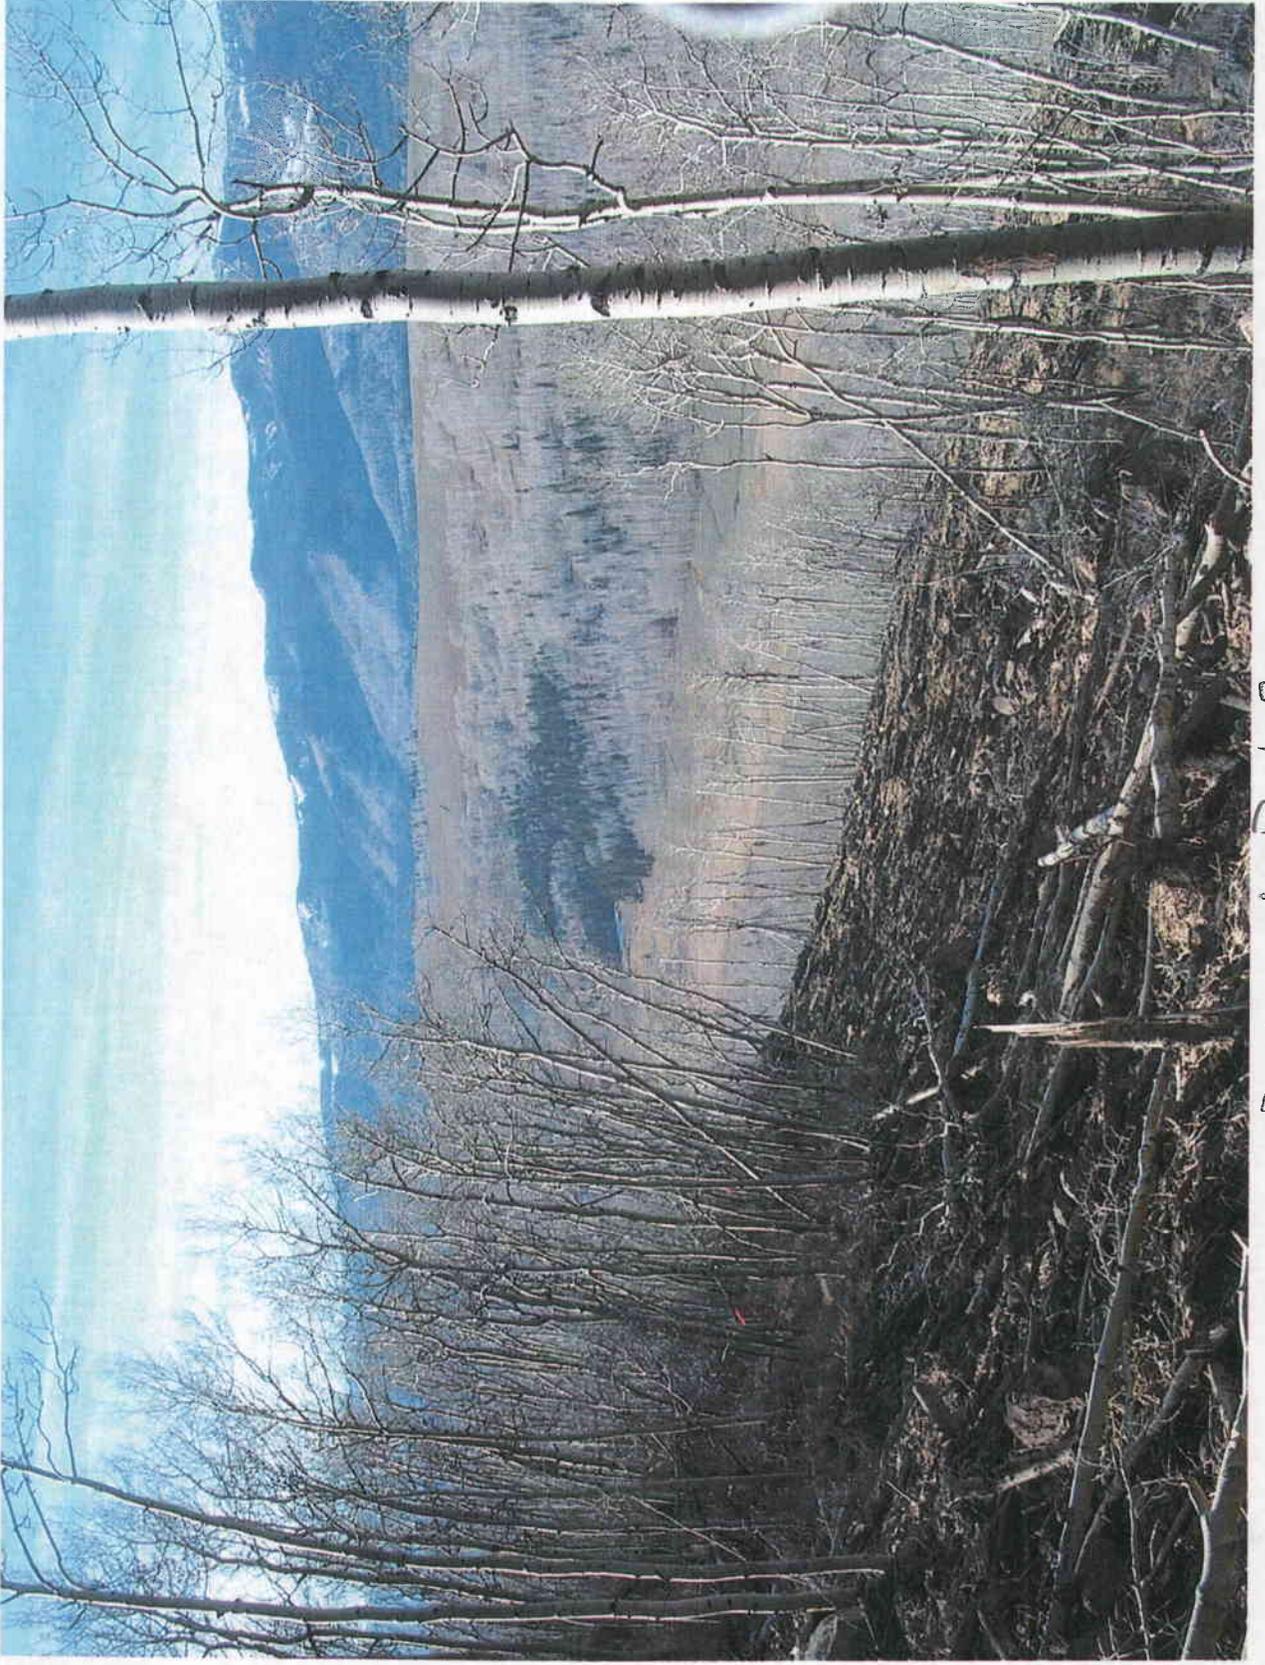
Reclaimed Pad 3

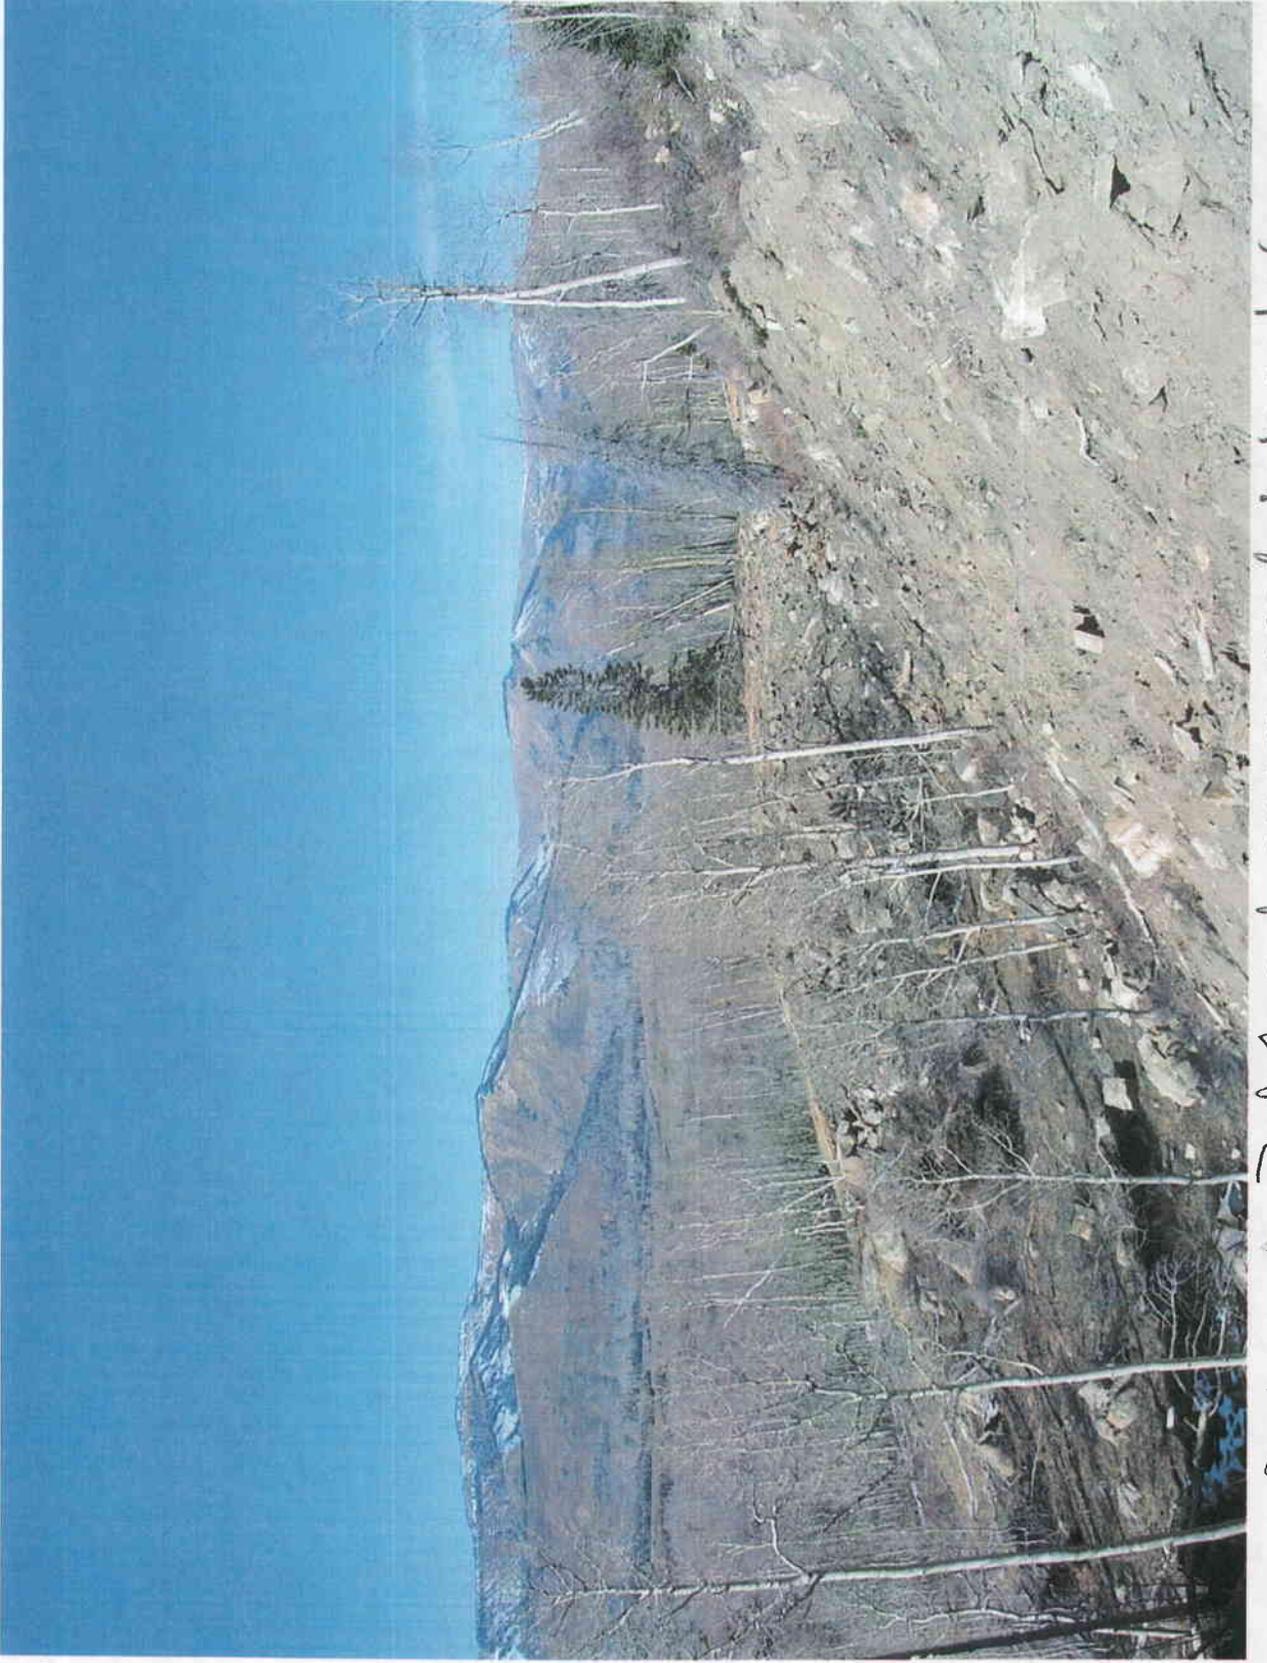
Reclaimed Pad 4 and access road below ledge

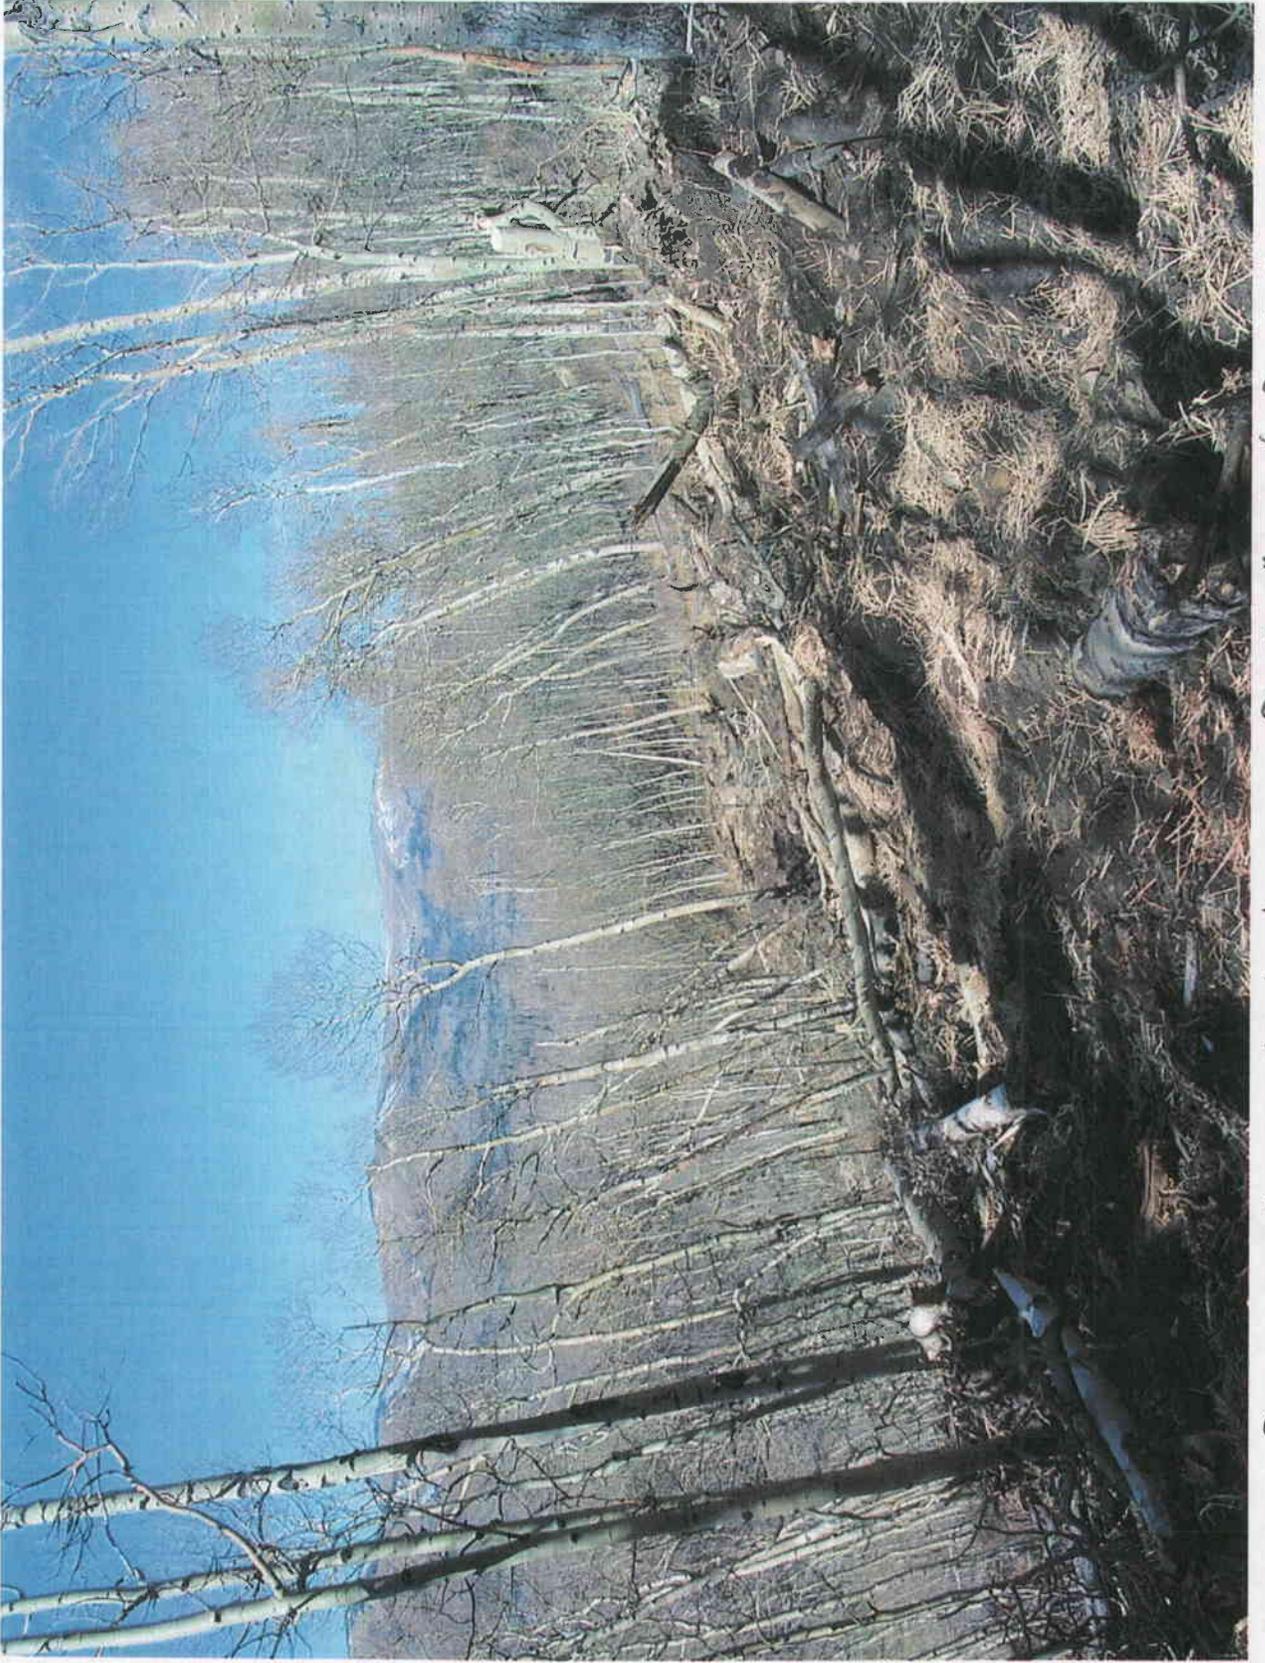
Reclaimed road between Pad 4 and Pad 3

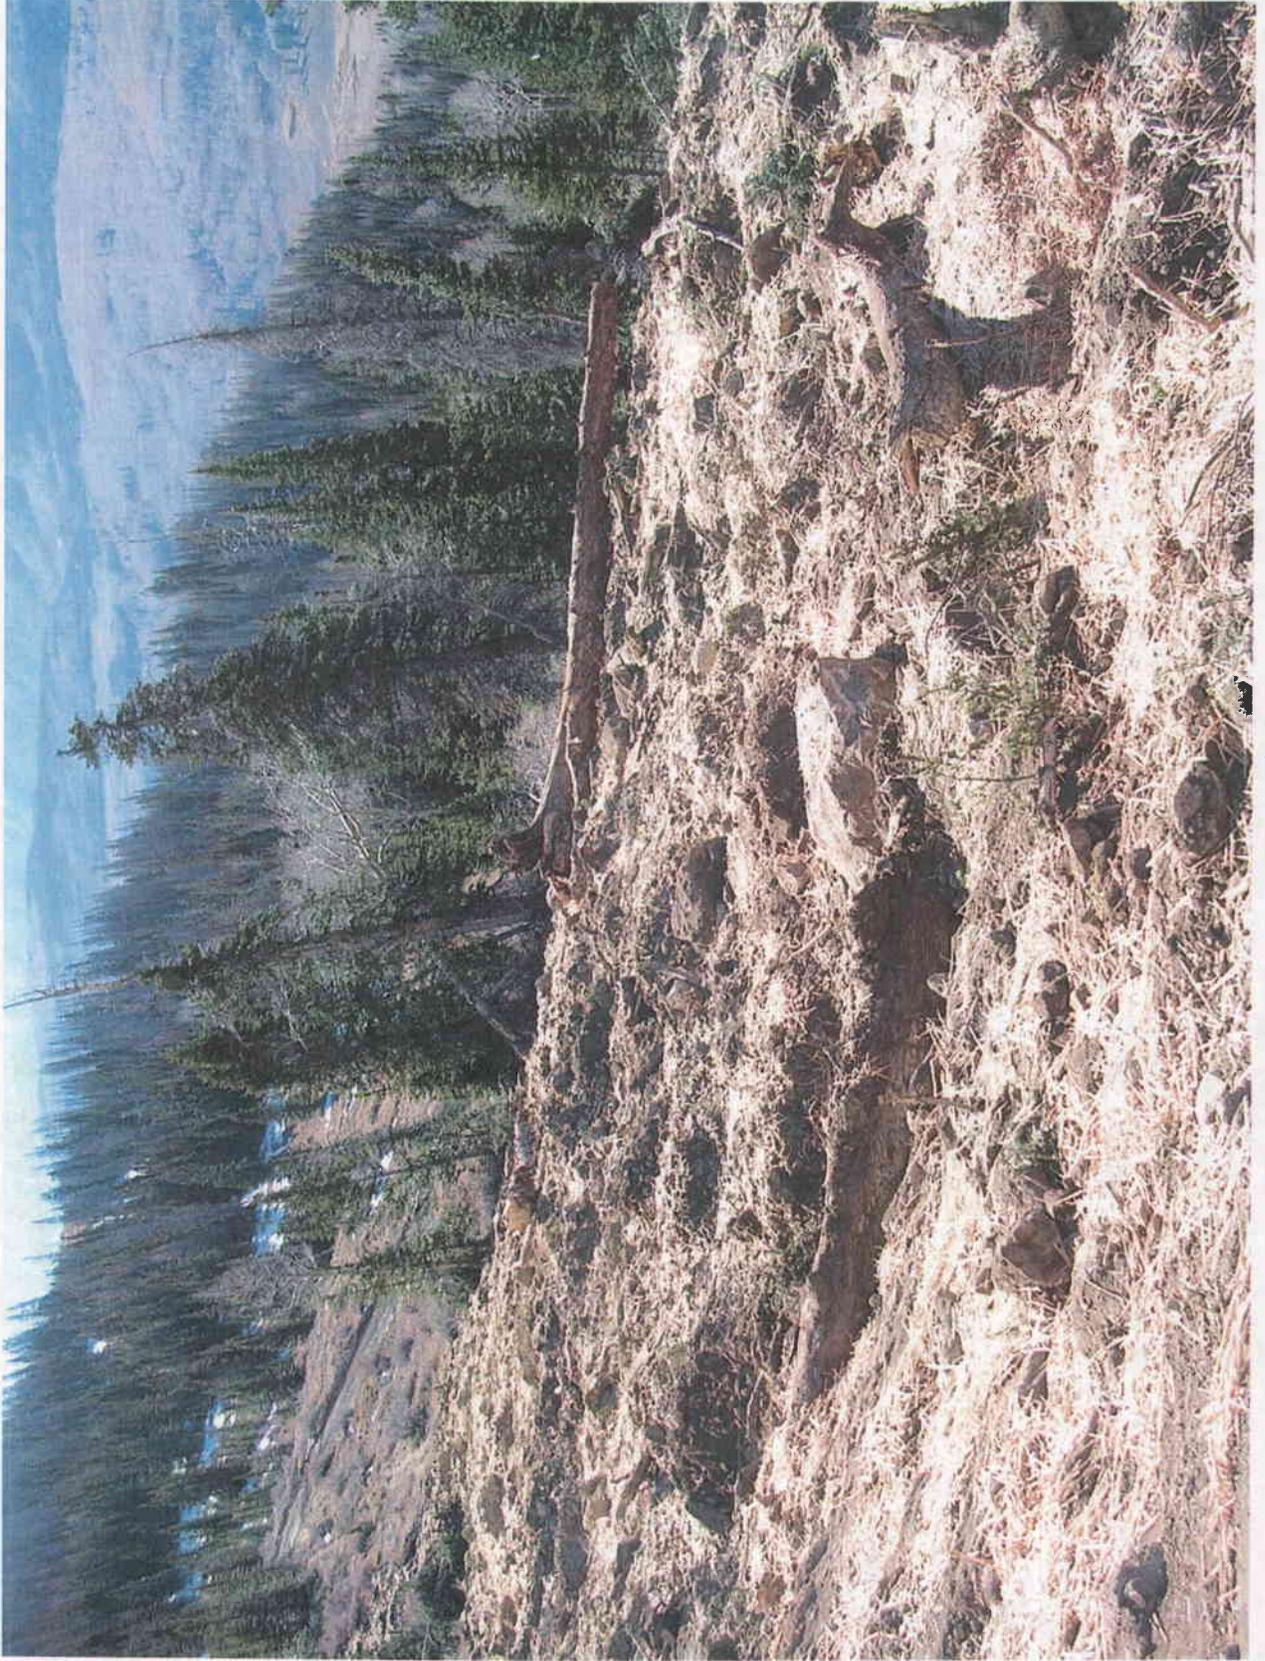
Reclaimed Pad 5
