# GENWAL MINE 015/032

## MINING AND RECLAMATION PLAN

ADDENDUM TO THE RECLAMATION PLAN  
FOR THE

EAST MOUNTAIN EMERGENCY  
DRILLPADS  
TASK # 2893

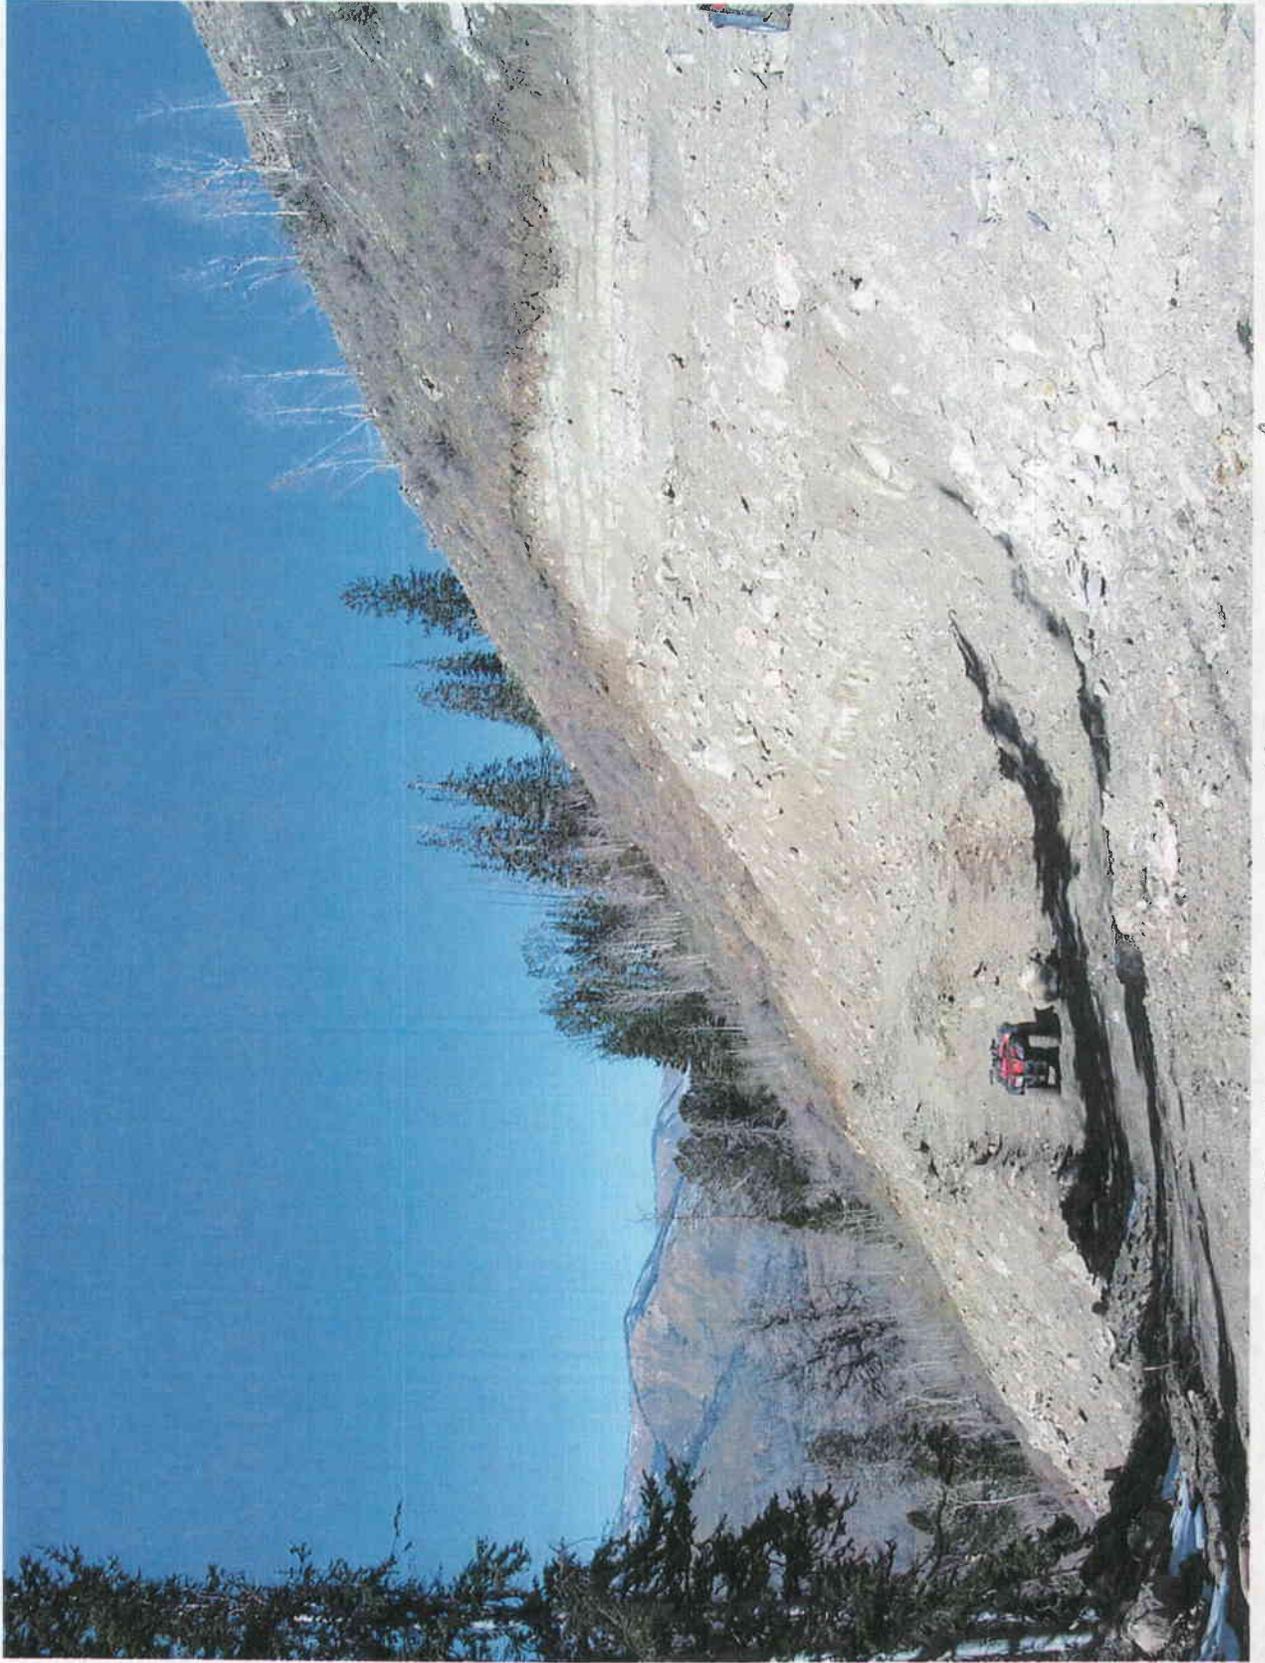
Pad 6, partially reclaimed

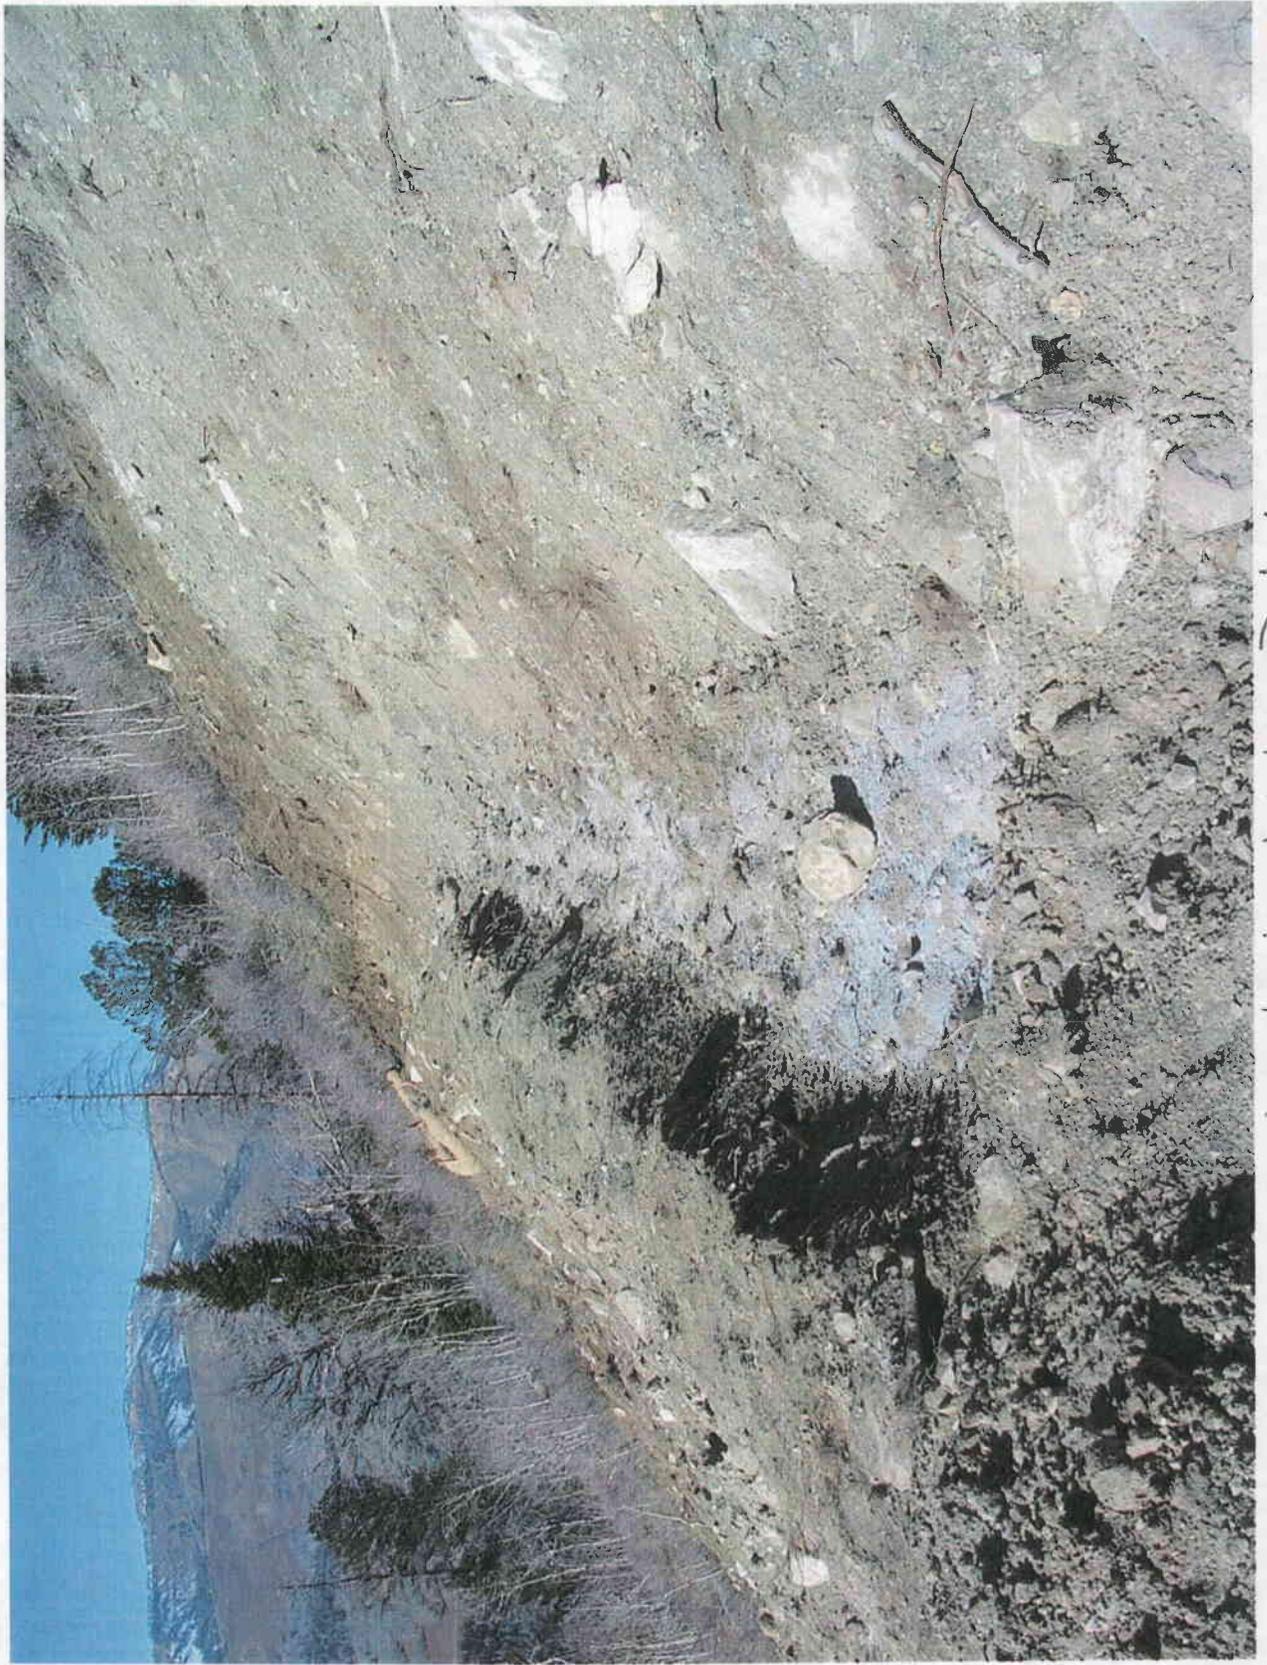
Interior drain ditch, Pod 6

reclaimed below. Next summer when work resumes (and after pads #2/6 have been totally reclaimed) the seep will be contained by laying a course of drainrock from the seep across the road, daylighting on the downhill side as close to native ground as possible. The drainrock courseway will then be covered with geotextile fabric. Based on flow conditions, a perforated-drain pipe may also be installed within the drainrock as determined by the Division field representative. The road will then be reclaimed from there to the top of the mountain by pulling as much sidecast material as possible back up from the outslope onto the roadcut and backfilling to approximate original contour. Seed mix (final) and wood straw will be staged ahead of time along the remaining length of roadside so that seeding and application of wood straw can be done by hand as the earthwork progresses up to the top. Once this road has been reclaimed there will no longer be any vehicular access to any part of the mountainside.

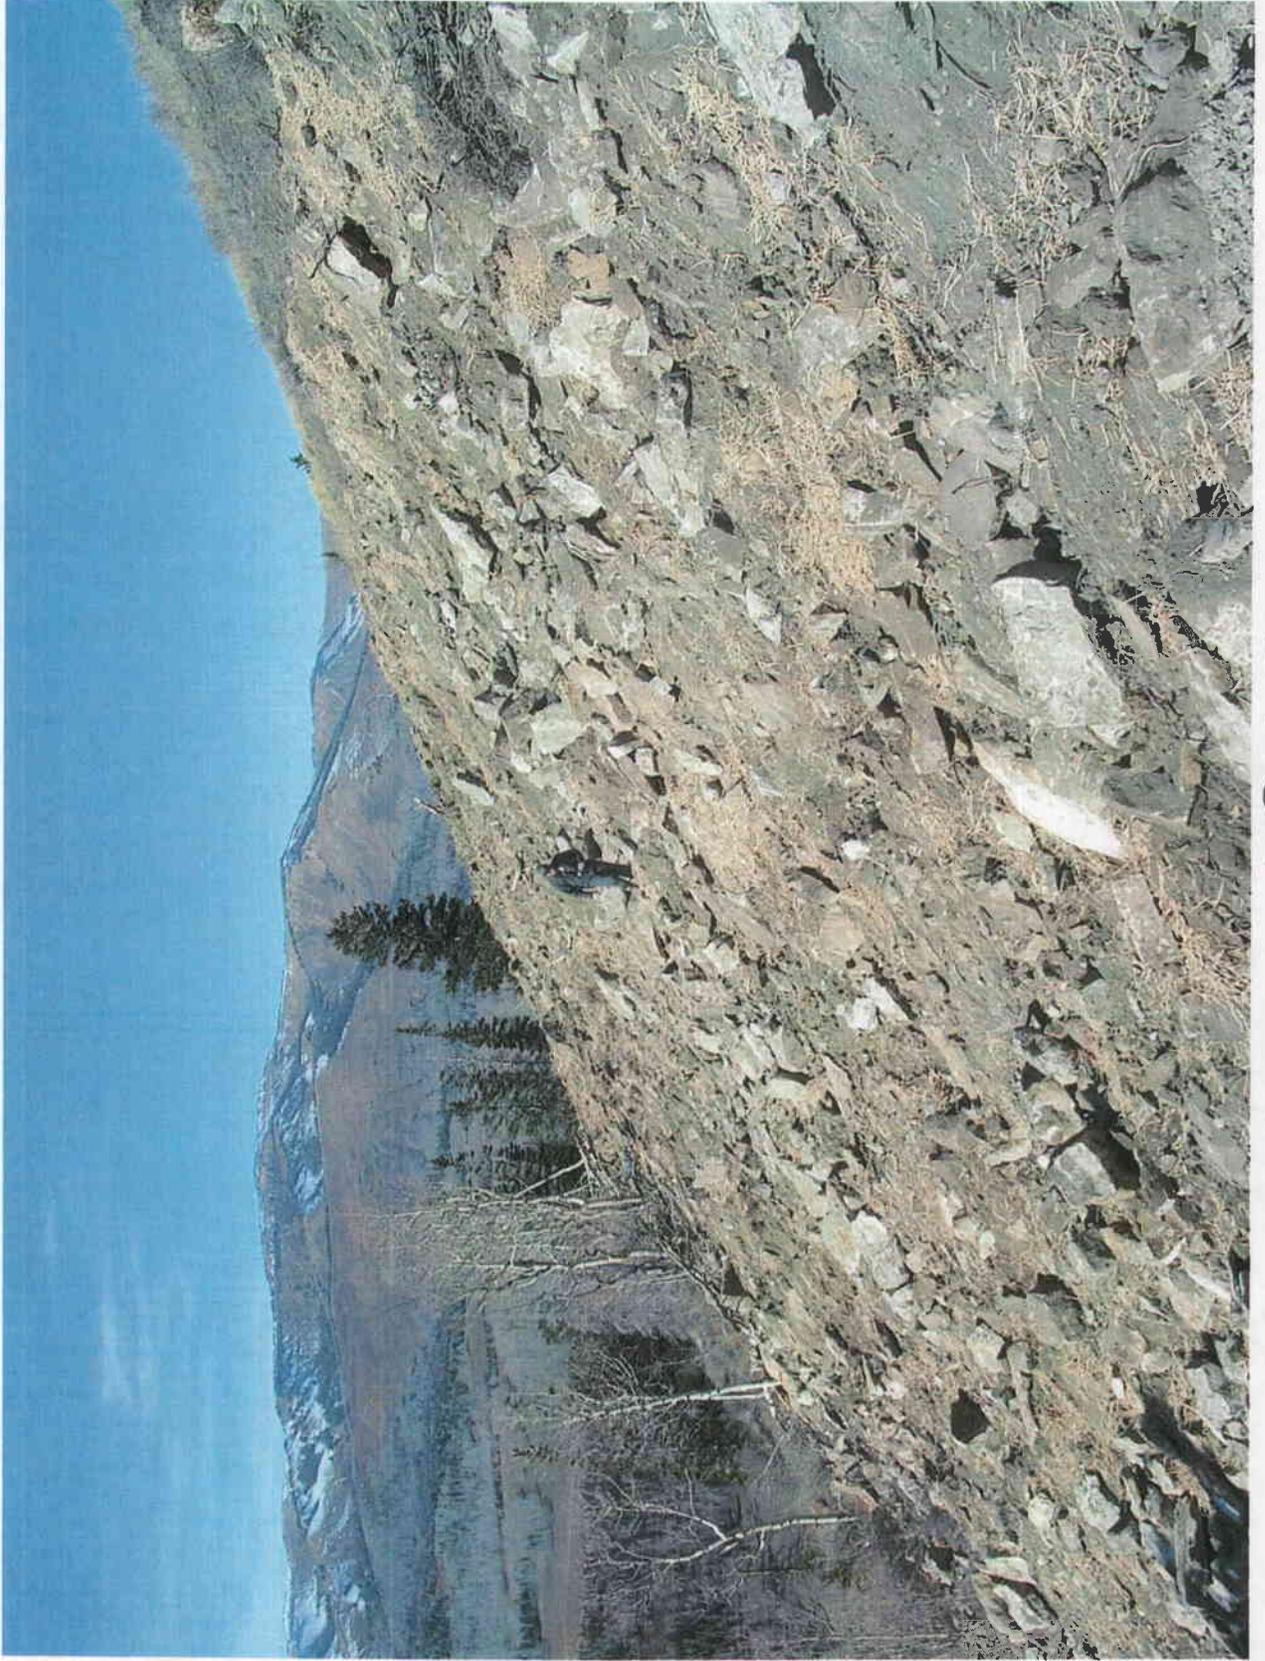
Reclaimed Pad 7

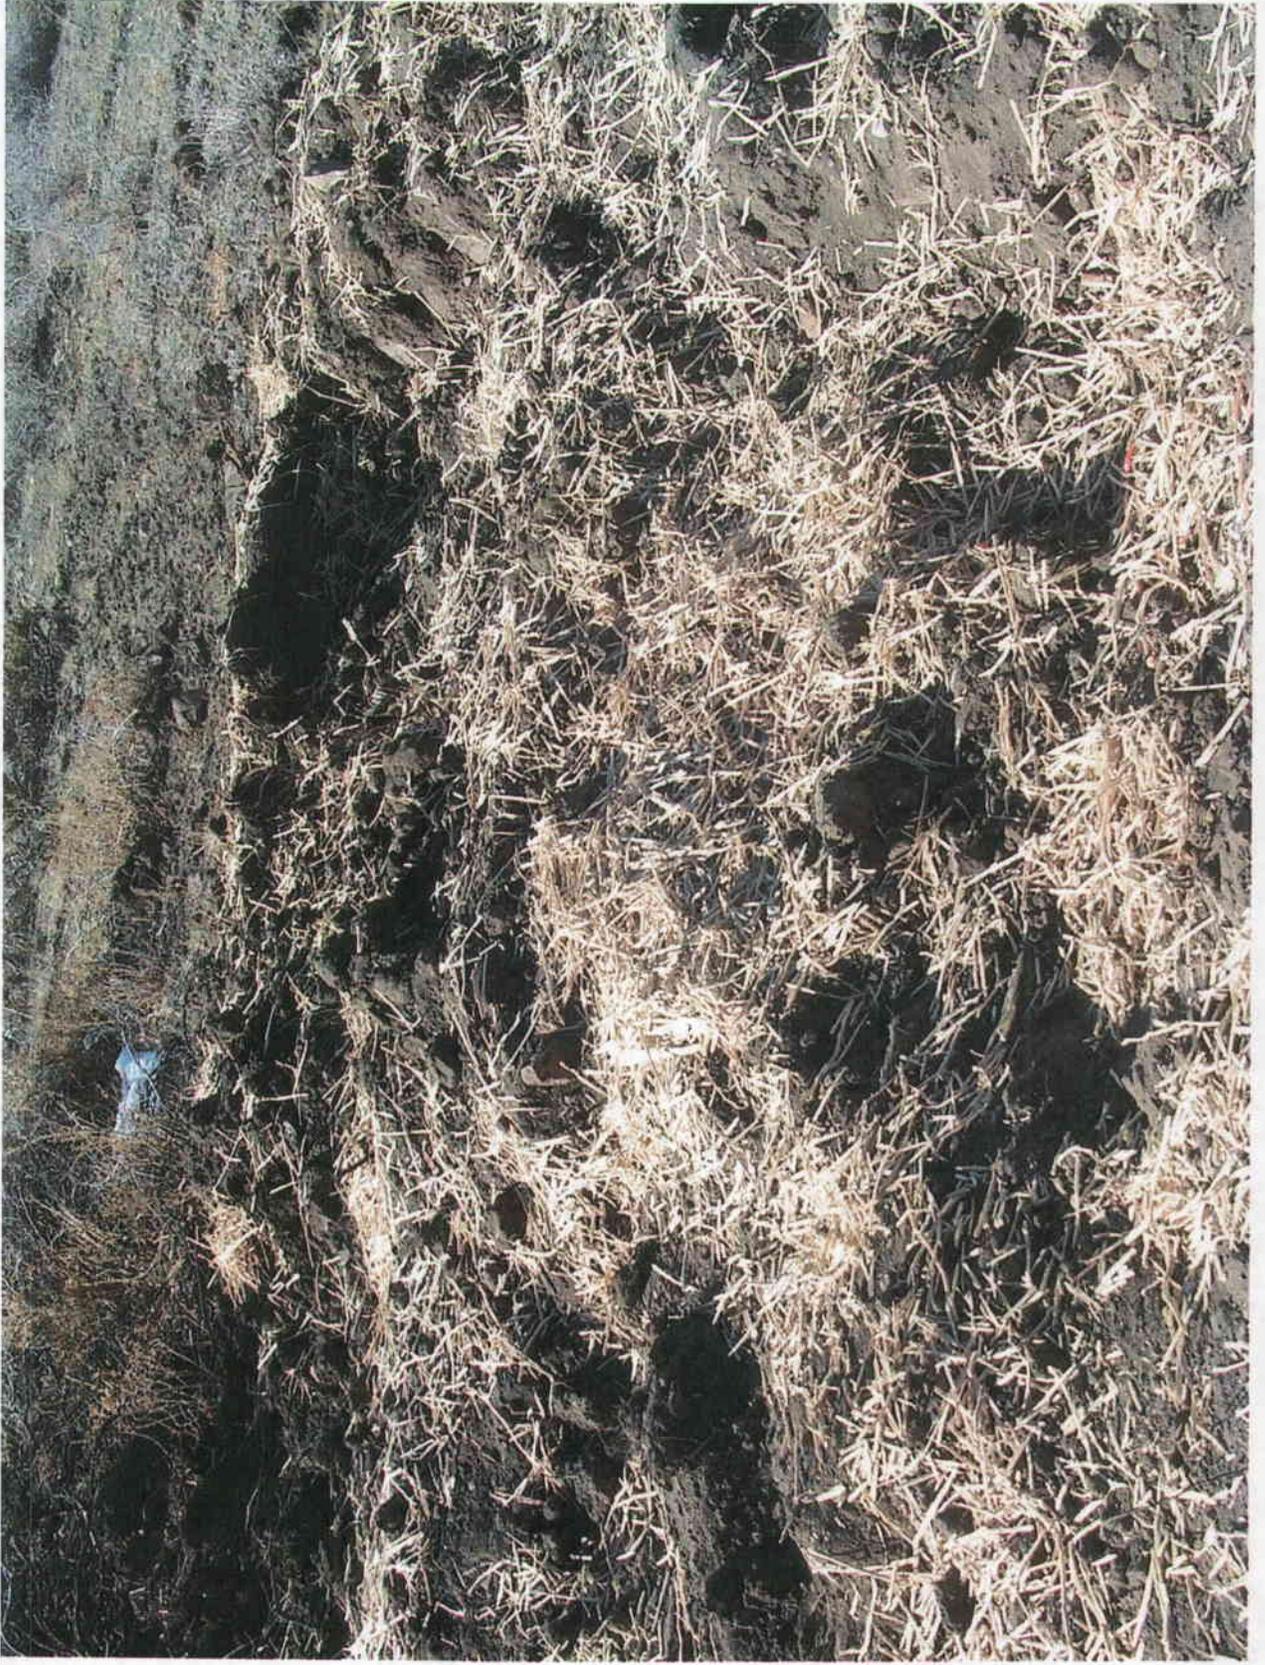
Typical wood straw application

After the backfilling and grading operations are complete the site will be roughened with pocks similar in size and spacing as those placed in the previously reclaimed pad areas. A permanent seed mix will then be applied, followed by putting down a layer of a wood straw. Density of seed application and wood straw application will be similar to that of the previously reclaimed pads, which in all cases exceeded pre-determined recommended application rates.

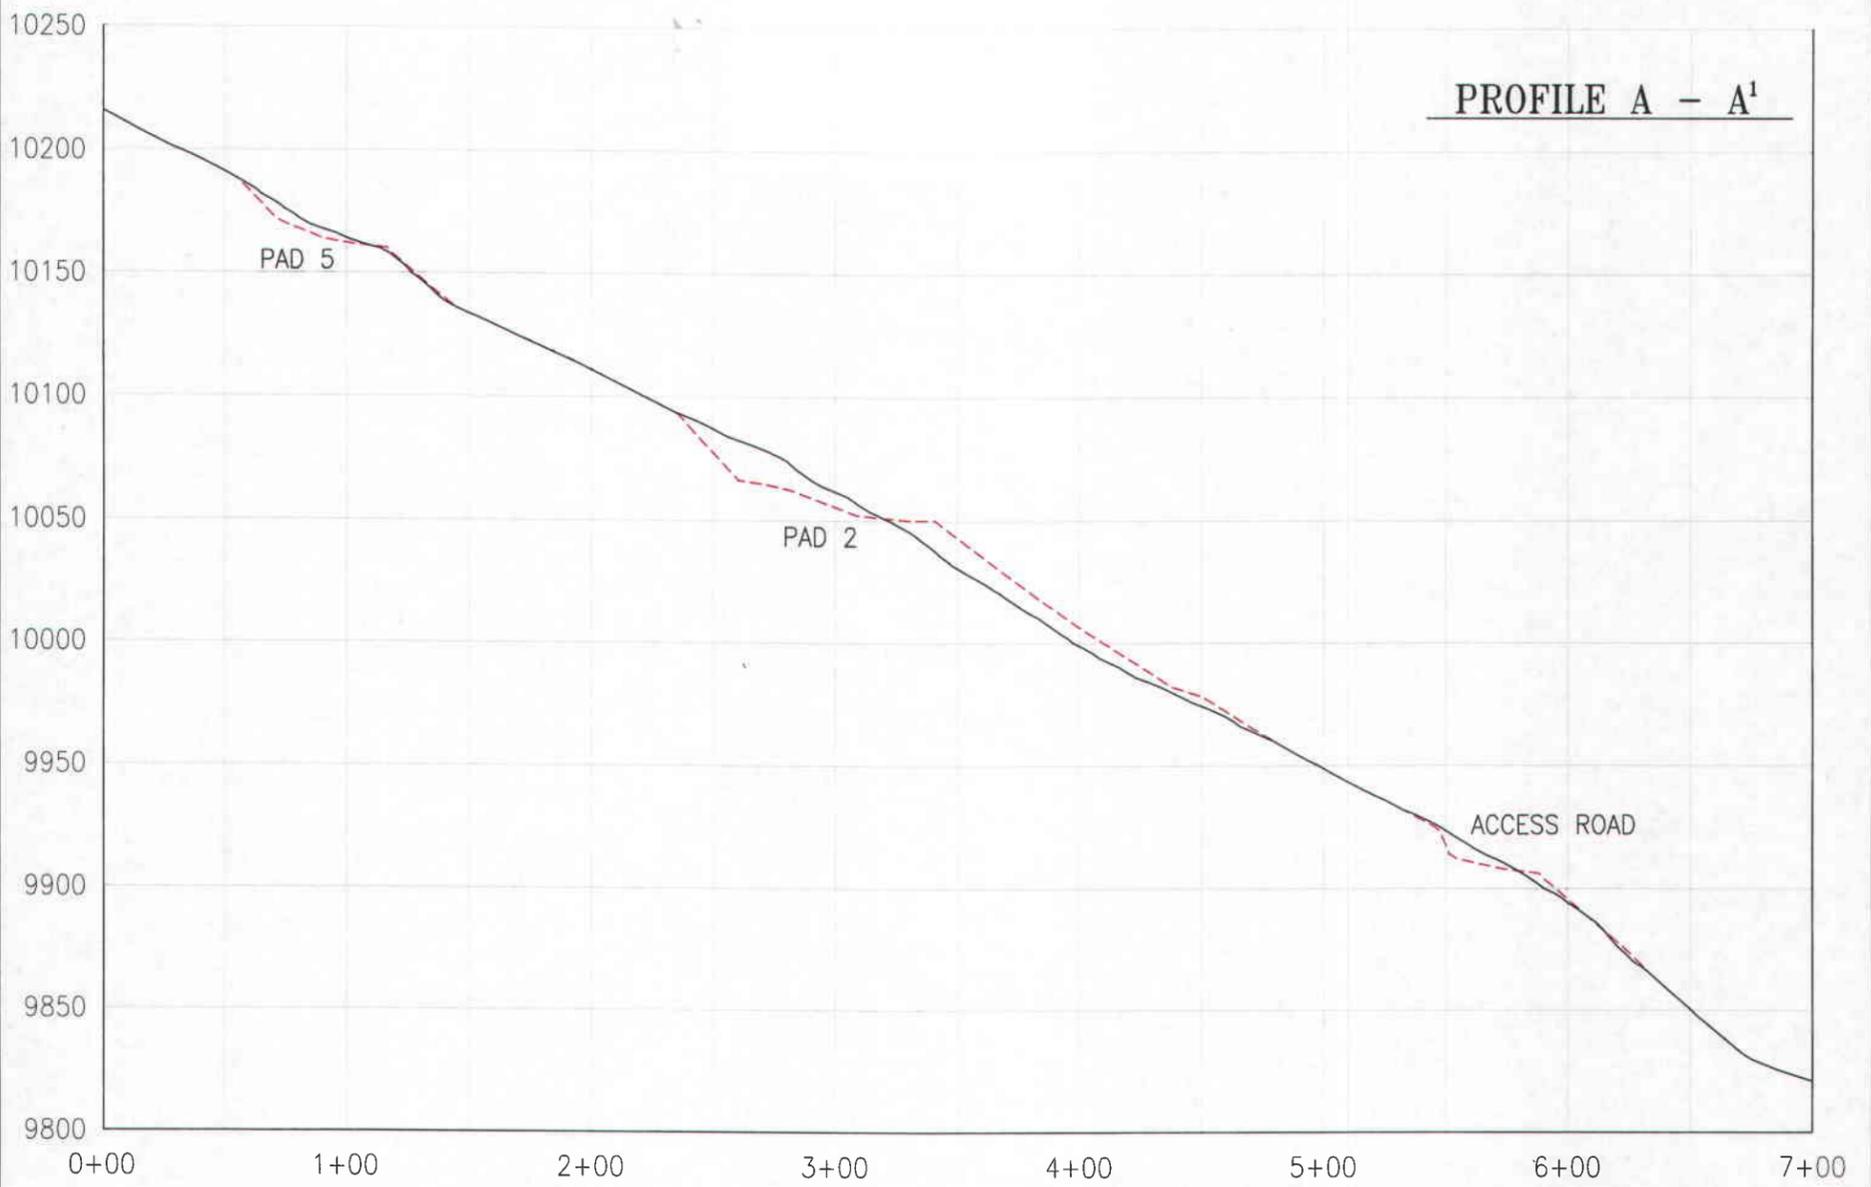
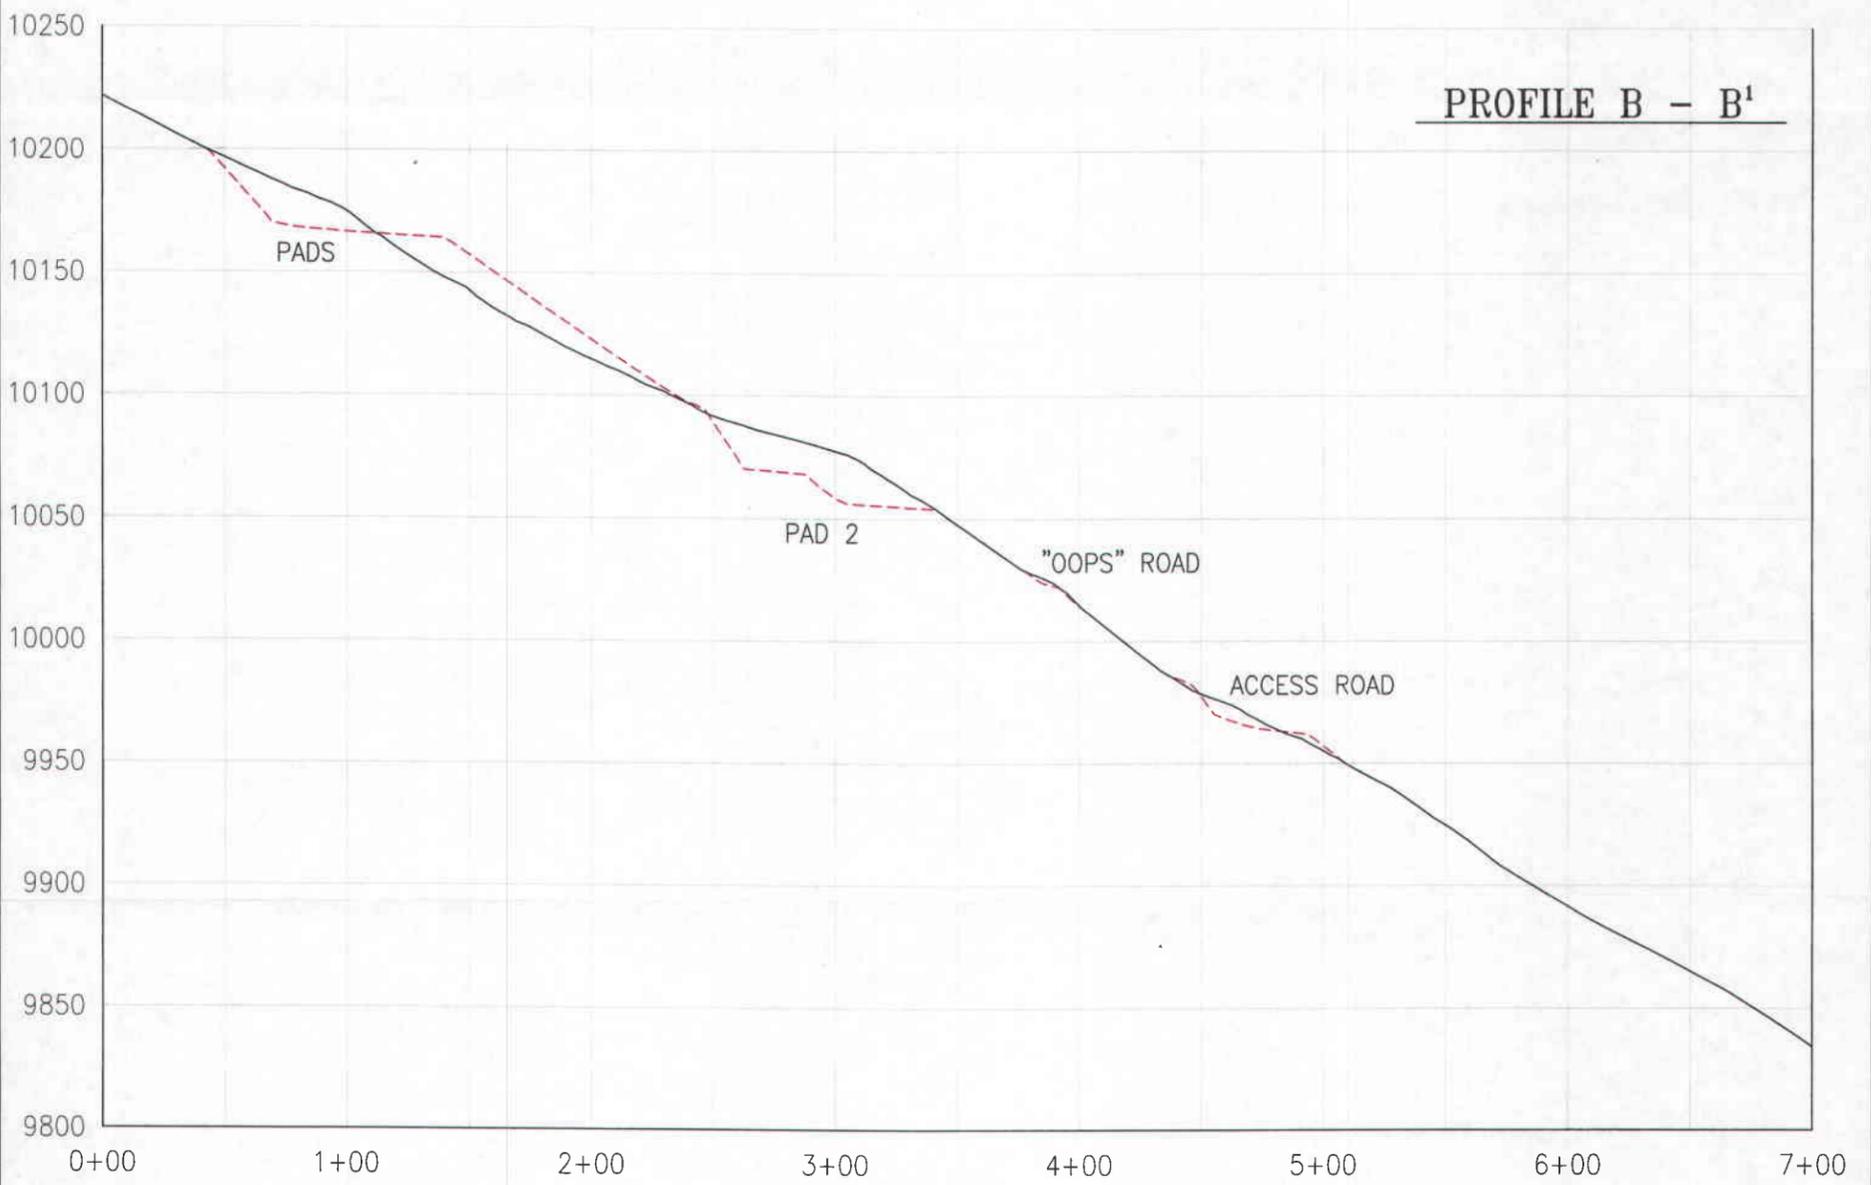
**ATTACHMENT 13  
DRILL PAD PROFILES**  
(SEE PLATES 1 AND 2, ATTACHMENT 13, FOR INDEX MAPS)

- PROPOSED RECLAIMED PROFILE
- - - EXISTING DISTURBED PROFILE

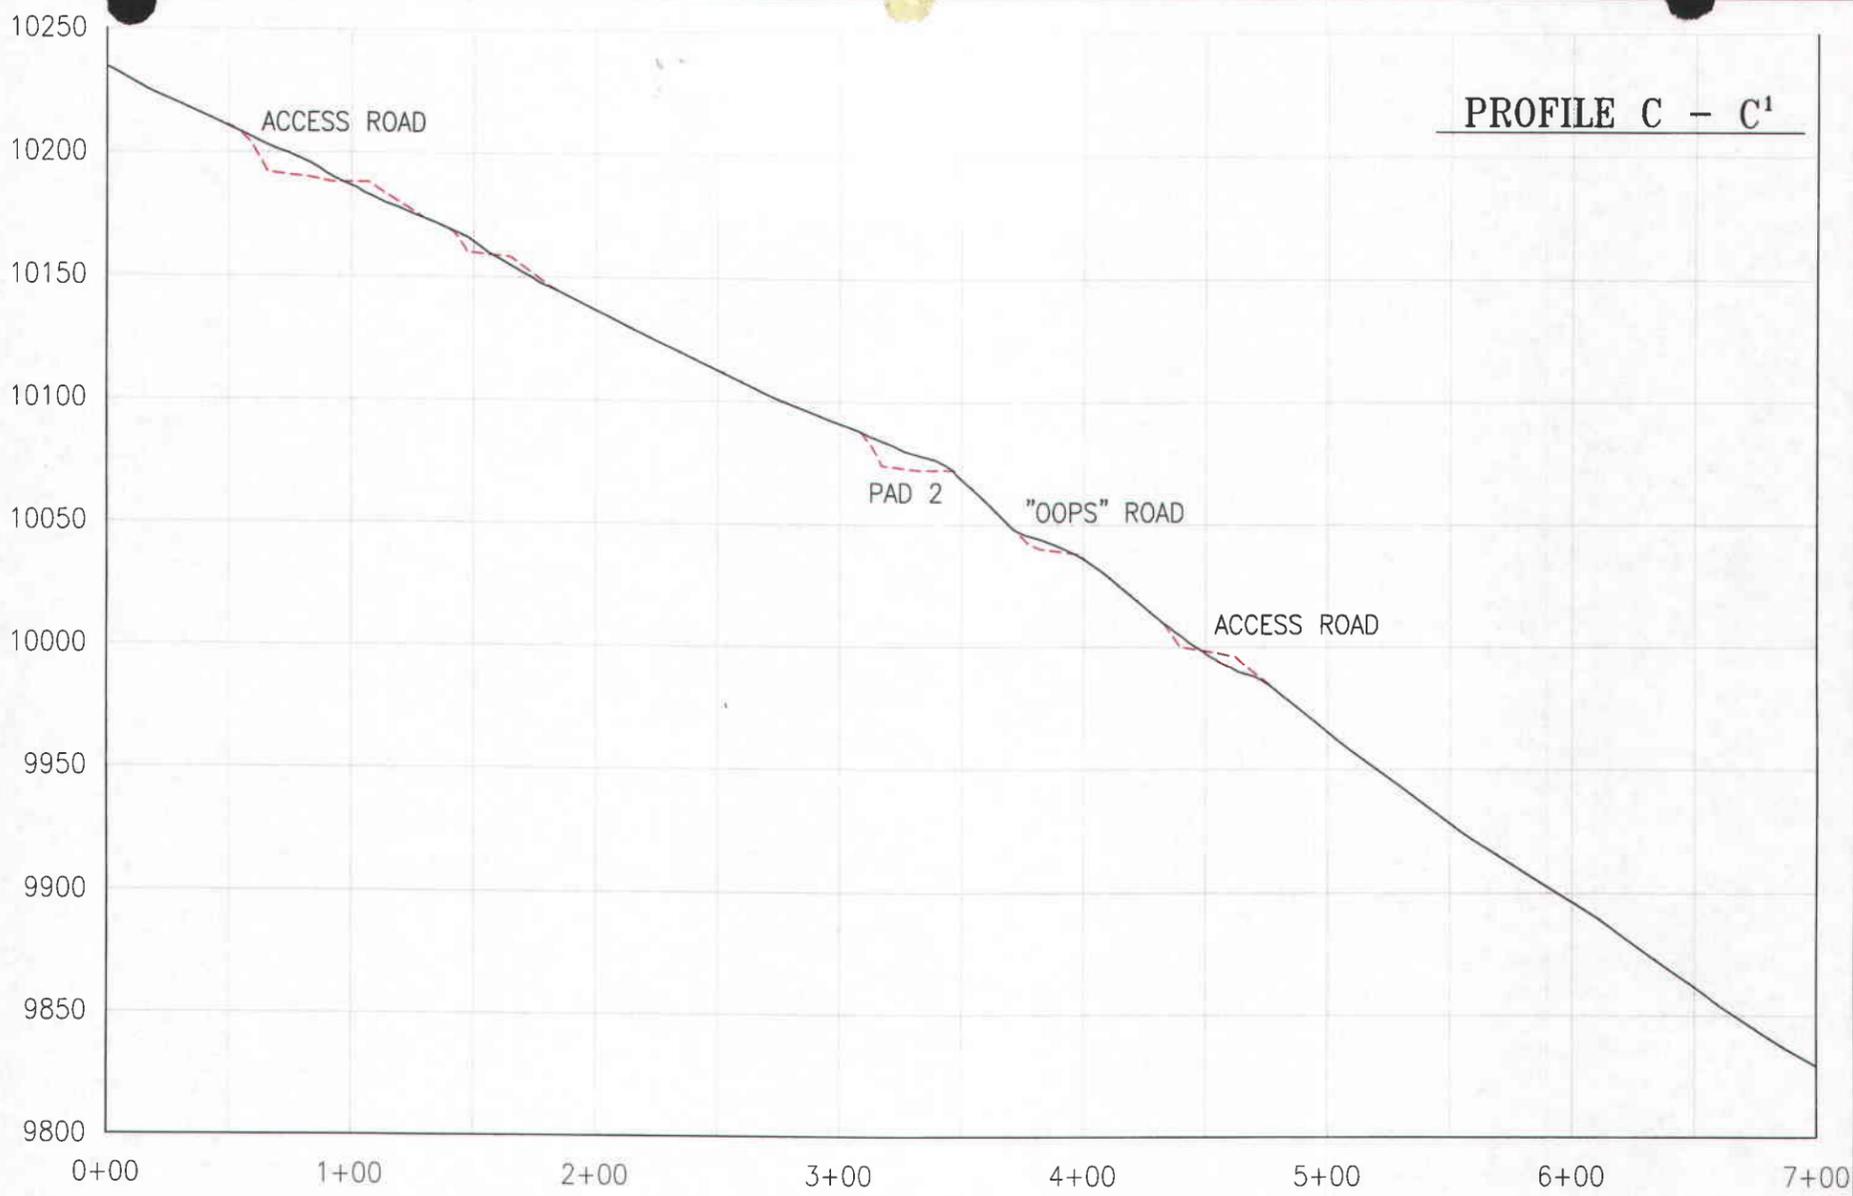
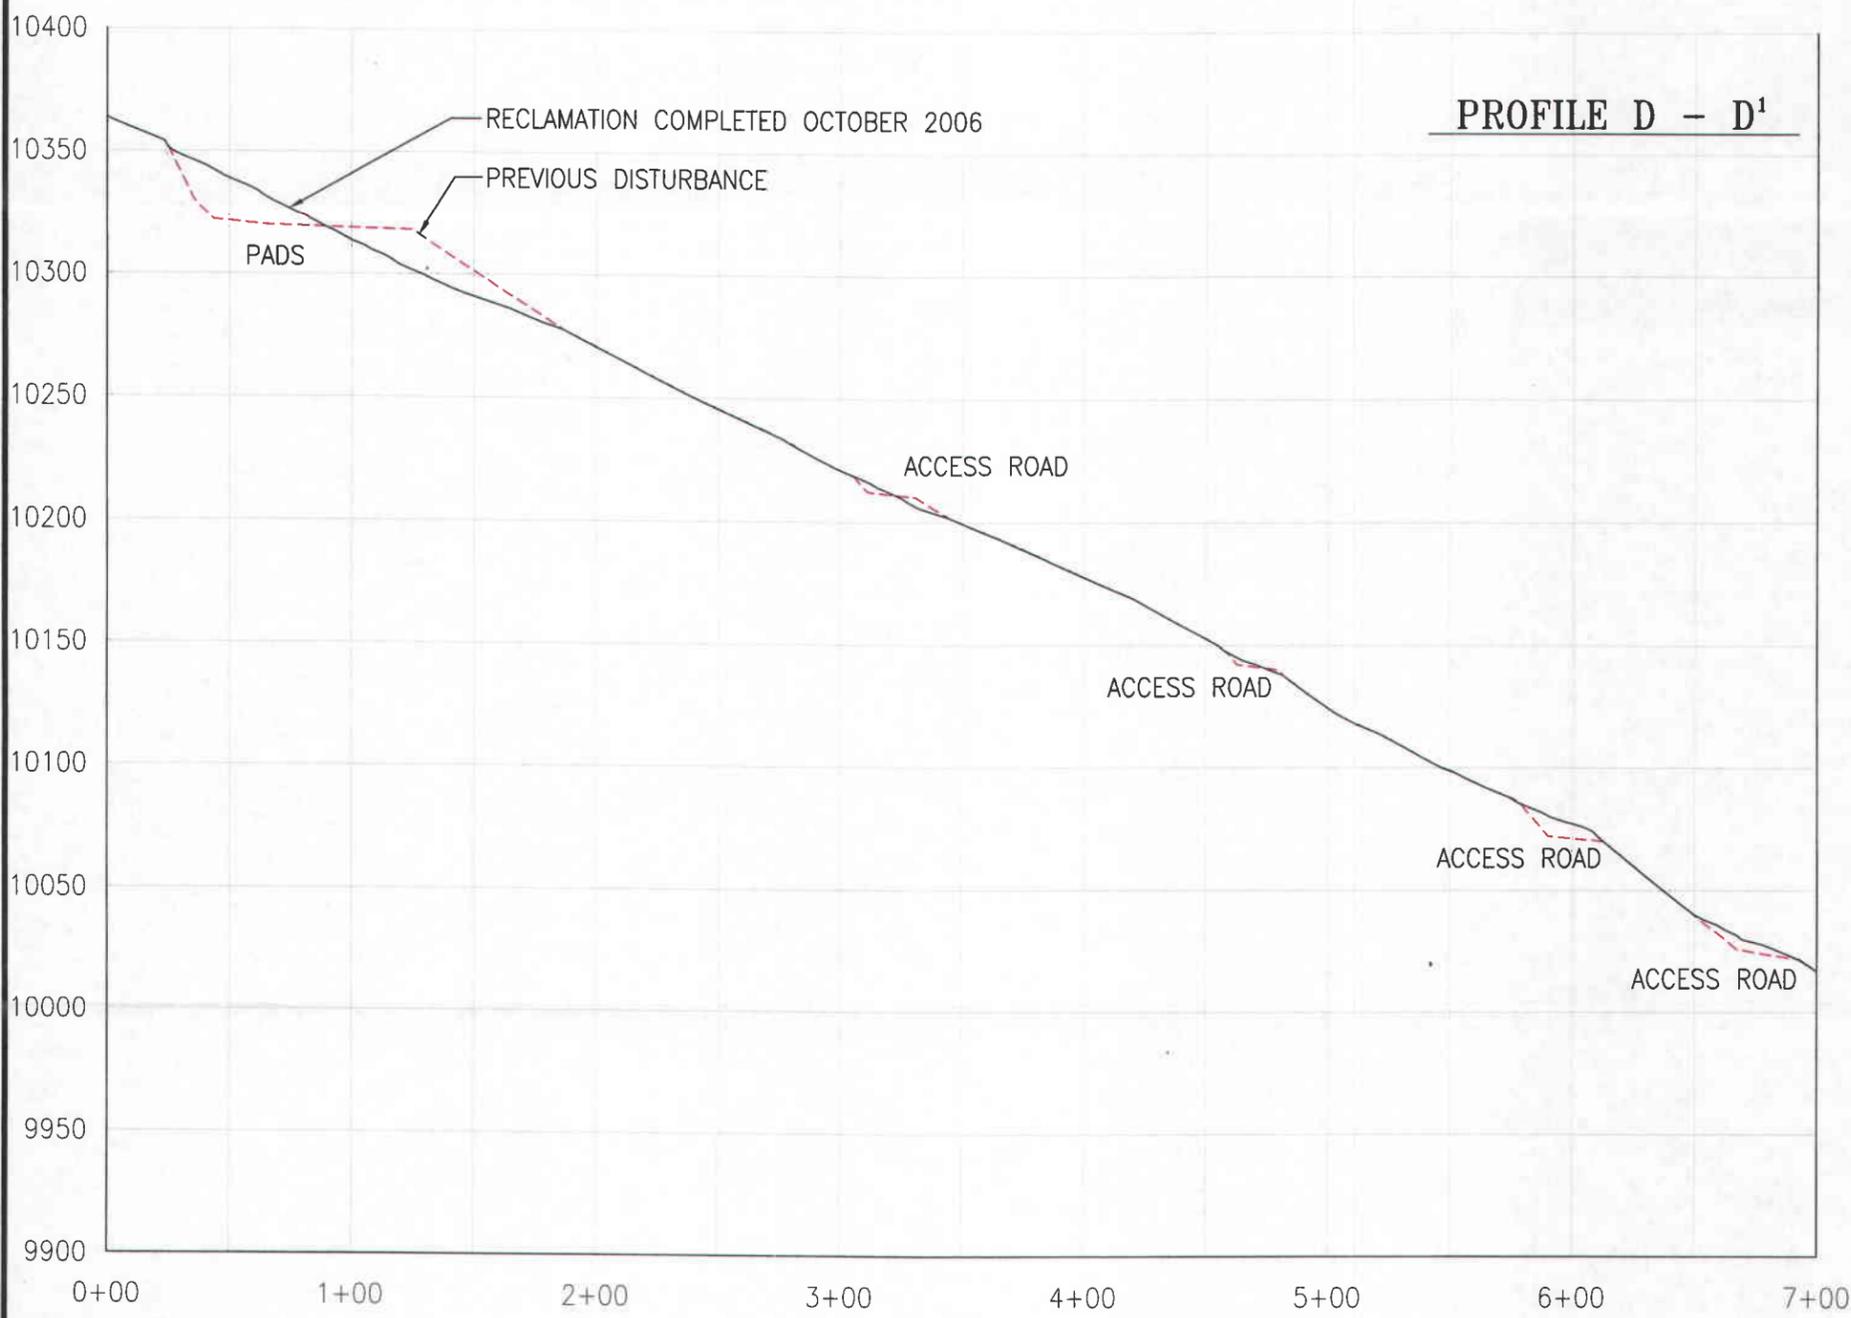
**ATTACHMENT 13  
DRILL PAD PROFILES  
(SEE PLATES 1 AND 2, ATTACHMENT 13, FOR INDEX MAPS)**

- PROPOSED RECLAIMED PROFILE
- - - EXISTING DISTURBED PROFILE
