Re: Crandall Canyon Mines, C/015/032
Mine Water Iron Treatment Facility
Citation 10043

**CRANDALL CANYON MINE
SEDIMENTATION AND DRAINAGE CONTROL PLAN**

CONSTRUCTION DETAILS
IRON TREATMENT FACILITY

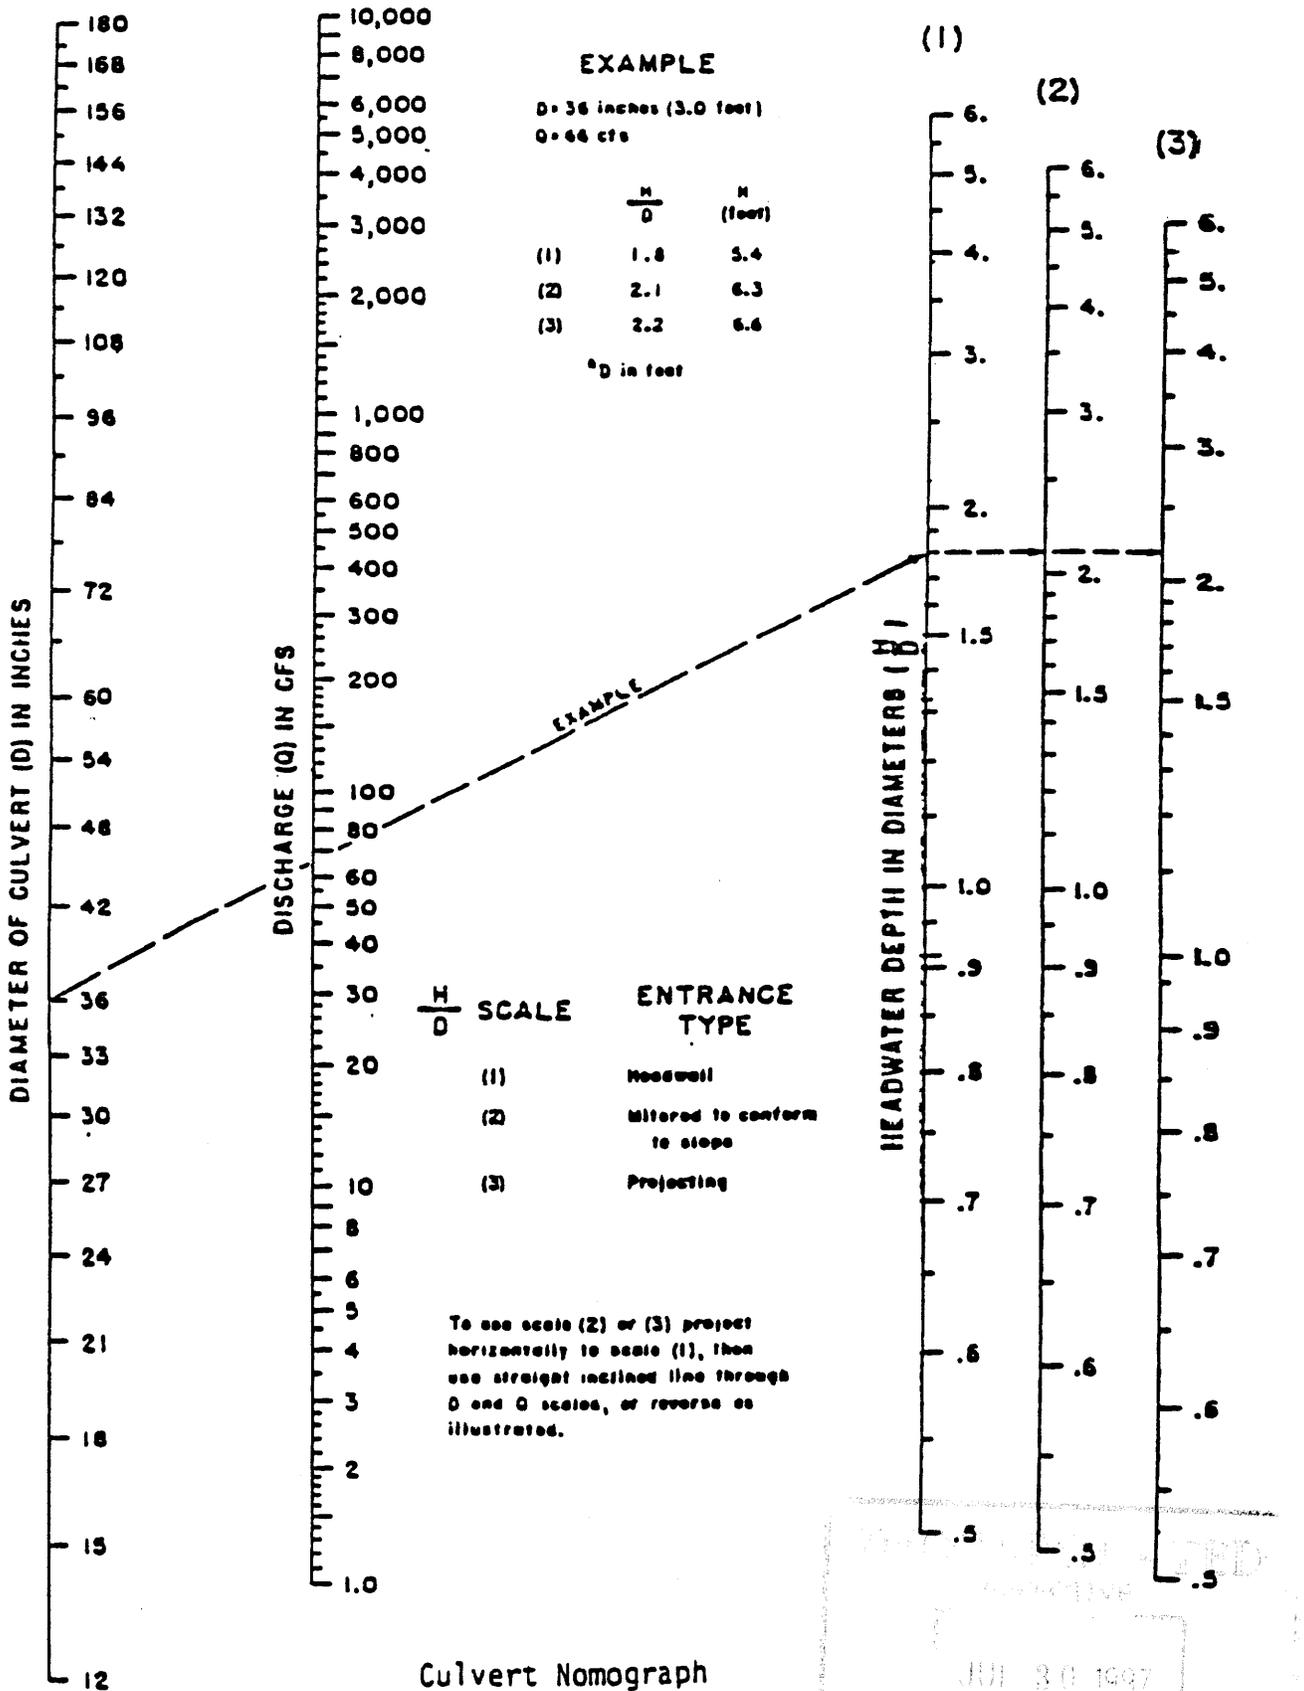
FIGURE 1

RIP-RAP CHART

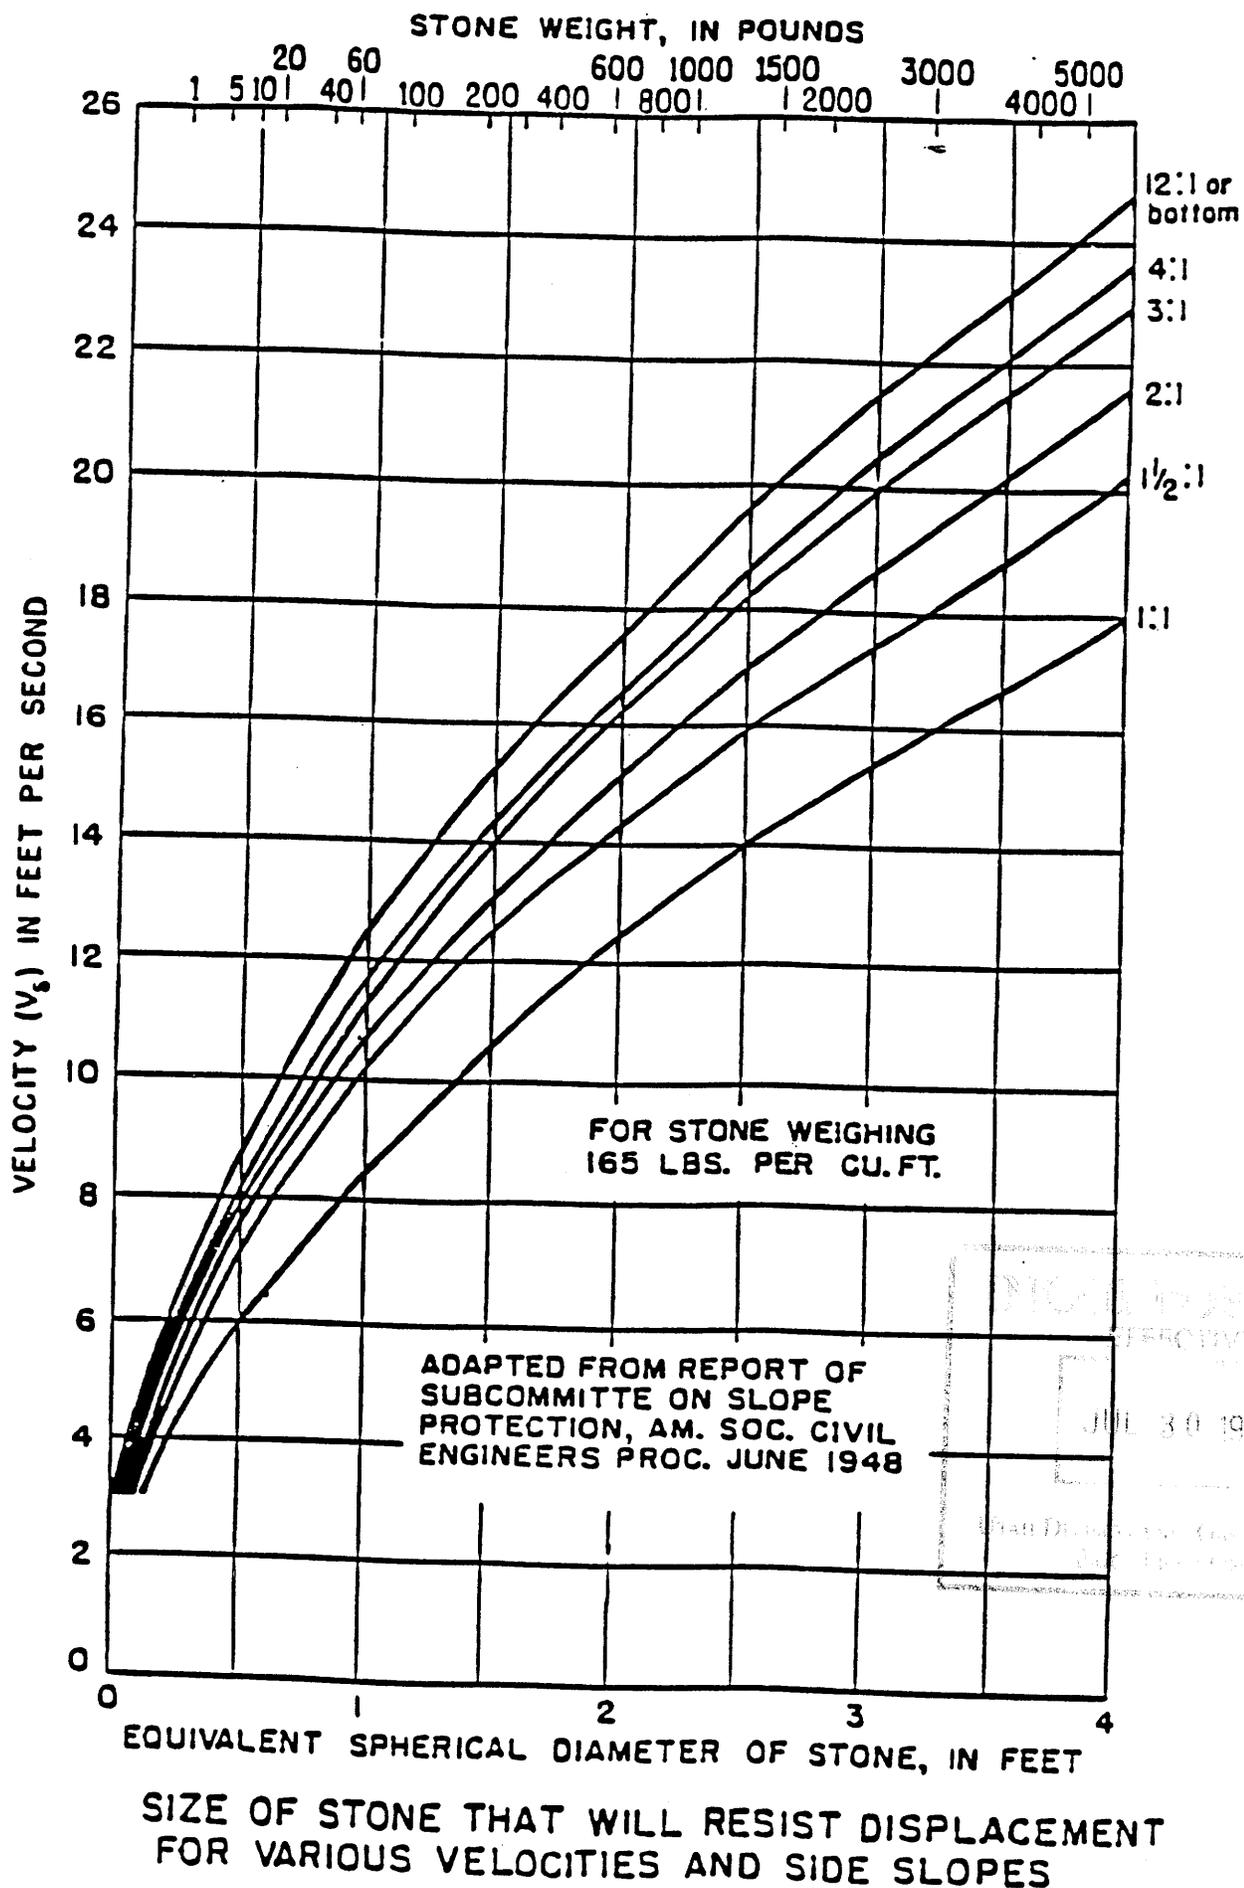
FIGURE 2

**UNDISTURBED AND DISTURBED DITCH
TYPICAL SECTION**

Similarly, ditches within the disturbed area are designed to pass the peak flow from the 10-year, 6-hour storm. Typical cross sections and design calculations are contained in Appendix 7-4 for these ditches. Ditches have been evaluated for adequacy in passing the 10 year-24 hour storm and found to be of adequate size (see Appendix 7-4).

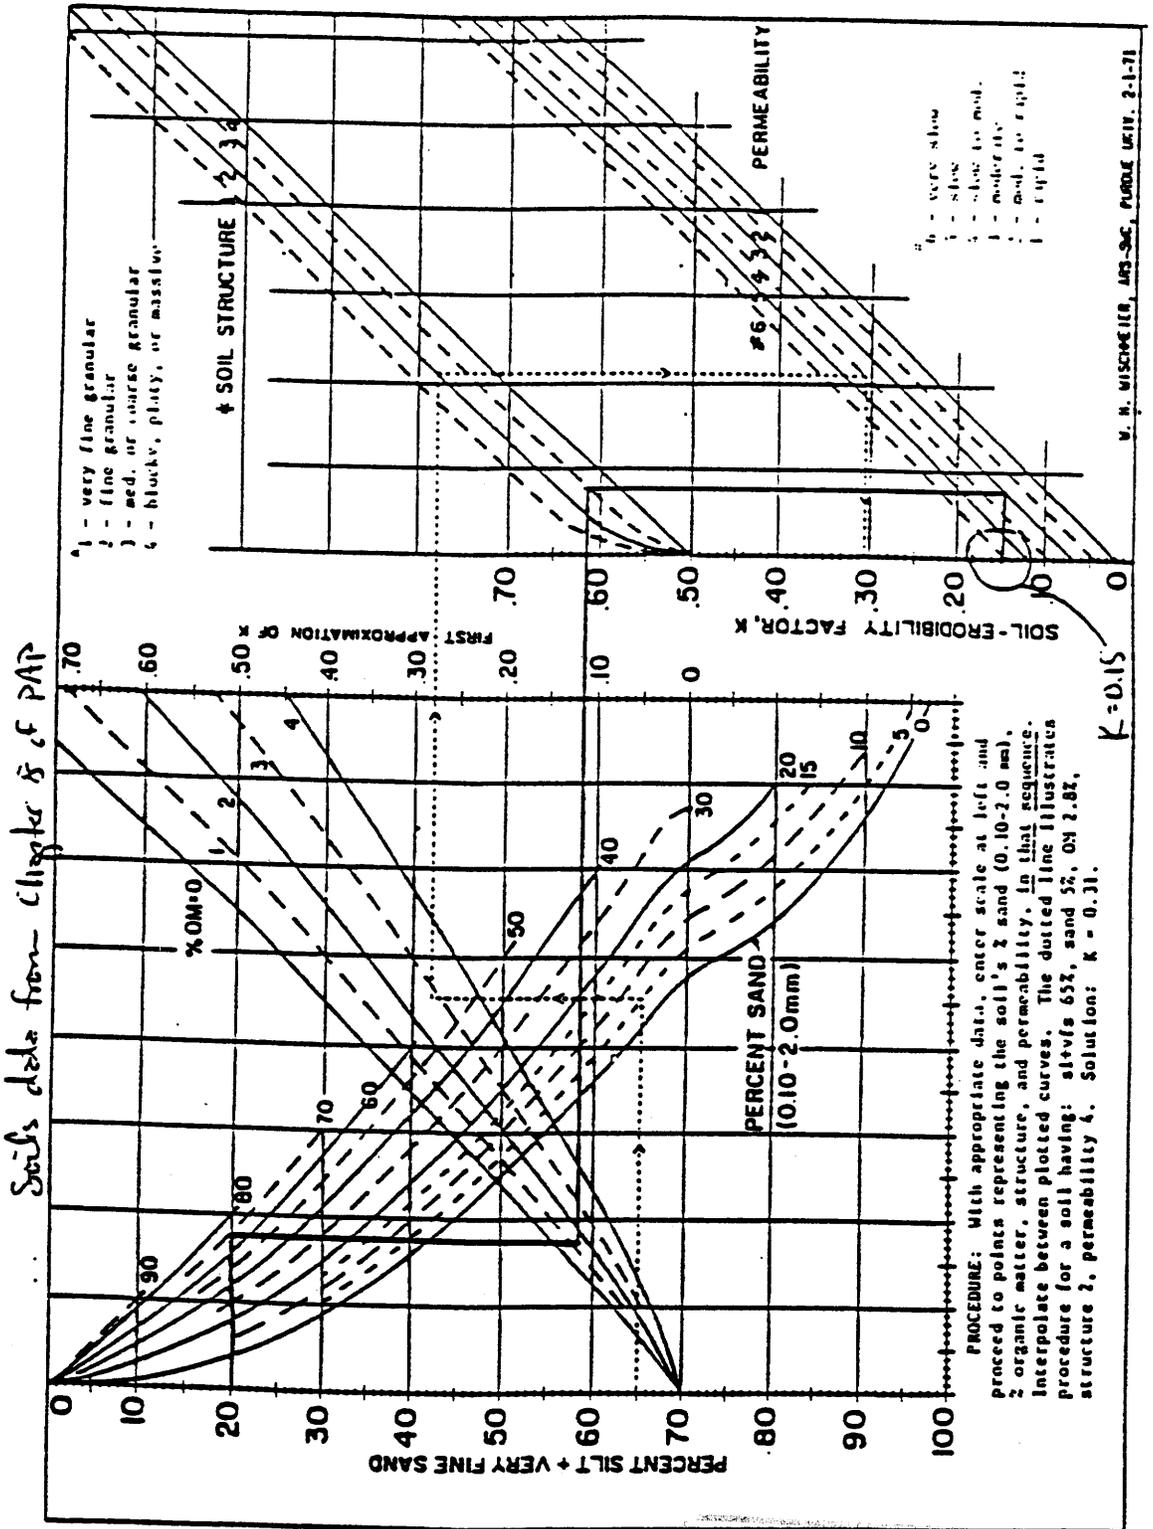
FIGURE 5

SOIL ERODIBILITY CHART (UNDISTURBED/RECLAIMED AREAS)

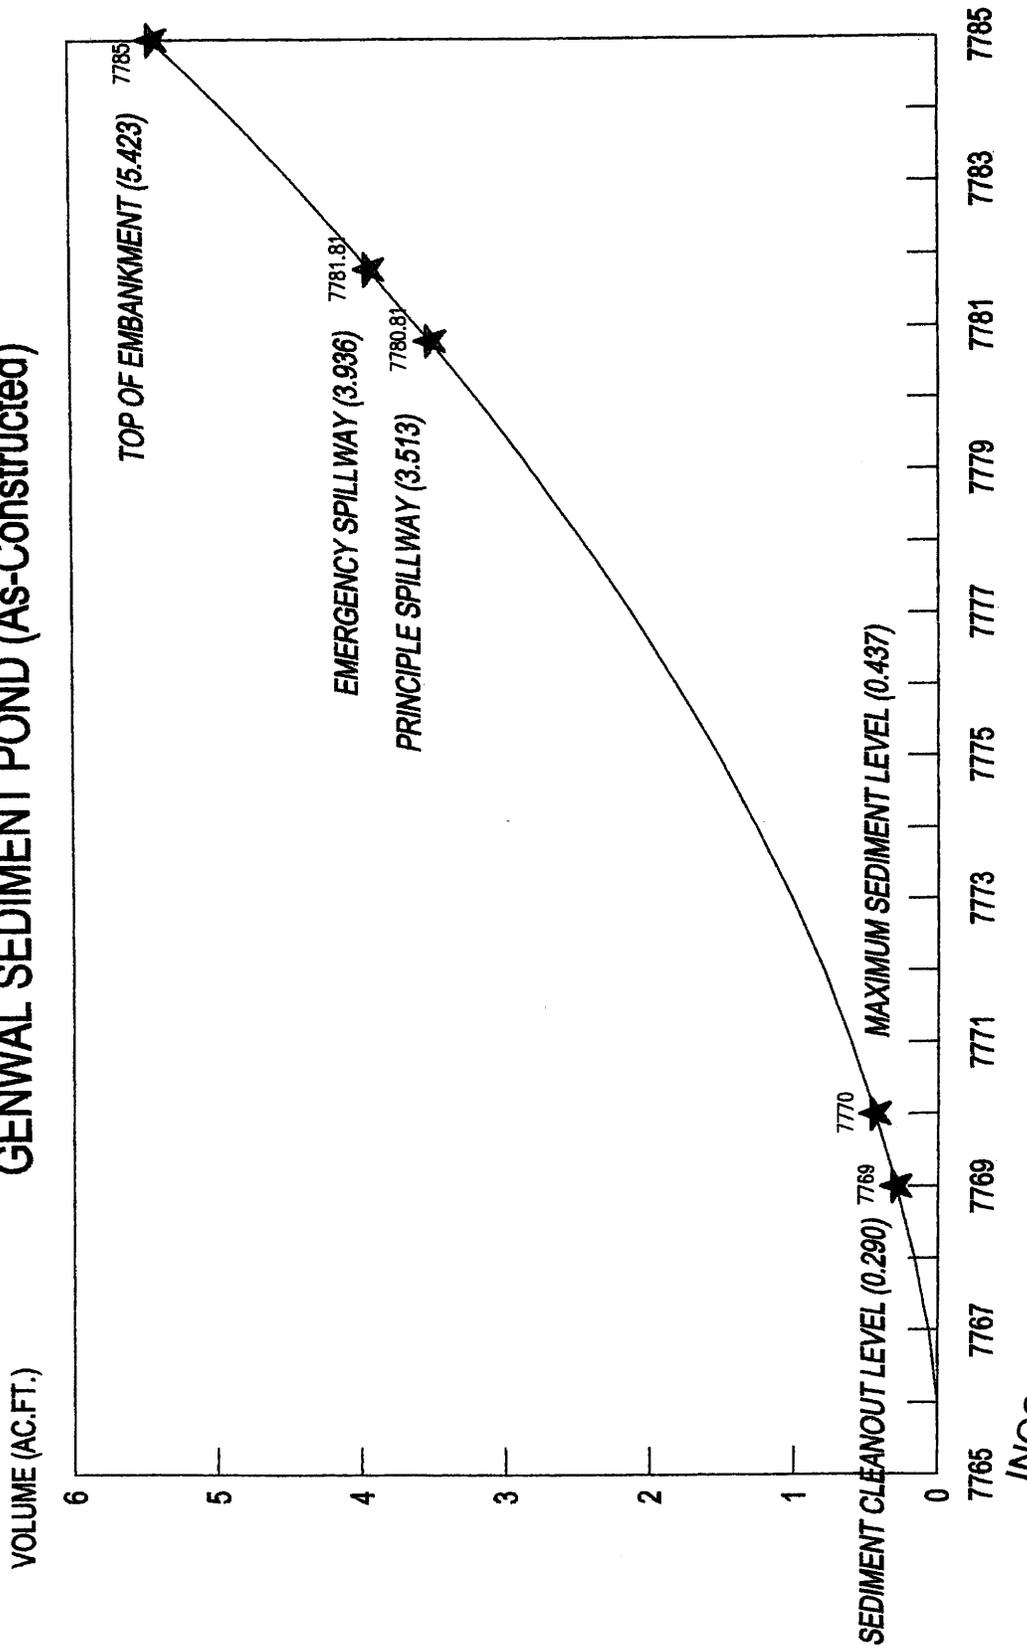
FIGURE 6

STAGE-VOLUME

GENWAL SEDIMENT POND (As-Constructed)

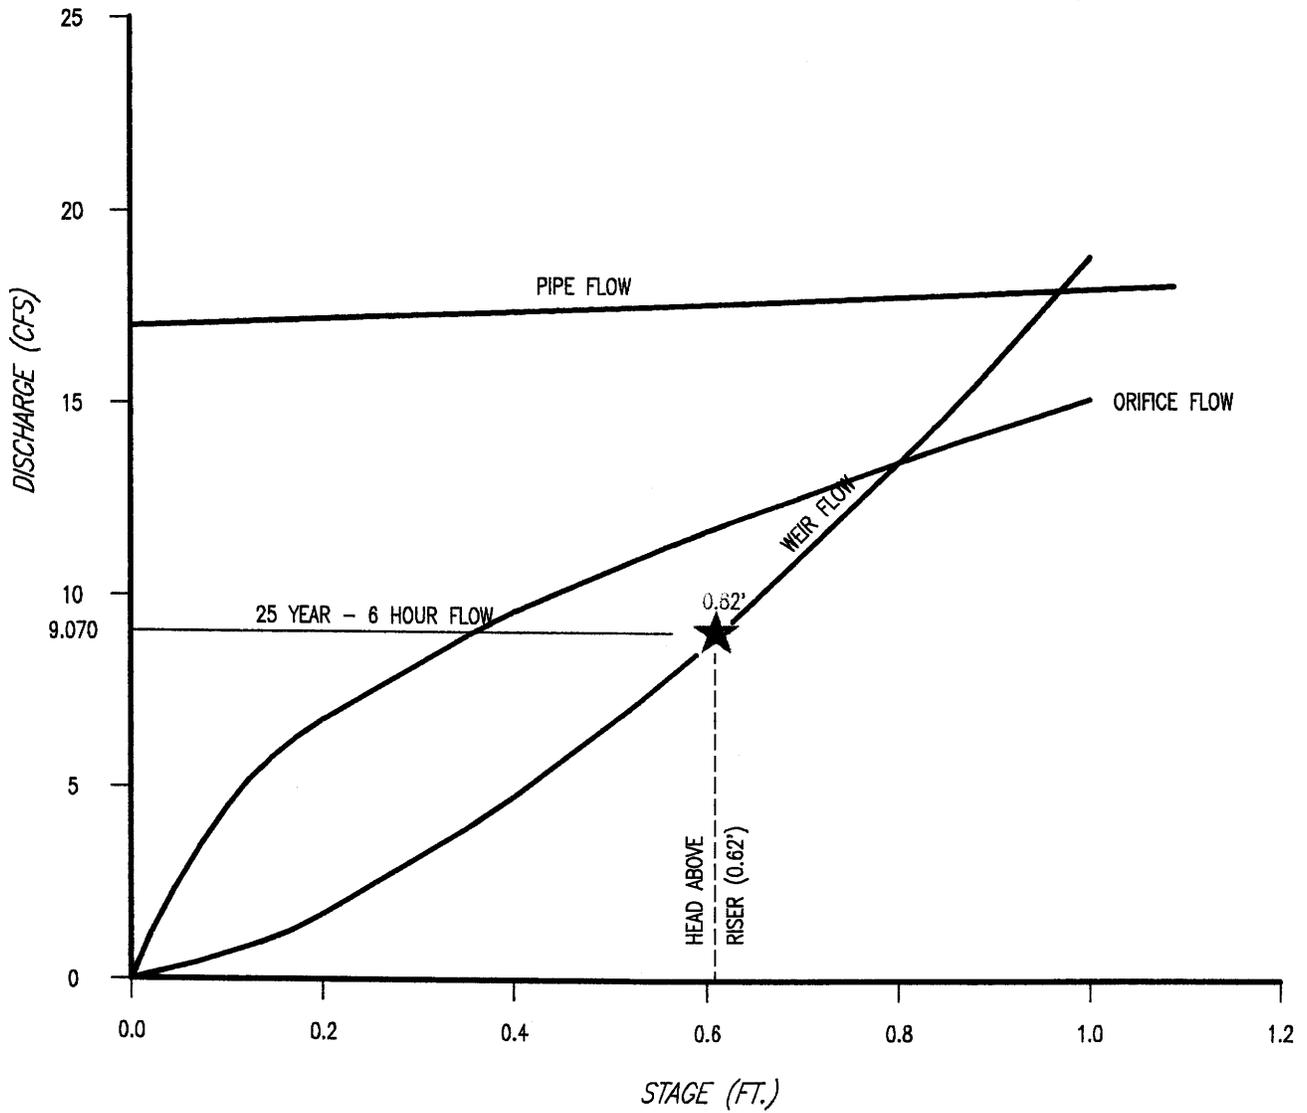
FIGURE 7

SEDIMENT POND
STAGE-DISCHARGE CURVE

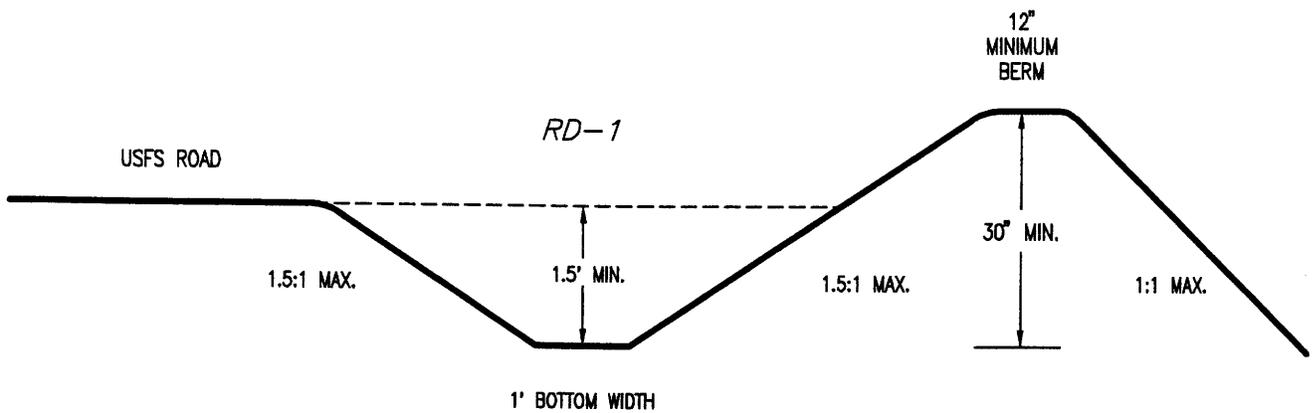
FIGURE 8

**RECLAMATION DITCH RD-1
TYPICAL SECTION**

<i>DITCH SIZING</i>		
<i>DITCH</i>	<i>FLOW DEPTH</i>	<i>FLOW AREA</i>
<i>RD-1</i>	<i>0.52</i>	<i>0.40</i>

DITCH CONFIGURATIONS MAY VARY IN FIELD; HOWEVER, MINIMUM FLOW DEPTHS AND AREAS WILL BE MAINTAINED.

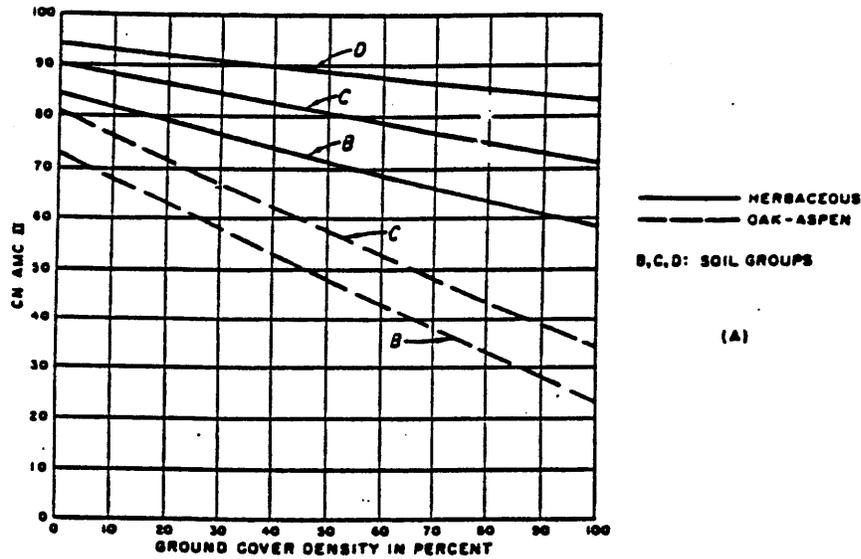
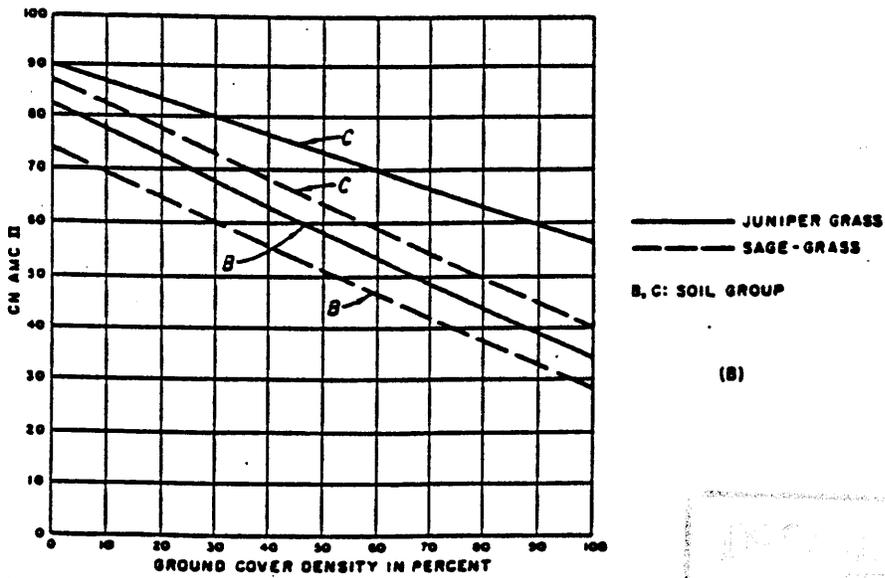
Figure 7-3. Runoff curve numbers for forest-range in the western U.S. (from U.S. Bureau of Reclamation, 1977).

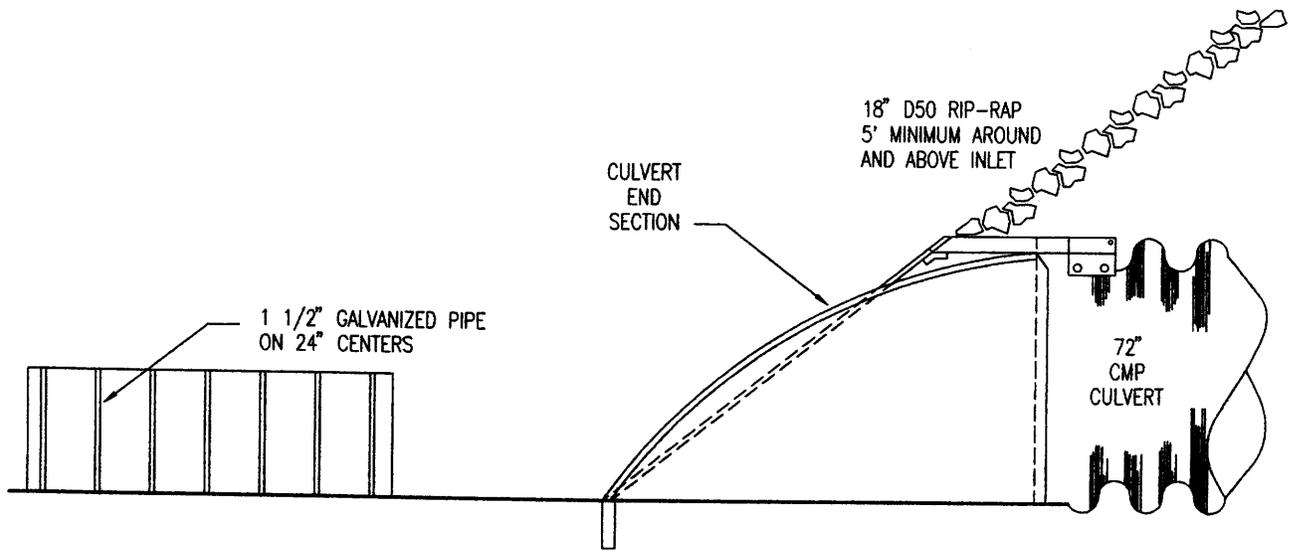
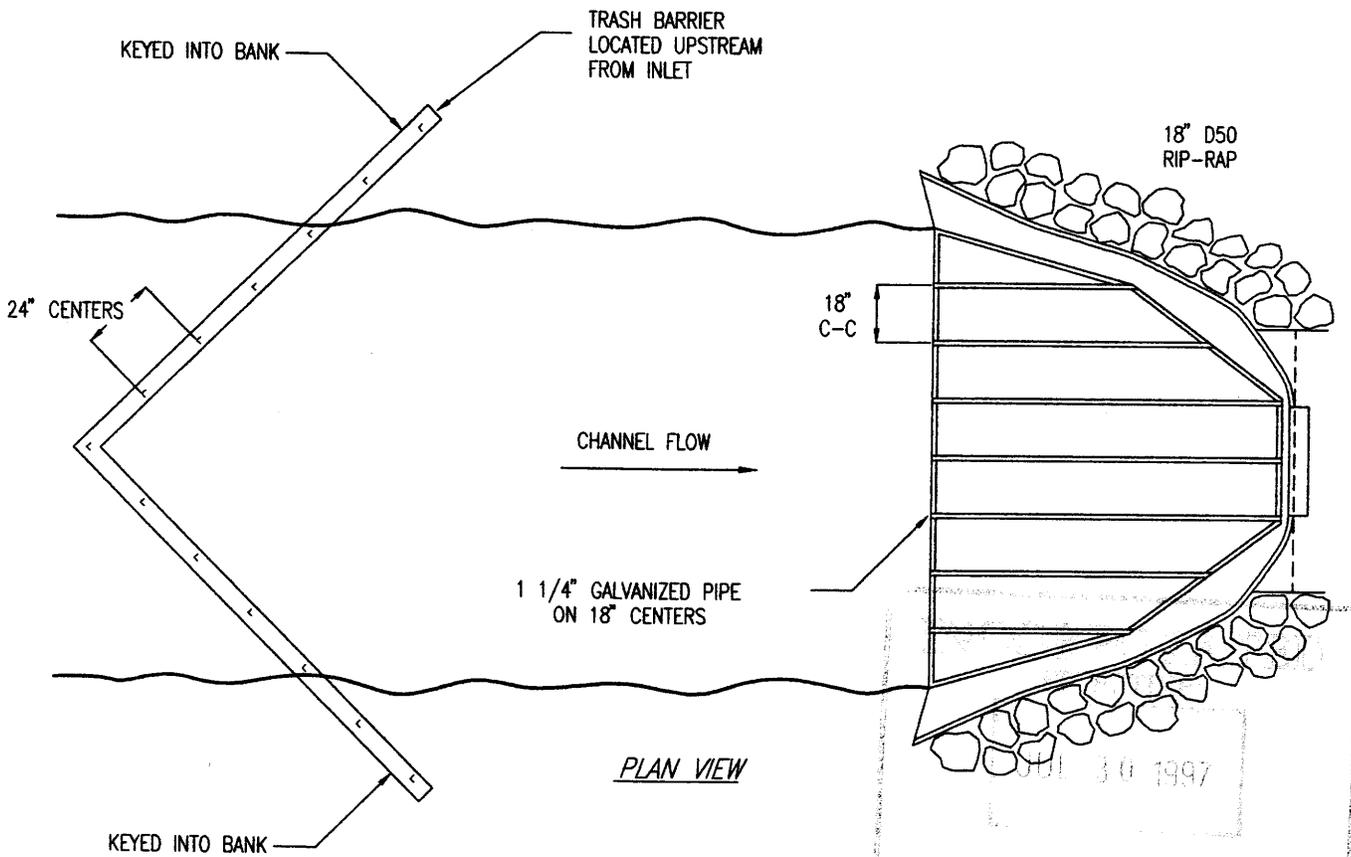
FIGURE 10

**MAIN CULVERT INLET
AND TRASH BARRIERS**

SIDE VIEW

PLAN VIEW

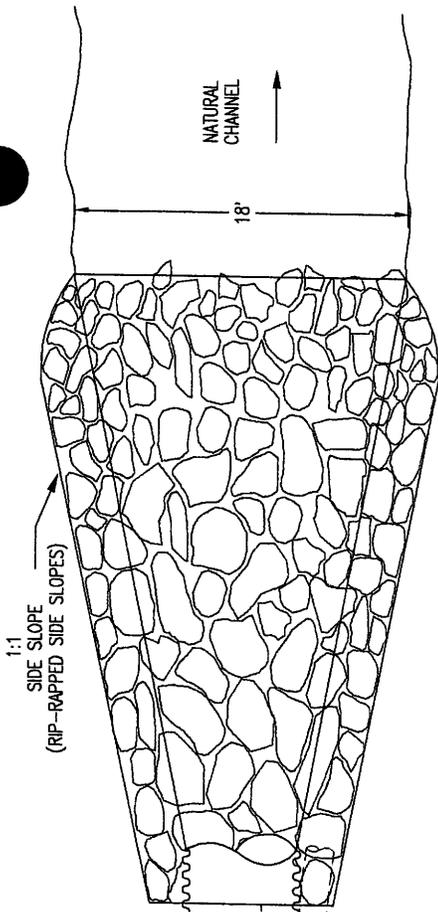
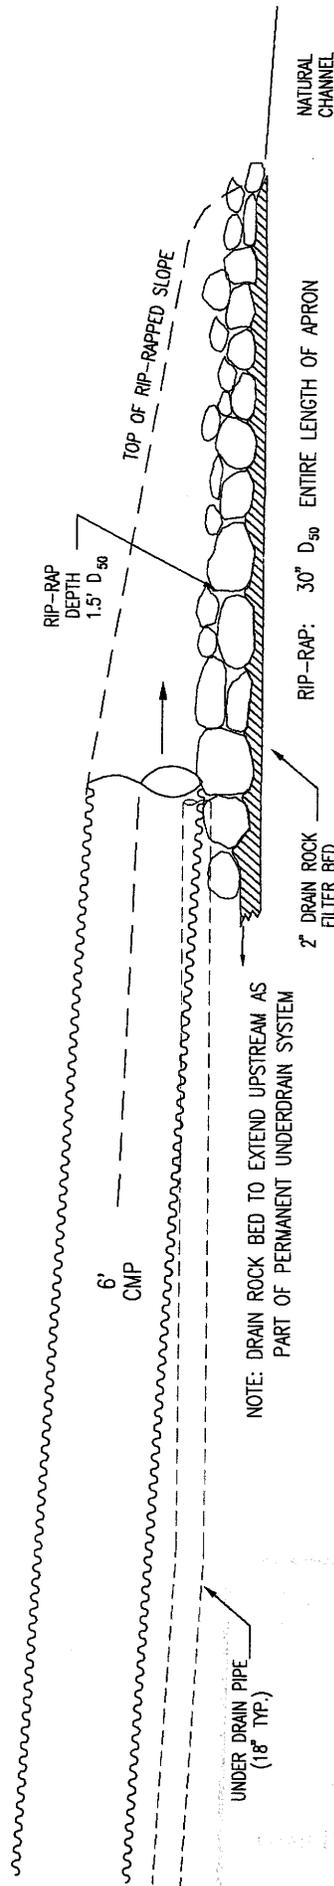
**MAIN CANYON
CULVERT OUTLET**

RIP-RAP: 30" D₅₀ ENTIRE LENGTH OF APRON

* DESIGN BASED ON FIGURE 7-26, DESIGN OF OUTLET PROTECTION - MAXIMUM TAILWATER CONDITION,
"APPLIED HYDROLOGY AND SEDIMENTOLOGY FOR DISTURBED AREAS", BARFIELD, WARNER & HANN, 1983.

The outlet of the 6' diameter main canyon culvert has been designed to flow into a rip-rap apron to protect against scouring and for energy dissipation. The rip-rap apron is designed to fit the natural channel configuration as closely as possible, and will allow runoff to re-enter the natural channel at a reduced velocity which is no greater than natural flow conditions. Runoff from the 100 year - 6 hour precipitation event in the canyon above the minesite has been calculated at 222.79 cfs.

The rip-rap apron design is based on Figure 7-26, Design of Outlet Protection - Maximum Tailwater Condition, "Applied Hydrology and Sedimentology for Disturbed Areas", Barfield, Warner and Haan, 1983. Based on the figure, the apron should be a minimum of 22' in length, widening from 6' to 15', with a 0% slope. The proposed length has been increased to 30', with an 18' width, to ensure adequate time for velocity reduction. The slope is kept at 0%. Rip-rap size is conservatively placed at 30" D_{50} . Rip-rap will be placed to a depth of 1.5 D_{50} and will be embedded in a 12" layer of 2" drain rock filter. Rip-rap will also be placed on 1:1 side slopes to the height of the culvert (6') at the culvert outlet tapering to 3' at the outlet of the apron. This rip rap apron has been sized and designed to adequately dissipate energy from flow velocities of a 100 year, 24 hour precipitation event and resist dislodgement. The drain rock filter bed will also serve to secure the rip rap boulders firmly in place, to add an additional element of stability, and prevent scouring underneath the boulder bed.

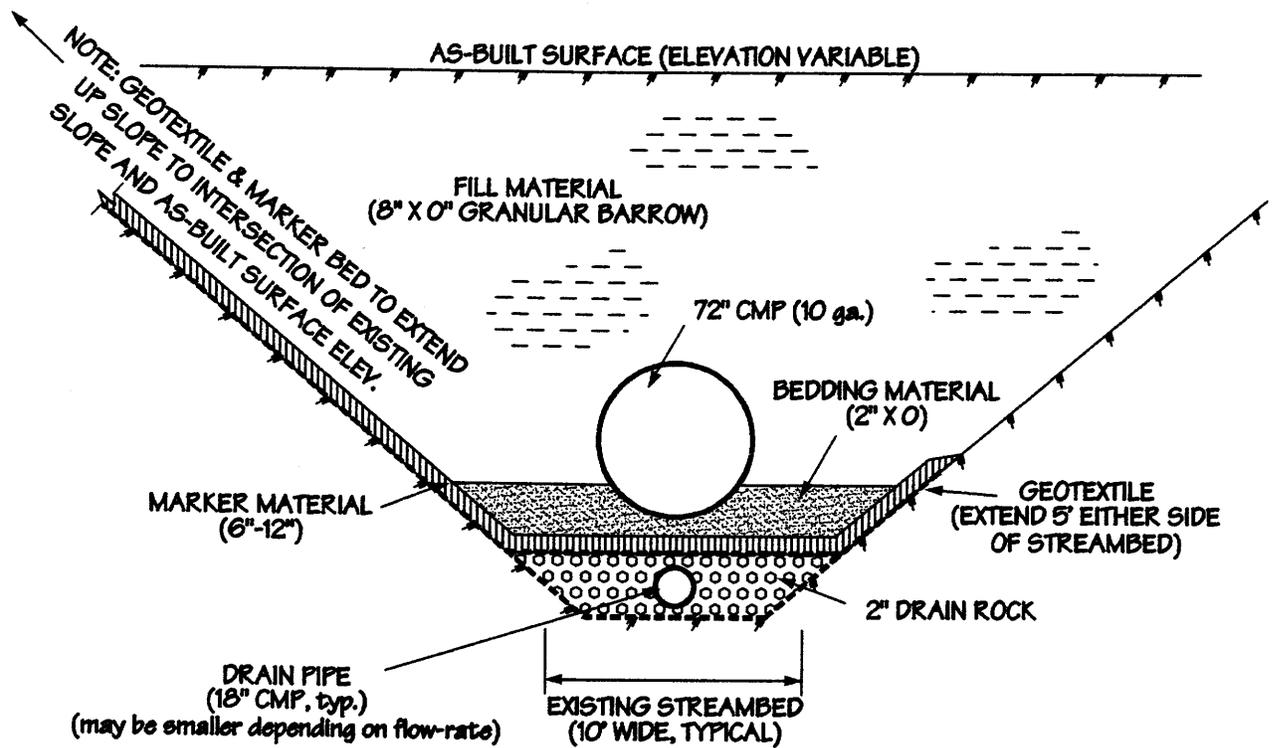
TYPICAL UNDERDRAIN CONSTRUCTION

Note: Culvert installation will generally follow the existing stream alignment, but may vary slightly to accommodate accepted engineering and installation standards.

carry any water, possibly coming from pin-hole leaks in the pit liner, directly out from the basin so that it cannot saturate any portion of the berm. The pit liner is fabricated as a single piece and is not expected to leak, but the underdrain system was installed as a measure of added insurance. It should be noted that the berm has been constructed on the site of the old loadout which was constructed on both solid rock blasted out of the ledge, and on previously compacted structural fill material.

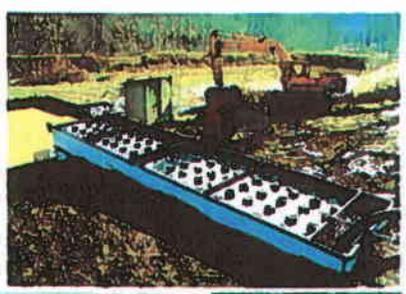
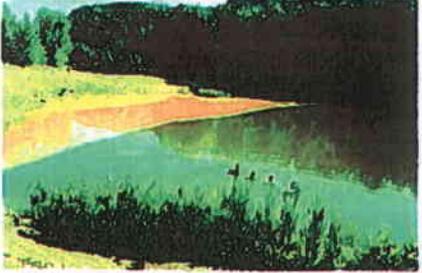
**Photos are of an installation that's treats 720,000 gallons per day of net alkaline
Acid Mine Drainage that contains 105 mg/l of iron. Effluent meets NPDES and Pa.
DEP discharge limitations. No chemicals are used in the treatment. Land area is
twenty times smaller than recommended for passive systems.**

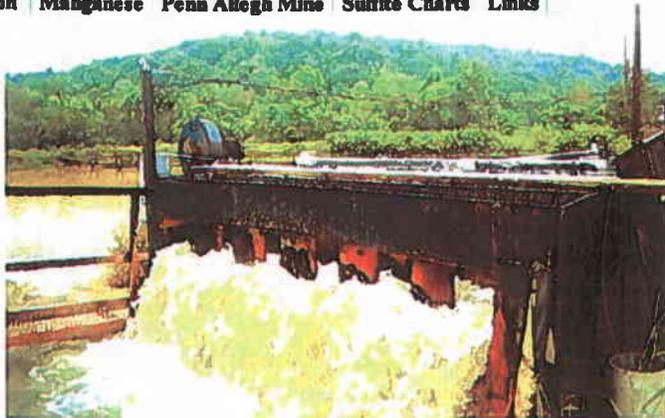
Maple Creek Mine—Pennsylvania

This Pennsylvania Mine has acidic water with a pH of 3.1. Total iron is 1900 milligrams per liter. The treatment flow is 1850 liters per minute (500 gallons) per minute. Oxygen saturation had to be replenished 28 times every minute to oxidize all of the iron to meet discharge limitations. The 15 horse power blower supplied the oxygen demand of 64 pounds per hour. This relates to more than 4 pounds of oxygen per horse power hour. Sodium Hydroxide was used to increase pH. In Figure 1, the water is turning green in the first reaction chamber. As it leaves the second reaction chamber 15 seconds later, it is already brown from the oxidation of the iron.

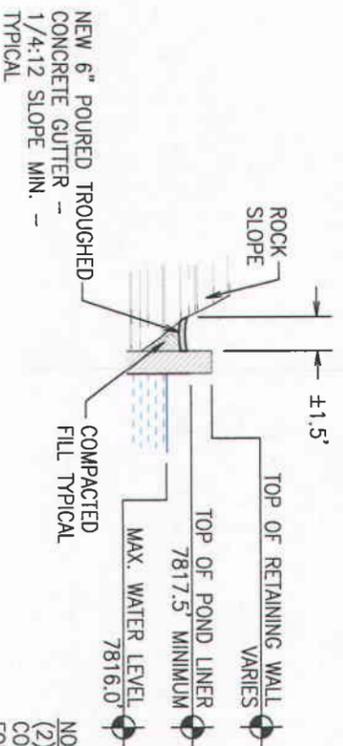
SEEP COLLECTOR SECTION

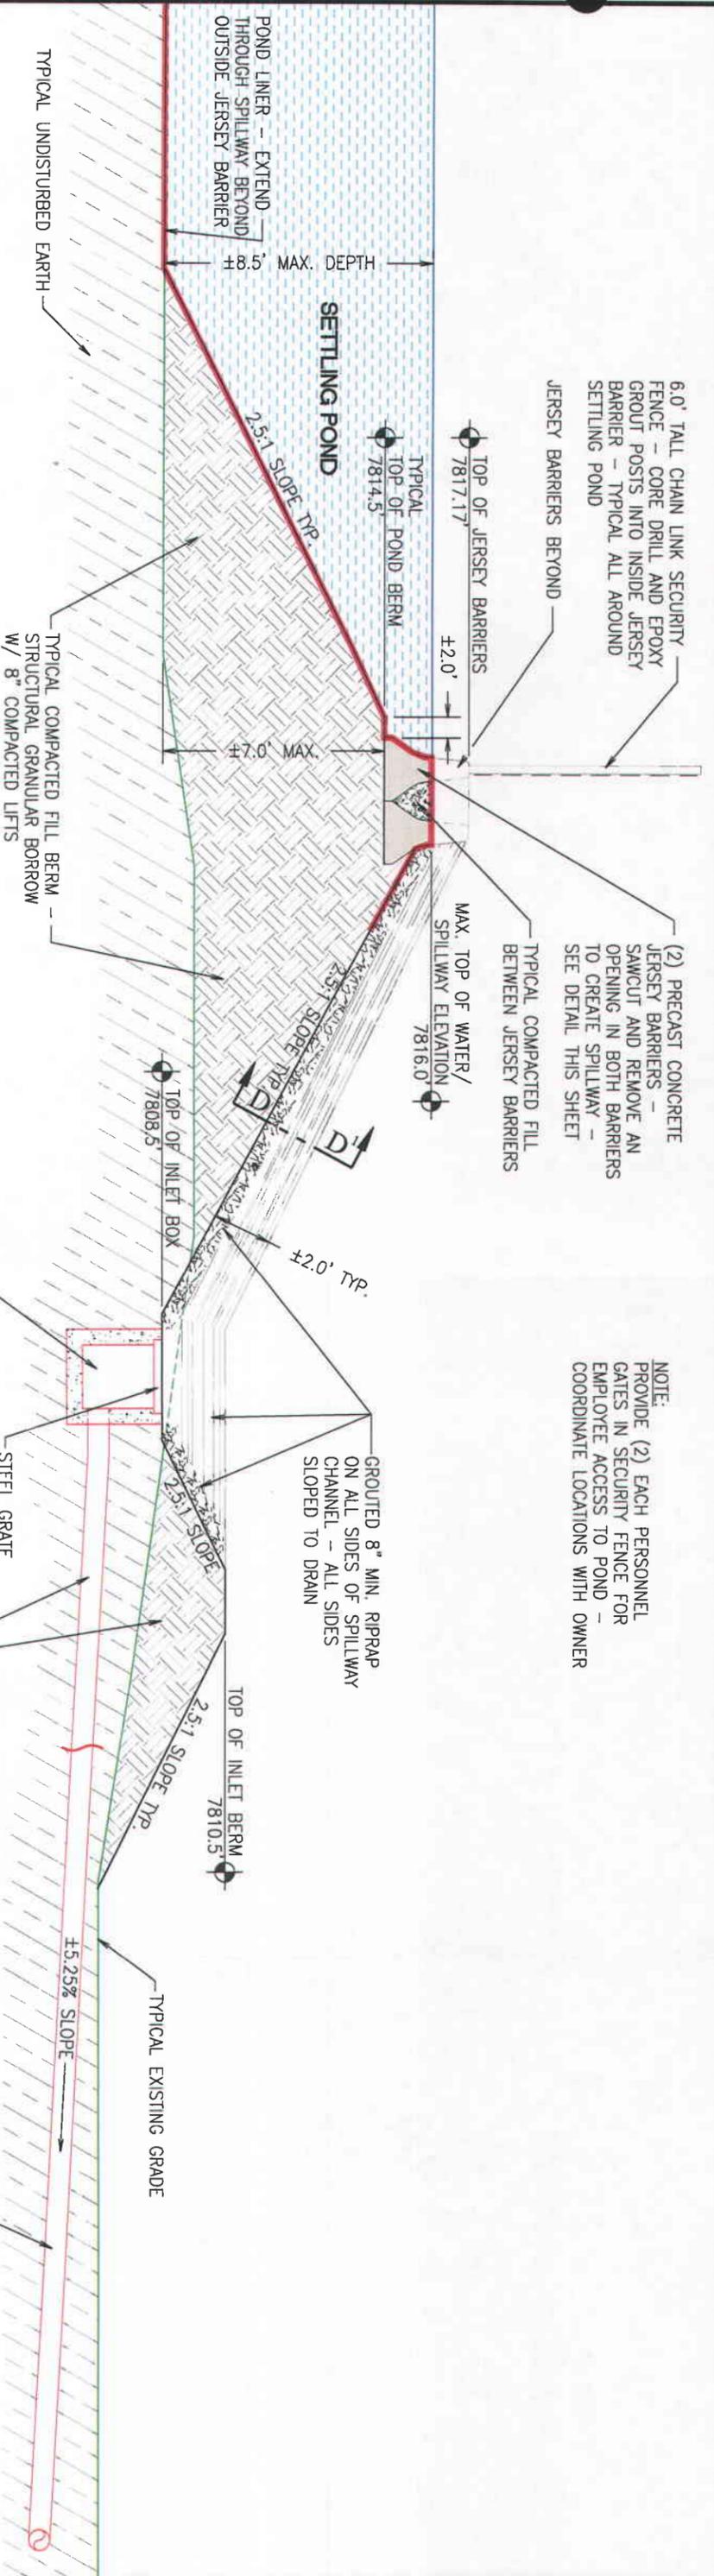
6.0' TALL CHAIN LINK SECURITY FENCE - CORE DRILL AND EPOXY GROUT POSTS INTO INSIDE JERSEY BARRIER - TYPICAL ALL AROUND SETTLING POND

NOTE: PROVIDE (2) EACH PERSONNEL GATES IN SECURITY FENCE FOR EMPLOYEE ACCESS TO POND - COORDINATE LOCATIONS WITH OWNER

The treated water from the oxidizer unit is then sent to a settling basin. This basin is constructed within a compacted earthen berm. Iron precipitates generated in the oxidizer unit will drop out of suspension and accumulate in the settling basin. The basin has been designed with twice the volume (i.e., retention time) recommended from the bench testing in order to maximize the potential for meeting UPDES compliance level. The treated water exits the basin through a spillway, dropping into an inlet structure to a discharge pipe which is buried under the road and connects to the existing discharge line leading to the designated UPDES outfall point. A flow meter has also been installed in the line. The UPDES water samples are taken at the outlet of the basin prior to entering the pipe leading to the outfall. This is similar to the manner

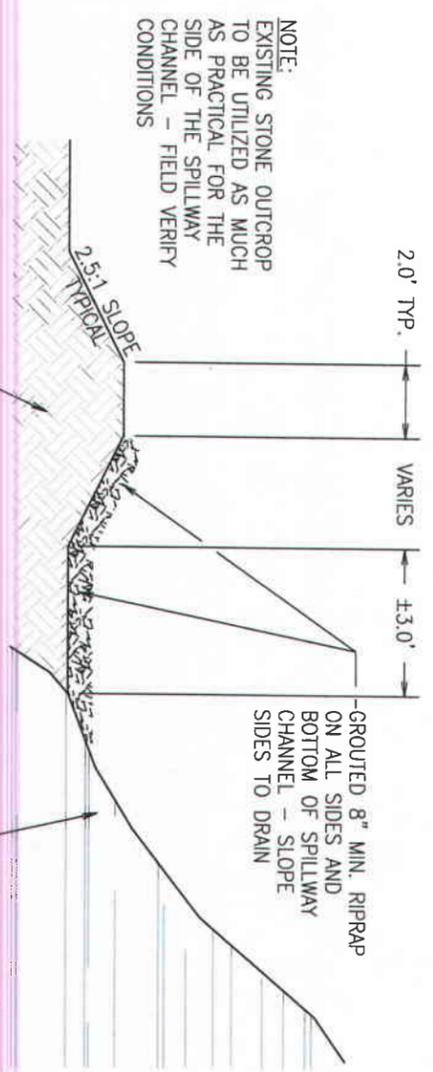
SECTION C-C'1
SPILLWAY SECTION

NOTE: EXISTING STONE OUTCROP TO BE UTILIZED AS MUCH AS PRACTICAL FOR THE SIDE OF THE SPILLWAY CHANNEL - FIELD VERIFY CONDITIONS

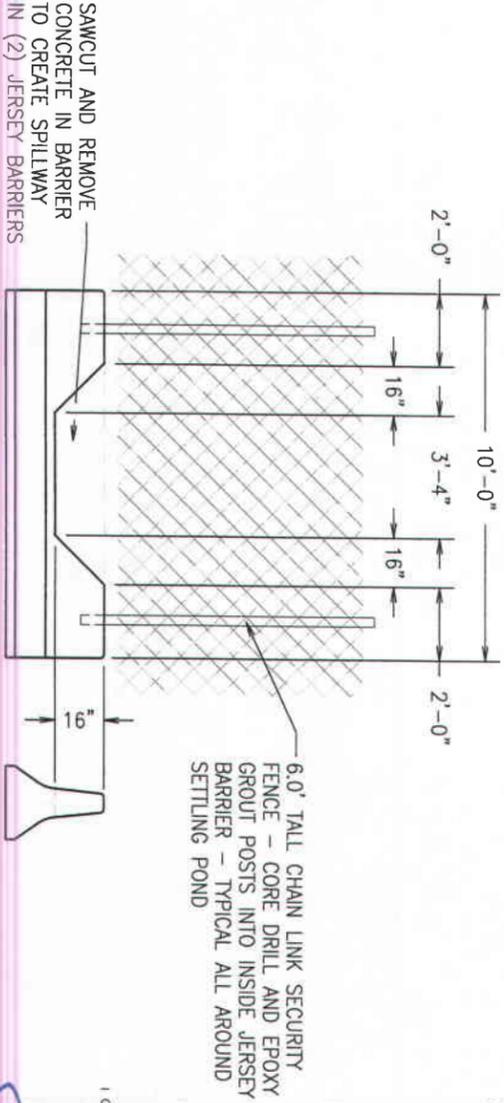
TYPICAL COMPACTED FILL BERM - STRUCTURAL GRANULAR BORROW W/ 8" COMPACTED LIFTS

SECTION D-D'1
TYPICAL SPILLWAY CROSS-SECTION

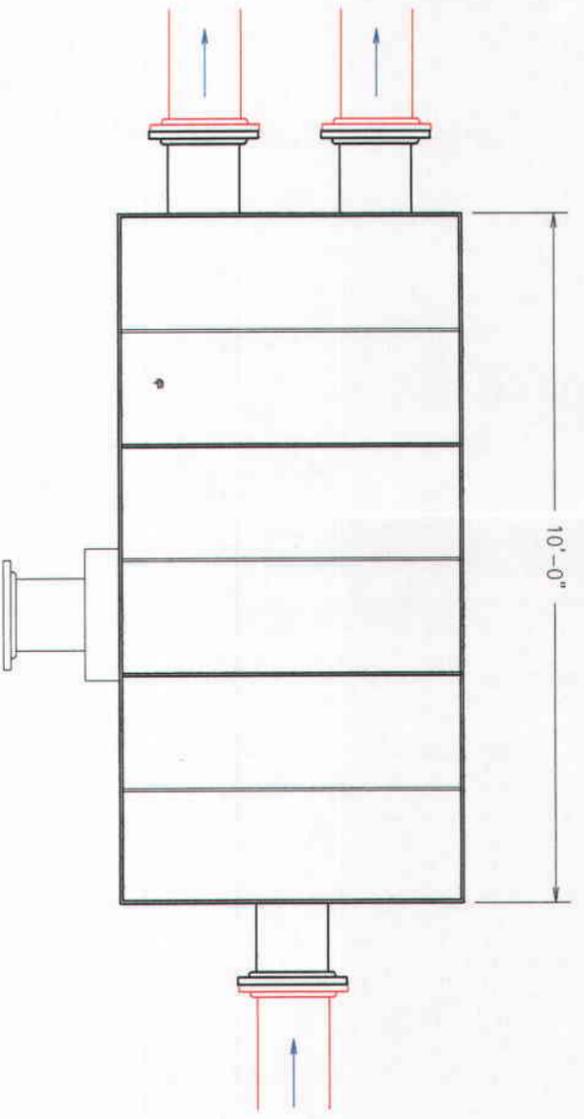
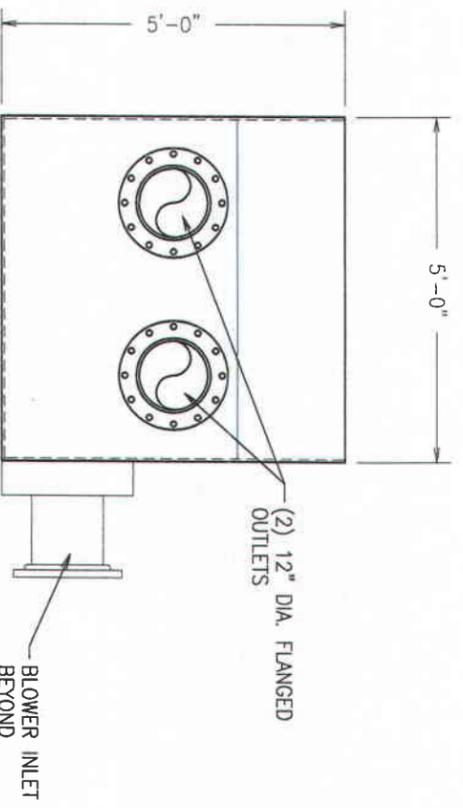
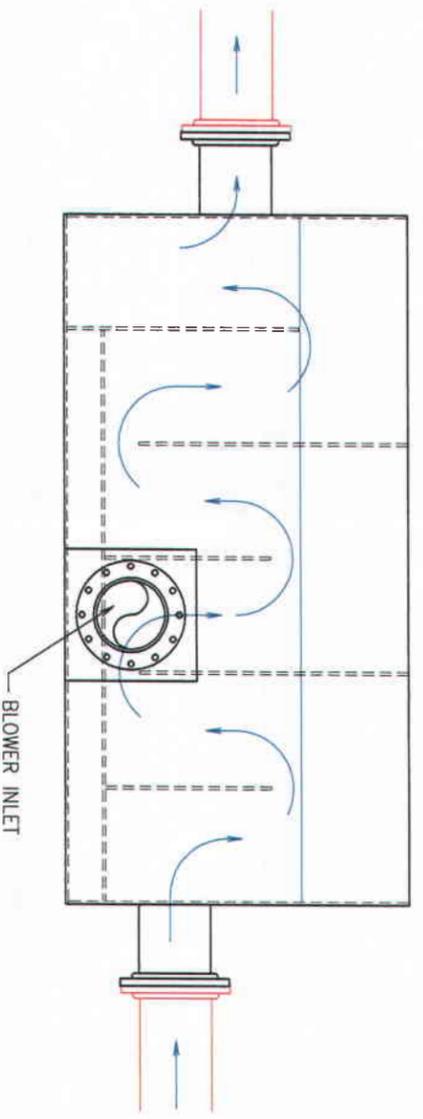
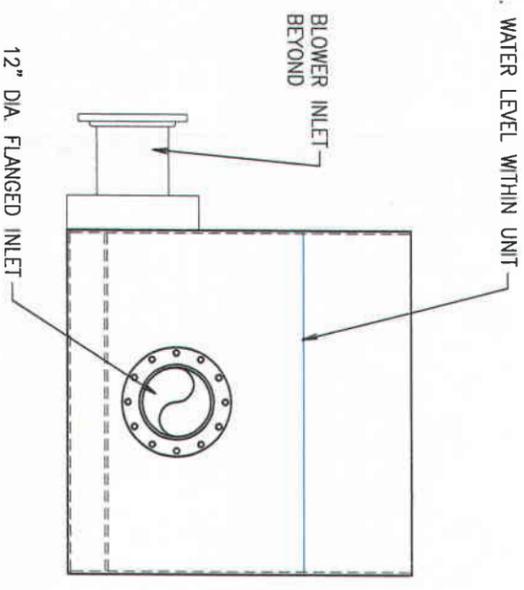
TOP VIEW

APPROX. MAX. WATER LEVEL WITHIN UNIT

OUTLET END

LEFT SIDE VIEW

INLET END

NOTES:
 ITEMS DENOTED WITH BLACK LINES ARE RELATED TO THE MAELSTROM OXIDIZER UNIT.
 ITEMS DENOTED WITH RED LINES ARE RELATED TO ITEMS THAT ARE TO BE FABRICATED.
 ALL JOINTS THAT CAN REASONABLY BE WELDED IN THE SHOP SHALL BE DONE SO.
 ALL WELDED JOINTS SHALL BE WATER TIGHT AND GROUND SMOOTH WHENEVER POSSIBLE.
 OXIDIZER UNIT MANUFACTURED BY:
 ENVIRONMENTAL SOLUTIONS, LLC
 314 POLO CLUB DRIVE
 MOON TOWNSHIP, PENNSYLVANIA 15108
 PHONE: (412) 262-2606 OR (412) 716-7600
