# Inspection Report

Permit Number:	C0150032
Inspection Type:	PARTIAL
Inspection Date:	Monday, April 17, 2017
Start Date/Time:	4/17/2017 10:00:00 AM
End Date/Time:	4/17/2017 1:00:00 PM
Last Inspection:	Tuesday, March 07, 2017

Permittee: **GENWAL RESOURCES INC**  
 Operator: **GENWAL RESOURCES INC**  
 Site: **CRANDALL CANYON MINE**  
 Address: **PO BOX 910, EAST CARBON UT 84520-0910**  
 County: **EMERY**  
 Permit Type: **PERMANENT COAL PROGRAM**  
 Permit Status: **INACTIVE**

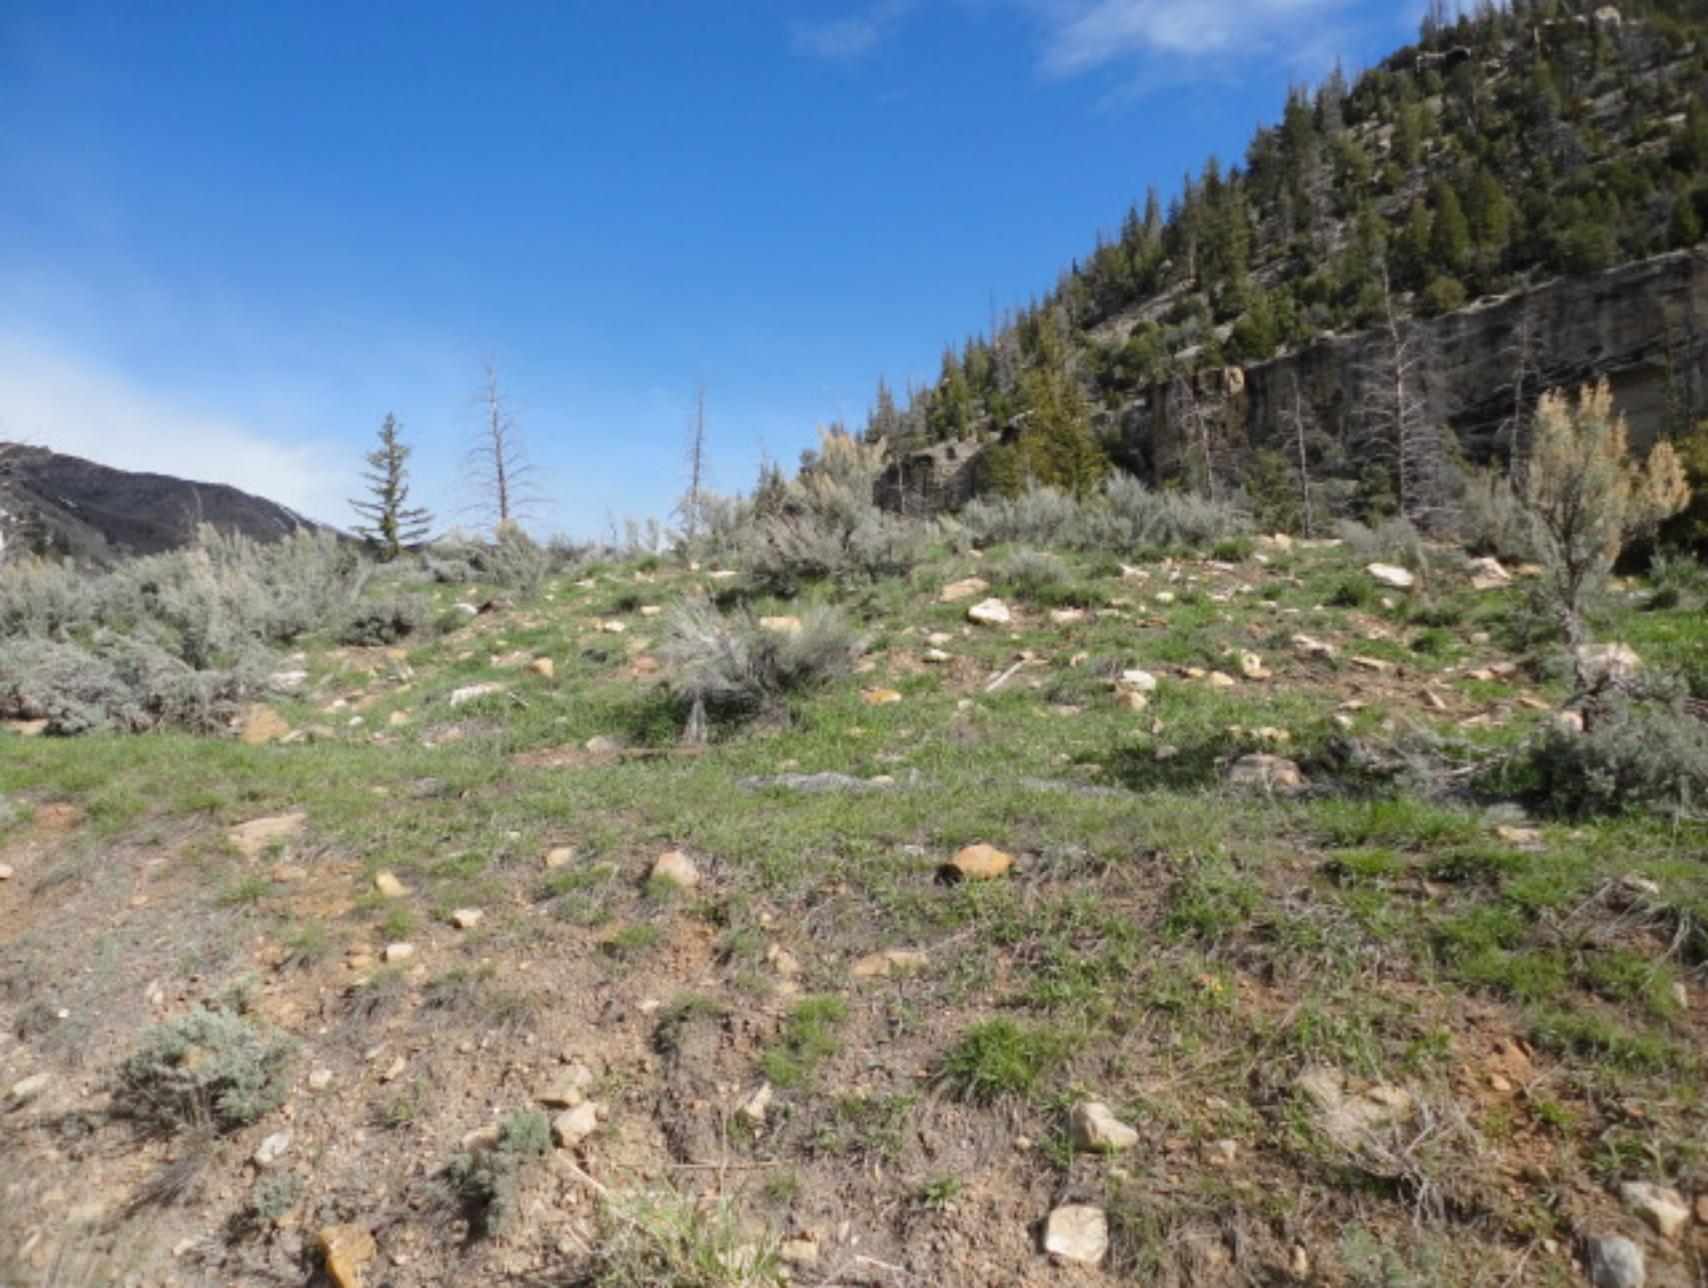
The USFS road by the sediment pond has partially fallen/slide towards the sediment pond. It has moved the rock gabions. The permittee plans on repairing the road. The road is under control of the USFS. See Photos

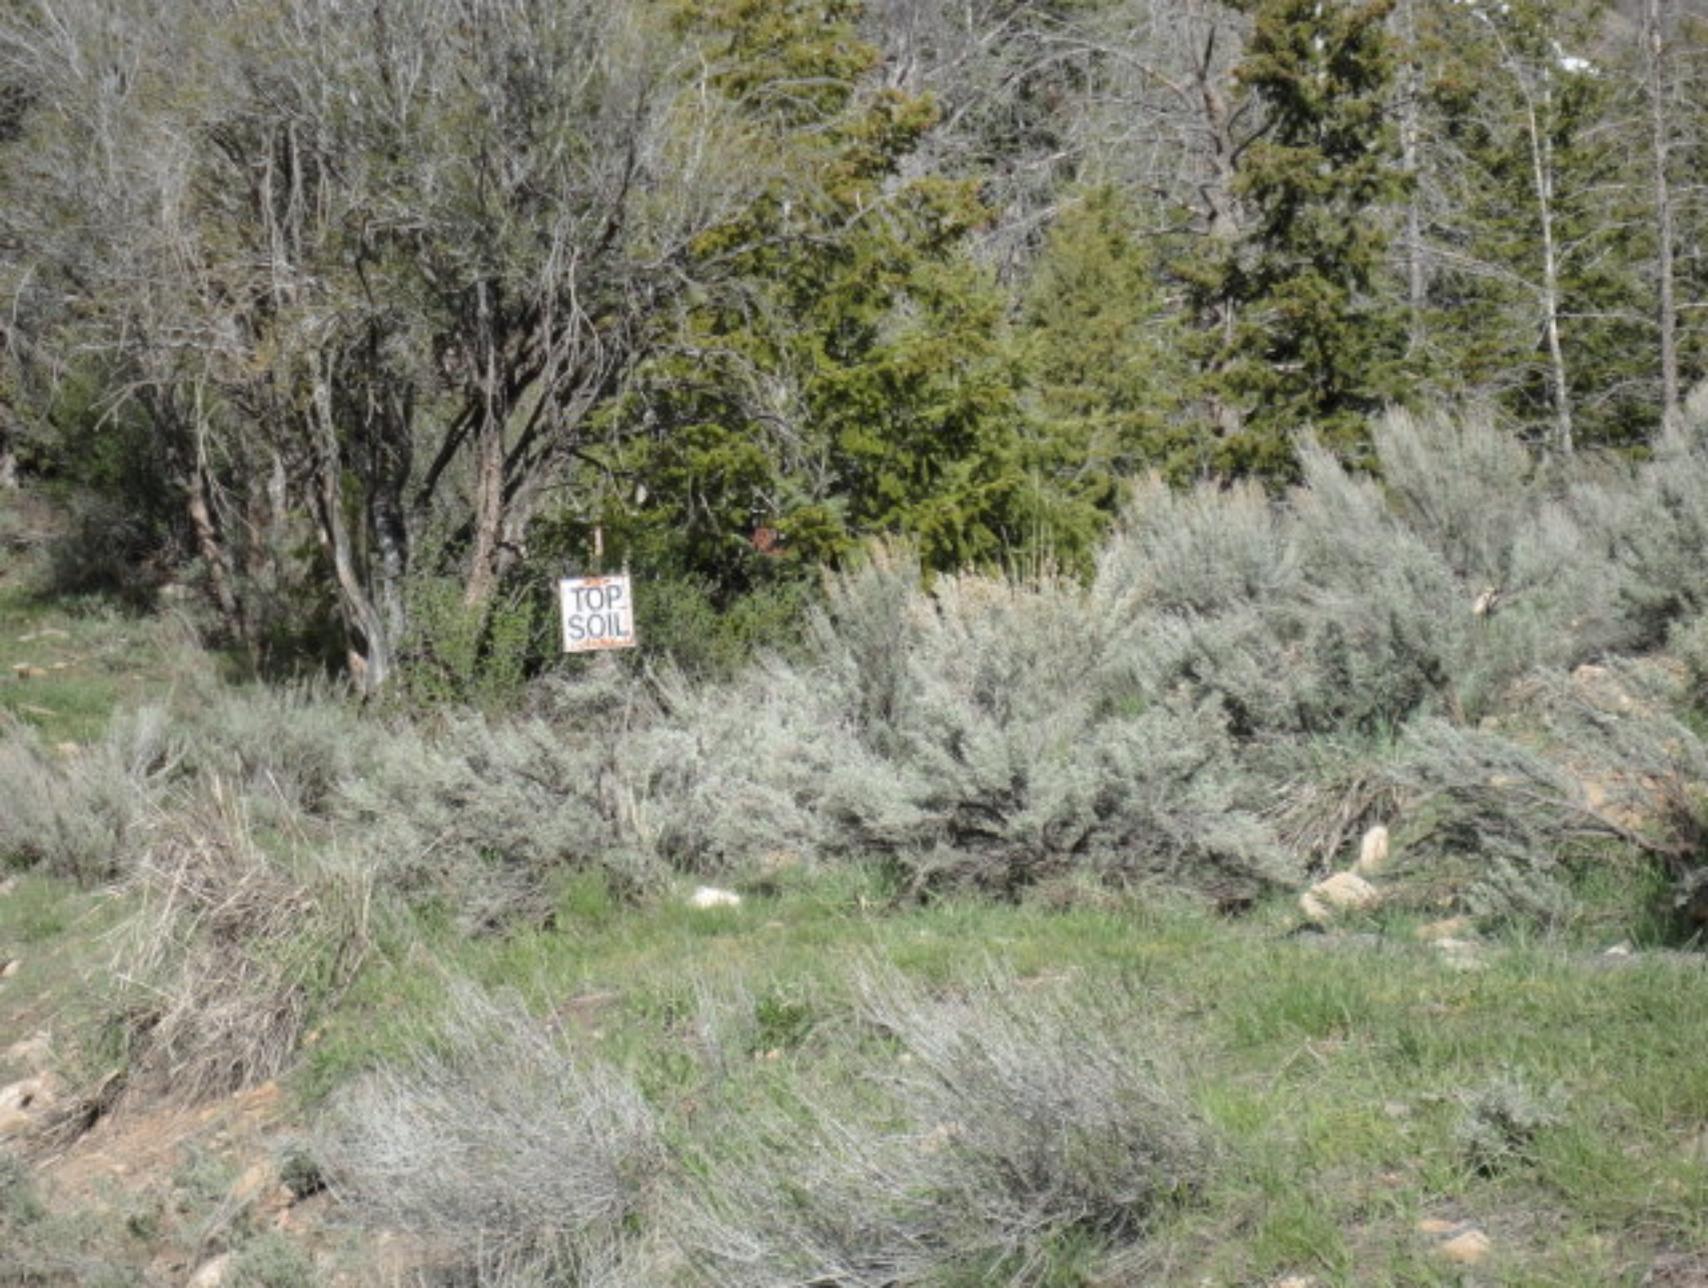
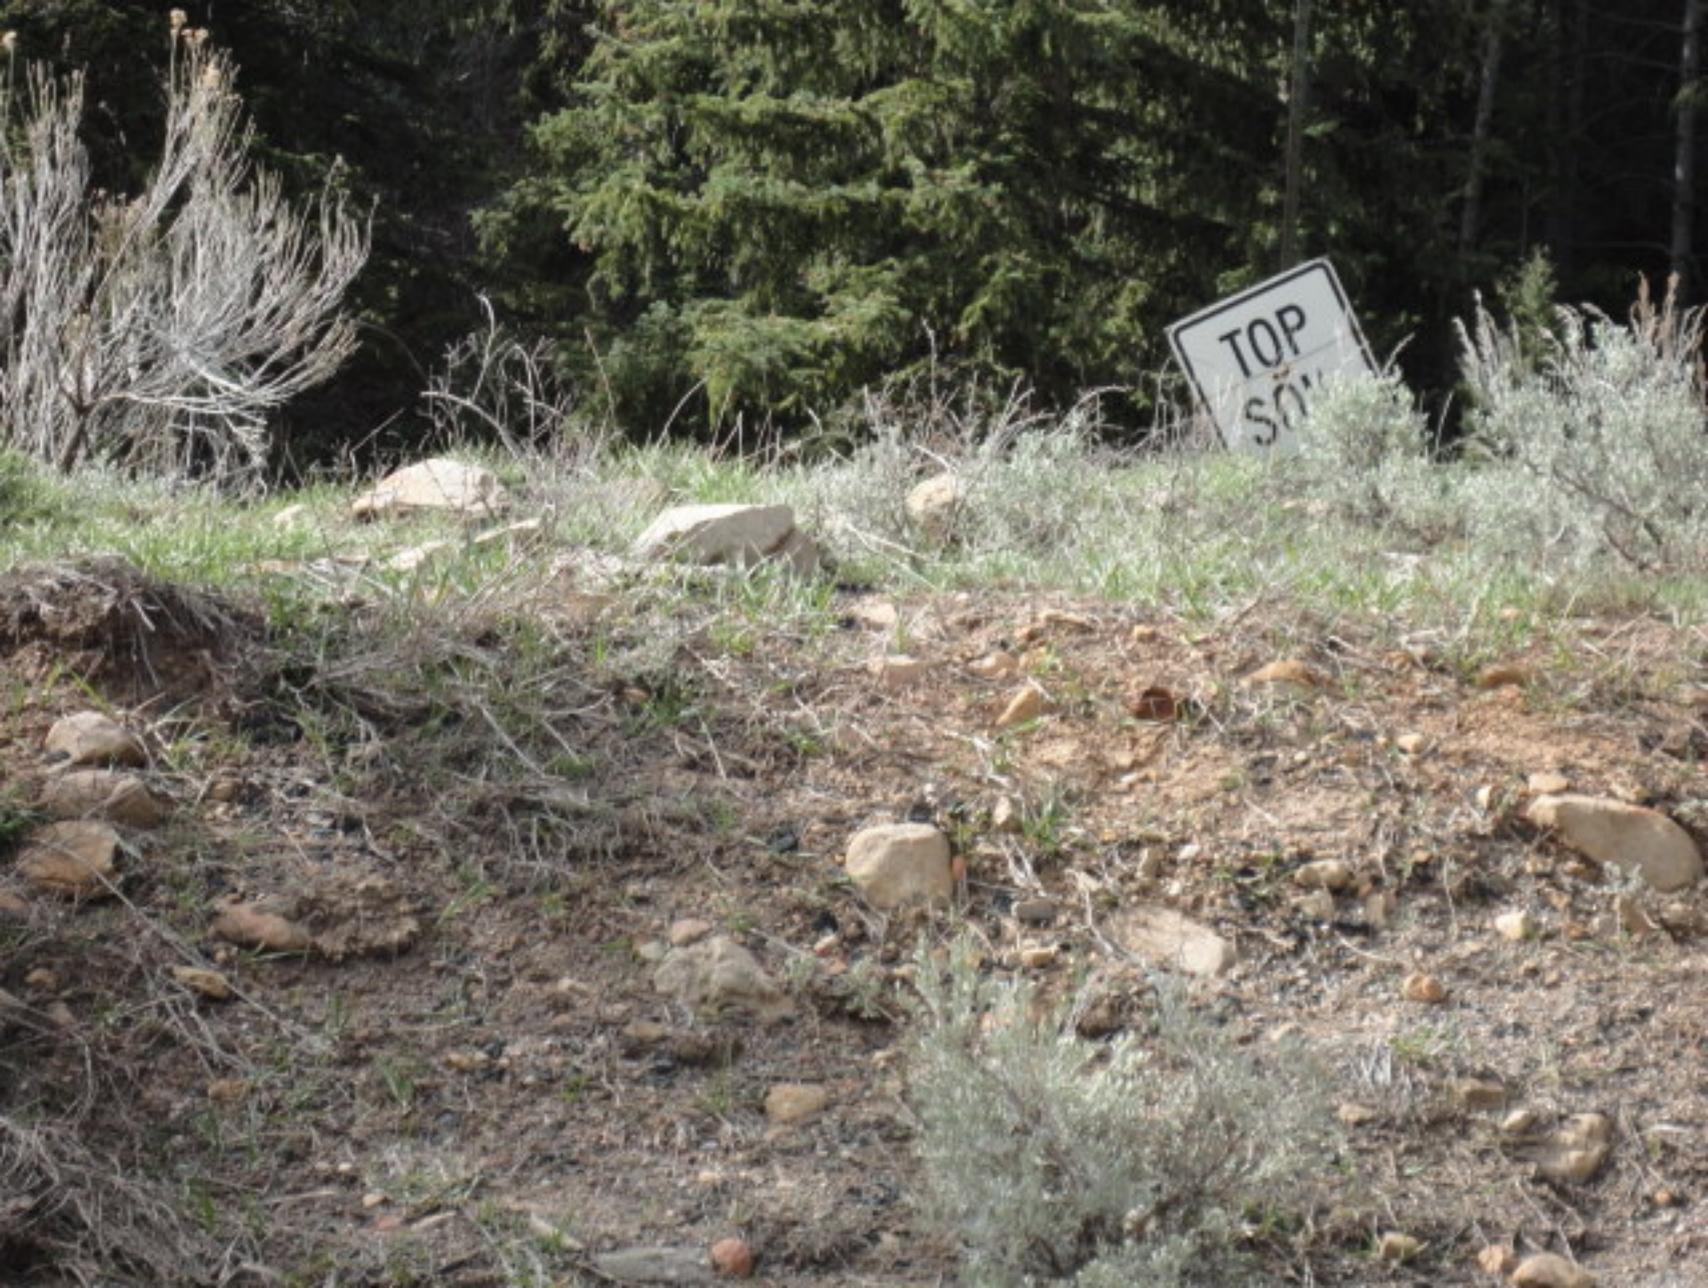
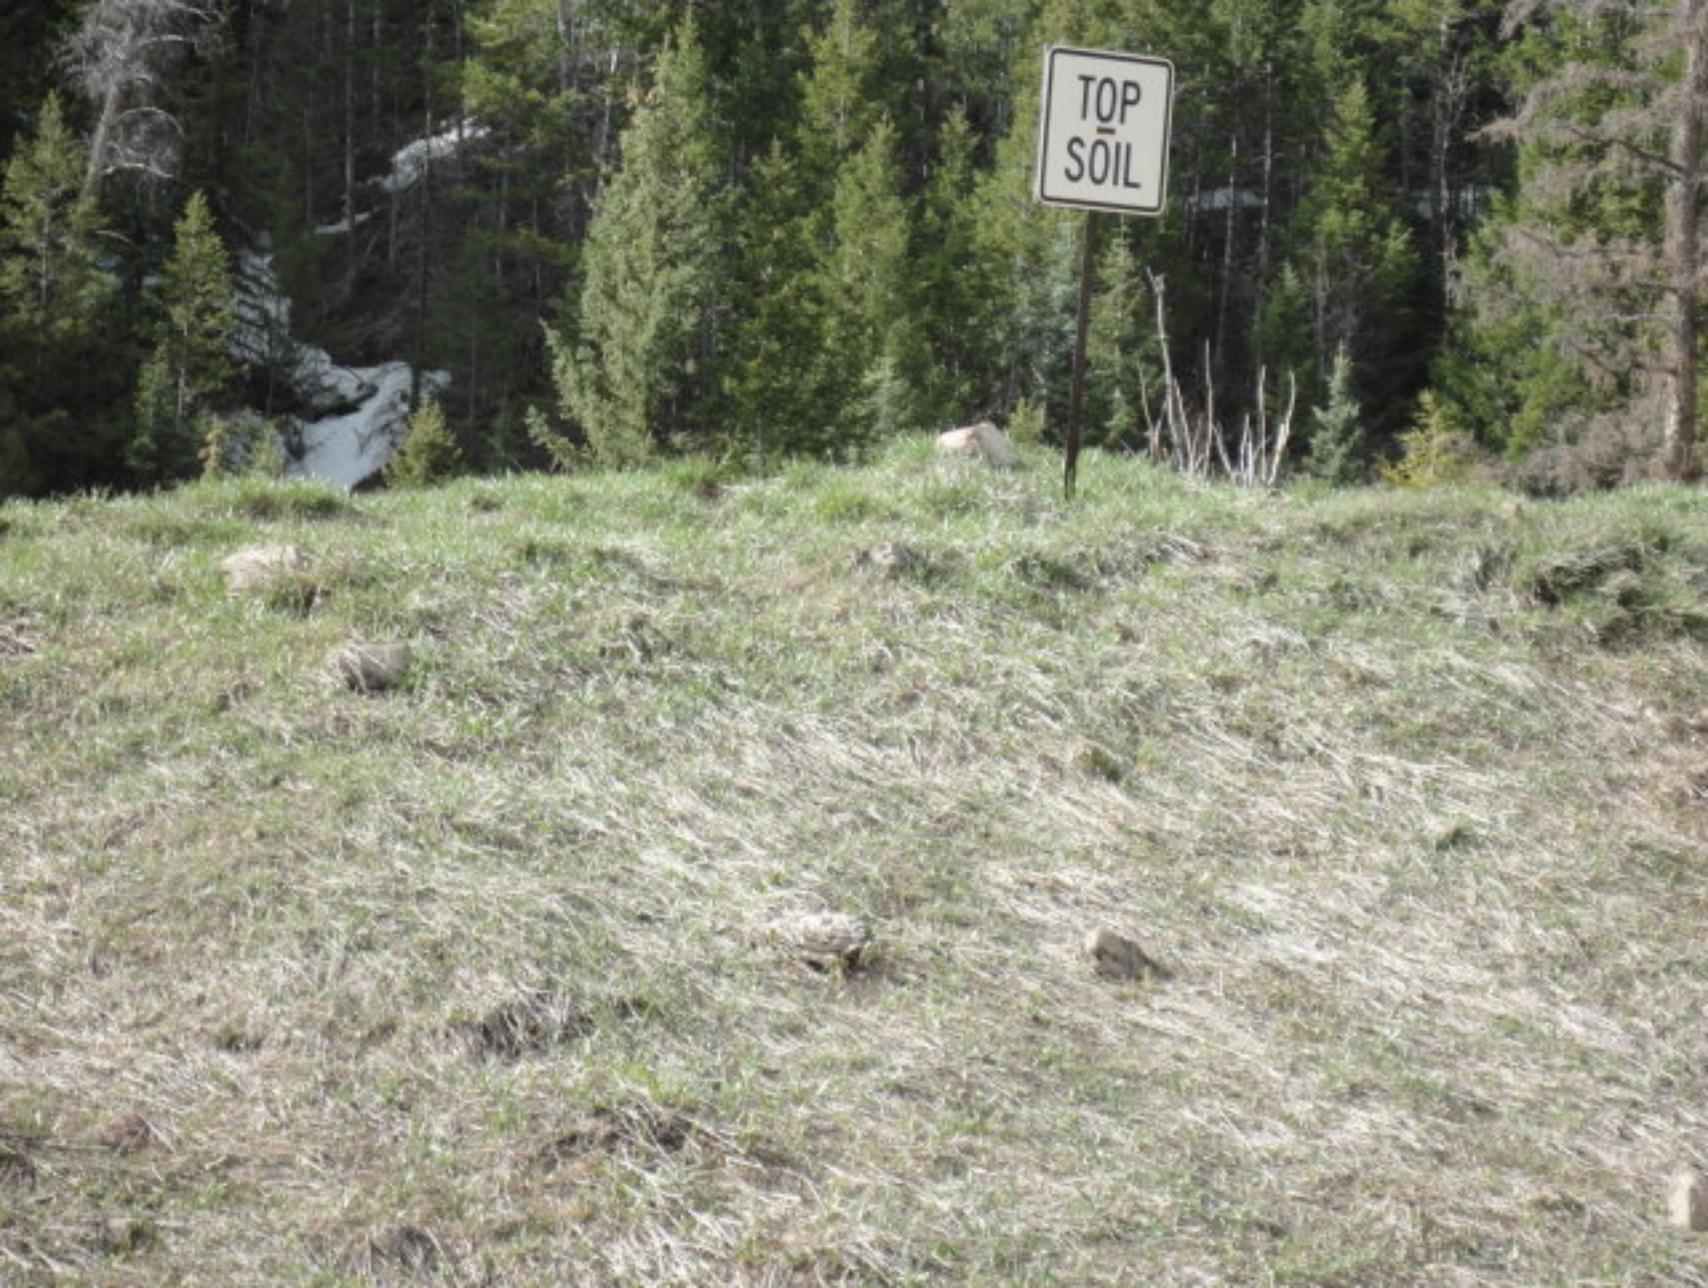
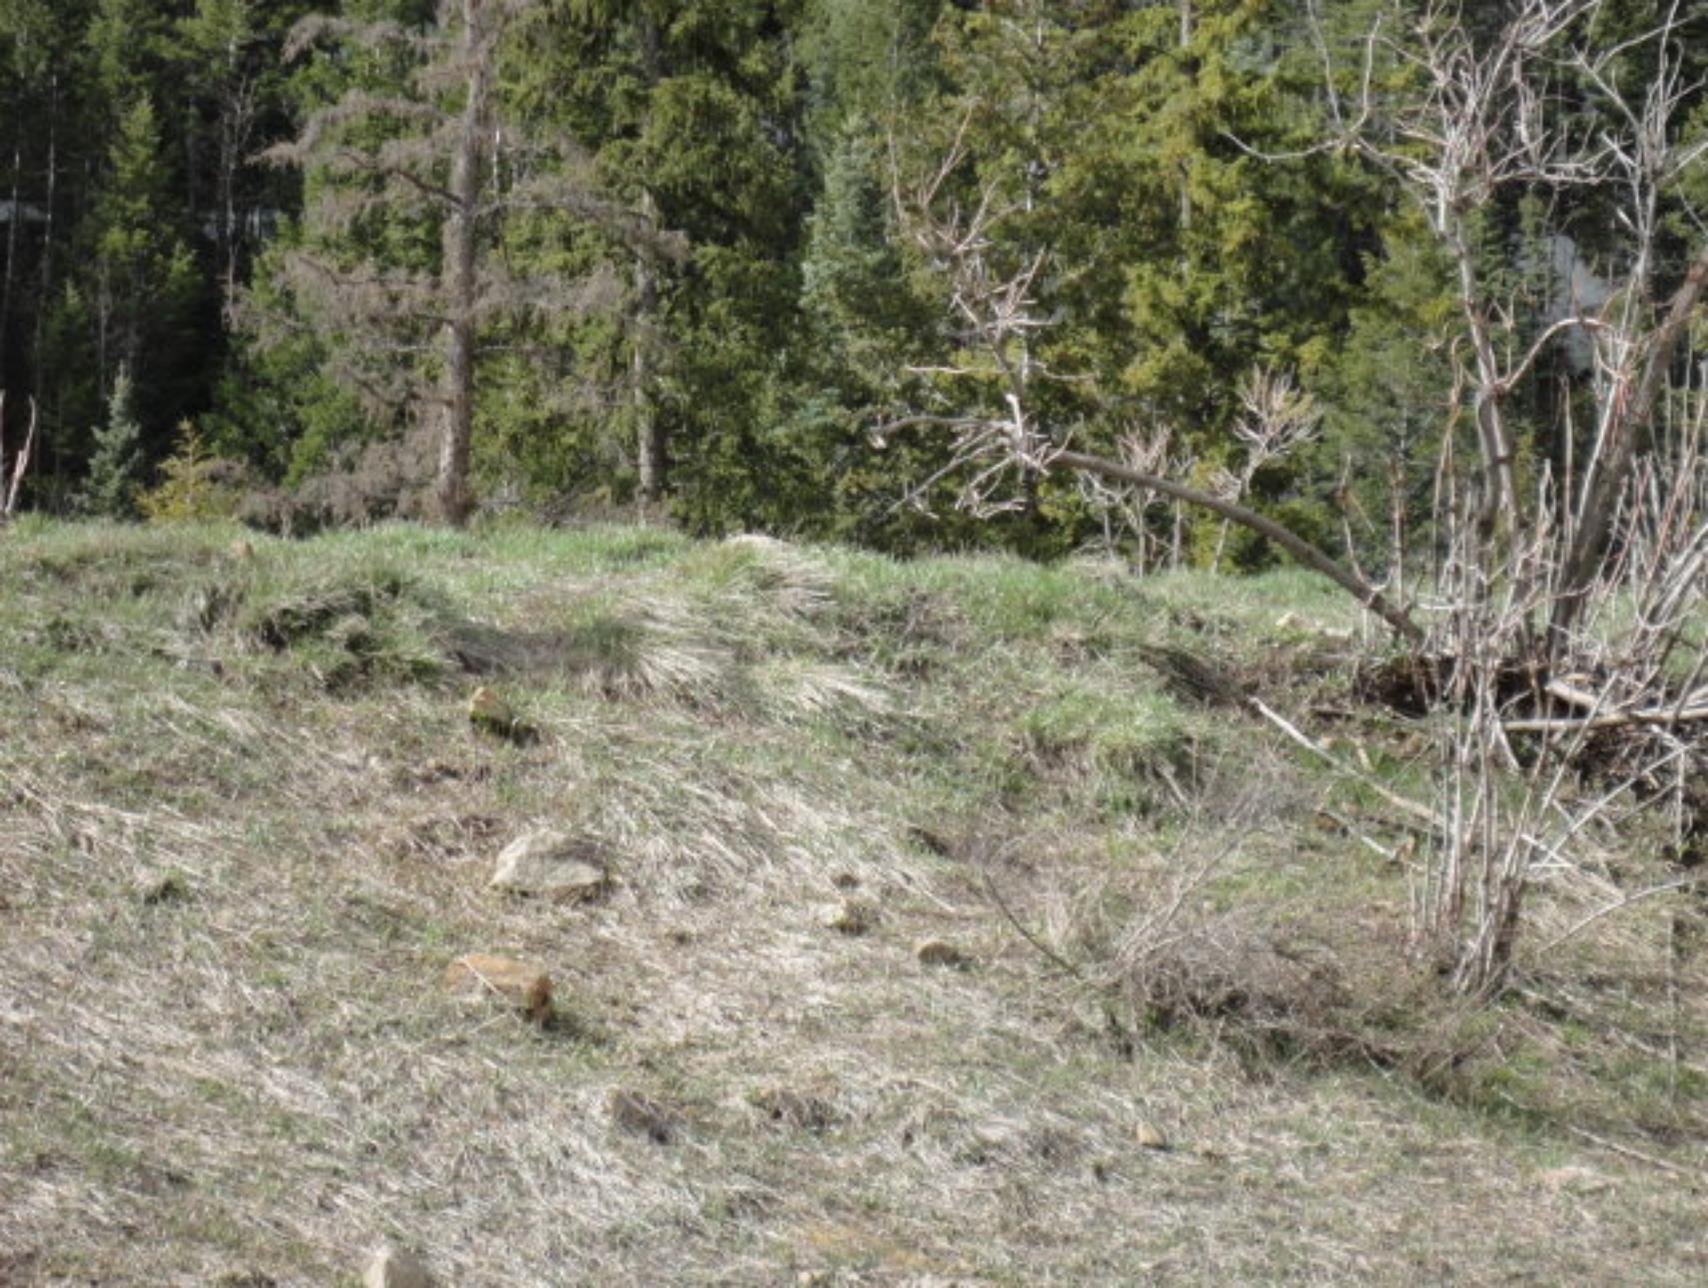
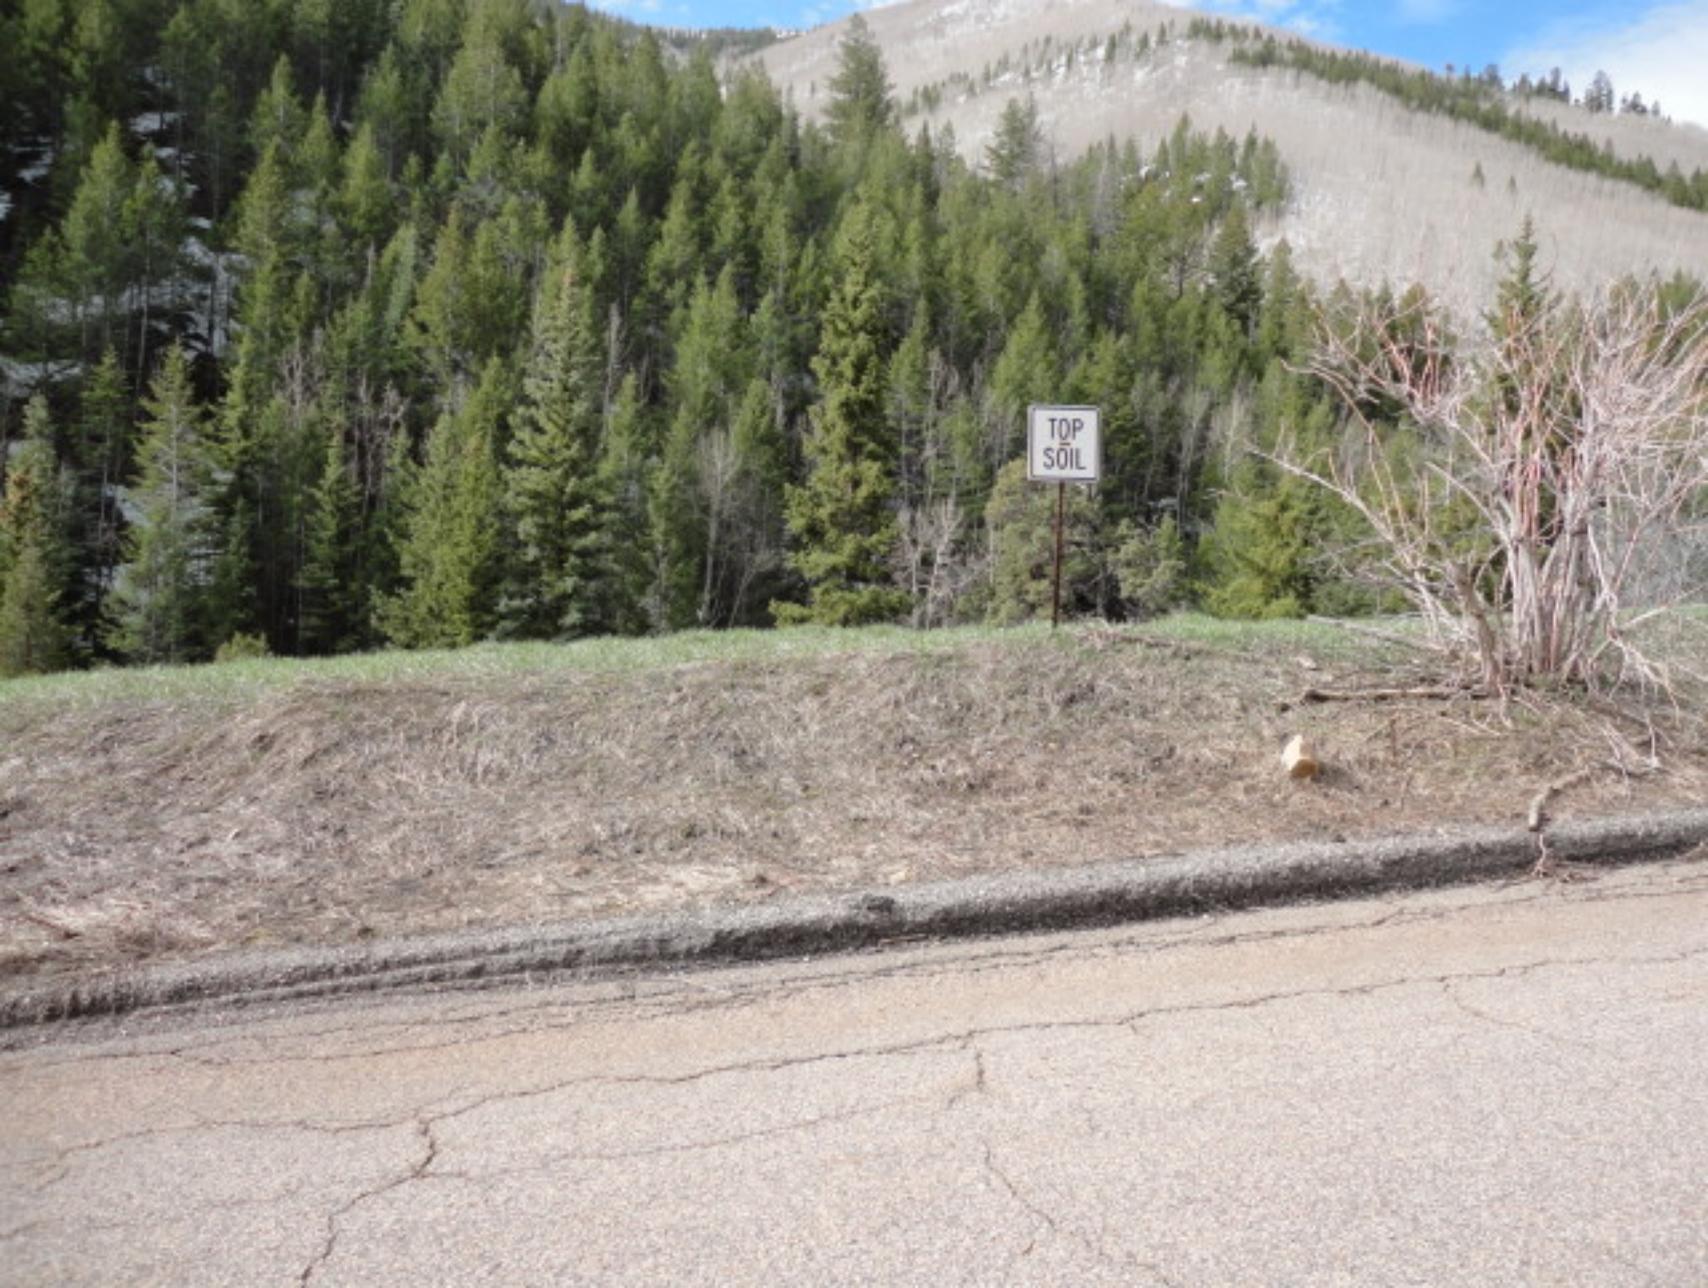
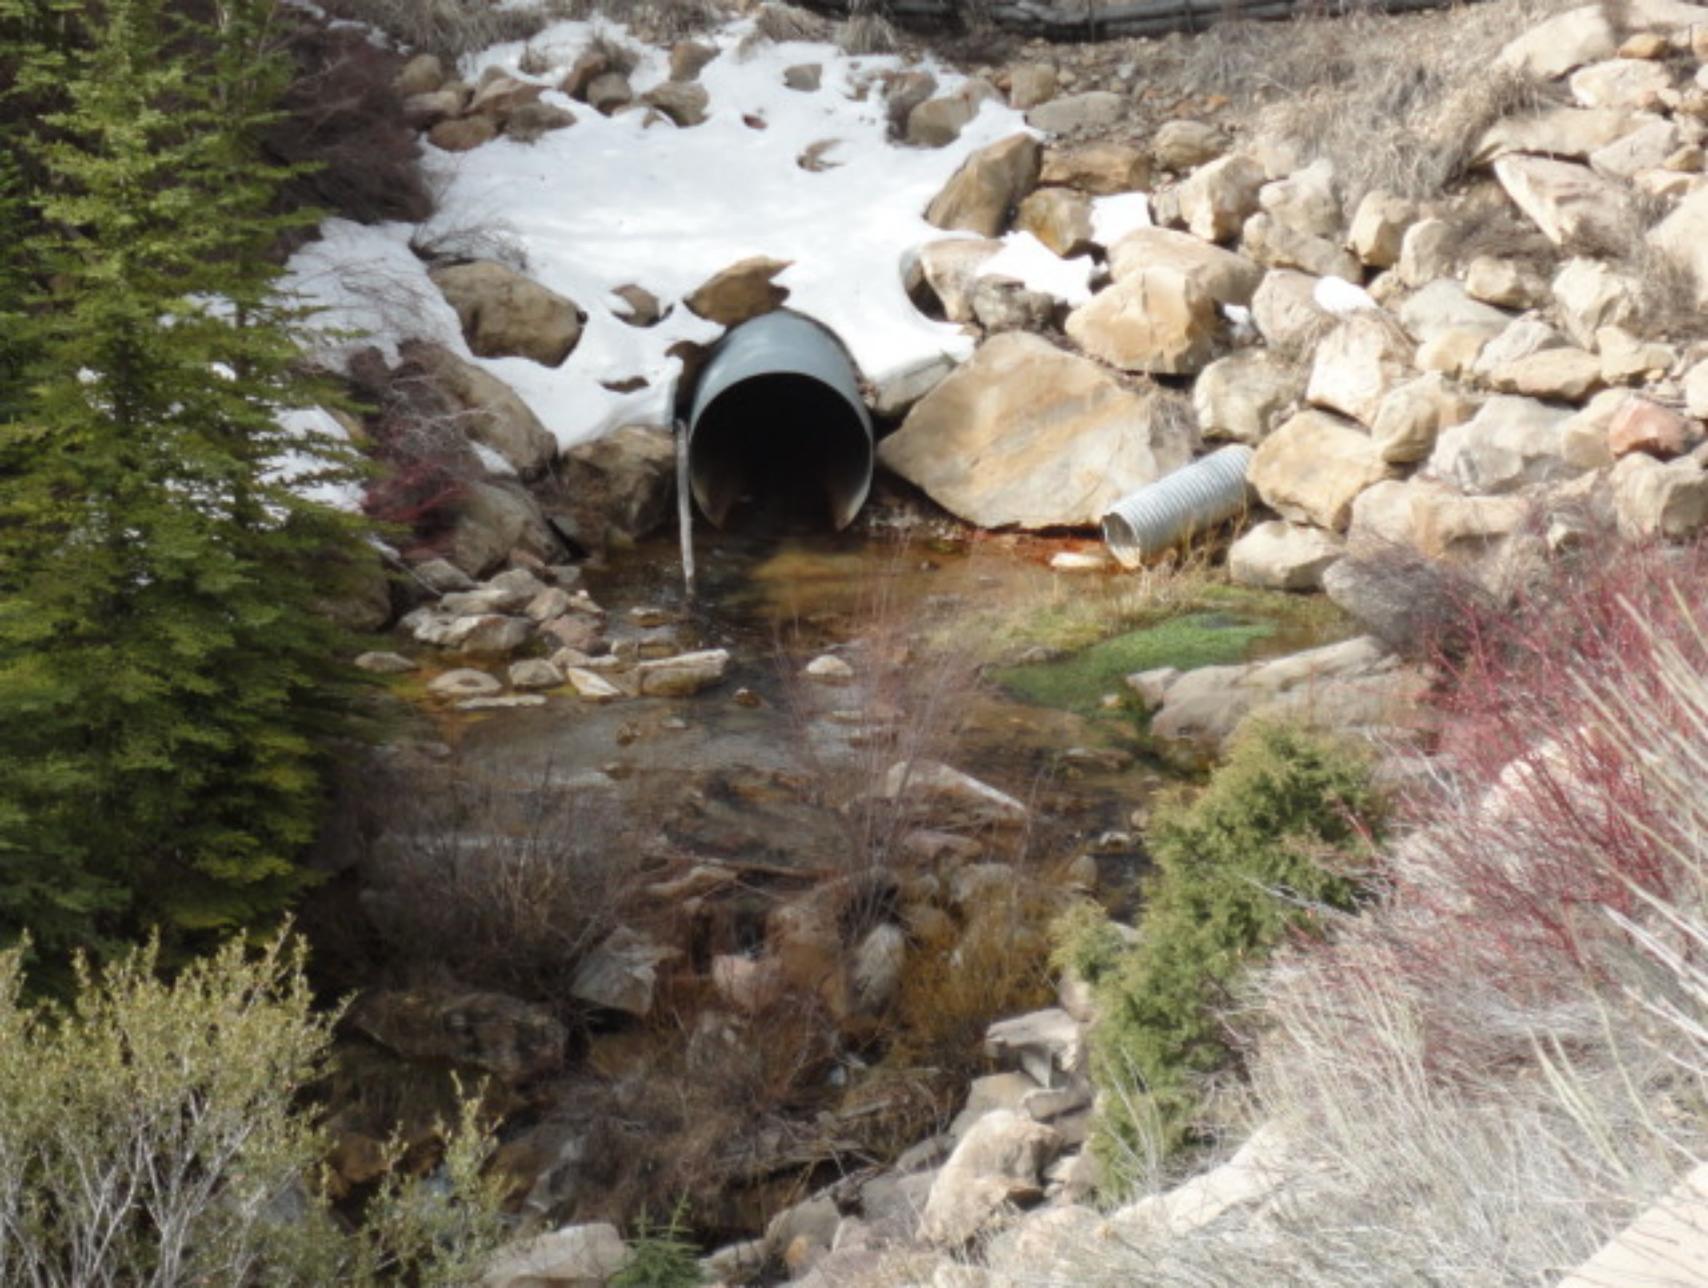
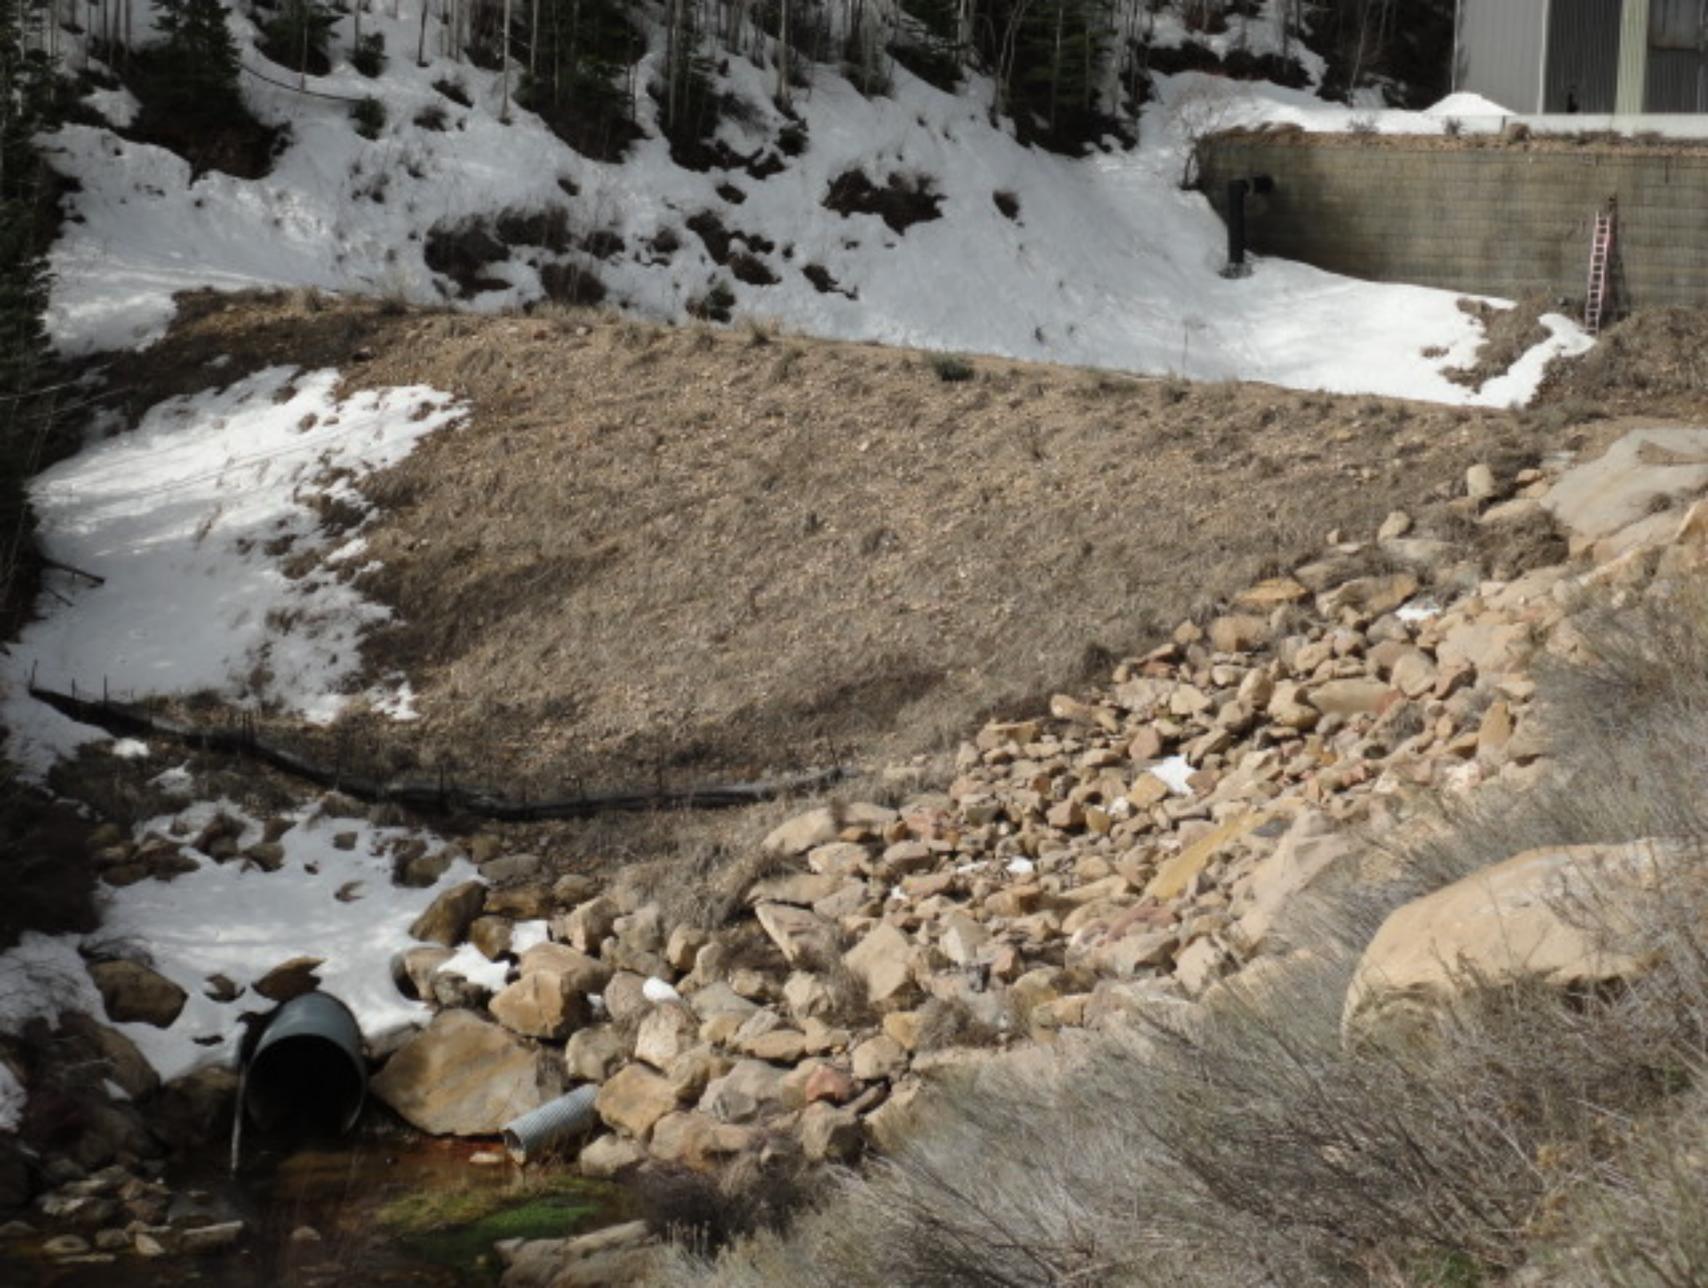
I inspected the topsoil piles and I did not see any signs of wind or water erosion. The topsoil piles appear to be stable and protected by a berm. See Photo

A photograph of a natural landscape featuring a mix of vegetation. In the foreground and middle ground, there are numerous bushes of silver cholla (Cylindropuntia) and clumps of tall, dry grass. The ground is covered with green grass and some rocks. In the background, there are several trees, including a large, leafless tree on the left and several evergreen trees on the right. A small white sign with black text is placed in the middle ground, partially obscured by the vegetation. The sign reads "TOP SOIL".
