# Inspection Report

Permit Number:	C0150032
Inspection Type:	PARTIAL
Inspection Date:	Monday, April 17, 2017
Start Date/Time:	4/17/2017 10:00:00 AM
End Date/Time:	4/17/2017 1:00:00 PM
Last Inspection:	Tuesday, March 07, 2017

Permittee: **GENWAL RESOURCES INC**  
 Operator: **GENWAL RESOURCES INC**  
 Site: **CRANDALL CANYON MINE**  
 Address: **PO BOX 910, EAST CARBON UT 84520-0910**  
 County: **EMERY**  
 Permit Type: **PERMANENT COAL PROGRAM**  
 Permit Status: **INACTIVE**

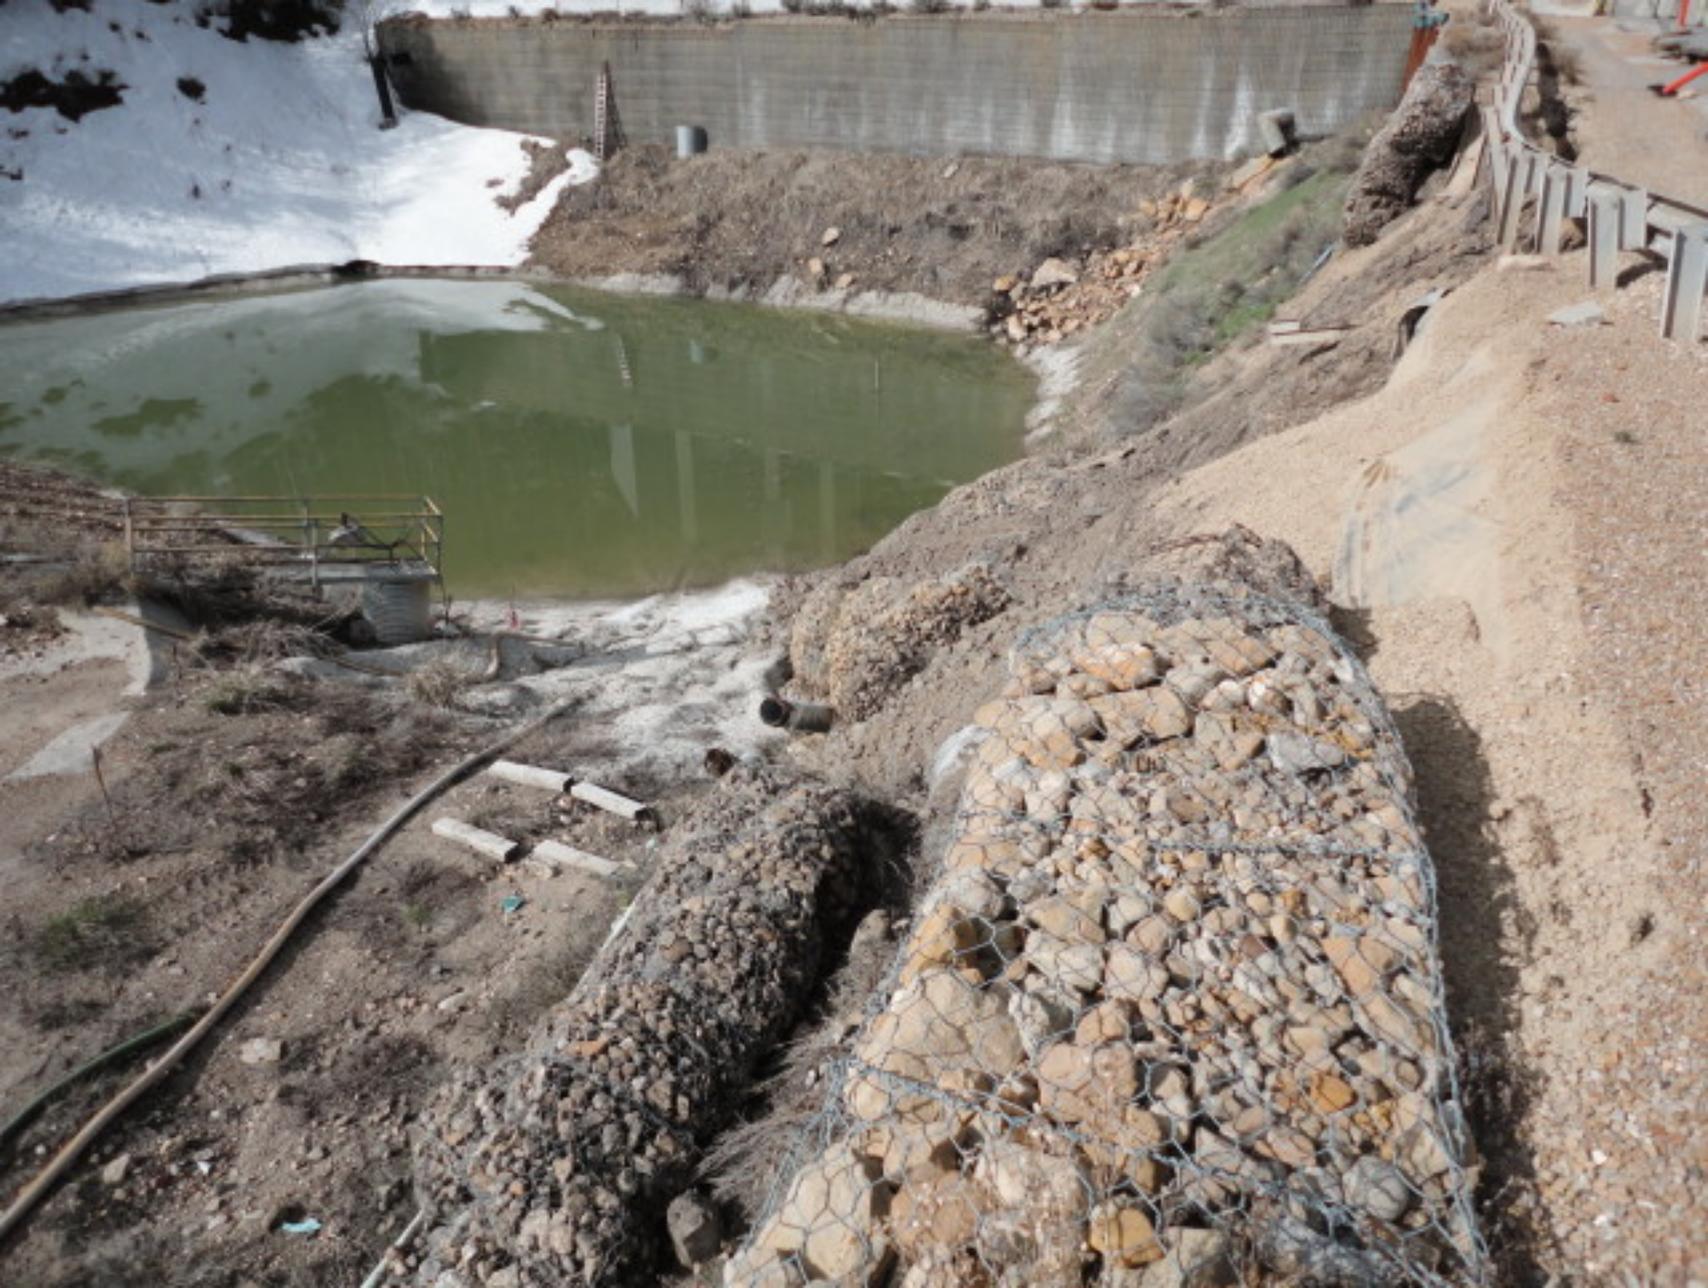
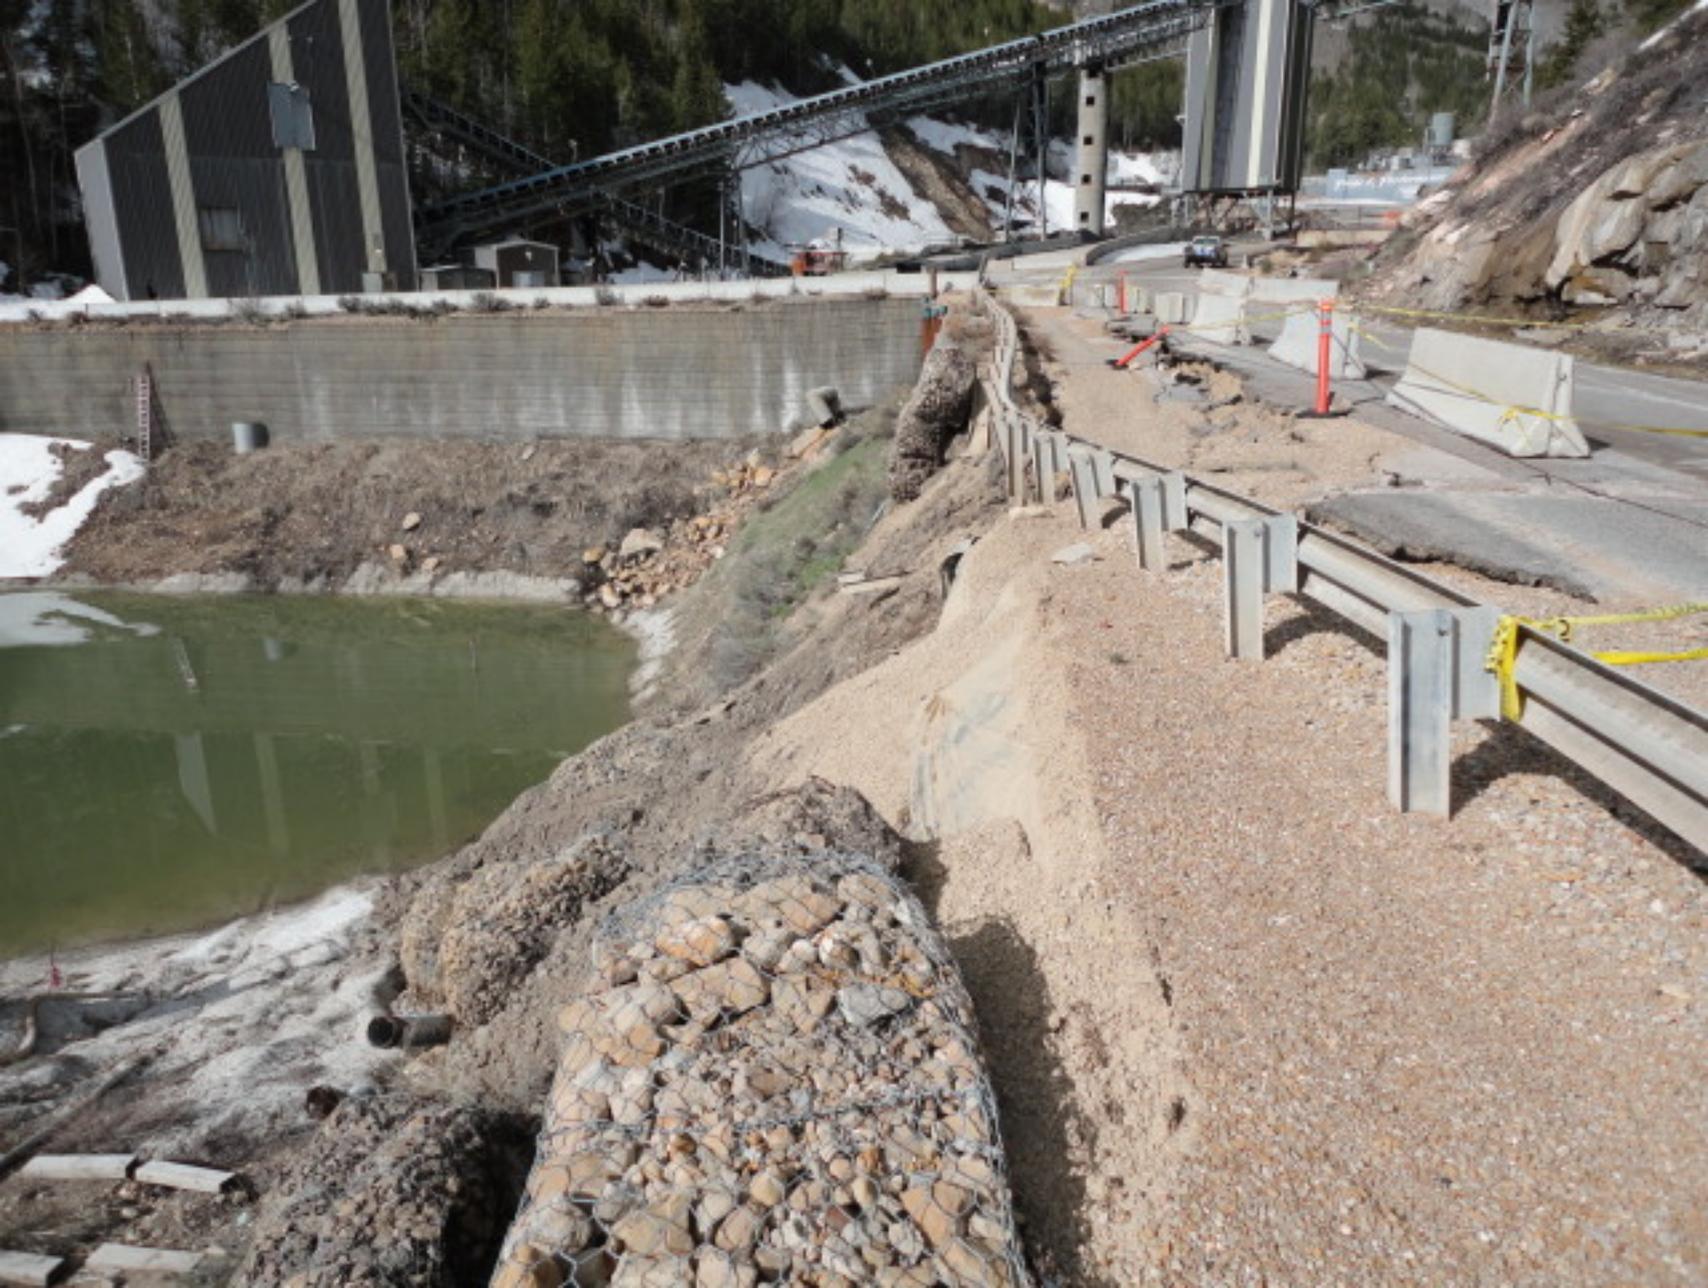
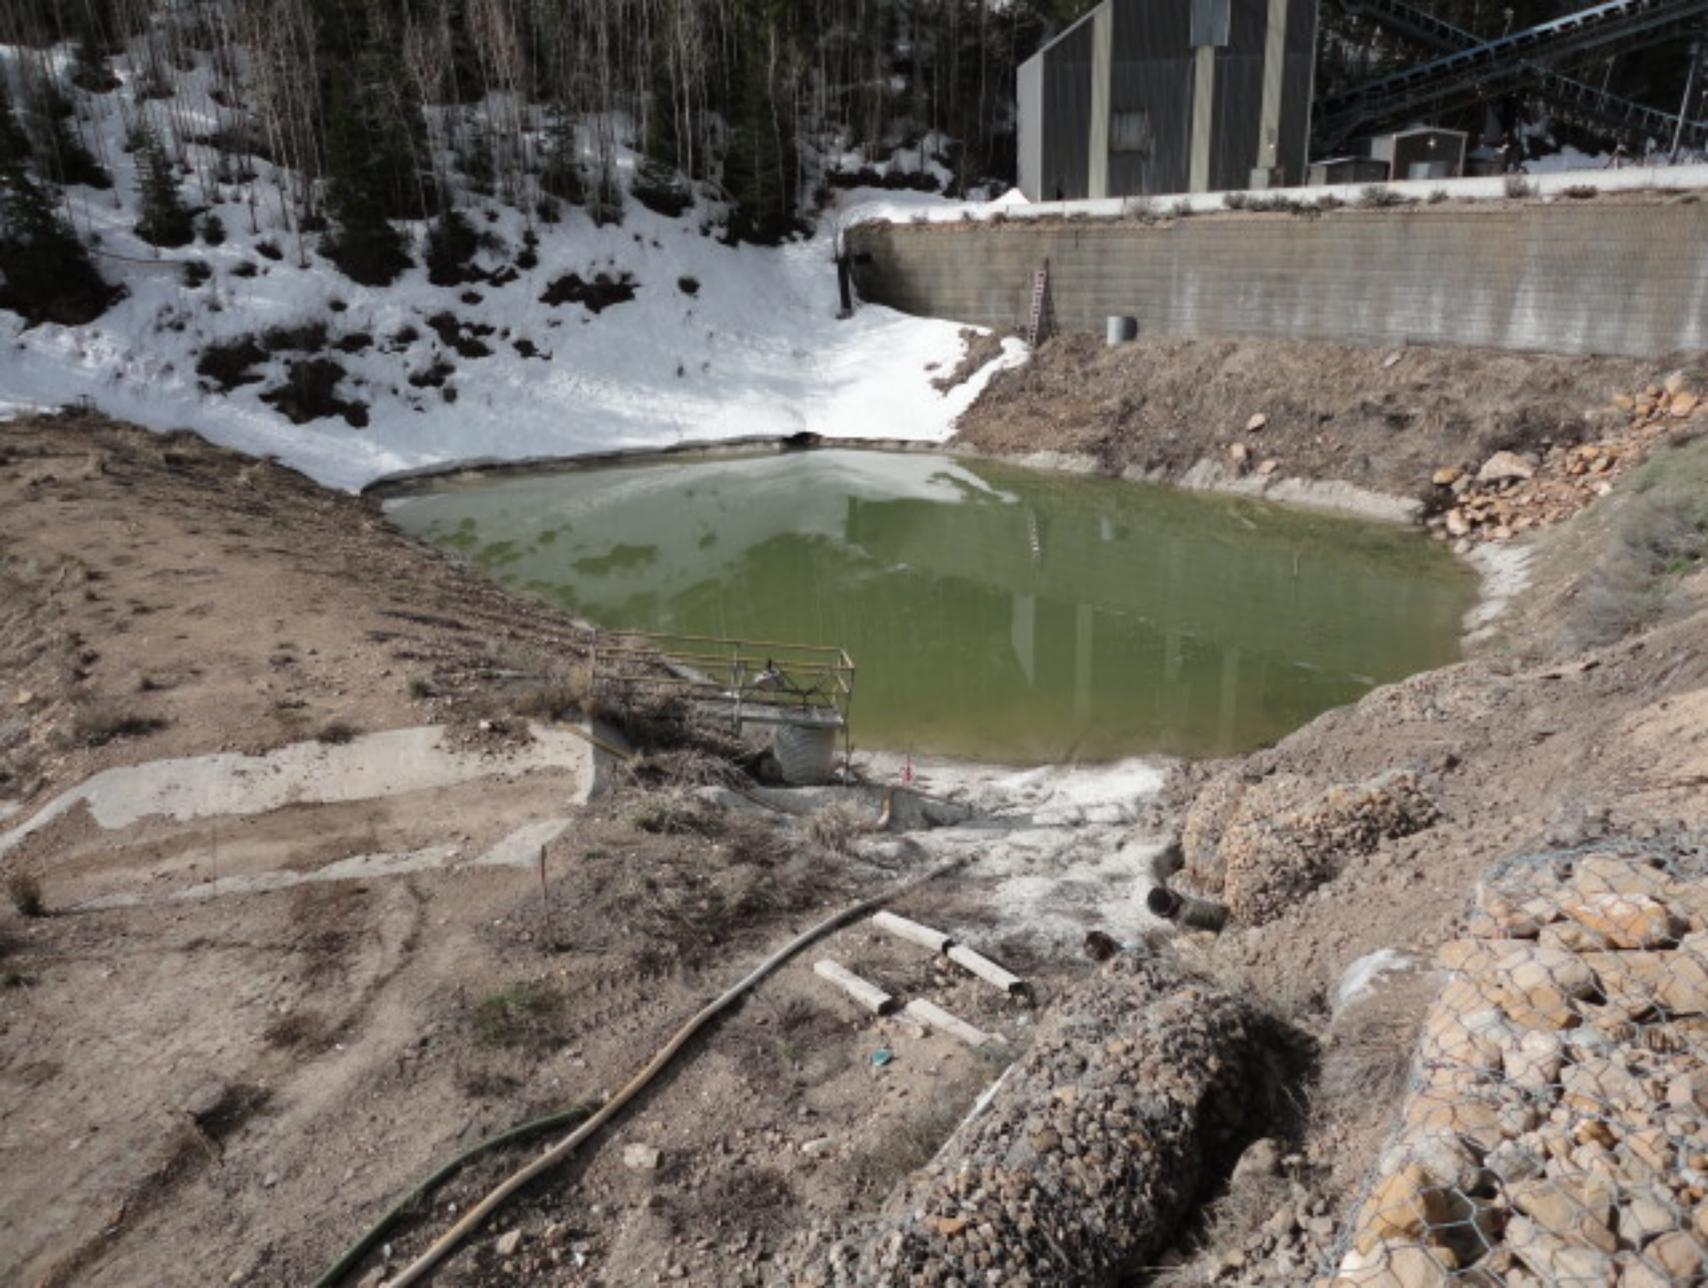
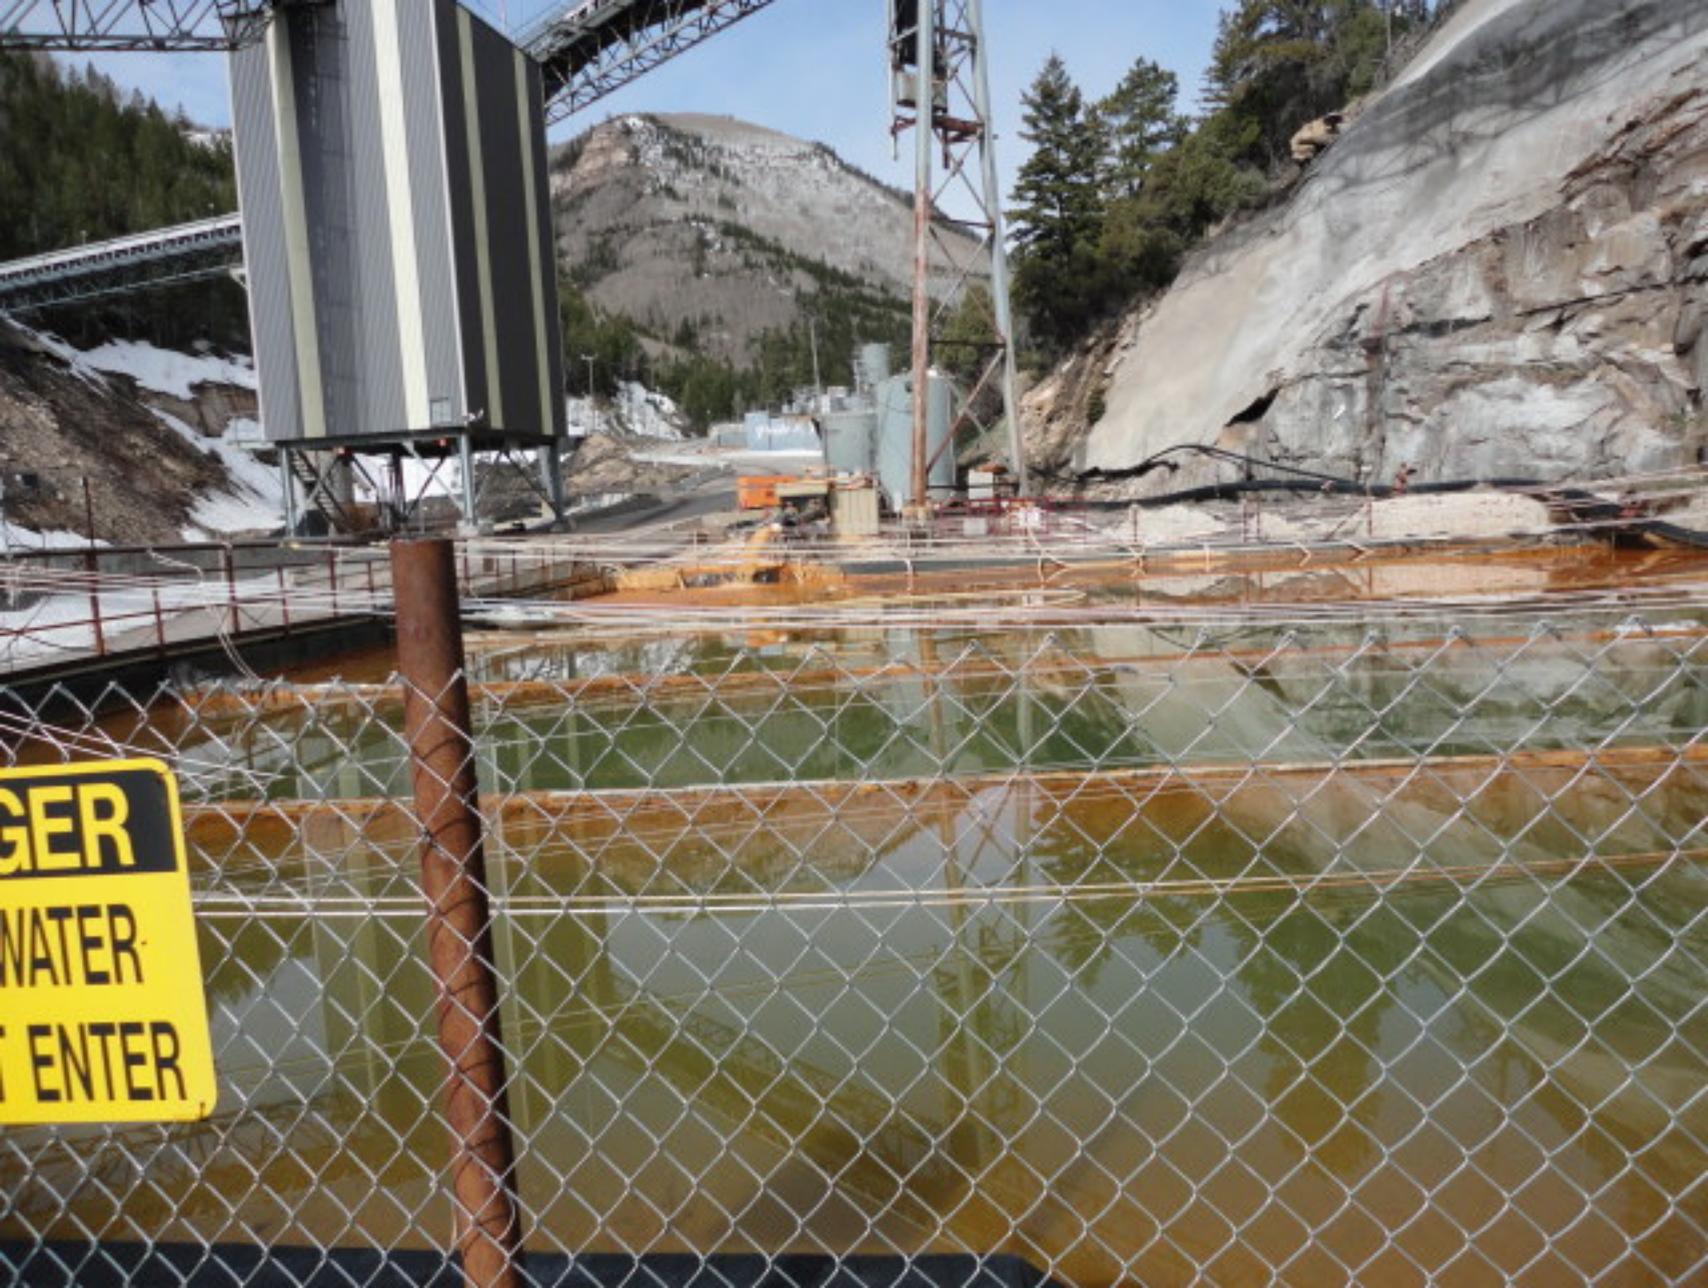
4b I inspected the sediment pond. It contained some water but was not discharging. It is unlikely this structure will discharge in the near future. The embankments appear to be stable. Inlets and outlets would function as designed. I did not see any hazardous conditions to this structure. See Photo

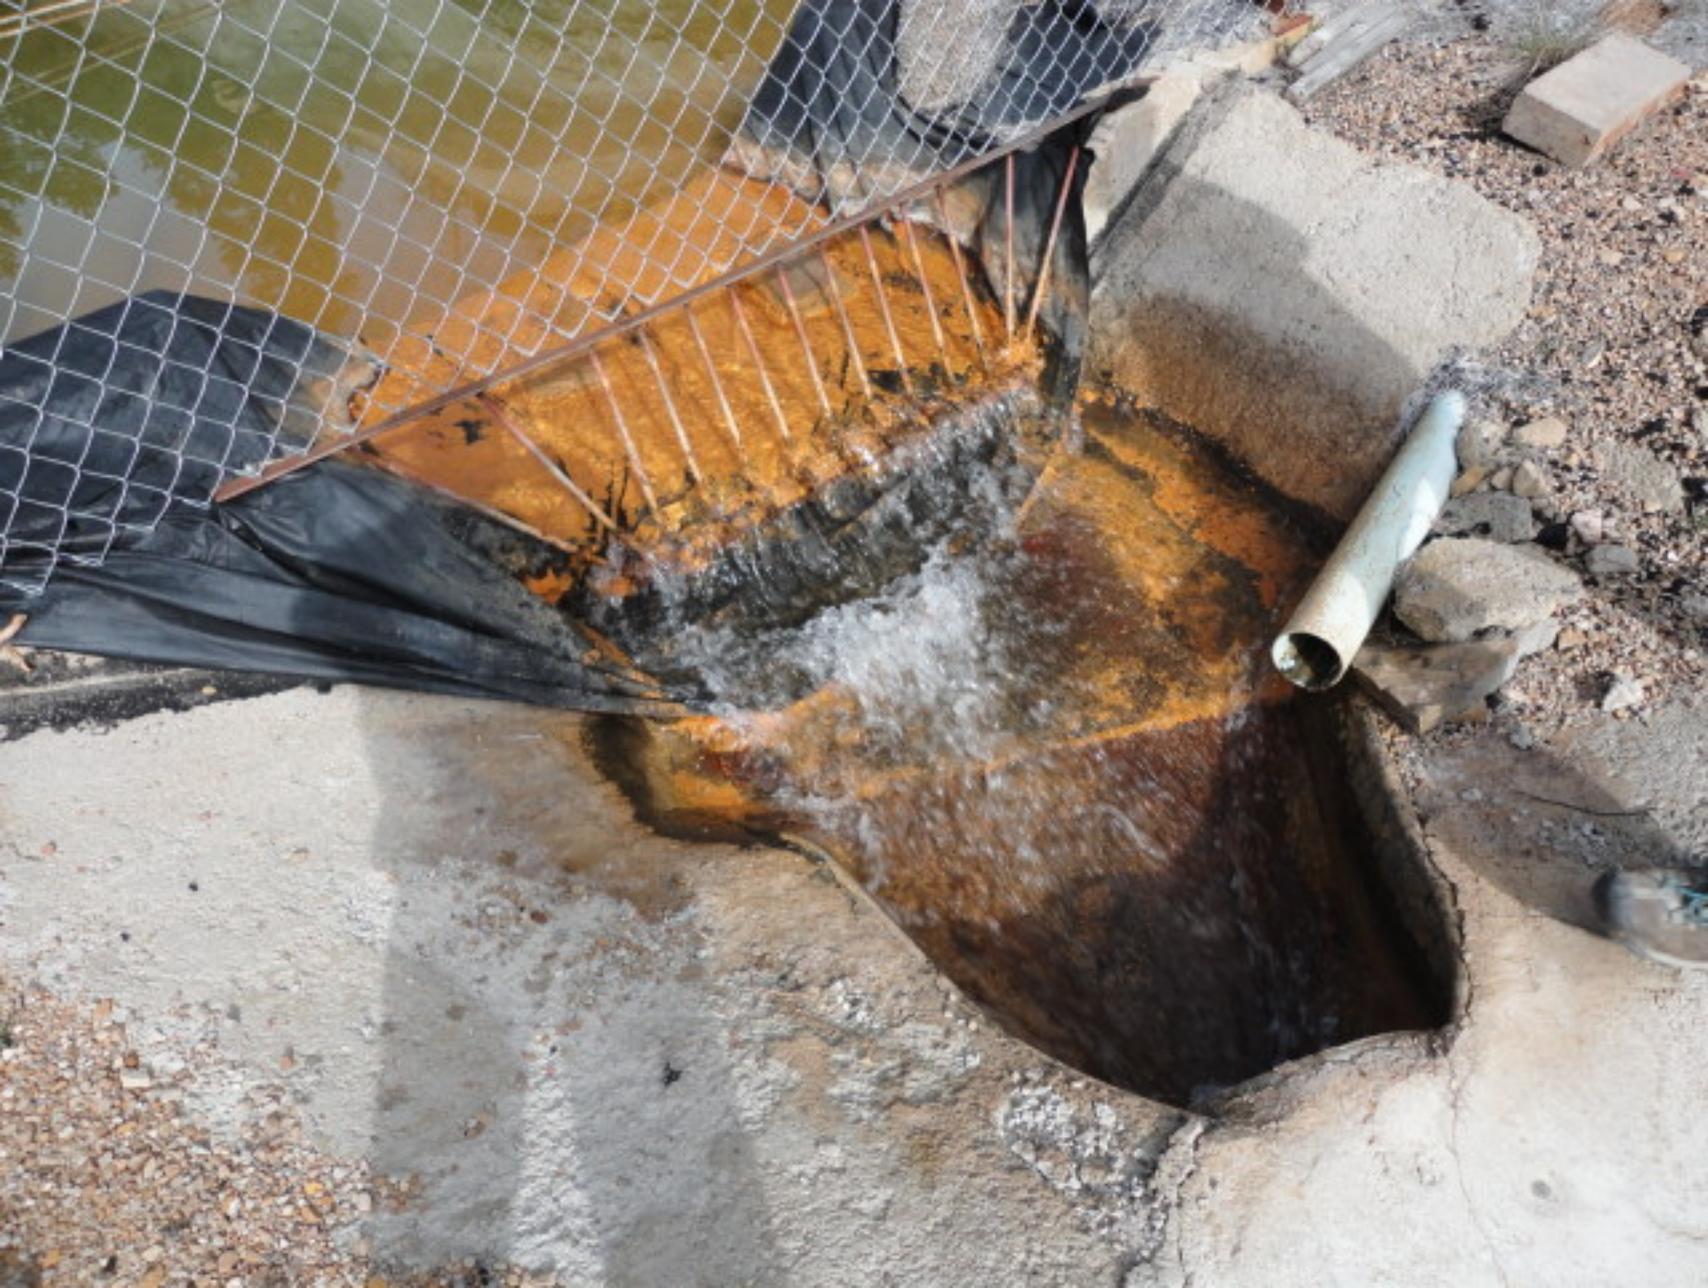
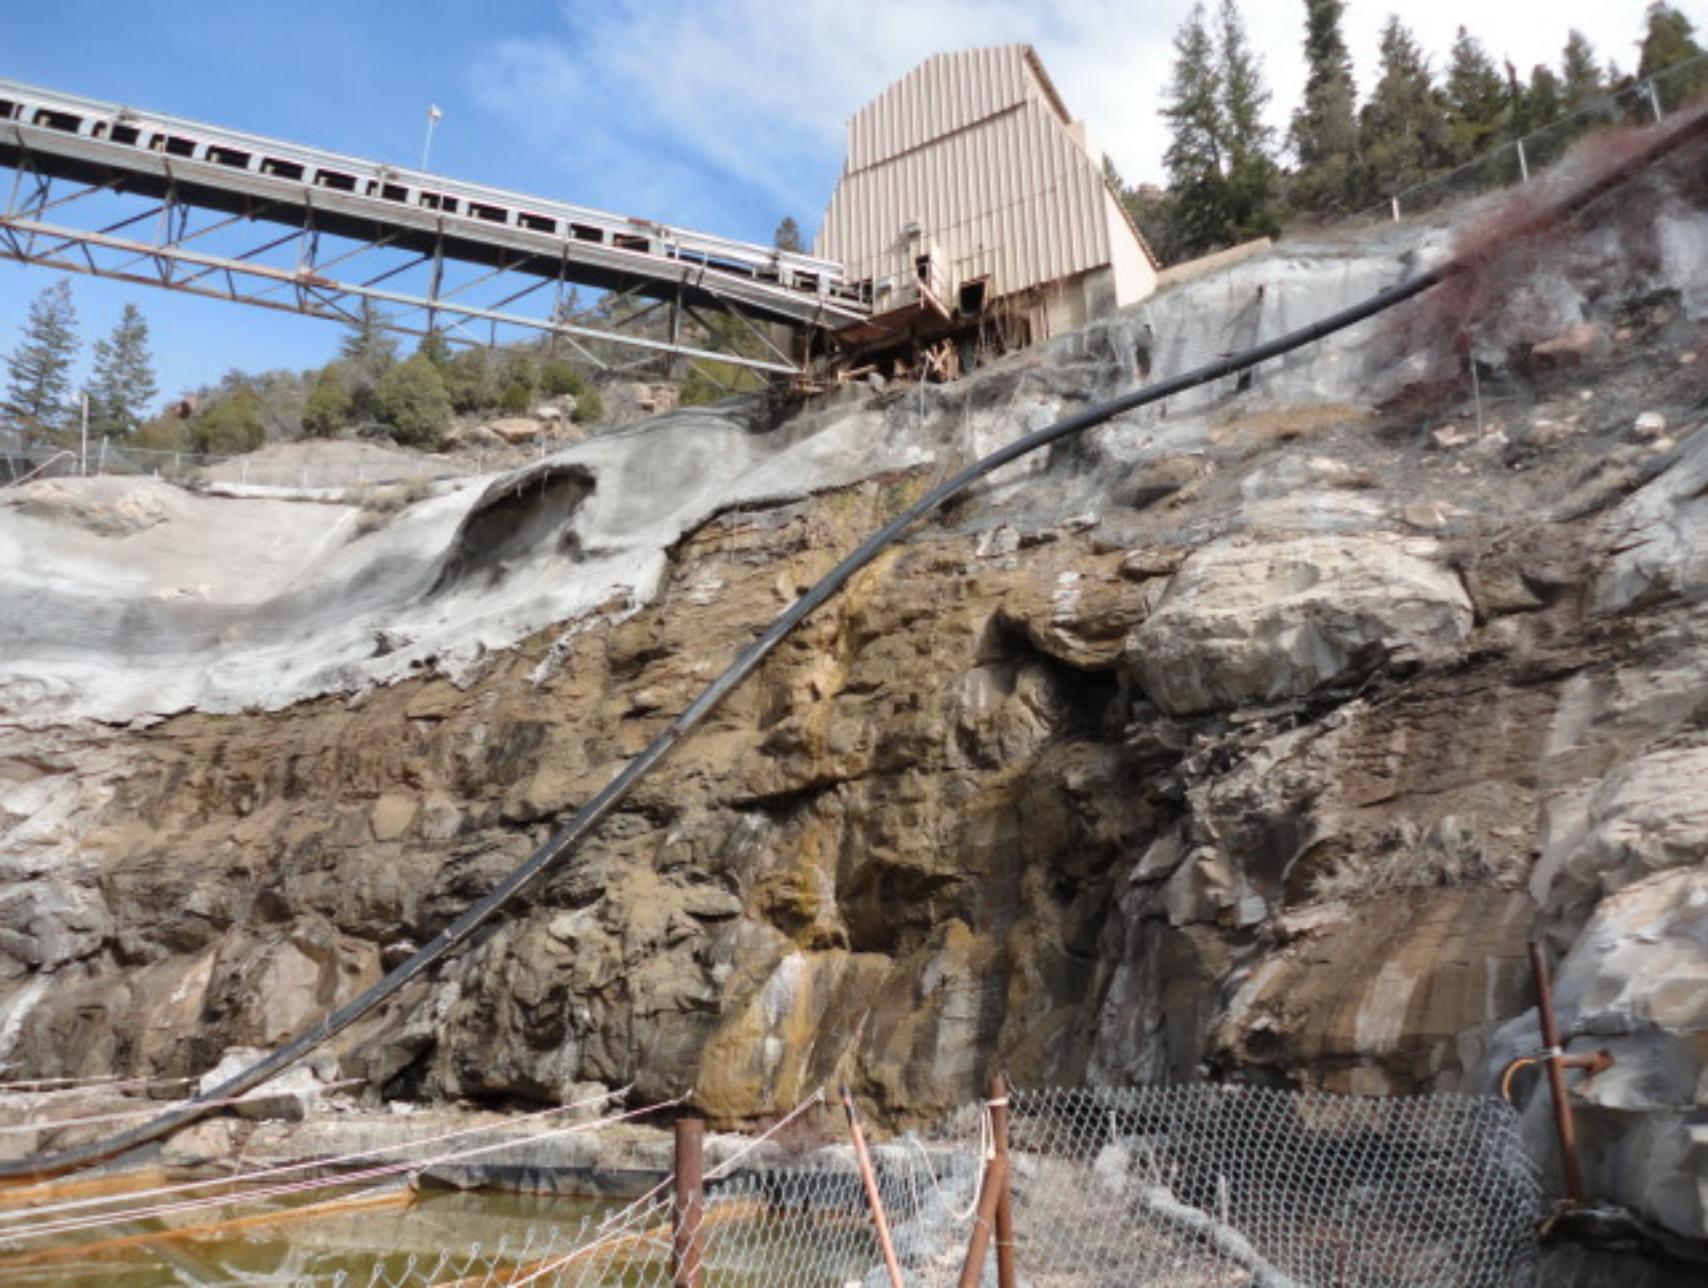
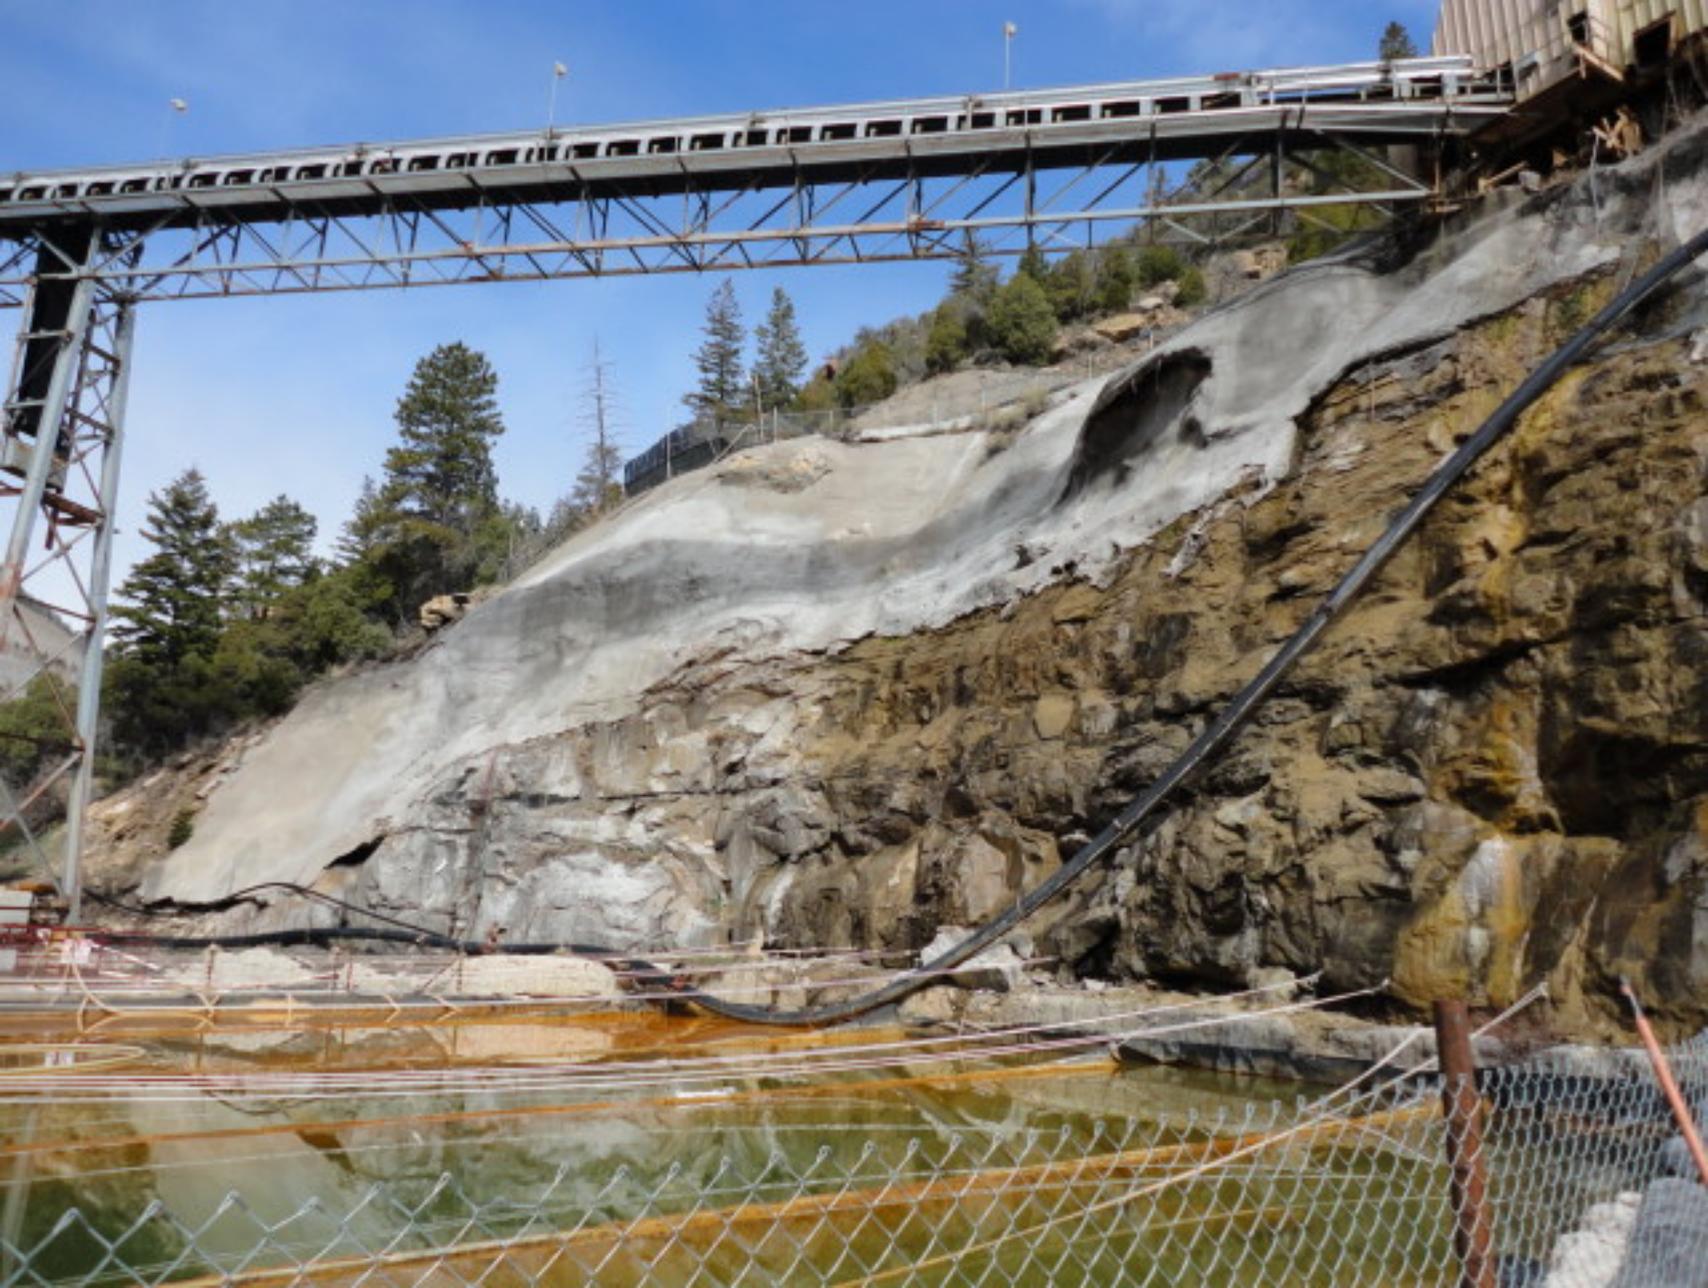
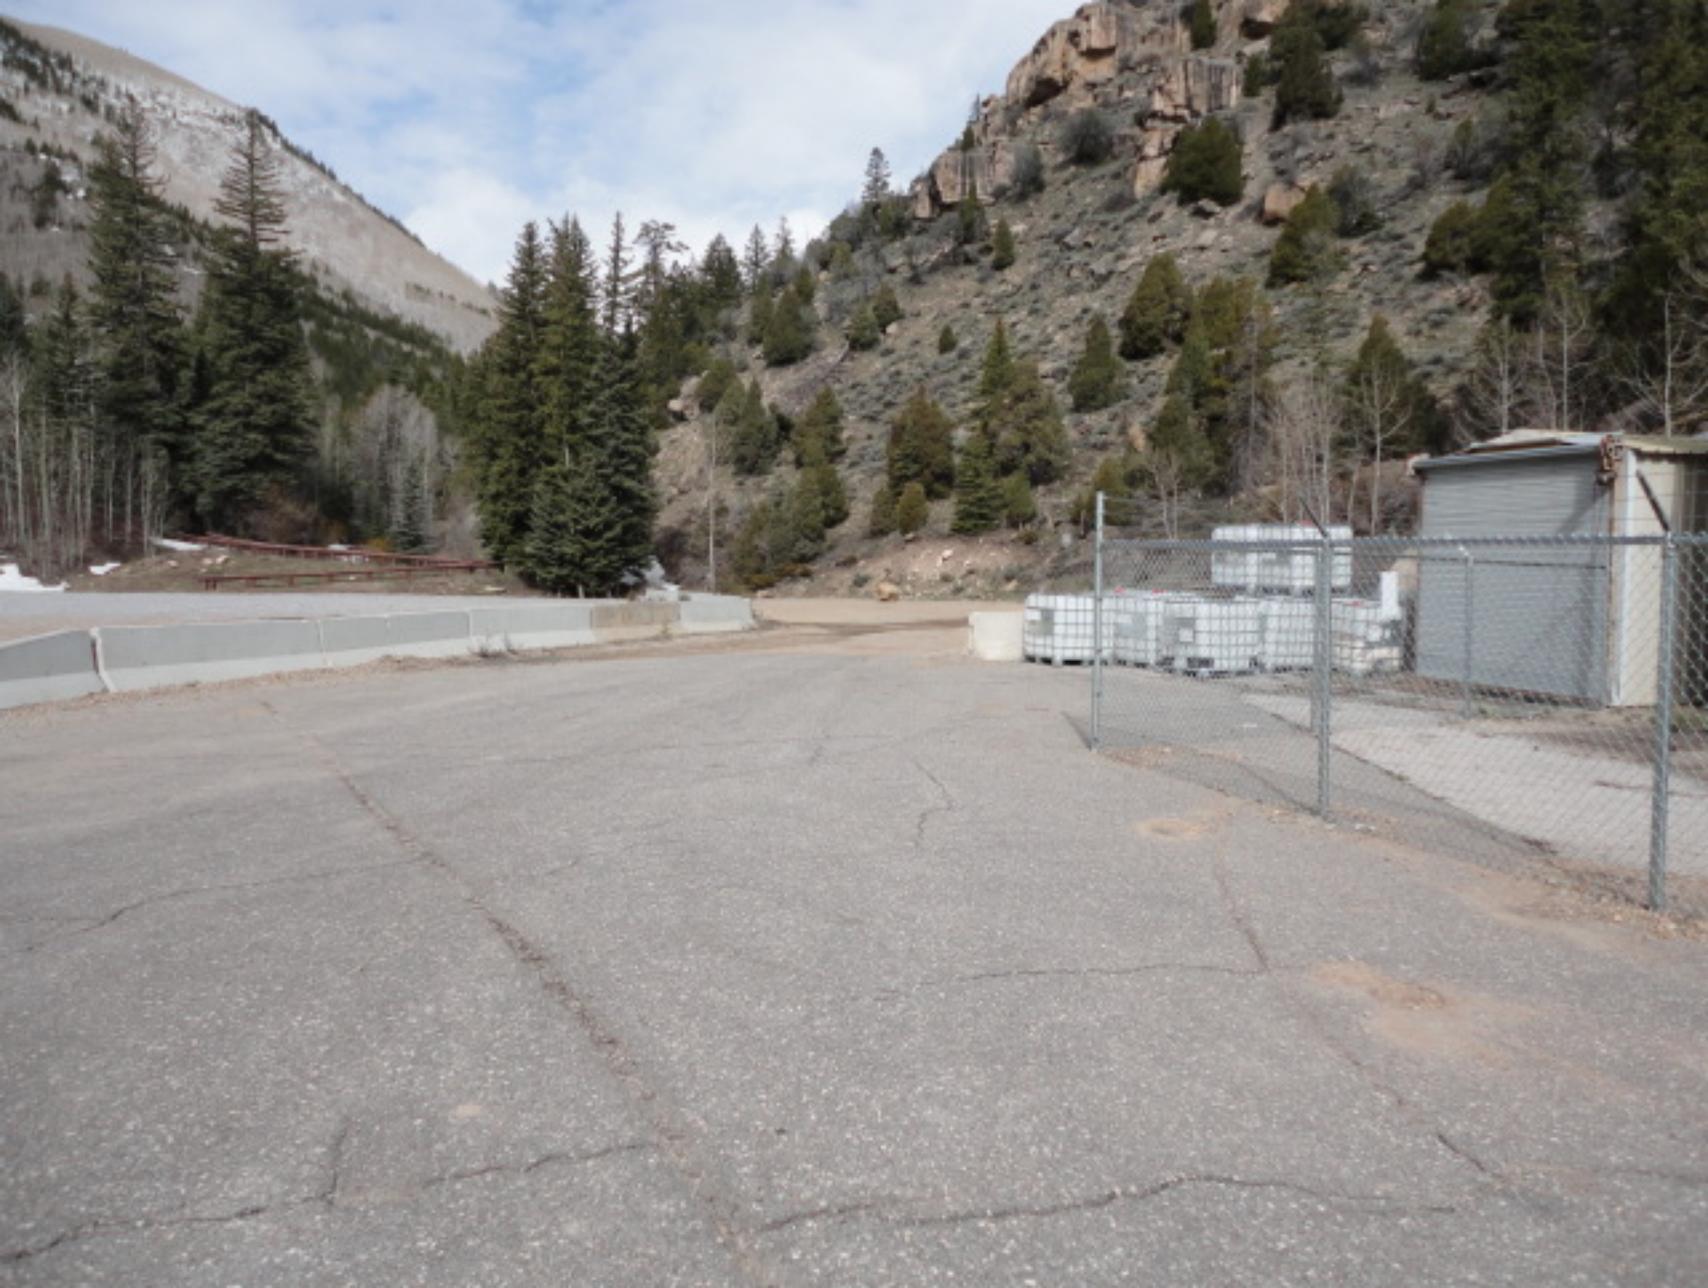
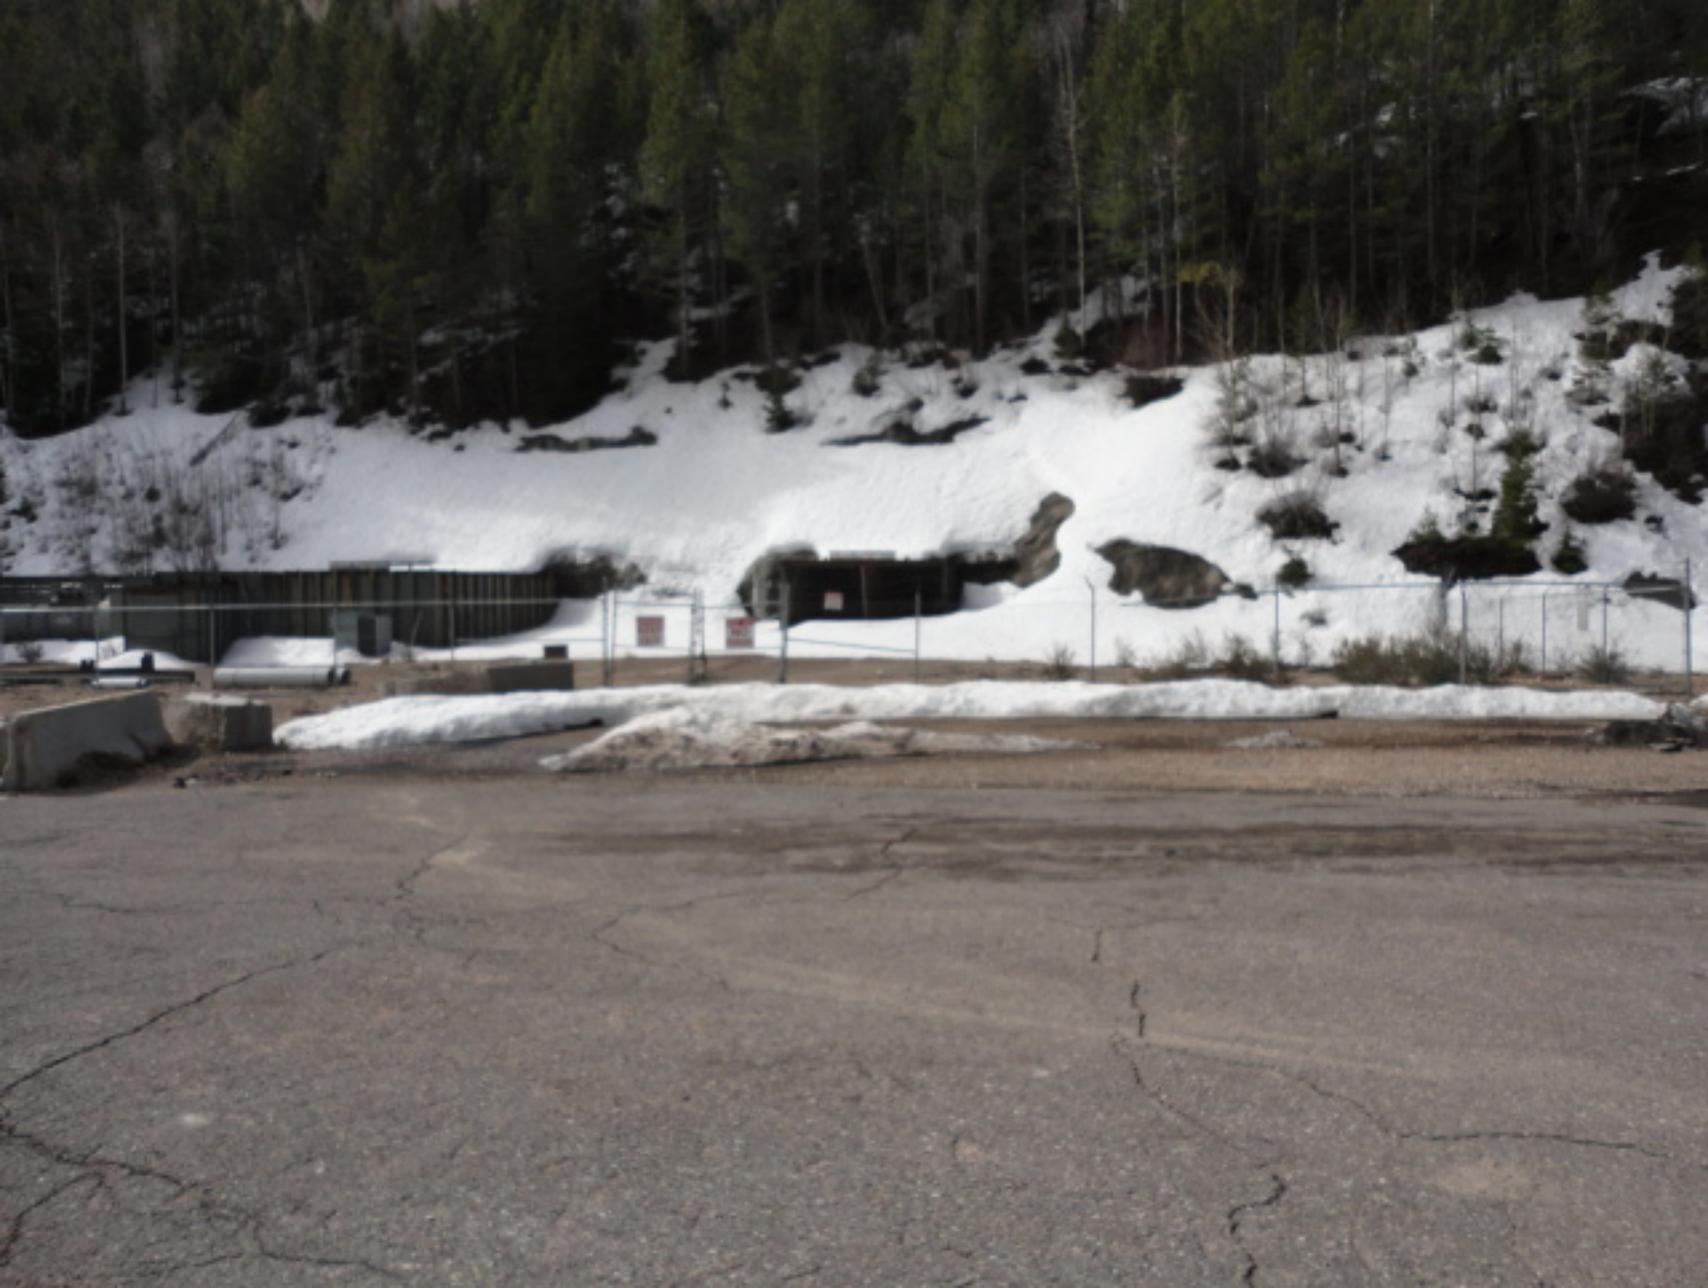
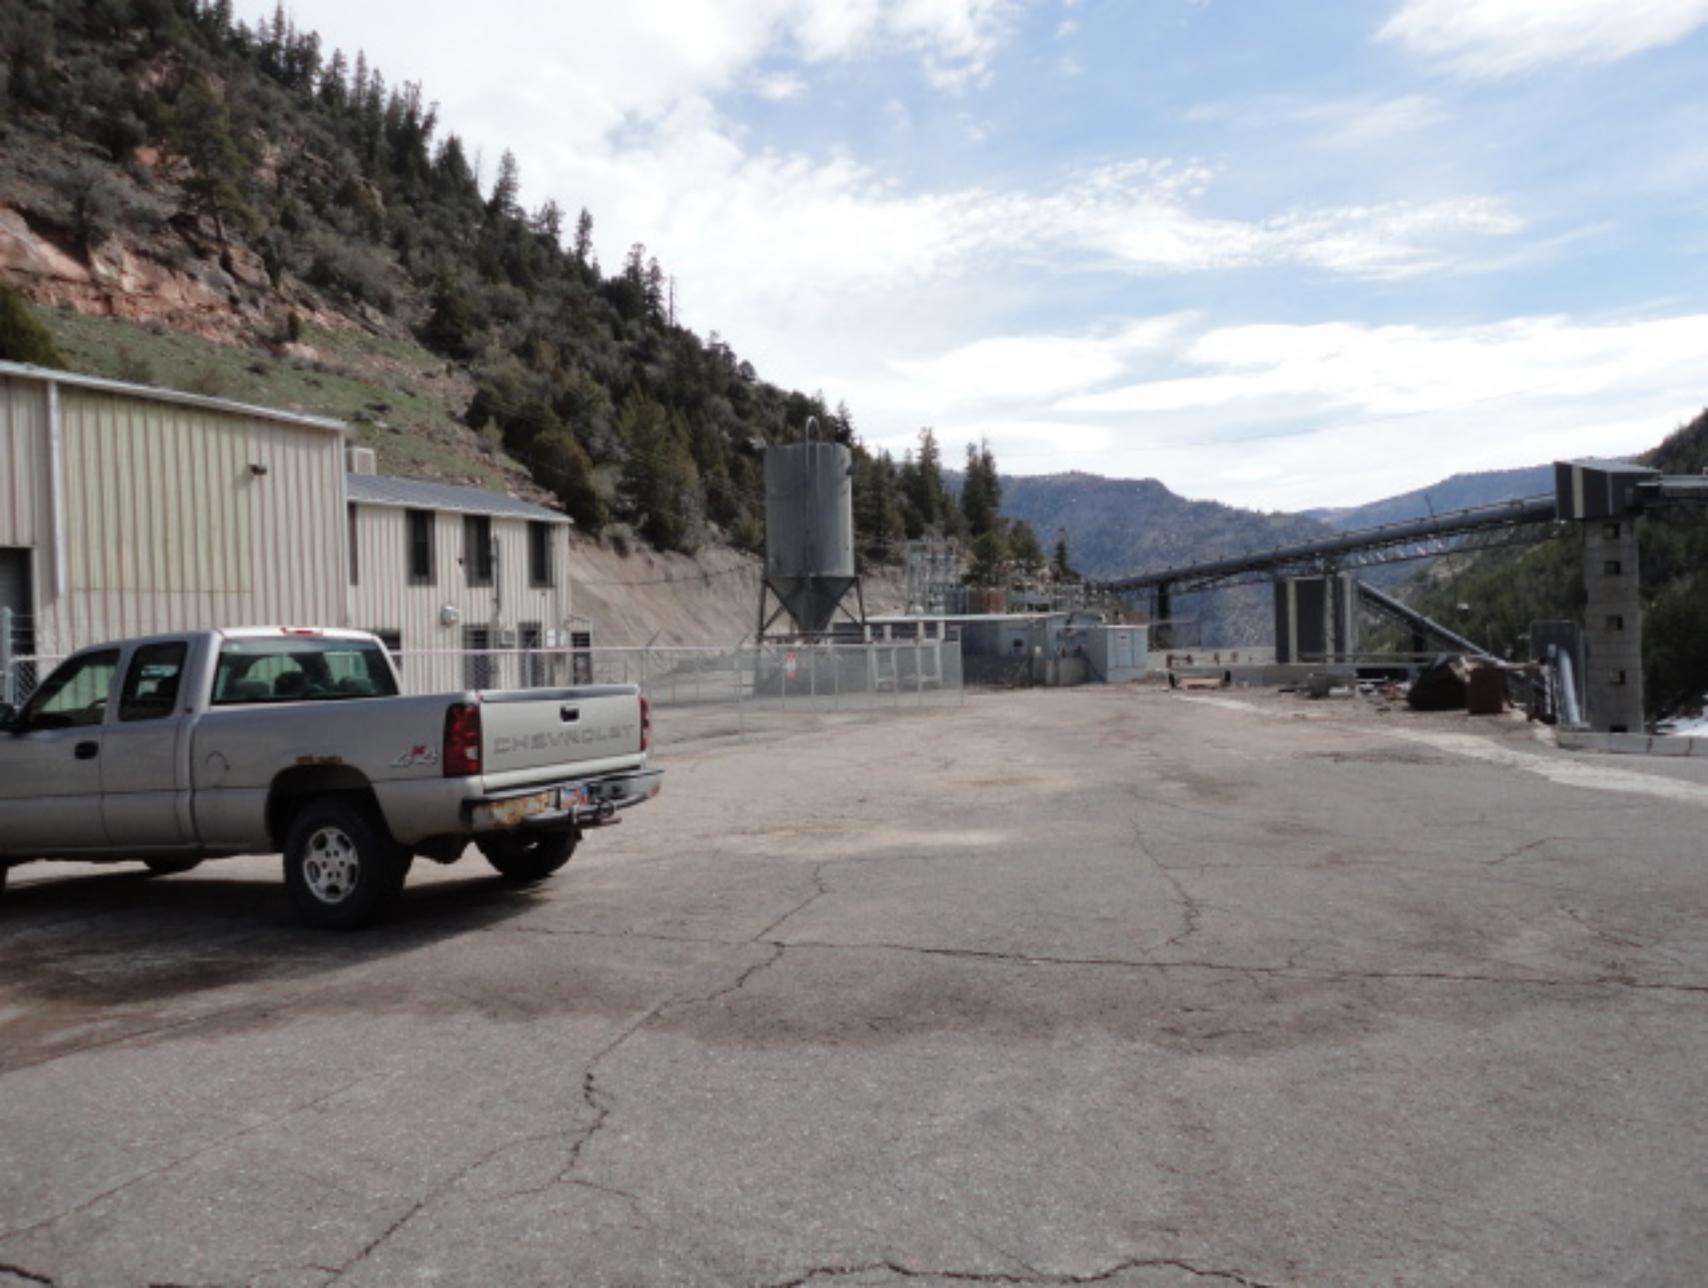
The mine site is inactive except for the water treatment plant.  
 The USFS road and part of the gabion baskets have failed. Permittee plans on repairing the road.  
 No people work on site regularly

The USFS road by the sediment pond has partially fallen/slide towards the sediment pond. It has moved the rock gabions. The permittee plans on repairing the road. The road is under control of the USFS. See Photos
