Inspection Report

Permit Number:	C0150036
Inspection Type:	COMPLETE
Inspection Date:	Tuesday, August 11, 2020
Start Date/Time:	8/11/2020 8:00:00 AM
End Date/Time:	8/11/2020 12:00:00 PM
Last Inspection:	Tuesday, July 14, 2020

Permittee: **CASTLE VALLEY MINING LLC**
 Operator: **CASTLE VALLEY MINING LLC**
 Site: **CASTLE VALLEY WASTE ROCK SITE**
 Address: **5550 W. BEAR CANYON ROAD, P.O. BOX 475 HUNTINGTON UT 84528**
 County: **EMERY**
 Permit Type: **PERMANENT COAL PROGRAM**
 Permit Status: **ACTIVE**

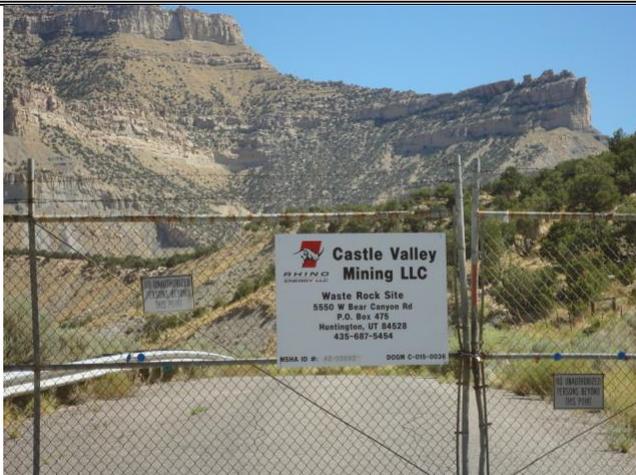
PHOTO 1

CVWR Identification Sign

The identification sign for this site is clearly posted on the gate entrance into the permitted site.

The sign contains the name, address, phone number and mining permit number through the Utah Coal Program. These items are required to be posted so that the public has access to this information.

The sign was checked and found to be in compliance.

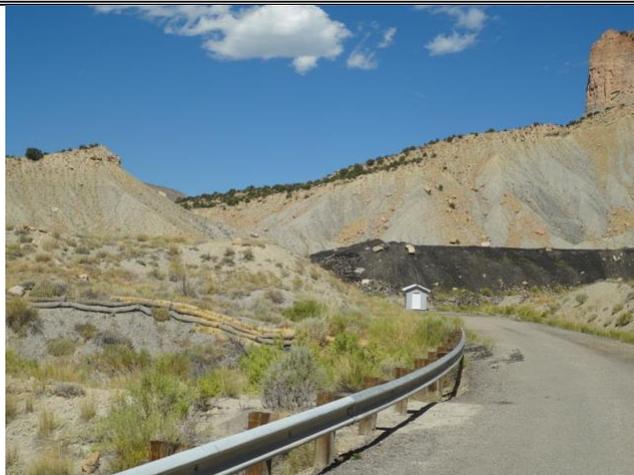
PHOTO 2

CVWR Topsoil Pile & Refuse Pile

The salvaged topsoil from this site is placed in piles along the side of the access road and piles that encircle the exterior boundaries of the refuse pile.

The piles are identified by topsoil pile signs to protect and identify them. Protection for the piles is provided by vegetation and/or berms, Straw Wattles.

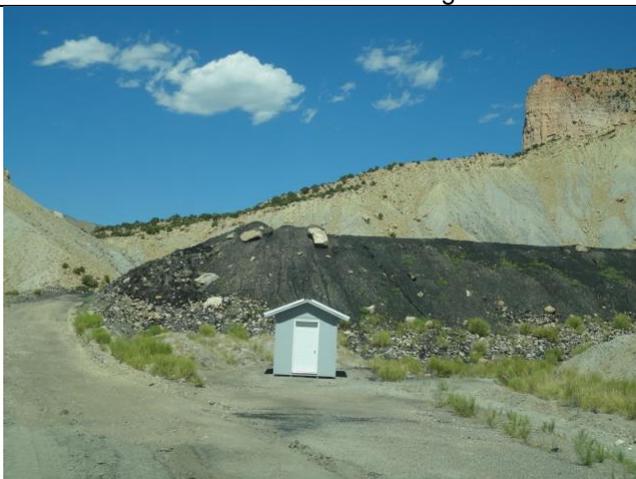
PHOTO 3

CVWR South Cell Refuse Pile, Access Road

The south cell of the refuse pile is graded and compacted. There are no current dump piles of refuse that need to be graded and compacted. Positive drainage to the west side of this cell is provided. Potential drainage would flow towards the sediment pond..

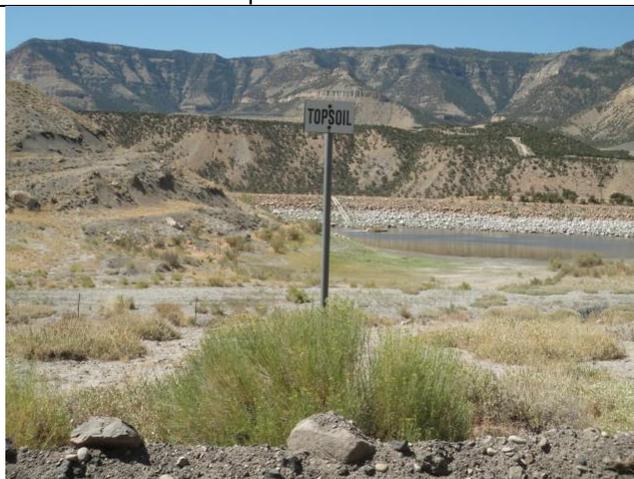
PHOTO 4

CVWR Topsoil Pile

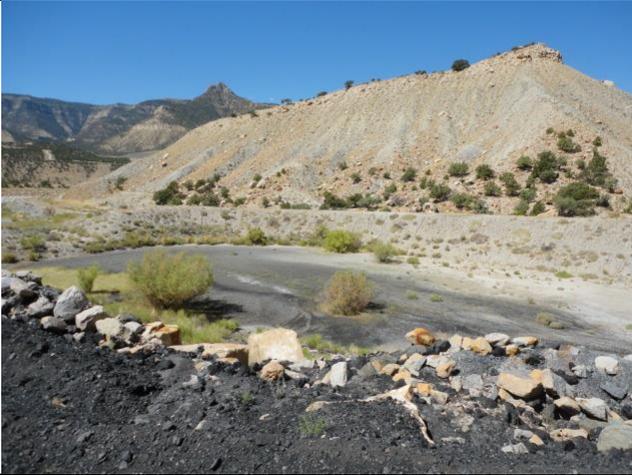
PHOTO 5

CWR Sediment Pond

The sediment pond at the refuse pile site is a large total containment pond.

There is no discharge permit or outfall for this site. The pond was dry.

The embankments were stable. No visible hazards were observed.

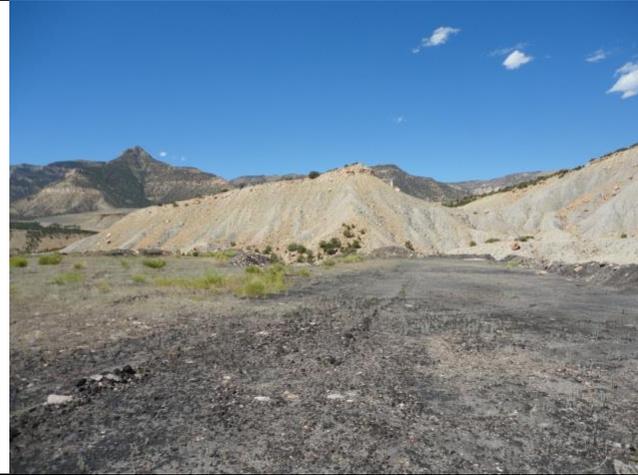
PHOTO 6

CVWR Surface North Refuse Cell

The North cell of the refuse pile is well graded and compacted. There is positive drainage to the west side of the cell. This drainage would flow towards the sediment pond. The surface elevation of this cell is near capacity.

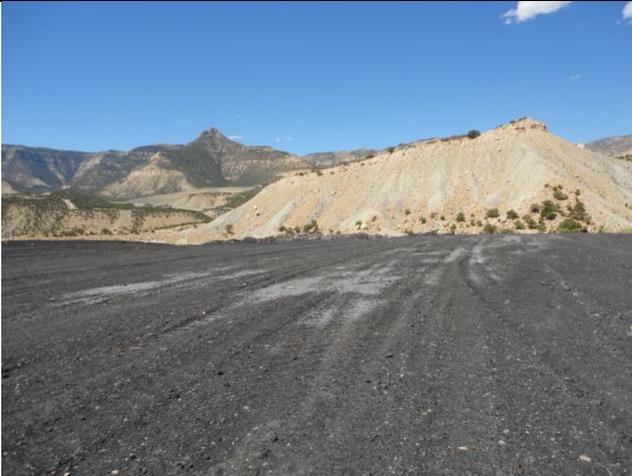
PHOTO 7

CVWR Surface South Refuse Cell

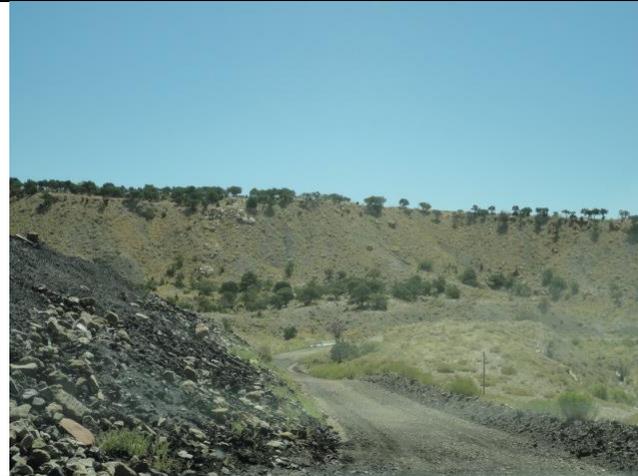
PHOTO 8

CVWR Access Road, South Cell Refuse Pile, Topsoil Pile

Roadways are well maintained.
