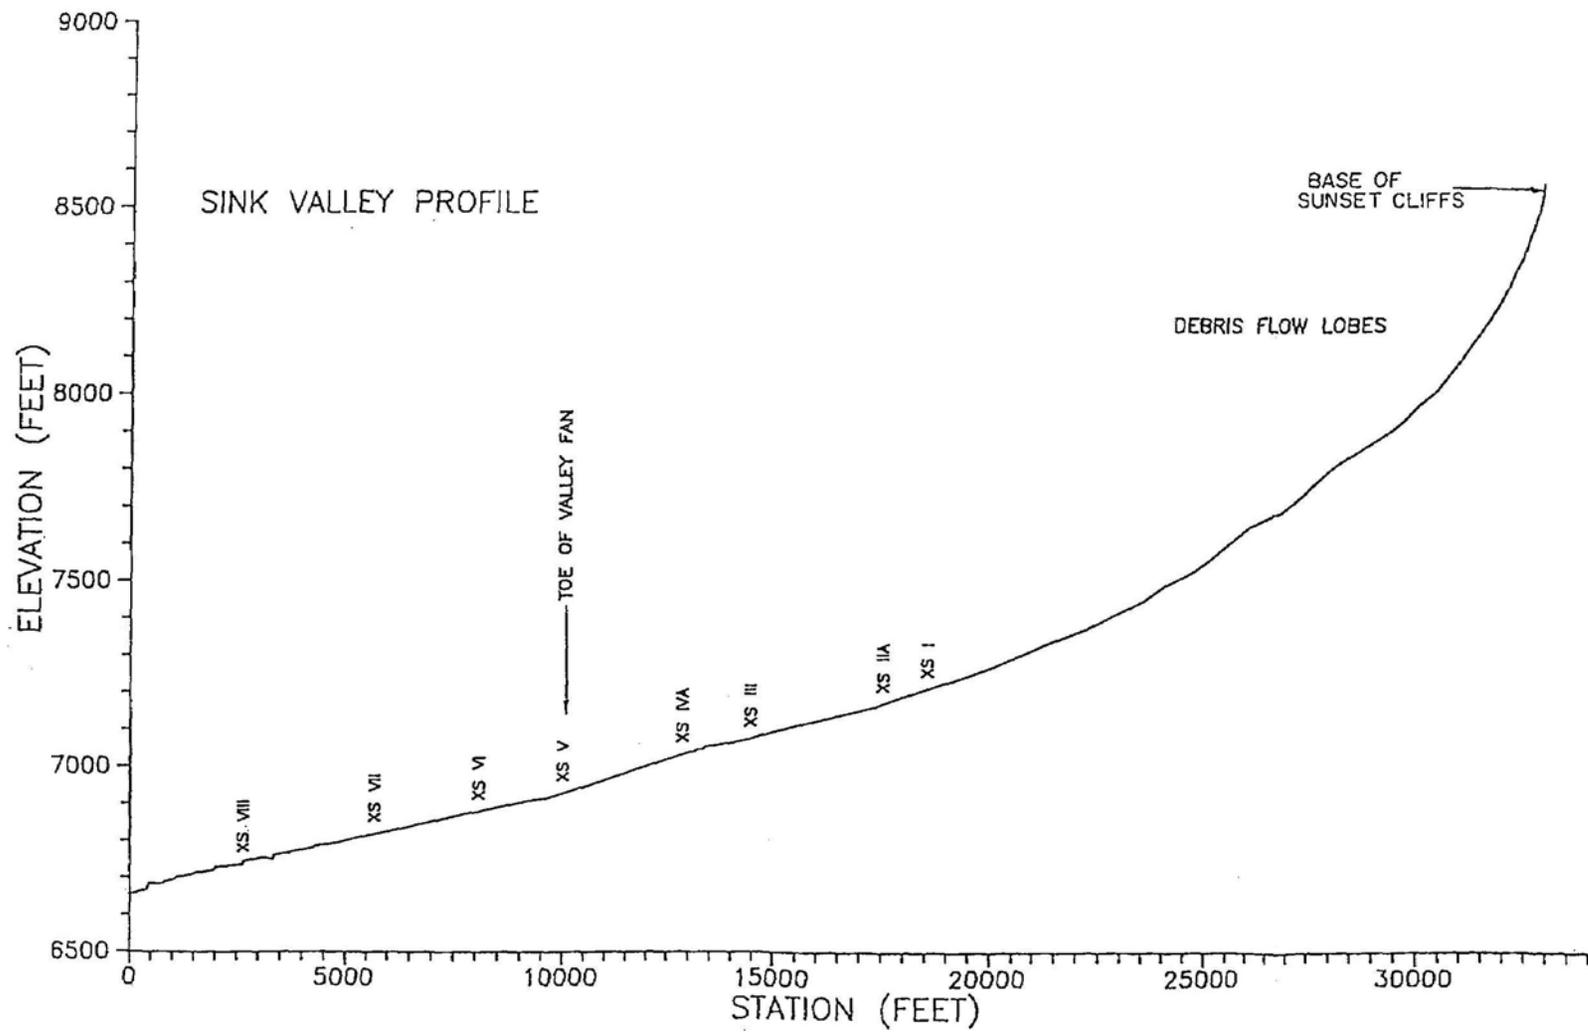
Figure 23 Longitudinal profile of Sink Valley from upper Water Canyon drainage to Sink Valley Wash (from Water Engineering & Technology, Inc., 1988).
