# Inspection Report

Permit Number:	C0250005
Inspection Type:	PARTIAL
Inspection Date:	Thursday, January 03, 2013
Start Date/Time:	1/3/2013 11:30:00 AM
End Date/Time:	1/3/2013 3:30:00 PM
Last Inspection:	Tuesday, December 04, 2012

Permittee: **ALTON COAL DEVELOPMENT LLC**  
 Operator: **ALTON COAL DEVELOPMENT LLC**  
 Site: **COAL HOLLOW**  
 Address: **463 North 100 West, Suite 1, CEDAR CITY UT 84720**  
 County: **KANE**  
 Permit Type: **PERMANENT COAL PROGRAM**  
 Permit Status: **ACTIVE**

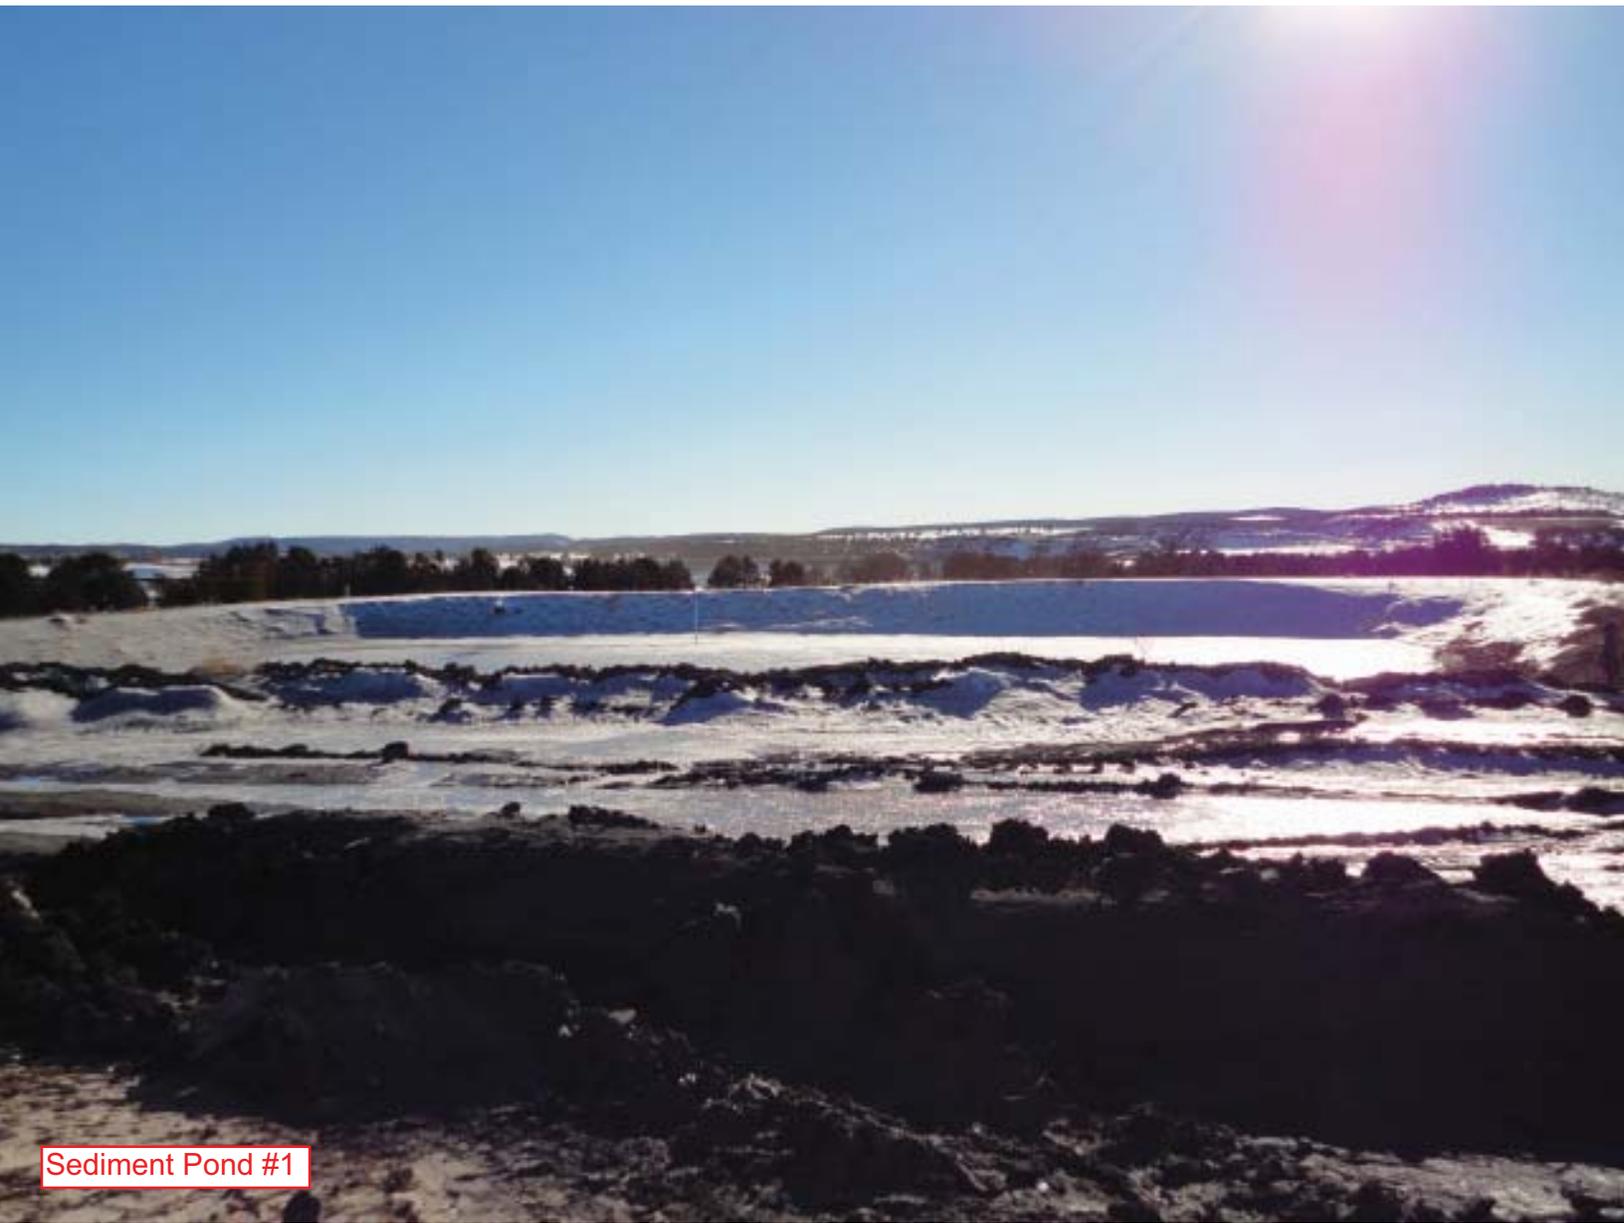
Sediment Pond #1

The sediment ponds were visited and photographed during the inspection. The photographs are attached as part of the partial inspection. The ponds appeared stable. No visible hazards were observed.

Reviewed the 4th quarter 2012 pond inspection reports. The reports still do not have an elevation listed for the estimated sediment level. This elevation needs to be determined and then the 4th quarter 2012 report needs to be revised and re-submitted to the Division.

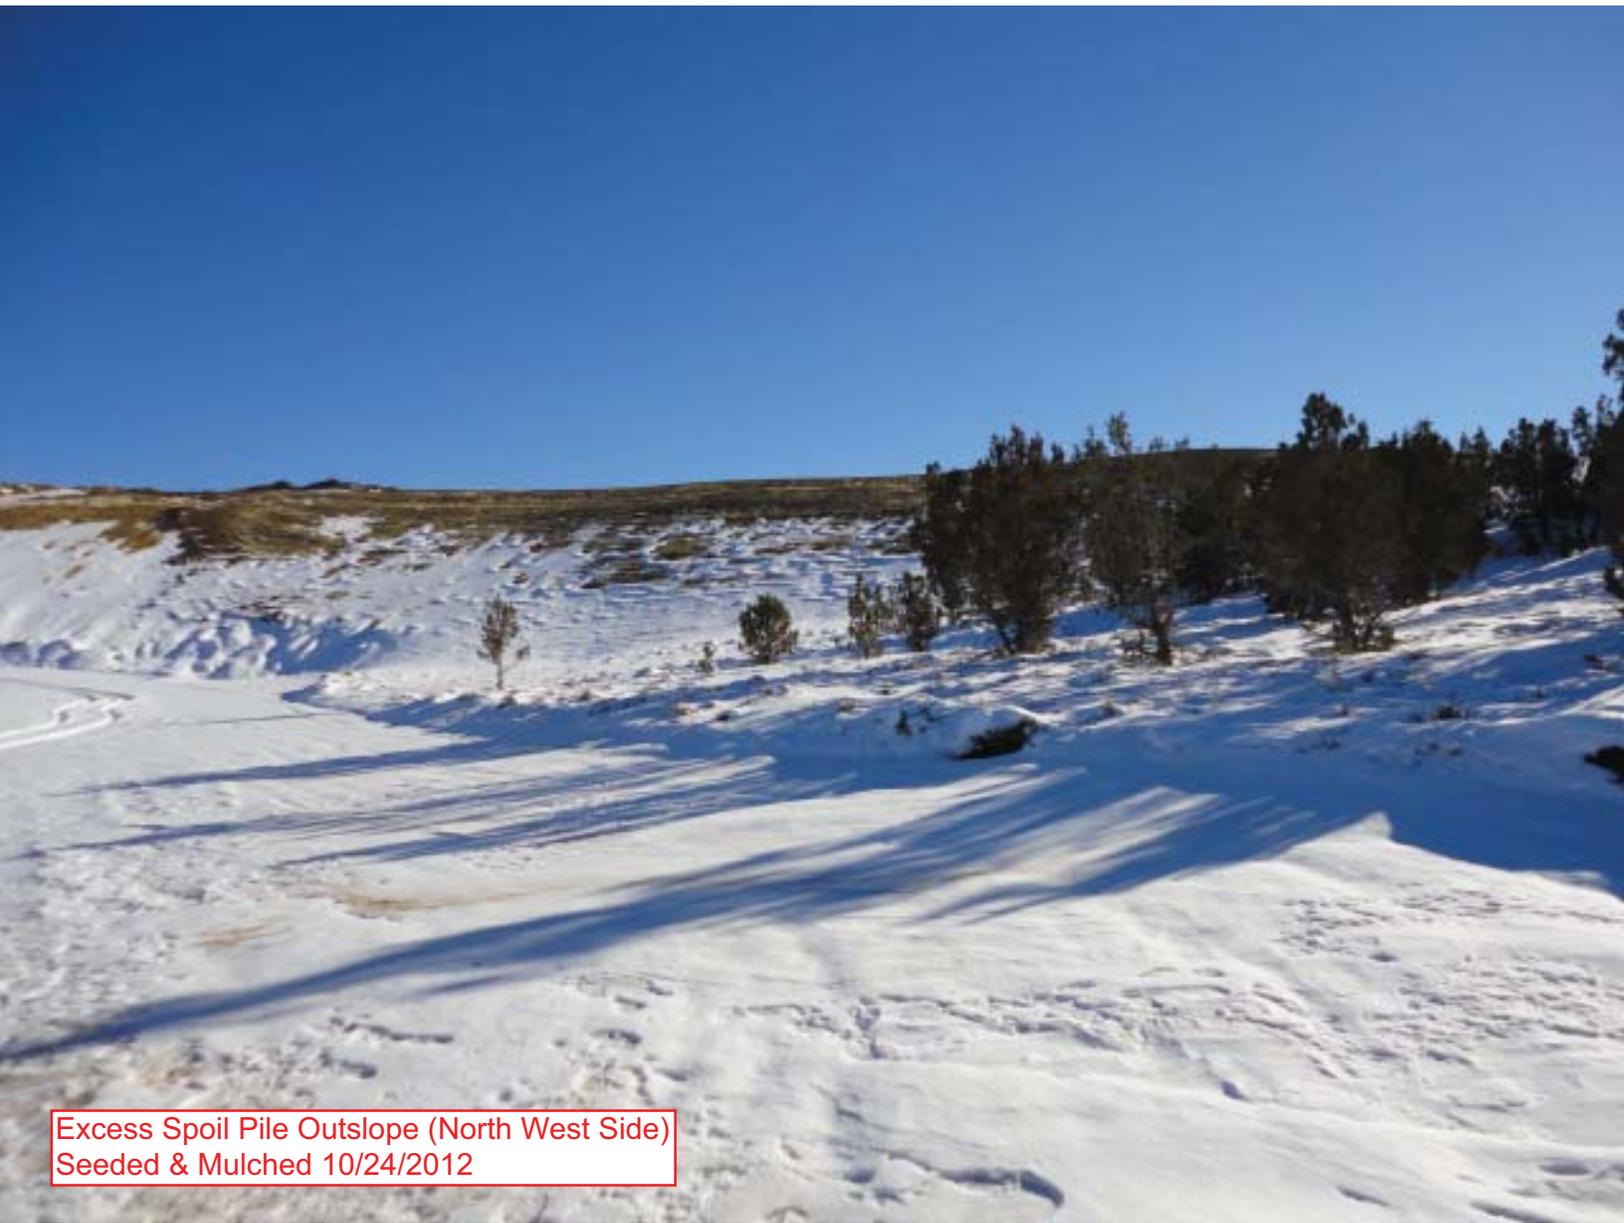
The excess spoil pile was visited and photographed. The photographs are of the North Side of the Excess Spoil Pile. The pile appeared stable. No visible hazards were observed.

Excess Spoil Pile Outslope (North West Side)  
Seeded & Mulched 10/24/2012

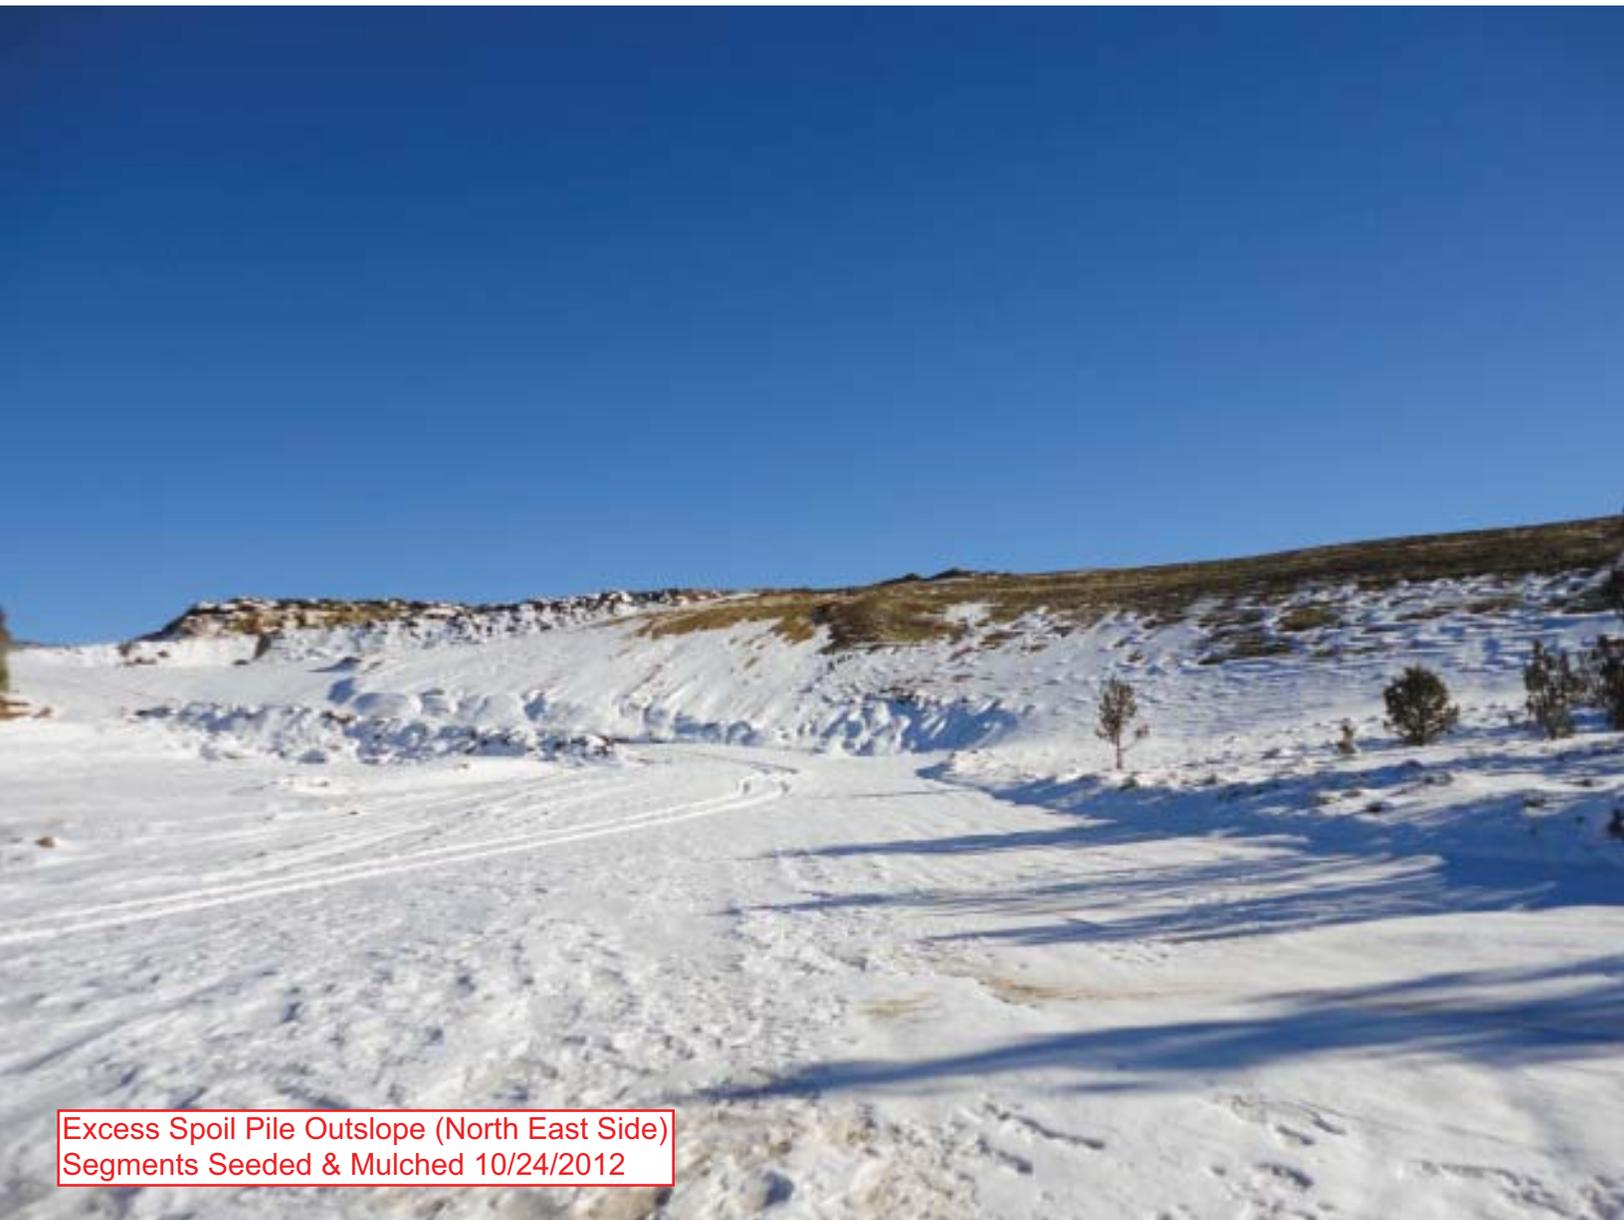
Excess Spoil Pile Outslope (North East Side)  
Segments Seeded & Mulched 10/24/2012

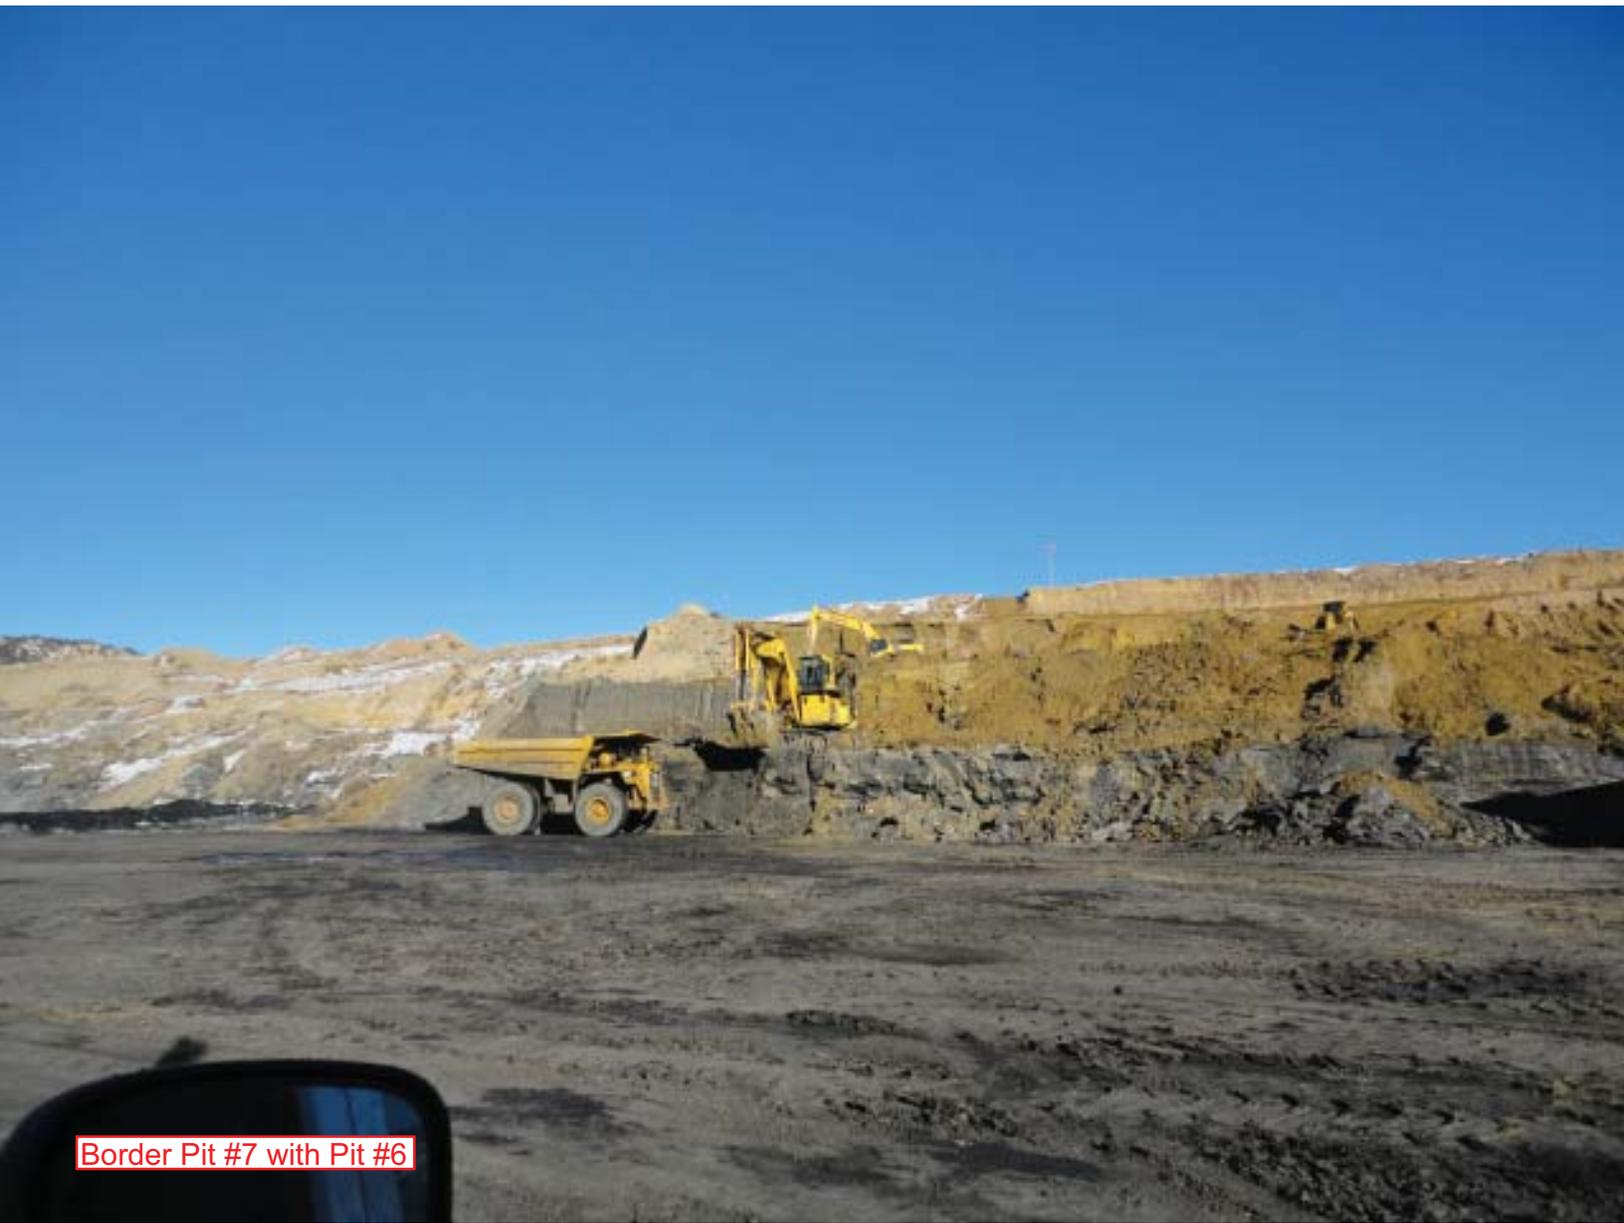
During the partial inspection overburden material at the junction of Pit #6 and Pit #7 was being excavated (see photographs). Mine site is blanked by recent snow events.

Border Pit #7 with Pit #6
