Re: Excess Spoil and behind pond 4

Keenan's pictures show that they are still working on the area that they have requested bond release! The excess spoil pile photo shows them working in the area of Pit 1A to Pit 8 or BRP1-5. The bond release application PUBLIC NOTICE says this area has achieved final grade, subsoil placement and shaping for drainage control and that the work was completed in 2013 and 2014. THEREFORE the public notice is NOT ACCURATE. They must state the correct date for completion of this area.

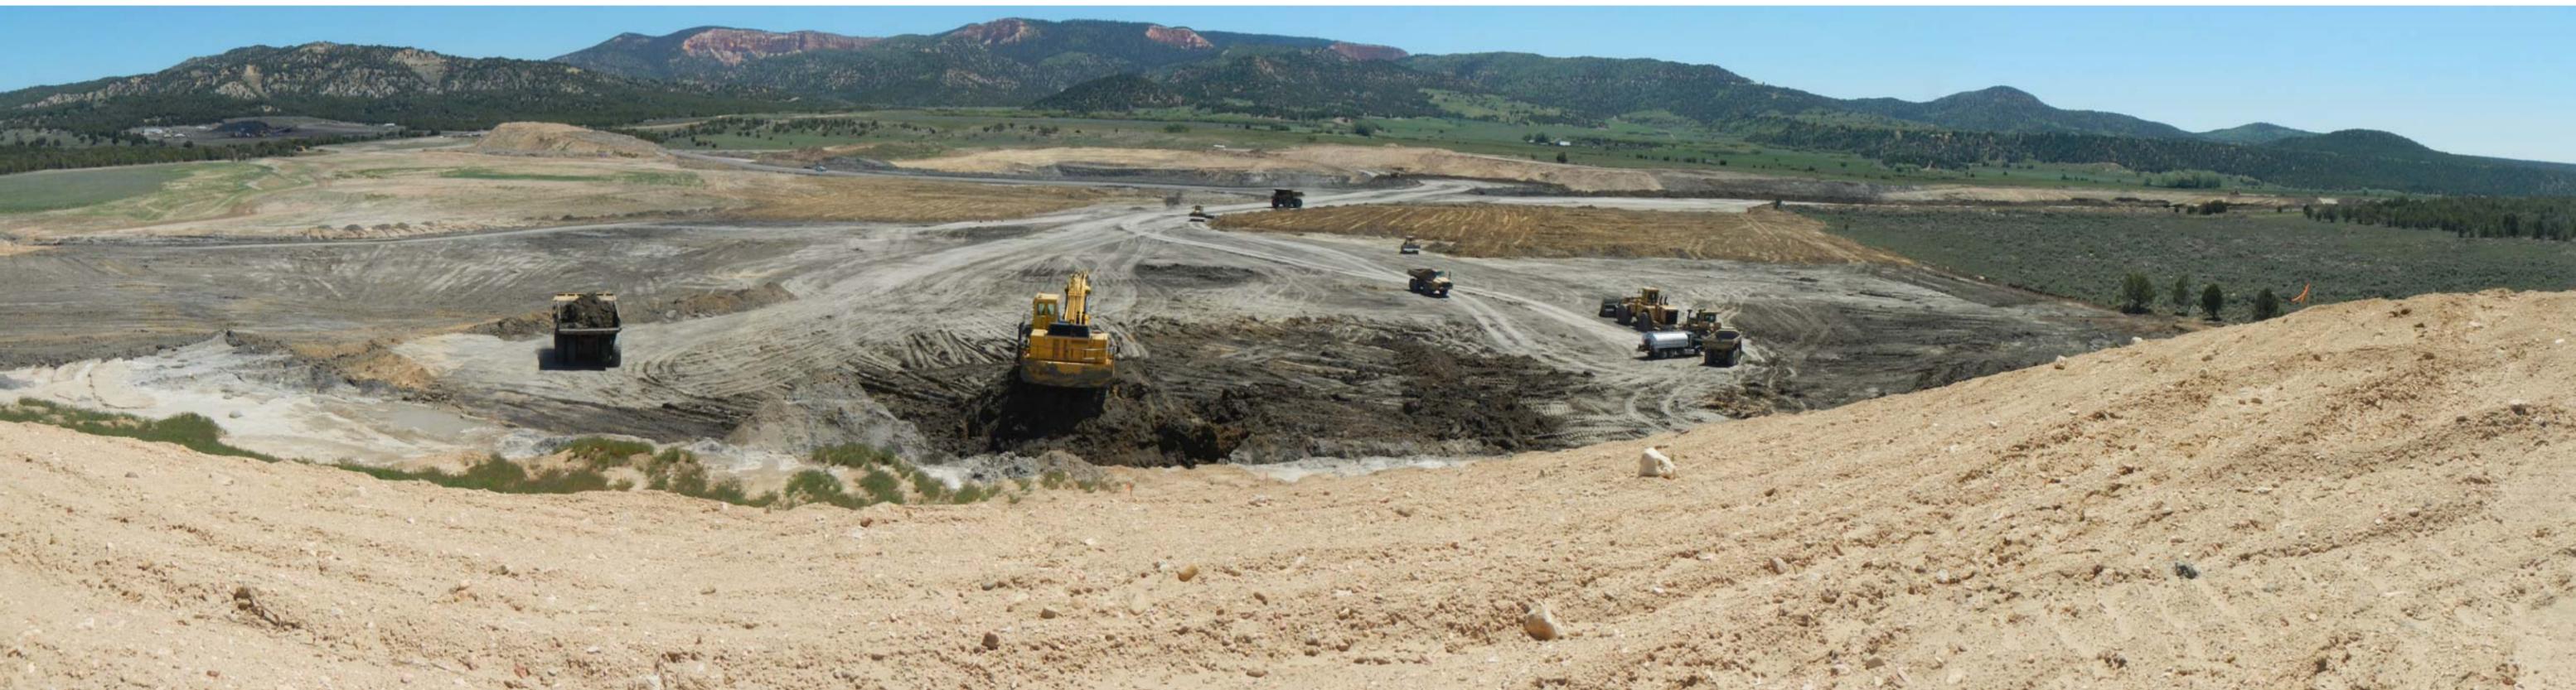
1. The Excess spoil pile is almost gone and they had the excavator working on it. To the upper right of the trucks they have begun spreading subsoil.
2. They lifted the area behind Pond 4. Joe the surveyor was out there making sure it was lifted to the correct height. Hopefully, it will work out. The inlet is not as smooth as I'd like to see it, but I think it'll be fine in the long run because it will be re-graded when they remove the pond.
