Coal Hollow mine phone call RE abatement of NOV 21164, 21165, 21167 and primary haul road certification

This email summarizes the topics of our phone conversation on March 9, 2016.

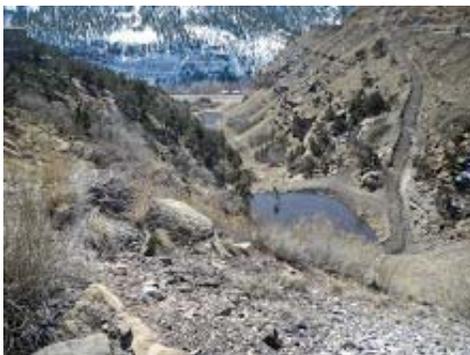
DSCN5477 mine ponds with turbidity curtains in lower pond.JPG
763K

I've attached a photo of pond with turbidity curtains installed to circulate flow. Another method we discussed was to have curtains go across the entire pond to ensure water must go down below curtains than across the pond to the next curtain and down again several times before exiting the pond.

- a. evaluate siltation structure and provide designs in accordance with R645-301-732.100 and R645-301-512.240.
- b. increase size of sump (provide designs)
- c. install sediment control on flow from bathhouse pad slopes
- d. sediment control/grading seeding on fill slopes to south
- e. install oil absorbing, turbidity curtains in pond 3
