## Inspection Report

Permit Number:	C0250005
Inspection Type:	PARTIAL
Inspection Date:	Monday, June 5, 2017
Start Date/Time:	6/5/2017 3:00:00 PM
End Date/Time:	6/6/2017 5:00:00 PM
Last Inspection:	Wednesday, May 10, 2017

Permittee: **ALTON COAL DEVELOPMENT LLC**  
 Operator: **ALTON COAL DEVELOPMENT LLC**  
 Site: **COAL HOLLOW**  
 Address: **463 North 100 West, Suite 1, CEDAR CITY UT 84720**  
 County: **KANE**  
 Permit Type: **PERMANENT COAL PROGRAM**  
 Permit Status: **ACTIVE**

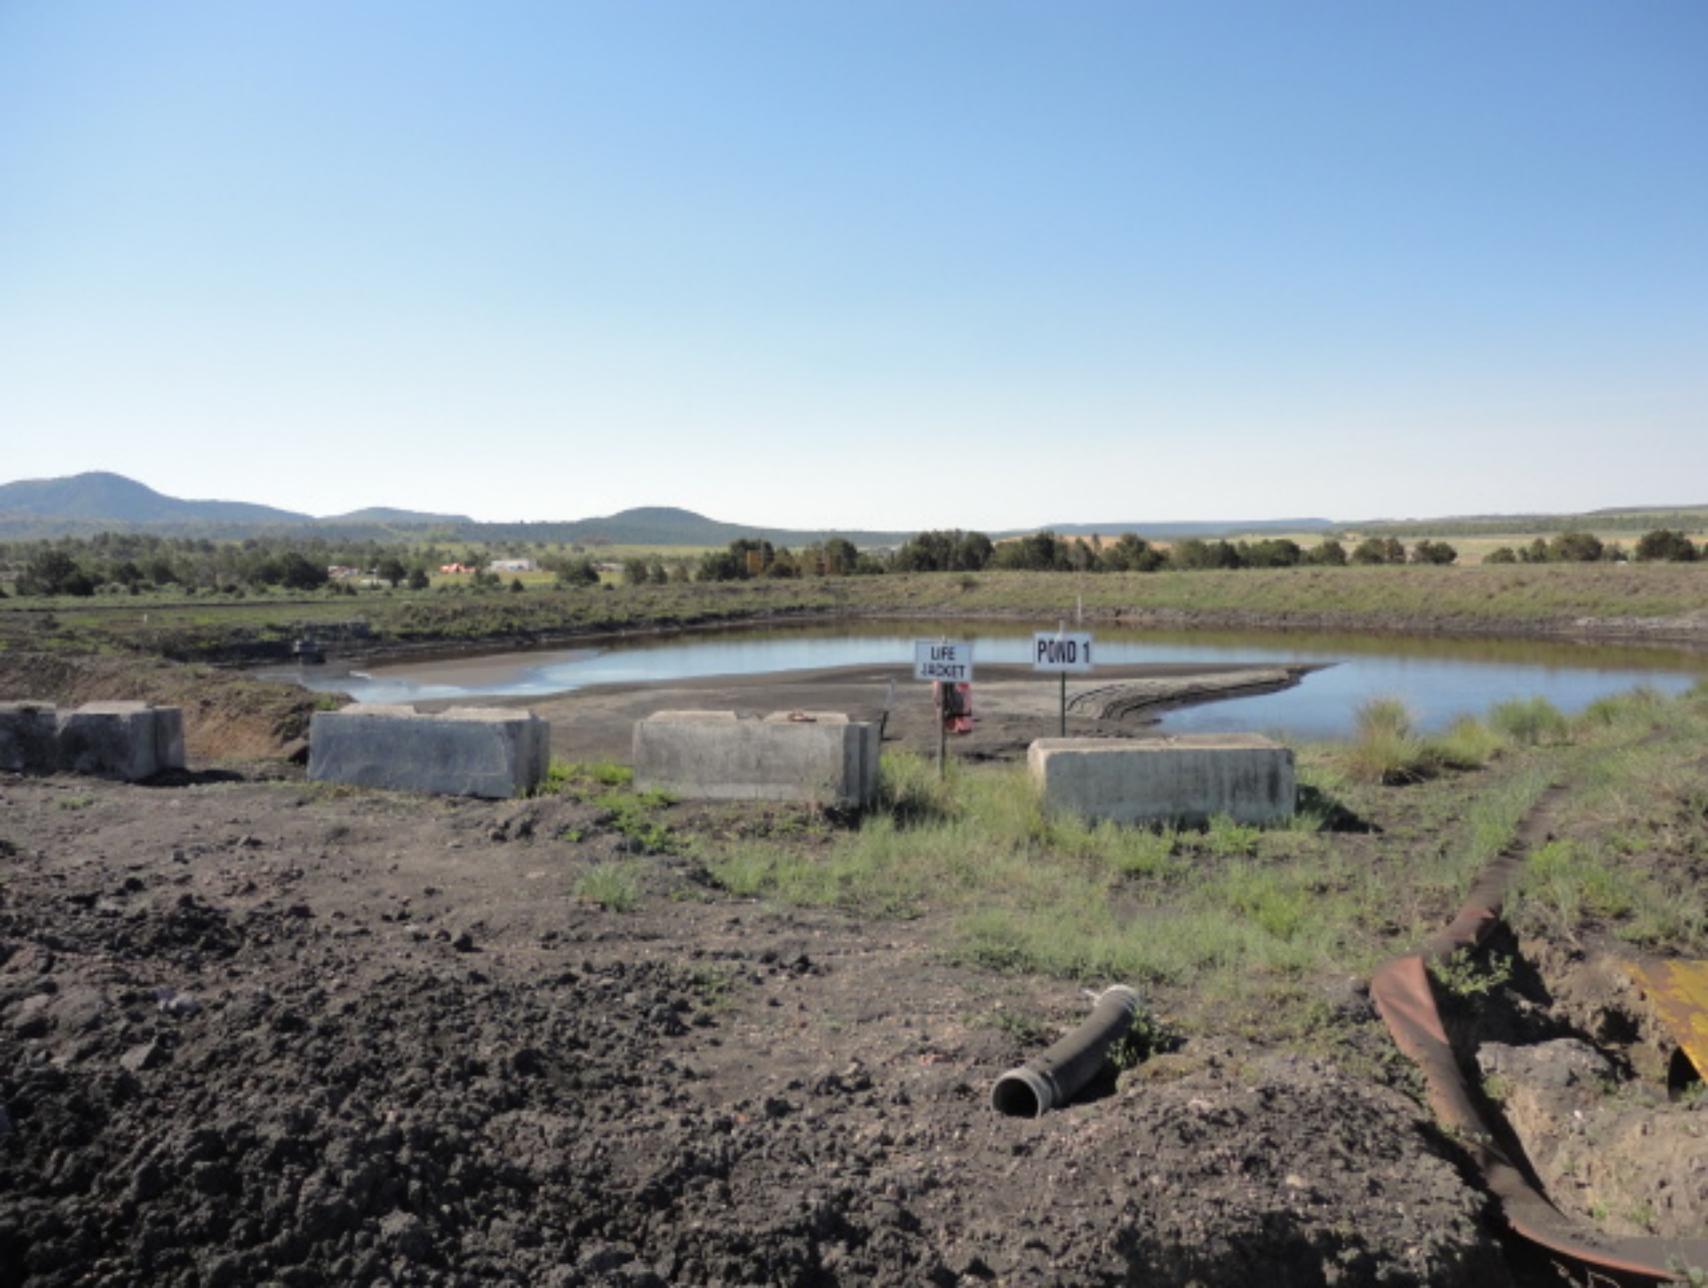
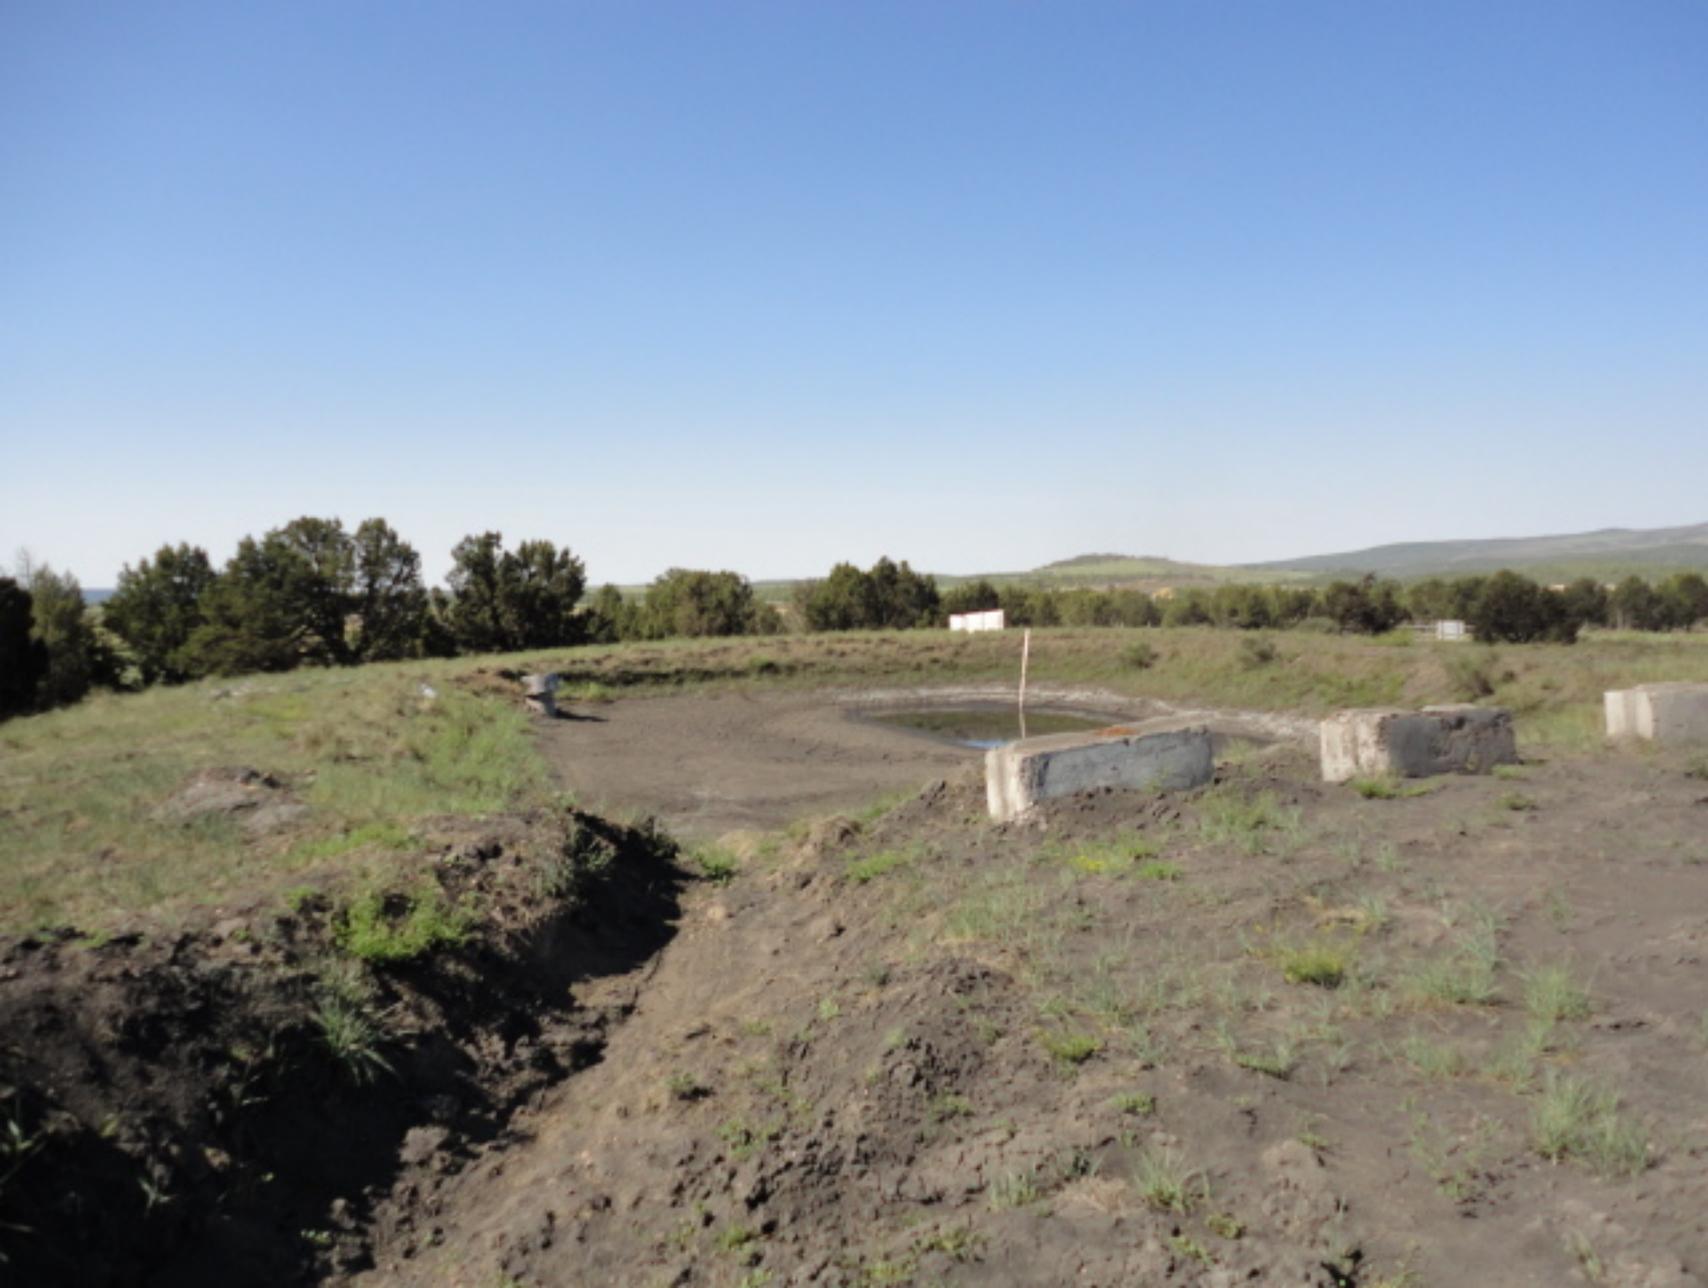
POND 1

I inspected the sediment ponds throughout the property. Some of the sediment ponds did contain water. Pond #3 will likely discharge in the near future since it is receiving 50 gallons /min of water from a disturb area. The embankments appear to be stable. Inlets and outlets would function as designed. I did not see any hazardous conditions to these structures. See Photos
