## Inspection Report

Permittee: **ALTON COAL DEVELOPMENT LLC**  
 Operator: **ALTON COAL DEVELOPMENT LLC**  
 Site: **COAL HOLLOW**  
 Address: **463 North 100 West, Suite 1, CEDAR CITY UT 84720**  
 County: **KANE**  
 Permit Type: **PERMANENT COAL PROGRAM**  
 Permit Status: **ACTIVE**

Coal Hollow Inspection July 9, 2018

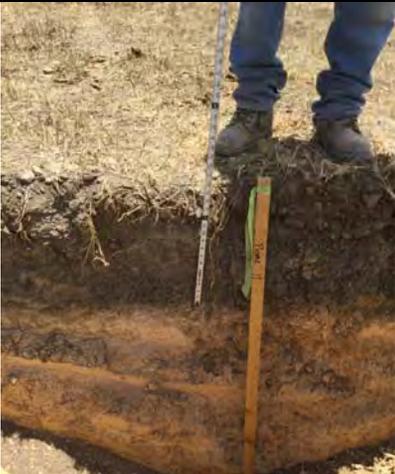
Within the prime farmland soils, soil pits have been excavated to 4 feet deep on 2.2 acre centers to evaluate the salvage depth. We observed seven of these soil pits and found the soil to be quite similar across the DRH soil map unit G, AAA Family. Soil pits 4 & 5 in map unit E, Atlatl-CCC soil, which East of the ravine have a pronounced alluvial deposit below the A horizon. Soil pH is being monitored during salvage. The pH values of A & B horizons (pH = 8.2) and of the C horizon (pH = 8.5) are similar in both map units G and E. Samples have been taken from each soil pit, by horizon or 12 inch depth, where horizonation is not apparent, for analysis of parameters described in Section R645-302-317.400. Density of each horizon was analyzed prior to salvage using a nuclear probe. This information was available during the inspection and is attached. Each 4 foot deep soil profile exposed in soil pits has been archived into a soil profile box. The pedons collected were compared to Soil Data Point locations 12AS018 (AAA soil or map unit G soil) and 12AS020 and 12AS025 (Atlatl-CCC or map unit E soil) shown on Soils Map 1 of the Prime Farmland Soil Survey (MRP Vol 10 - Supplemental Reports - Order 2 Soil Survey for the North Private Lease Expansion).

PIT 11- MAP UNIT G

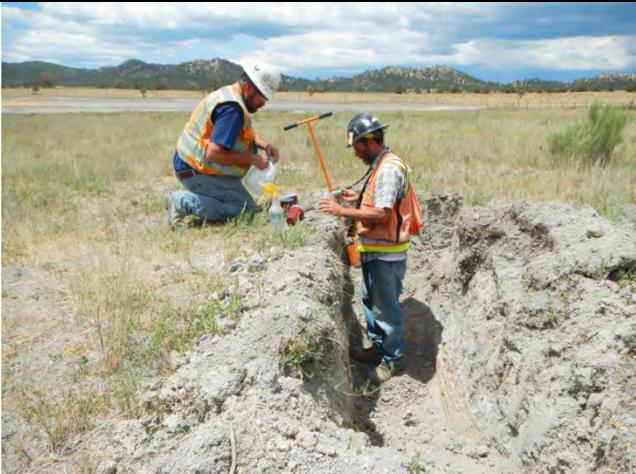
PIT 10 MAP UNIT G

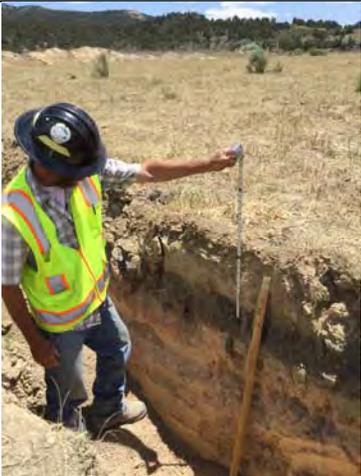
PIT 5 - MAP UNIT E

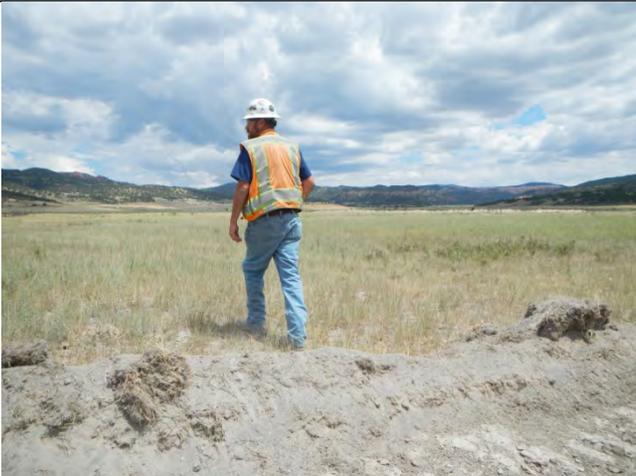
undisturbed DRH Prime Farmland

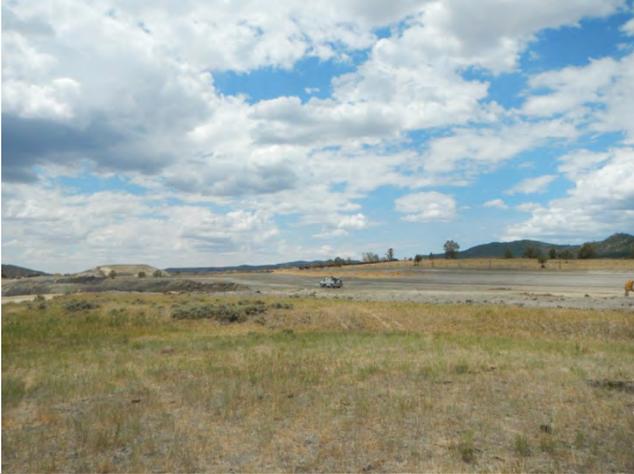
Using road graders in tandem, approximately 1 foot of topsoil and 3 feet of subsoil has been stripped from A2-Other and prime farmland DRH soil types A1, D and G, North of the elk fence for about 400 feet to the boundary of Pit 18 coal and East about half way across, above the surface of pit 18 coal.

**“DRH G” foreground, A2 OTHER” distance**

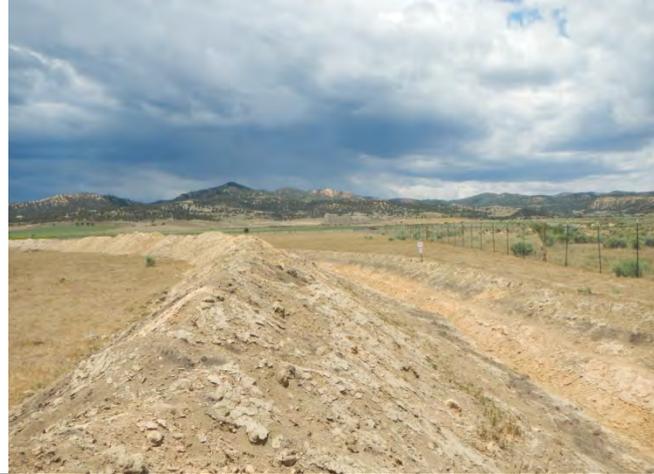
**UD DITCH 14 AND FENCELINE to be moved Eastward**

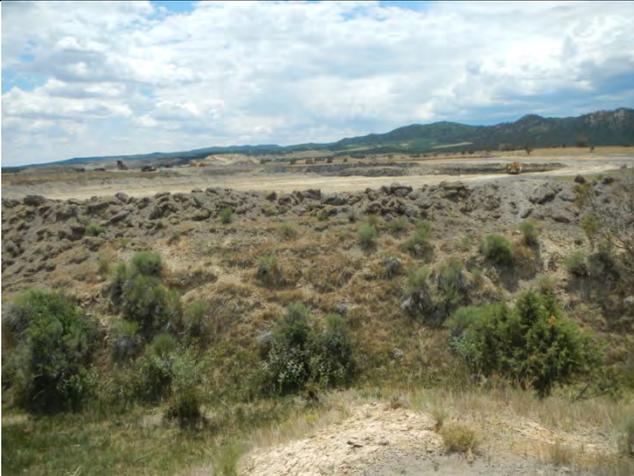
Landowner DRH topsoil A and subsoil piles B & C are under construction in the locations shown on Dwg 5-51B. Topsoil salvage will continue along the landowner fenceline North and East to the permit boundary as shown on Dwg 2-4. When the A2 soils in the ravine are encountered, they will be included in the DRH C horizon stockpile.

**A2 OTHER - RAVINE SOIL**

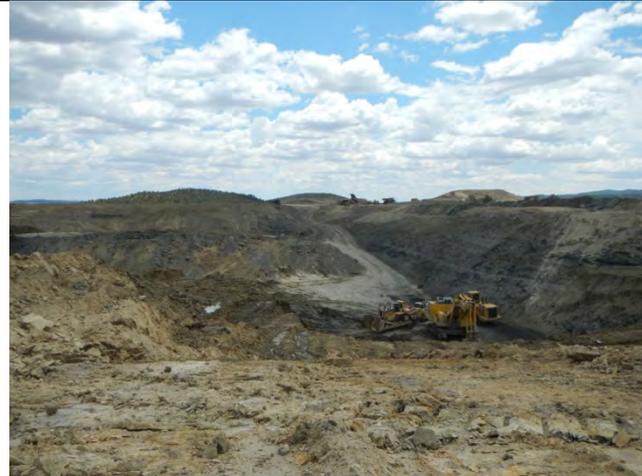
Mining activity is in Pit 16 West half, however no trucks were being loaded during the inspection. Pits 11 - 14 are backfilled, but not graded. During the inspection two dozers were pushing alluvium from above Pit 17 into the East half of Pit 16.

**MINING PIT 16**
