## Inspection Report

Permit Number:	C0250005
Inspection Type:	PARTIAL
Inspection Date:	Tuesday, June 9, 2020
Start Date/Time:	6/9/2020 8:30:00 AM
End Date/Time:	6/9/2020 2:30:00 PM
Last Inspection:	Tuesday, May 19, 2020

Permittee: **ALTON COAL DEVELOPMENT LLC**  
 Operator: **ALTON COAL DEVELOPMENT LLC**  
 Site: **COAL HOLLOW**  
 Address: **463 North 100 West, Suite 1, CEDAR CITY UT 84720**  
 County: **KANE**  
 Permit Type: **PERMANENT COAL PROGRAM**  
 Permit Status: **ACTIVE**

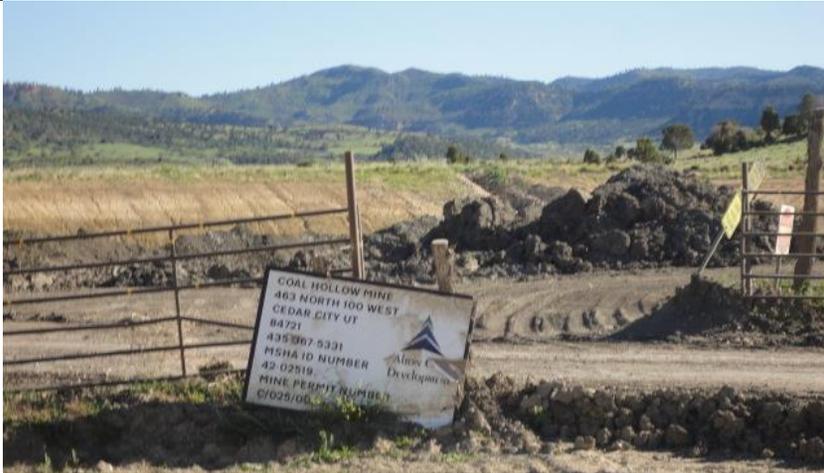
**PHOTO 1**  
Identification Sign

The identification sign was inspected and it meets the requirements of the R645 Coal Rules. See Photo

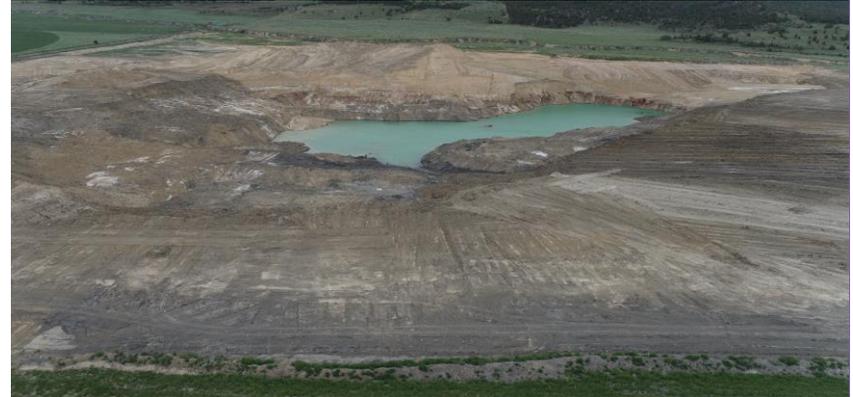
**PHOTO 2**  
North Lease looking East

The permittee was mining in Pit F-2 in the South Lease. Pit 10 is Backfilled with spoil material. It still needs to be graded with subsoil and topsoil. The North lease has two dozers pushing material into the pit. Grade stakes are used to meet final grade.

The permittee was pushing spoil material into the pits in the North lease with two dozers.

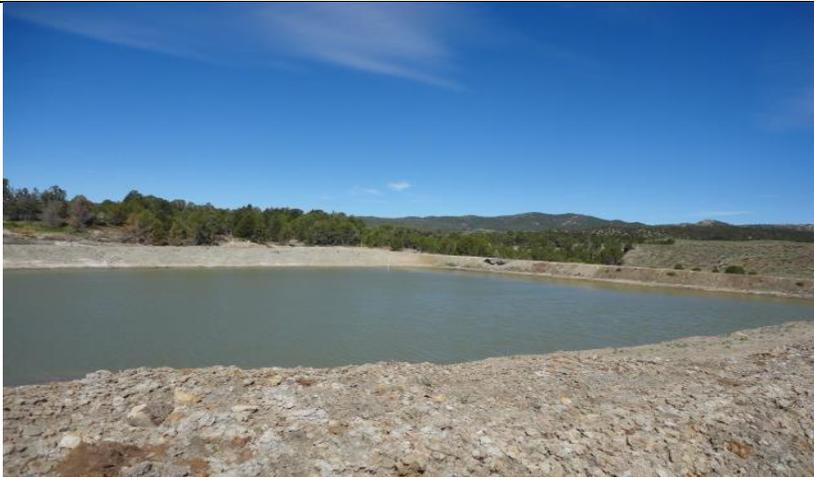
**PHOTO 3**  
Sediment Pond #3

I inspected sediment ponds 1, 1b, 3, 5, 6 and 7. The ponds were stable and inlets and outlets were functioning as design. Ponds 1, 1B, 3, and 7 had some water. No sediment pond was discharging.

Baby ducks were at Sediment pond #3.
