Inspection Report

Permit Number:	C0250005
Inspection Type:	PARTIAL
Inspection Date:	Tuesday, July 7, 2020
Start Date/Time:	7/7/2020 8:30:00 AM
End Date/Time:	7/7/2020 2:00:00 PM
Last Inspection:	Tuesday, June 9, 2020

Permittee: **ALTON COAL DEVELOPMENT LLC**
 Operator: **ALTON COAL DEVELOPMENT LLC**
 Site: **COAL HOLLOW**
 Address: **463 North 100 West, Suite 1, CEDAR CITY UT 84720**
 County: **KANE**
 Permit Type: **PERMANENT COAL PROGRAM**
 Permit Status: **ACTIVE**

ATTACHMENT A – Coal Hollow

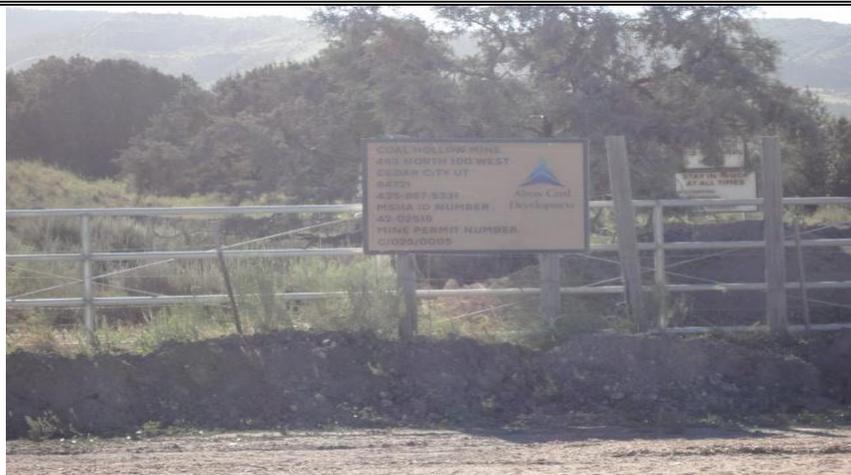
PHOTO 1
Identification Sign

The identification sign was inspected and it meets the requirements of the R645 Coal Rules. See Photo

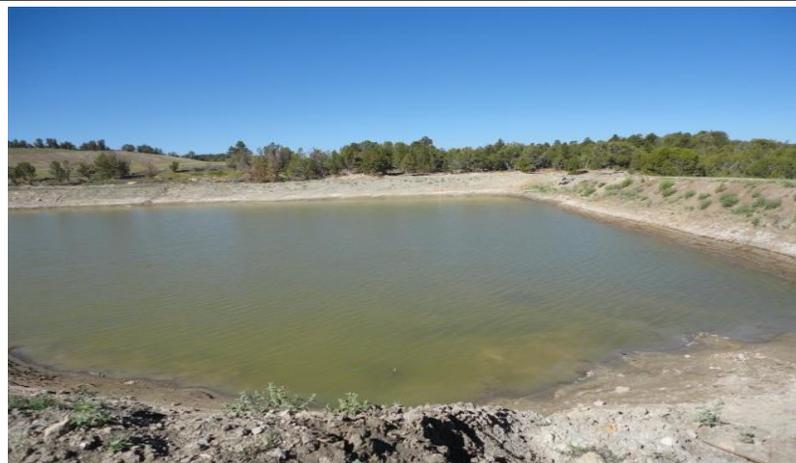
PHOTO 2
Pond #3

I inspected the sediment ponds throughout the property. They did contain water. It is unlikely these structures will discharge in the near future. Ponds #3 and #7 are used to water the roads. The embankments appear to be stable. Inlets and outlets are open. I did not see any hazardous conditions to these structures.

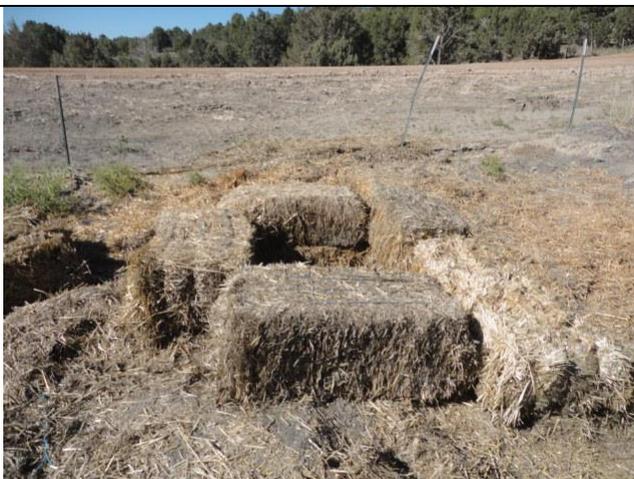
PHOTO 3
ASCA North Lease

The ASCA have new straw bales to treat the water. See photos

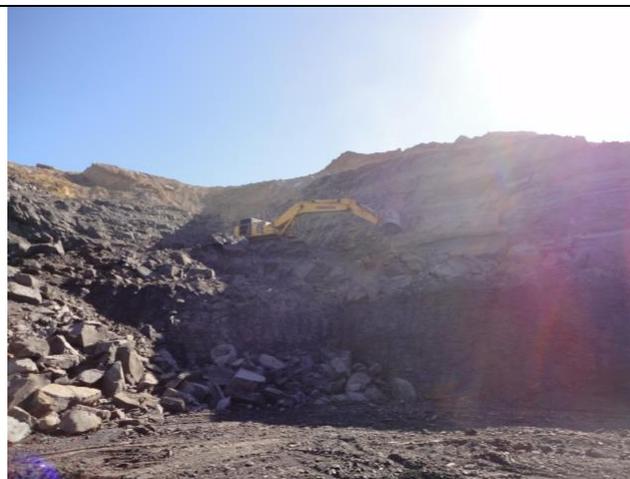
PHOTO 4
Pit F1 Last Block of Coal

The permittee was mining coal in Federal Lease (F1) on the eastside of the pit. This should be the last area to be mined in F1. It is plan that auger drilling will take place on the eastside of F1 after this last cut. The Westside of F2 was getting uncovered of overburden material. Mining of this area should take place in less than a day.

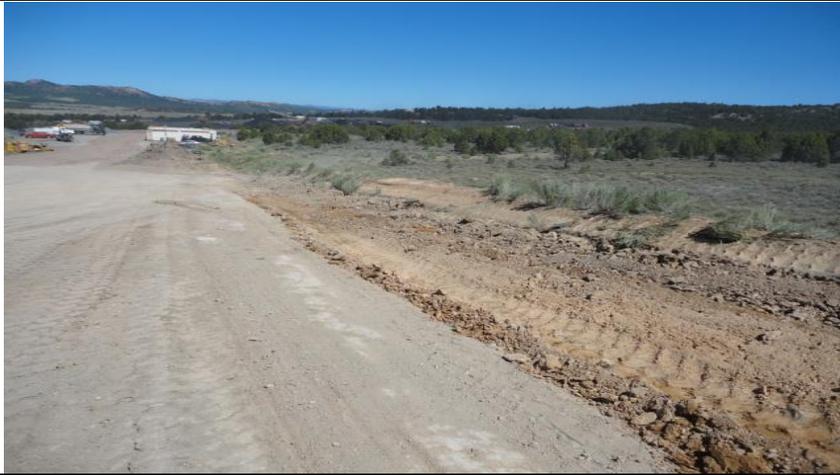
PHOTO 5

The permittee was in the process of cleaning and removing weeds within the diversions during the inspection. The diversions and culverts were open and could convey water to the sediment ponds during a storm event. See Photos

Road diversions were getting graded during the inspection. Diversions and culverts were open throughout the property.

Maintenance Road Diversion

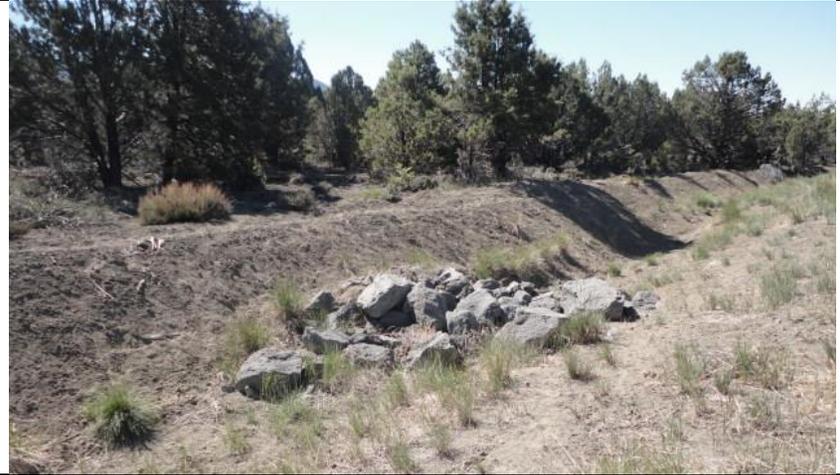
PHOTO 6

UD-1

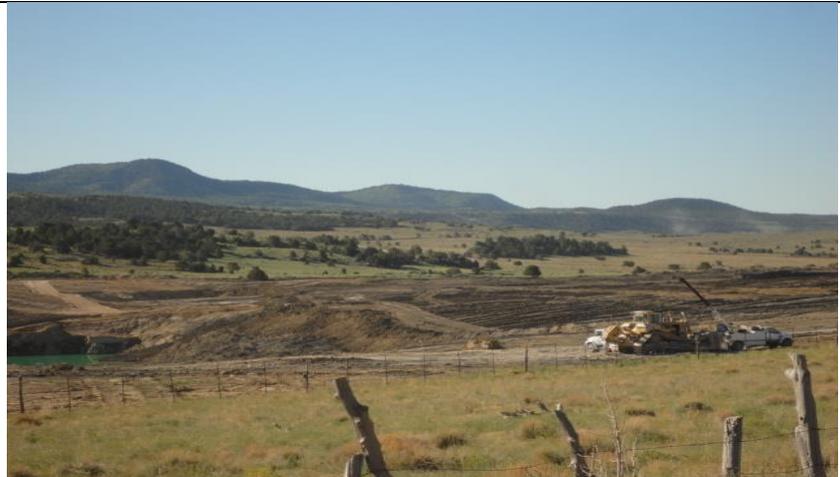
PHOTO 7

The North lease the permittee was still in the process of grading and filling in the pit areas. There are two dozers reclaiming this area. Today, one of the dozer was broken down.

The North lease is getting backfilled and graded by two dozers. This area should be finish in November. See Photos

North Lease Reclamation

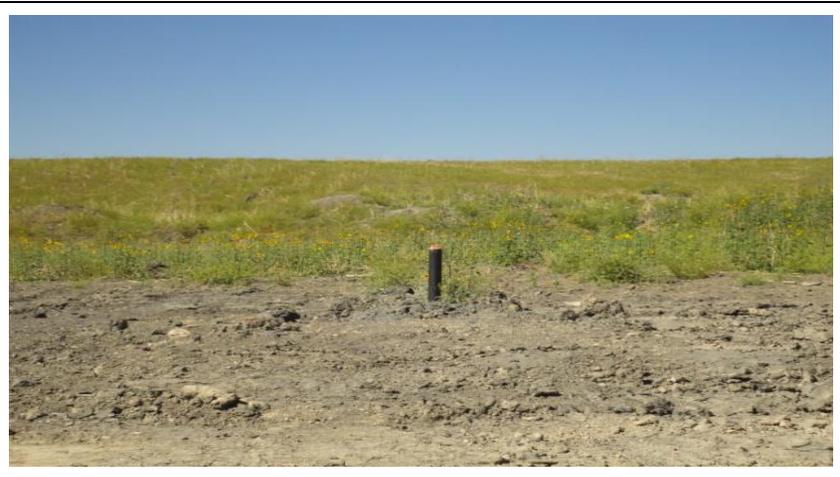
PHOTO 8

North Lease Water Well in Spoil/Reclaimed Area
