Inspection Report

Permit Number:	C0250005
Inspection Type:	COMPLETE
Inspection Date:	Tuesday, August 4, 2020
Start Date/Time:	8/4/2020 8:30:00 AM
End Date/Time:	8/4/2020 2:00:00 PM
Last Inspection:	Tuesday, July 7, 2020

Permittee: **ALTON COAL DEVELOPMENT LLC**
 Operator: **ALTON COAL DEVELOPMENT LLC**
 Site: **COAL HOLLOW**
 Address: **463 North 100 West, Suite 1, CEDAR CITY UT 84720**
 County: **KANE**
 Permit Type: **PERMANENT COAL PROGRAM**
 Permit Status: **ACTIVE**

ATTACHMENT A – Coal Hollow

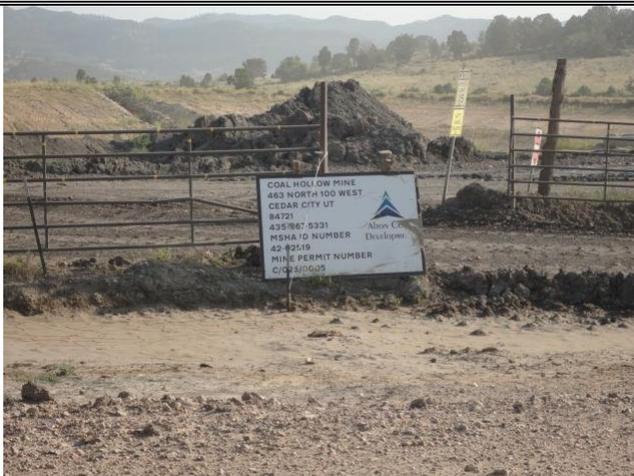
PHOTO 1
Identification Sign

The identification sign was inspected and it meets the requirements of the R645 Coal Rules. See Photo

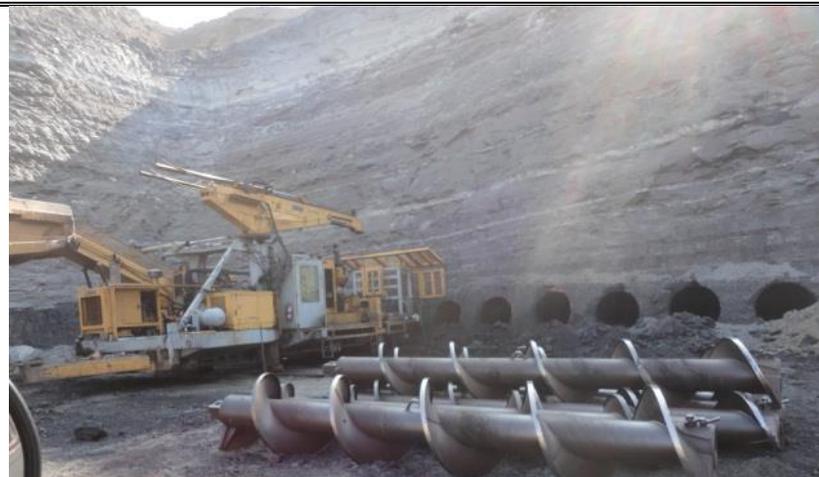
PHOTO 2
Auger Mining in F1

The mining was mining coal in the South Lease, and reclaiming the North Lease. The permittee was auger mining in Pit-F1 and removing spoil material in Pit-F2. In the North Lease the permittee was using two (2) Dozers, one (1) shovel, and two (2) haul trucks to reclaim the pits, grading surrounding areas around pits, and grading a swell area for water flow. The permittee plans on submitting an amendment for Phase 1 bond release for Pits 10 thru F1 in the South Lease in October and another bond release for Phase 1 in the North Lease in November.

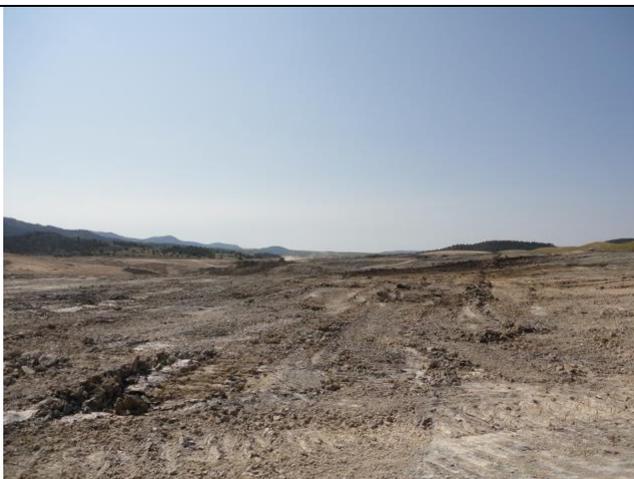
PHOTO 3
Grade at North Lease

The permittee was backfilling approximately pits 20 thru 17 in the North Lease. The dozers during the inspection were grading slopes around these pits. Haul trucks were dumping excess spoil material from the over filled pit and backfilling the open pits. The Shovel was removing material and shaping the swell area.
