Inspection Report

Permit Number:	C0250005
Inspection Type:	PARTIAL
Inspection Date:	Wednesday, September 9, 2020
Start Date/Time:	9/9/2020 9:00:00 AM
End Date/Time:	9/9/2020 2:30:00 PM
Last Inspection:	Tuesday, August 4, 2020

Permittee: **ALTON COAL DEVELOPMENT LLC**
 Operator: **ALTON COAL DEVELOPMENT LLC**
 Site: **COAL HOLLOW**
 Address: **463 North 100 West, Suite 1, CEDAR CITY UT 84720**
 County: **KANE**
 Permit Type: **PERMANENT COAL PROGRAM**
 Permit Status: **ACTIVE**

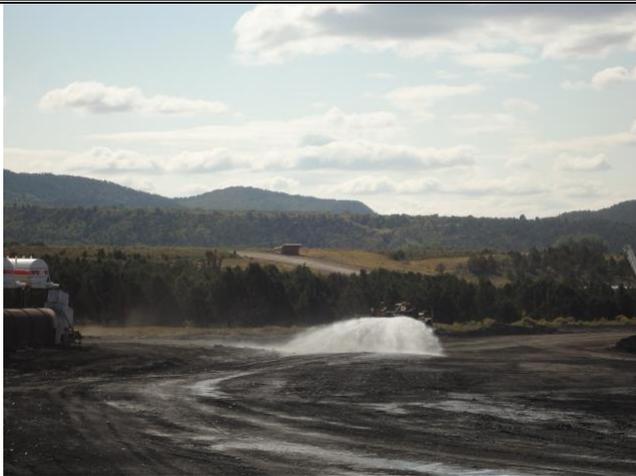
The roads were compacted with no dust control problem. The roads were wet and had been recently water.

PHOTO 1
Watering Roads

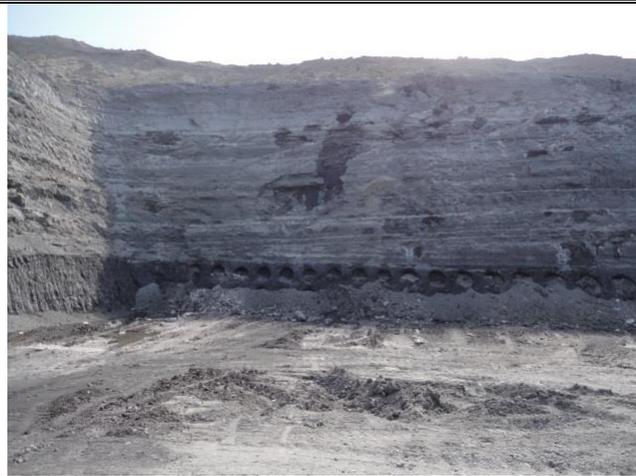
PHOTO 2
Auger Mining F-1

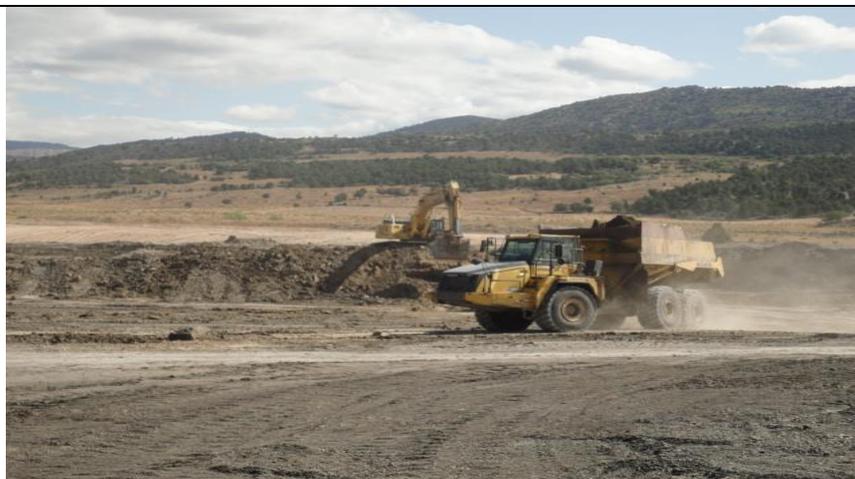
The permittee was backfilling the pits 20 through 18 in the North lease. It is possible that the permittee will be asking for Phase I Bond release at the end of this year. The pits 10 and 10B will be backfilled and graded once pit F-2 has been auger mined.

PHOTO 3
Reclaiming North Lease

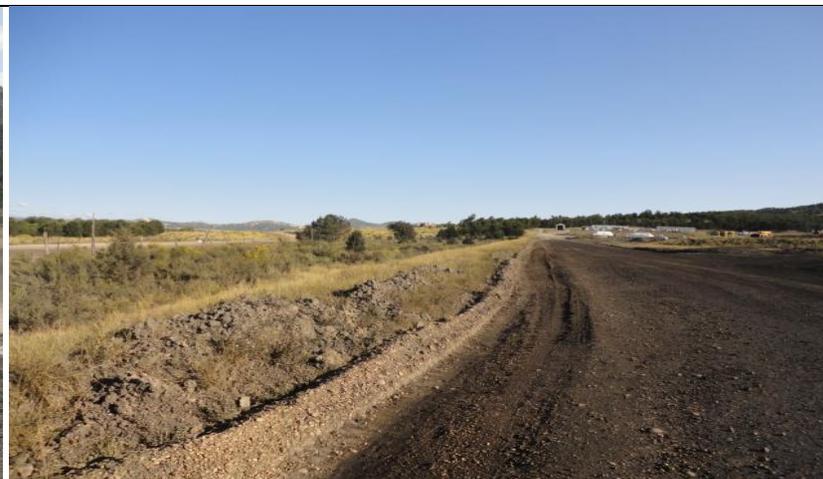
I inspected diversions and culverts throughout the property. They were open and would function during in a storm event. The mine site has not received much rain this summer. See Photos.

PHOTO 4
Diversion DD-3
