Monitoring Report South Fork of Quitchupah

Vicky Miller <vmiller@bowieresources.com>

Tue, Apr 22, 2014 at 7:45 AM

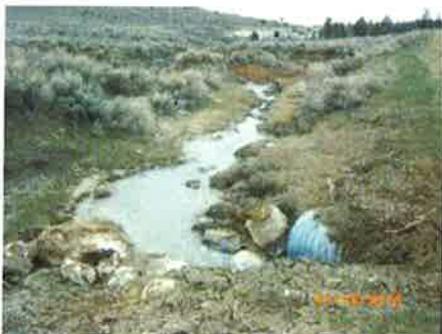
IMGP2425.JPG
1807K

Flow on the 10th was estimated at 85 gpm, flow on the 16th was approximately 70 gpm at the road crossing. The water was laden with sediment on both days (see attached photo). We received approximately 1.5 inches of snow at the mine site during the two week period.
