Monitoring Report South Fork of Quitchupah Creek

Mon, Oct 20, 2014 at 2:00 PM

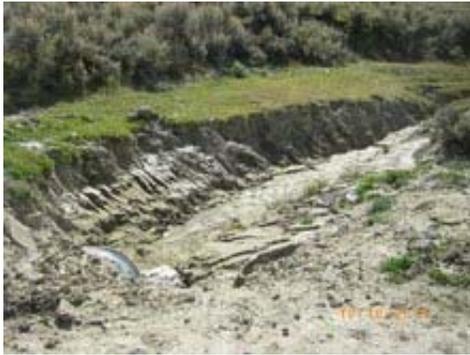
IMGP4691.JPG
1820K

The South Fork of Quitchupah Creek was observed on October 7, 10, 13, 15 and 16th. Flow was measured at Sufco 006 at 20 gpm on the 7th (4564), 4 gpm on the 10th (4598) with no flow the 13 (4646), 15, and 16th. (4691). On October 1, the Forest Service diverted the flow from the upper most South Fork/ Skumtupah diversion to the SKutumpah Reservoir drainage, which cut off the flow to South Fork except for the few springs along the channel below the diversion.

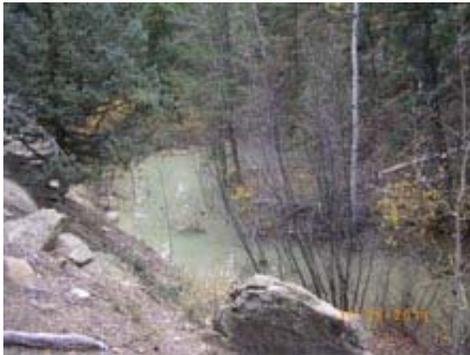
IMGP4662.JPG
1903K

North Duncan and North Duncan Flat ponds were full on the 7th and had a little water still in them on the 13th. The beaver ponds (4662) near monitoring point 006D still held water on the 15th.

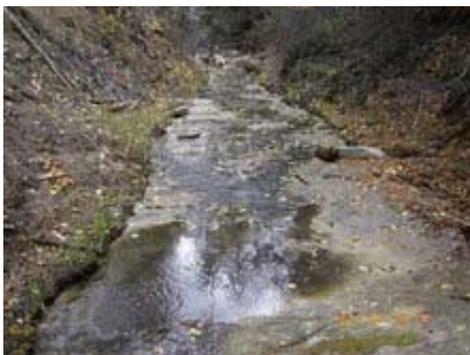
IMGP4666.JPG
1927K

On the 13th water was visible at the upper most springs (006A, Roberts, etc.) and at Wedge and Amanda Spring, however the channel was dry or puddled between the sets of springs. On the 15th there was still no flow in the channel from Spring 006A until approximately 100 meters above monitoring location 006C, where 10 gpm was flowing into the channel beneath a rock outcrop (4666), the water was still flowing at 10gpm on the 16th.
