South Fork of Quitchupah Monitoring

Attached is a map showing the location of mining on November 2, 2014.

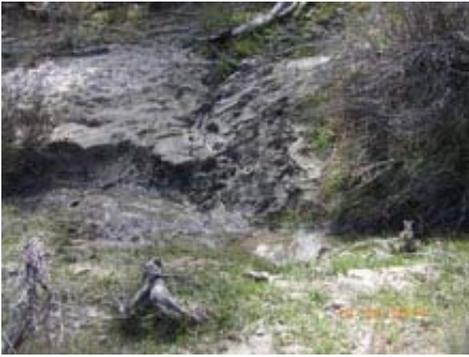
IMG4714.JPG
1895K

On the dates listed above the channel became dry approximately 100 meters above where the culvert crosses the road to just below monitoring location 006C (4742, 4812). The flow was estimated to be 5 to 8 gpm at the location below 006C and the channel continued to gain flow until it joined with the flow for the Wedge and Amanda Springs. The springs along the South Fork were all flowing during the two week monitoring period (4714, 4719, 4806).

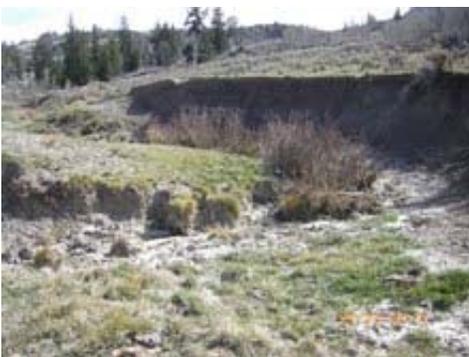
IMGP4795.JPG
1941K

Slow moving water above monitoring location 006 was observed to be covered with ice, during the monitoring on the 27th and 31st (4795). The ponds were dry and no livestock was observed in the area.
