Subject: Sufco Mine Sinkhole

### ATTACHMENT A – Sufco Sink Hole

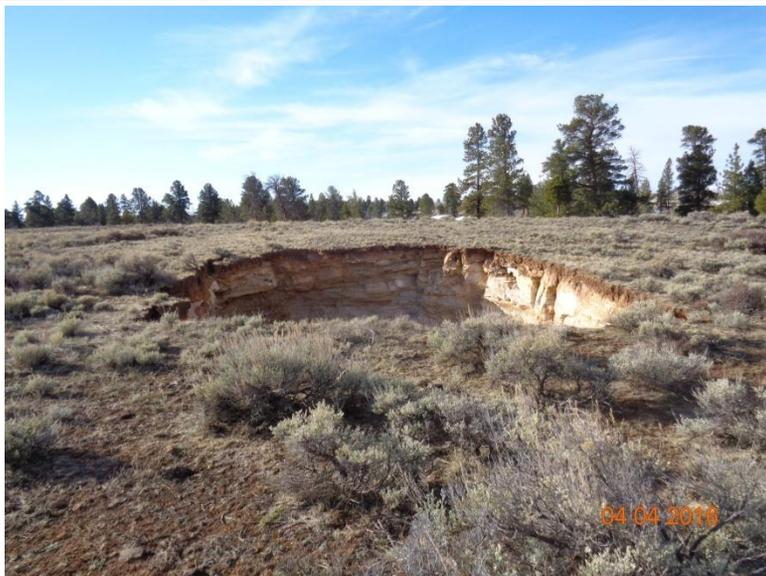
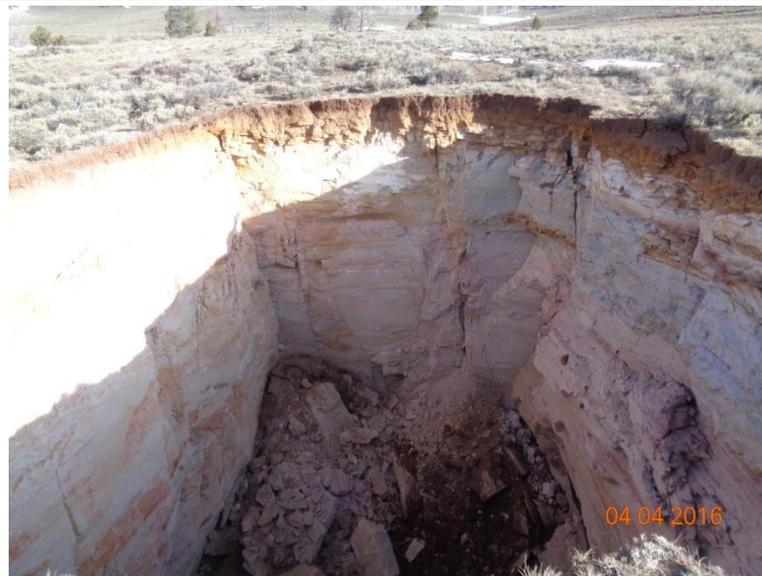
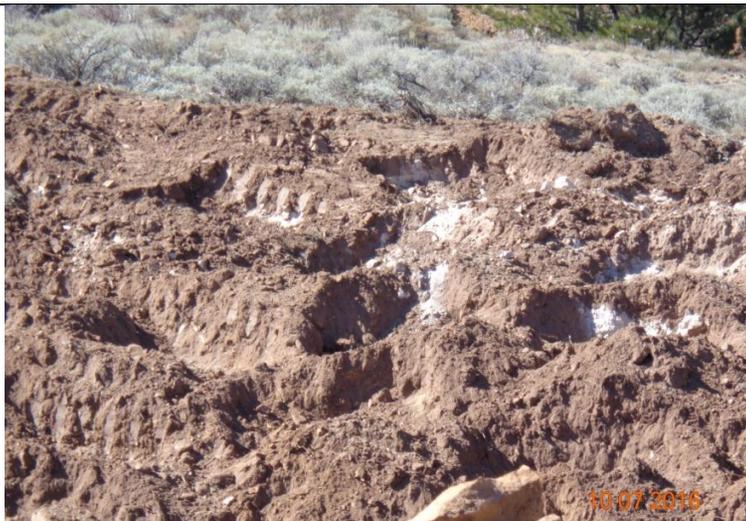
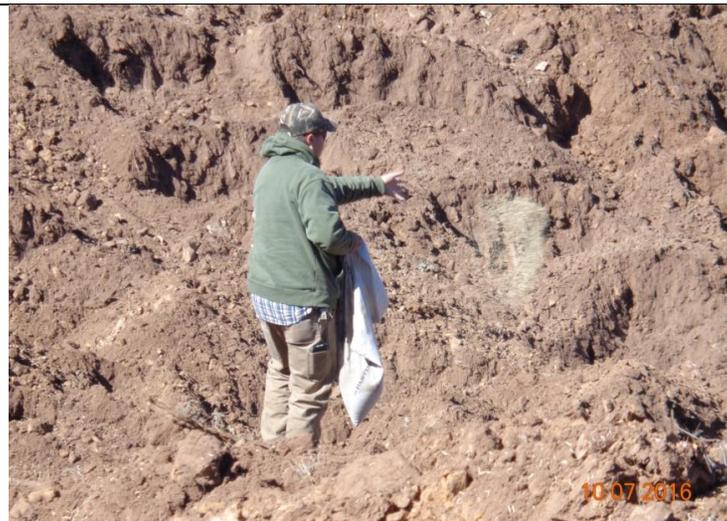
In December 2016, Sufco mine located a sinkhole on the surface above the 2RWL panel within the Castlegate Sandstone. It is located near mid-panel in an area mined in December 2016. The sinkhole measures roughly 40 ft. W X 50 ft. L X 40 ft. deep. It is located along a fault zone that was crossed in that area at depth.

Subsidence features are known to occur naturally in the Castlegate Sandstone along the Mud Springs Hollow fault zone nearby to the east. It is suspected that mining-related subsidence triggered the collapse into some sort of cavity within the fault zone. Exploration drilling over the years in this area has encountered voids on occasion but such voids have always been interpreted as limited zones of open fractures. In this case there may have been a large open fracture that allowed accommodation space for the sinkhole to develop.

In October, Sufco notified the Division the sinkhole has been repaired and reclamation was complete.

On November 8, 2016, I met with Vicky Miller and Bryant Bunnell from Sufco Mine and made a field visit to the location to verify it had been reclaimed. As described by Bryant, heavy equipment was used to scale down the side slopes and existing top soil was used as a top dressing. The side was then broadcast seeded using a seed mix requested by the U.S. Forest Service (landowner).
