Re: Phase 3,4 Construction As-built Information Amendment, Canyon Fuel Company, LLC, Sufco Mine, Sufco Waste Rock Site, Permit Number C/041/0002

Title: WRS As-Built Amendment

Phase 3, 4 Construction
Soil Survey and Soil Salvage Reports

Sufco Mine Waste Rock Site Disposal Site Phase 3 and 4 Expansion Soil Salvage Project

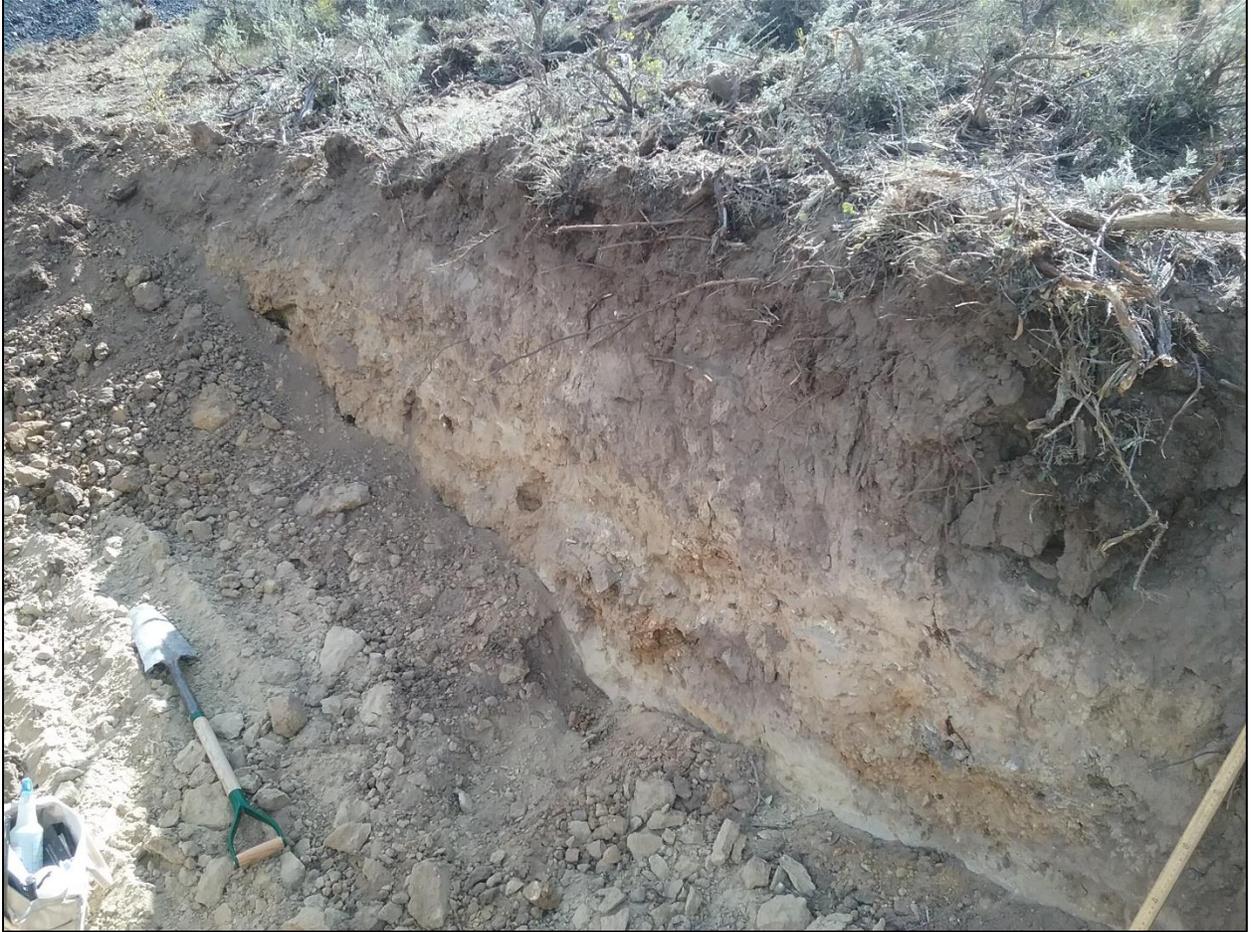
Figure 2. Test Pit TP-3.1.

Test Pit TP-3.1

O – 0 to 1 cm (0 to 0.4 in.); 10YR dry; 10YR moist; leaves and twigs.

A – 1 to 36 cm (0.4 to 14 in.); 10YR 4/2 dry; 10YR 2/2 moist; sandy loam; soft; weak medium subangular blocky to moderate medium granular structure.

B – 36 to 79 cm (14 to 31 in.); 10YR 5/2 dry; 10YR 3/2 moist; sandy loam; slightly hard; moderate medium subangular blocky structure.

C – 79 to 128 cm (31 to 50.5 in.); 2.5Y 7/4 dry; 2.5Y 6/4 moist; sand; slightly hard; gravel and cobbles 25% by volume; moderate medium subangular blocky structure.

R – Castlegate sandstone at 128 cm (50.5 in.) depth

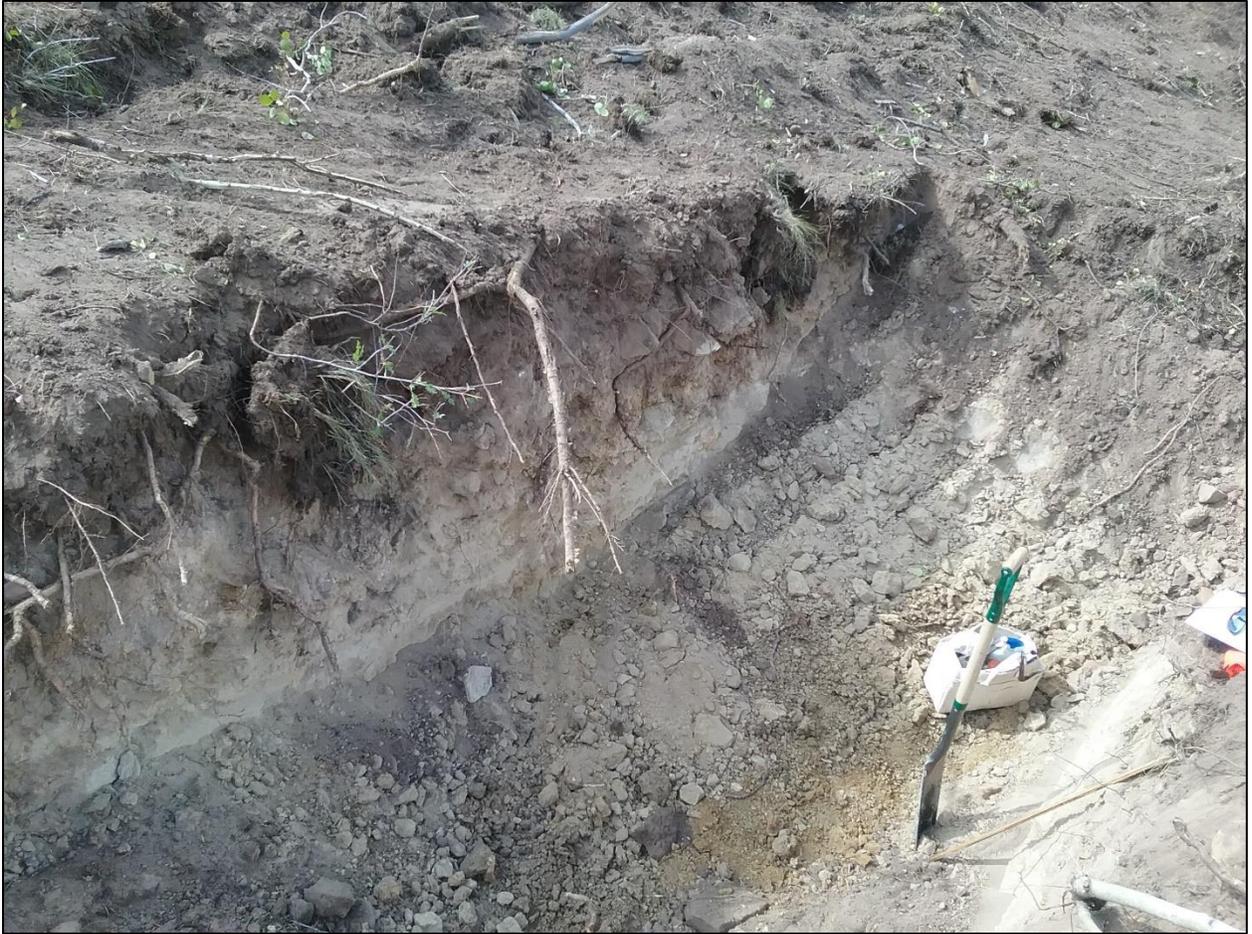
Figure 3. Test Pit TP-3.2.

Test Pit TP-3.2

O – 0 to 1 cm (0 to 0.4 in.); 10YR dry; 10YR moist; leaves and twigs.

A – 1 to 25 cm (0.4 to 10 in.); 10YR 4/2 dry; 10YR 3/2 moist; sandy loam; soft; weak medium subangular blocky to moderate medium granular structure.

B – 25 to 64 cm (10 to 25 in.); 10YR 5/2 dry; 10YR 3/2 moist; sandy loam; slightly hard; some 10-inch diameter boulders in horizon; moderate medium subangular blocky structure.

C – 64 to 84 cm (25 to 33 in.); 10YR 6/3 dry; 10YR 6/4 moist; sand; slightly hard; gravel and cobbles throughout horizon 50% by volume; weak to moderate medium subangular blocky structure.

R – Castlegate sandstone at 84 cm (33 in.) depth

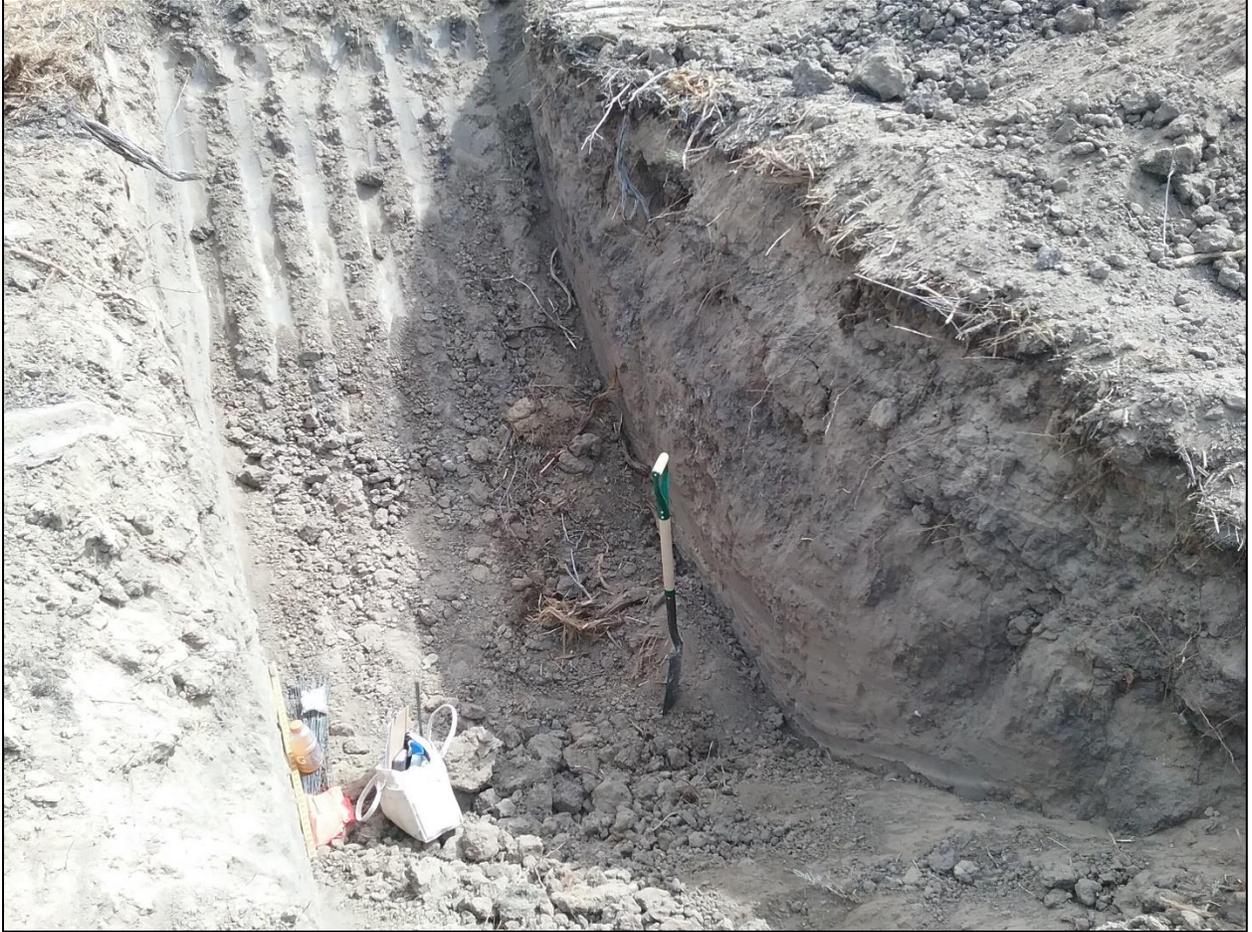
Figure 4. Test Pit TP-3.3.

Test Pit TP-3.3

A – 0 to 34 cm (0 to 13.5 in.); 10YR 6/3 dry; 10YR 4/3 moist; sandy loam; soft; weak medium subangular blocky to moderate medium granular structure.

AB – 34 to 72 cm (13.5 to 28.5 in.); 10YR 5/2 dry; 10YR 4/2 moist; sandy loam; slightly hard. Narrow band (2 inches) of increased clay content, but is not representative of the horizon as a whole; weak to moderate medium subangular blocky structure.

Bt – 72 to 168 cm (28.5 to 66 in.); 10YR 4/2 dry; 10YR 3/2 moist; silty clay loam; slightly hard; white streaking throughout horizon, likely carbonate leaching; moderate medium subangular blocky structure.

Restrictive Layer: None

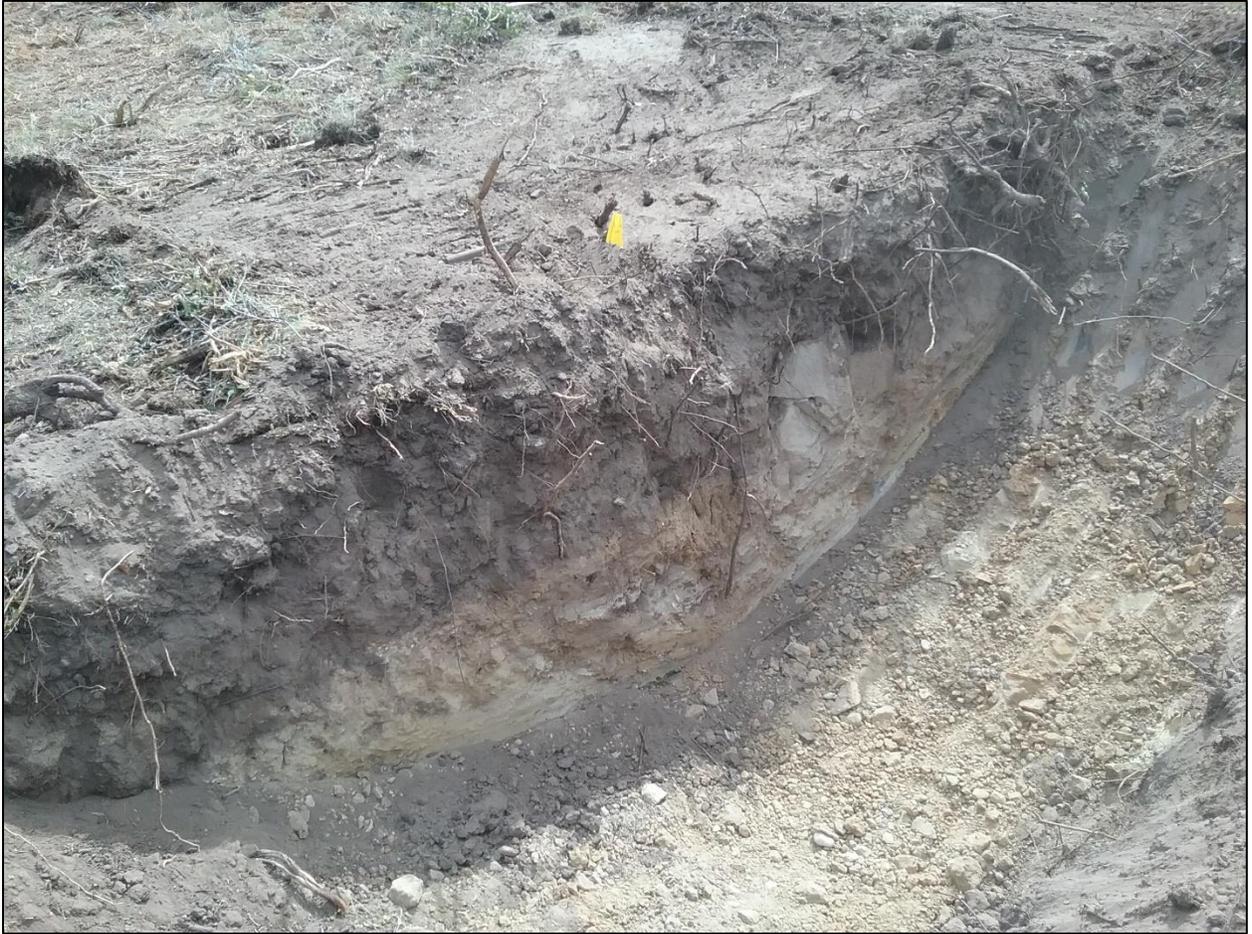
Figure 5. Test Pit TP-3.4

Test Pit TP-3.4

O – 0 to 1 cm (0 to 0.4 in.); 10YR dry; 10YR moist; Leaves and Twigs.

A – 1 to 46 cm (0.4 to 18 in.); 10YR 4/2 dry; 10YR 2/2 moist; sandy loam; soft; weak medium subangular blocky to moderate medium granular structure.

B – 46 to 74 cm (18 to 29 in.); 10YR 4/2 dry; 10YR 2/2 moist; sandy loam; slightly hard; occasional sandstone boulder in horizon, but no other rock; moderate medium subangular blocky structure.

C – 74 to 100 cm (29 to 39.5 in.); 10YR 6/4 dry; 10YR 5/4 moist; sandy clay loam; very hard; few rocks scattered throughout horizon; strong medium subangular blocky structure.

R – Castlegate sandstone at 100 cm (39.5 in.) depth

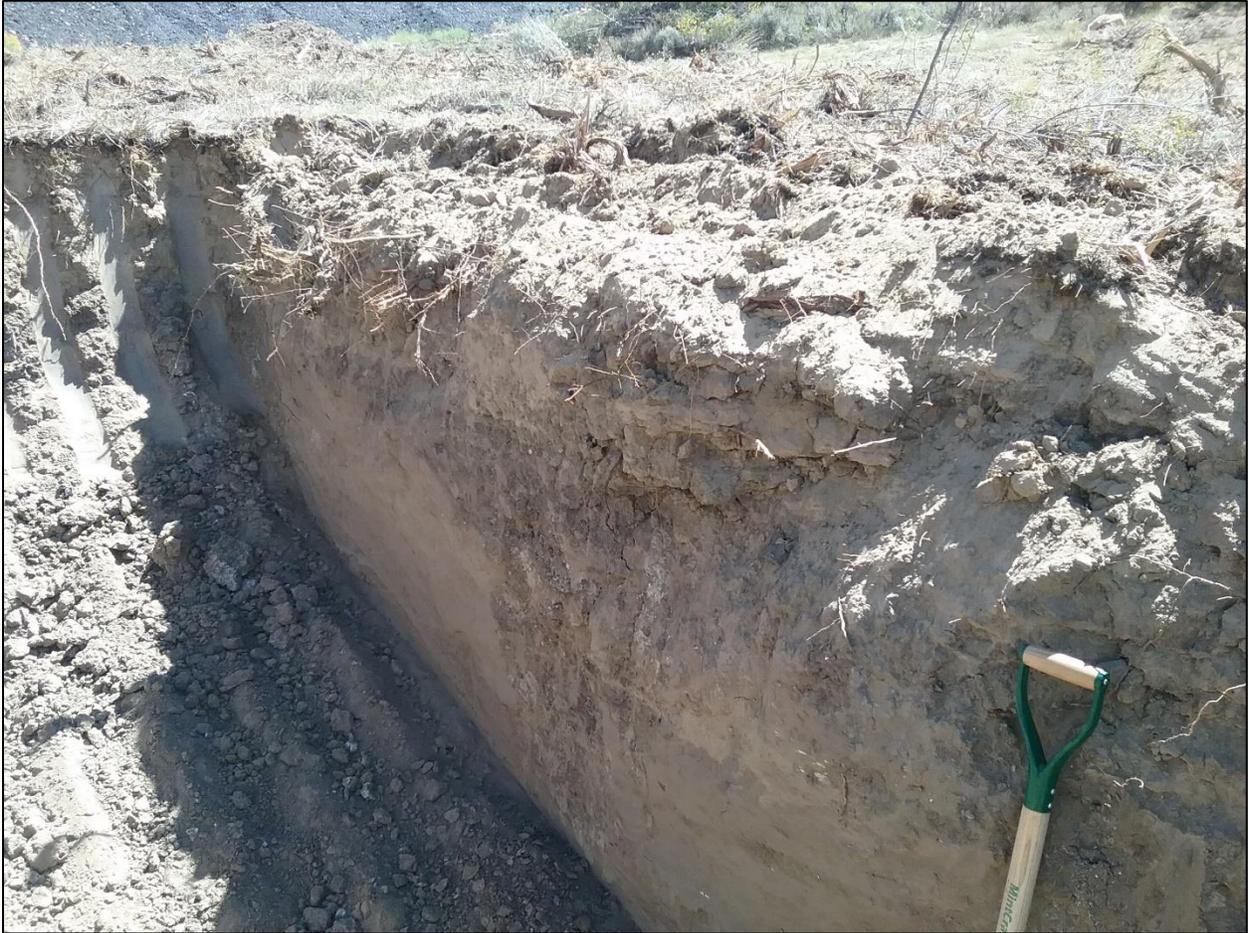
Figure 6. Test Pit TP-3.5.

Test Pit TP-3.5

A – 0 to 48 cm (0 to 19 in.); 10YR 5/2 dry; 10YR 3/2 moist; silty clay loam; slightly hard; weak medium subangular blocky to moderate medium granular structure.

AB – 48 to 99 cm (19 to 39 in.); 10YR 4/2 dry; 10YR 2/2 moist; silt loam; moderately hard; white streaking throughout, likely carbonate leaching; weak to moderate medium subangular blocky structure.

Bt – 99 to 168 cm (39 to 66 in.); 10YR 4/2 dry; 10YR 3/2 moist; clay loam; slightly hard; white streaking throughout, likely carbonate leaching; moderate medium subangular blocky structure.

Restrictive Layer: None

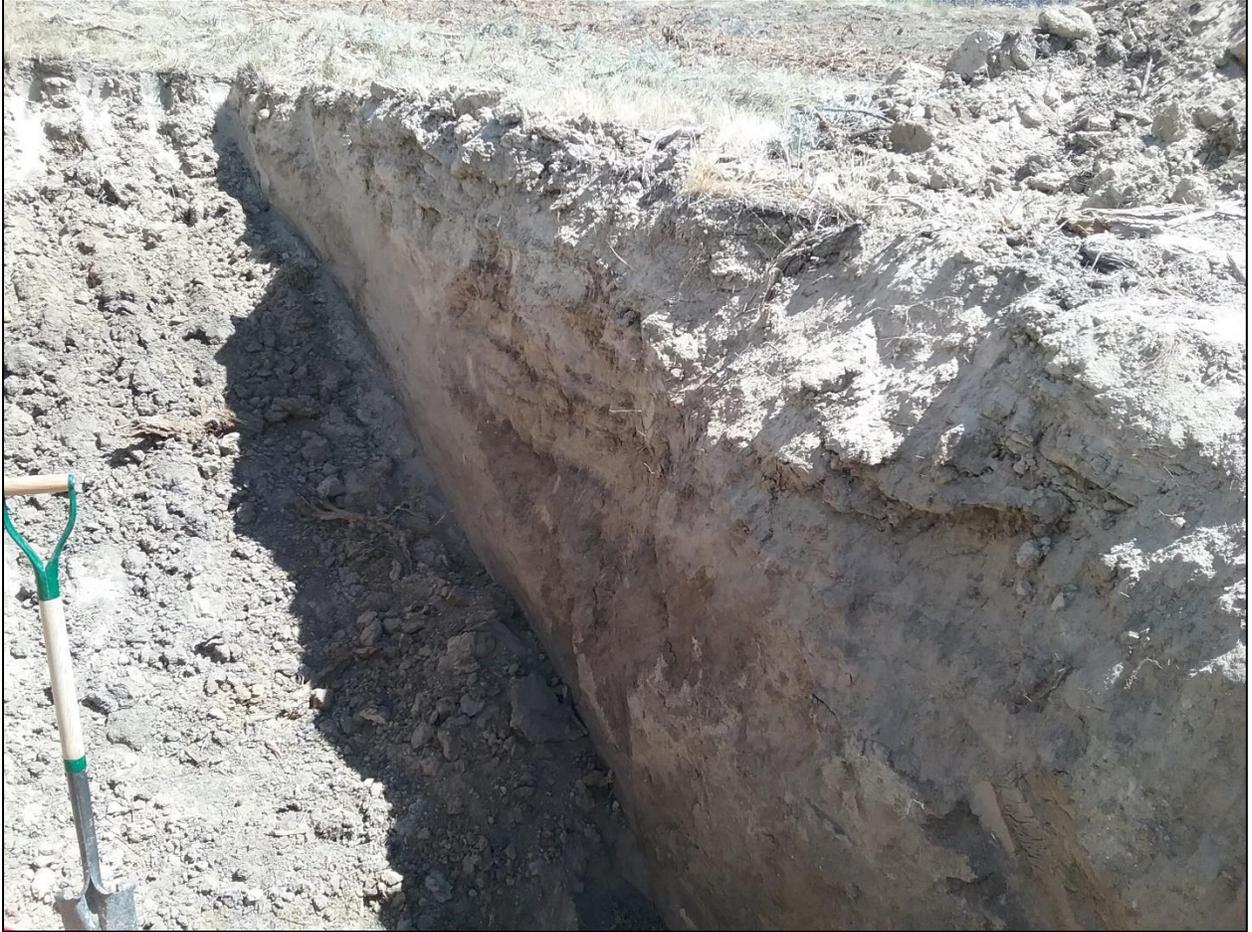
Figure 7. Test Pit TP-3.6.

Test Pit TP-3.6

A1 – 0 to 34 cm (0 to 13.5 in.); 2.5Y 7/3 dry; 2.5Y 6/3 moist; silt loam; very hard; moderate medium platy structure (30% by volume), strong medium subangular blocky structure (70% by volume).

A2 – 34 to 77 cm (13.5 to 30.5 in.); 10YR 5/3 dry; 10YR 3/3 moist; sandy loam; soft; weak medium subangular blocky to moderate medium granular structure.

Bt – 77 to 168 cm (30.5 to 66 in.); 10YR 4/2 dry; 10YR 3/2 moist; clay loam; slightly hard; moderate medium subangular blocky structure.

Restrictive Layer: None

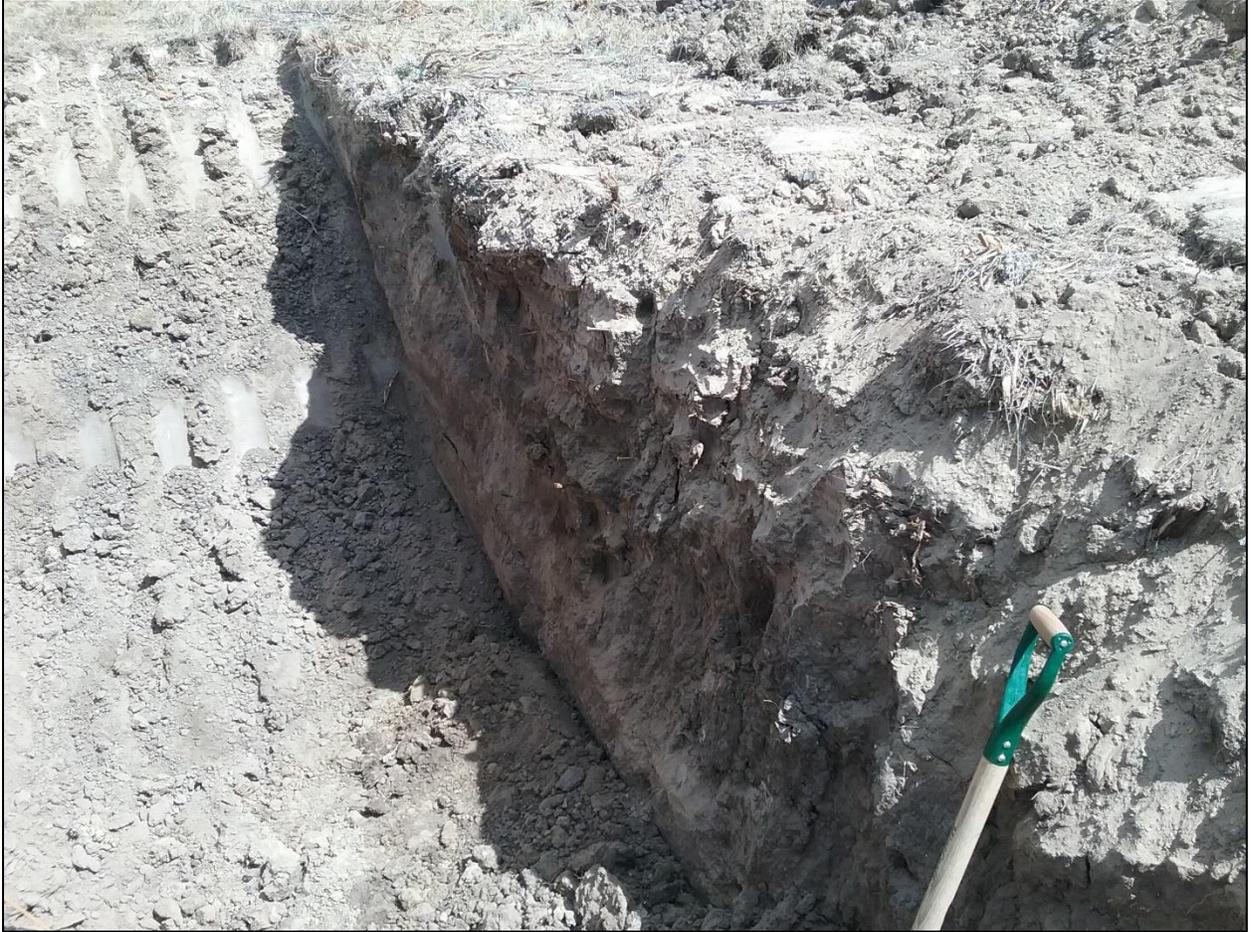
Figure 8. Test Pit TP-3.7.

Test Pit TP-3.7

A1 – 0 to 33 cm (0 to 13 in.); 2.5Y 6/2 dry; 2.5Y 5/2 moist; clay; very hard; moderate medium platy structure.

A2 – 33 to 66 cm (13 to 26 in.) 10YR 5/3 dry; 10YR 4/3 moist; sandy loam; hard; moderate medium subangular blocky structure.

B – 66 to 168 cm (26 to 66 in.); 10YR 4/2 dry; 10YR 2/2 moist; silt loam; slightly hard; moderate medium subangular blocky structure.

Restrictive Layer: None

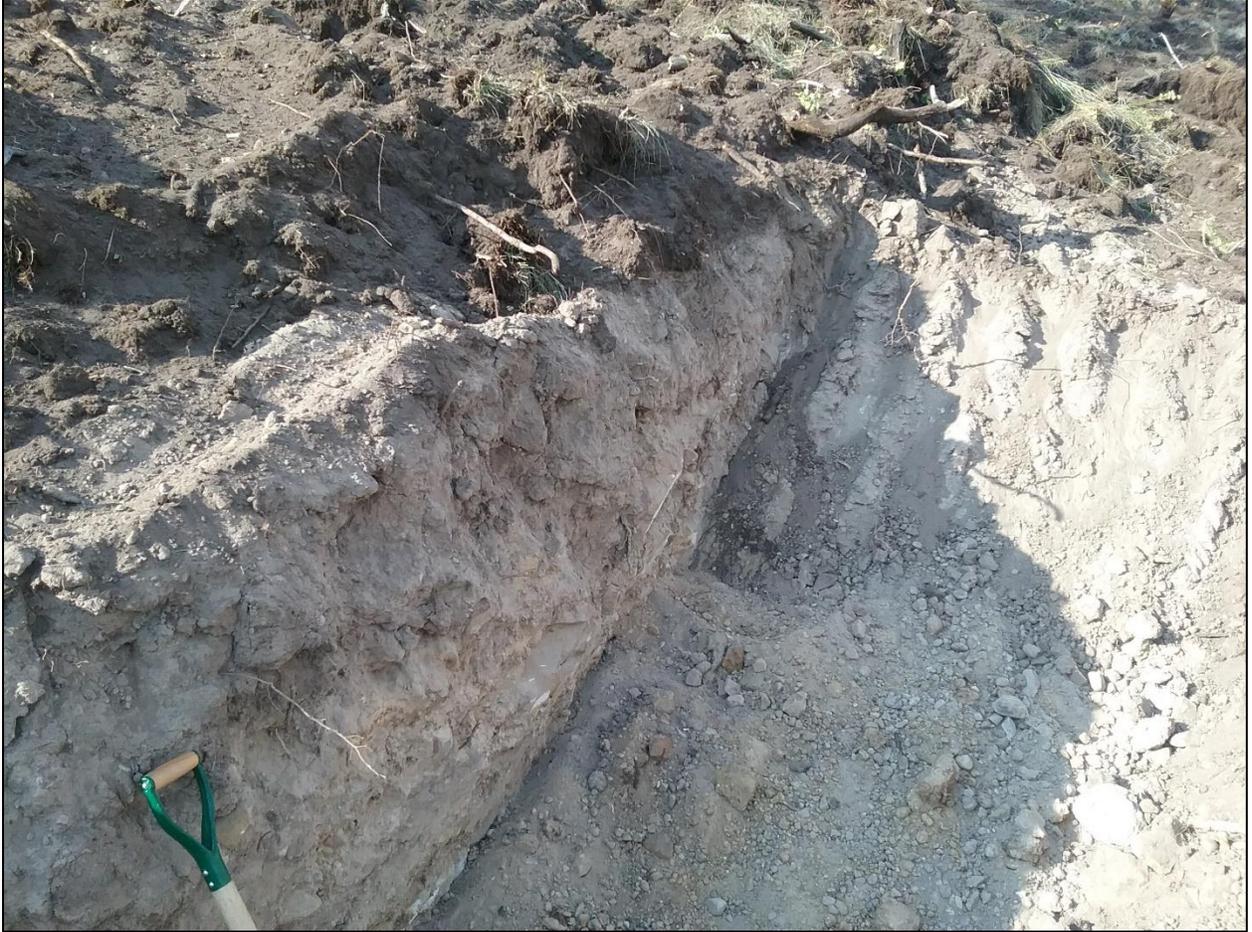
Figure 9. Test Pit TP-4.1.

Test Pit TP-4.1

O – 0 to 1 cm (0 to 0.4 in.); 10YR dry; 10YR moist; Leaves and Twigs.

A – 1 to 36 cm (0.4 to 14 in.); 10YR 5/2 dry; 10YR 3/2 moist; sandy loam; soft; weak medium granular structure.

B – 36 to 86 cm (14 to 34 in.) 10YR 5/2 dry; 10YR 3/2 moist; sandy loam; slightly hard; moderate medium subangular blocky structure.

C – 86 to 127 cm (34 to 50 in.): 10YR 6/3 dry and 10YR 5/4 moist (50%); 10YR 6/6 dry and 10YR 5/6 moist (50%); loamy sand; slightly hard; weak medium granular structure; gravel and cobbles throughout, with some sandstone boulders.

Restrictive Layer: gravel and cobbles in C Horizon.

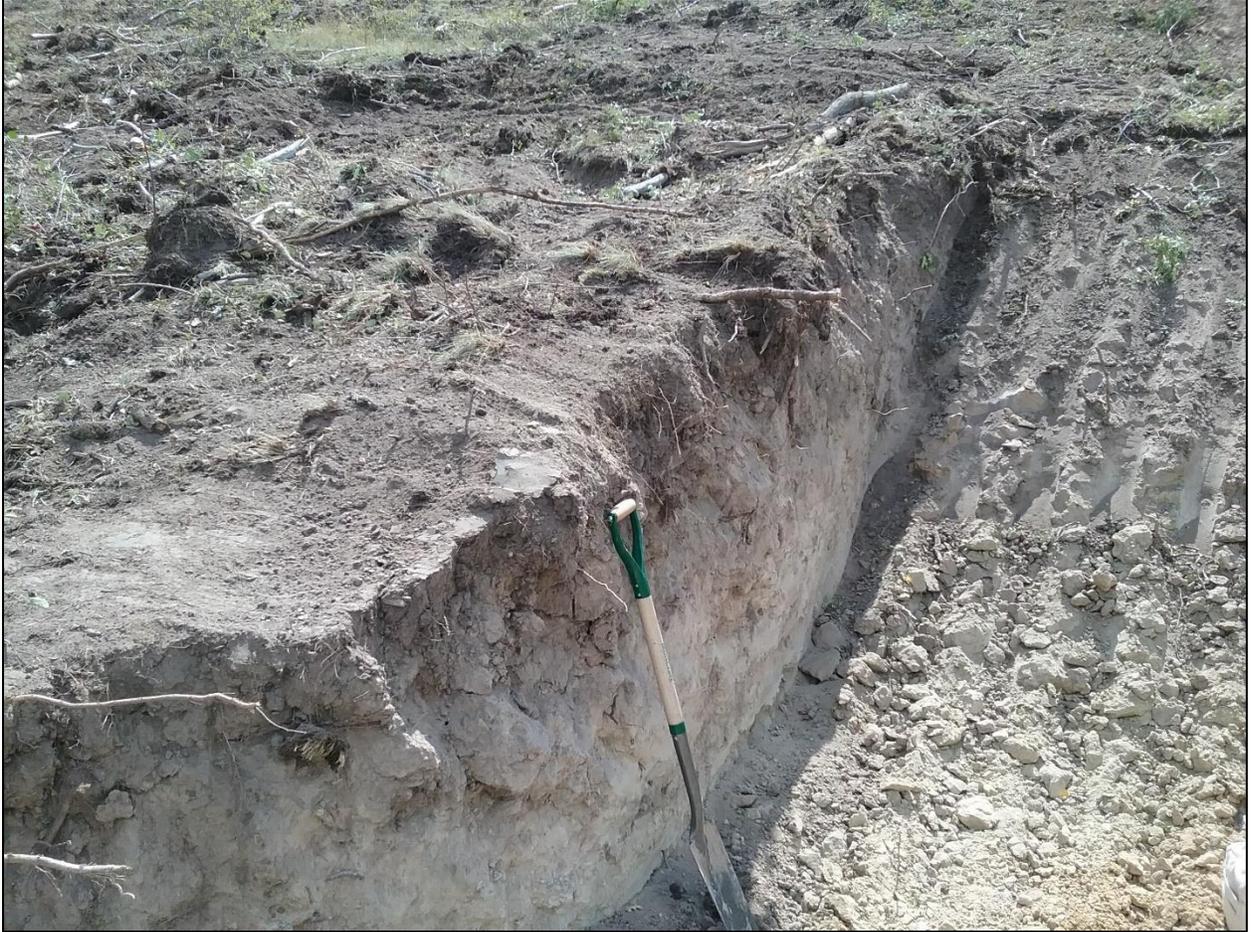
Figure 10. Test Pit TP-4.2

Test Pit TP-4.2

O – 0 to 1 cm (0 to 0.4 in.); 10YR dry; 10YR moist; Leaves and Twigs.

A – 1 to 28 cm (0.4 to 11 in.); 10YRY 5/2 dry; 10YR 2/2 moist; sandy loam; soft; weak medium subangular blocky to weak medium granular structure.

B – 28 to 79 cm (11 to 31 in.) 10YR 6/3 dry; 10YR 4/3 moist; loamy sand; moderately hard; moderate medium subangular blocky structure.

C – 79 to 142 cm (31 to 56 in.): 10YR 7/2 dry; 10YR 5/3 moist; sandy loam; soft; moderate medium granular structure.

Restrictive Layer: Some rock in C Horizon.

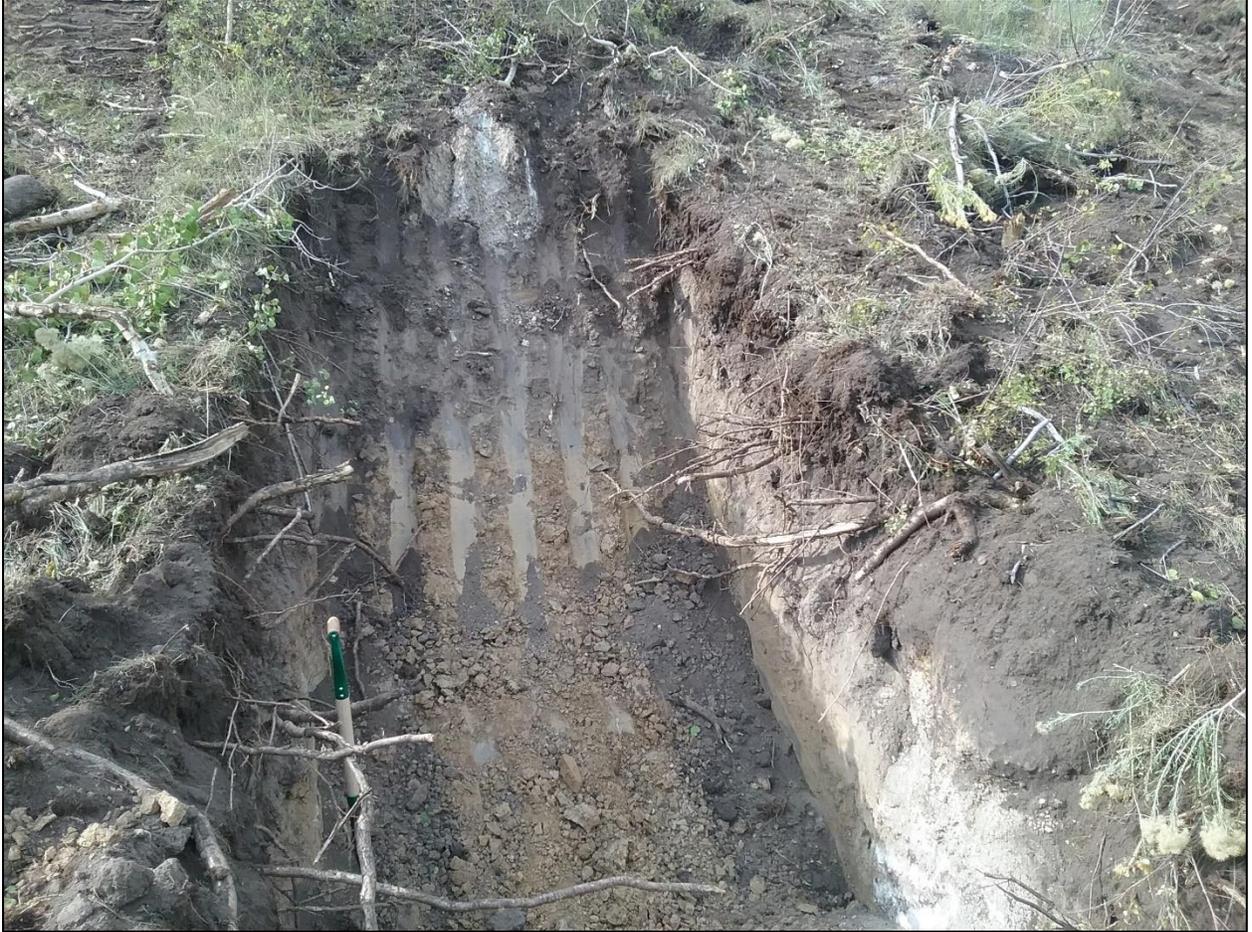
Figure 11. Test Pit TP-4.3.

Test Pit TP-4.3

O – 0 to 1 cm (0 to 0.4 in.); 10YR dry; 10YR moist; Leaves and Twigs.

A – 1 to 39 cm (0.4 to 15.5 in.); 10YR 3/2 dry; 10YR 2/2 moist; sandy loam; soft; weak medium granular structure.

B – 39 to 90 cm (15.5 to 35.5 in.) 10YR 5/2 dry; 10YR 3/2 moist; sandy loam; moderately hard; moderate medium subangular blocky structure.

B – 90 to 152 cm (35.5 to 60 in.): 10YR 5/3 dry; 10YR 4/4 moist; sandy loam; slightly hard; weak fine subangular blocky structure.

Restrictive Layer: Some cobbles and gravel at approximately 50 inches depth.

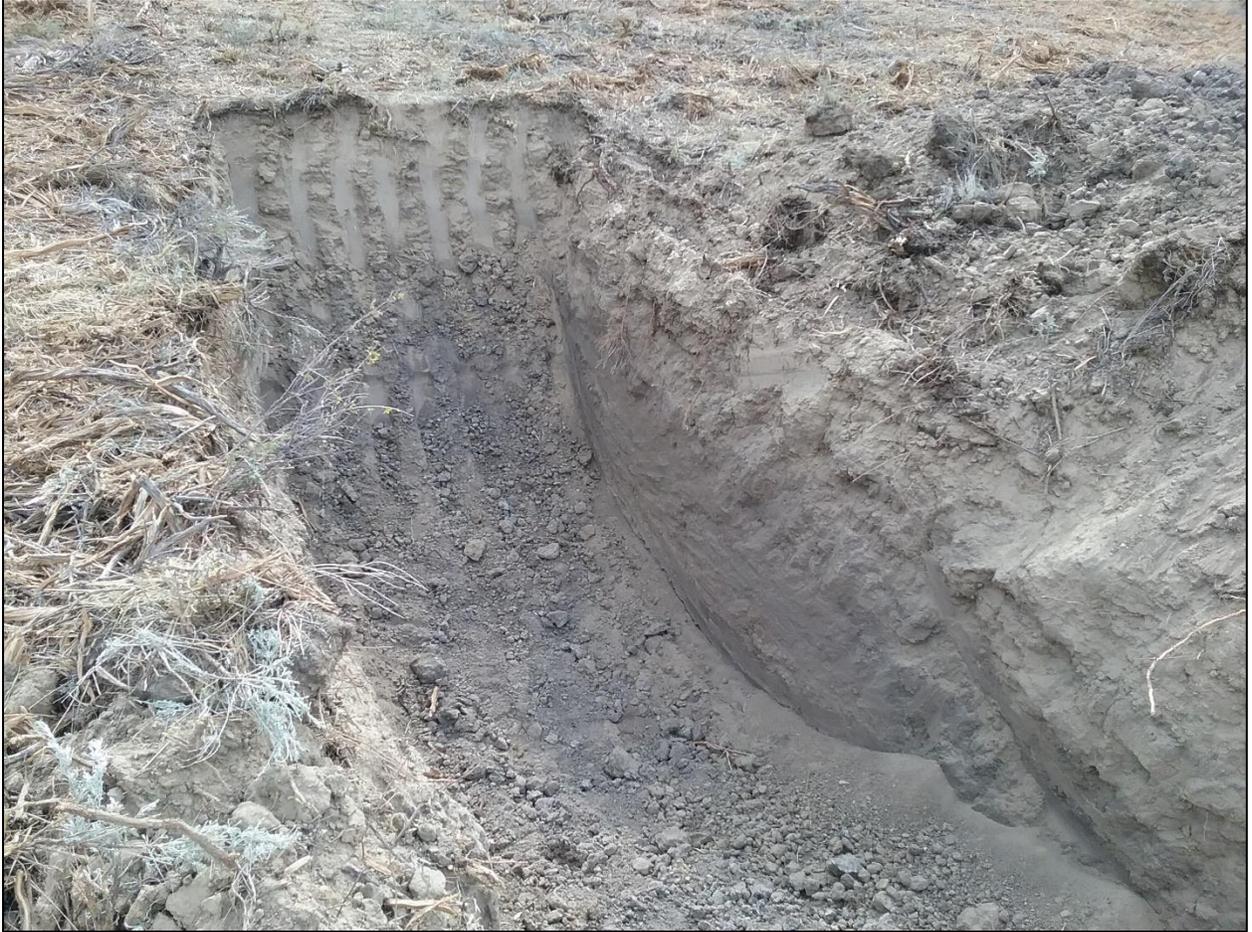
Figure 12. Test Pit TP-4.4.

Test Pit TP-4.4

A – 0 to 38 cm (0 to 15 in.); 10YR 5/2 dry; 10YR 4/2 moist; silt loam; soft to slightly hard; moderate medium granular to weak medium subangular blocky structure.

AB – 38 to 75 cm (15 to 29.5 in.) 10YR 5/3 dry; 10YR 4/2 moist; sandy loam; slightly hard; weak to moderate medium subangular blocky structure.

B – 75 to 168 cm (29.5 to 66 in.): 10YR 4/2 dry; 10YR 3/2 moist; sandy clay loam; soft to slightly hard; weak medium subangular blocky structure; white streaking throughout horizon, likely carbonate leaching.

Restrictive Layer: None

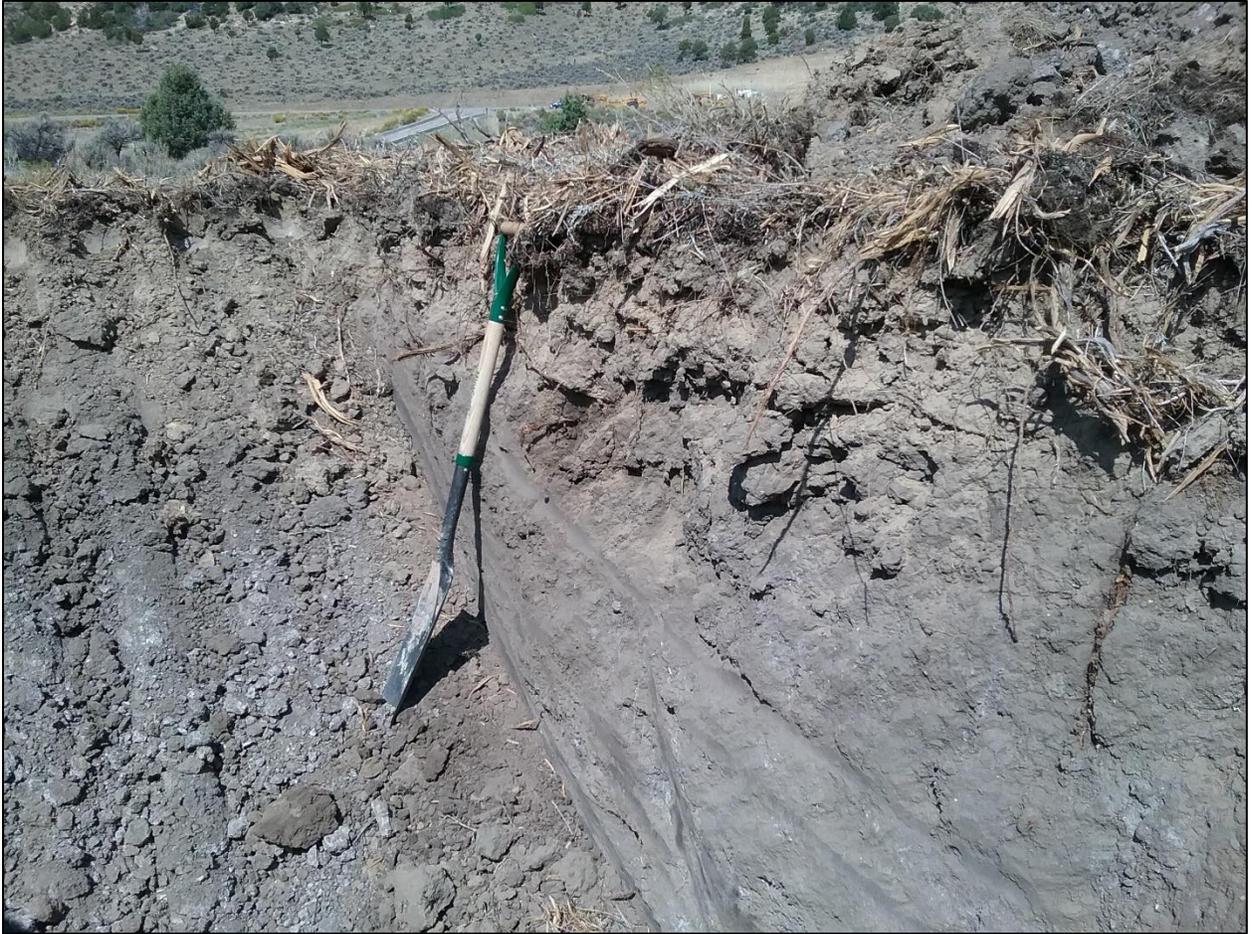
Figure 13. Test Pit TP-4.5.

Test Pit TP-4.5

O – 0 to 1 cm (0 to 0.4 in.); 10YR dry; 10YR moist; Leaves and Twigs.

A1 – 1 to 23 cm (0.4 to 9 in.); 10YR 5/2 dry; 10YR 3/2 moist; silty clay loam; moderately hard; moderate medium subangular blocky to moderate medium granular structure.

Bt – 23 to 168 cm (9 to 66 in.): 10YR 4/2 dry; 10YR 2/2 moist; silty clay loam; moderately hard; moderate medium subangular blocky structure; 6% clay film on all faces of peds.

Restrictive Layer: None

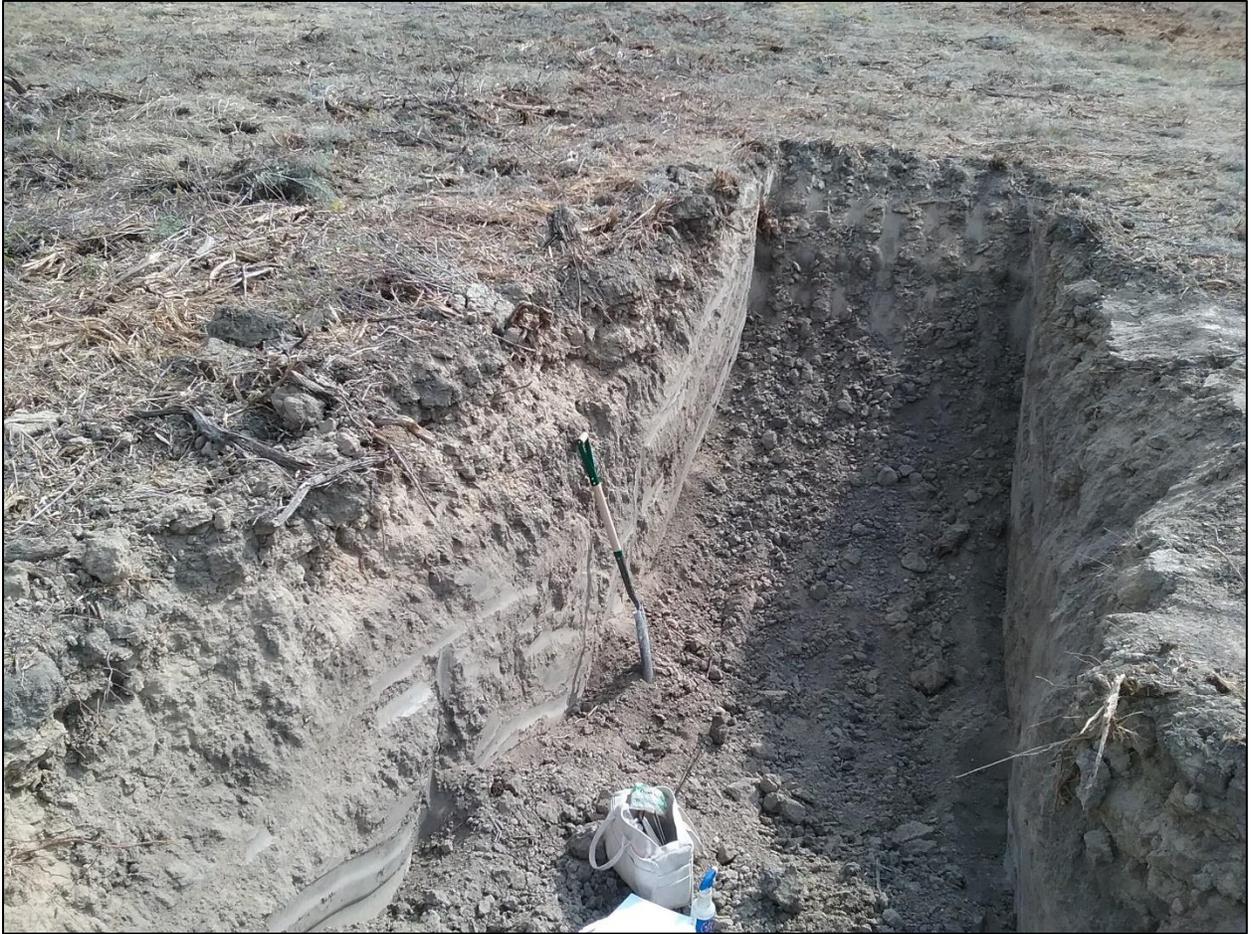
Figure 14. Test Pit TP-4.6.

Test Pit TP-4.6

A1 – 0 to 23 cm (0 to 9 in.); 10YR 5/2 dry; 10YR 4/2 moist; clay; very hard; moderate medium platy structure.

A2 – 23 to 53 cm (9 to 21 in.)

Sandy loam (50%): 10YR 6/3 dry; 10YR 5/3 moist; moderately hard; moderate medium subangular blocky structure.

Sandy clay loam (50%): 10YR 6/2 dry; 10YR 4/2 moist; moderately hard; moderate medium subangular blocky structure.

B – 53 to 168 cm (21 to 66 in.): 10YR 4/2 dry; 10YR 3/2 moist; silty clay loam; moderately hard; weak medium subangular blocky structure.

Restrictive Layer: None

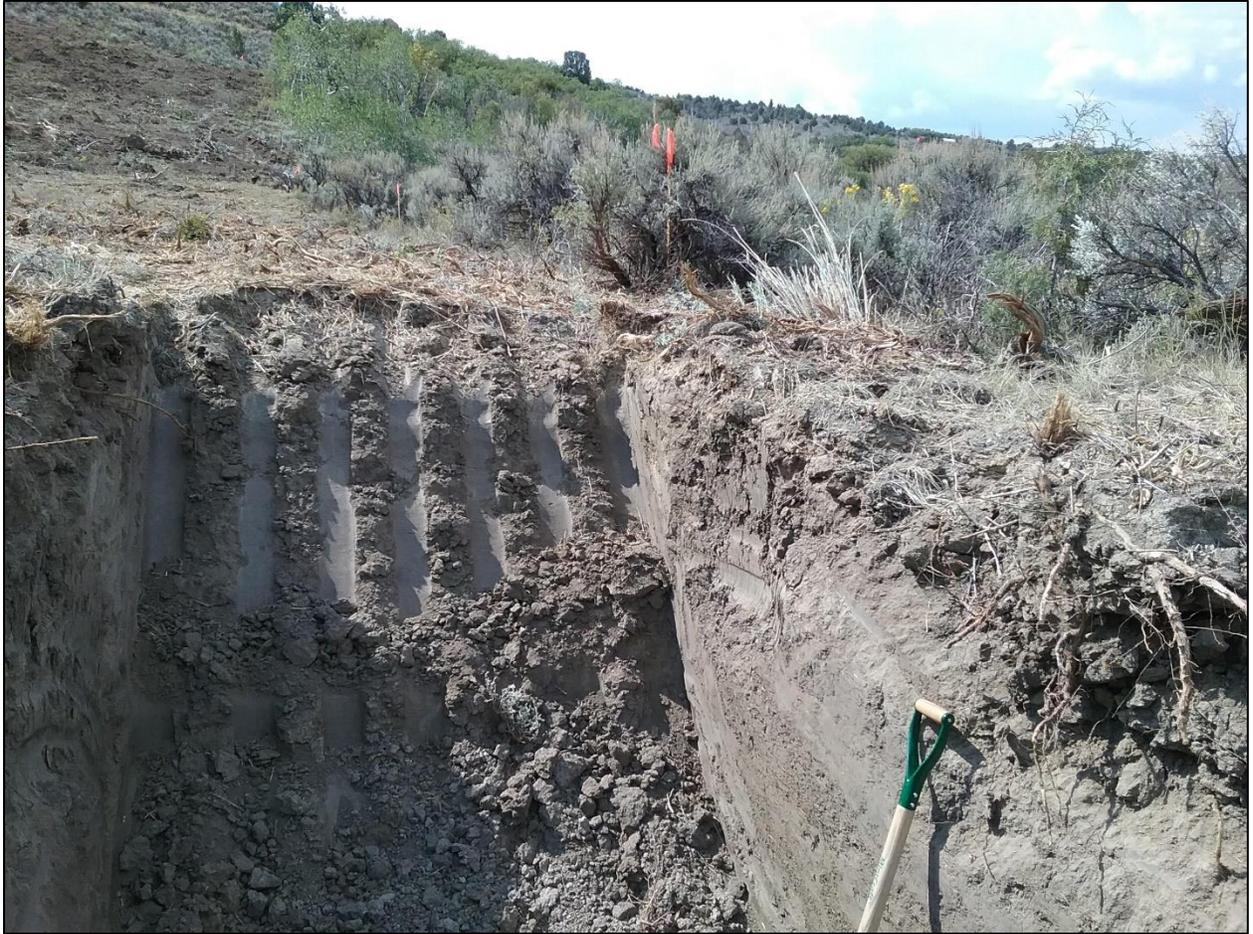
Figure 15. Test Pit TP-4.7.

Test Pit TP-4.7

A – 0 to 18 cm (0 to 7 in.); 10YR 6/2 dry; 10YR 4/2 moist; clay; very hard; moderate medium platy structure.

Bt – 18 to 74 cm (7 to 29 in.) 10YR 5/2 dry; 10YR 3/2 moist; silty clay loam; moderately hard; strong medium subangular blocky structure; 12% clay film on all faces of peds.

B – 74 to 168 cm (29 to 66 in.): 10YR 5/2 dry; 10YR 3/2 moist; silty clay loam; moderately hard; strong medium subangular blocky structure.

Restrictive Layer: None

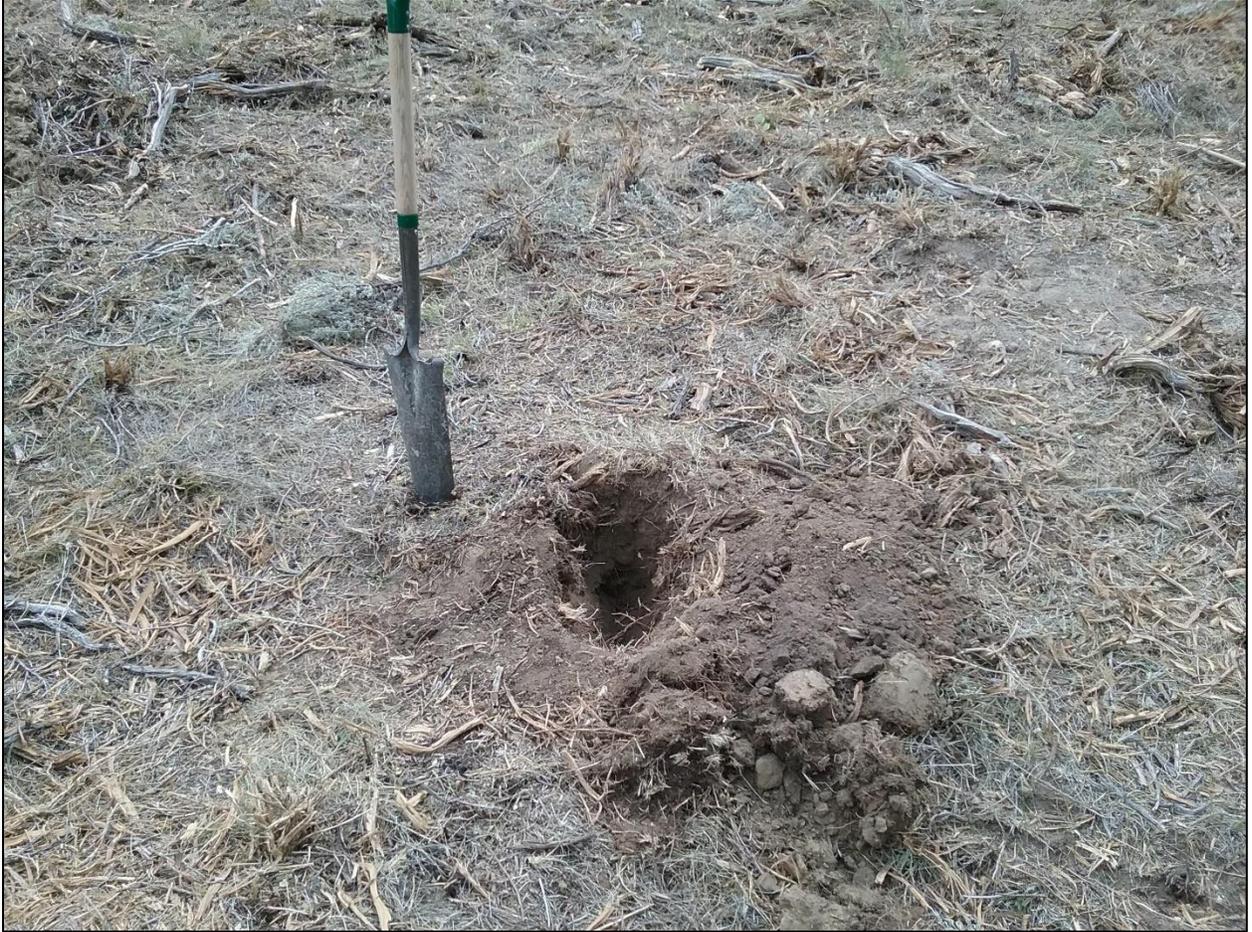
Figure 16. Test Pit TP-4.8.

Test Pit TP-4.8

Hand-excavated pit revealed approximately 11.5 inches of topsoil associated with this location.

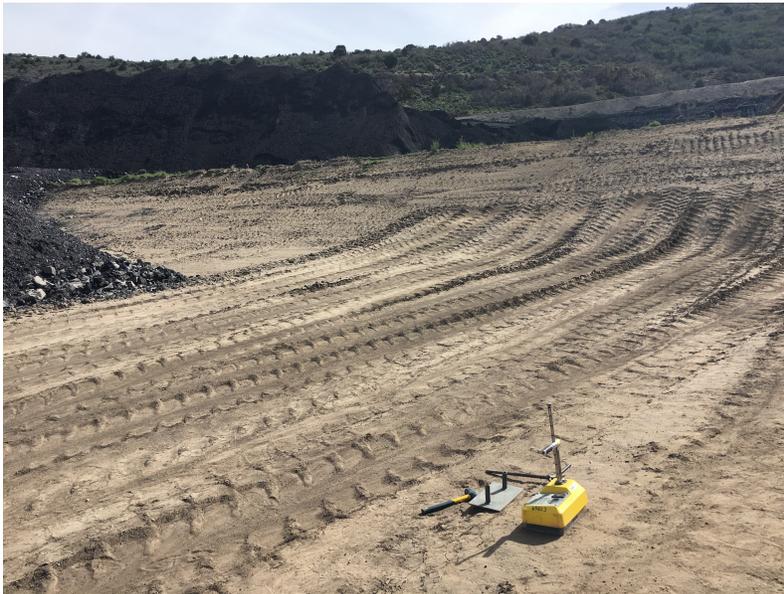
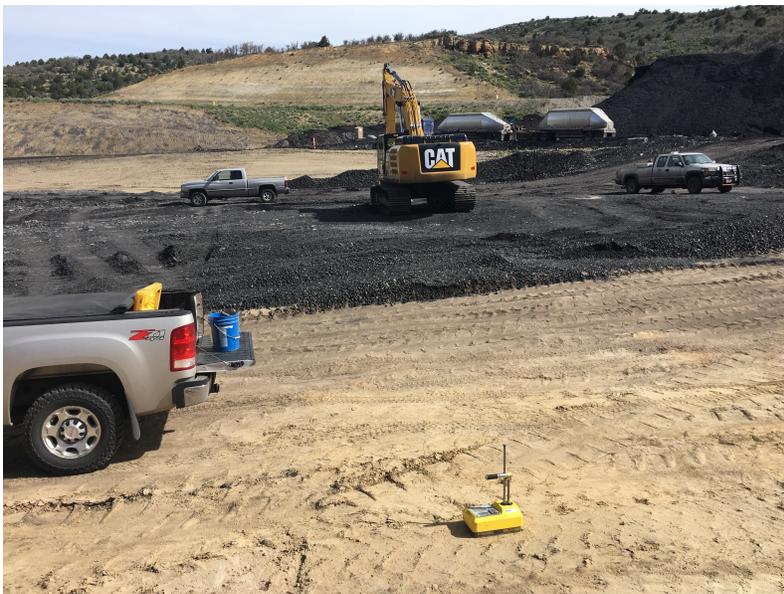
ATTACH PICTURE:

TEST RESULTS:							
TEST STATION	OFFSET	REFERENCE /LIFT	PROB DEPTH	WET DENSITY	DRY DENSITY	% MOISTURE	% COMPACTION
slope, east side 7		top	6"	127.3	116.4	9.4	97.4
slope, middle 8		top	6"	128.2	116.4	10.1	97.4
slope, west side 9		top	6"	127.6	118.7	7.5	99.3
