**Re: Phase 3,4 Construction As-built Information Amendment, Canyon Fuel Company, LLC, Sufco Mine, Sufco Waste Rock Site, Permit Number C/041/0002**

## Sufco Mine Waste Rock Site Disposal Site Phase 3 and 4 Expansion Soil Salvage Project

Phase 3,4 Construction

As-Built Information

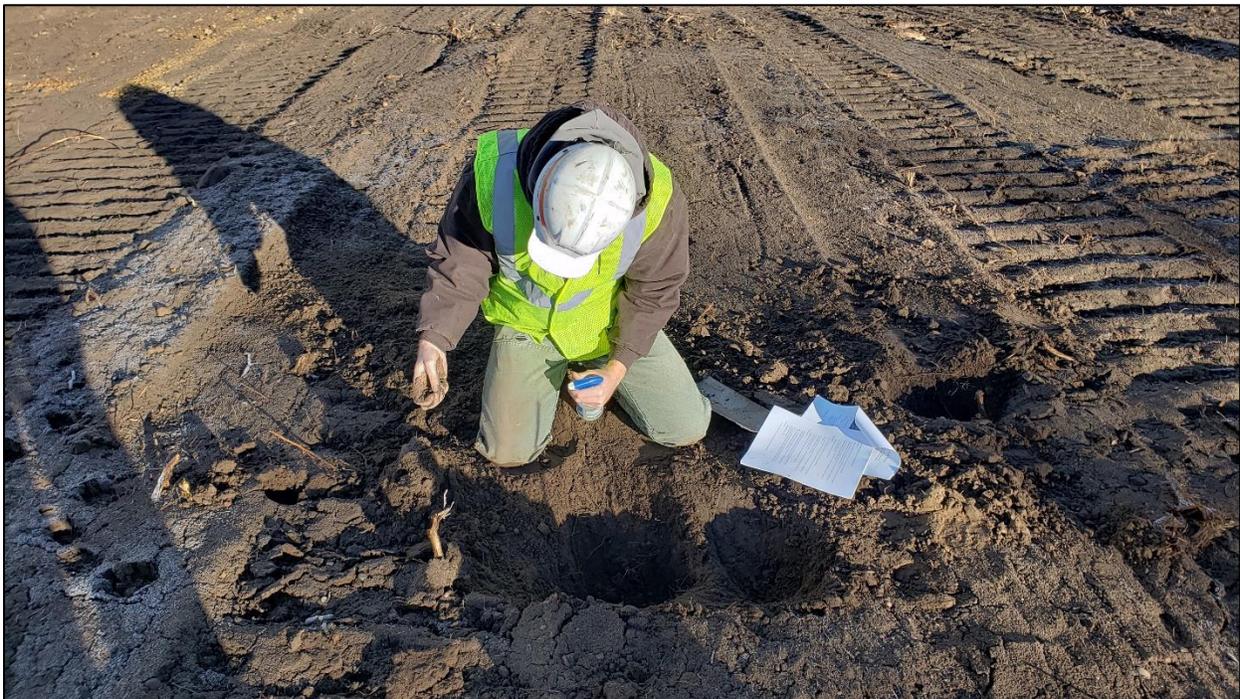
*Figure 1. Located at the southern end of Phase 3 (facing north), analyzing soil characteristics following topsoil salvage operations of the area.*

Throughout the slope on the southern end of Phases 3 and 4, exposed soil consisted of either a yellow sand or loamy sand, or a somewhat dark and grey sandy loam or loamy sand. An evaluation of soil characteristics on the slope determined that the yellow sand or loamy sand was the C horizon, and the darker sandy loam or loamy sand was the B horizon. The darkness of the B horizon was made more noticeable than it would be otherwise because of the abundant soil moisture resulting from recent precipitation events. The apparent variation of soil color and distribution is a result of inconsistencies in the subsoil horizon depths below the topsoil, and portions of the yellow C horizon protruding into the darker B horizon.

Very little subsoil was salvaged from this area as the subsoil on the hill slope is generally quite rocky and would yield poor available water capacity for reclamation purposes.

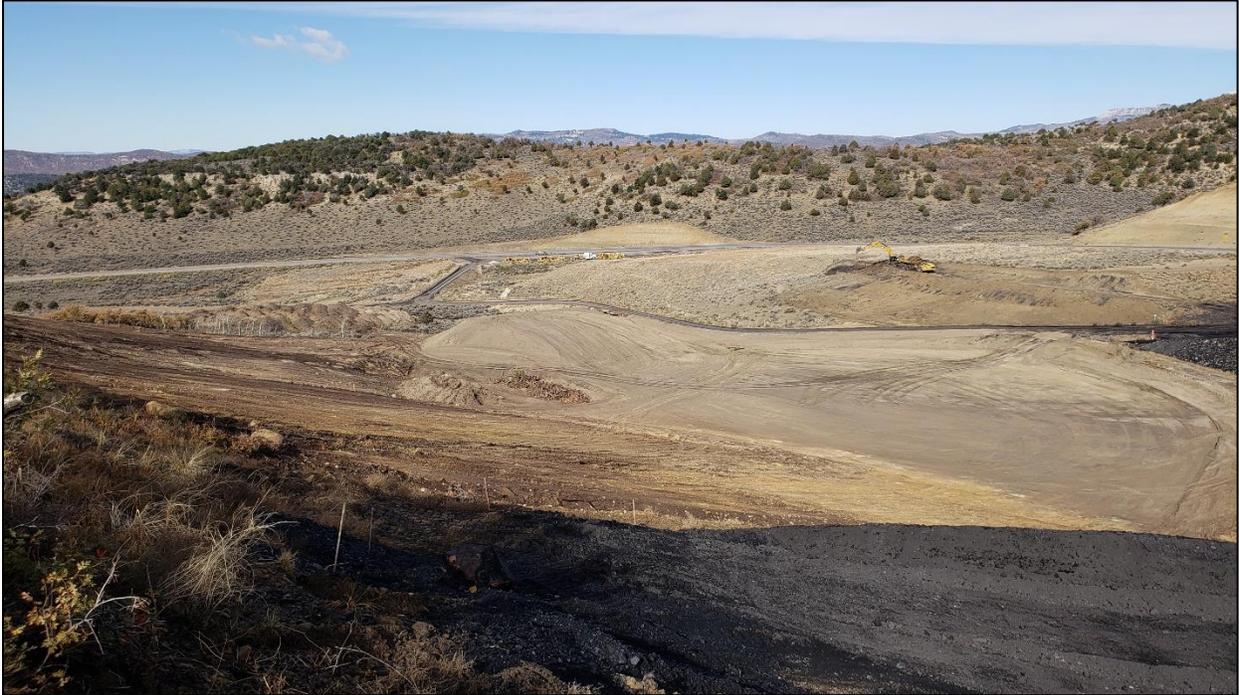
*Figure 2. Located at the southeastern end of Phase 3 (facing northwest), following topsoil salvage operations of the area.*

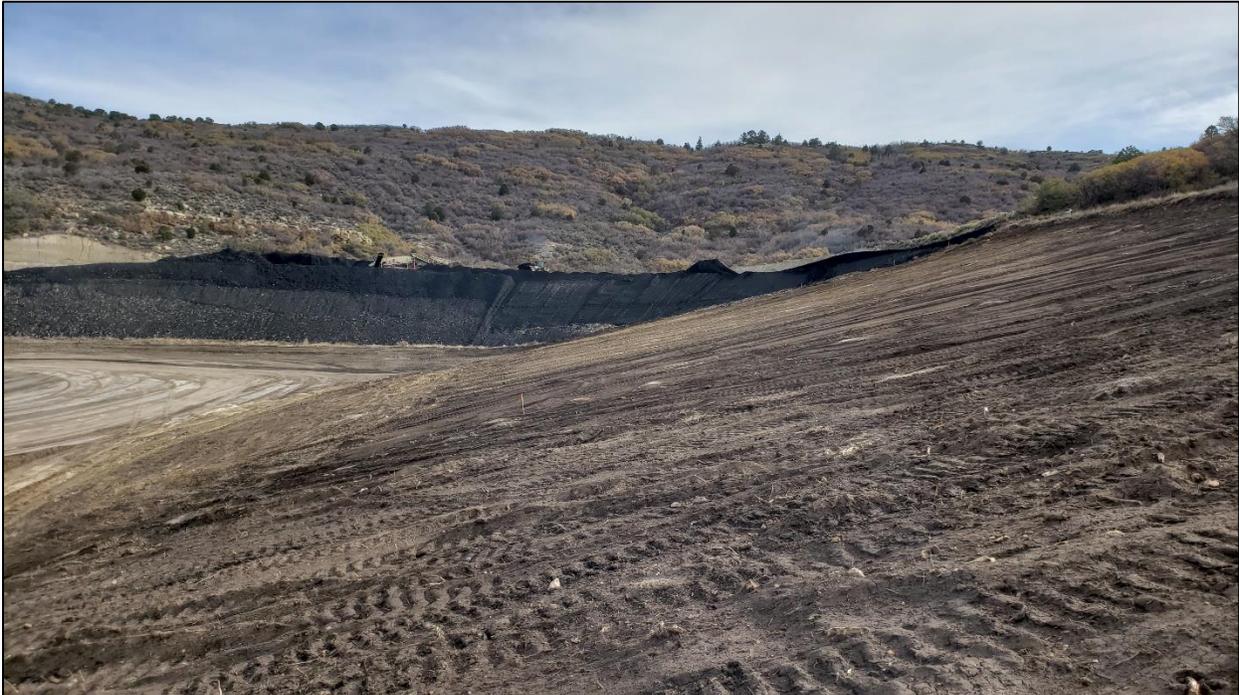
*Figure 3. Located at the southern end of Phase 4 (facing east), following topsoil salvage operations of the area.*

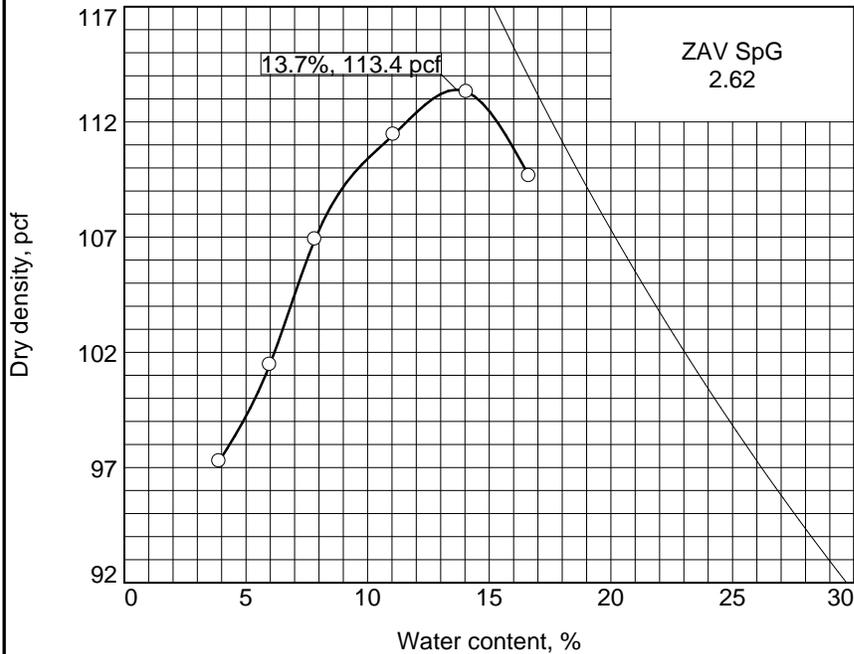
Curve No. 571

Preparation Method	As Received	
Rammer: Wt.	5.5 lb.	Drop 12 in.
Type	automatic	
Layers: No.	three	Blows per 56
Mold Size	0.075 cu. ft.	
Test Performed on Material	Passing 3/4 in. Sieve	
%>3/4 in.	%<No.200	
Atterberg (D 4318): LL	PI	
NM (D 2216)	Sp.G. (D 854) 2.62	
USCS (D 2487)		
AASHTO (M 145)		
Date: Sampled	11/15/18	
Received	11/15/18	
Tested	11/16/18	
Tested By	Kurt Bosshardt

### COMPACTION TESTING DATA AASHTO T 99-15 Method D Standard

Maximum dry density = 113.4 pcf  
Optimum moisture = 13.7 %

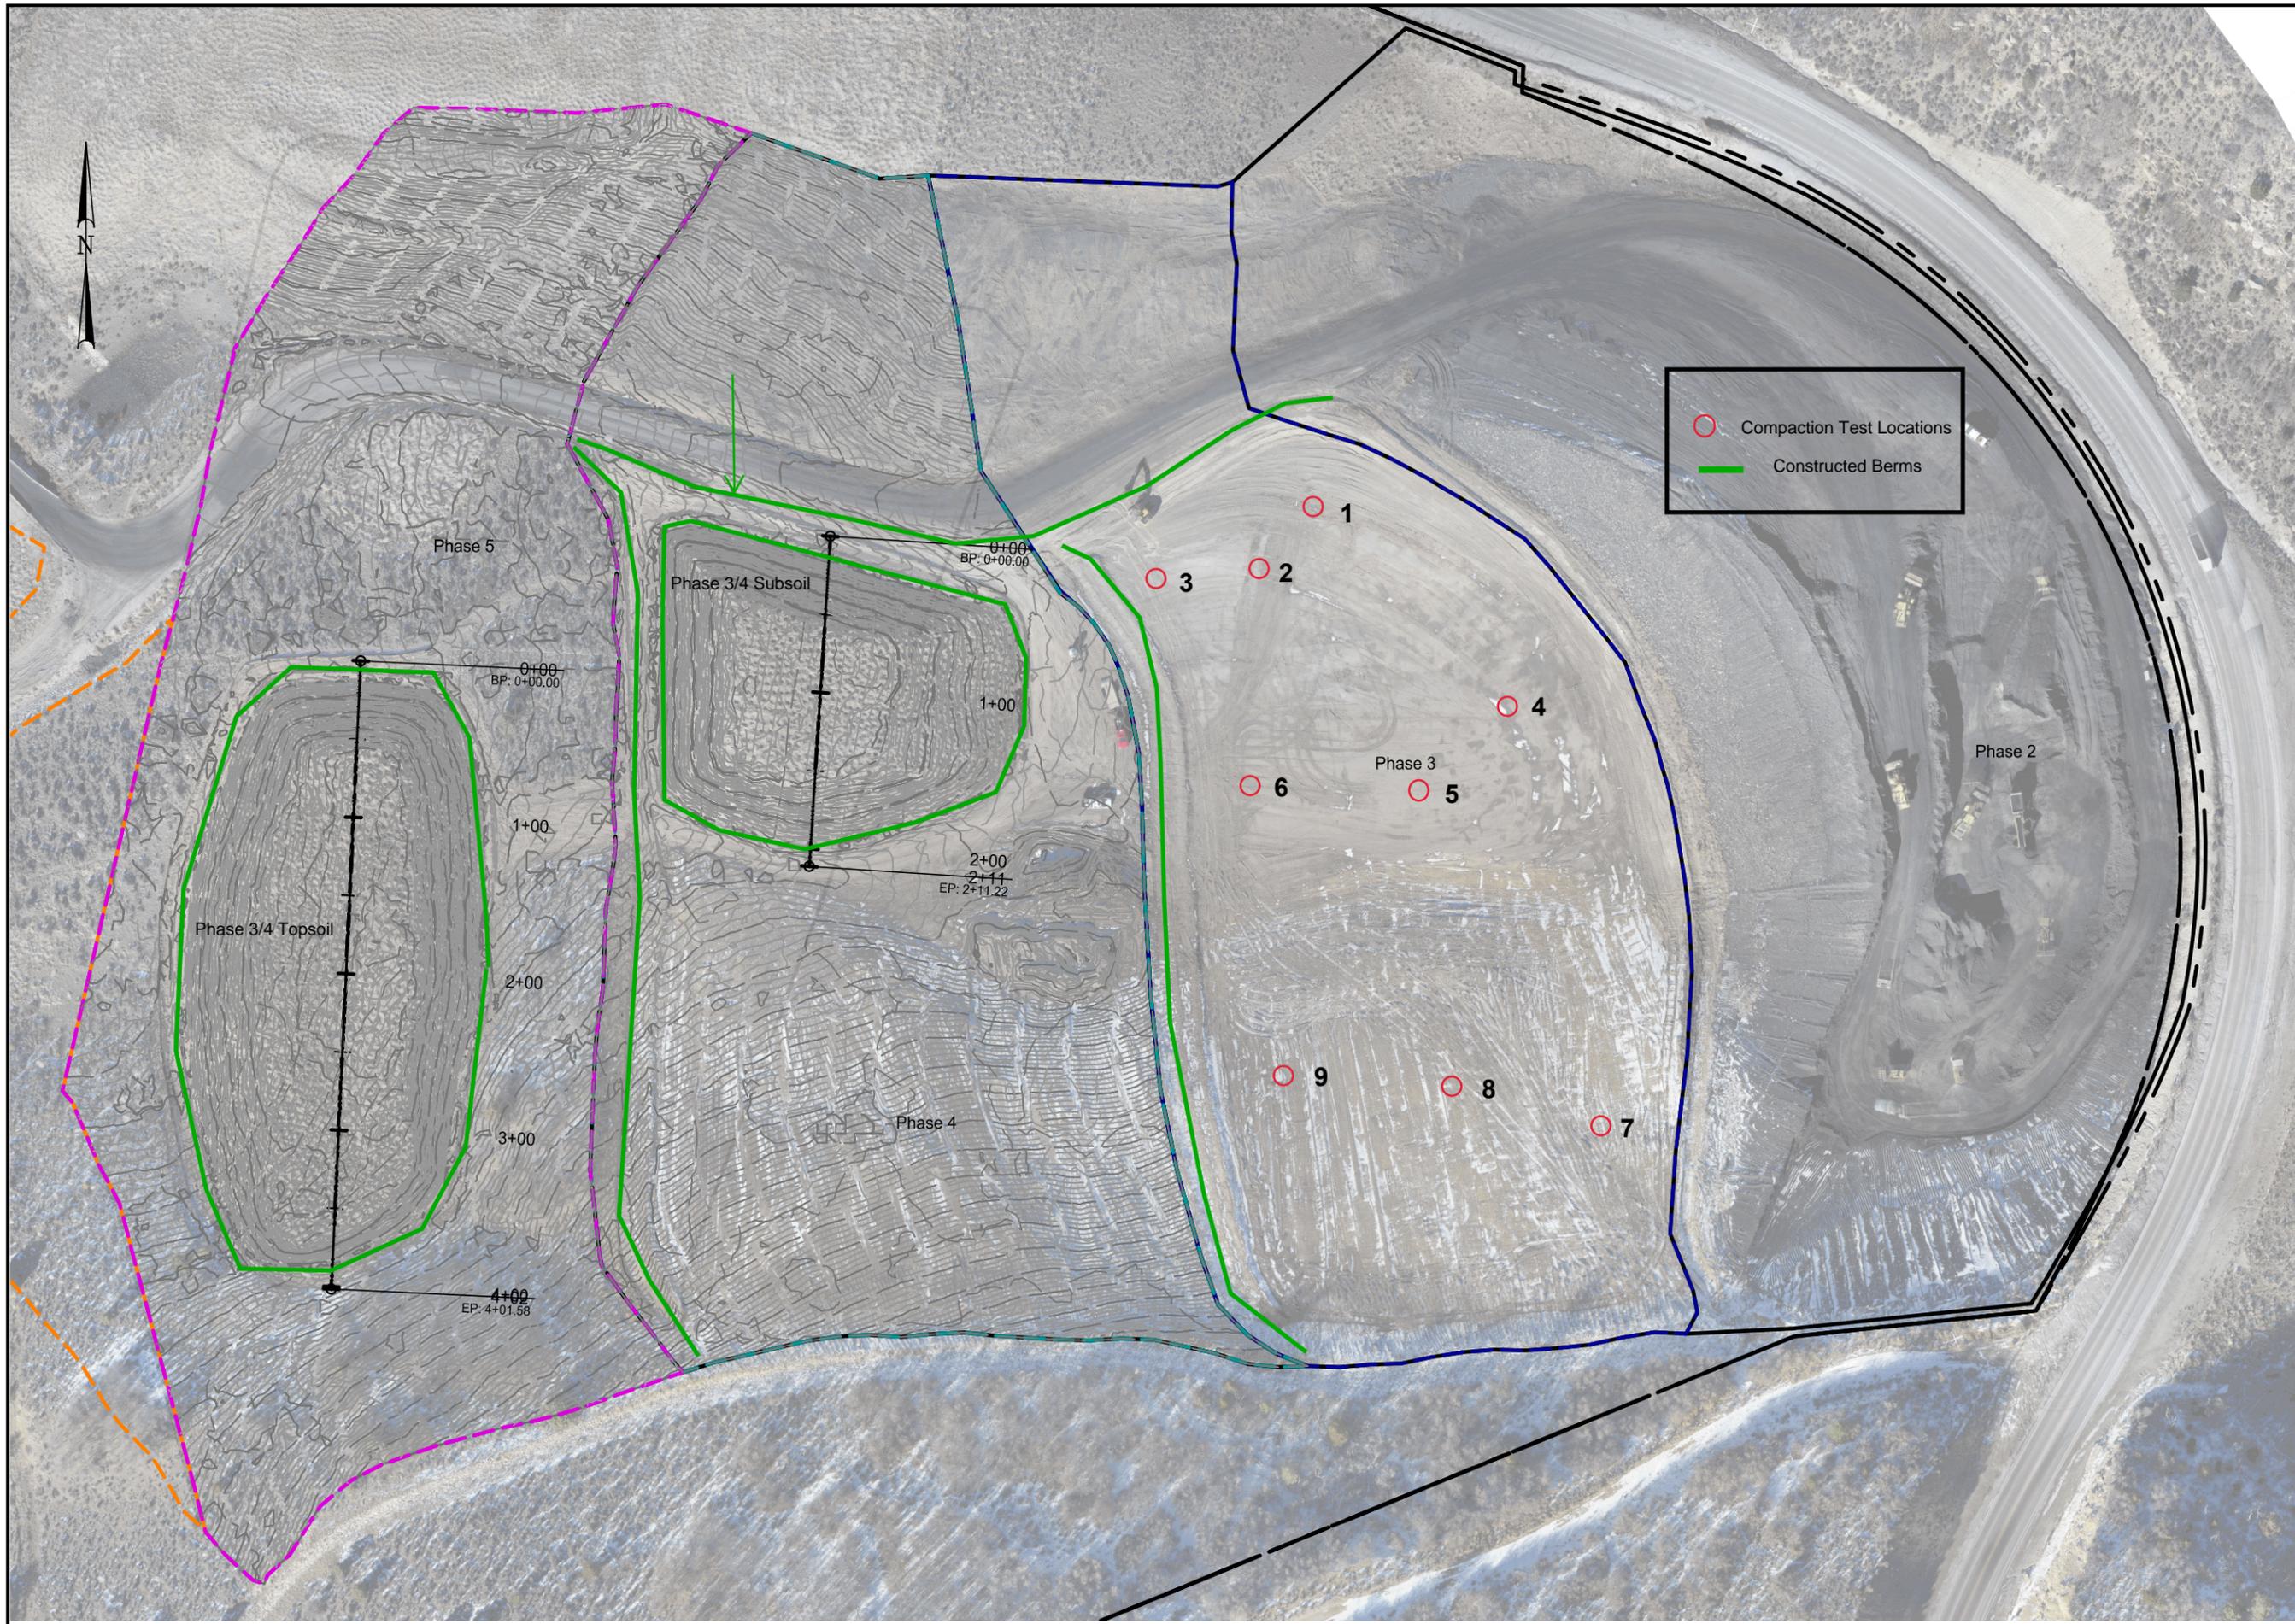
○ Compaction Test Locations  
— Constructed Berms
