Wild West Equipment & Hauling, LLC
Wildcat Load Out
5495 West 3550 North, Helper, Utah 84526
P.O. Box 1, Price, Utah 84501
Phone: (435) 472-3988 – Fax: (435) 472-3456

Re: C/007/033 Wildcat Loadout 2013 Annual Report

WILDCAT LOADOUT REFUSE PILE INSPECTION REPORT

Quarterly Inspection Form - Refuse Disposal Areas

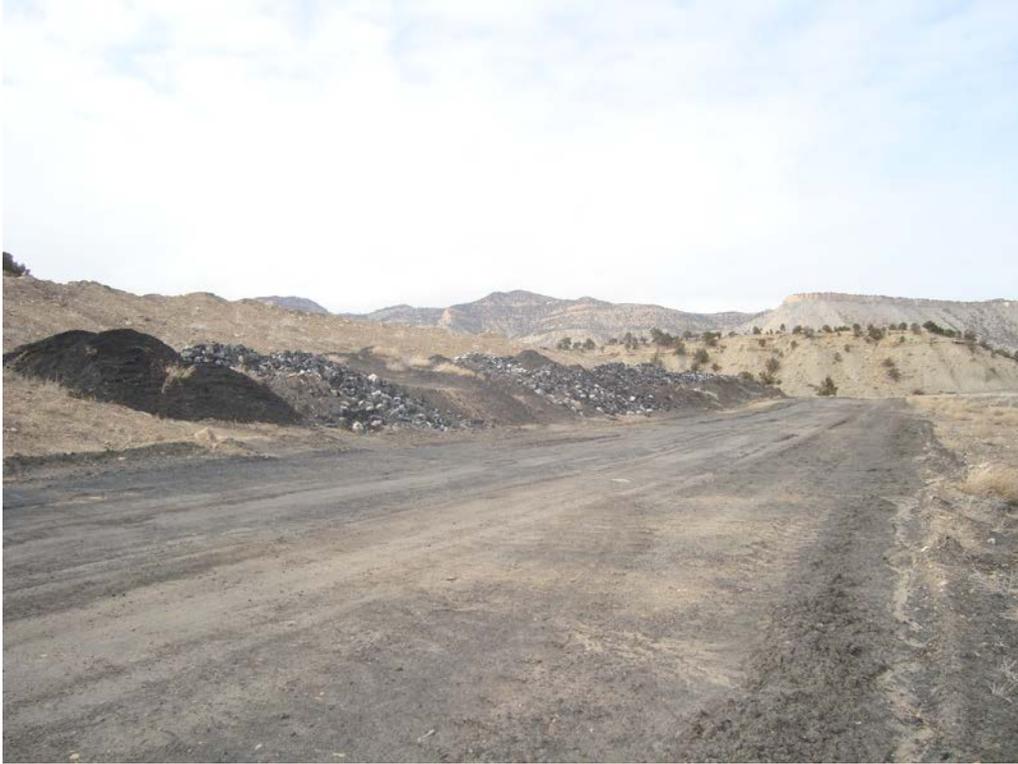
ITEM	REMARKS
(1) Potential Safety Hazards	NONE OBSERVED
(2) Slope Stability	NONE OBSERVED
(3) Removal of Topsoil/ Organics	N/A
(4) Construction and Maintenance Performance Standards	NONE
(5) Recommendations/Comments	NONE

Side of Refuse Pile

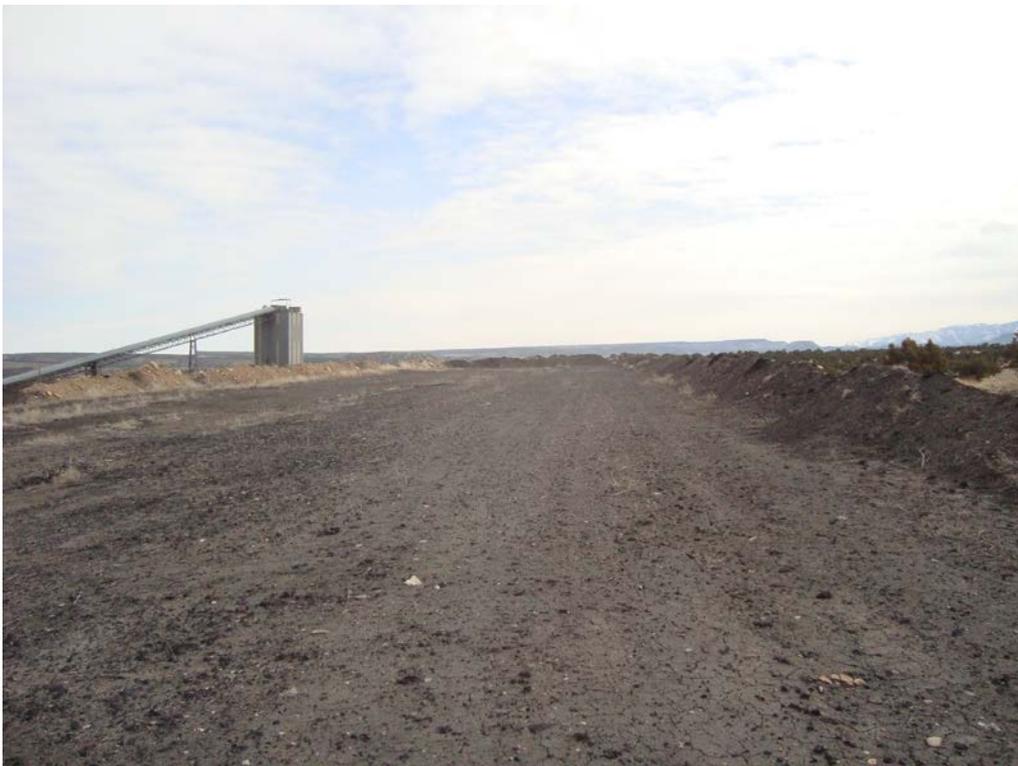
Top of Refuse Pile

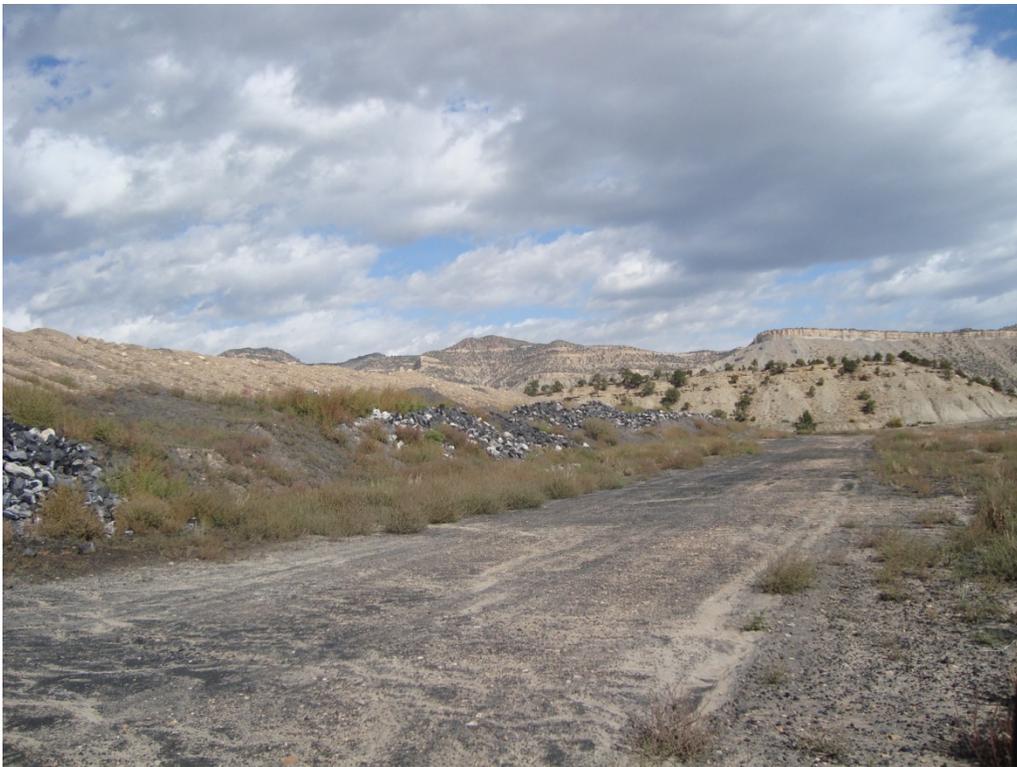
9. Describe any appearances of instability, structural weakness, or other hazardous conditions :
None noticed

EAST SIDE OF REFUSE PILE

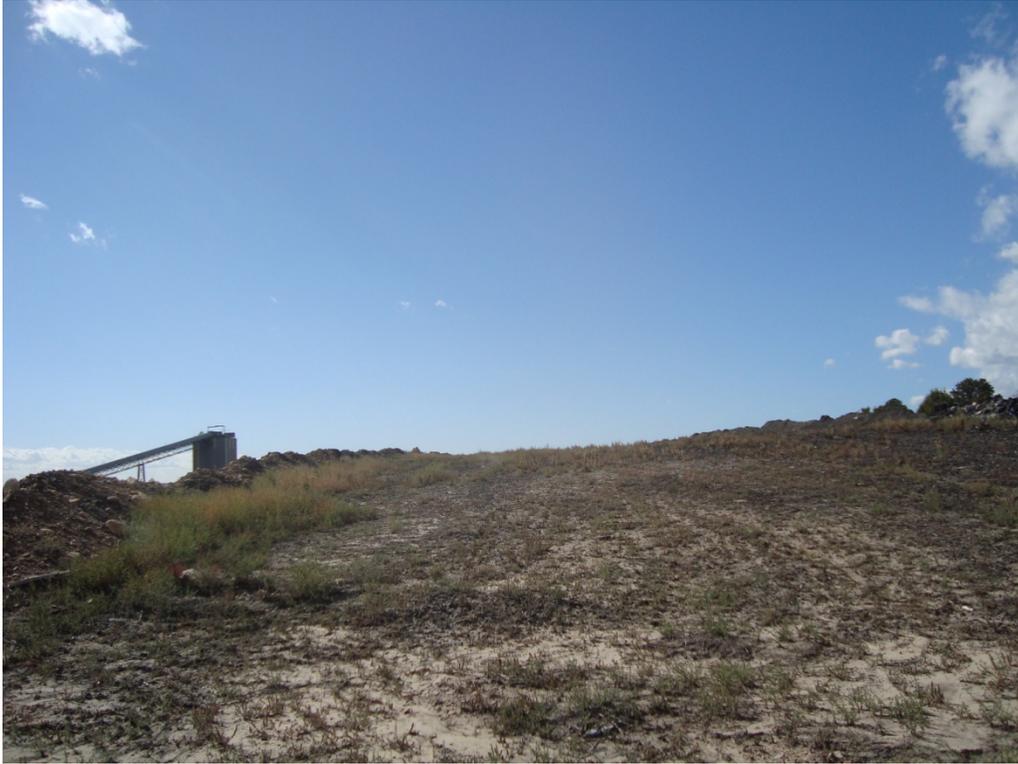
TOP OF REFUSE PILE

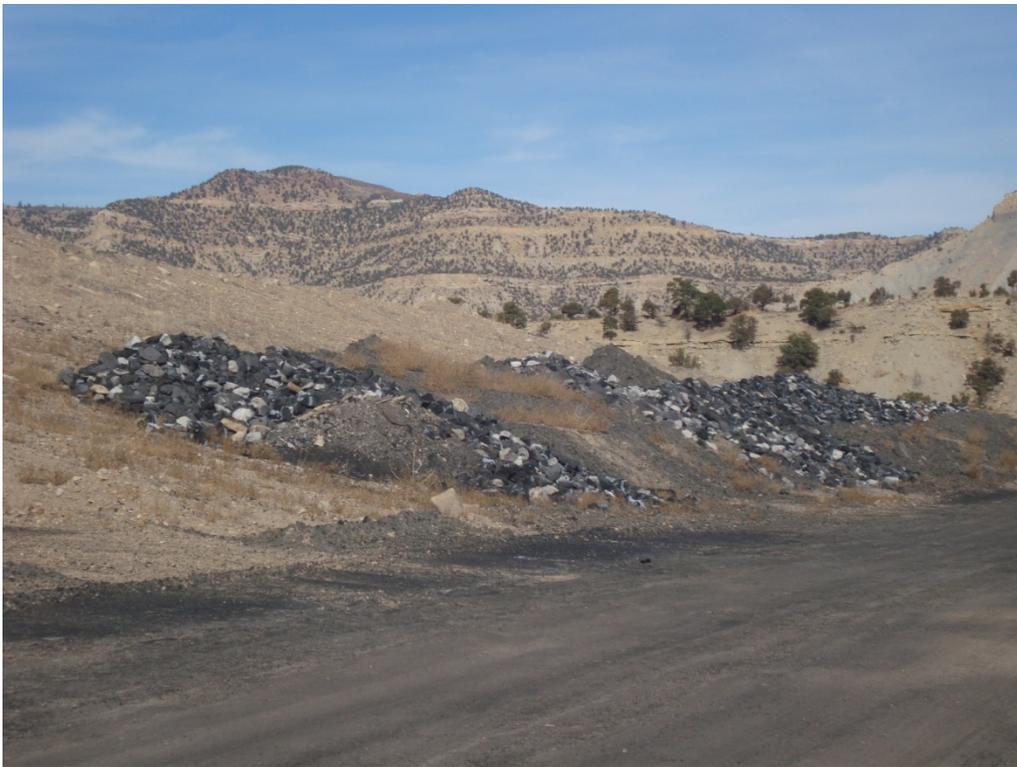
9. Describe any appearances of instability, structural weakness, or other hazardous conditions:
None noticed

EAST SIDE OF REFUSE PILE (NO NEW REFUSE ADDED)

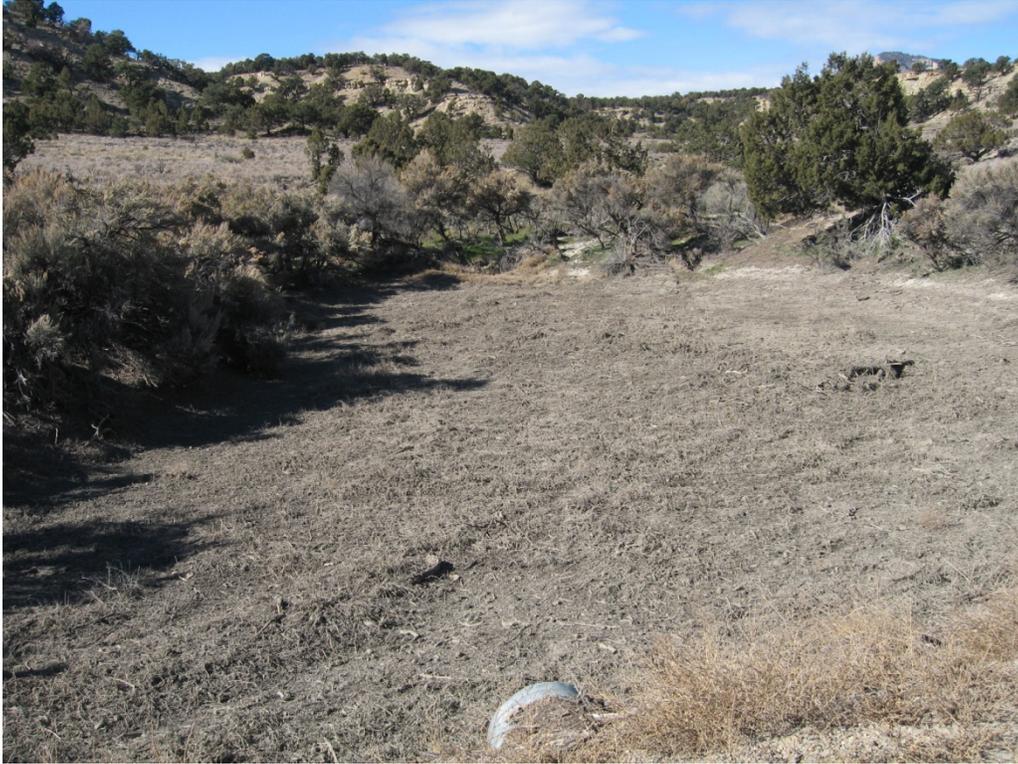
Permanent Impoundment (Upper Cell)

1. Describe any appearances of any instability, structural weakness, or any other hazardous condition.			
The pond's dam shows no signs of structural instability or other hazardous conditions.			
Required for an impoundment which functions as a SEDIMENTATION POND	2. Sediment storage capacity and storage volumes.		
	Existing Storage Capacity: 0.437 ac-ft (Upper) and 1.114 ac-ft (Lower)		
	Existing Sediment Storage Capacity (To Cleanout): NA

4. Field Information: Provide current water elevation, whether pond is discharging, type and number of samples taken, monitoring/instrumentation information, inlet/outlet conditions or other related activities associated with the pond including but not limited to sediment cleanout, pond decanting, embankment erosion/repairs, monitoring information, vegetation on outslopes of embankment erosion/repairs, monitoring information, vegetation on outslopes of embankments, etc.			
During the annual inspection November 6, 2013, the vegetative cover looked good with no signs of erosion. Signs if oast high water.

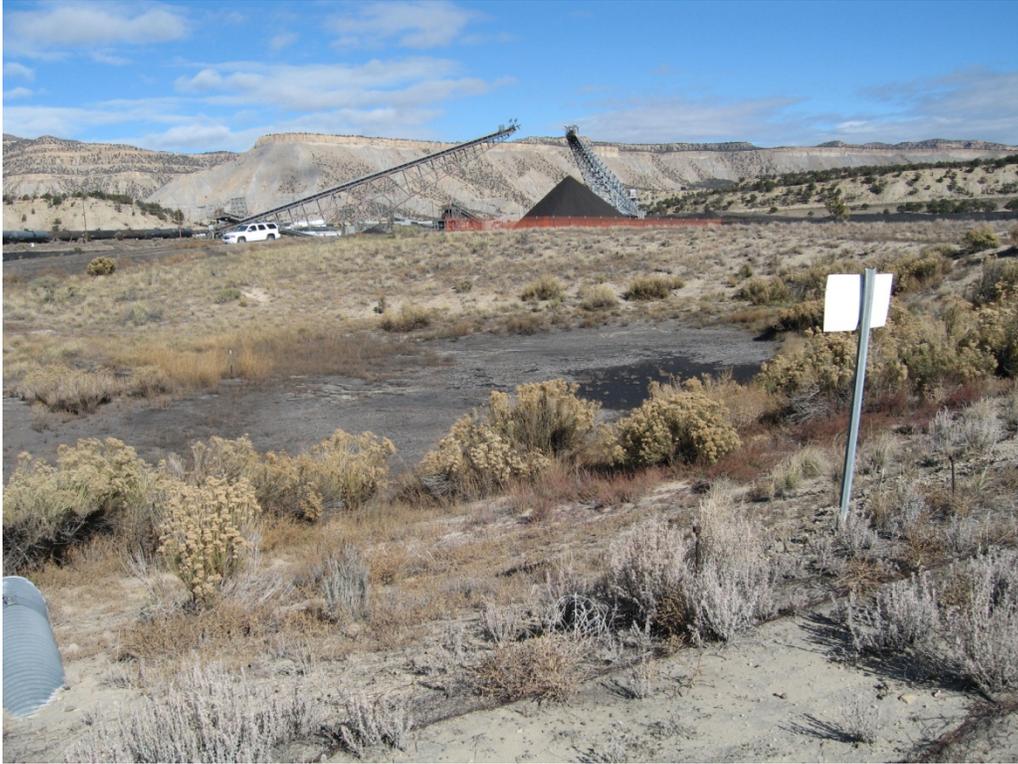
Sediment Pond A

1. Describe any appearances of any instability, structural weakness, or any other hazardous condition.	
The pond's dam shows no signs of structural instability or other hazardous conditions.	
Required for an impoundment which functions as a SEDIMENTATION POND	2. Sediment storage capacity and storage volumes.
	Existing Storage Capacity: 2.9 ac-ft
	Existing Sediment Storage Capacity (To Cleanout): .48 ac-ft
	3. Principle and emergency spillway elevations
	Principle spillway elevation: 6,149.0'
	Emergency spillway elevation: 6,150.0'

4. Field Information: Provide current water elevation, whether pond is discharging, type and number of samples taken, monitoring/instrumentation information, inlet/outlet conditions or other related activities associated with the pond including but not limited to sediment cleanout, pond decanting, embankment erosion/repairs, monitoring information, vegetation on out slopes of embankment erosion/repairs, monitoring information, vegetation on out slopes of embankments, etc.
During the annual inspection, November 6, 2013, the vegetative cover looked good with no signs of erosion. Both spillways look good with no signs of stability problems.

5. Field Evaluation: Describe any changes in the geometry of the impounding structure, average and maximum depths and elevations of impounded water, estimated sediment or slurry volume and remaining storage capacity, estimated volume of water impounded and any other aspect of the impounding structure affecting its stability or function which has occurred during the reporting period.
The sediment pond is dry, see the attached photograph. Sediment is approximately 24" below cleanout level.

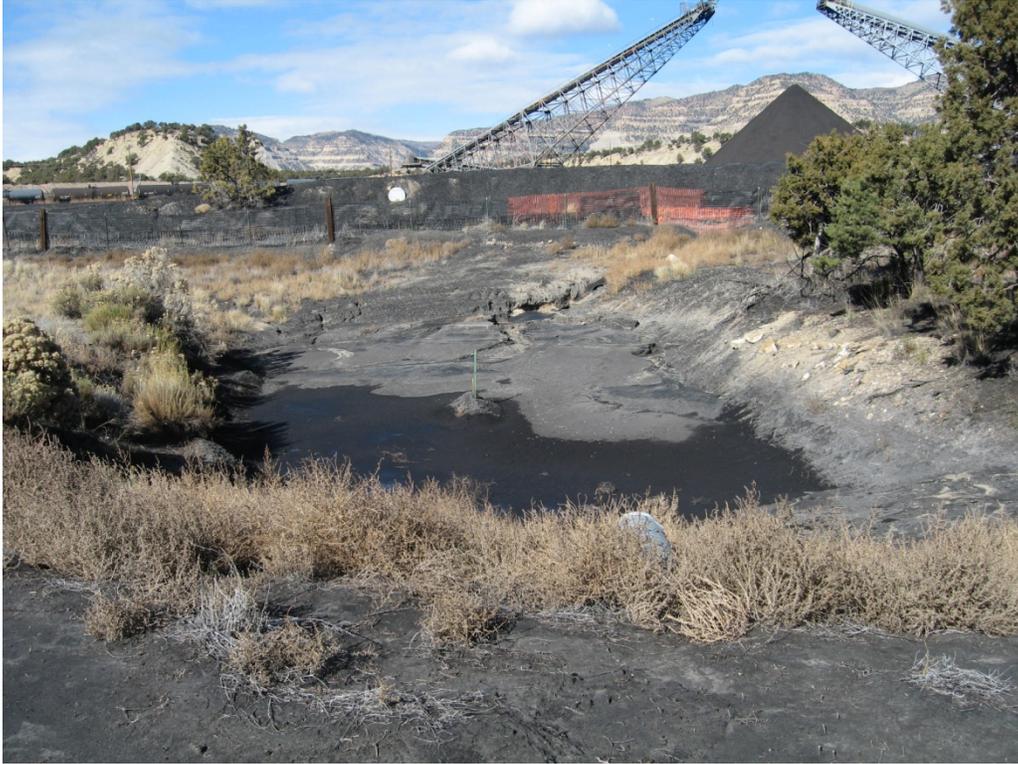
Sediment Pond B

1. Describe any appearances of any instability, structural weakness, or any other hazardous condition.			
The pond's dam shows no signs of structural instability or other hazardous conditions.			
Required for an impoundment which functions as a SEDIMENTATION POND	2. Sediment storage capacity and storage volumes.		
	Existing Storage Capacity: 0.41 ac-ft		
	Existing Sediment Storage Capacity (To Cleanout): 0.13 ac-ft

3. Principle and emergency spillway elevations		
	Principle spillway elevation: 6,138.0'		
	Emergency spillway elevation: 6,139.0'		
4. Field Information: Provide current water elevation, whether pond is discharging, type and number of samples taken, monitoring/instrumentation information, inlet/outlet conditions or other related activities associated with the pond including but not limited to sediment cleanout, pond decanting, embankment erosion/repairs, monitoring information, vegetation on out slopes of embankment erosion/repairs, monitoring information, vegetation on out slopes of embankments, etc.			
During the annual inspection, November 6, 2013, the vegetative cover looked good with no signs of erosion.

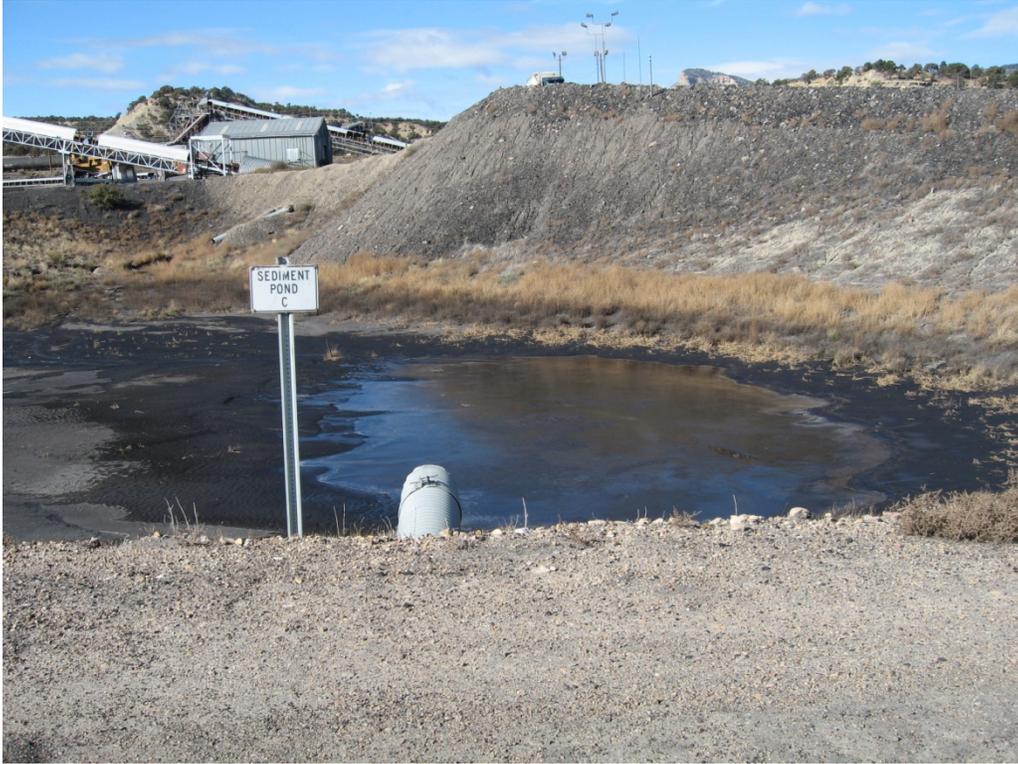
Sediment Pond C

1. Describe any appearances of any instability, structural weakness, or any other hazardous condition.			
The pond's dam shows no signs of structural instability or other hazardous conditions.			
Required for an impoundment which functions as a SEDIMENTATION POND	2. Sediment storage capacity and storage volumes.		
	Existing Storage Capacity: 4,174 ac-ft		
	Existing Sediment Storage Capacity (To Cleanout): 0.64 ac-ft

3. Principle and emergency spillway elevations		
	Principle spillway elevation: 6,137.0'		
	Emergency spillway elevation: 6,138.0'		
4. Field Information: Provide current water elevation, whether pond is discharging, type and number of samples taken, monitoring/instrumentation information, inlet/outlet conditions or other related activities associated with the pond including but not limited to sediment cleanout, pond decanting, embankment erosion/repairs, monitoring information, vegetation on out slopes of embankment erosion/repairs, monitoring information, vegetation on out slopes of embankments, etc.			
During the annual inspection, November 6, 2013, the vegetative cover looked good with no signs of erosion. There is a small amount of sediment in the emergency spillway inlet that should be removed.

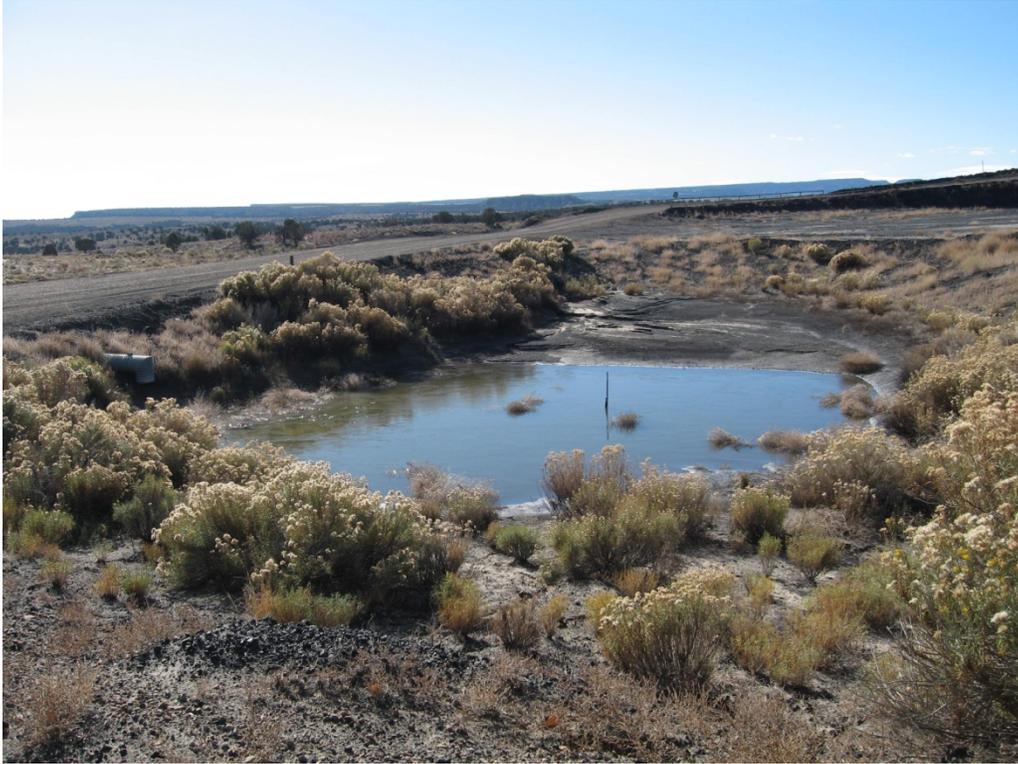
Sediment Pond D

1. Describe any appearances of any instability, structural weakness, or any other hazardous condition.			
The pond's dam shows no signs of structural instability or other hazardous conditions.			
Required for an impoundment which functions as a SEDIMENTATION POND	2. Sediment storage capacity and storage volumes.		
	Existing Storage Capacity: .98 ac-ft		
	Existing Sediment Storage Capacity (To Cleanout): 0.10 ac-ft

3. Principle and emergency spillway elevations		
	Principle spillway elevation: 6,139.0'		
	Emergency spillway elevation: 6,140.0'		
4. Field Information: Provide current water elevation, whether pond is discharging, type and number of samples taken, monitoring/instrumentation information, inlet/outlet conditions or other related activities associated with the pond including but not limited to sediment cleanout, pond decanting, embankment erosion/repairs, monitoring information, vegetation on out slopes of embankment erosion/repairs, monitoring information, vegetation on out slopes of embankments, etc.			
During the annual inspection, November 6, 2013, the vegetative cover looked good with no signs of erosion.

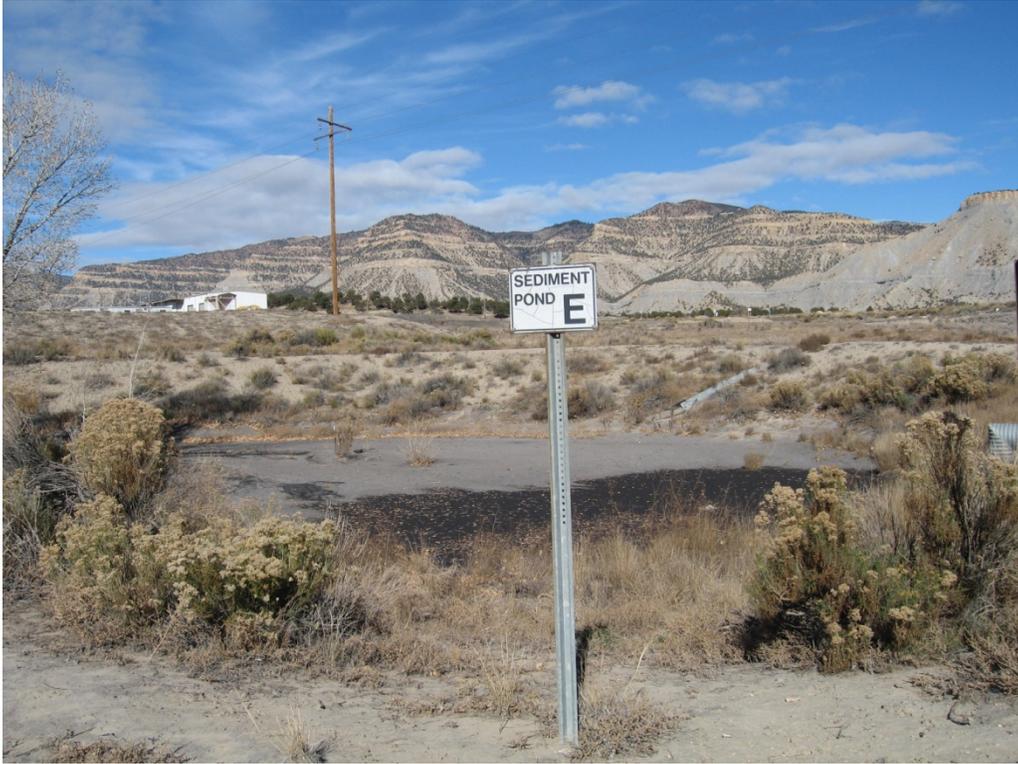
Sediment Pond E

1. Describe any appearances of any instability, structural weakness, or any other hazardous condition.			
The pond's dam shows no signs of structural instability or other hazardous conditions.			
Required for an impoundment which functions as a SEDIMENTATION POND	2. Sediment storage capacity and storage volumes.		
	Existing Storage Capacity: 1.092 ac-ft		
	Existing Sediment Storage Capacity (To Cleanout): 0.18 ac-ft

3. Principle and emergency spillway elevations		
	Principle spillway elevation: 6,145.0'		
	Emergency spillway elevation: 6,146.0'		
4. Field Information: Provide current water elevation, whether pond is discharging, type and number of samples taken, monitoring/instrumentation information, inlet/outlet conditions or other related activities associated with the pond including but not limited to sediment cleanout, pond decanting, embankment erosion/repairs, monitoring information, vegetation on out slopes of embankment erosion/repairs, monitoring information, vegetation on out slopes of embankments, etc.			
During the annual inspection, November 6, 2013, the vegetative cover looked good with no signs of erosion.

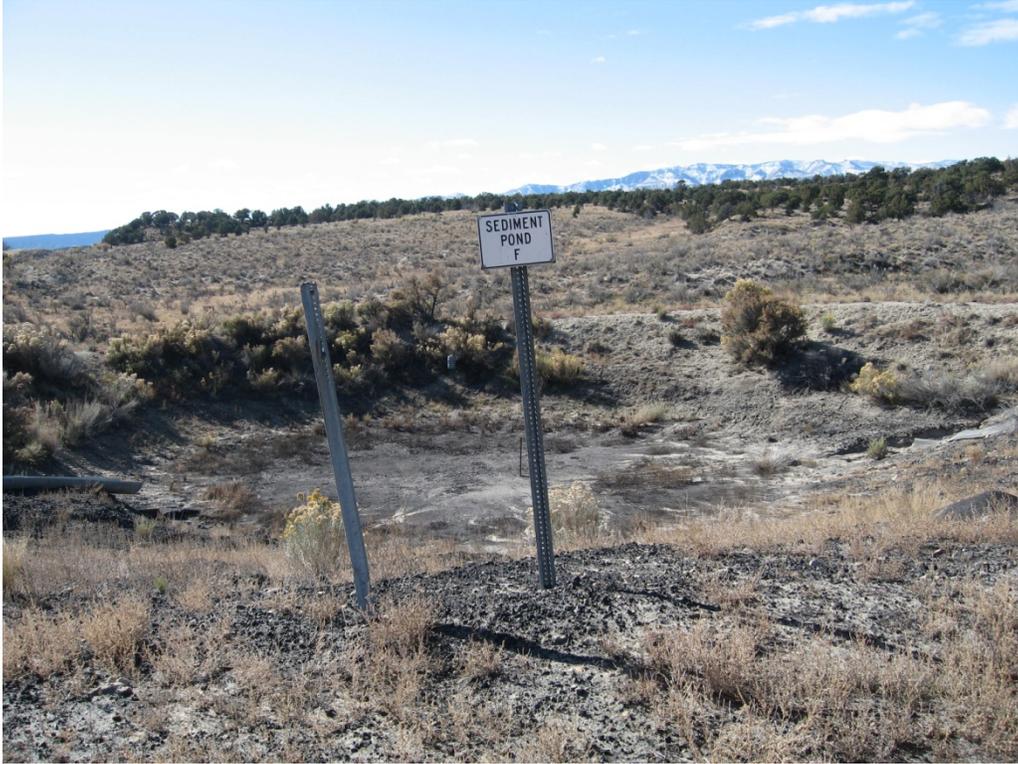
Sediment Pond F

1. Describe any appearances of any instability, structural weakness, or any other hazardous condition.			
The pond's dam shows no signs of structural instability or other hazardous conditions.			
Required for an impoundment which functions as a SEDIMENTATION POND	2. Sediment storage capacity and storage volumes.		
	Existing Storage Capacity: 0.869 ac-ft		
	Existing Sediment Storage Capacity (To Cleanout): 0.16 ac-ft

3. Principle and emergency spillway elevations		
	Principle spillway elevation: 6,173.0'		
	Emergency spillway elevation: 6,174.0'		
4. Field Information: Provide current water elevation, whether pond is discharging, type and number of samples taken, monitoring/instrumentation information, inlet/outlet conditions or other related activities associated with the pond including but not limited to sediment cleanout, pond decanting, embankment erosion/repairs, monitoring information, vegetation on outslopes of embankment erosion/repairs, monitoring information, vegetation on outslopes of embankments, etc.			
During the annual inspection, November 6, 2013, the vegetative cover looked good with no signs of erosion.

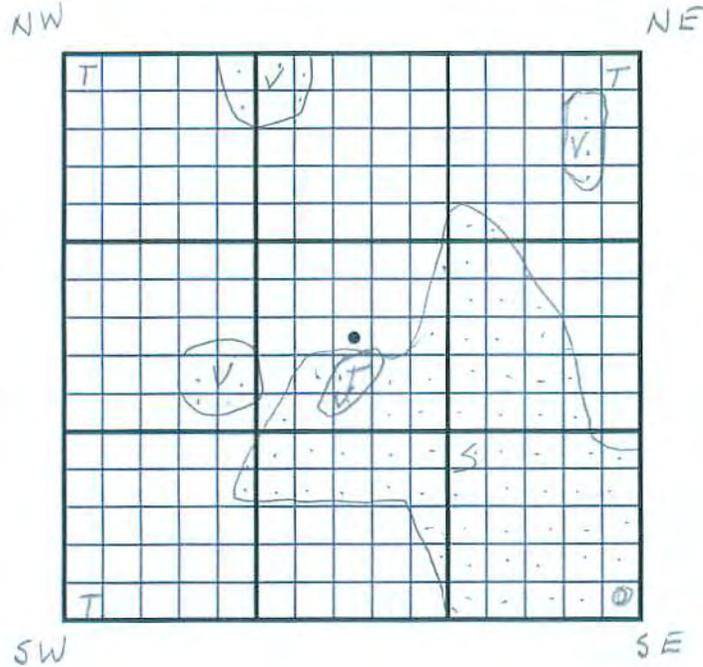
Site: N14
Date: 3/25/13

VEGETATION: 4, 3.75, 2.5, 1.5 = 11.75
SOIL: 55.75 SQ
COAL: 157.5 SQ

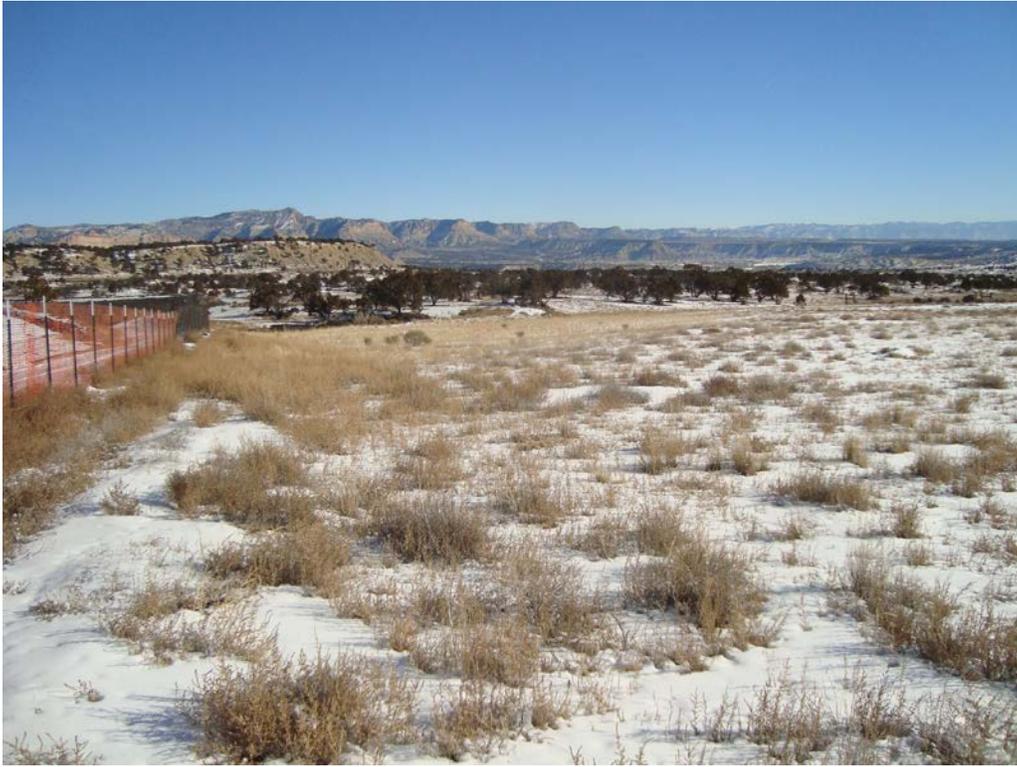
Snow accumulation along with the frozen ground conditions found at the site on December 11, 2013, made it impossible to see the ground at the Wildcat Loadout. See the attached photographs. Therefore, no ground cover measurements were taken for the fourth quarter. On November 26, 2013, Citation for Non-Compliance #10132 was issued for the permittee failing to do the following:

PHOTOGRAPH TAKEN 12/11/2013

SOUTH AREA LOOKING NORTHEAST

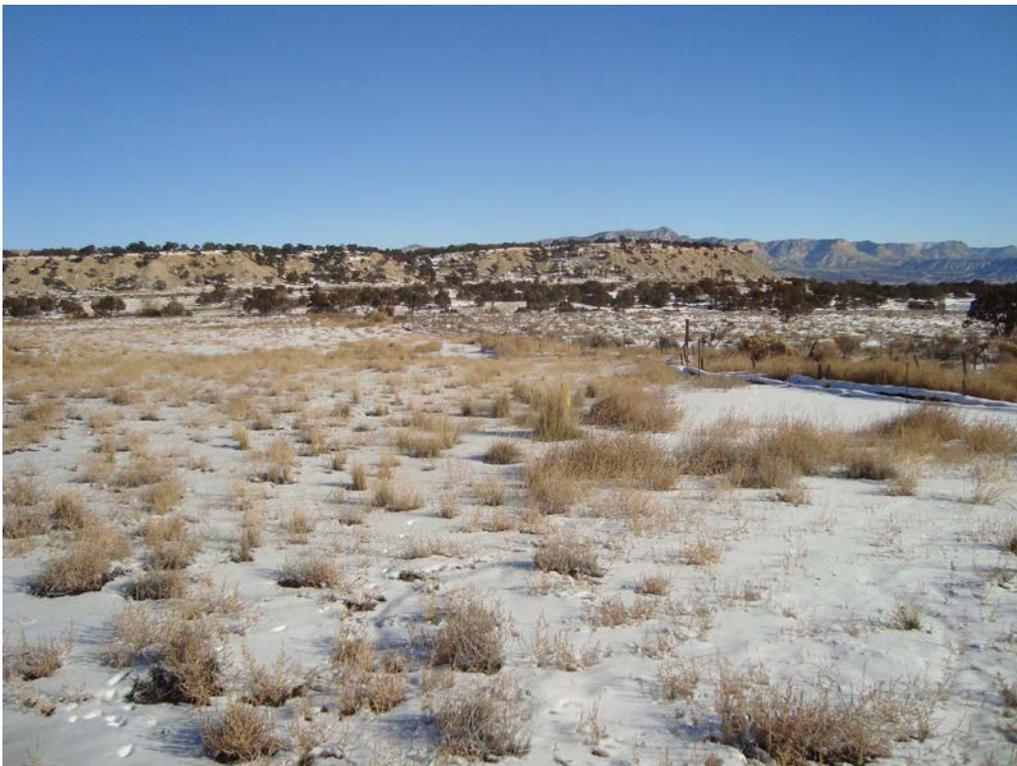
NORTH AREA LOOKING NORTHEAST
