Re: C/007/030 Wildcat Load Out 2015 Annual Report

Wild West Equipment & Hauling, LLC, on behalf of Intermountain Power Agency, respectfully submits the 2015 Annual Report for the Wildcat Load Out Permit C/007/030 on the enclosed CD.

Annual Report

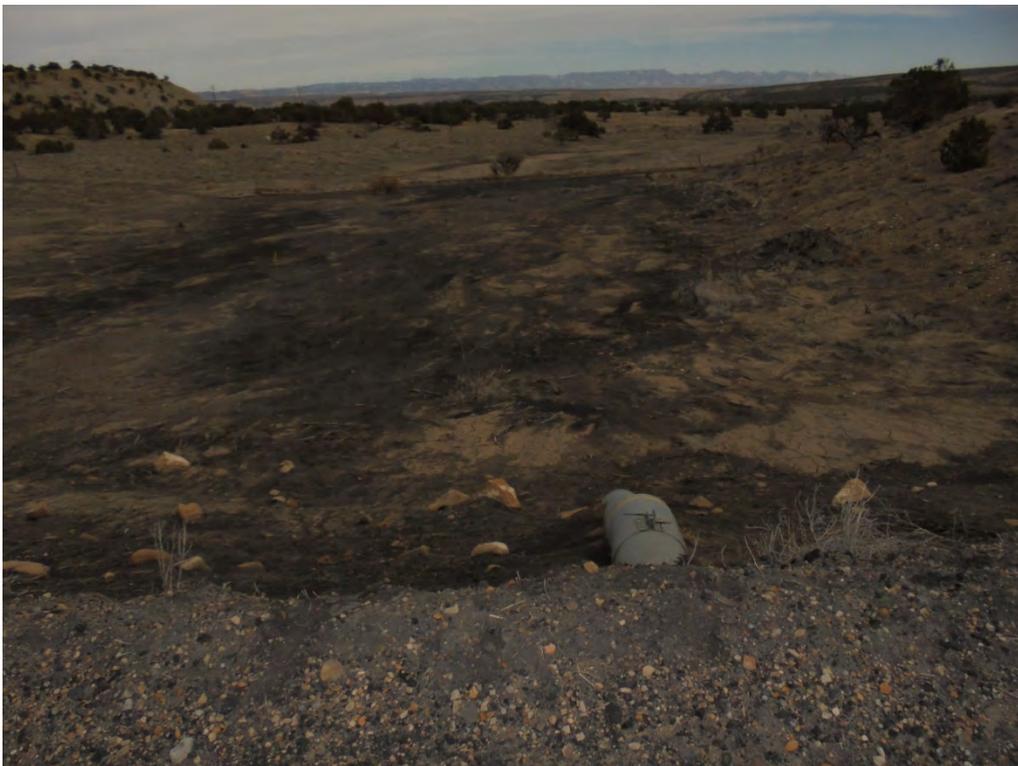
ABOVE N6 LOOKING SOUTHEAST

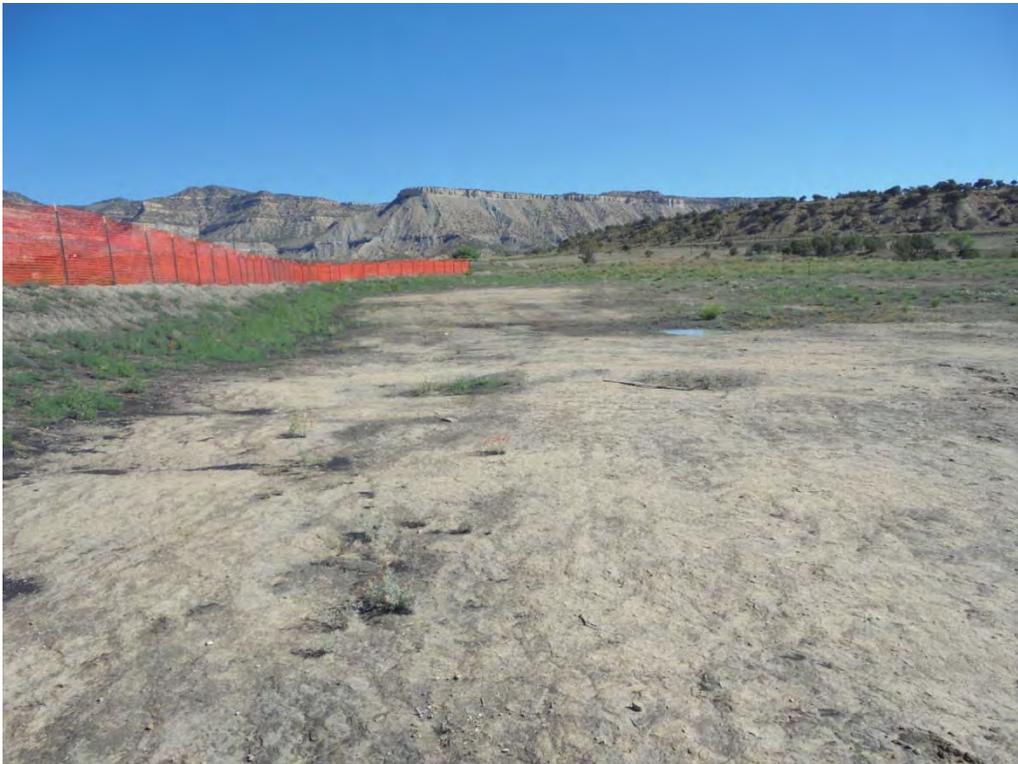
FROM N3 LOOKING NORTH

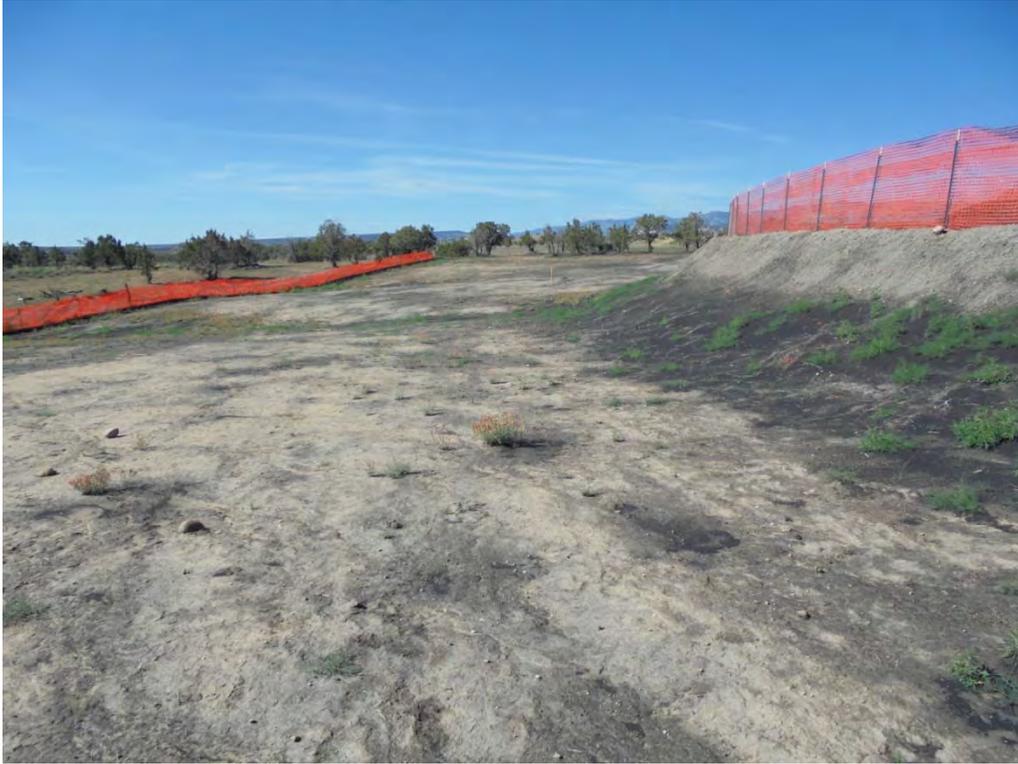
FROM N3 LOOKING SOUTH

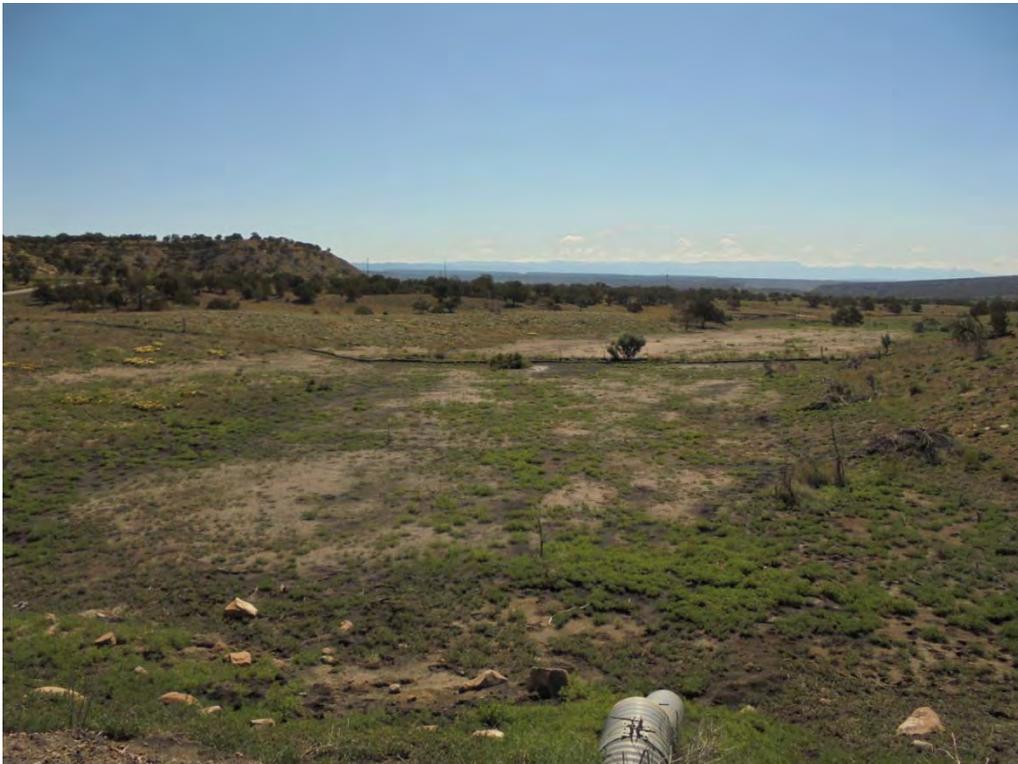
ABOVE N6 LOOKING EAST

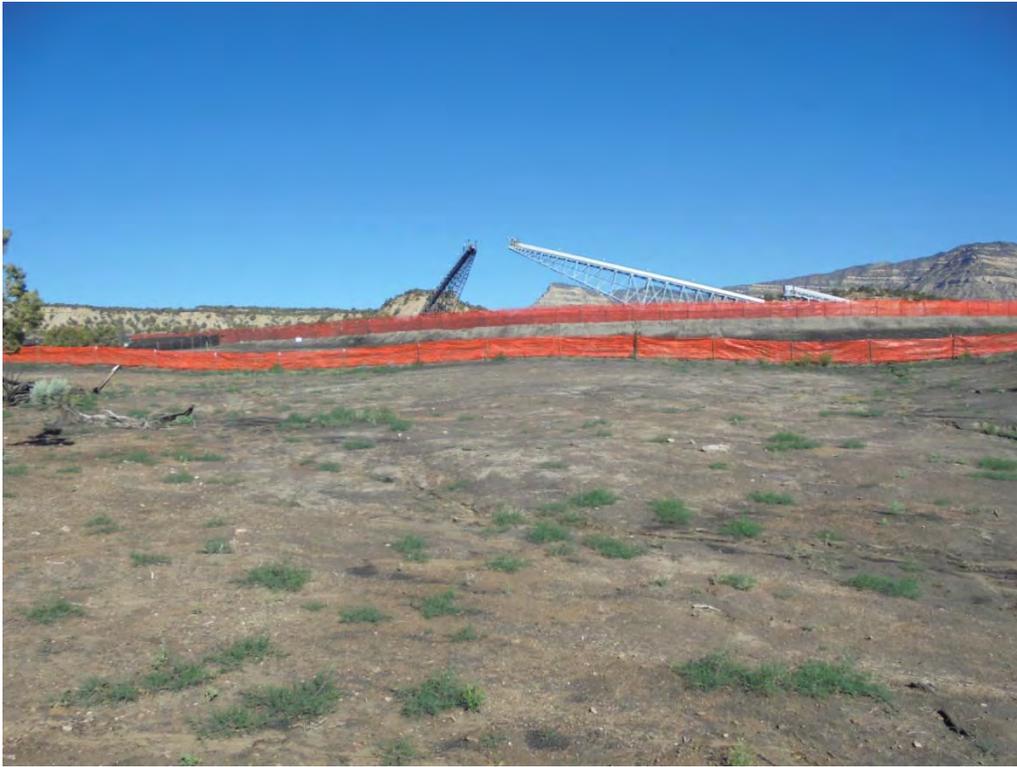
FROM N16 LOOKING WEST

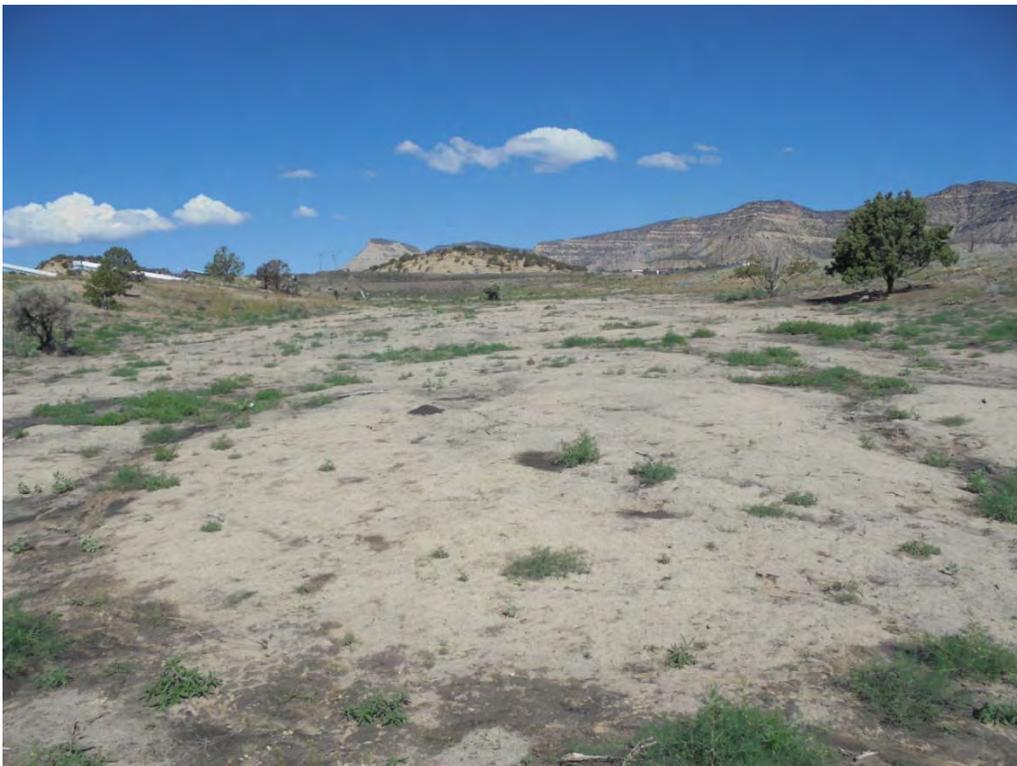
FROM N21 LOOKING WEST

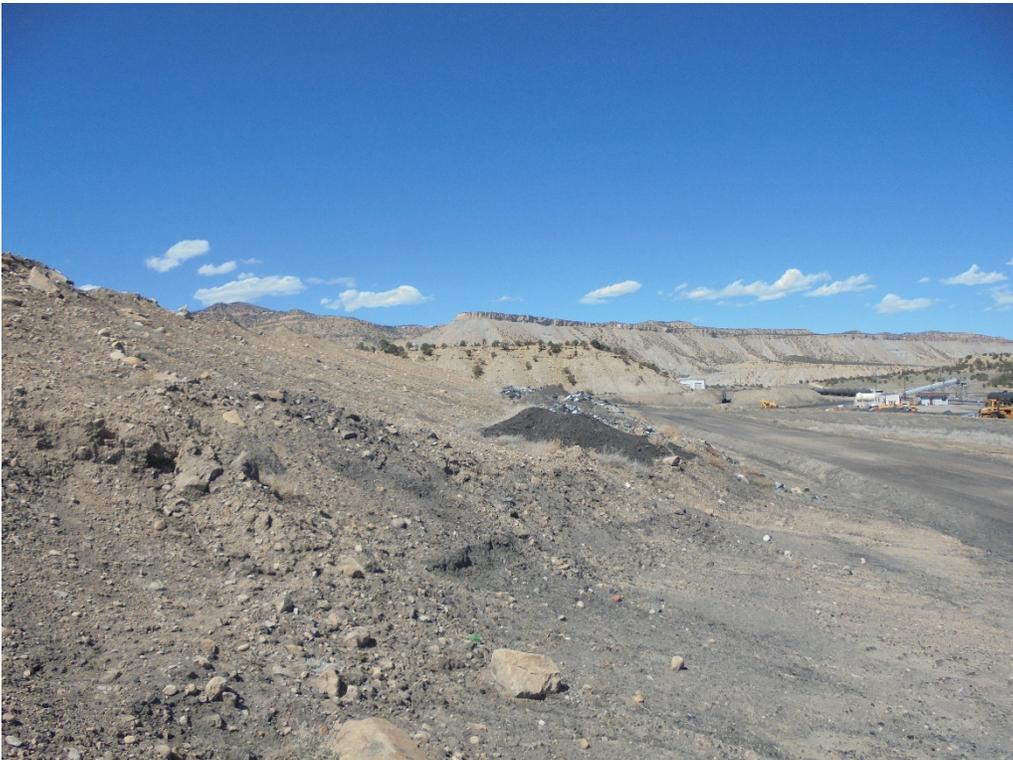
EAST SIDE OF REFUSE PILE LOOKING NORTH

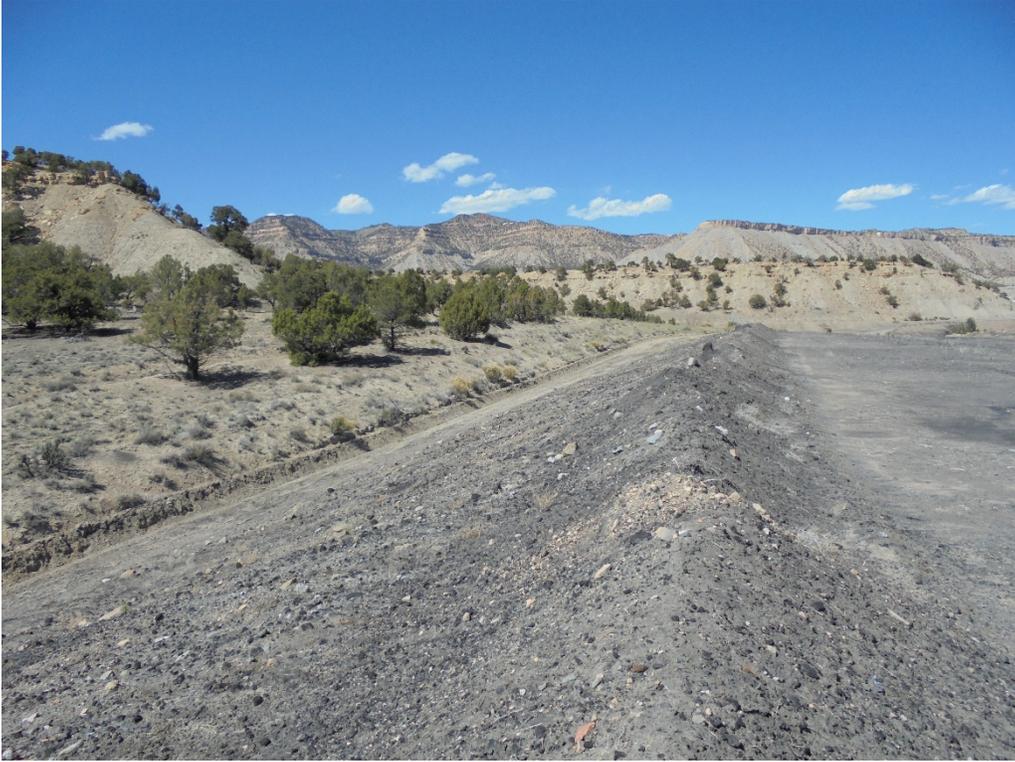
WEST SIDE OF REFUSE PILE LOOKING NORTH

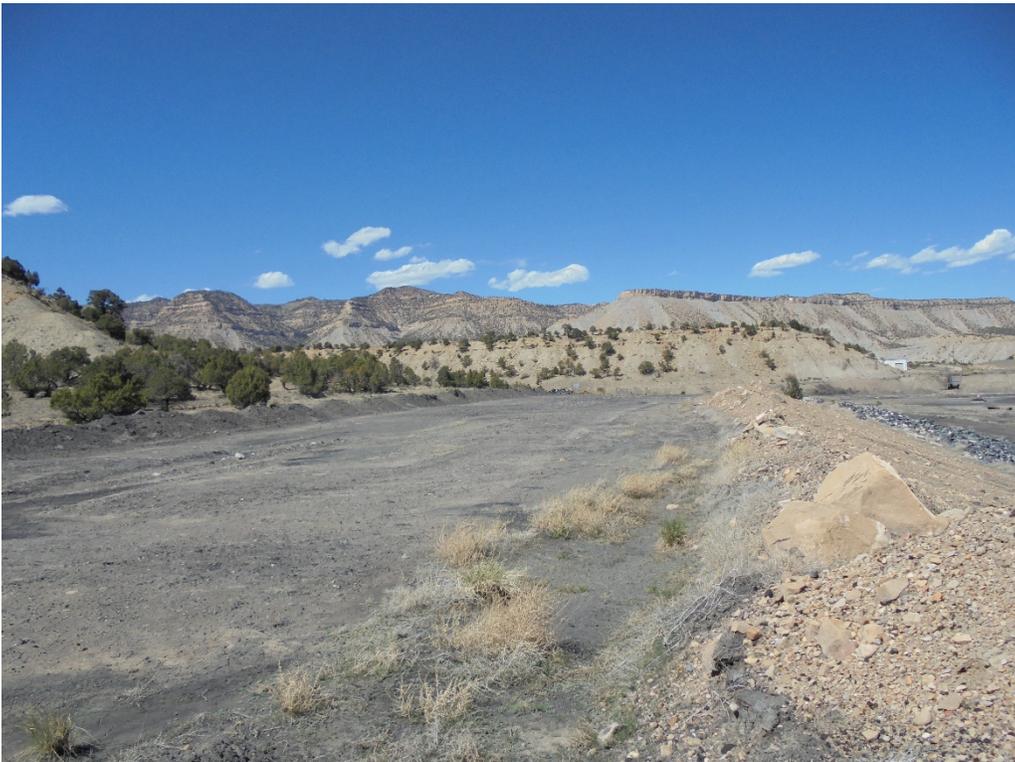
TOP OF REFUSE PILE LOOKING NORTH

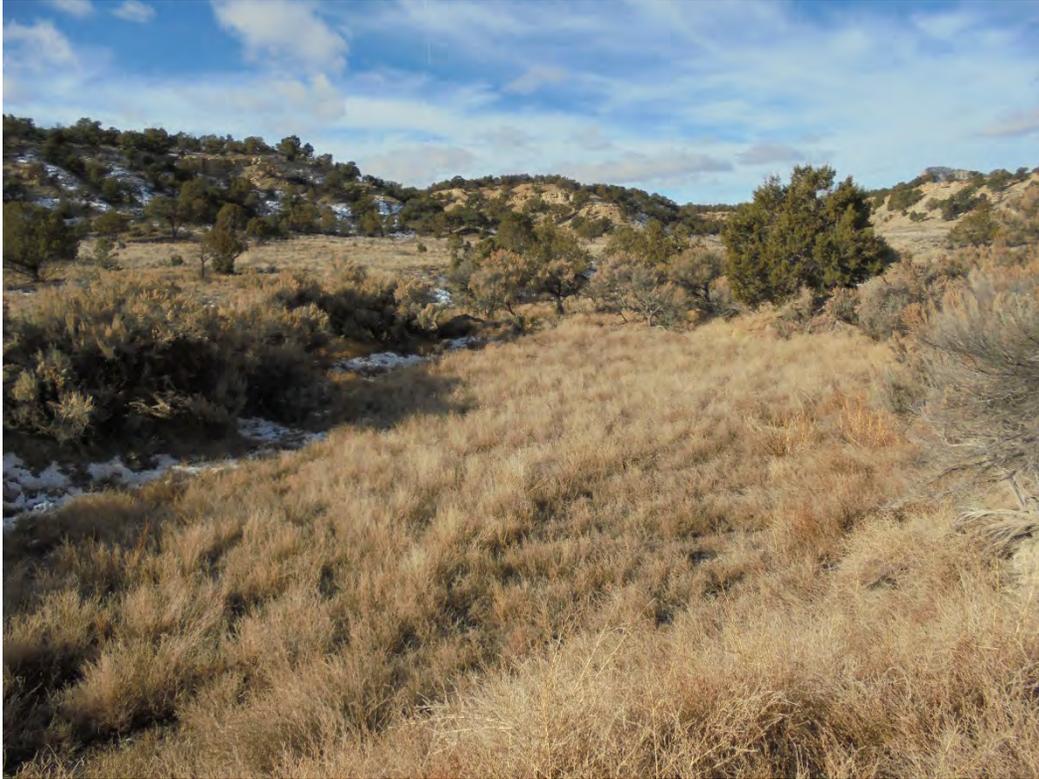
PERMANENT IMPOUNDMENT UPPER CELL

4. Field Information: Provide current water elevation, whether pond is discharging, type and number of samples taken, monitoring/instrumentation information, inlet/outlet conditions or other related activities associated with the pond including but not limited to sediment cleanout, pond decanting, embankment erosion/repairs, monitoring information, vegetation on out slopes of embankment erosion/repairs, monitoring information, vegetation on out slopes of embankments, etc.			
During the annual inspection December 8, 2015, the vegetative cover looked good with no signs of erosion. Weeds need to be removed from inlet of principle spillway. See attached photograph.

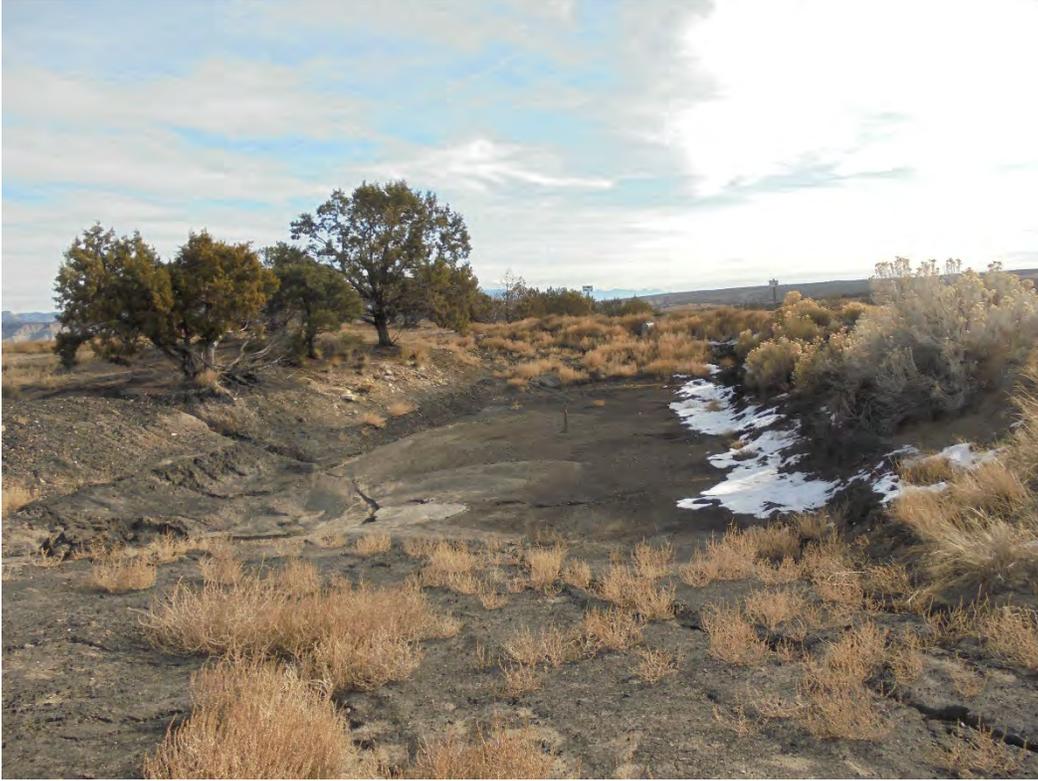
POND B

3. Principle and emergency spillway elevations		
	Principle spillway elevation: 6,138.0'		
	Emergency spillway elevation: 6,139.0'		
4. Field Information: Provide current water elevation, whether pond is discharging, type and number of samples taken, monitoring/instrumentation information, inlet/outlet conditions or other related activities associated with the pond including but not limited to sediment cleanout, pond decanting, embankment erosion/repairs, monitoring information, vegetation on out slopes of embankment erosion/repairs, monitoring information, vegetation on out slopes of embankments, etc.			
During the annual inspection, December 8, 2015, the vegetative cover looked good with no signs of erosion. Weeds in the emergency spillway need to be clean out. Refer to the attached photograph.

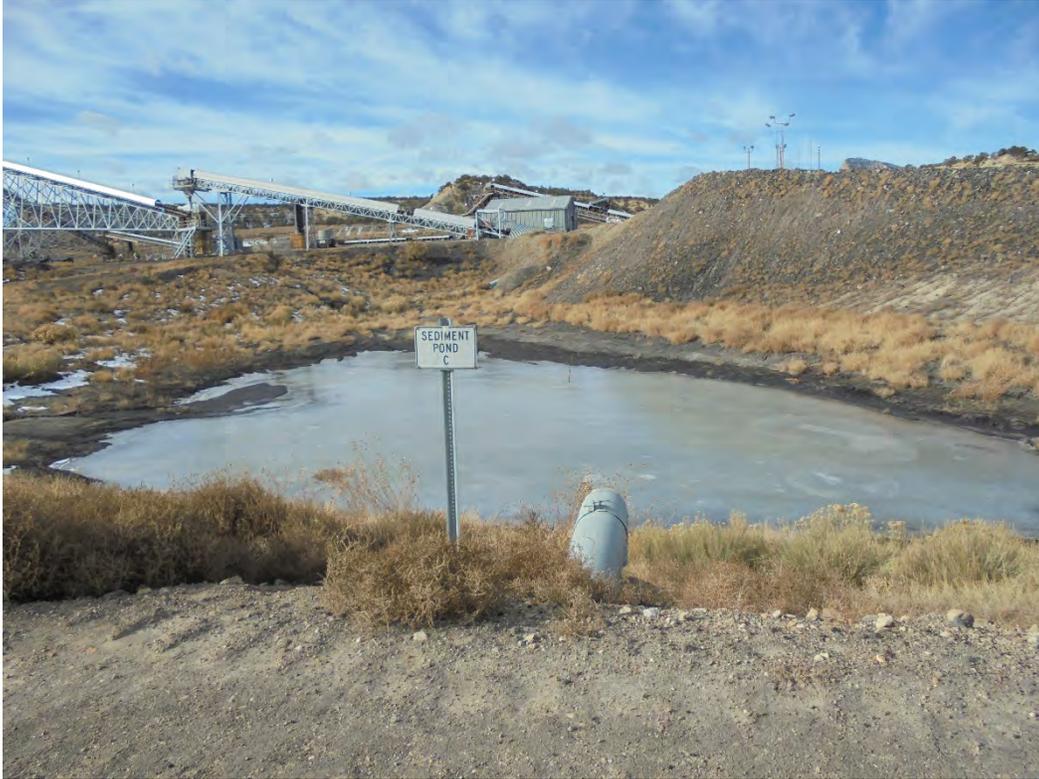
POND C

3. Principle and emergency spillway elevations		
	Principle spillway elevation: 6,137.0'		
	Emergency spillway elevation: 6,138.0'		
4. Field Information: Provide current water elevation, whether pond is discharging, type and number of samples taken, monitoring/instrumentation information, inlet/outlet conditions or other related activities associated with the pond including but not limited to sediment cleanout, pond decanting, embankment erosion/repairs, monitoring information, vegetation on out slopes of embankment erosion/repairs, monitoring information, vegetation on out slopes of embankments, etc.			
During the annual inspection, December 8, 2015, the vegetative cover looked good with no signs of erosion. Weeds at inlet and outlet of emergency spillway need to be removed. See the attached photograph.

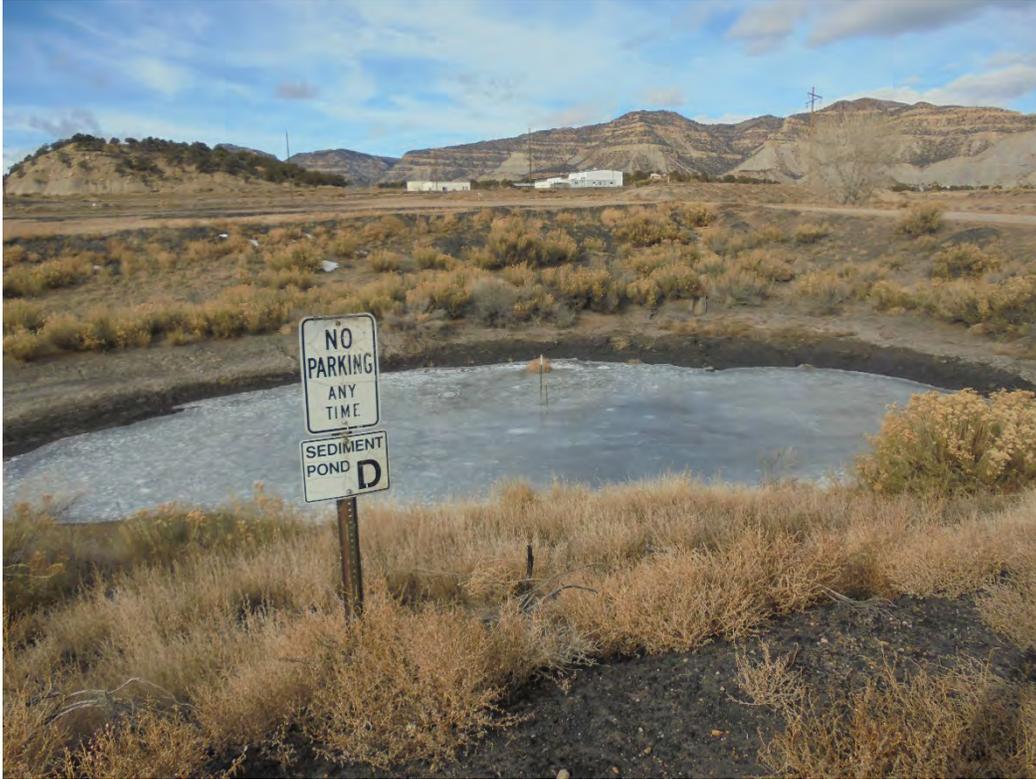
POND D

3. Principle and emergency spillway elevations		
	Principle spillway elevation: 6,139.0'		
	Emergency spillway elevation: 6,140.0'		
4. Field Information: Provide current water elevation, whether pond is discharging, type and number of samples taken, monitoring/instrumentation information, inlet/outlet conditions or other related activities associated with the pond including but not limited to sediment cleanout, pond decanting, embankment erosion/repairs, monitoring information, vegetation on outslopes of embankment erosion/repairs, monitoring information, vegetation on outslopes of embankments, etc.			
During the annual inspection, December 8, 2015, the vegetative cover looked good with no signs of erosion. Erosion belt on discharge of principle spillway needs to be straightened out. See attached photograph.

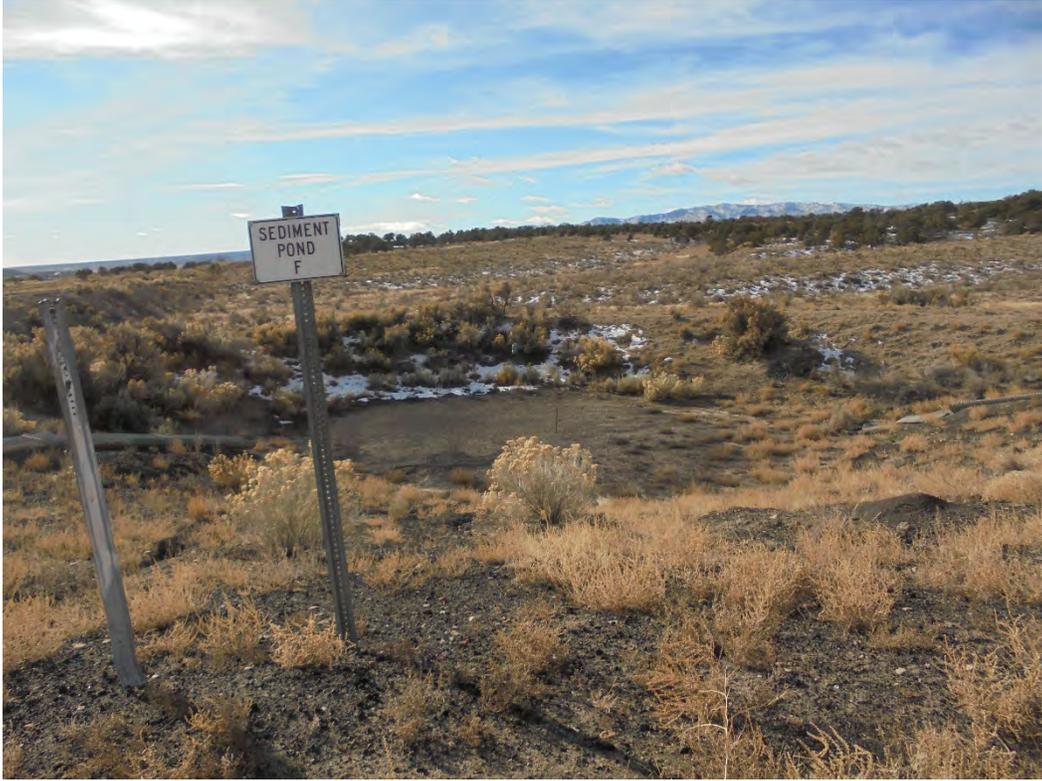
POND F

3. Principle and emergency spillway elevations		
	Principle spillway elevation: 6,173.0'		
	Emergency spillway elevation: 6,174.0'		
4. Field Information: Provide current water elevation, whether pond is discharging, type and number of samples taken, monitoring/instrumentation information, inlet/outlet conditions or other related activities associated with the pond including but not limited to sediment cleanout, pond decanting, embankment erosion/repairs, monitoring information, vegetation on out slopes of embankment erosion/repairs, monitoring information, vegetation on out slopes of embankments, etc.			
During the annual inspection, December 8, 2015, the vegetative cover looked good with no signs of erosion. Principle spillway outlet and east inlet need to be cleaned. See attached photograph.
