ANNUAL REPORT

Company Name	Intermountain Power Agency	Mine Name	Wildcat Loadout
Permit Number	C/007/0033	Permit expiration Date	May 5, 2019
Operator Name	Wild West Equipment & Hauling, LLC	Phone Number	+1 (435) 650-7339
Mailing Address	P.O. Box 1	Email	kit@emerytelcom.net
City	Price		
State	Utah	Zip Code	84501

Quarterly Inspection Form - Refuse Disposal Areas
 (please provide to DOGM promptly after inspection is complete)

**WILDCAT COAL FINES ISSUE
DIVISION ORDER-04 (WIND BLOWN FINES)
SECOND QUARTER 2017**

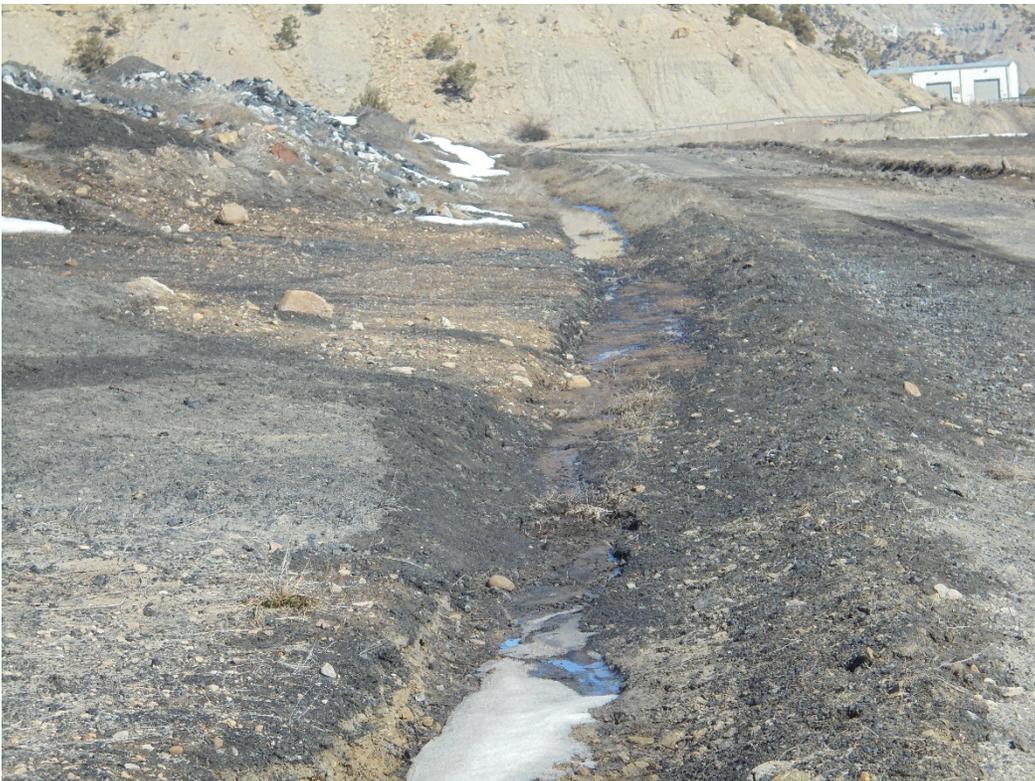
EAST DRAINAGE DITCH NEEDING CLEANING

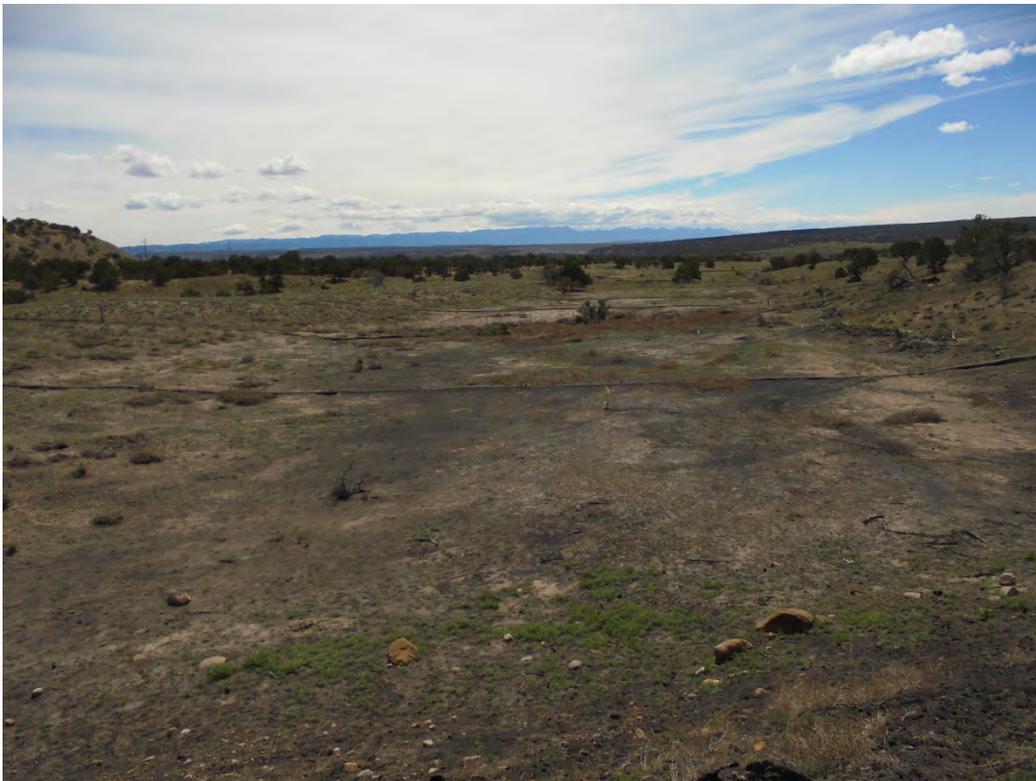
LOOKING SOUTHEAST FROM ABOVE N6

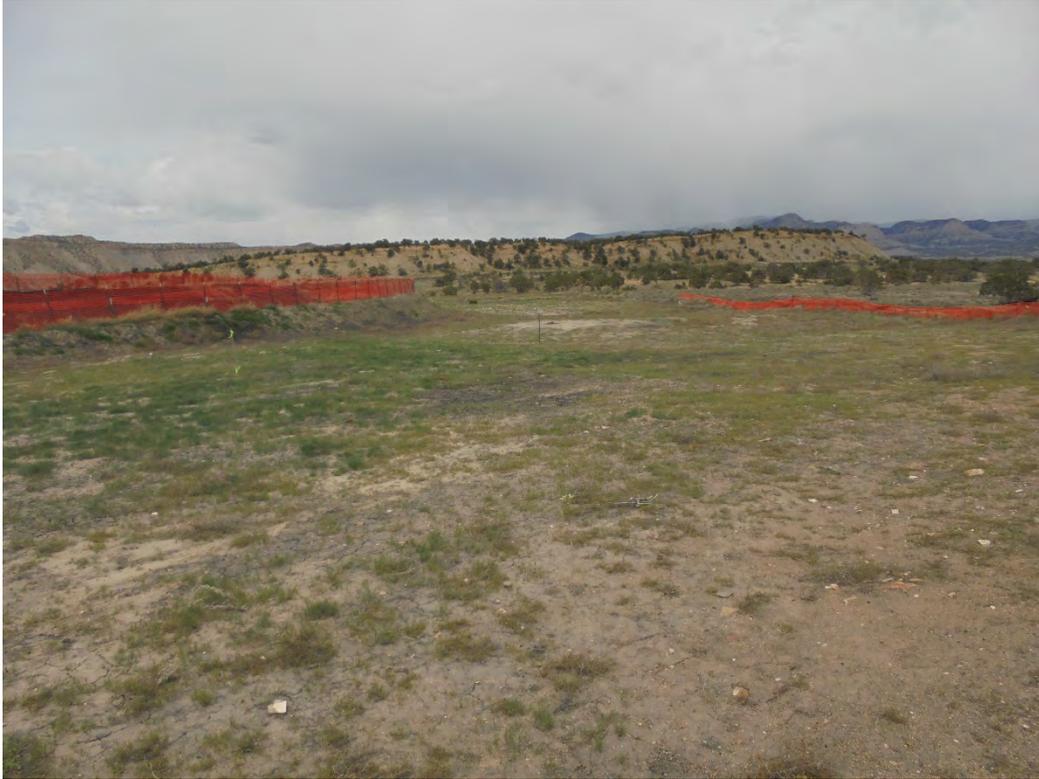
LOOKING NORTHEAST FROM N7

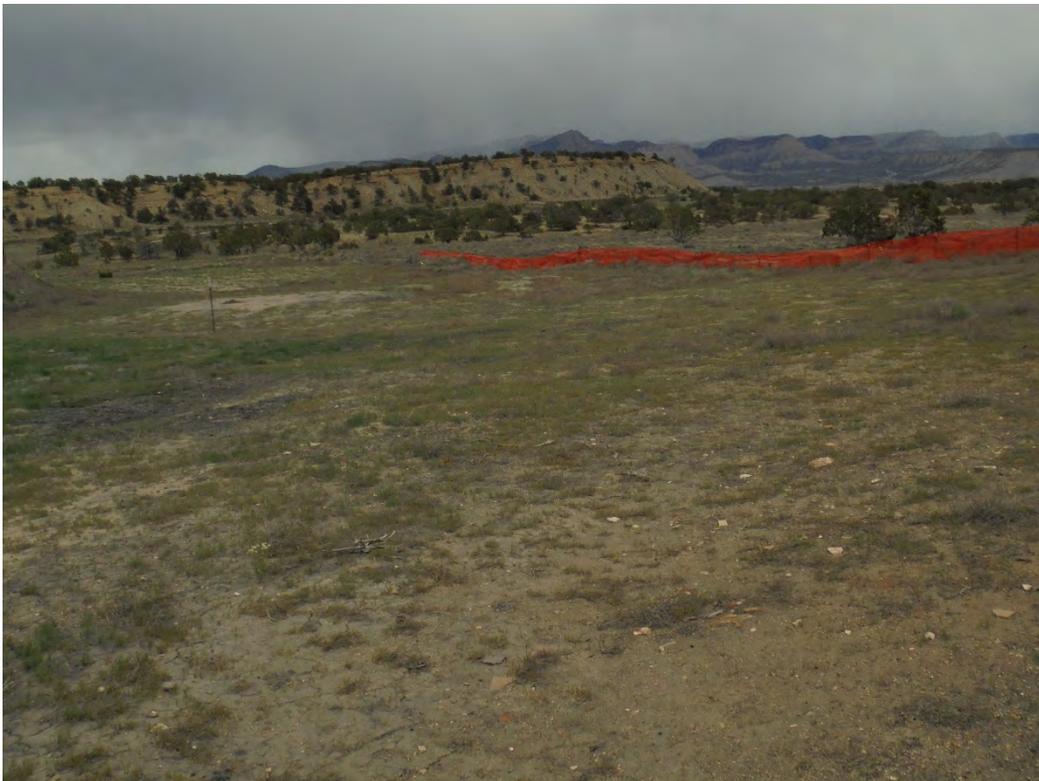
LOOKING NORTHEAST FROM N19

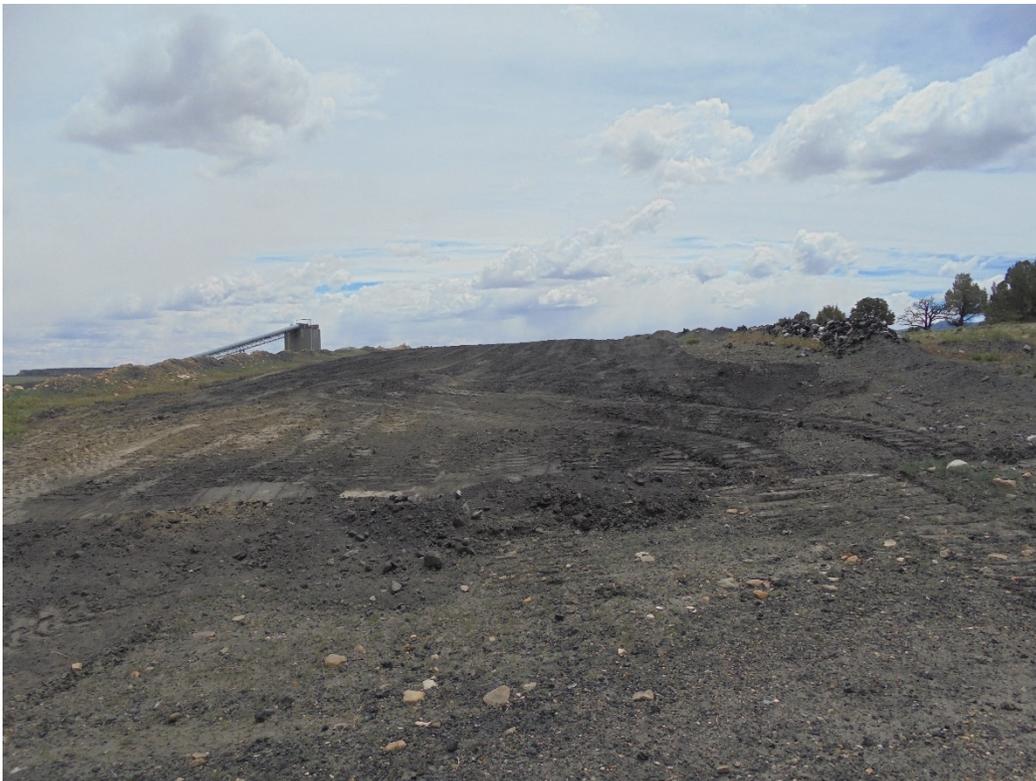
LOOKING SOUTH

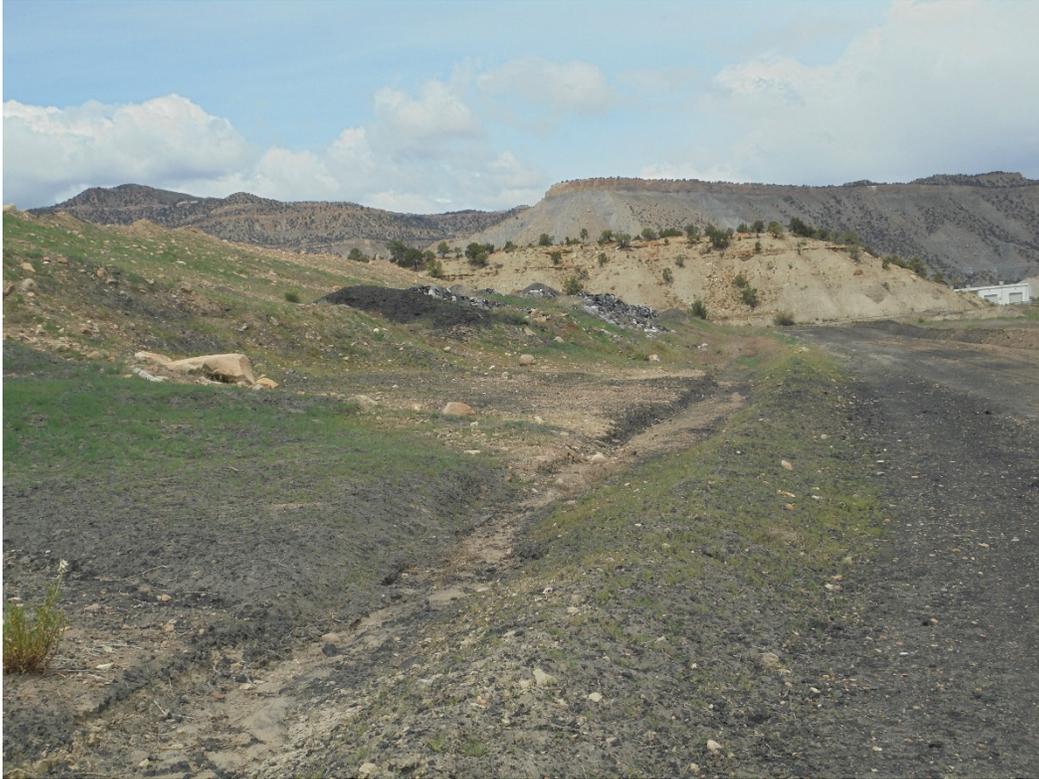
EAST DRAINAGE DITCH (NEEDS CLEANING SHORTLY)

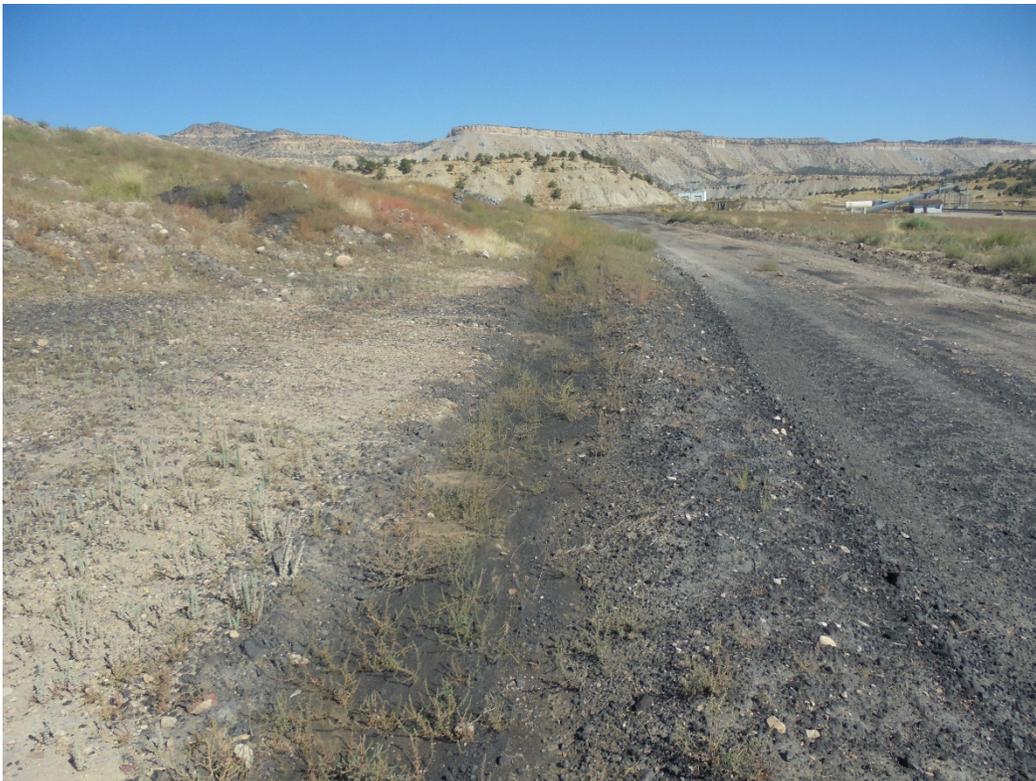
EAST DRAINAGE DITCH (LOOKING NORTH NEEDS CLEANING SHORTLY)

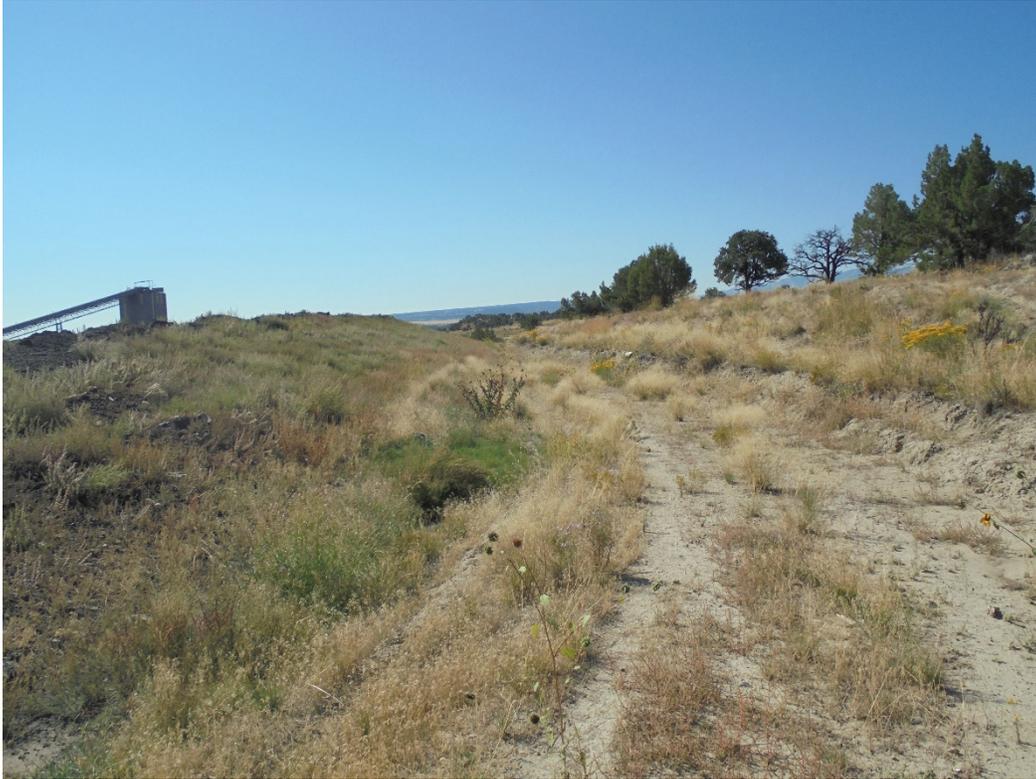
WEST DRAINAGE DITCH (LOOKING SOUTH)

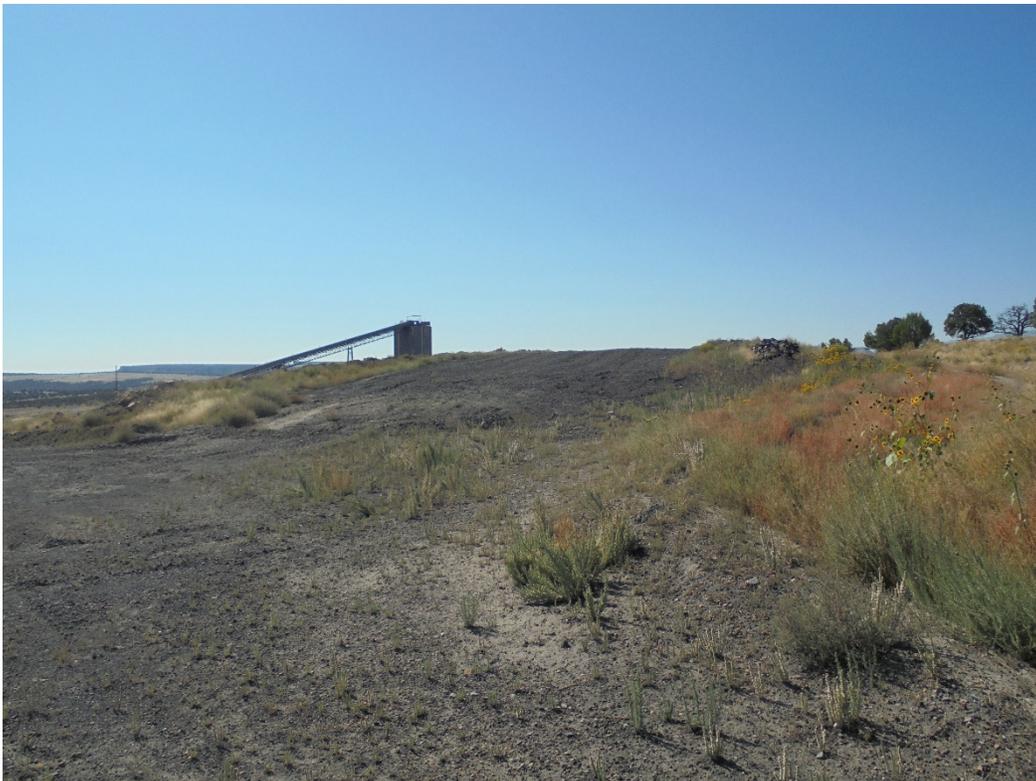
LOOKING SOUTH AT ENTRANCE TO REFUSE PILE

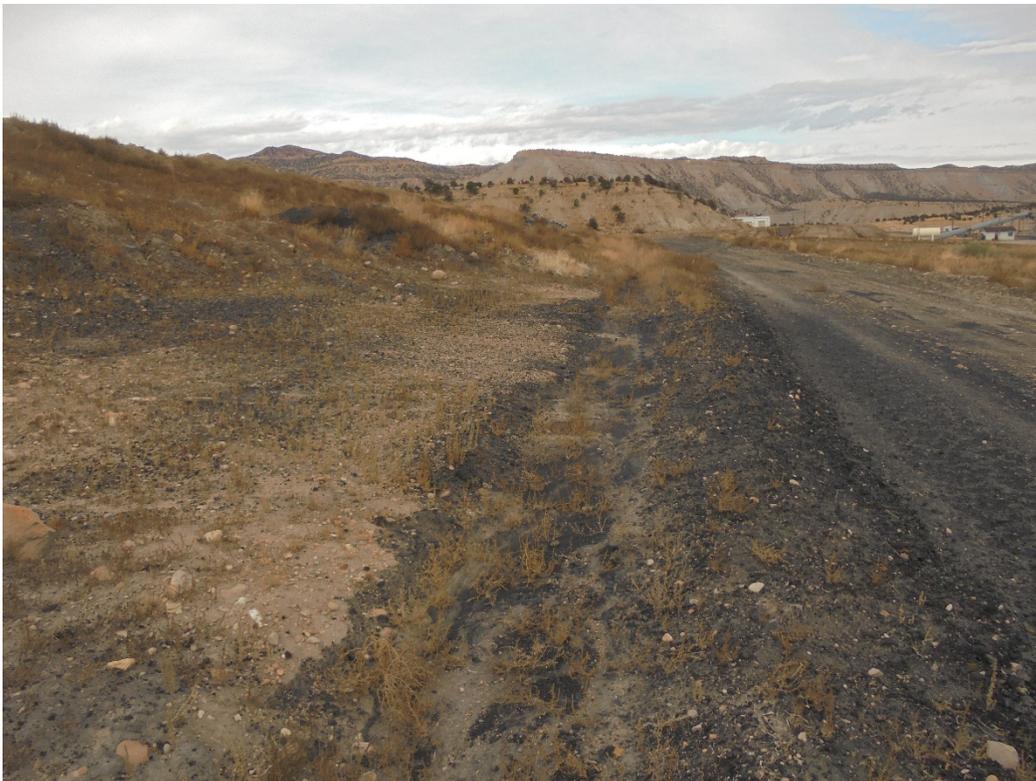
EAST DRAINAGE DITCH (NEEDS TO BE CLEANOUT SHORTLY)

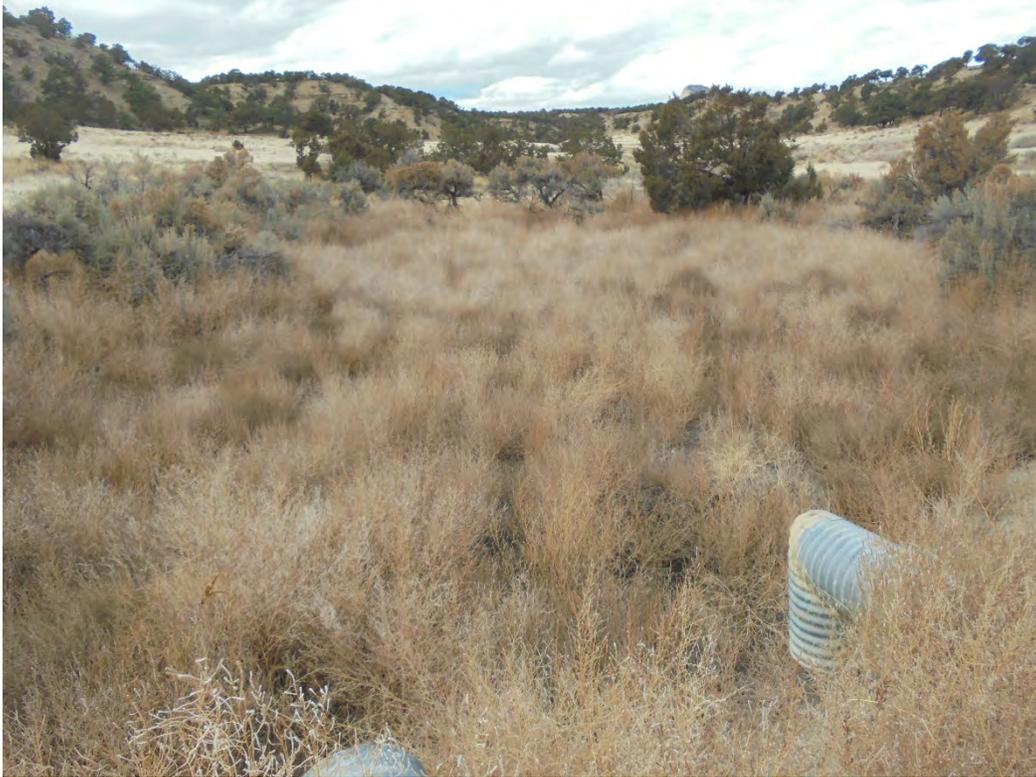
PERMANENT IMPOUNDMENT UPPER CELL

4. Field Information: Provide current water elevation, whether pond is discharging, type and number of samples taken, monitoring/instrumentation information, inlet/outlet conditions or other related activities associated with the pond including but not limited to sediment cleanout, pond decanting, embankment erosion/repairs, monitoring information, vegetation on out slopes of embankment erosion/repairs, monitoring information, vegetation on out slopes of embankments, etc.			
During the annual inspection November 27, 2017, the vegetative cover looked good with no signs of erosion.

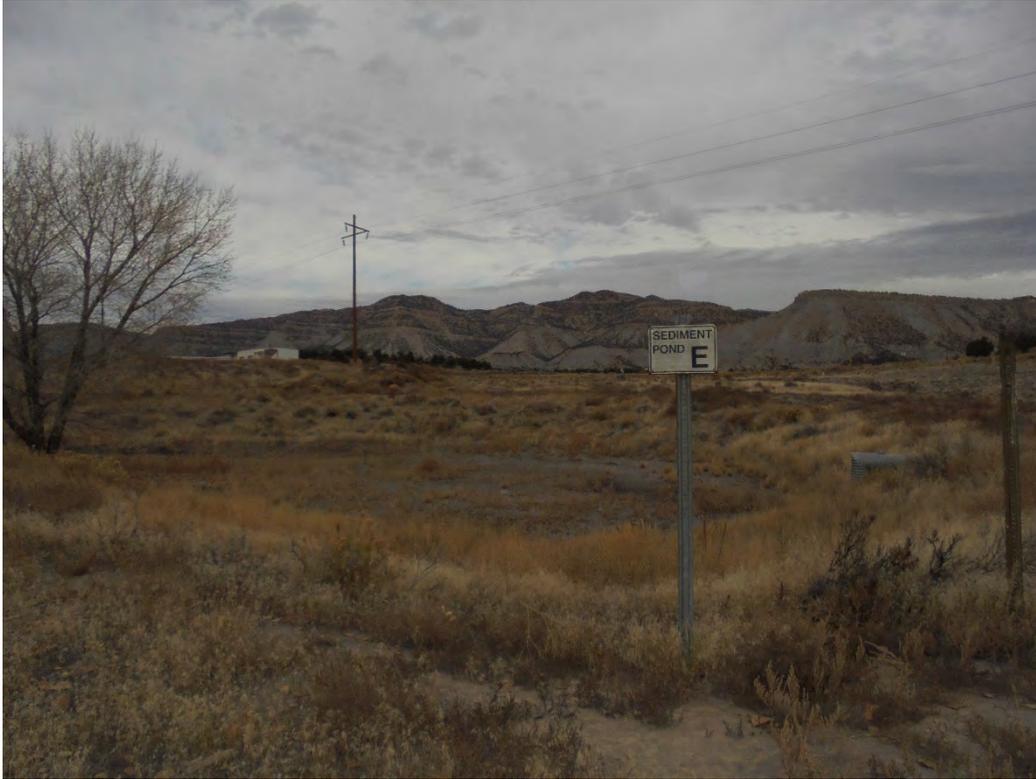
POND E

3. Principle and emergency spillway elevations		
	Principle spillway elevation: 6,145.0'		
	Emergency spillway elevation: 6,146.0'		
4. Field Information: Provide current water elevation, whether pond is discharging, type and number of samples taken, monitoring/instrumentation information, inlet/outlet conditions or other related activities associated with the pond including but not limited to sediment cleanout, pond decanting, embankment erosion/repairs, monitoring information, vegetation on out slopes of embankment erosion/repairs, monitoring information, vegetation on out slopes of embankments, etc.			
During the annual inspection, November 27, 2017, the vegetative cover looked good with no signs of erosion. Northeast and West inlets need weeds removed. See attached photographs.

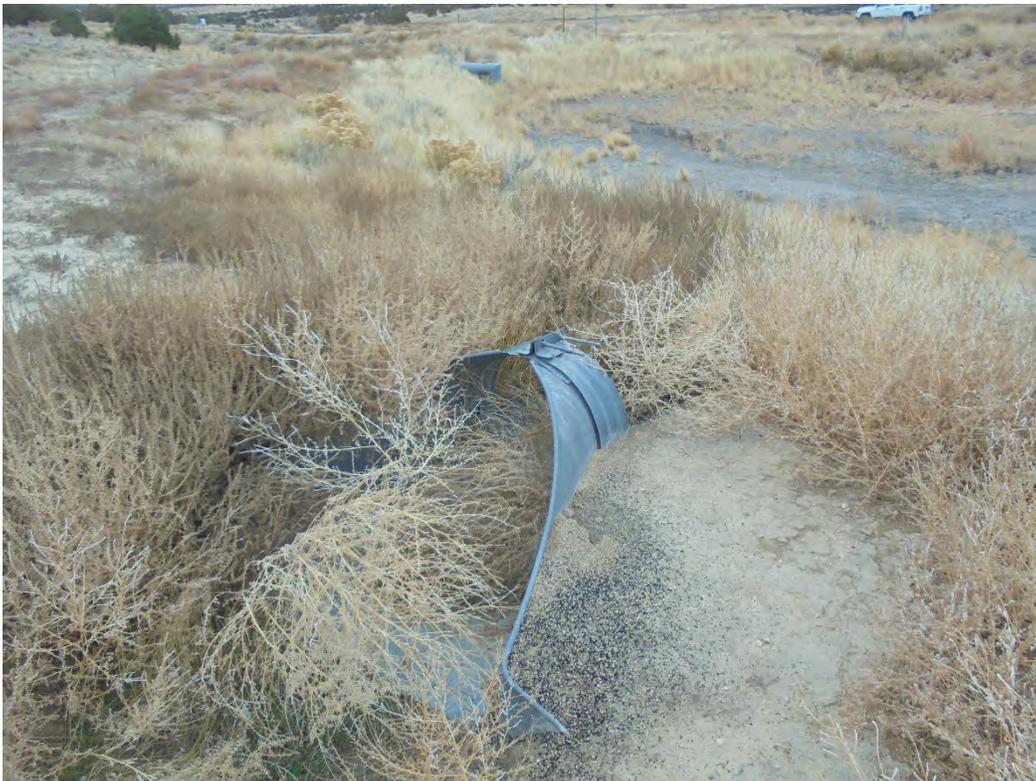
POND E NORTHEAST INLET NEEDS WEEDS REMOVED
