Re: **Annual Report, Wildcat Load Out, Coal Energy Group 2, LLC, Permit No. C/007/0033**

# 2018 ANNUAL REPORT

**WILDCAT COAL FINES ISSUE  
DIVISION ORDER-04 (WIND BLOWN FINES)  
SECOND QUARTER 2017**

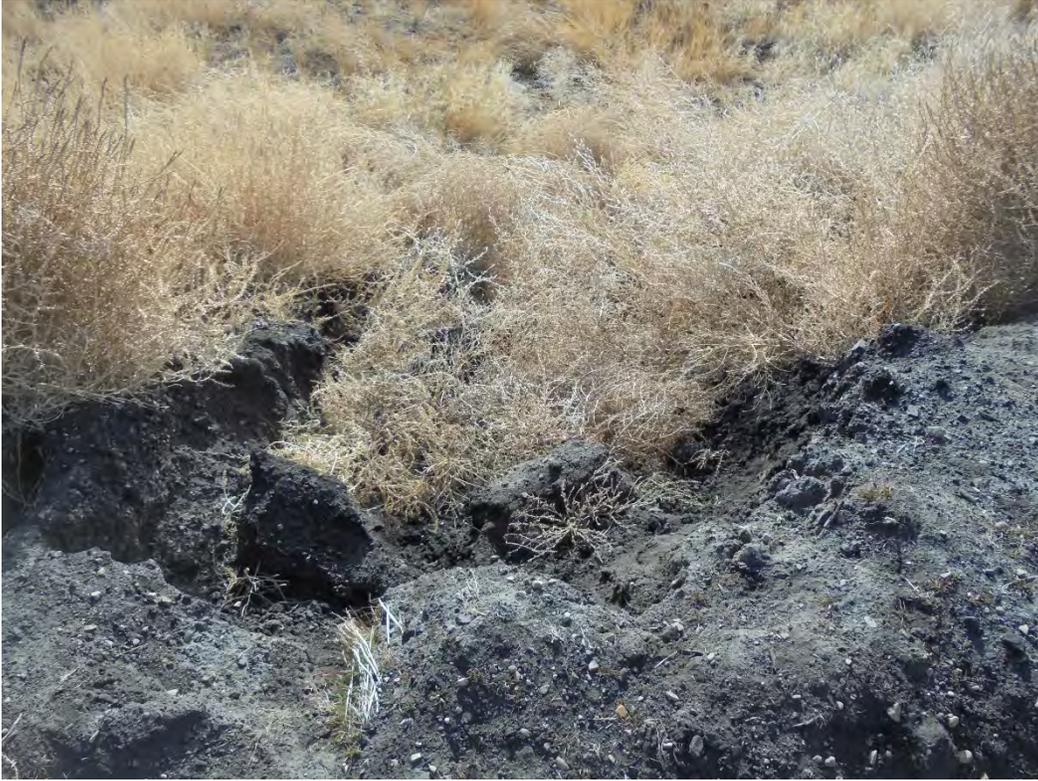
BANK ERROSION ABOVE WEEDS IS PREVIOUS PHOTOGRAPH

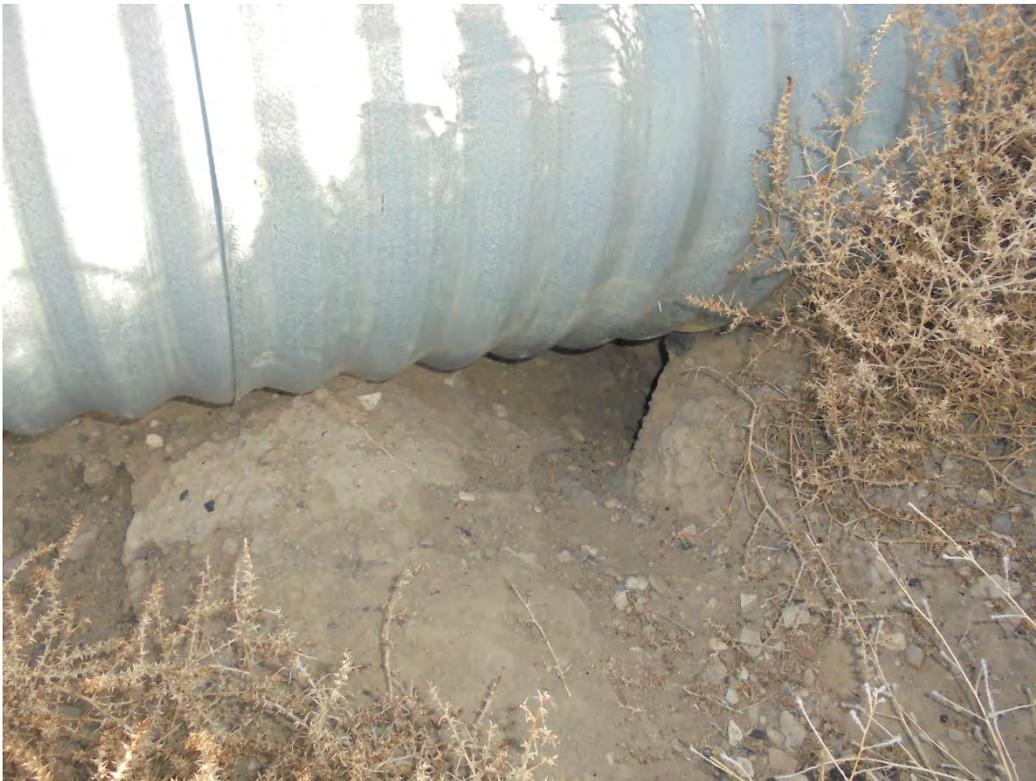
ANIMAL BURROW BY INLET OF PRINCIPLE SPILLWAY

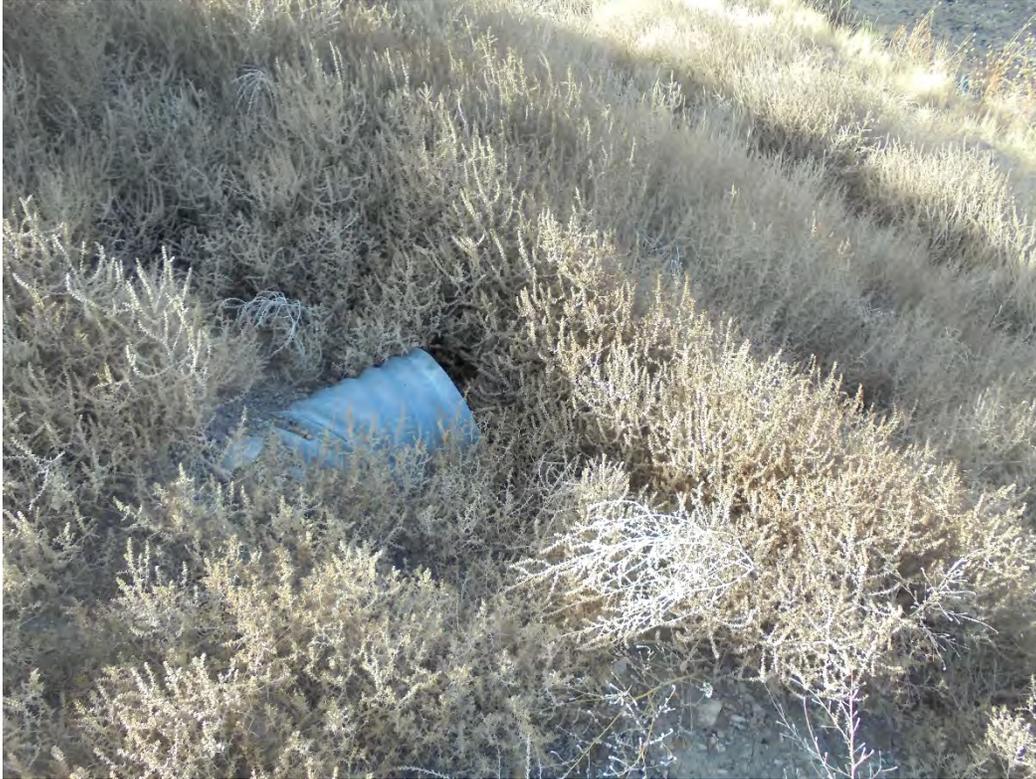
WEEDS BY INLET OF EMERGENCY SPILLWAY

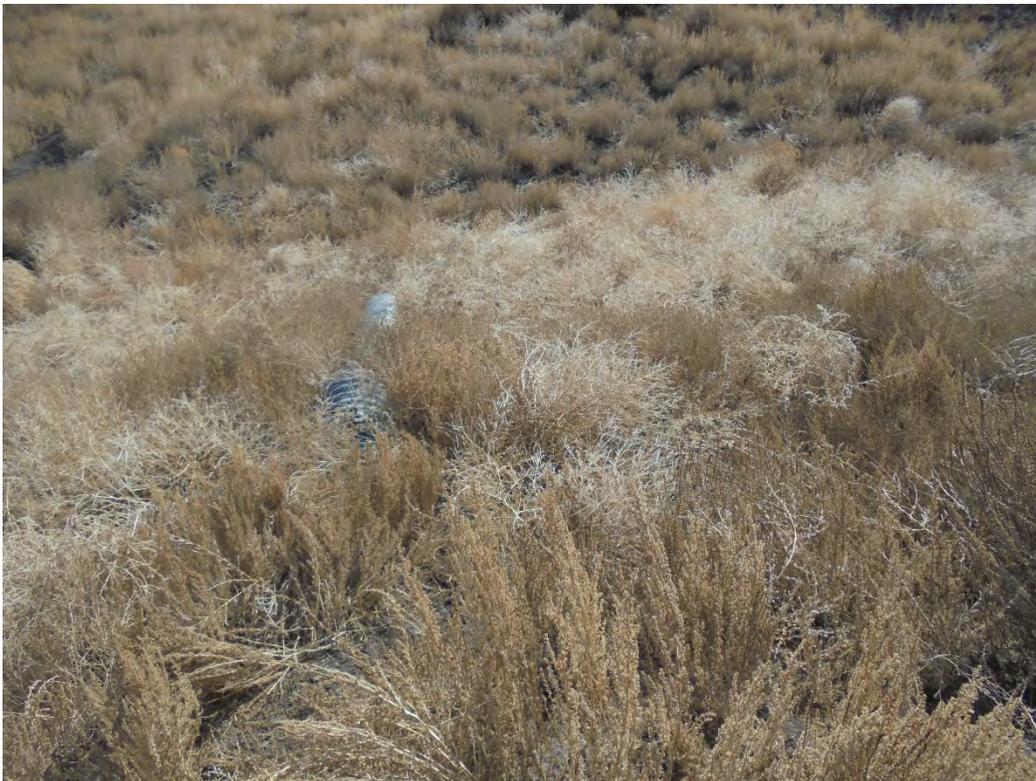
WEEDS BY OUTLET OF BOTH SPILLWAYS

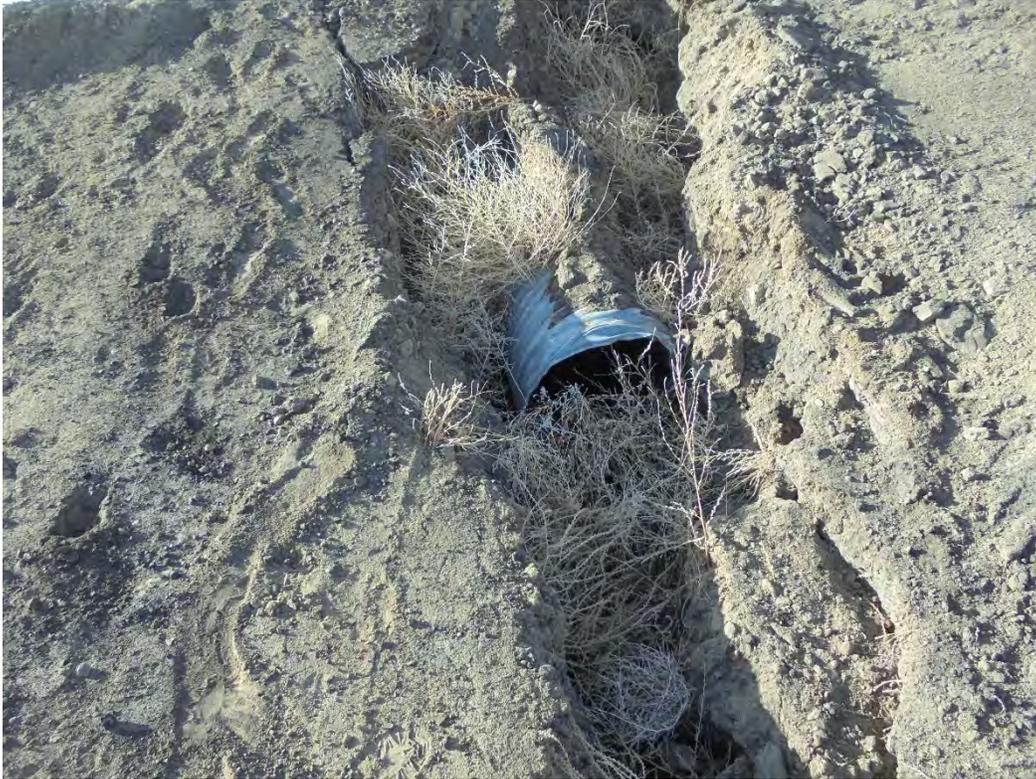
OUTLET OF SOUTH INLET UNDERCUTTING

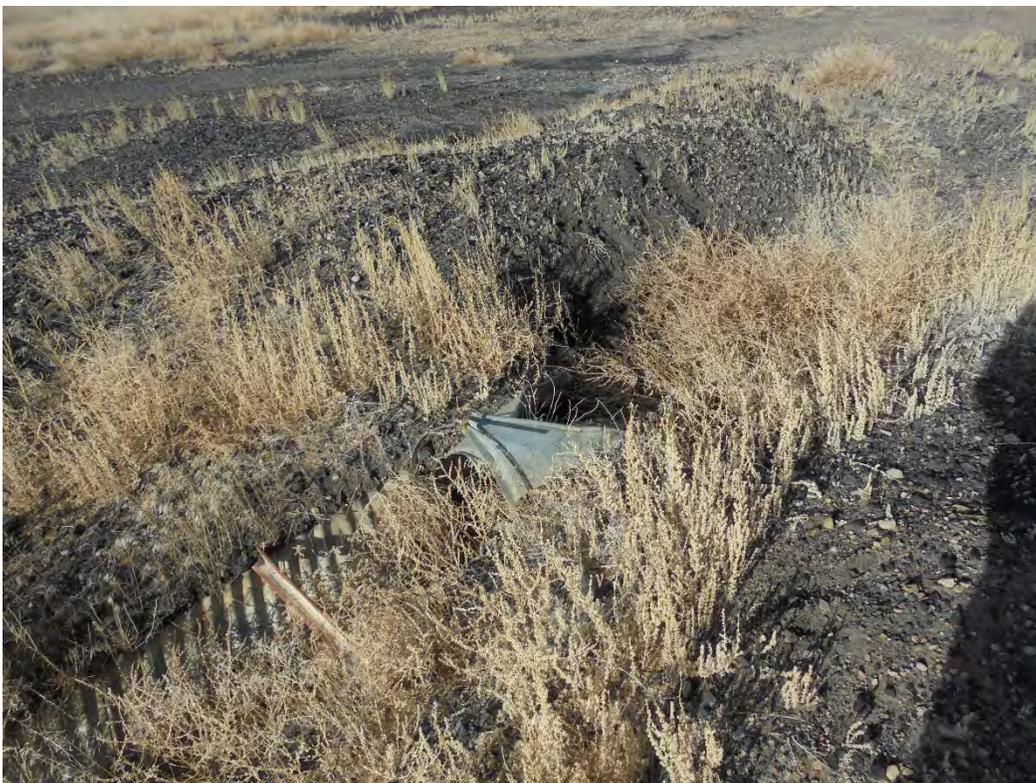
NORTH INLET WEEDS

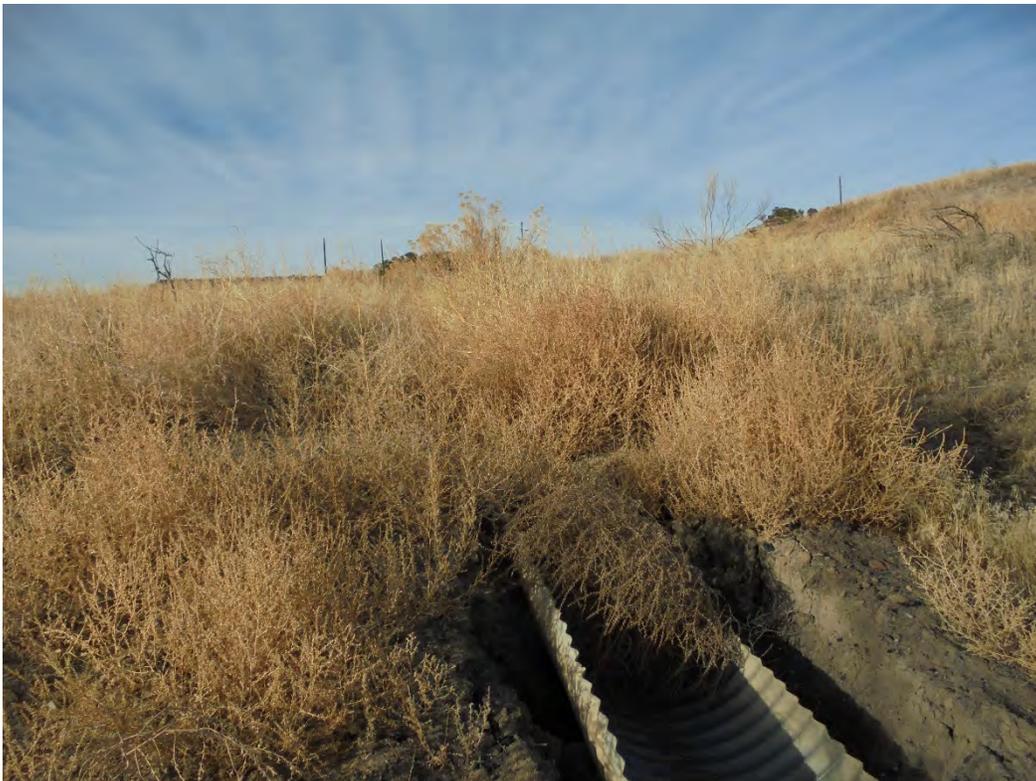
WEEDS IN WEST INLET NEEDS TO BE REMOVED

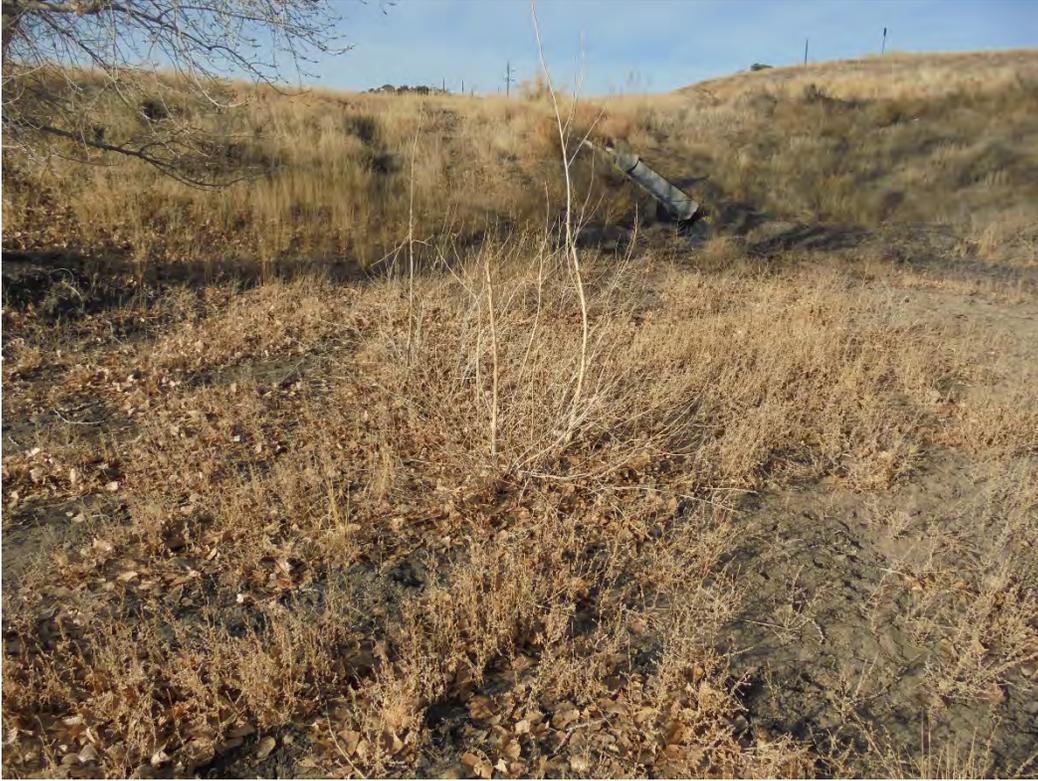
TREES IN POND STARTING TO GROW AGAIN (SHOULD BE REMOVED)

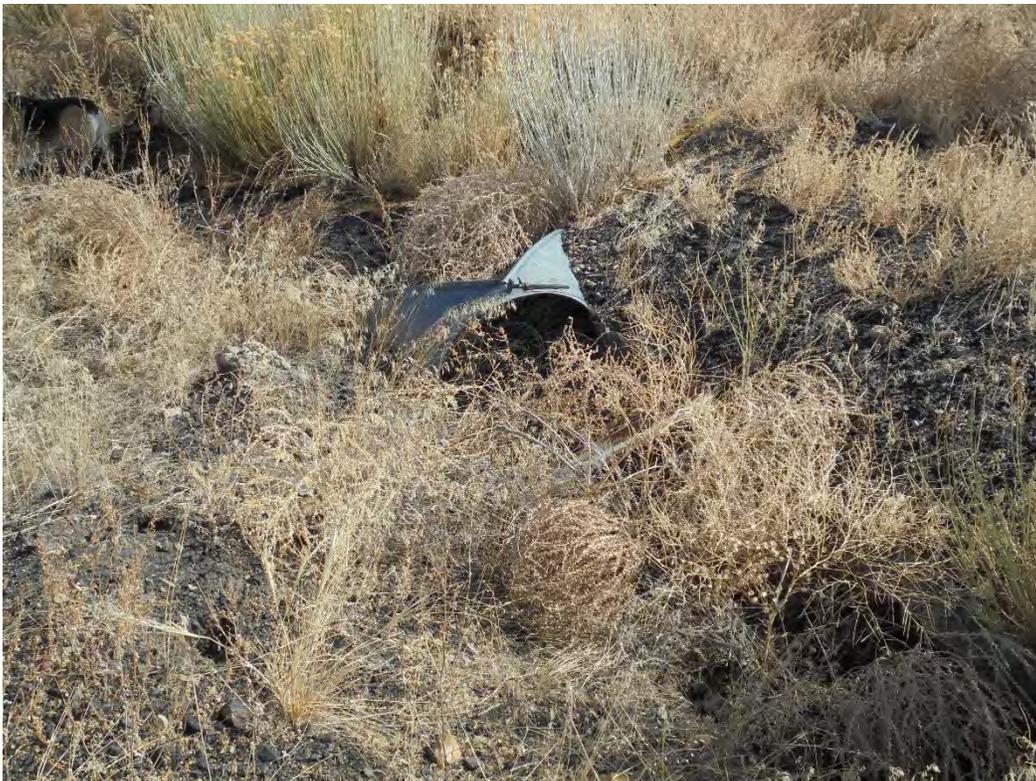
WEEDS & COAL FINES IN EAST INLET NEED TO BE REMOVED

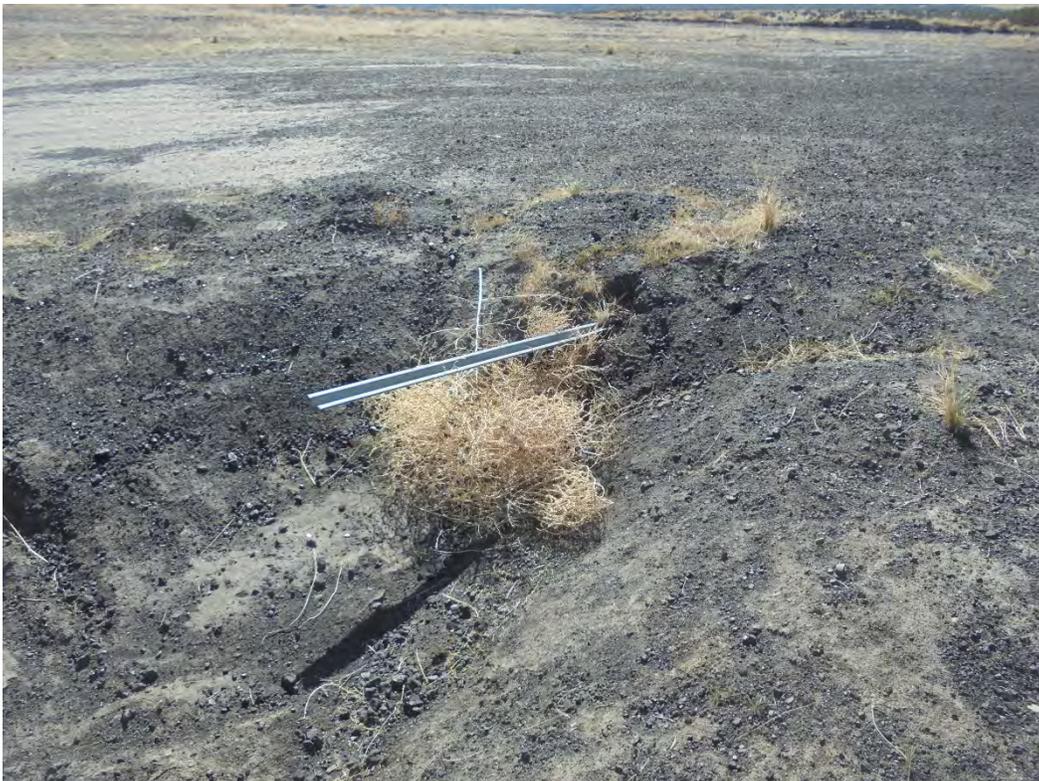
WEST INLET WEEDS

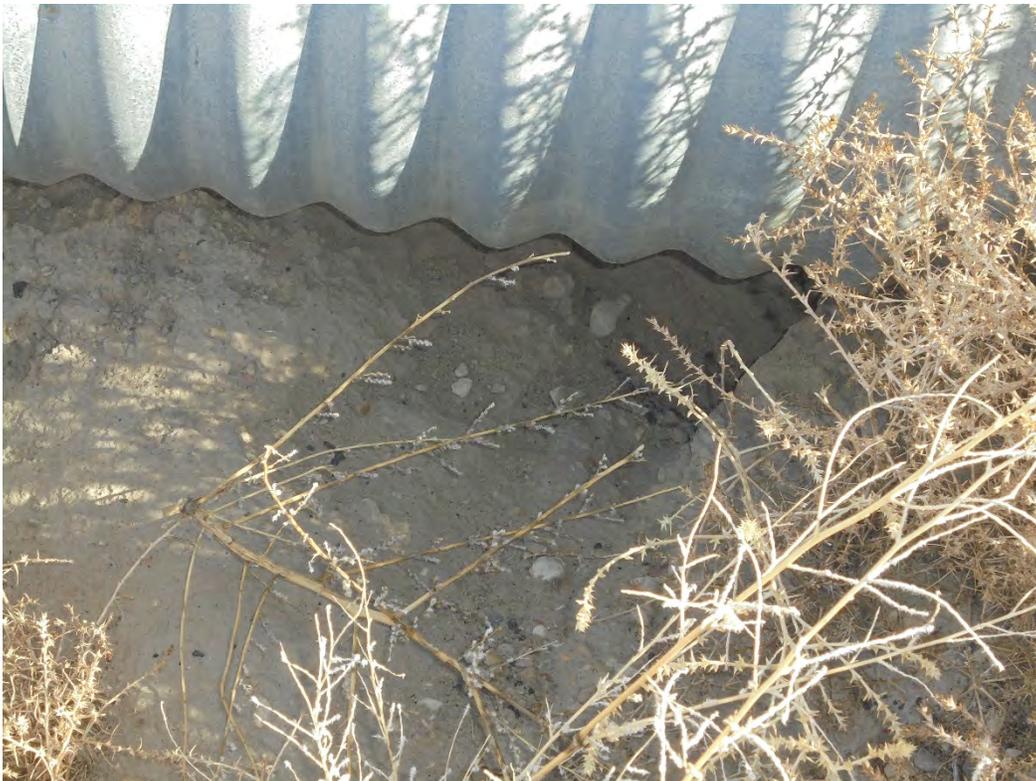
PRINCIPLE SPILLWAY ANIMAL HOLE

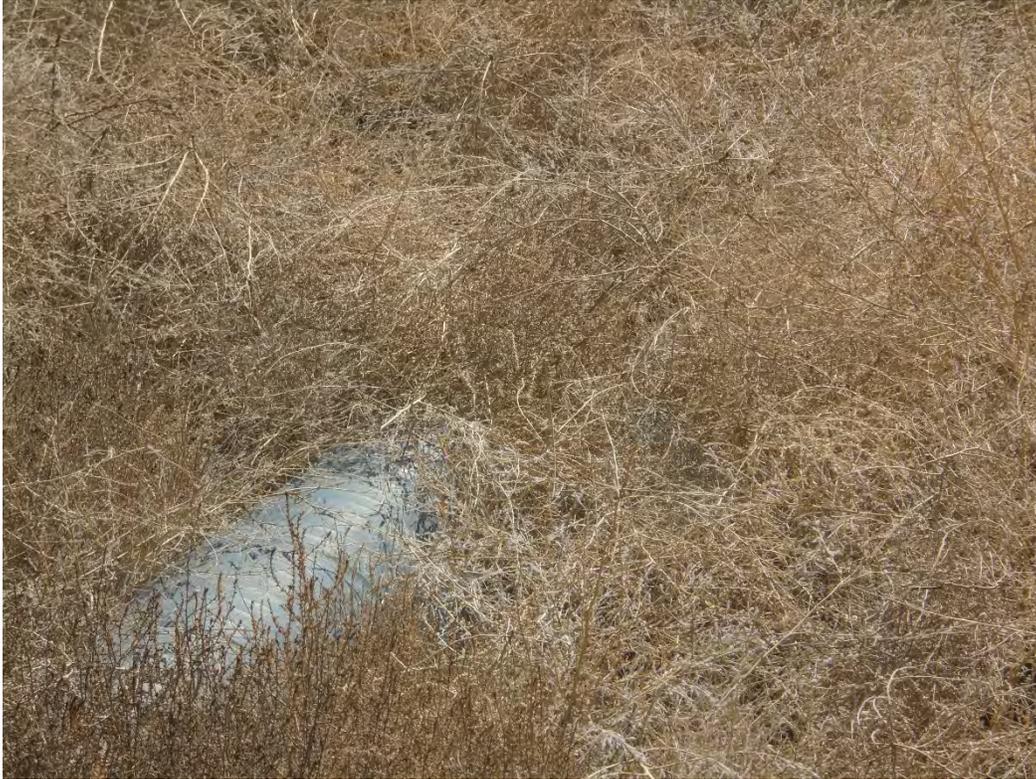
EMERGENCY SPILLWAY INLET WEEDS

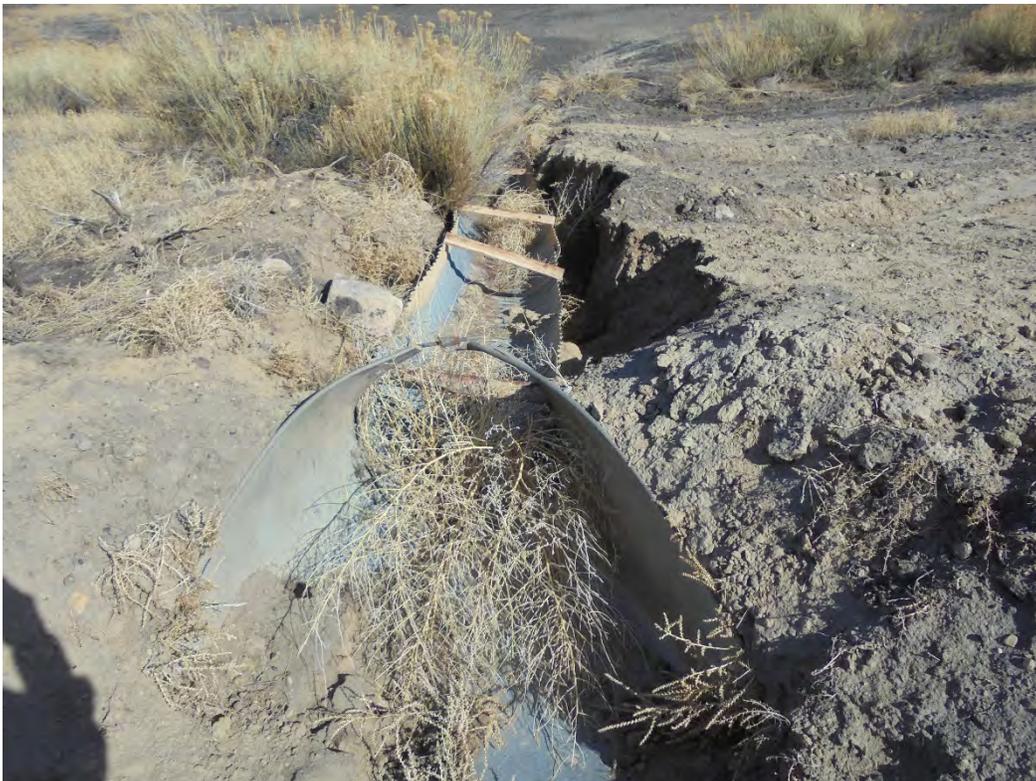
SOUTH INLET UNDERCUTTING

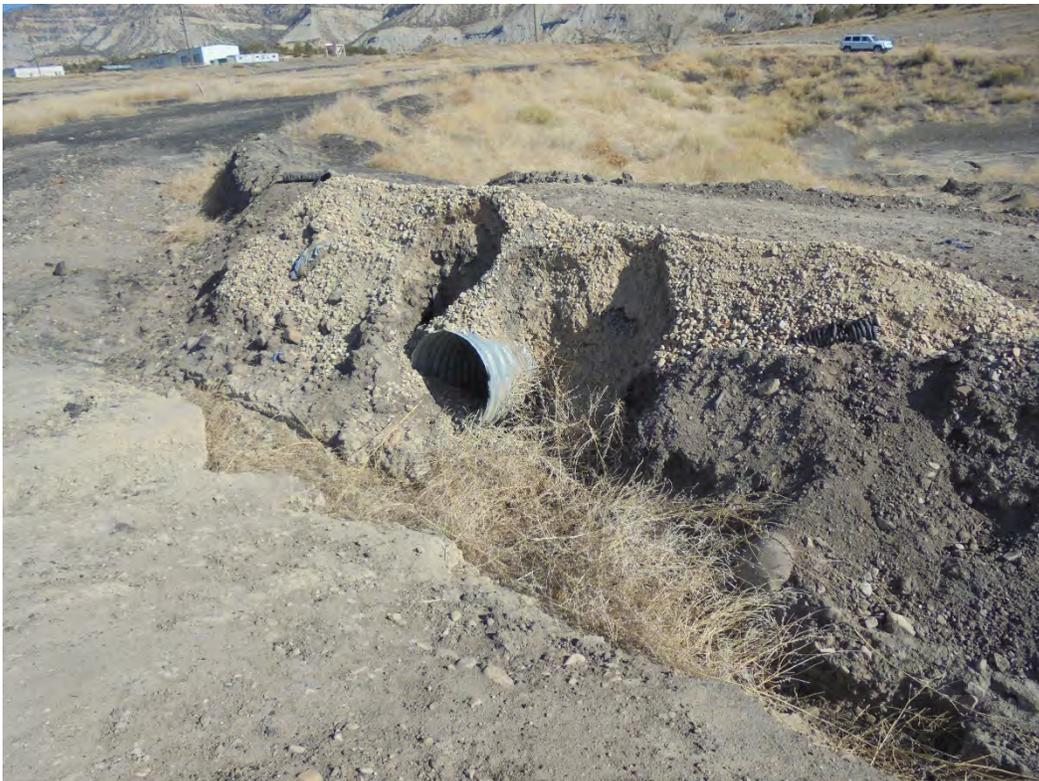
SOUTH INLET UNDERCUTTING

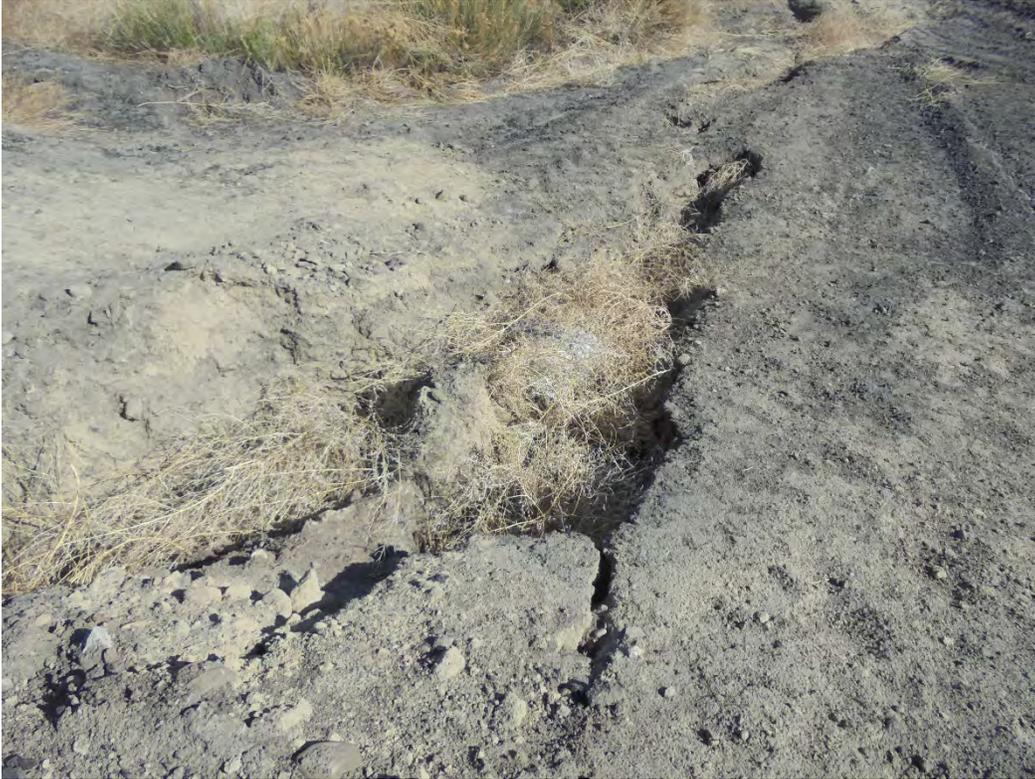
OUTLET OF SOUTH INLET IS UNDERCUTTING

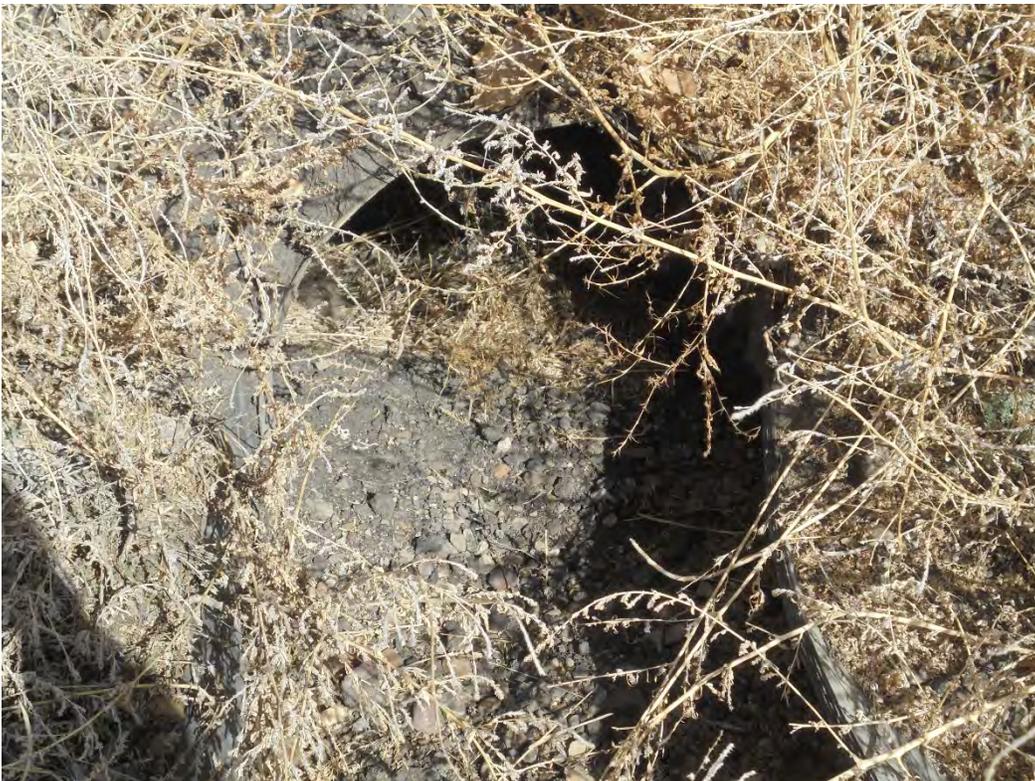
EMERGENCY SPILLWAY OUTLET NEEDS CLEANING

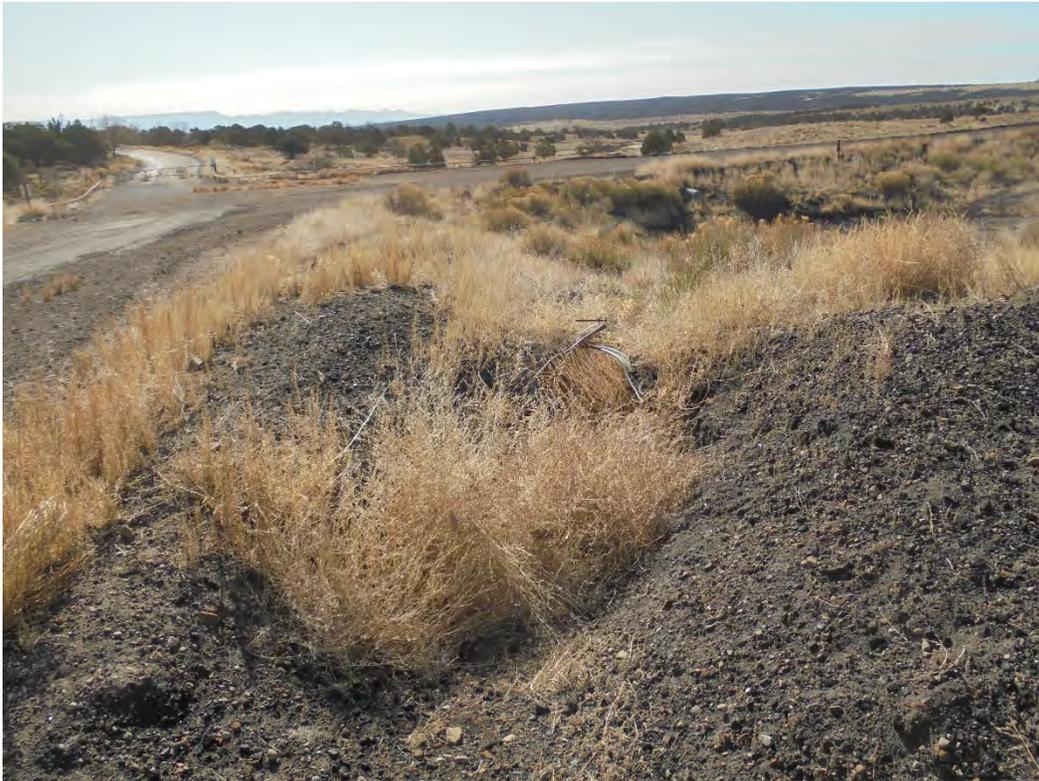
NORTH INLET NEEDS WEEDS REMOVED

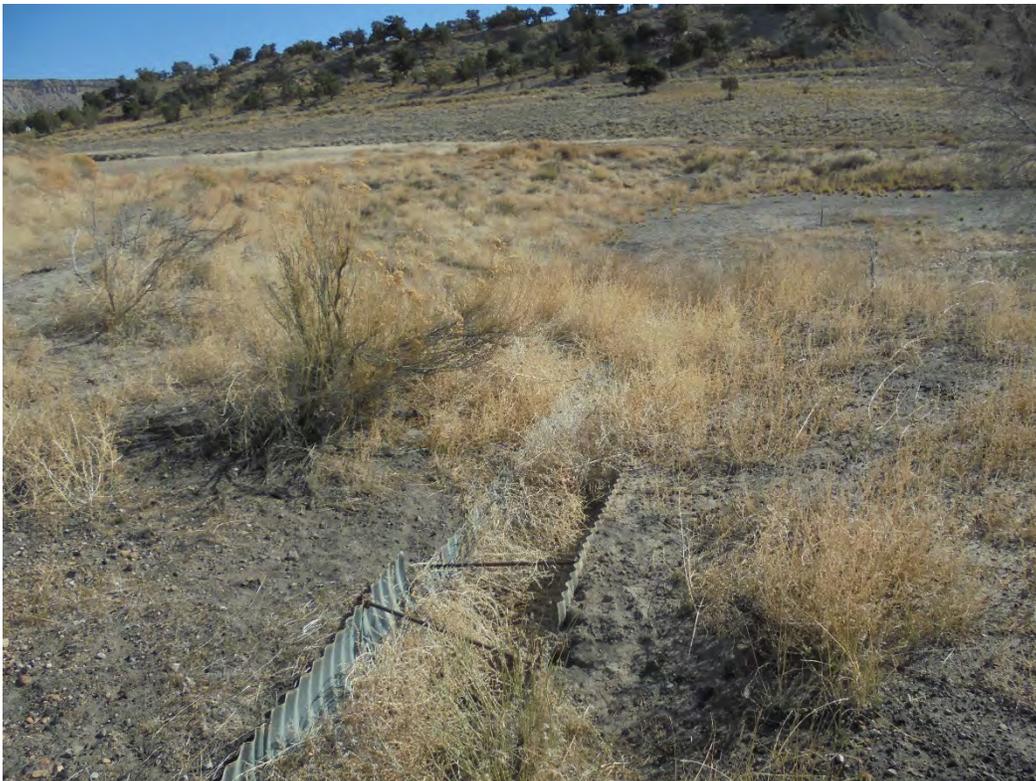
WEST INLET NEEDS CLEANING

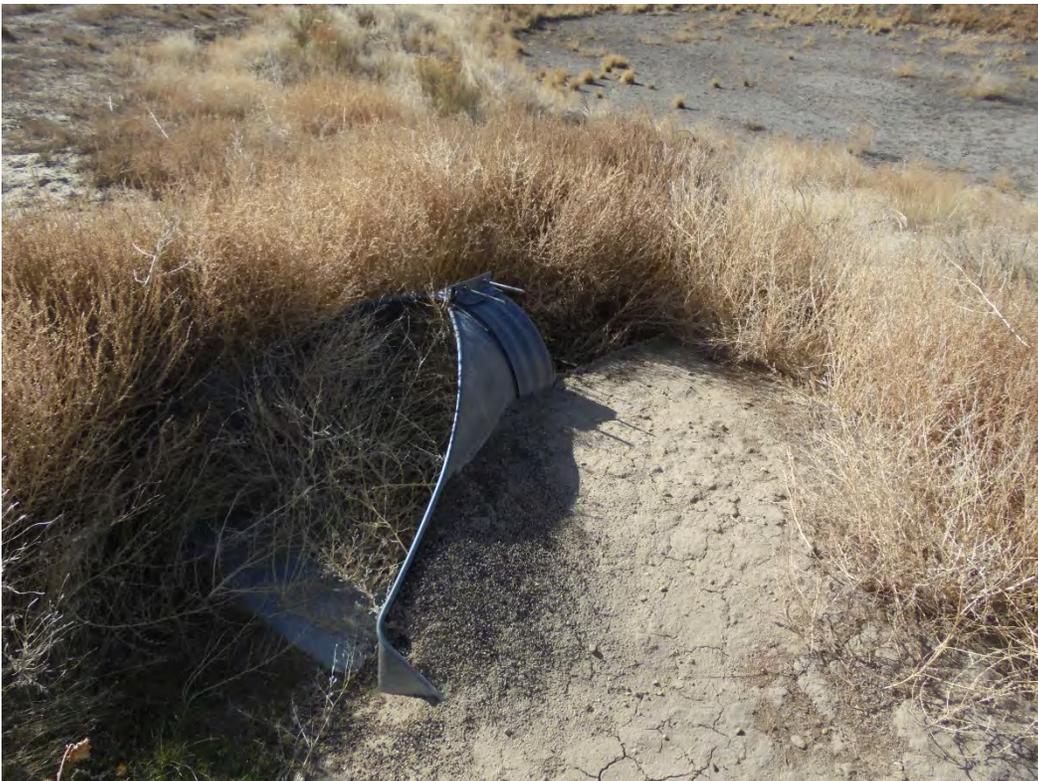
NORTH INLET NEEDS CLEANING

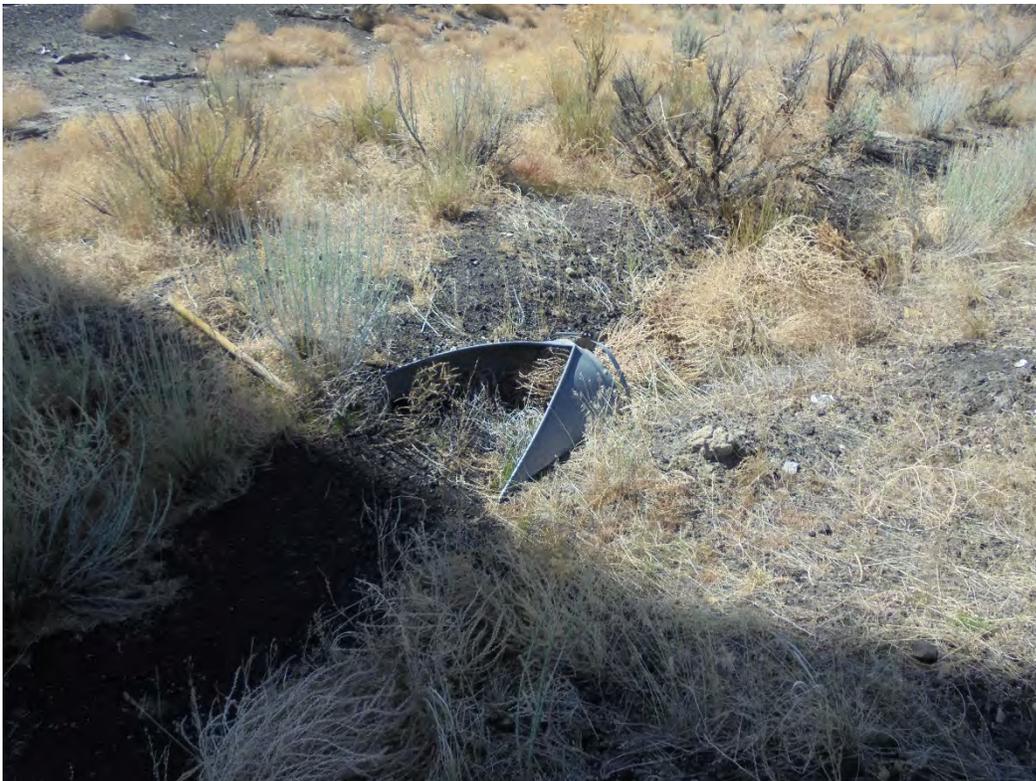
EAST INLET FULL OF WEEDS AND COAL FINES (NEEDS CLEANING)

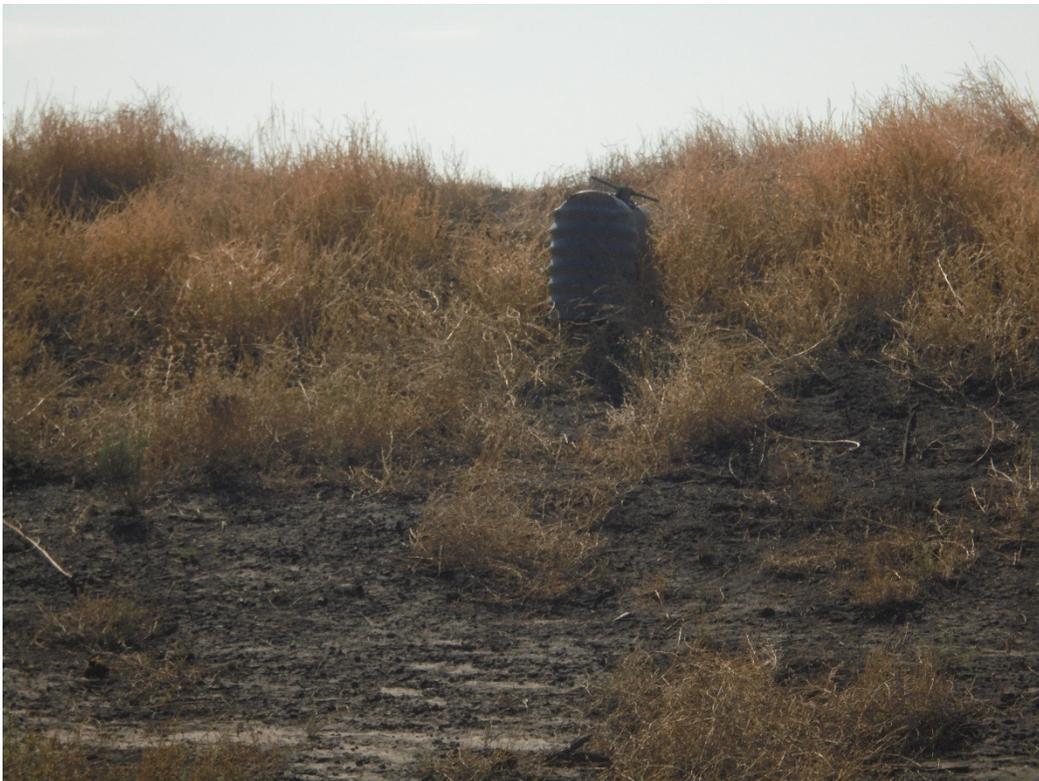
POND B WEEDS AT PRINCIPLE SPILLWAY INLET

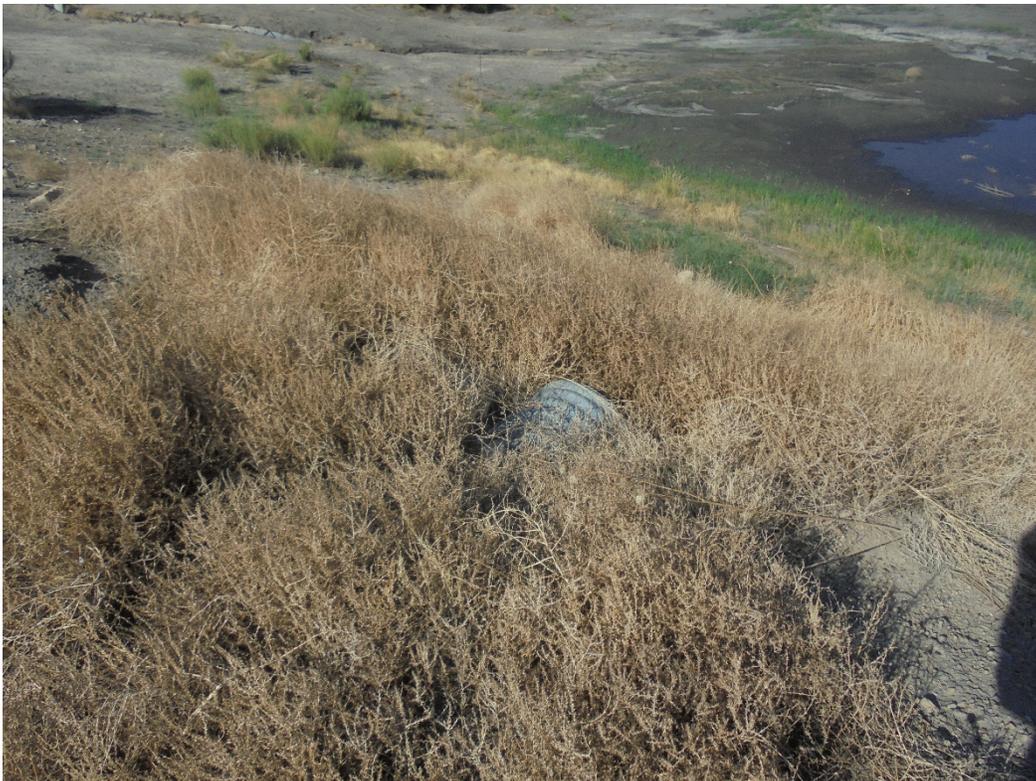
POND C EMERGENCY SPILLWAY INLET WEEDS

ANIMAL BURROW UNDER INLET OF PRINCIPAL SPILLWAY SHOULD  
BE FILLED, EMERGENCY SPILLWAY INLET WEEDS NEED TO BE  
REMOVED. EMERGENCY & PRINCIPLE OUTLET SPILLWAYS NEED  
TO HAVE WEEDS REMOVED. SOUTH INLET CMP IS BEING  
UNDERCUT AND SHOULD BE REPAIRED.

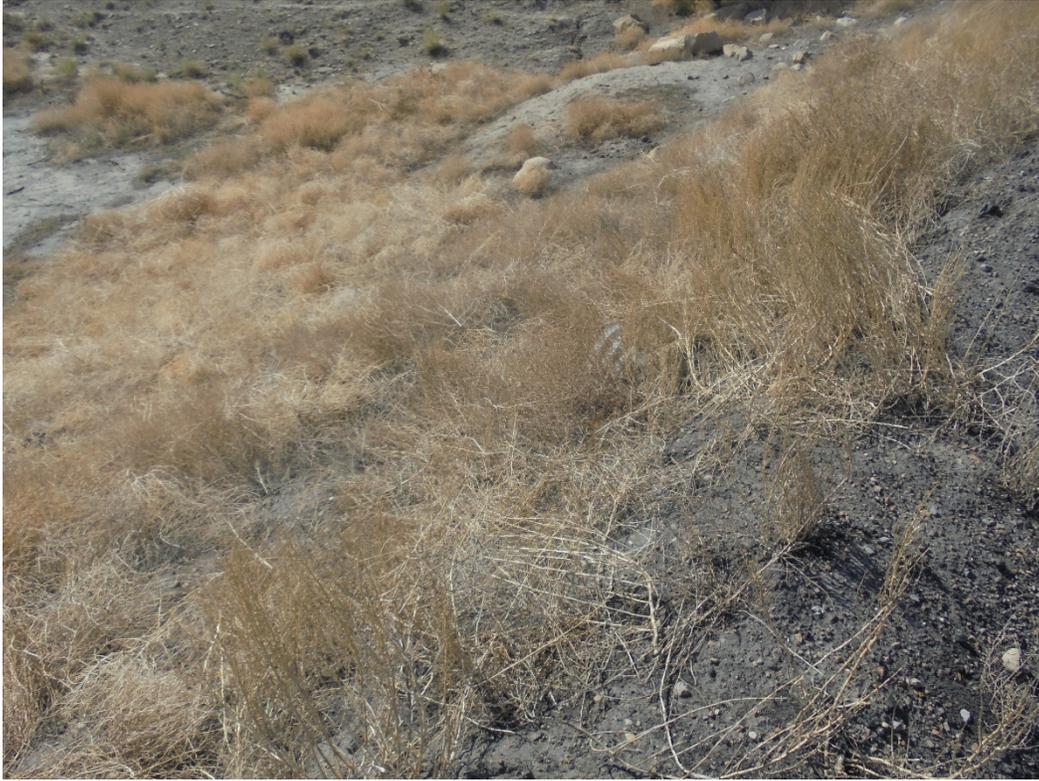
POND C EMERGENCY SPILLWAY OUTLET WEEDS

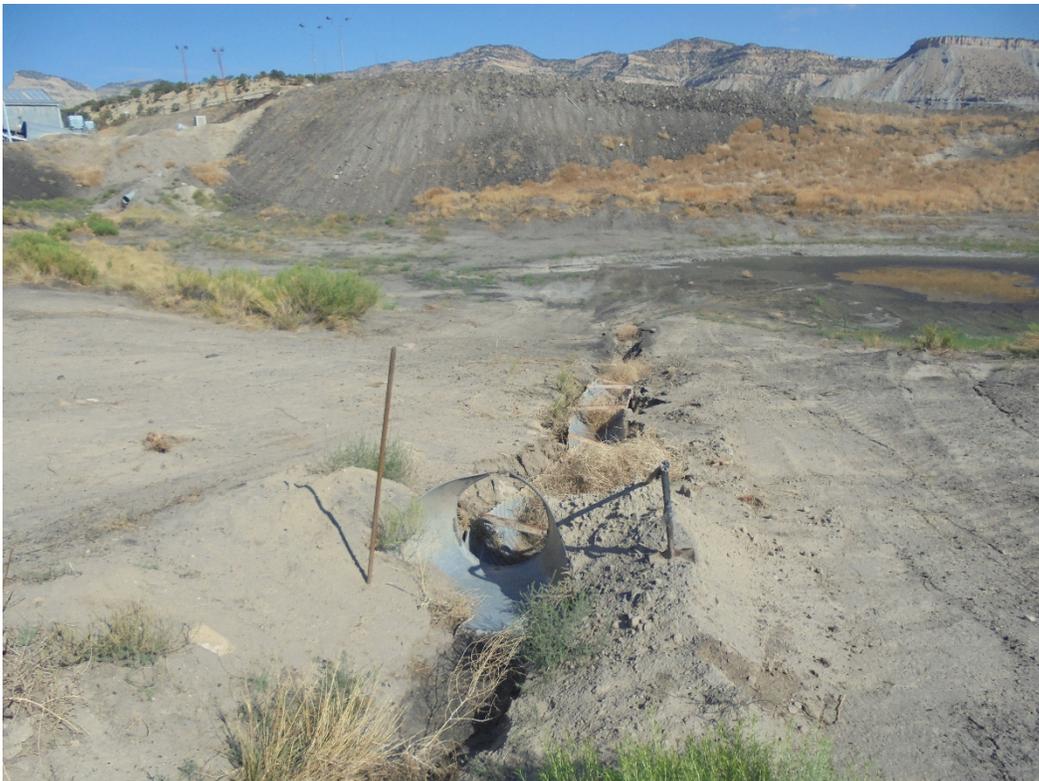
POND C SOUTH INLET UNDERCUTTING

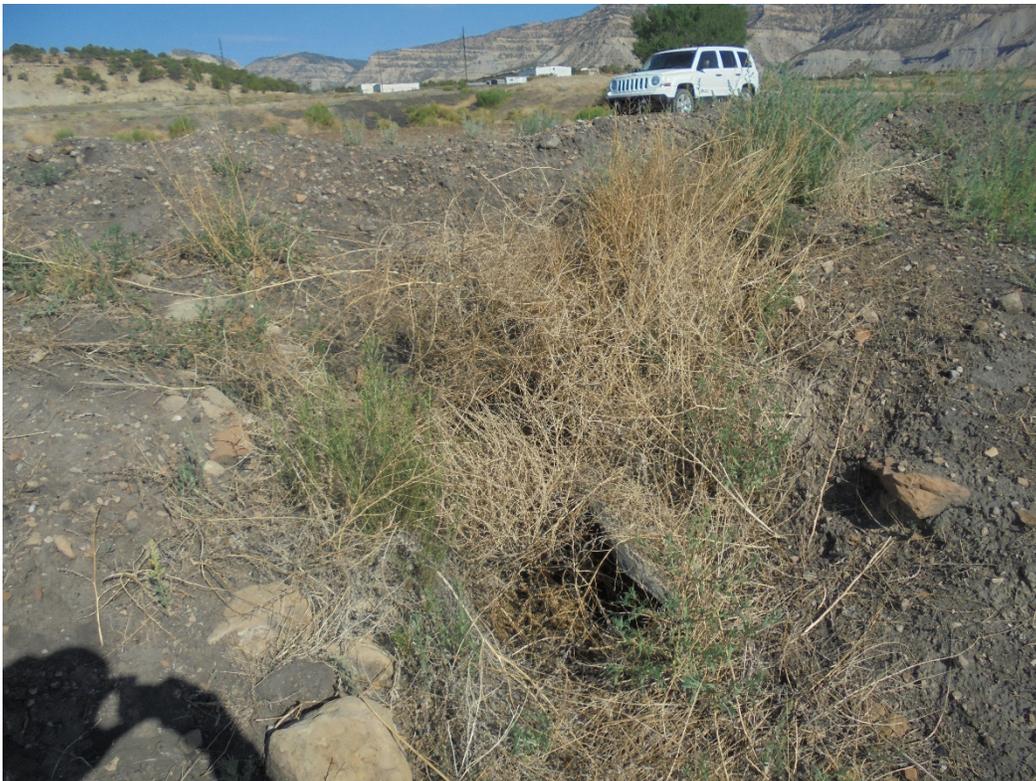
EMERGENCY SPILLWAY OUTLET NEEDS WEEDS REMOVED

Existing Storage Capacity: 1.131 ac-ft		
	Existing Sediment Storage Capacity (To Cleanout): 0.34 ac-ft (See Section 4)		
	<b>3. Principle and emergency spillway elevations</b>		
	Principle spillway elevation: 6,139.0'		
	Emergency spillway elevation: 6,140.0'		
<b>4. Field Information:</b> Provide current water elevation, whether pond is discharging, type and number of samples taken, monitoring/instrumentation information, inlet/outlet conditions or other related activities associated with the pond including but not limited to sediment cleanout, pond decanting, embankment erosion/repairs, monitoring information, vegetation on outslopes of embankment erosion/repairs, monitoring information, vegetation on outslopes of embankments, etc.			
During the annual inspection, December 3, 2018, the vegetative was covered with snow with no signs of erosion. The sediment cleanout level was 13" before the pond had to be clean out. The spillway outlet needs weeds removed. See attached photograph.

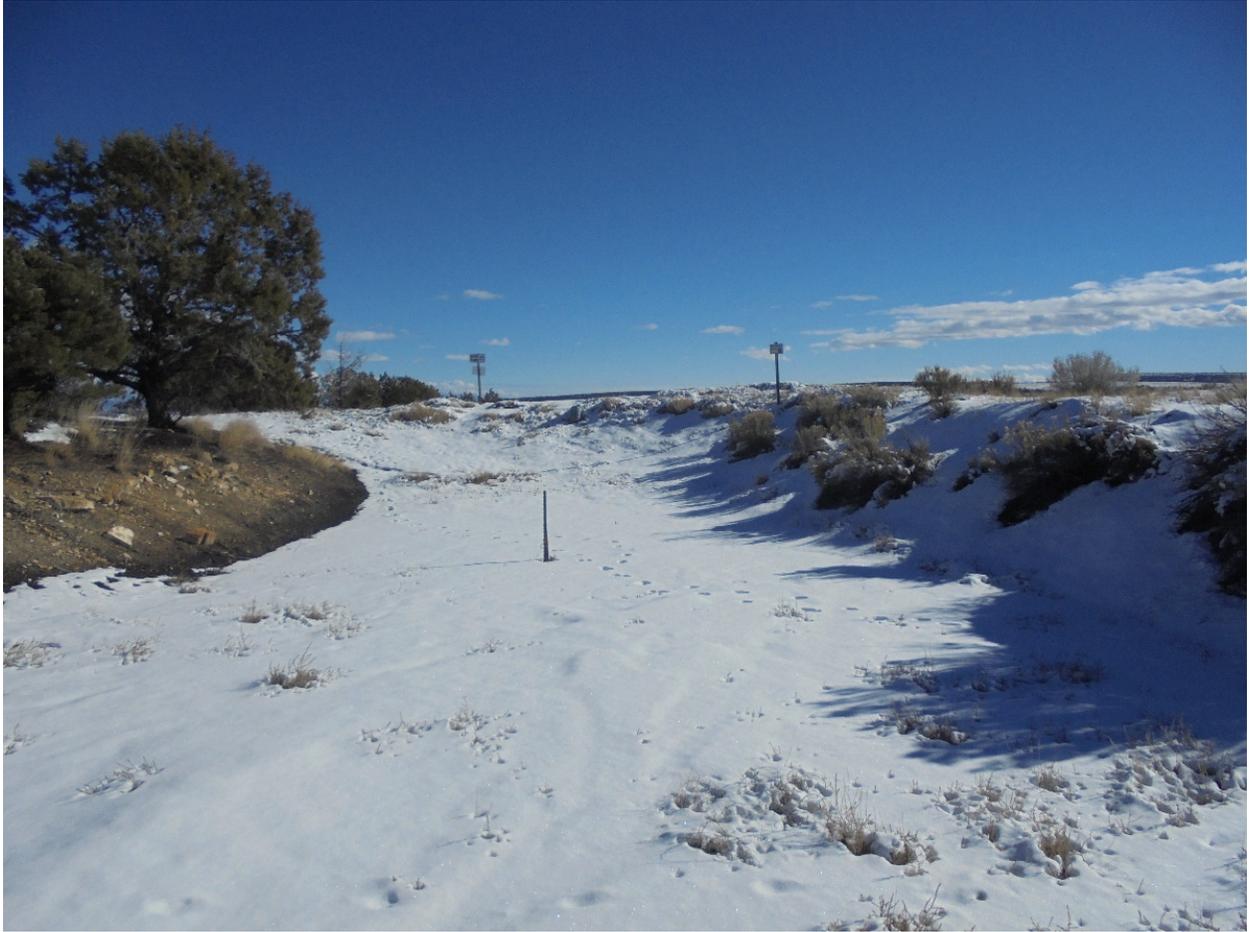
POND B

The sediment pond was dry, see the attached photograph. Sediment is 20.5" below cleanout level.			
<b>Qualified Statement</b>		I hereby certify that I am experienced in the construction of impoundments; I am qualified and authorized under the direction of a Registered Professional Engineer to inspect the condition and appearance of impoundments in accordance with the certified and approved designs for this structure, that the impoundment has been maintained in accordance with approved design and meet or exceed the minimum design requirements under all applicable federal, state and local regulations; and, that inspections and inspection reports are made by myself and include any appearances of instability, structural weakness or other hazardous conditions of the structure affecting stability.
