Re: **Annual Report, Wildcat Load Out, Coal Energy Group 2, LLC, Permit No. C/007/0033**

# 2018 ANNUAL REPORT

**WILDCAT COAL FINES ISSUE  
DIVISION ORDER-04 (WIND BLOWN FINES)  
SECOND QUARTER 2017**

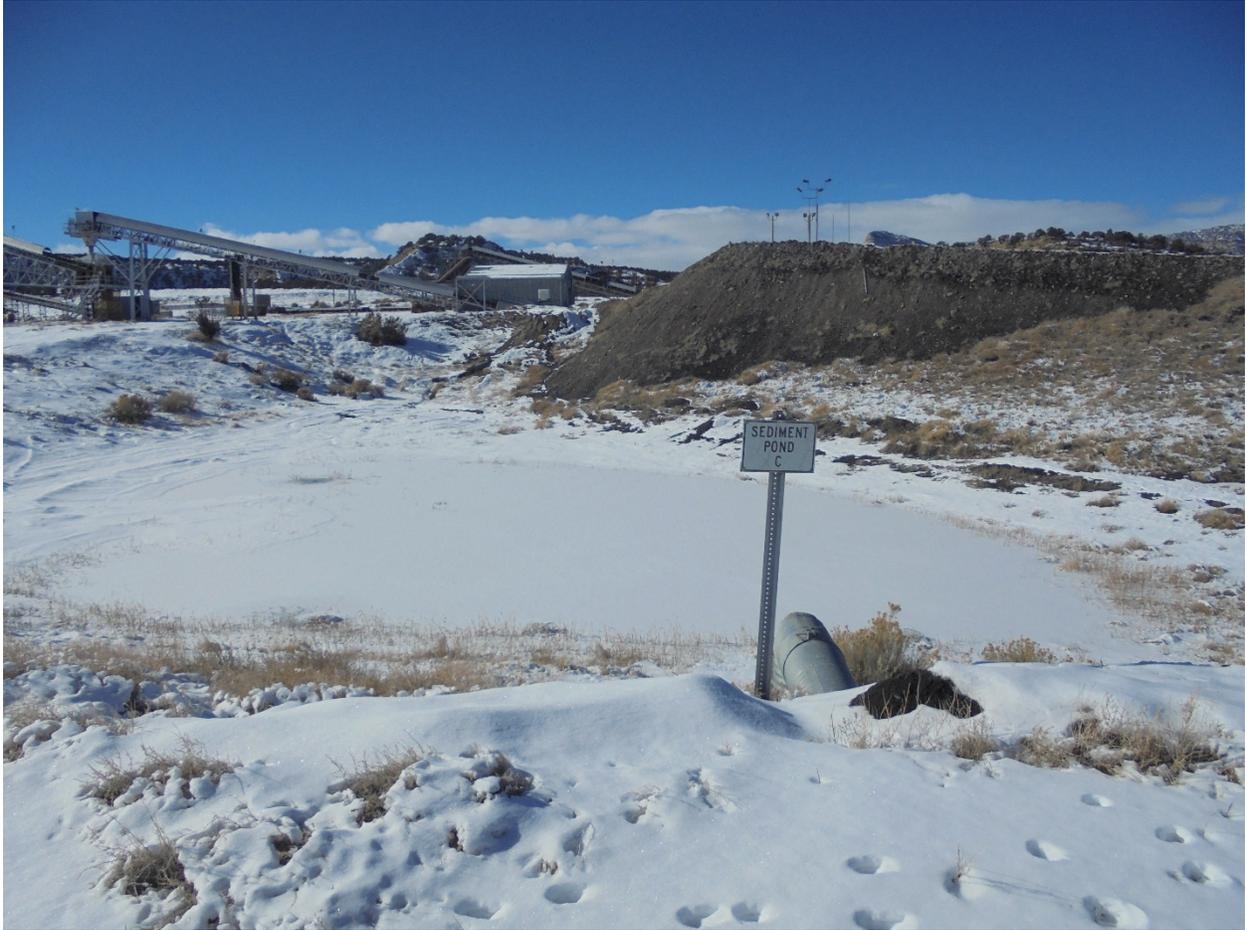
POND C

Existing Storage Capacity: 4.174 ac-ft		
	Existing Sediment Storage Capacity (To Cleanout): 1.08 ac-ft		
	<b>3. Principle and emergency spillway elevations</b>		
	Principle spillway elevation: 6,137.0'		
	Emergency spillway elevation: 6,138.0'		
<b>4. Field Information:</b> Provide current water elevation, whether pond is discharging, type and number of samples taken, monitoring/instrumentation information, inlet/outlet conditions or other related activities associated with the pond including but not limited to sediment cleanout, pond decanting, embankment erosion/repairs, monitoring information, vegetation on out slopes of embankment erosion/repairs, monitoring information, vegetation on out slopes of embankments, etc.			
During the annual inspection, December 3, 2018, the vegetative was covered with snow with no signs of erosion. Animal hole under inlet of principle spillway needs to be filled. Emergency spillway inlet needs weeds removed. Emergency and principle outlet spillways need to have weeds also removed.

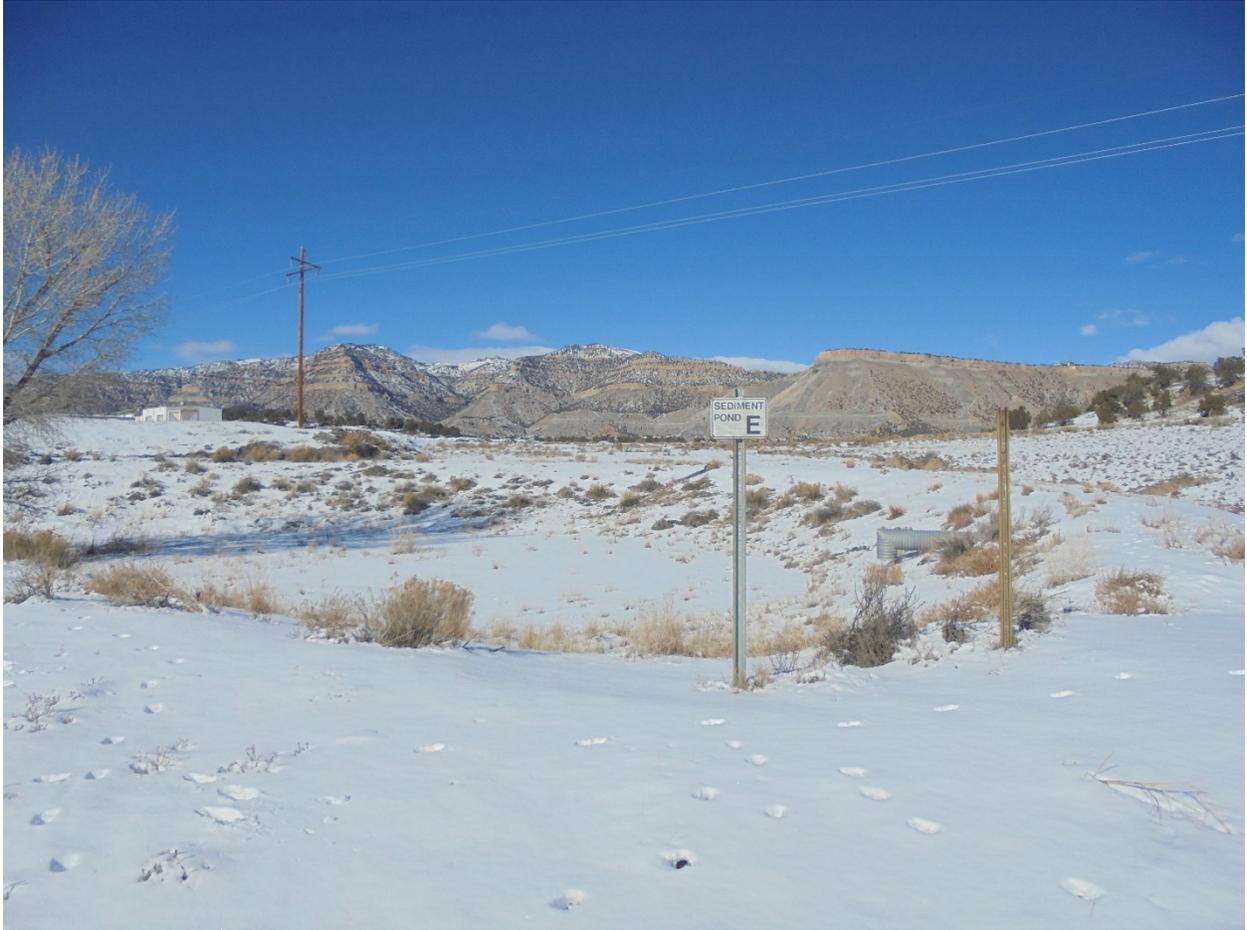
POND E

Existing Storage Capacity: 1.092 ac-ft		
	Existing Sediment Storage Capacity (To Cleanout): 0.39 ac-ft		
	<b>3. Principle and emergency spillway elevations</b>		
	Principle spillway elevation: 6,145.0'		
	Emergency spillway elevation: 6,146.0'		
<b>4. Field Information:</b> Provide current water elevation, whether pond is discharging, type and number of samples taken, monitoring/instrumentation information, inlet/outlet conditions or other related activities associated with the pond including but not limited to sediment cleanout, pond decanting, embankment erosion/repairs, monitoring information, vegetation on outslopes of embankment erosion/repairs, monitoring information, vegetation on outslopes of embankments, etc.			
During the annual inspection, December 3, 2018, the vegetative was covered with snow with no signs of erosion. Trees are starting to grow again in the pond and should be removed.

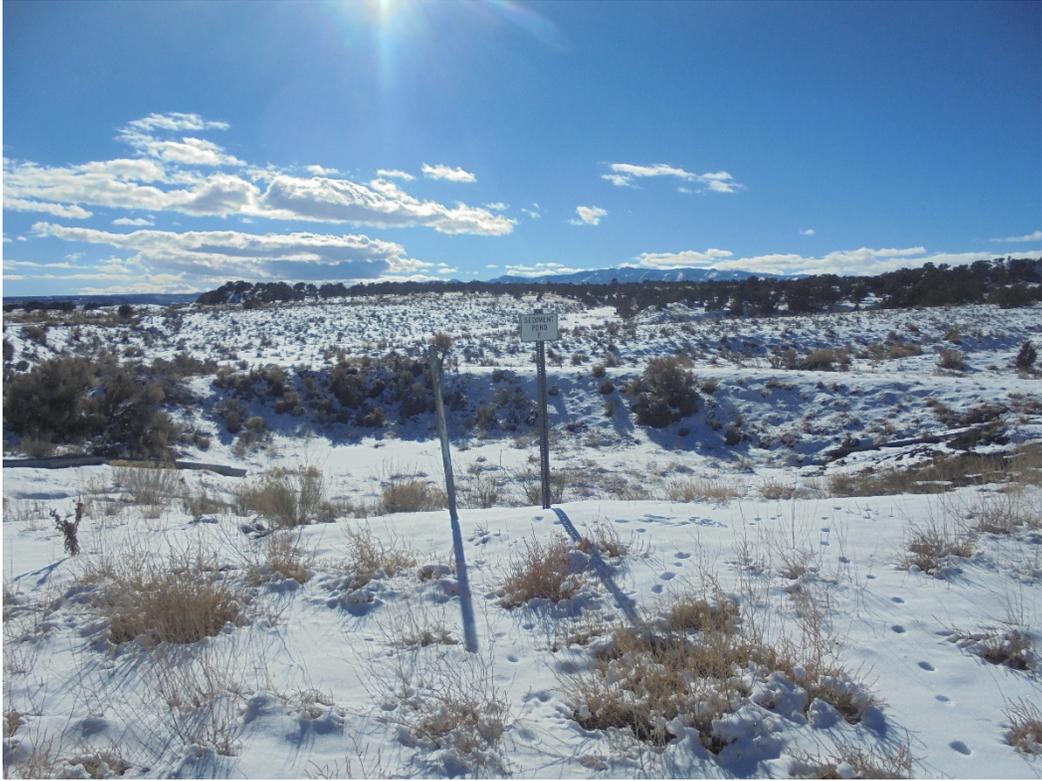
POND F

The sediment pond was dry. See the attached photograph. Sediment is approximately 12.5" below cleanout level.
