Coal Energy Group 2

Re: **2019 Annual Report, Permit No. C/007/0033**

On behalf of Coal Energy Group 2, LLC, Attached to this letter is the 2019 annual report for the Wildcat Loadout, Permit No. C/007/0033.

2019 ANNUAL REPORT

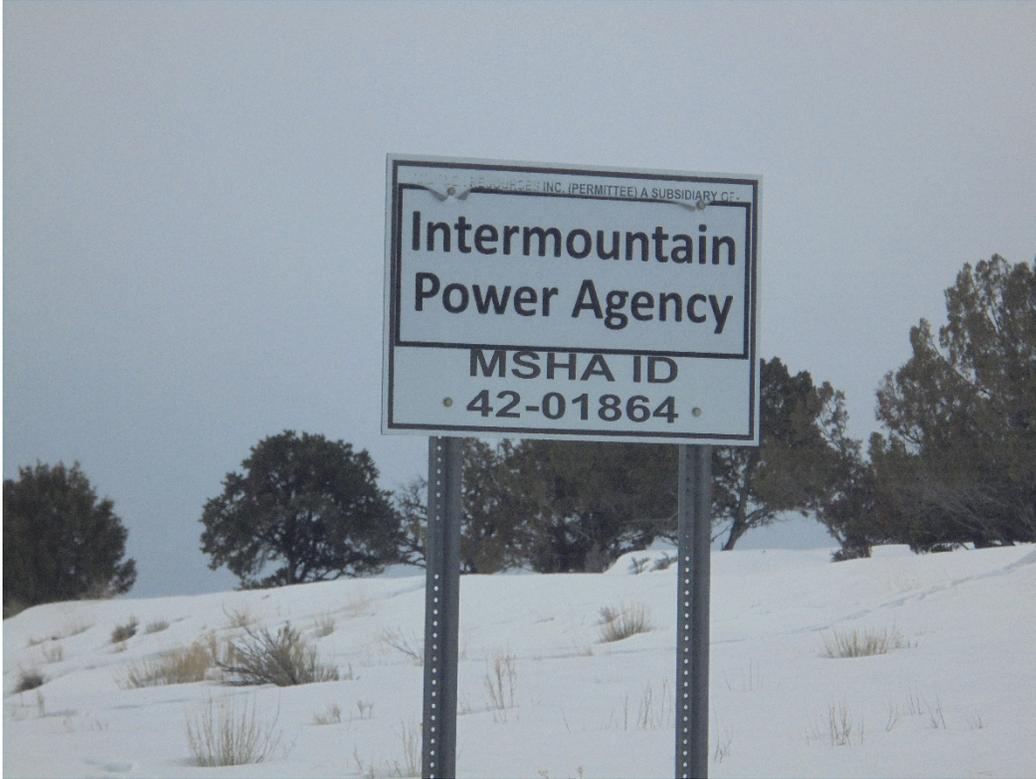
REFUSE PILE SIGN

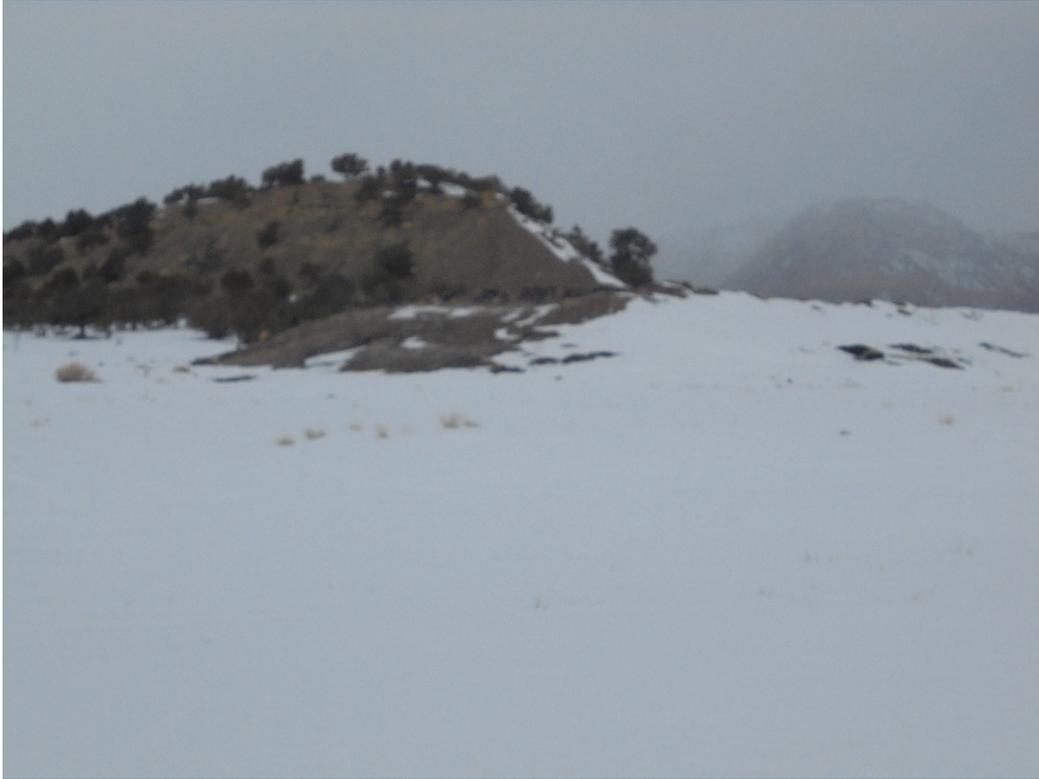
SOUTH SIDE OF REFUSE PILE

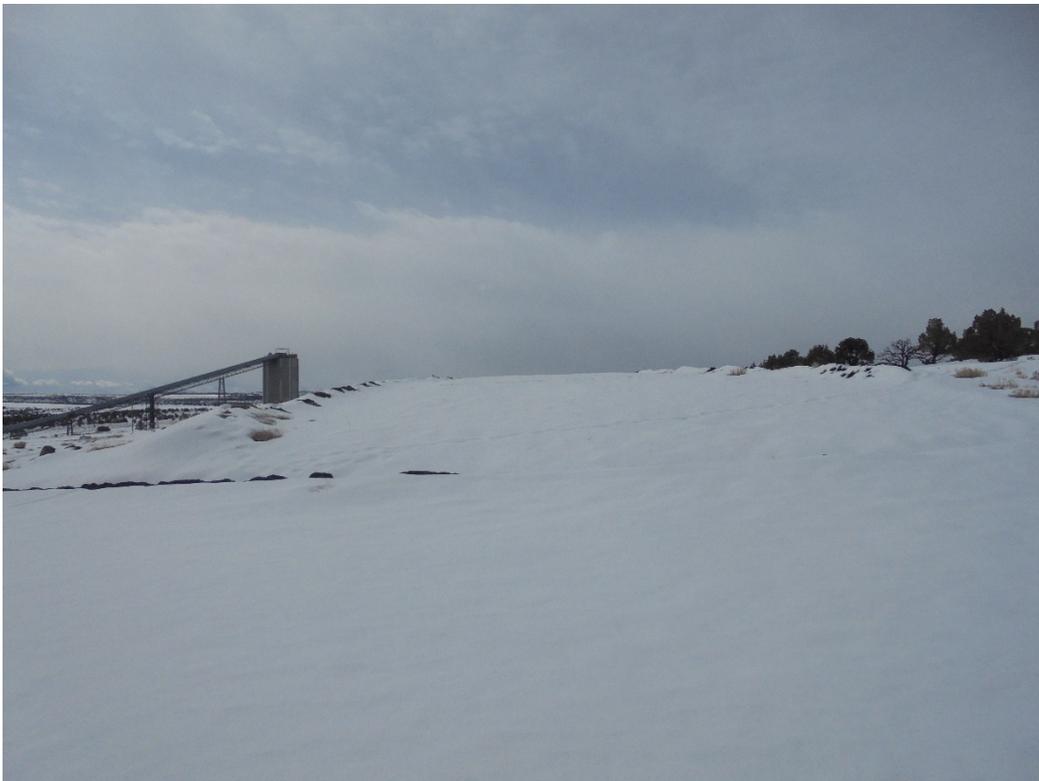
NORTH SIDE OF REFUSE PILE

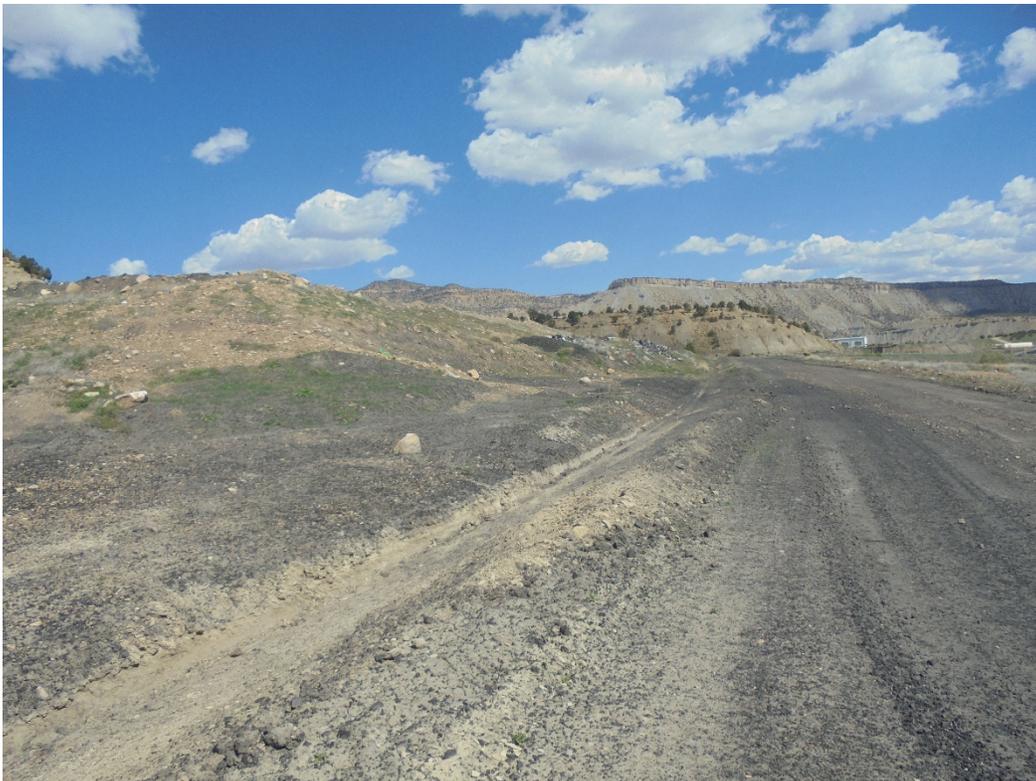
EAST DRAINAGE DITCH

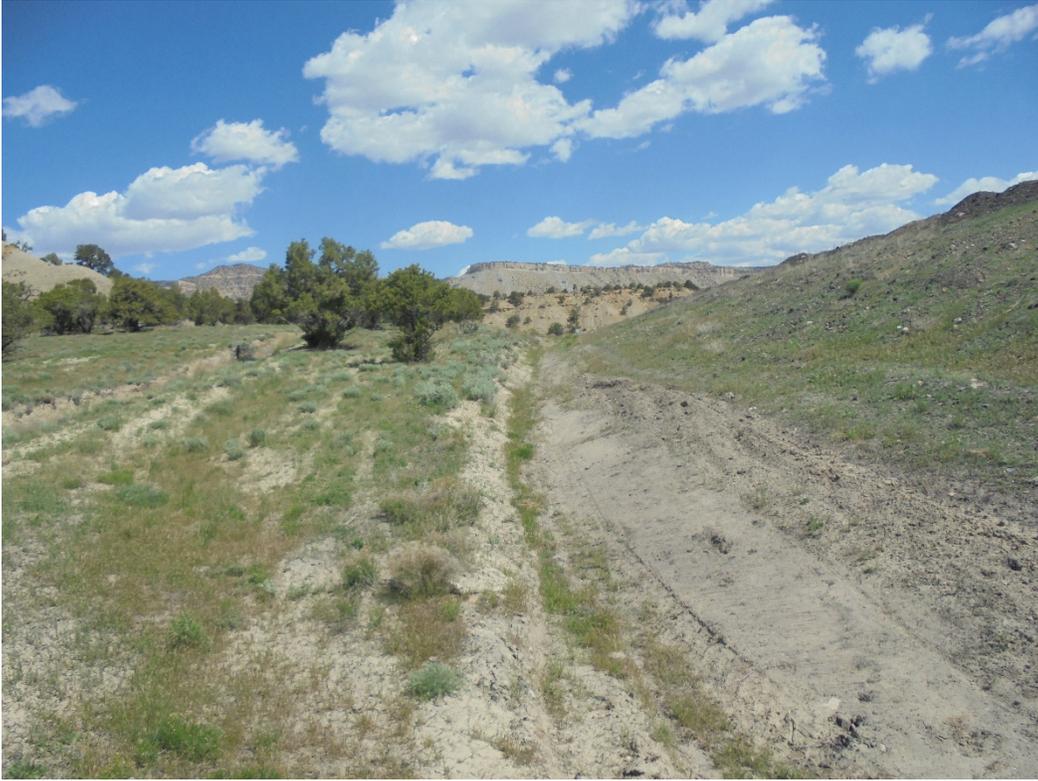
WEST DRAINAGE DITCH

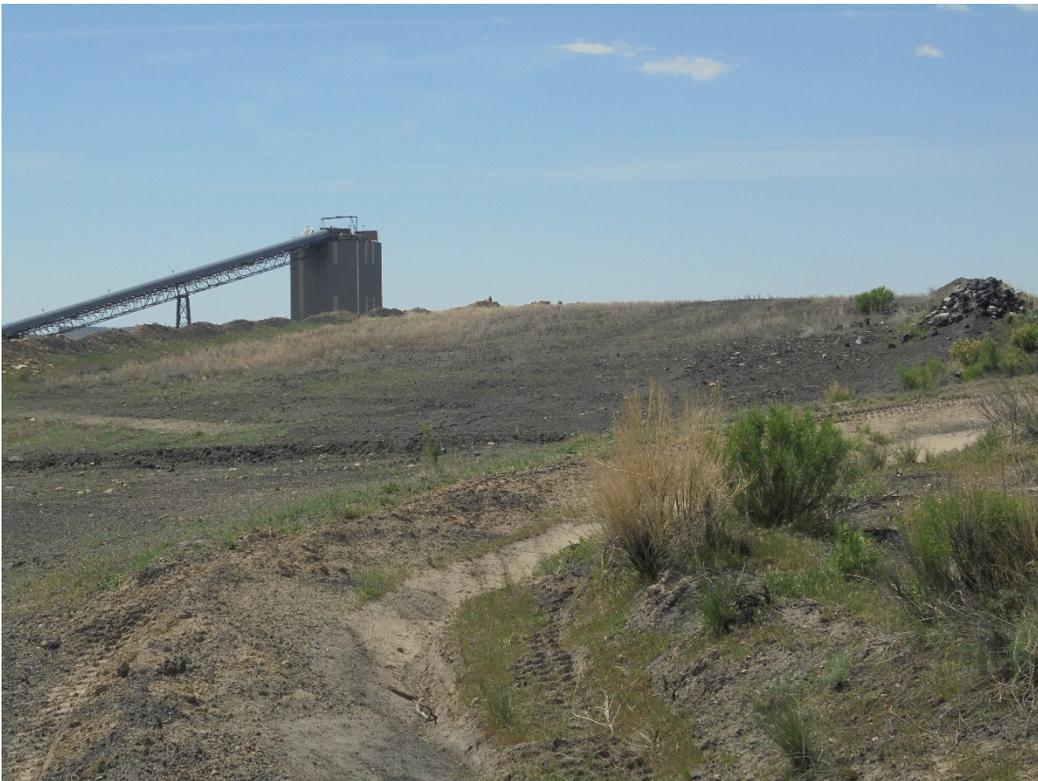
LOOKING SOUTH TOWARDS TOP OF REFUSE PILE

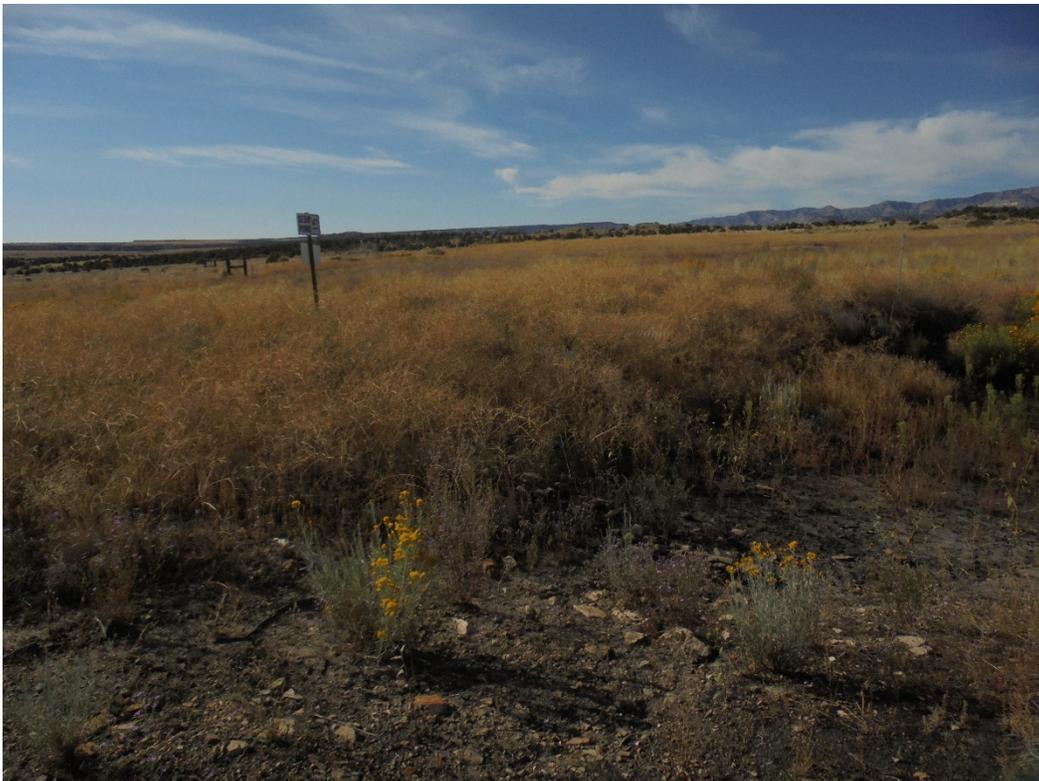
POND B WEEDS AT DISCHARGE

3. Principle and emergency spillway elevations		
	Principle spillway elevation: 6,137.0'		
	Emergency spillway elevation: 6,138.0'		
4. Field Information: Provide current water elevation, whether pond is discharging, type and number of samples taken, monitoring/instrumentation information, inlet/outlet conditions or other related activities associated with the pond including but not limited to sediment cleanout, pond decanting, embankment erosion/repairs, monitoring information, vegetation on outslopes of embankment erosion/repairs, monitoring information, vegetation on outslopes of embankments, etc.			
During the annual inspection, November 26, 2019, the vegetative looked good. Animal hole under inlet of principle spillway needs to be filled. Emergency and principle spillway outlets need to have weeds removed.

EMERGENCY & PRINCIPLE SPILLWAYS NEED TO HAVE WEEDS REMOVED.

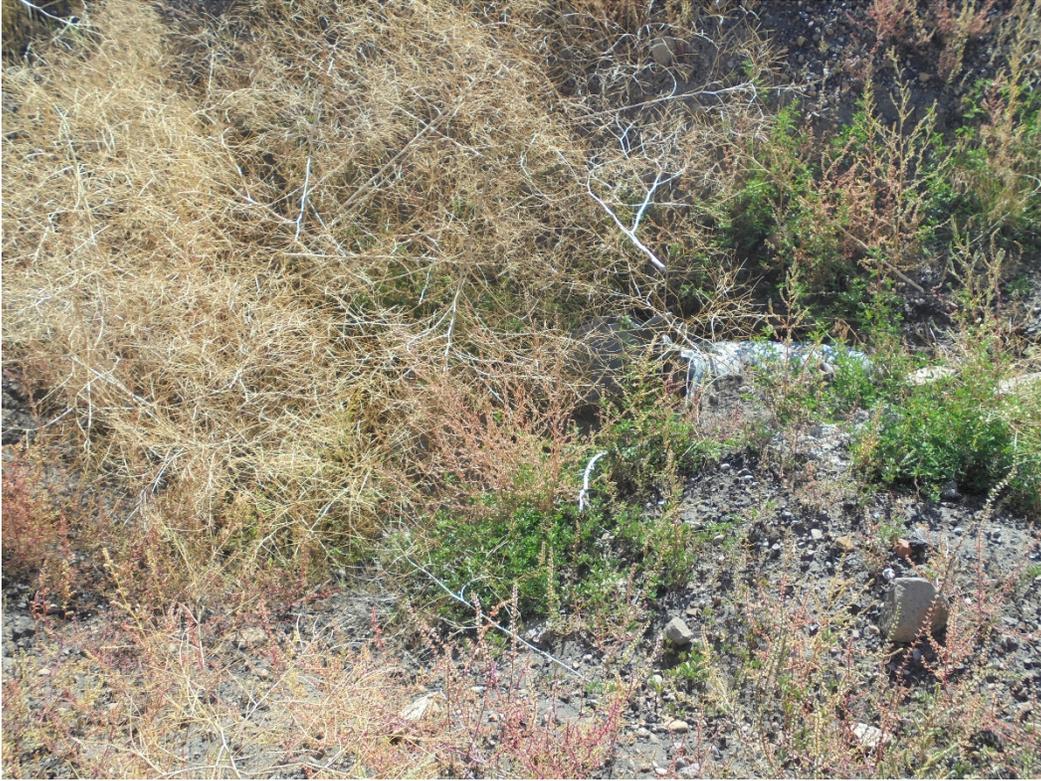
POND C WEST INLET WEEDS

3. Principle and emergency spillway elevations		
	Principle spillway elevation: 6,139.0'		
	Emergency spillway elevation: 6,140.0'		
4. Field Information: Provide current water elevation, whether pond is discharging, type and number of samples taken, monitoring/instrumentation information, inlet/outlet conditions or other related activities associated with the pond including but not limited to sediment cleanout, pond decanting, embankment erosion/repairs, monitoring information, vegetation on outslopes of embankment erosion/repairs, monitoring information, vegetation on outslopes of embankments, etc.			
During the annual inspection, November 26, 2019, the vegetation looked good with no signs of erosion. The emergency and principle spillway outlets need to have weeds removed. Also, the south inlet needs weeds removed. See the attached photographs.

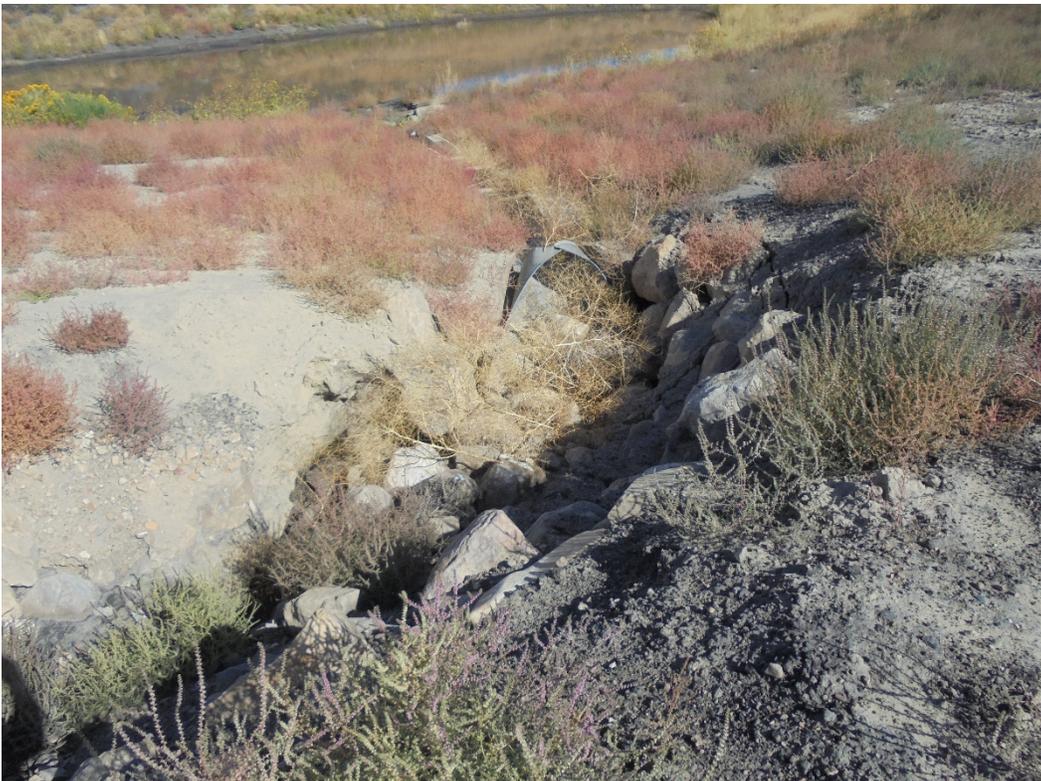
POND C SOUTH INLET ROCKS SINKING

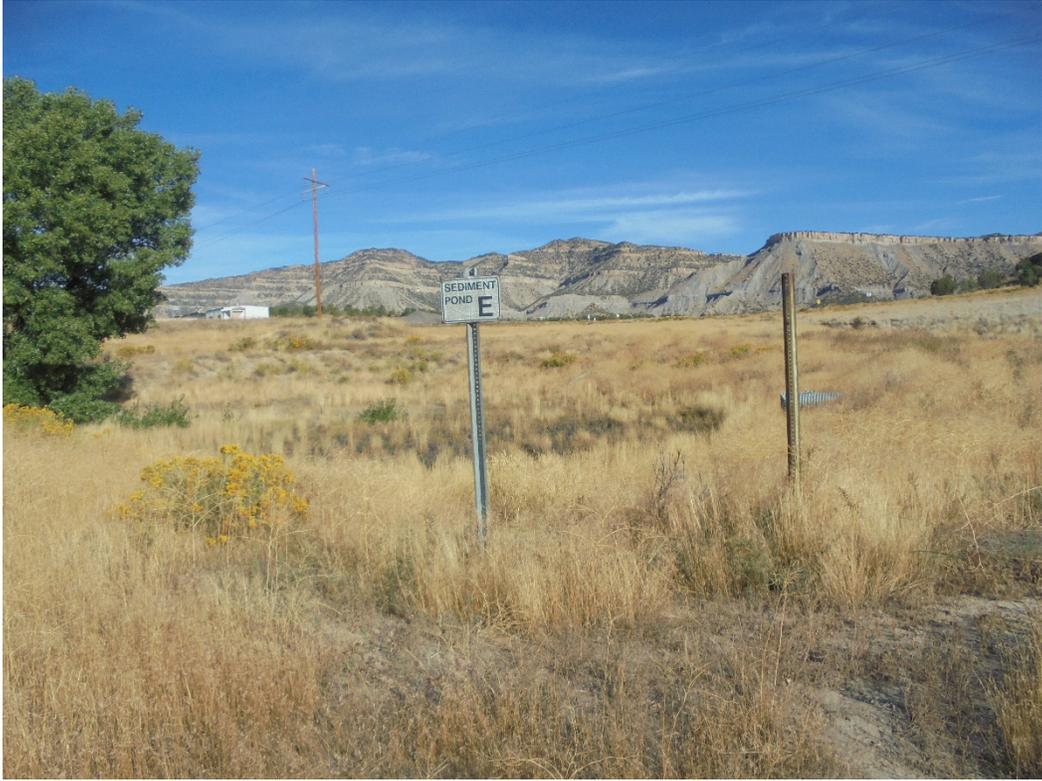
POND E

TREES ARE STARTING TO GROW IN SEDIMENT POND.
THESE SHOULD BE REMOVED. WEST INLET HALF ROUND
CULVERT IS BEING UNDERCUT AN NEEDS TO BE
REPAIRED.

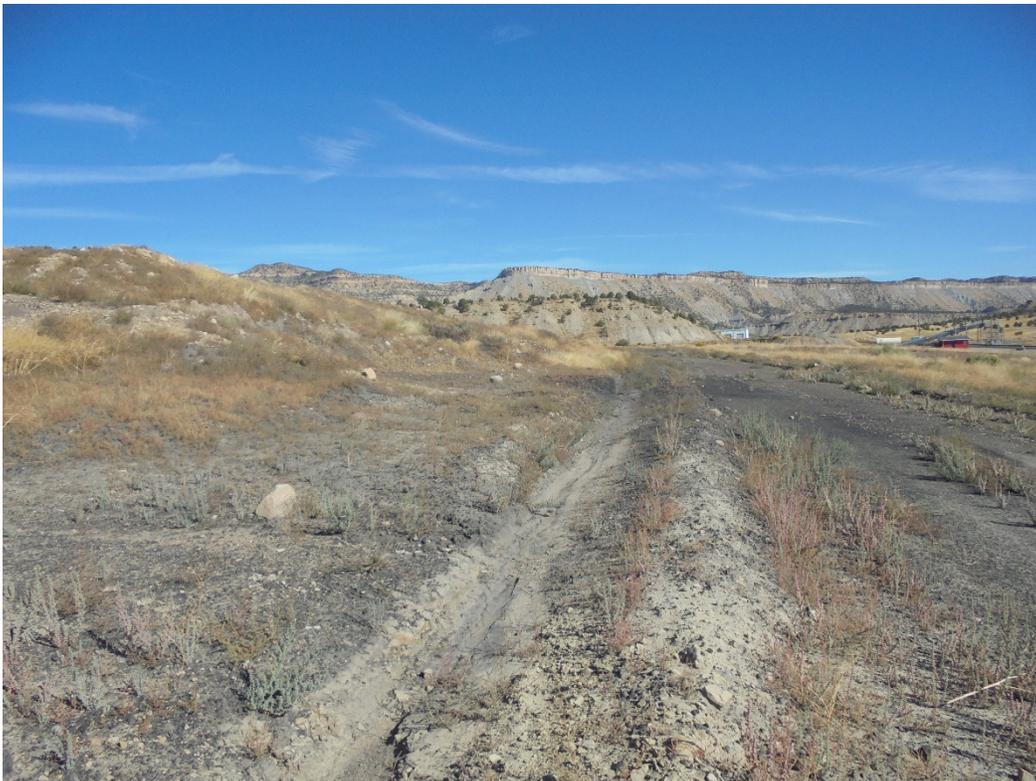
EAST DRAINAGE DITCH LOOKING NORTH

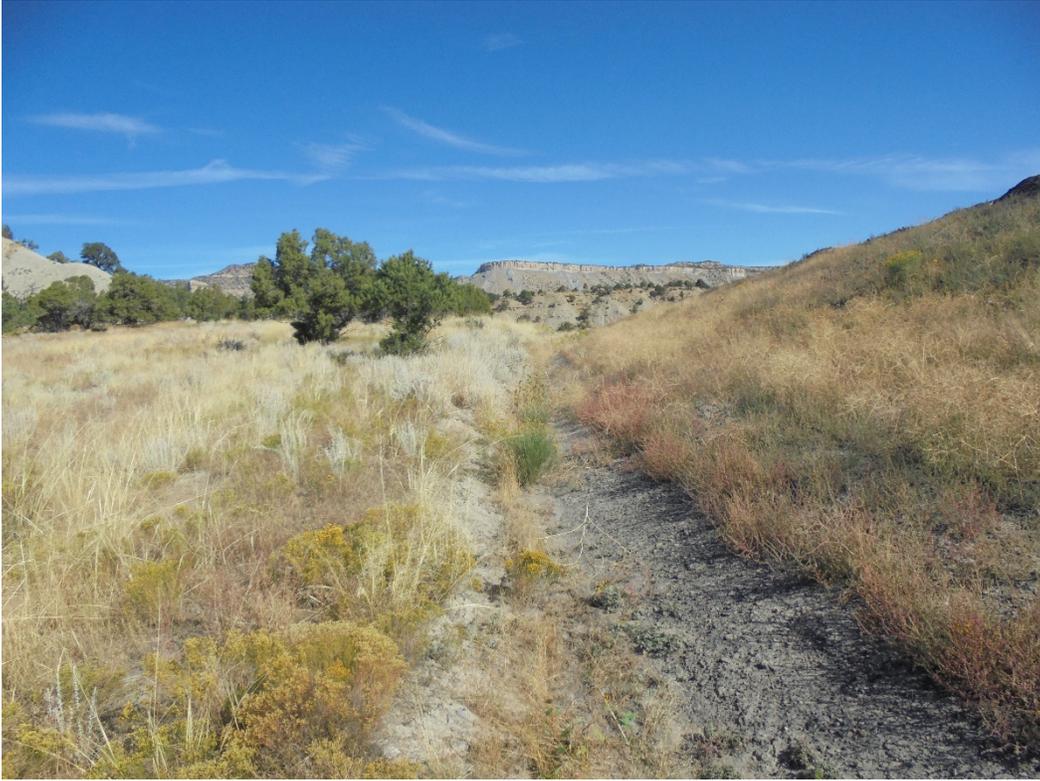
WEST DRAINAGE DITCH LOOKING NORTH

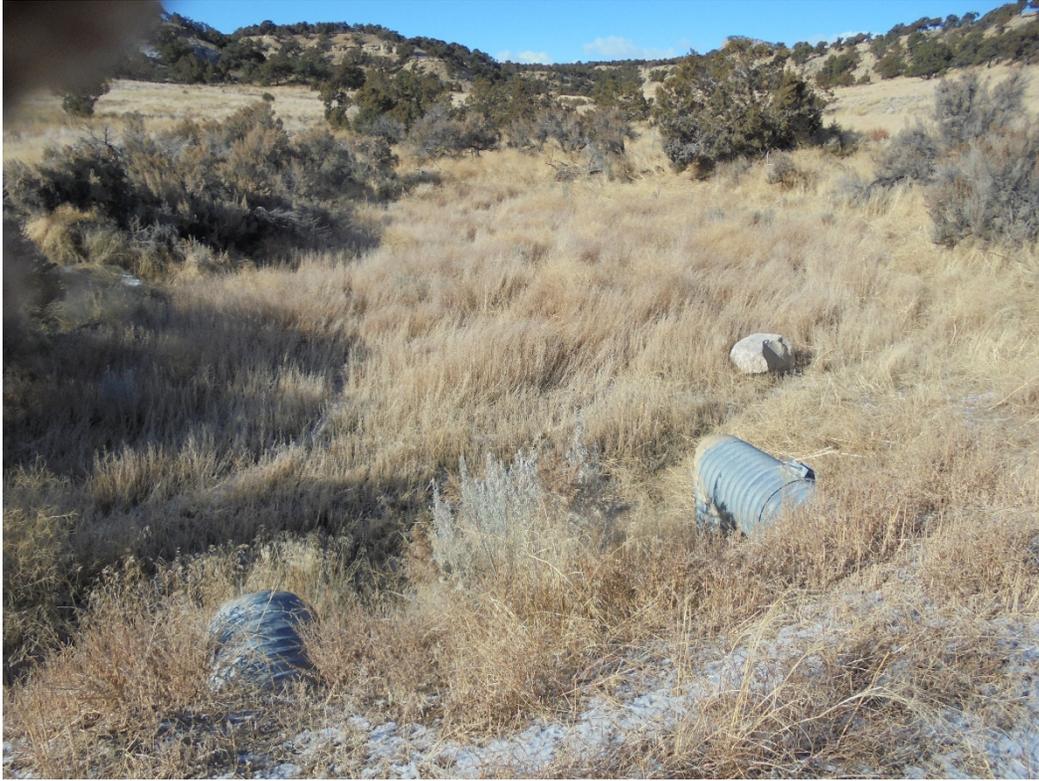
PERMANENT IMPOUNDMENT UPPER CELL

4. Field Information: Provide current water elevation, whether pond is discharging, type and number of samples taken, monitoring/instrumentation information, inlet/outlet conditions or other related activities associated with the pond including but not limited to sediment cleanout, pond decanting, embankment erosion/repairs, monitoring information, vegetation on outsoles of embankment erosion/repairs, monitoring information, vegetation on outsoles of embankments, etc.			
During the annual inspection, November 26, 2019, the vegetative cover looked good with no signs of erosion. There was a lot of weeds in upper cell.

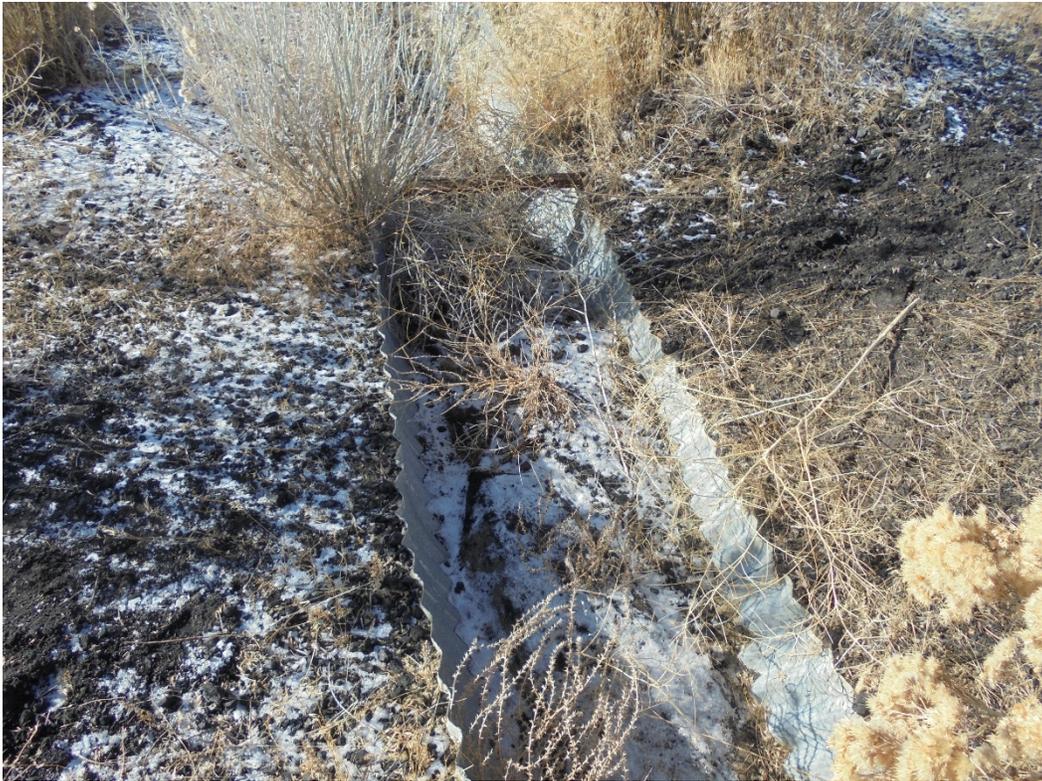
3. Principle and emergency spillway elevations		
	Principle spillway elevation: 6,173.0'		
	Emergency spillway elevation: 6,174.0'		
4. Field Information: Provide current water elevation, whether pond is discharging, type and number of samples taken, monitoring/instrumentation information, inlet/outlet conditions or other related activities associated with the pond including but not limited to sediment cleanout, pond decanting, embankment erosion/repairs, monitoring information, vegetation on outslopes of embankment erosion/repairs, monitoring information, vegetation on outslopes of embankments, etc.			
During the annual inspection, November 26, 2019, the vegetative cover looked good with no signs of erosion. There was sediment in the east inlet that needs to be removed. See attached photographs.

POND F EAST INLET FILLING WITH SEDIMENT

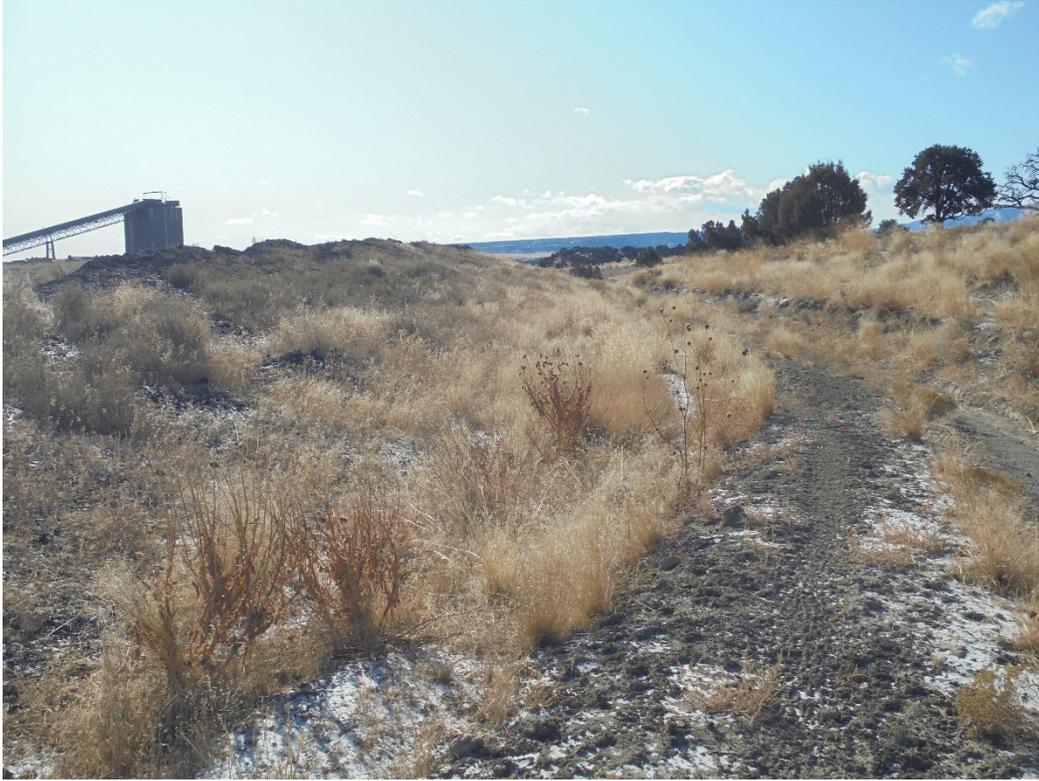
REFUSE PILE WEST DRAINAGE DITCH
