Inspection Report

Permit Number:	C0070039
Inspection Type:	PARTIAL
Inspection Date:	Tuesday, August 20, 2013
Start Date/Time:	8/20/2013 7:00:00 AM
End Date/Time:	8/20/2013 3:30:00 PM
Last Inspection:	Tuesday, August 06, 2013

Site: **DUGOUT CANYON MINE**

On August 20th, 2013, Division of Oil, Gas and Mining staff (the Division) conducted a field inspection of the gob gas vent hole sites (the sites) at the Dugout Canyon Mine. The purpose of the field inspection was to document the condition of the sites and associated access roads and to inspect recently initiated/completed reclamation work. Overall, the condition of the degas sites (both reclaimed and un-reclaimed) was very good. No evidence of off-site impacts was observed during the field inspection. Some minor maintenance work is required on the skid road to degas pad G-19 and on the AMV Road's water bar (See discussion below).

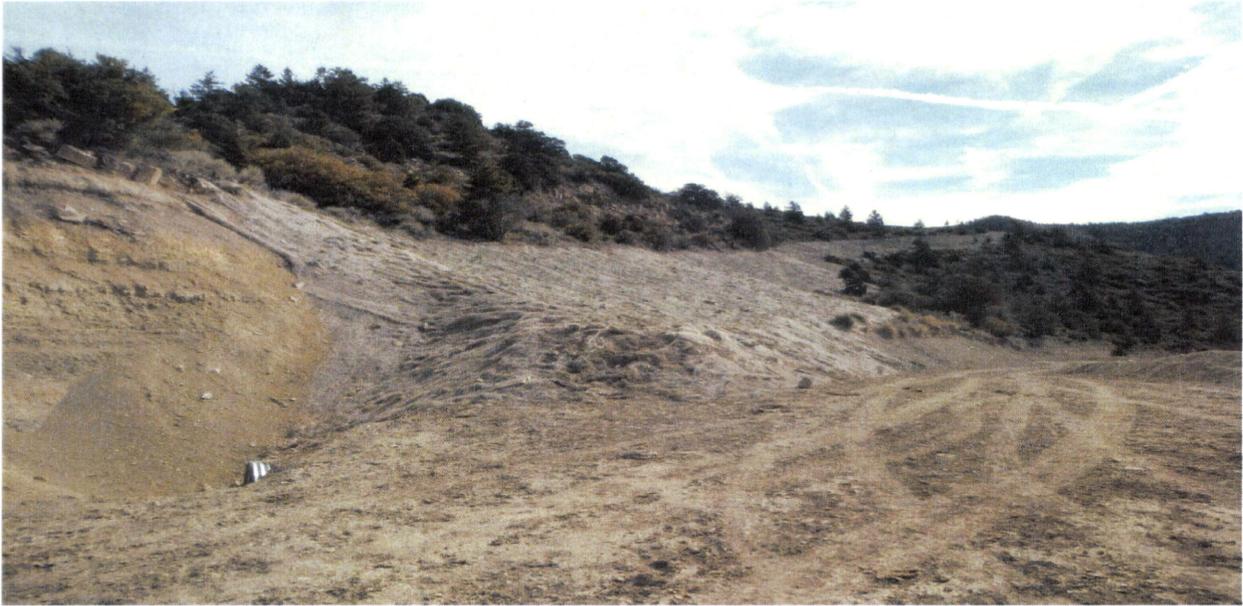
East View: AMV Road and Reclaimed Section between Sites G-18 and G-31

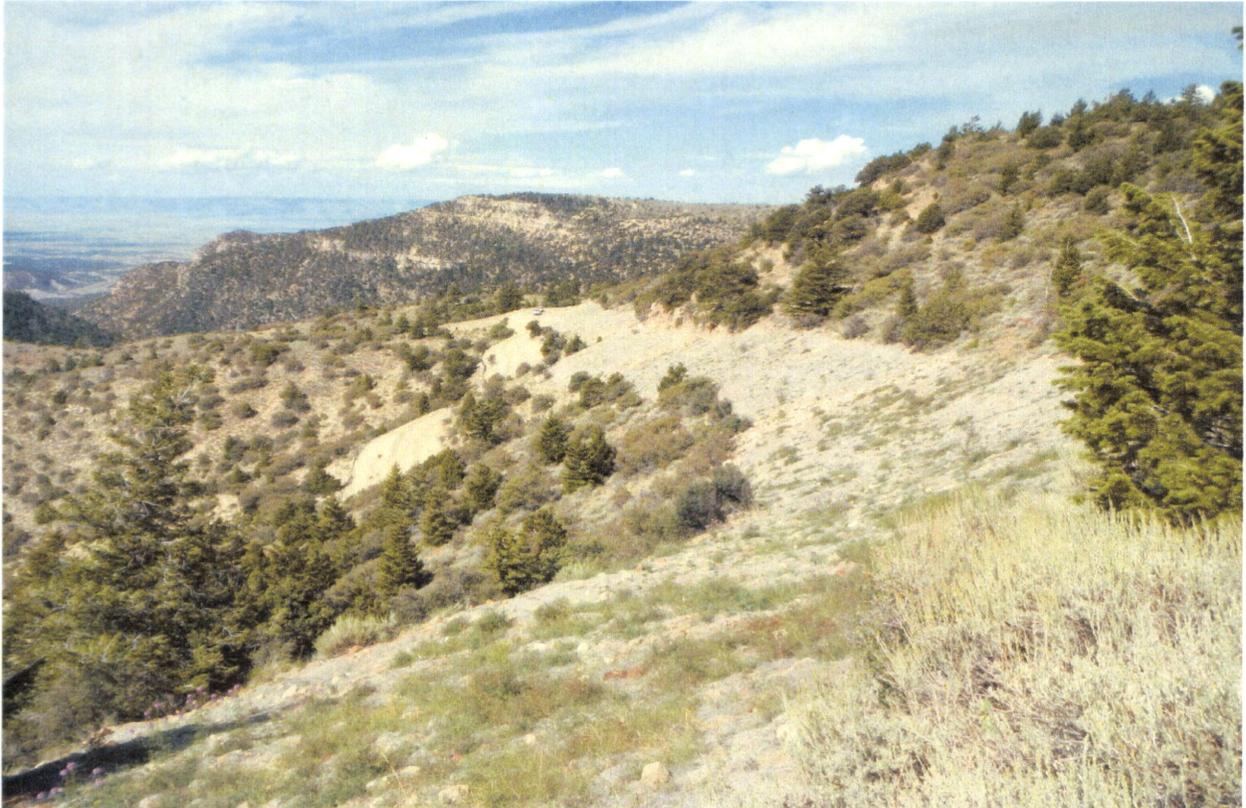
West View: Reclaimed Access Road to Site G-18

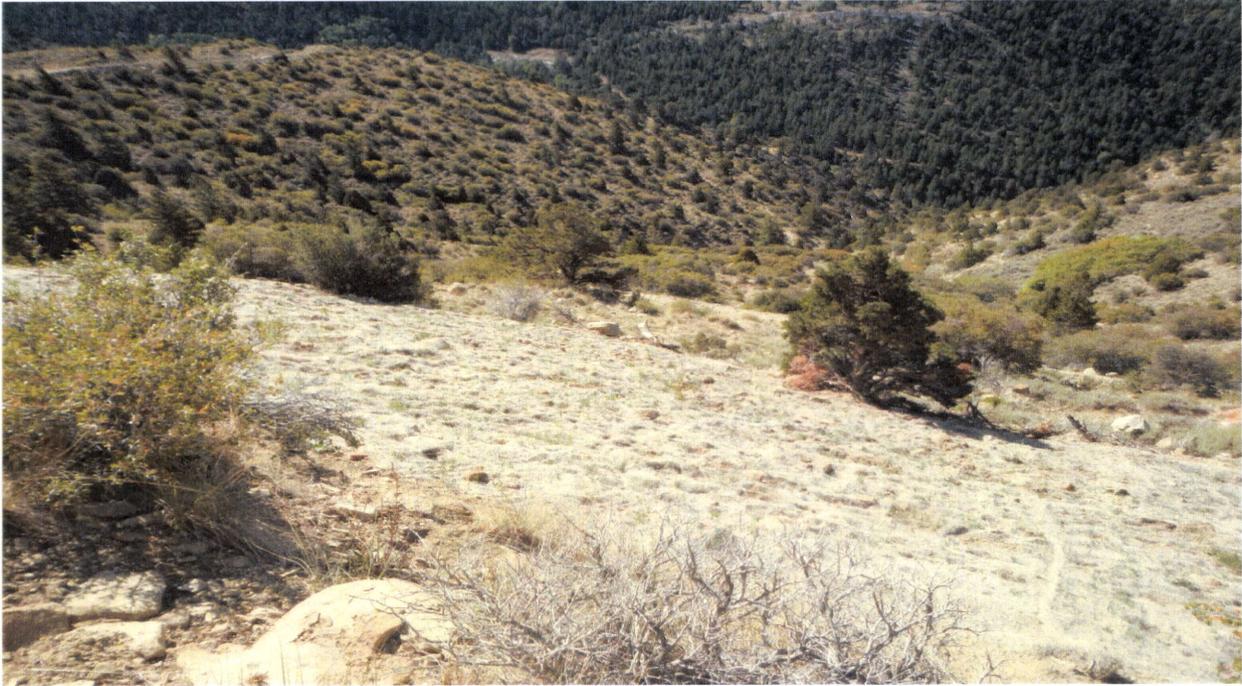
Reclaimed Access Road to Site G-18
