**RE: Bronco Utah Operations LLC
Emery Mine
DOGM Permit No. C/015/0015
Emery 2 Full Extraction Revision**

Title: Emery 2 Full Extraction

The purpose of this report is to present baseline surface conditions prior to full extraction operations from the Emery 2 portal of the Bronco Utah Operations, LLC. (Bronco) Emery Mine, Emery County, Utah. The areas covered in this report include the following:

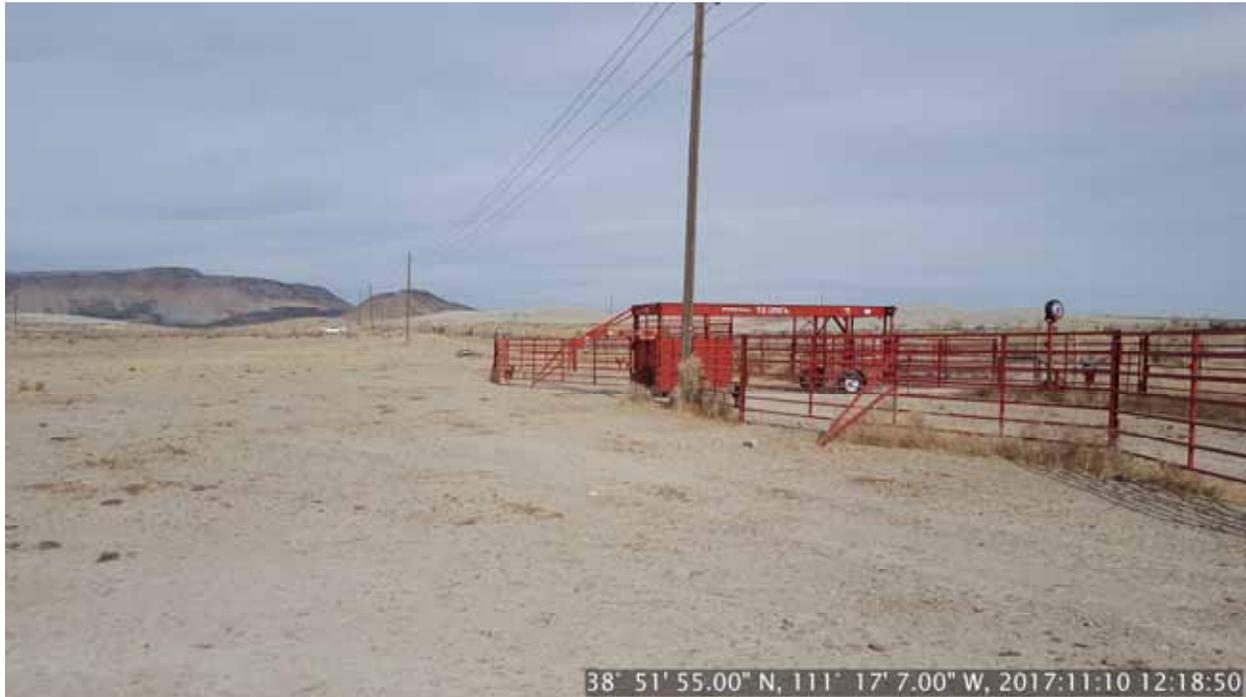
Feature 36. Utility Power Line. The description of this feature has been updated from the Valley Engineering (1980) report. A portion of this feature is located within a buffer zone, depicted on Figure 1 and Plate V-5, where subsidence is not anticipated. The electrical power line is a single line that supplies electricity to the ranch house and buildings (Feature 35). The poles are typical power line poles, approximately 35 feet tall and in good condition. The eastern most pole in this line, which also forms a part of the north/south power line (Feature 5) that this line ties into, leans to the south and west.

Feature 36. Utility Power Line. Looking northwest. Top of pole in foreground leans slightly left.

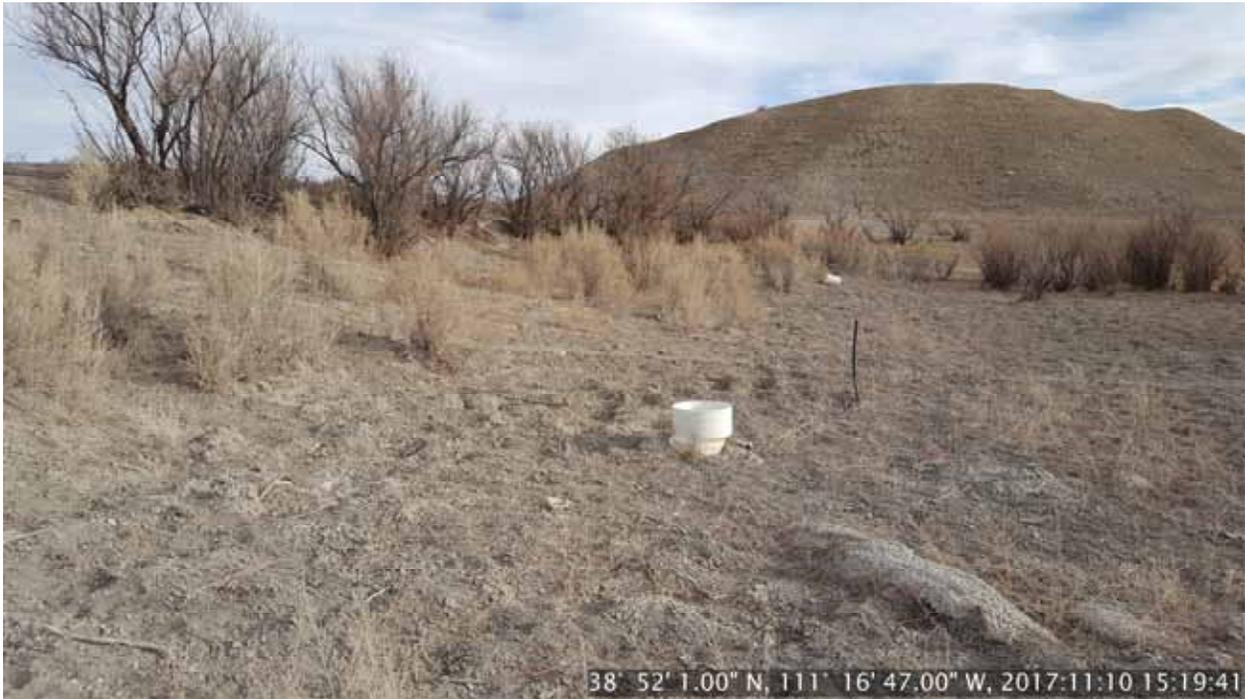
Feature 41. Pond. The description of this feature has been updated from the Valley Engineering (1980) report. The pond was constructed by installing an approximately 8 foot tall berm between two small hills. The berm is approximately 250 feet long and approximately 6 feet wide at its crest. The berm is located approximately 100 yards north of the section corner marker (Feature 40). A 25 foot long by 3 foot deep path has been worn through the western end of the berm. Water flows out of the pond via a 16” PVC riser. The pond was dry at the time of the survey.

Feature 41. Pond. Looking southwest at face of earthen dam. This dam situated between two small hills forms the north side of the pond.

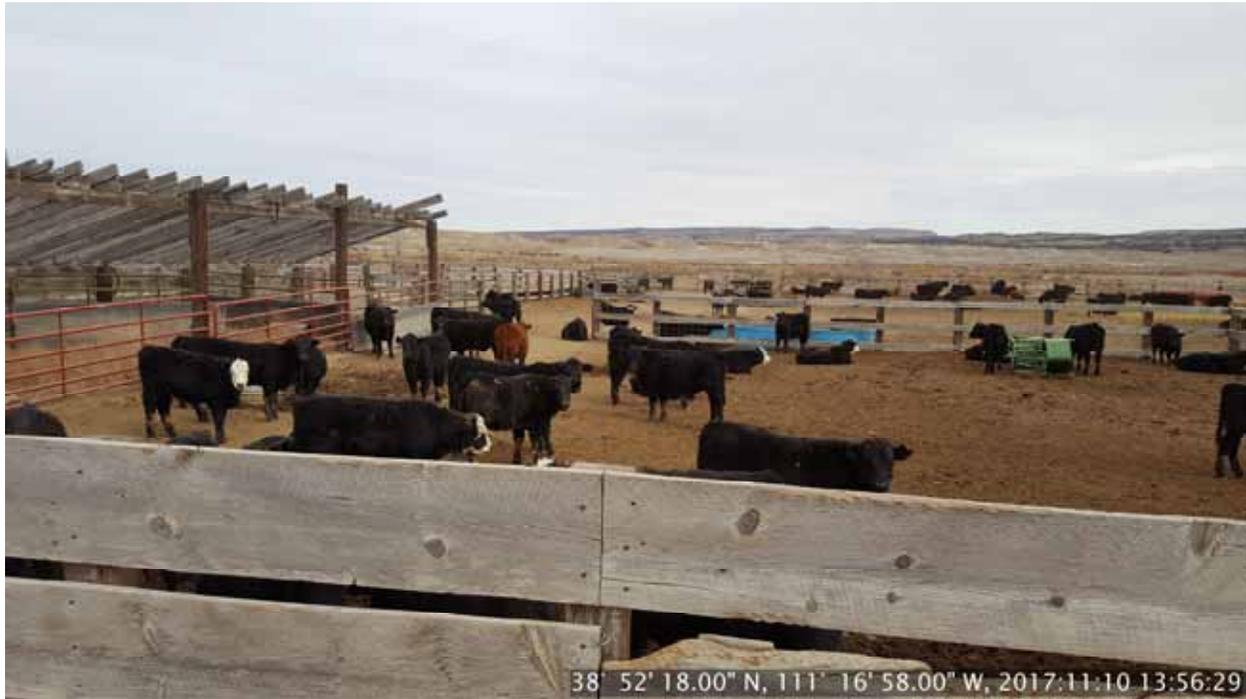
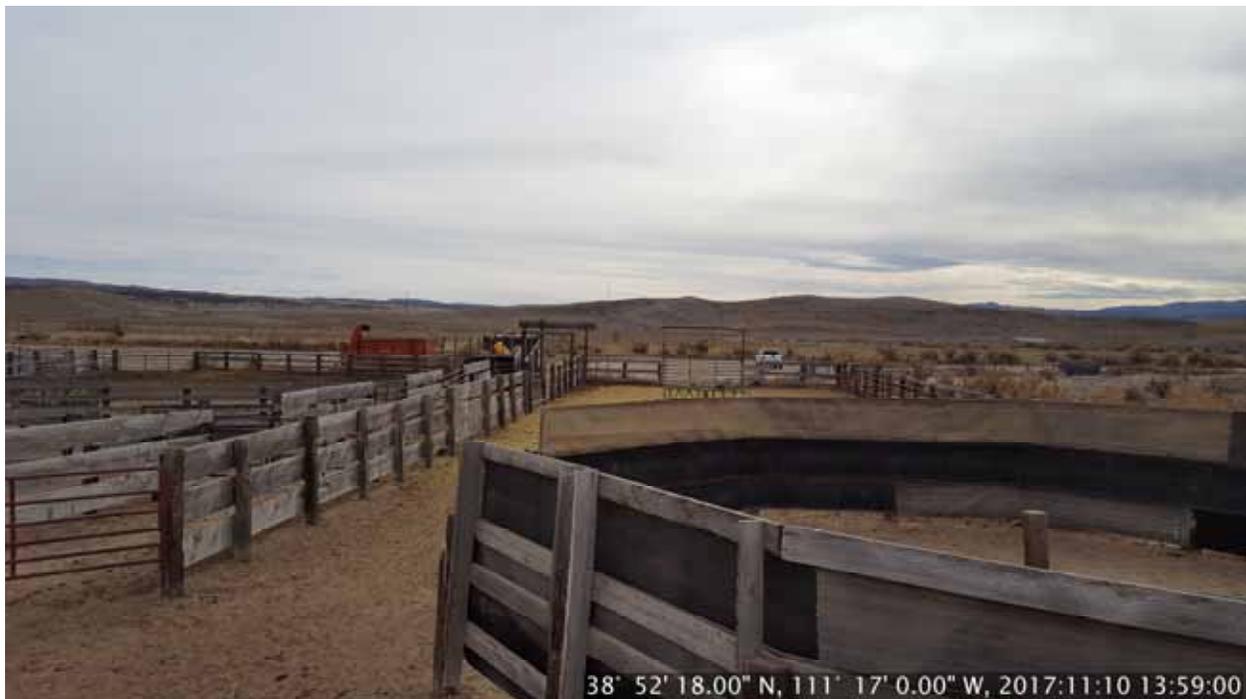
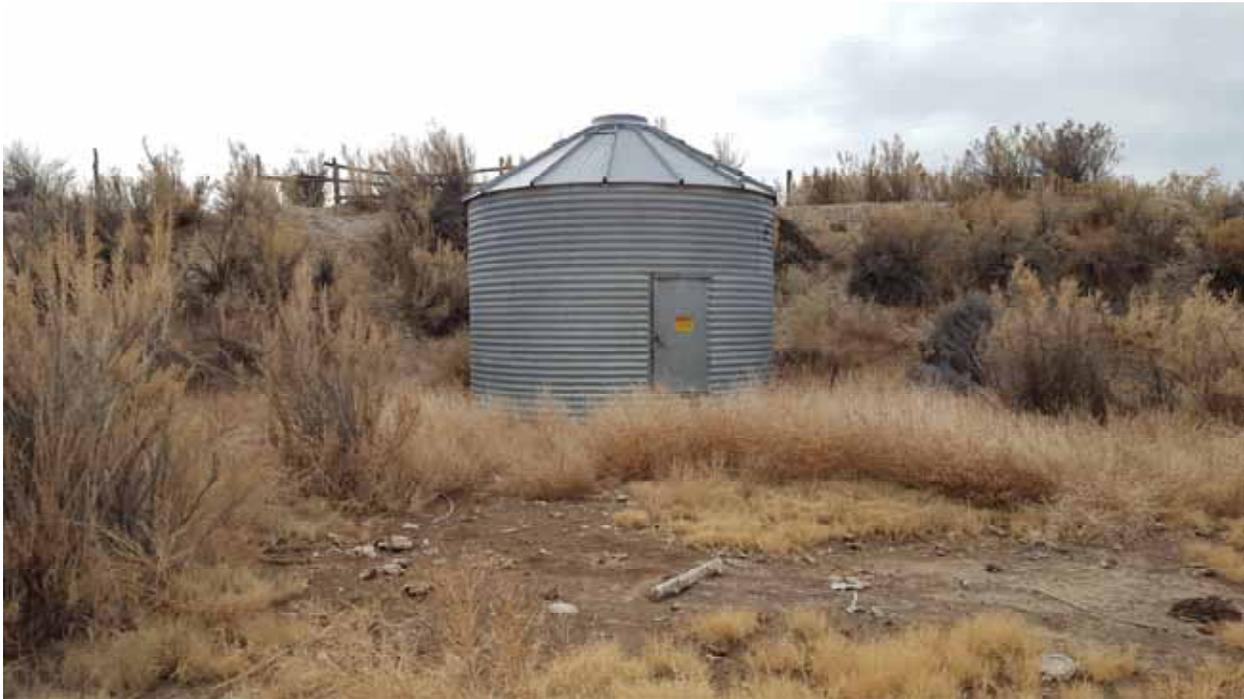
Feature 43. Corrals and Grain Silo. The description of this feature has been updated from the Valley Engineering (1980) report. This feature is located within a buffer zone, depicted on Figure 1 and Plate V-5, where subsidence is not anticipated. The corrals and feeding areas are constructed of rough cut lumber, timber posts, and railroad ties and are in good condition. The gates to the corrals are made of steel pipes and are in good condition. The galvanized steel grain silo, located approximately 180 yards west of the southwestern corner of the corrals, rests on a concrete pad and is in good condition.

Feature 43. Corrals and Grain Silo. Looking north from center of corral.

Feature 43. Corrals and Grain Silo. Looking east from center of corral.

Feature 43. Corrals and Grain Silo. Looking west from center of corral.

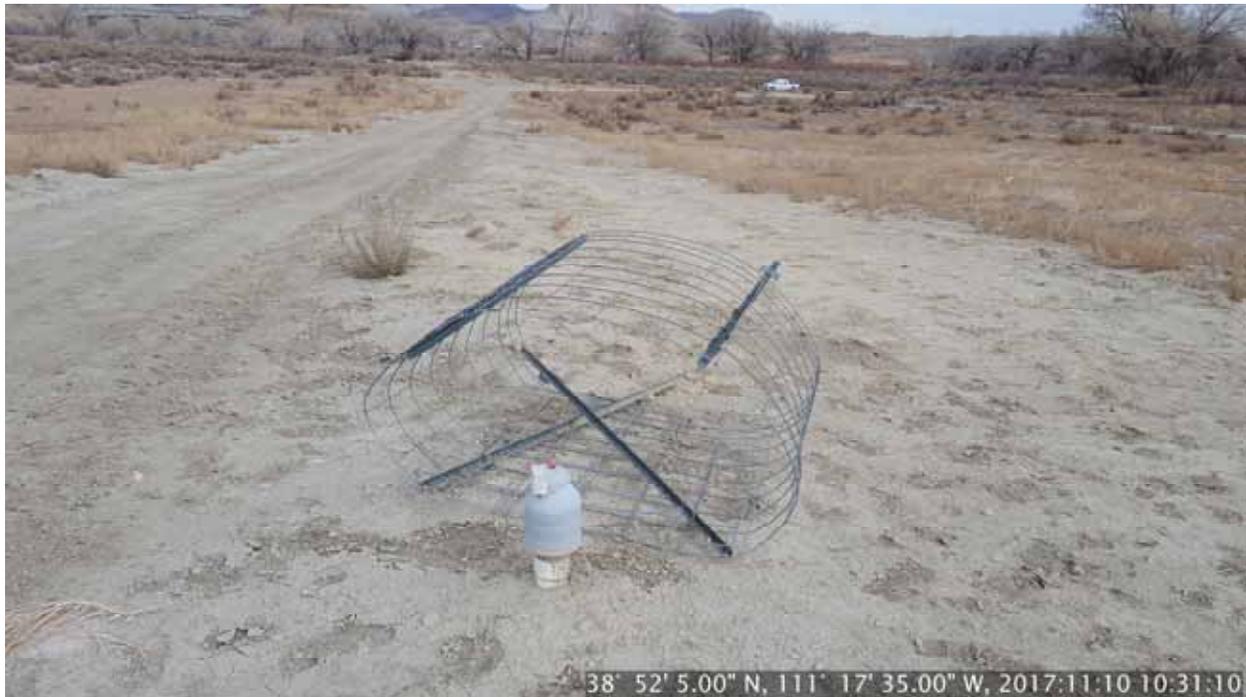
Feature 44. Pond, Livestock Waterer, and Water Line Air Vent. Livestock waterer on concrete slab.

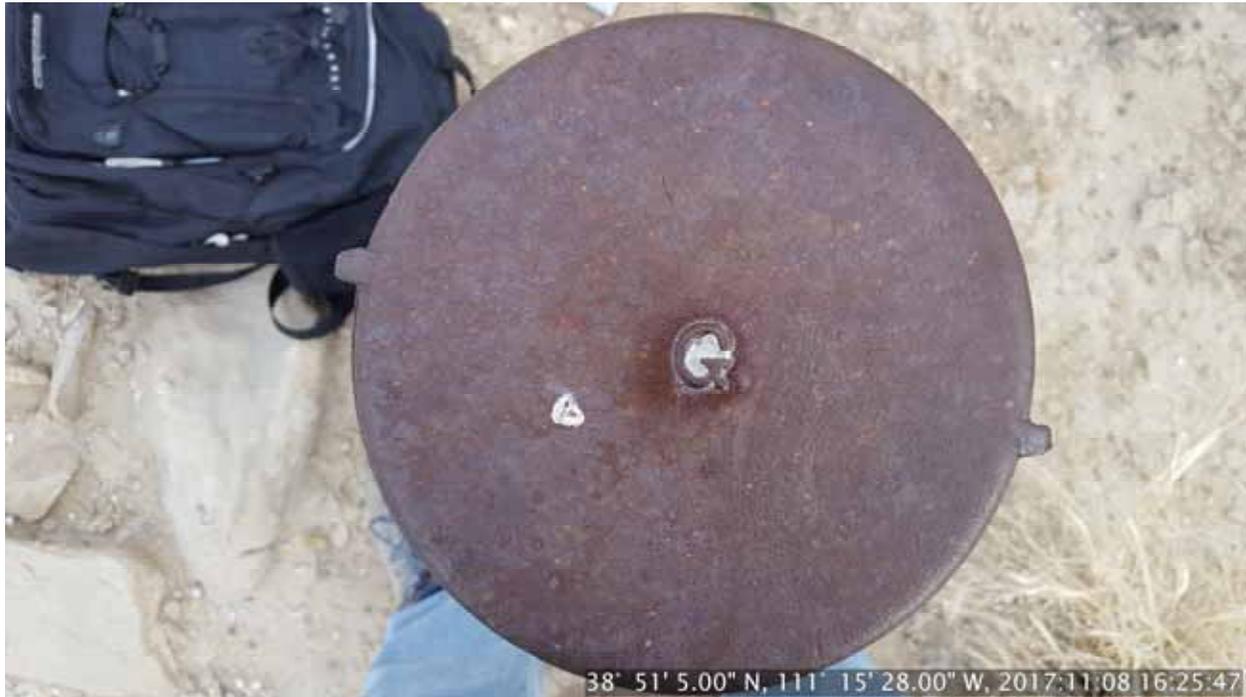
Feature 119. Quarter Section Corner Marker. Looking east.

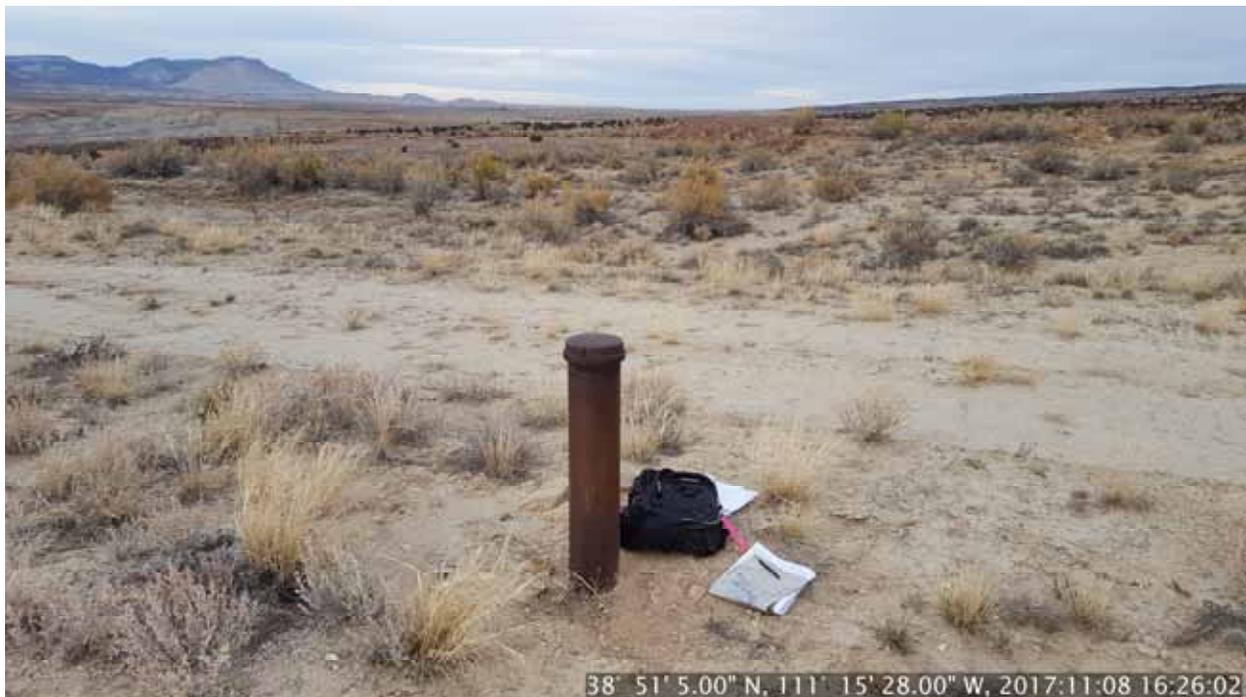
Feature 120. Steel Pipes. This feature description remains essentially the same as described in the Valley Engineering (1980) report, which states the following: “These pipes are approximately 6 inches in diameter with steel caps. The pipes extend about 2½ feet to 3 feet out of the ground. There were three pipes found in this area. The purpose of these pipes is unknown.” Two additions to the above description are added in this document: the steel caps are threaded and only two of the three pipes were found.

Feature 120. Steel Pipes. Top view of 1st pipe.

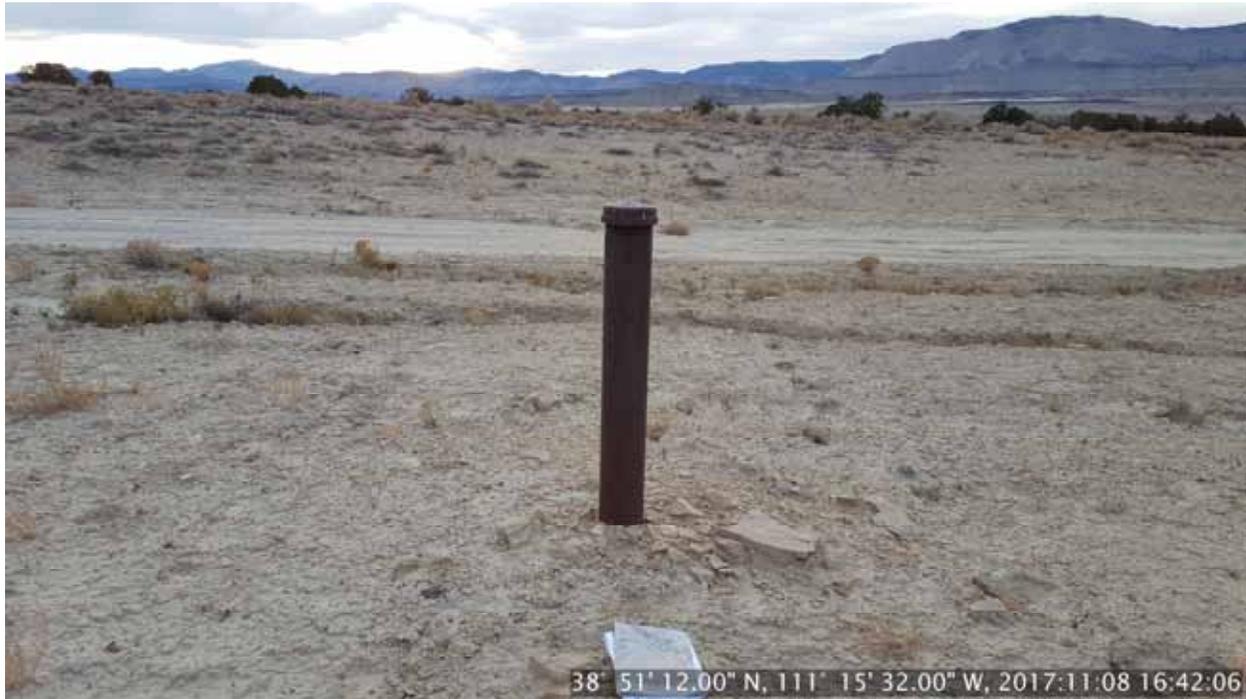
Feature 120. Steel Pipes. Side view of 1st pipe.

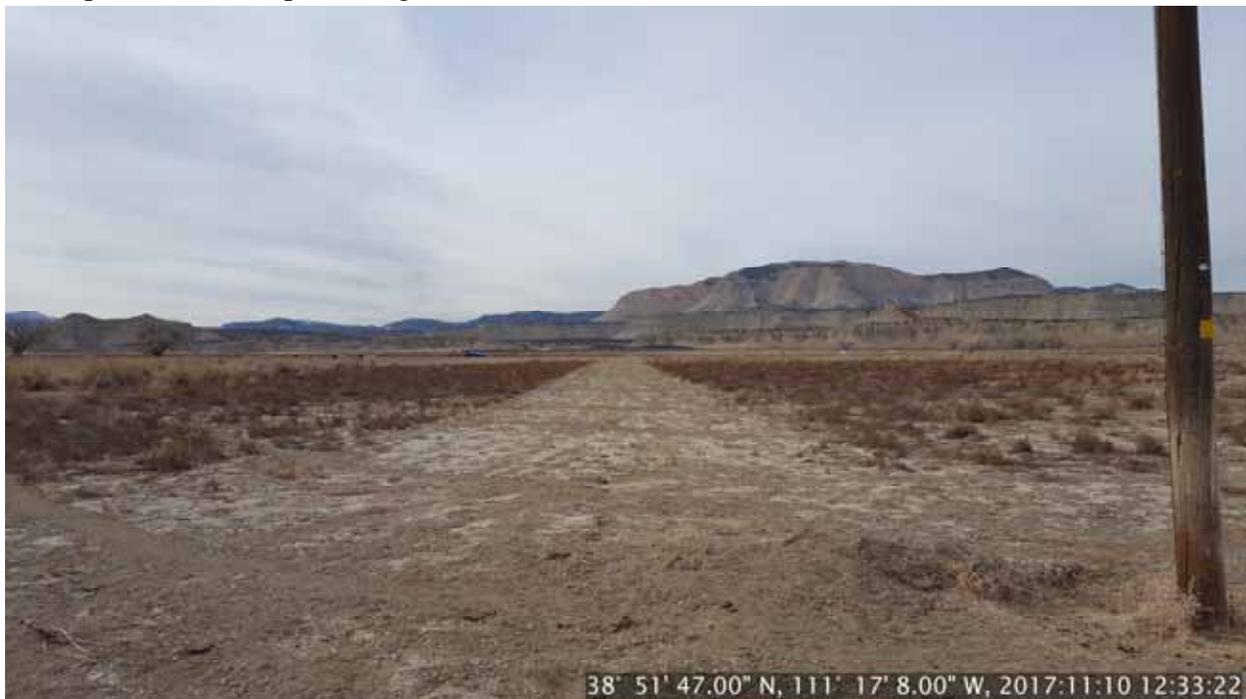
Feature 129. Underground Electrical Feed. Looking north. Underground electrical conduit stub-up is attached to pole at right.
