**RE: Bronco Utah Operations LLC
Emery Mine
DOGM Permit No. C/015/0015
Emery 2 Second Left Panel Full Extraction Revision**

GEOLOGY AND SUBSIDENCE

The purpose of this report is to present baseline surface conditions prior to full extraction operations from the Emery 2 portal of the Bronco Utah Operations, LLC. (Bronco) Emery Mine, Emery County, Utah. The areas covered in this report include the following:

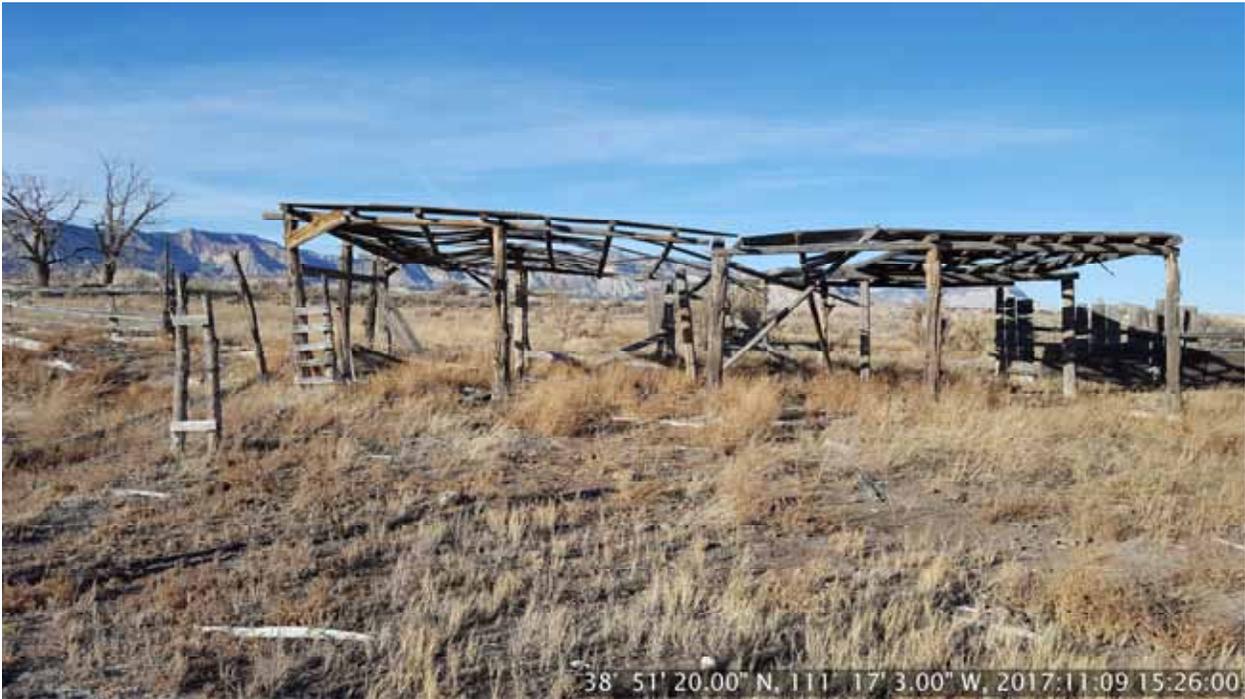
Feature 1. Ranch House, Buildings, and Corrals. Corrals.

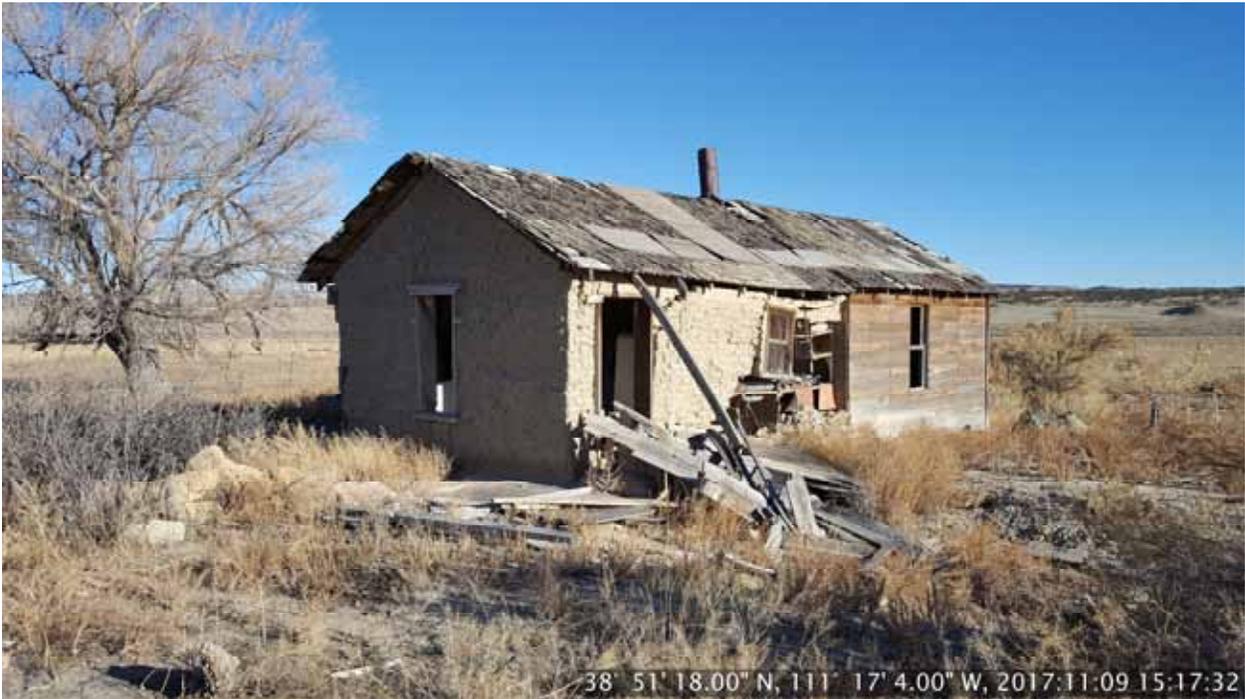
Feature 1. Ranch House, Buildings, and Corrals. Ranch House.

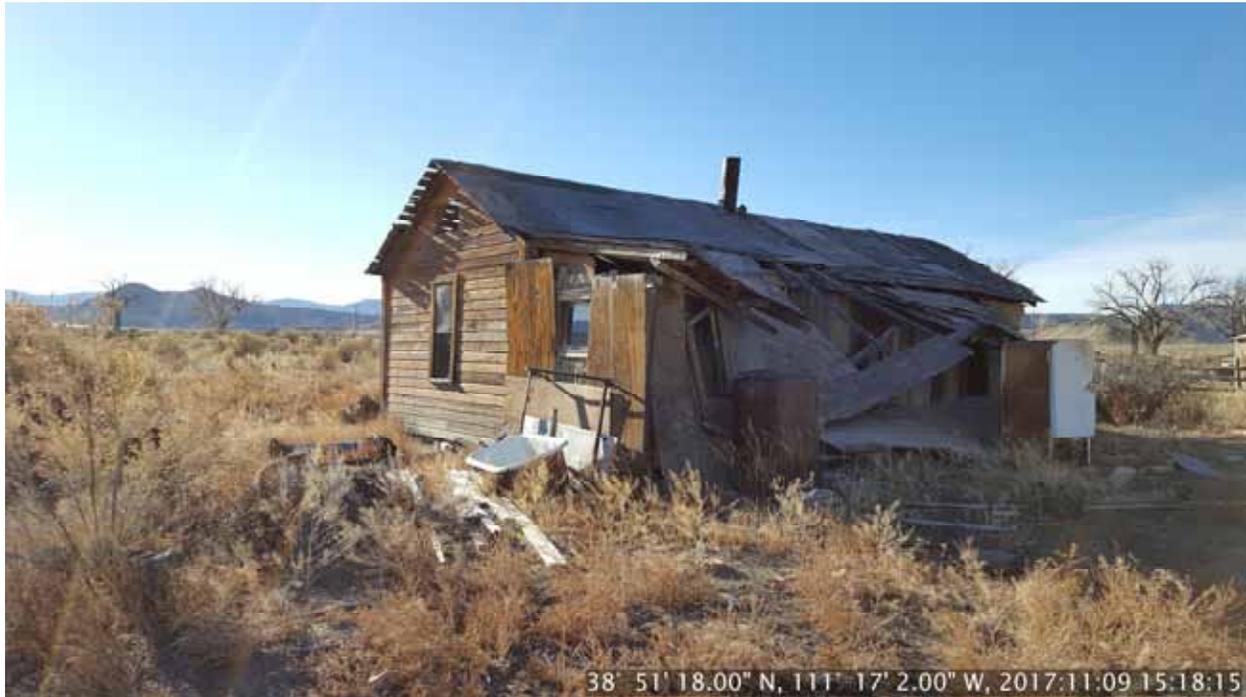
Feature 1. Ranch House, Buildings, and Corrals. Ranch House.

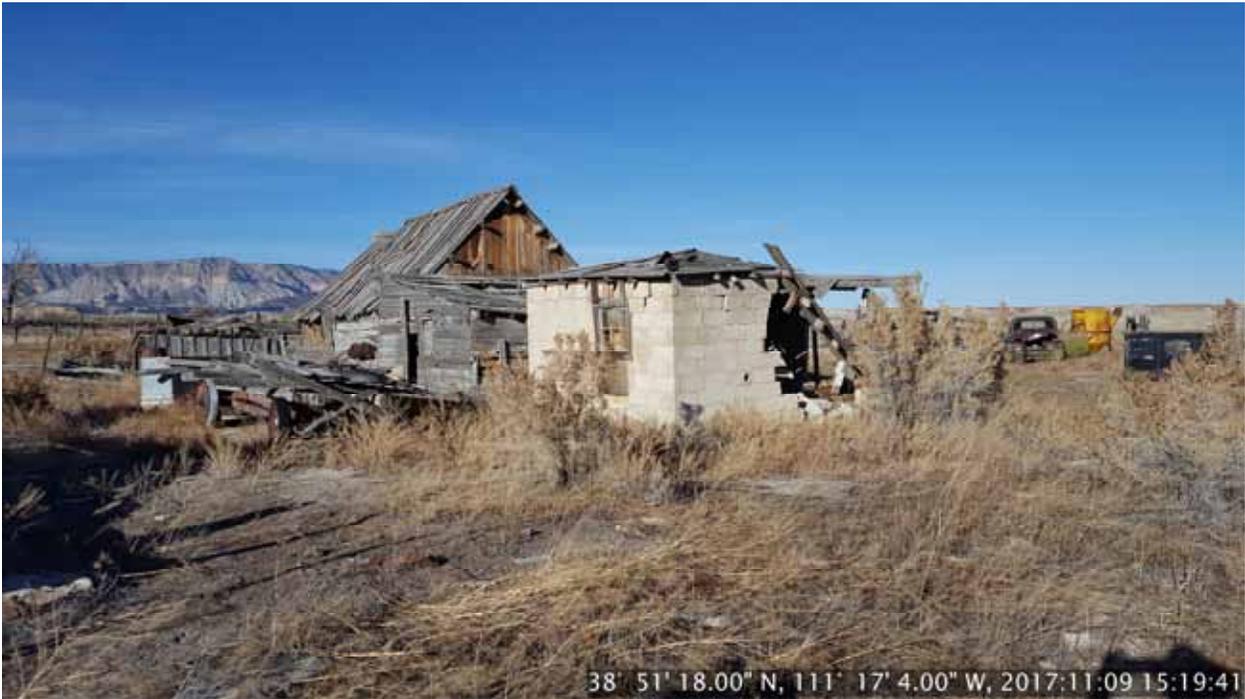
Feature 1. Ranch House, Buildings, and Corrals. Buildings. Cinder block building in foreground.

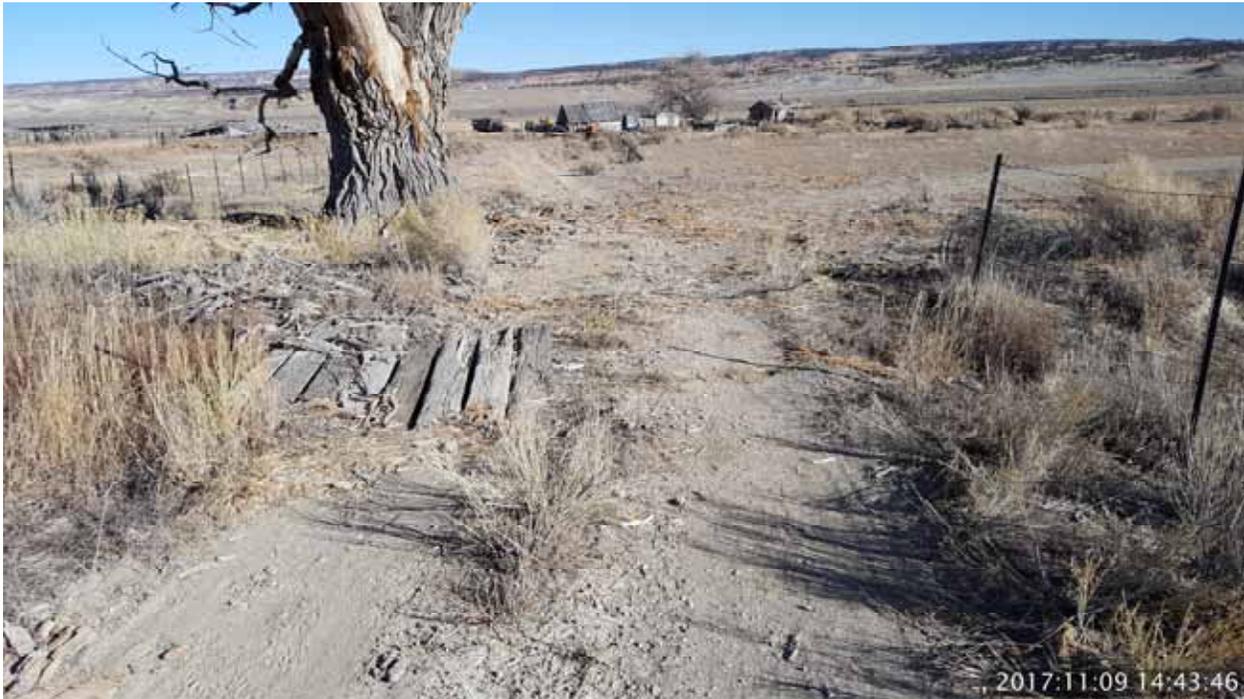
Feature 2. Irrigation Ditch and Bridge. Looking east.

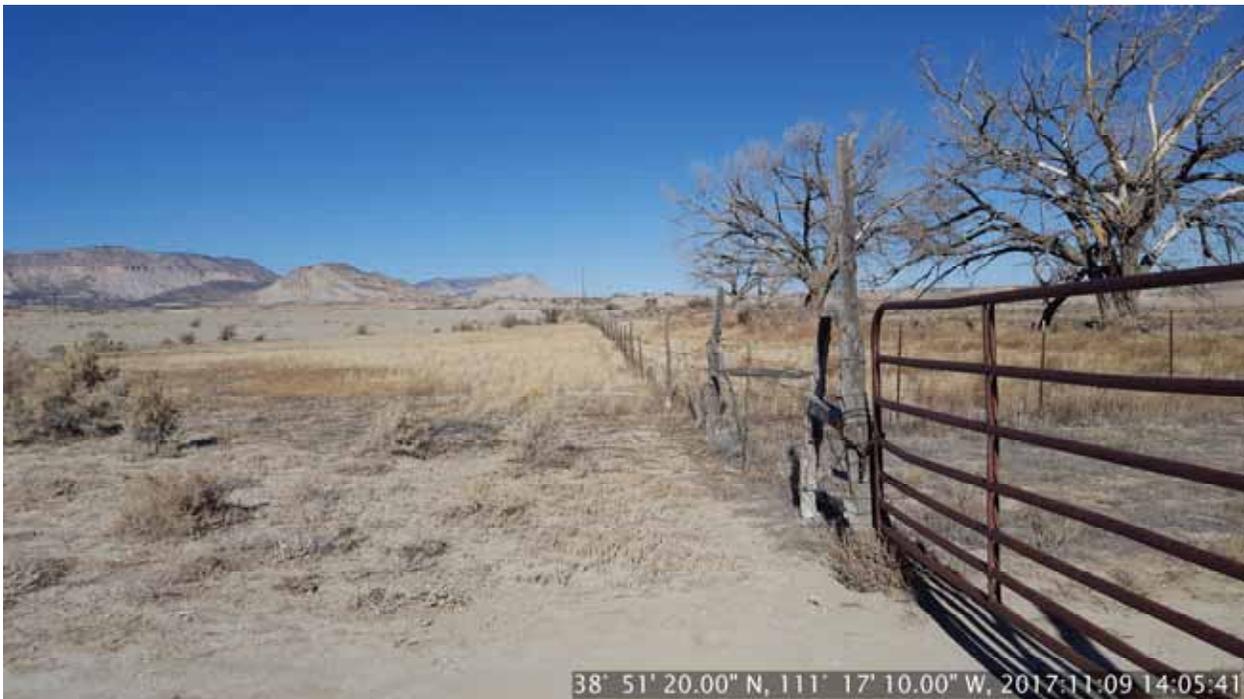
Feature 3. Ranch Fence Line. Looking north along gated entrance to Feature 1.

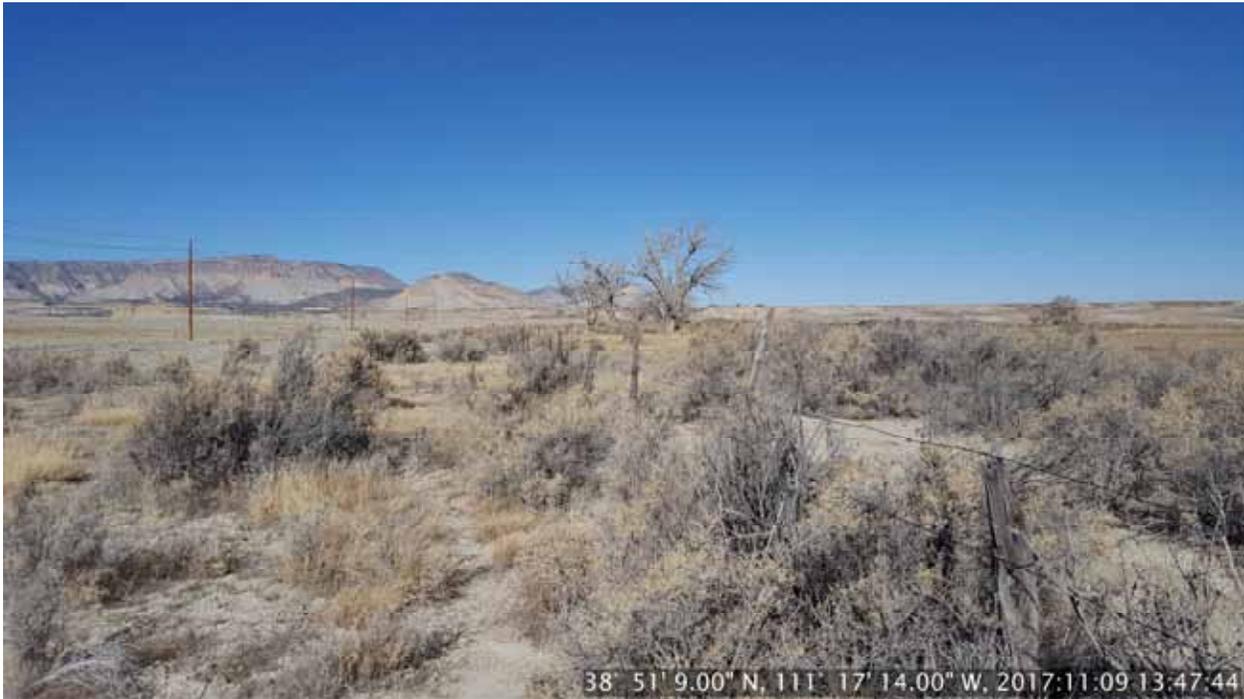
Feature 3. Ranch Fence Line. Looking north.

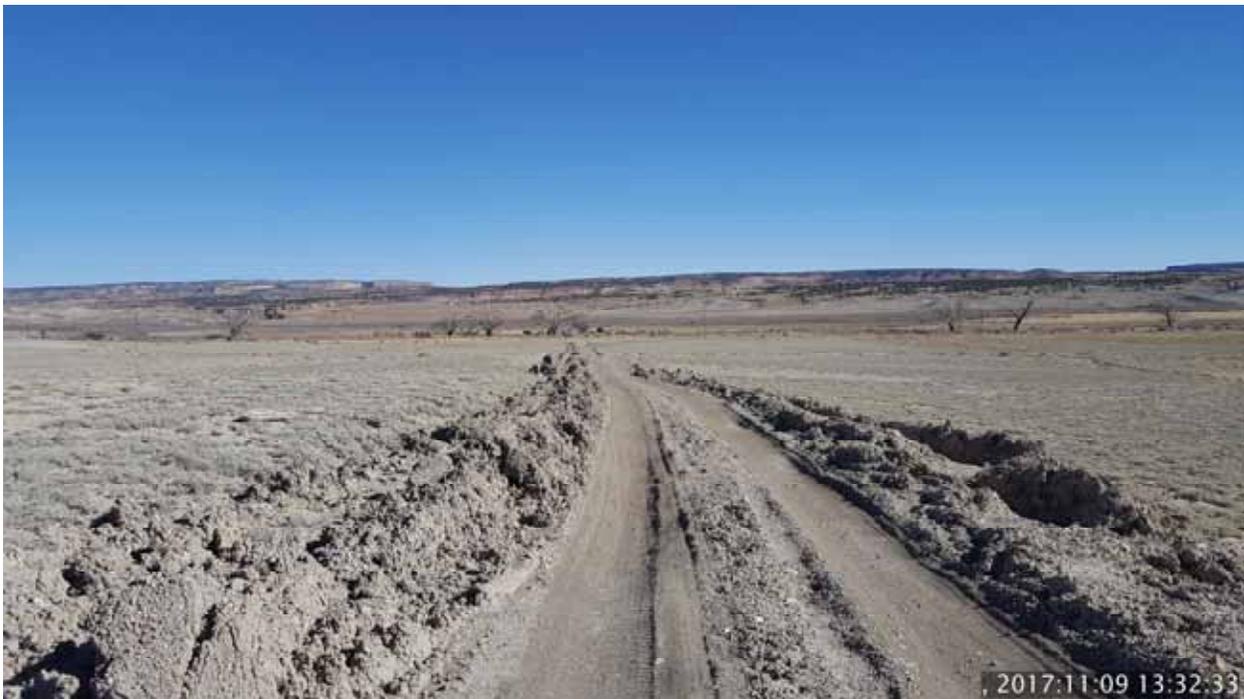
Feature 4. Ranch Access Road. Looking east.

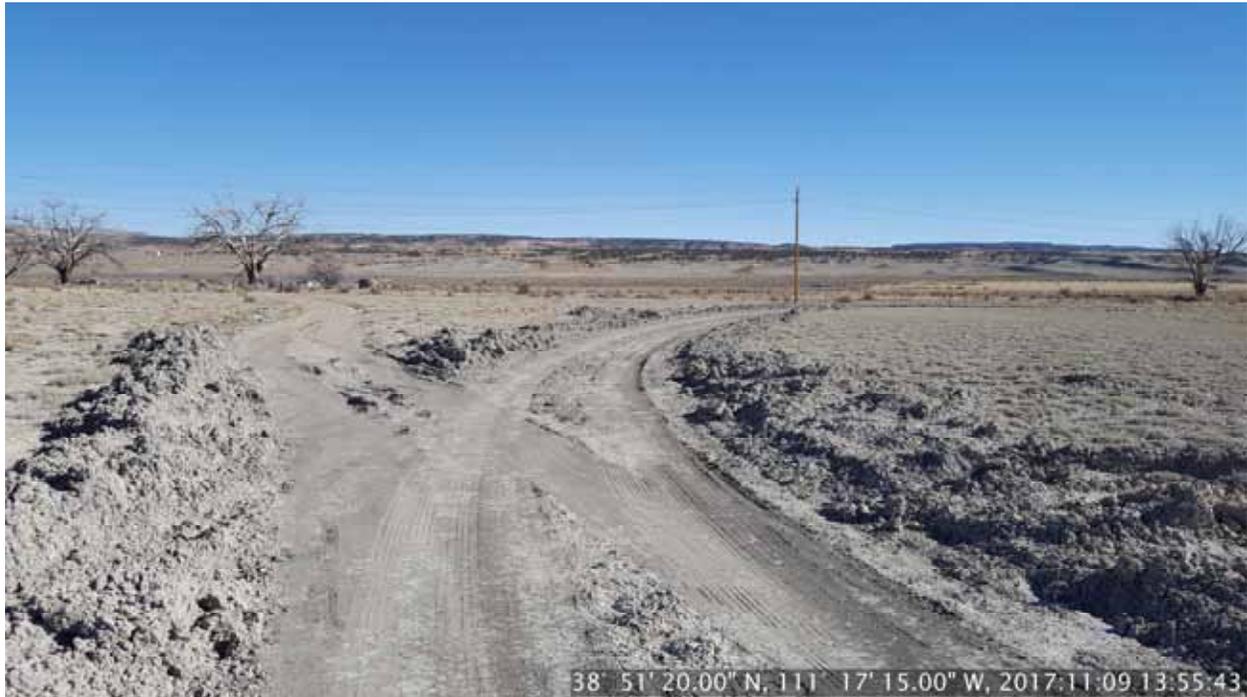
Feature 4. Ranch Access Road. Photo is taken farther east at split to Feature 11.

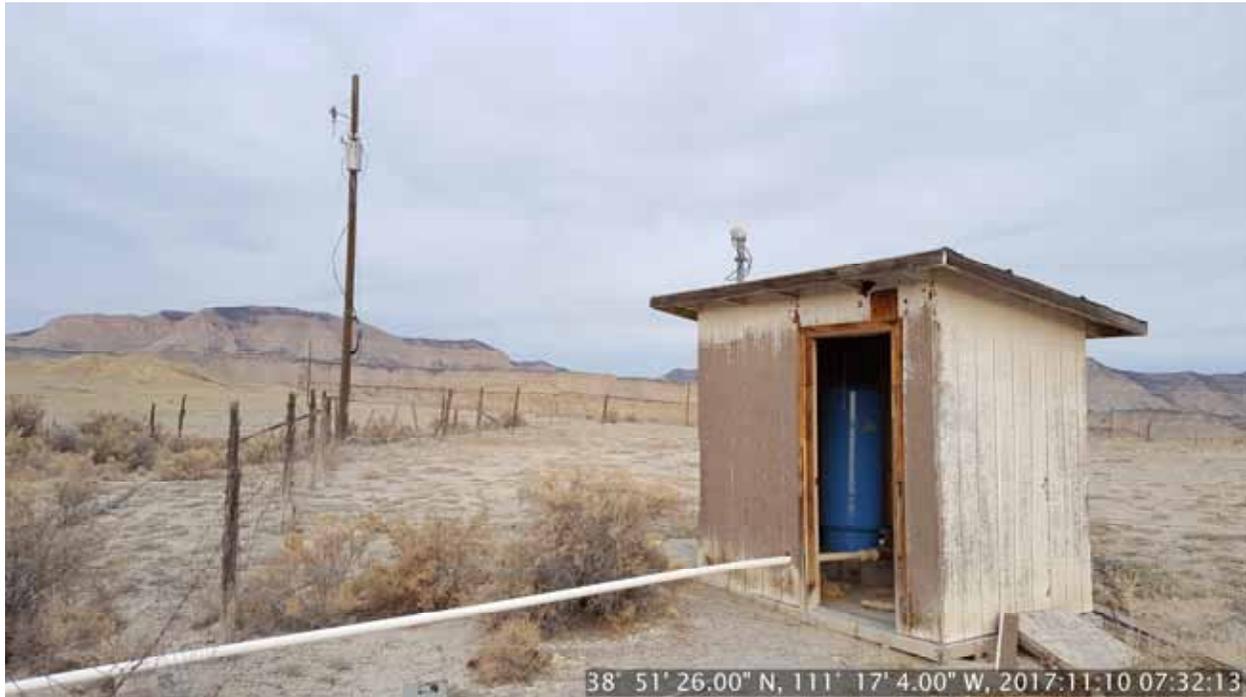
Feature 8. Well. Power line from pole to pump-house is disconnected.

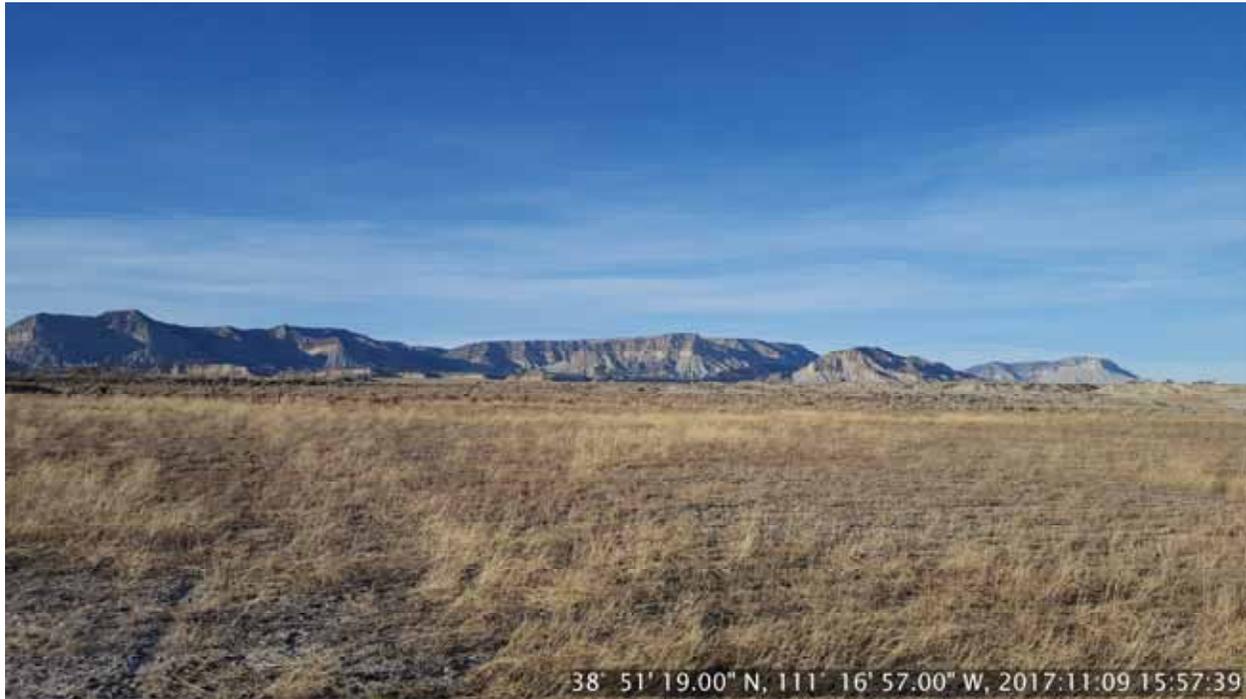
Feature 9. Farm Lands.

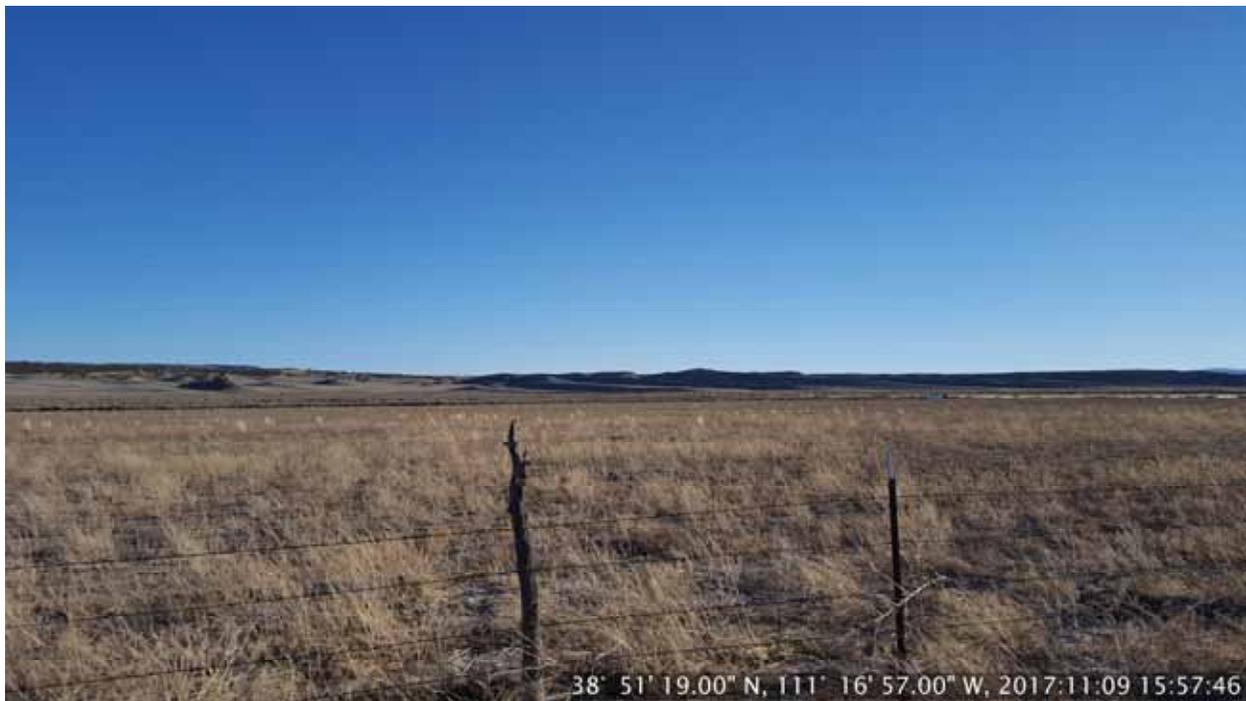
Feature 9. Farm Lands.

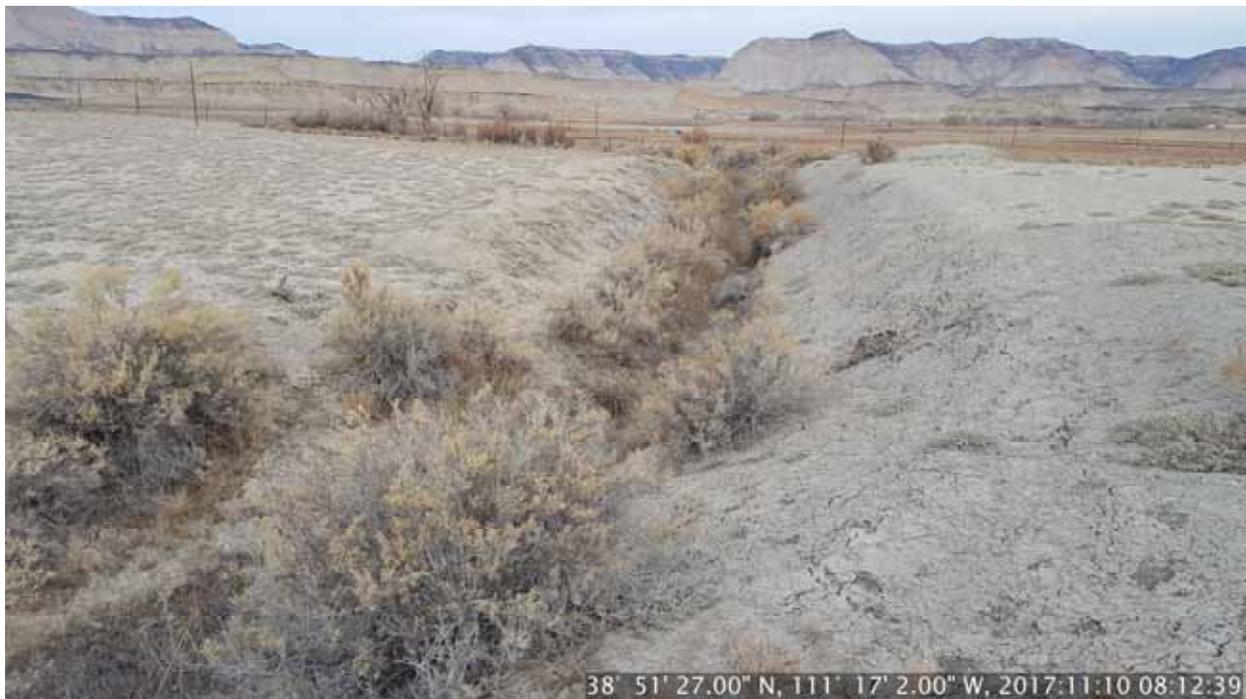
Feature 10. Irrigation Ditch. Looking west.

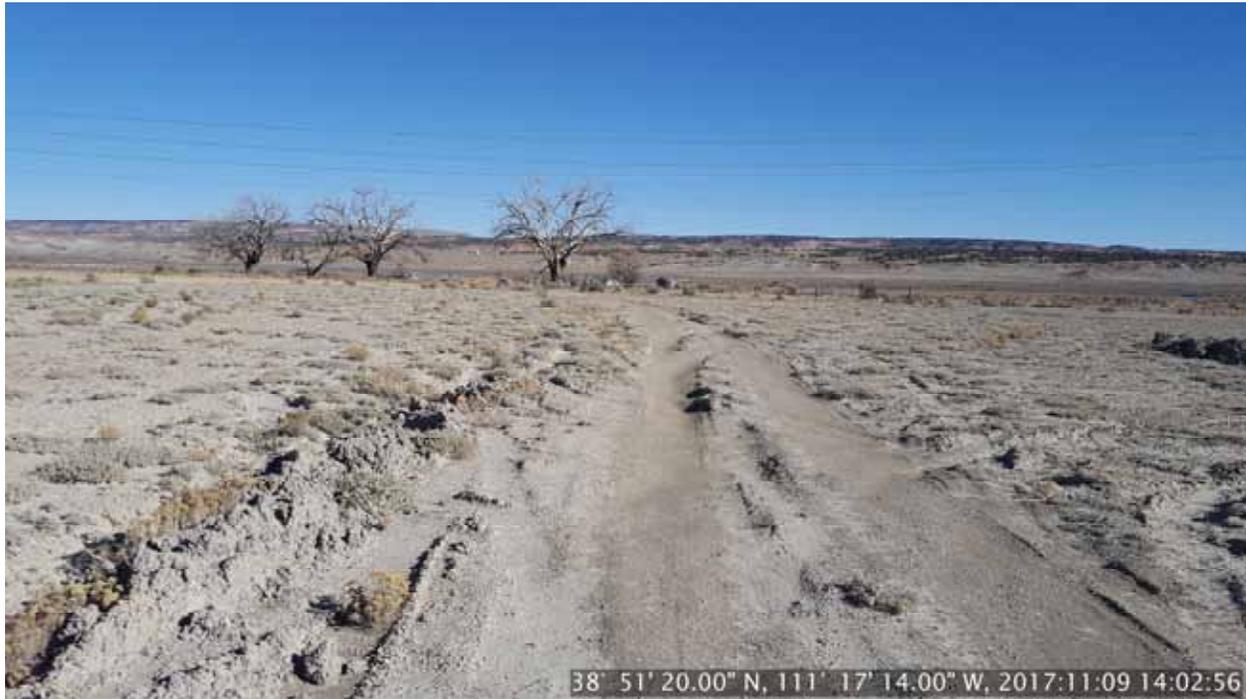
Feature 11. Unimproved Dirt Road. Looking east. This road leads to the ranch house, buildings, and corrals identified as Feature 1.

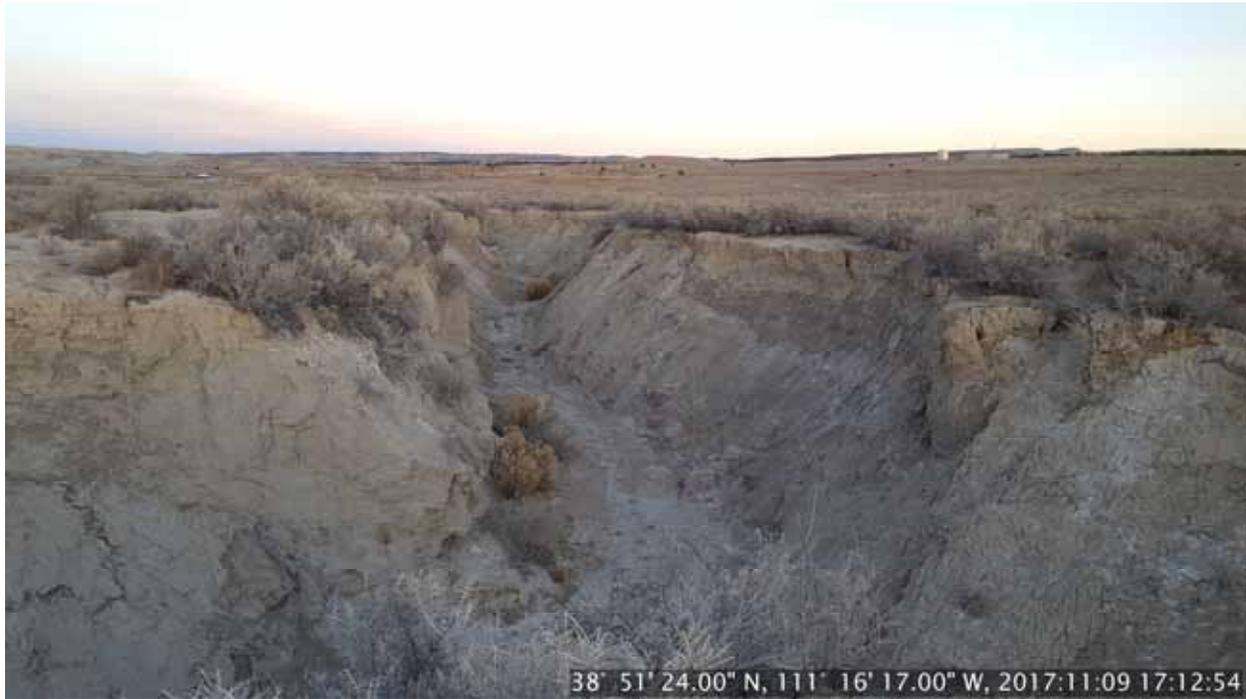
Feature 22. Dry Wash. Looking east.

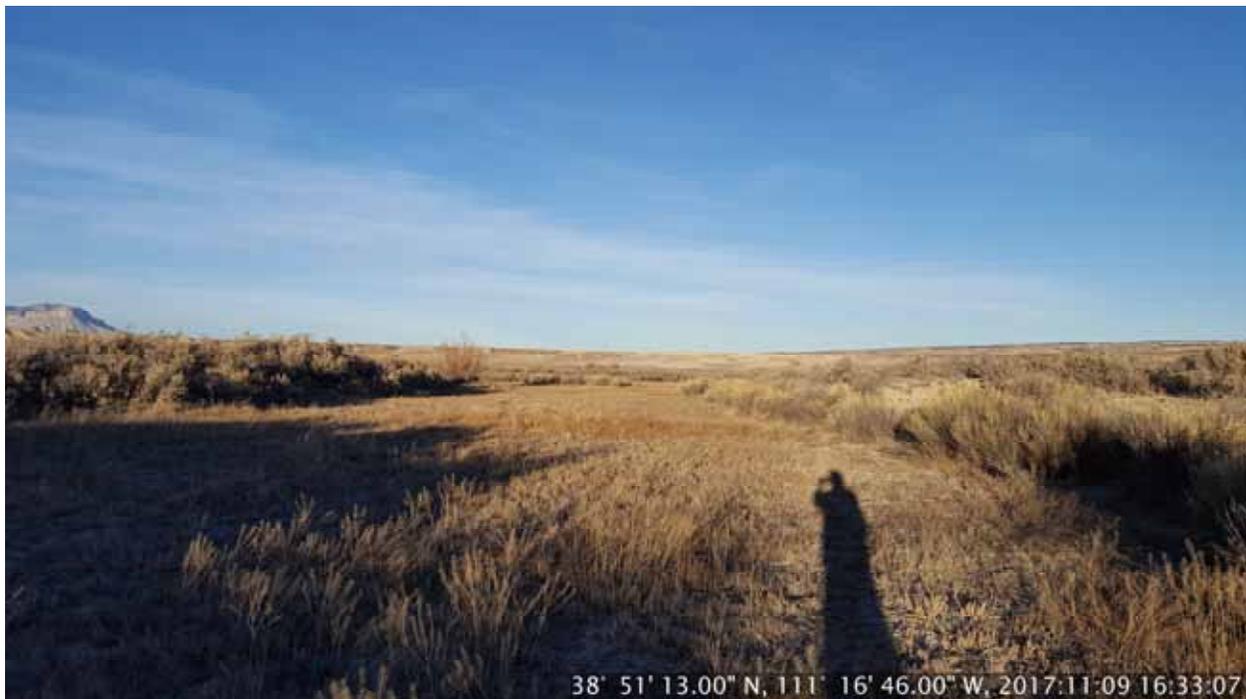
Feature 23. Grassy Area. Looking east.

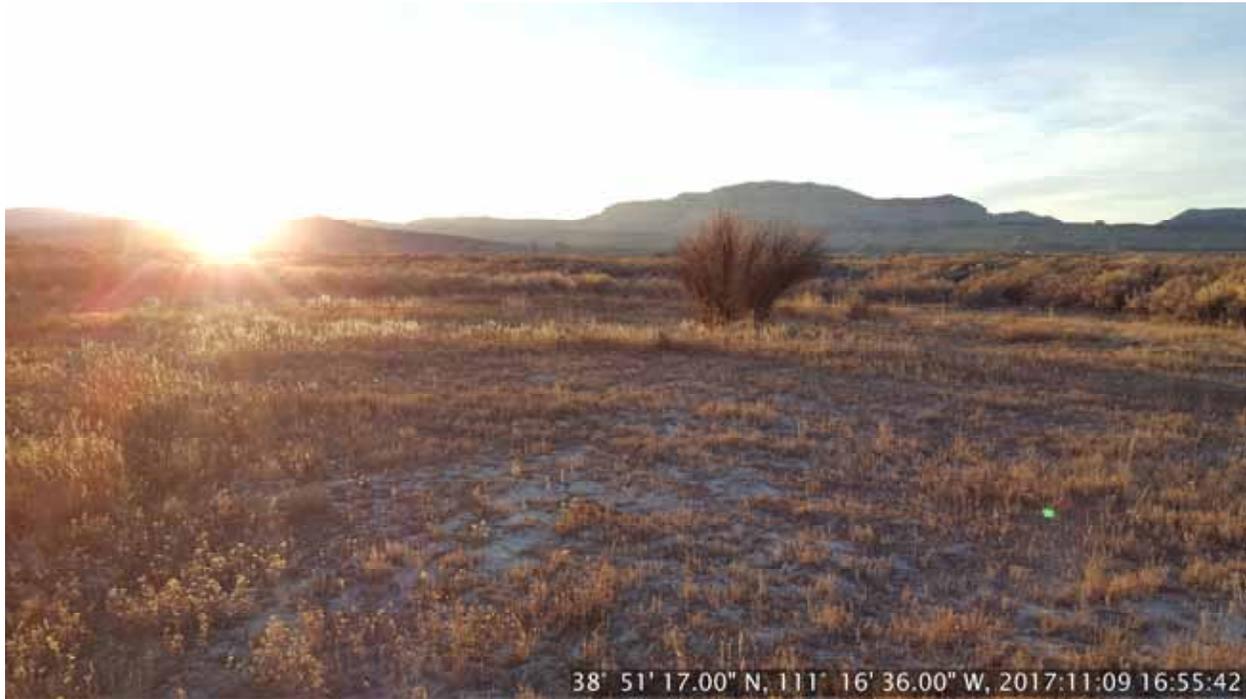
Feature 23. Grassy Area. Looking west.

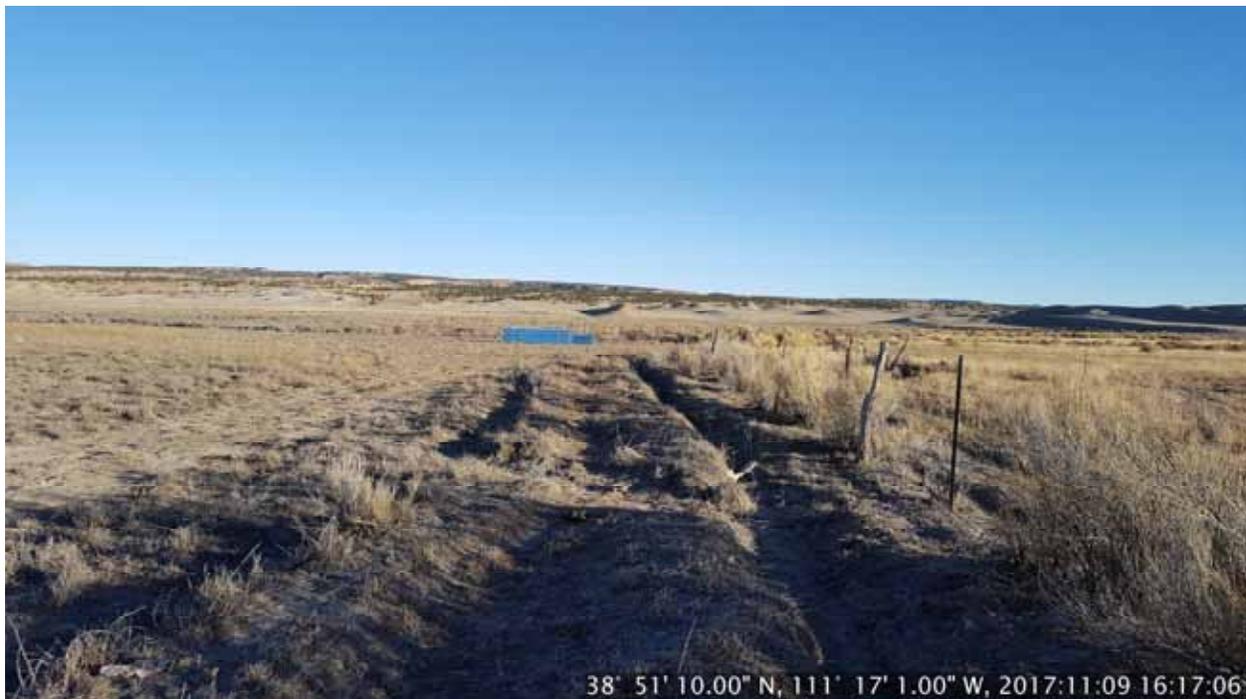
Feature 24. Irrigation Ditch Junction.

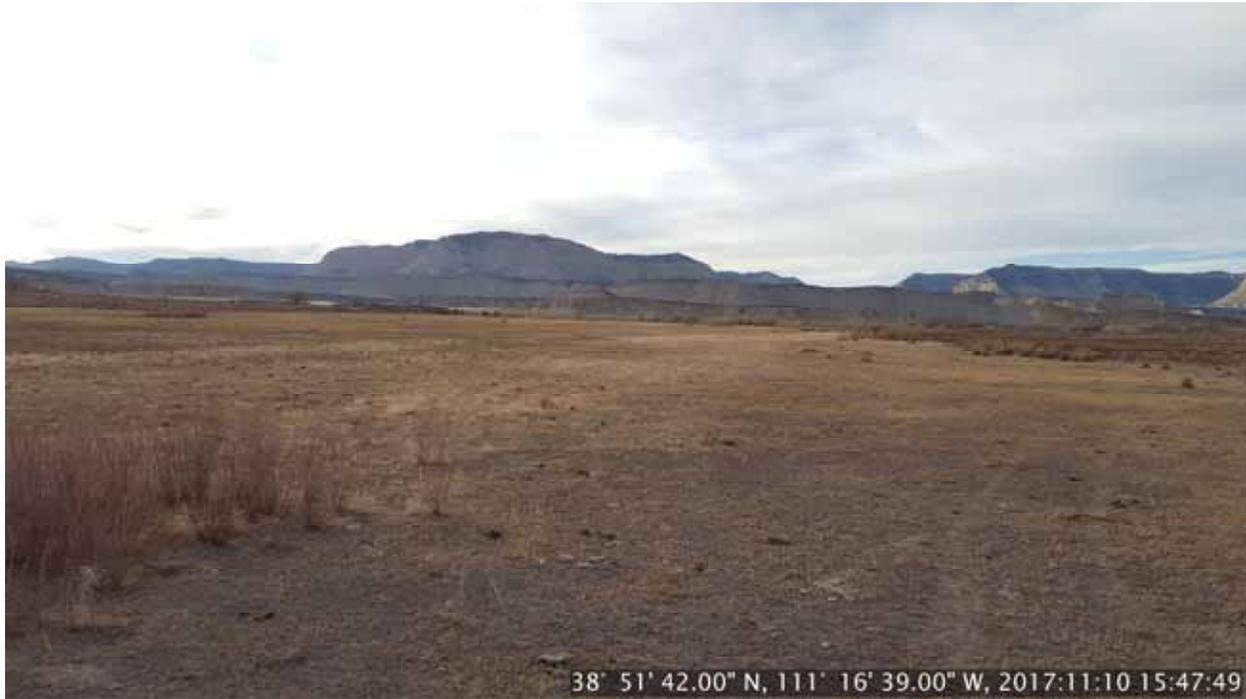
Feature 25. Grassy Area. Looking east.

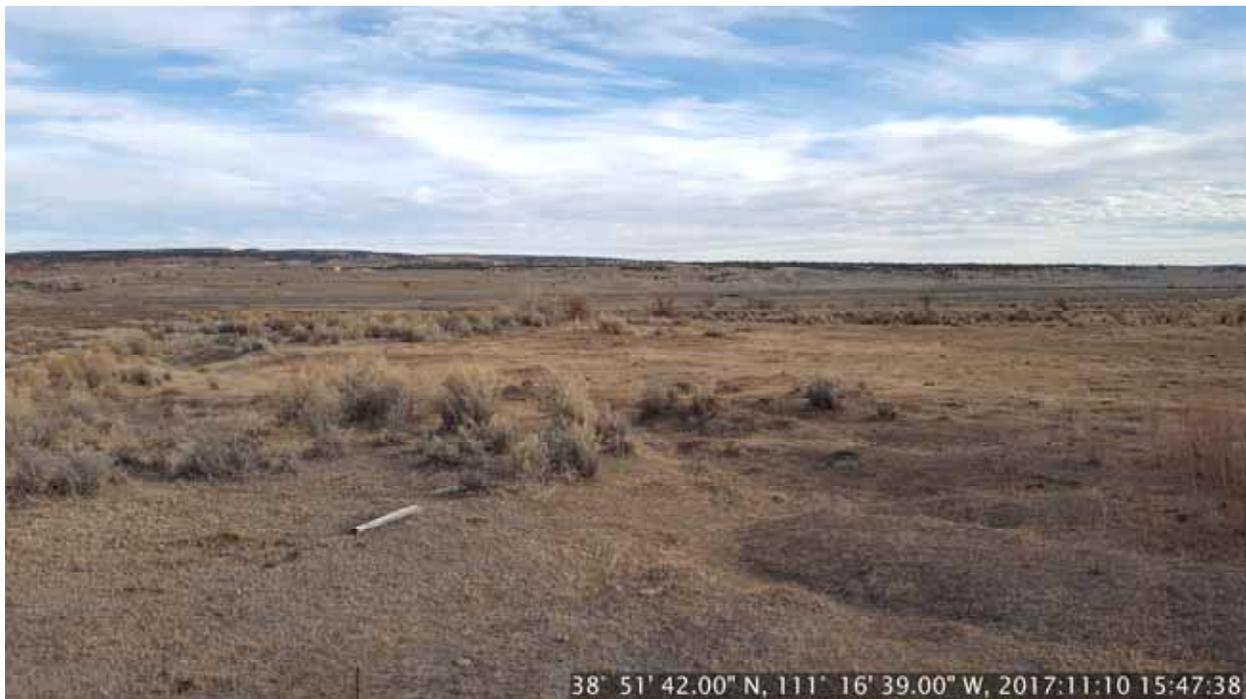
Feature 25. Grassy Area. Looking west.

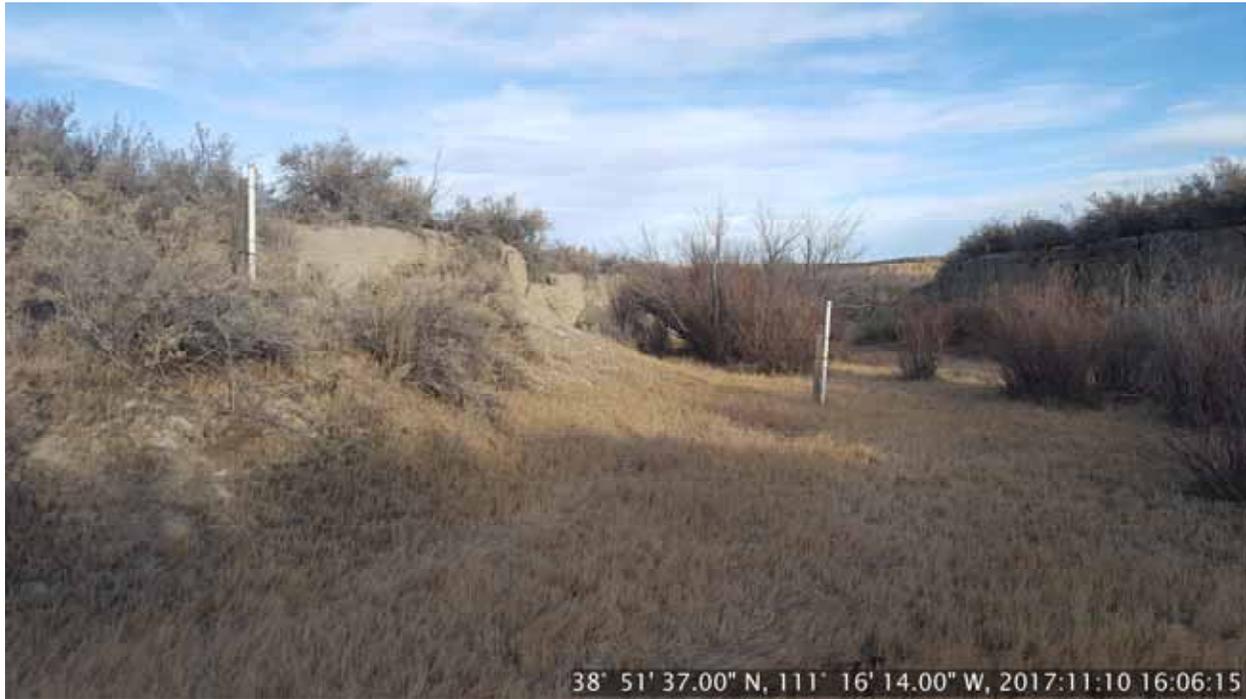
Feature 26. PVC Pipe Water Depth Gauge.

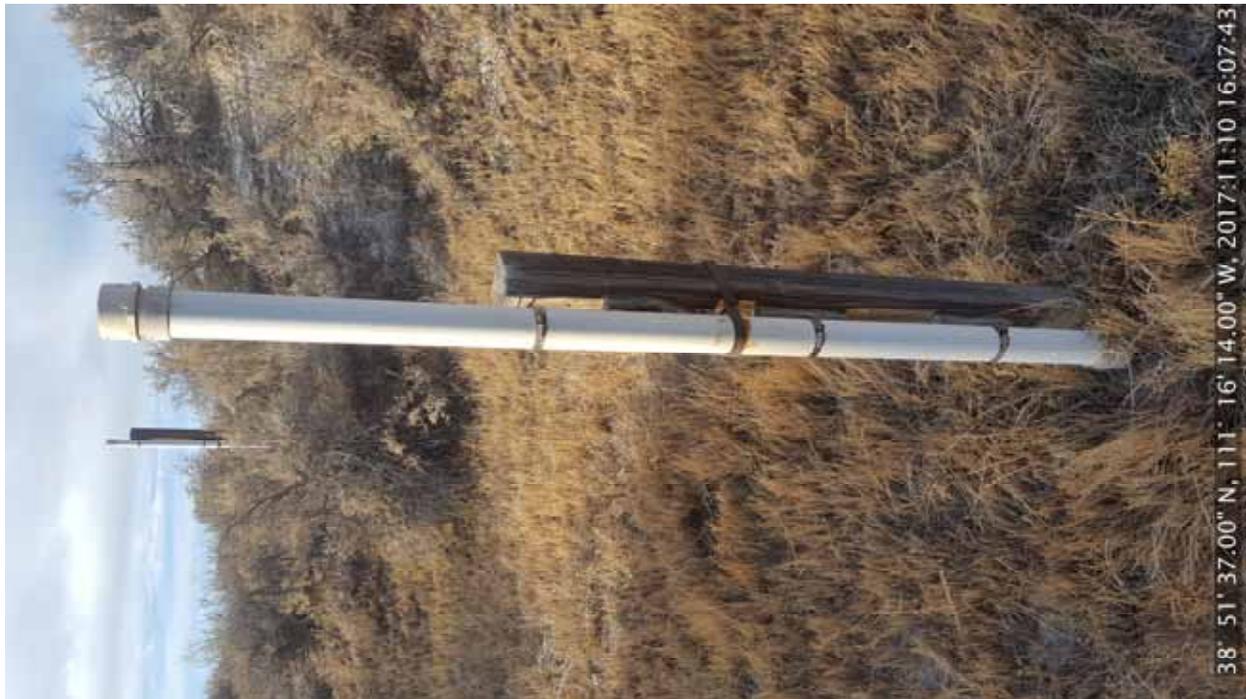
Feature 26. PVC Pipe Water Depth Gauge. *Rotate photo clockwise.*

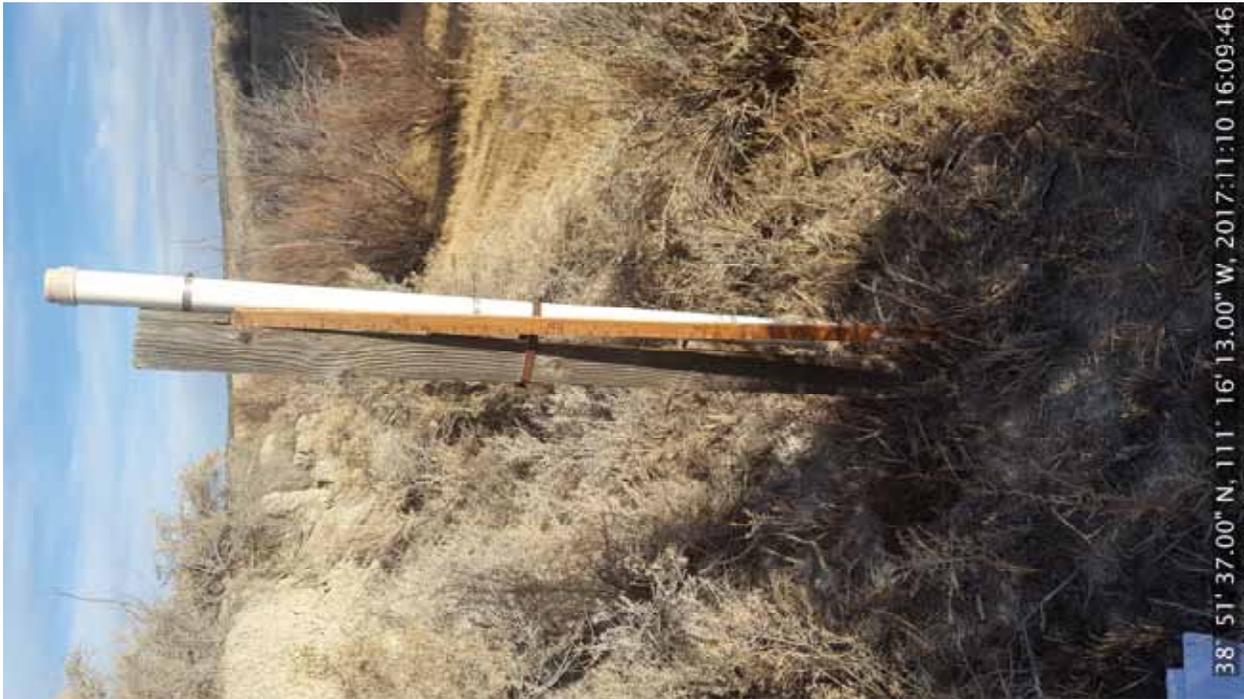
Feature 26. PVC Pipe Water Depth Gauge. *Rotate photo clockwise*. Graduated scale located in PVC tube.

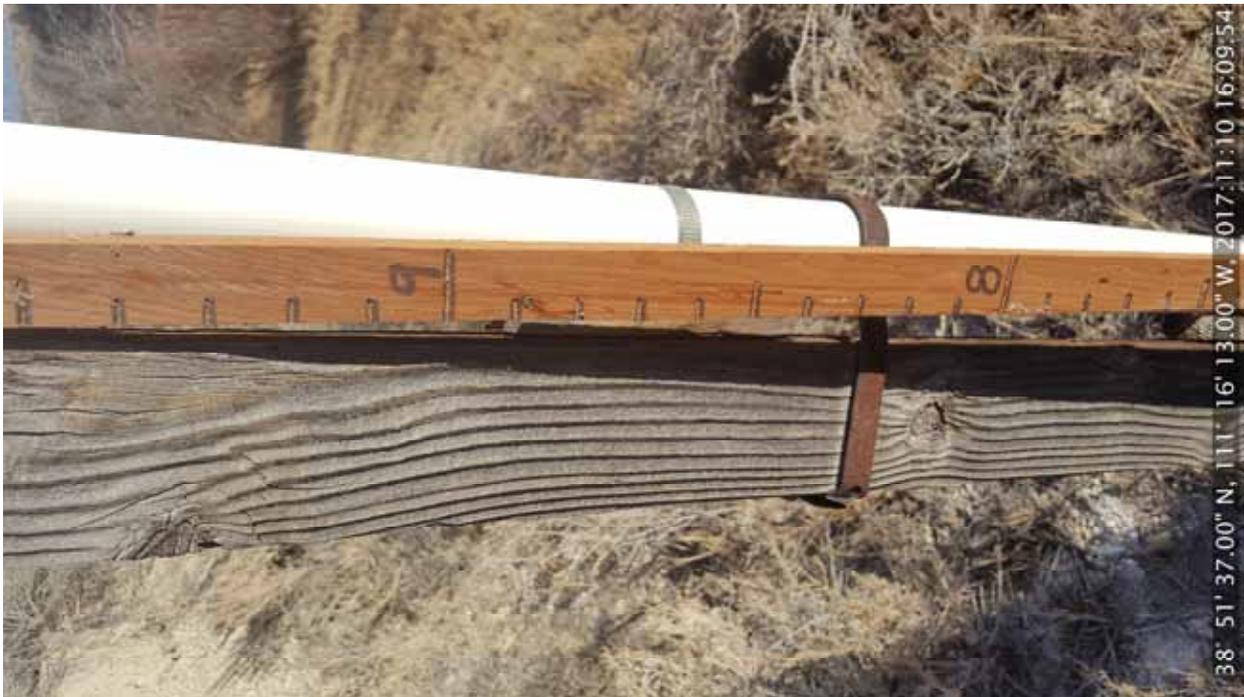
Feature 26. PVC Pipe Water Depth Gauge. *Rotate photo clockwise*. Close up photo of graduated scale.

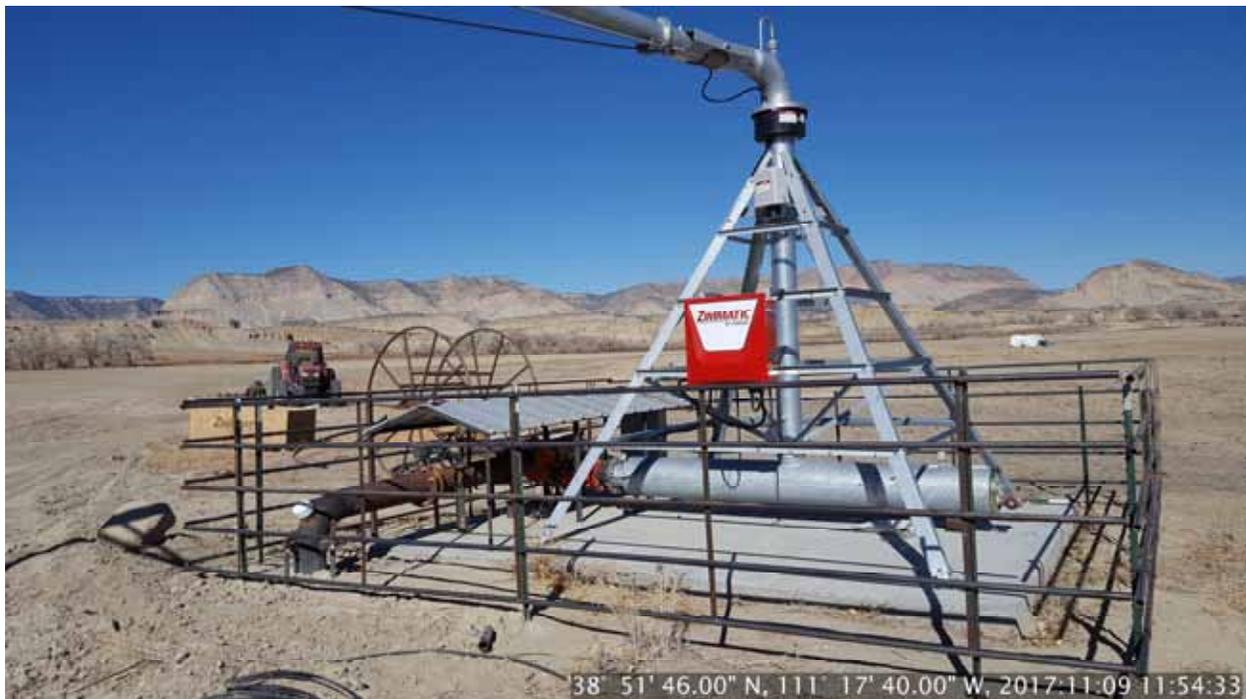
Feature 32. Irrigation Ditch and Farm Land. Foundation for pivot sprinklers.

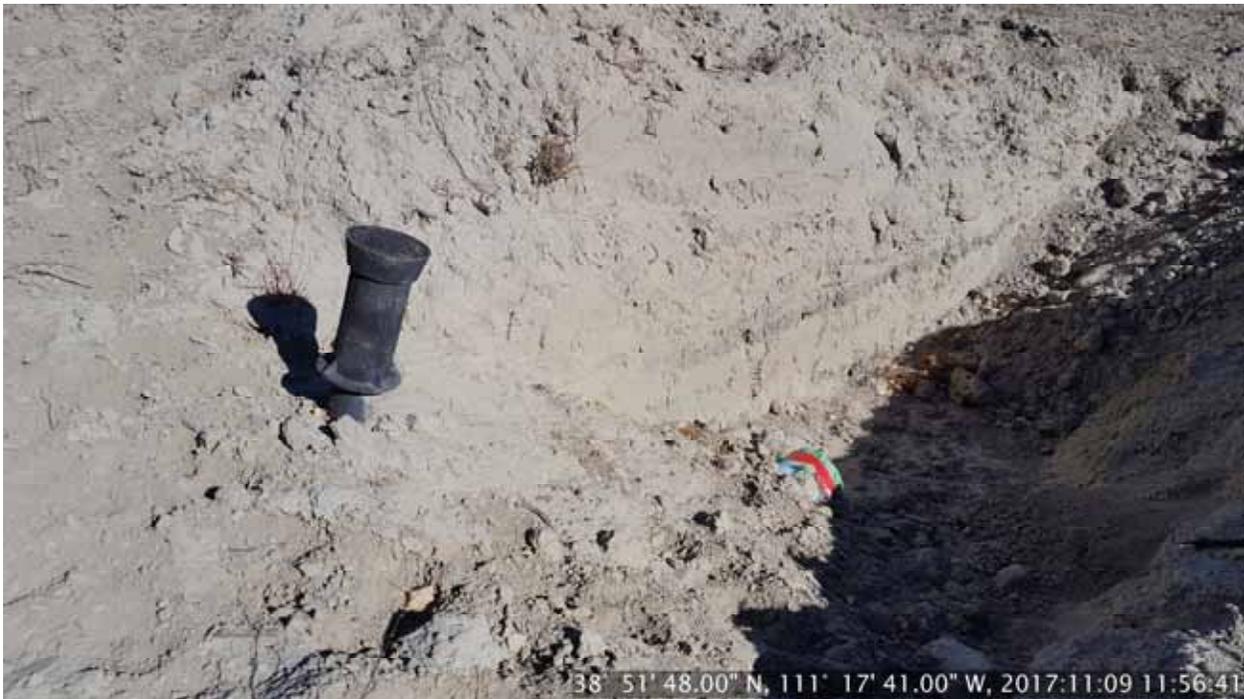
Feature 32. Irrigation Ditch and Farm Land. Underground water line feeding pivot sprinklers.
