**RE: Bronco Utah Operations LLC
Emery Mine
DOGM Permit No. C/015/0015
Emery 2 Second Left Panel Full Extraction Revision**

GEOLOGY AND SUBSIDENCE

The purpose of this report is to present baseline surface conditions prior to full extraction operations from the Emery 2 portal of the Bronco Utah Operations, LLC. (Bronco) Emery Mine, Emery County, Utah. The areas covered in this report include the following:

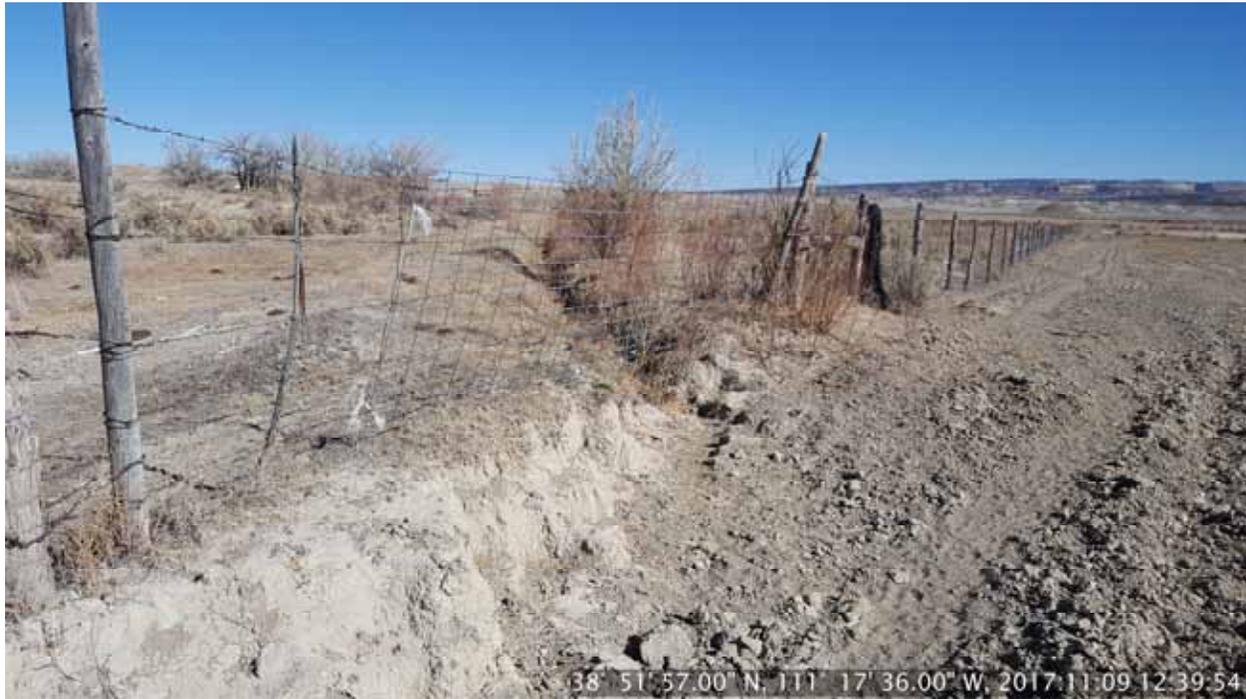
Feature 33. Irrigation Ditch. The description of this feature has been updated from the Valley Engineering (1980) report. A section of this feature is located within a buffer zone, depicted on Figure 1 and Plate V-5, where subsidence is not anticipated. The section of this irrigation ditch that traversed the farm land (Feature 32) has been eliminated. This ditch used to traverse the farm land (Feature 32) and continue on to feed the farm lands (Feature 9) located approximately ½ mile southeast of this location. It is our understanding that the farm lands identified in Features 9 and 32 will be watered with pressurized underground piping and pivot irrigation systems. The photo shows where the ditch was cut through at the north end of the farm land (Feature 32).

Feature 33. Irrigation Ditch. Photo taken at north end of farm land (Feature 32.). The farm land was expanded and regraded, eliminating need for irrigation ditch.

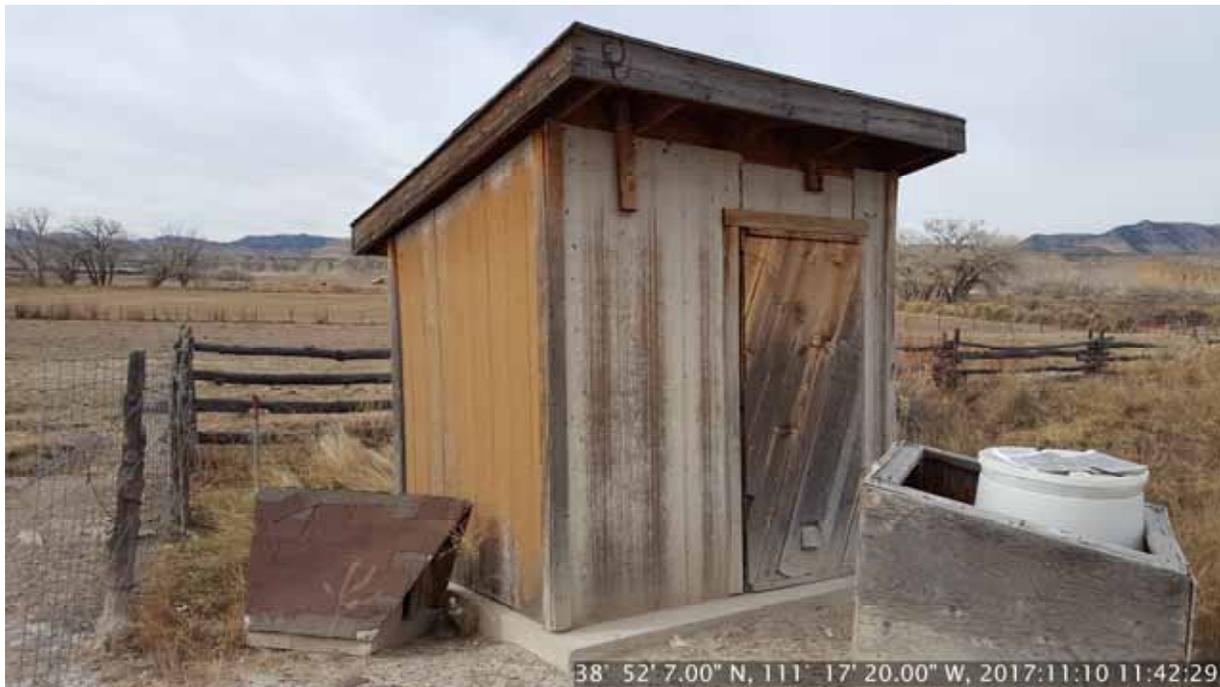
Feature 34. Culinary Well. The description of this feature has been updated from the Valley Engineering (1980) report. This feature is located within a buffer zone, depicted on Figure 1 and Plate V-5, where subsidence is not anticipated. The well, shown on Plate VI-4 as

Feature 34. Culinary Well.

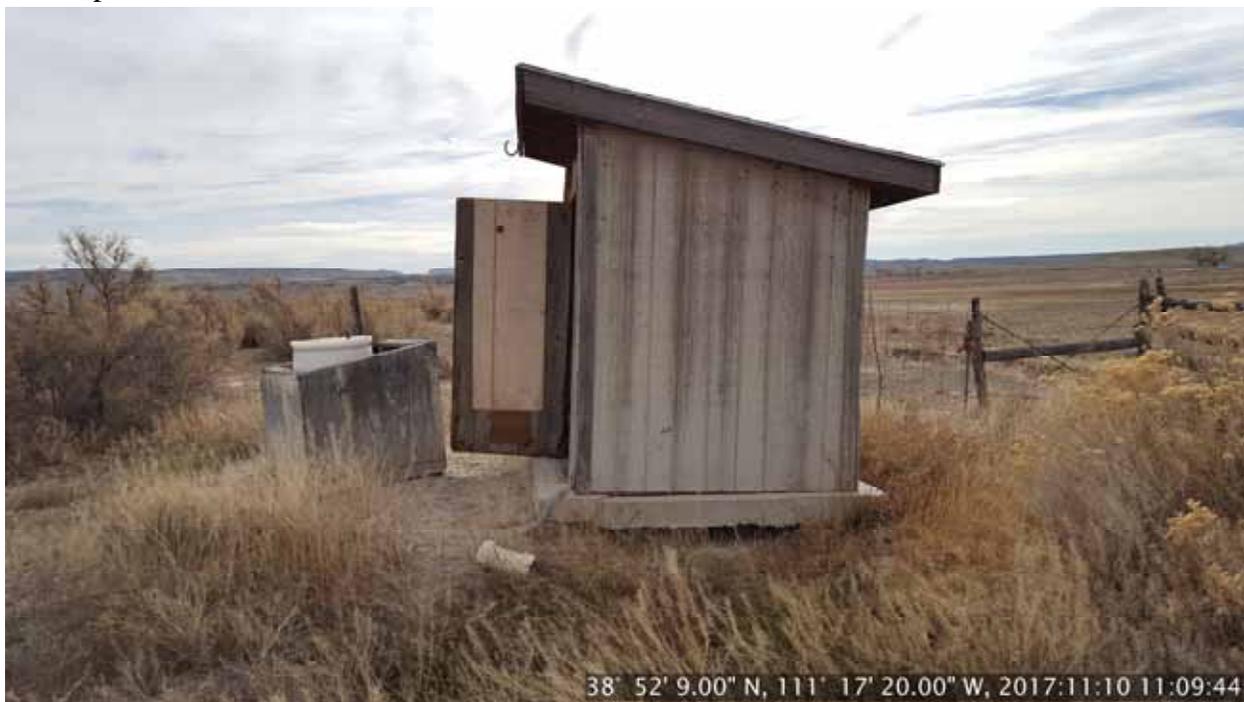
Feature 34. Culinary Well.

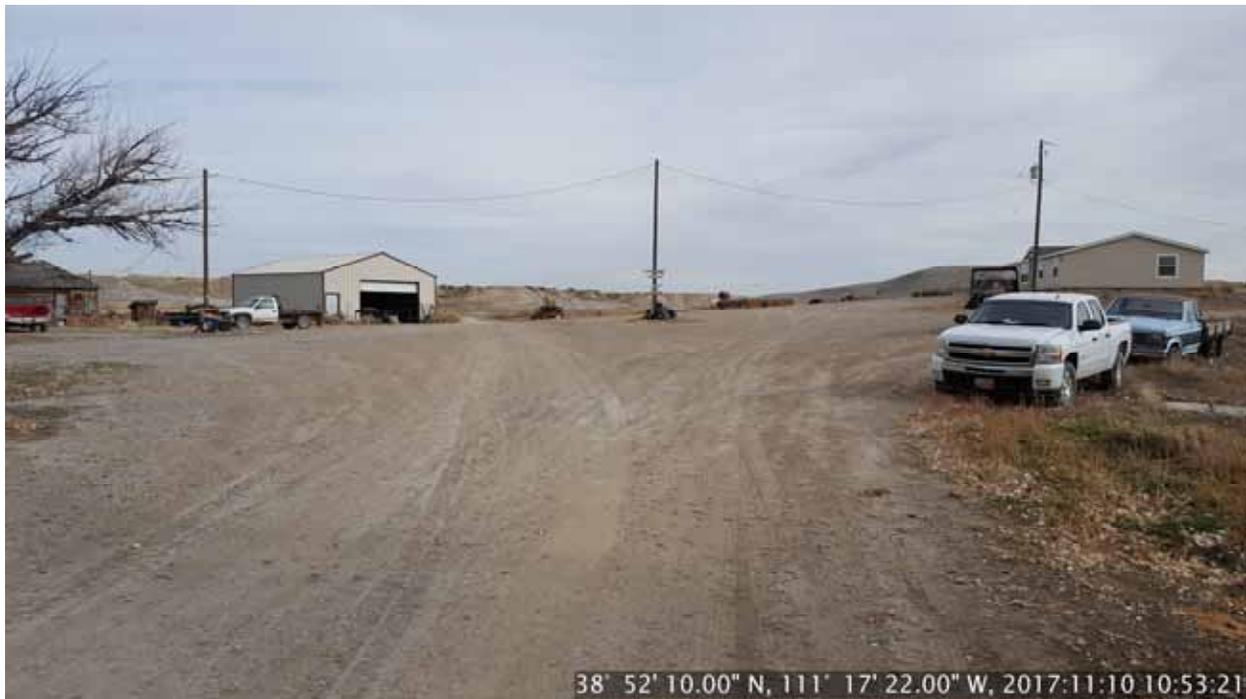
Feature 35. Ranch House and Buildings. Overview looking east.

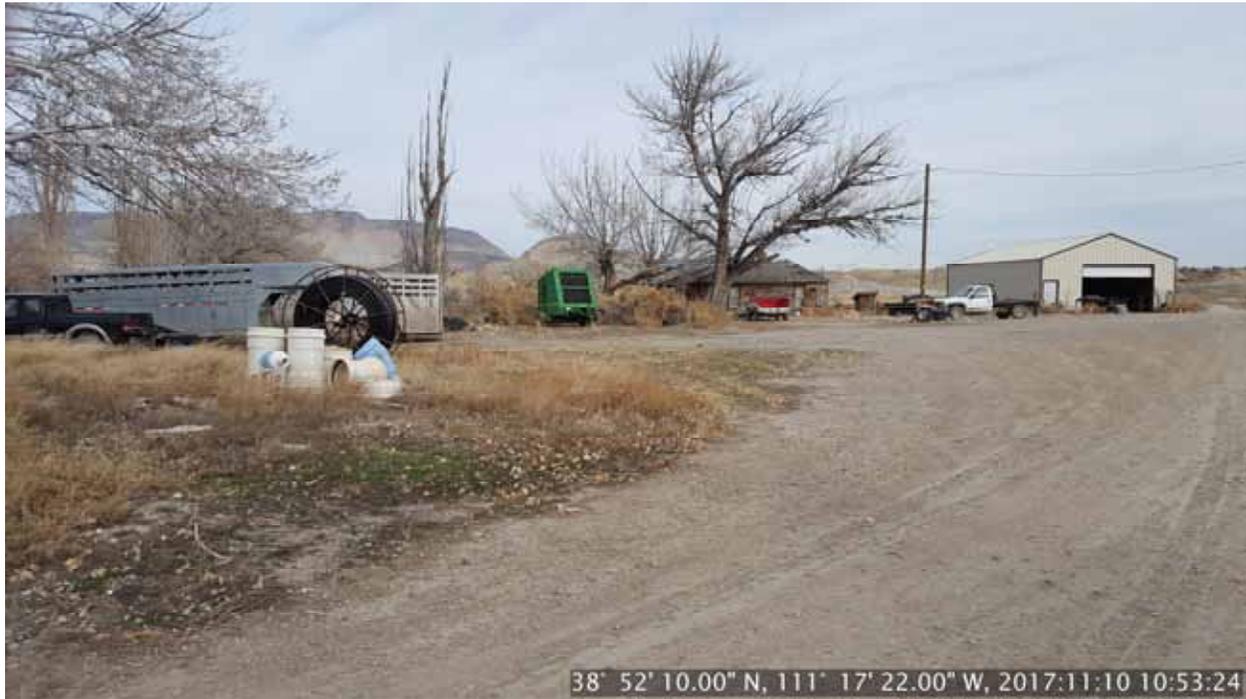
Feature 35. Ranch House and Buildings. Overview looking northeast.

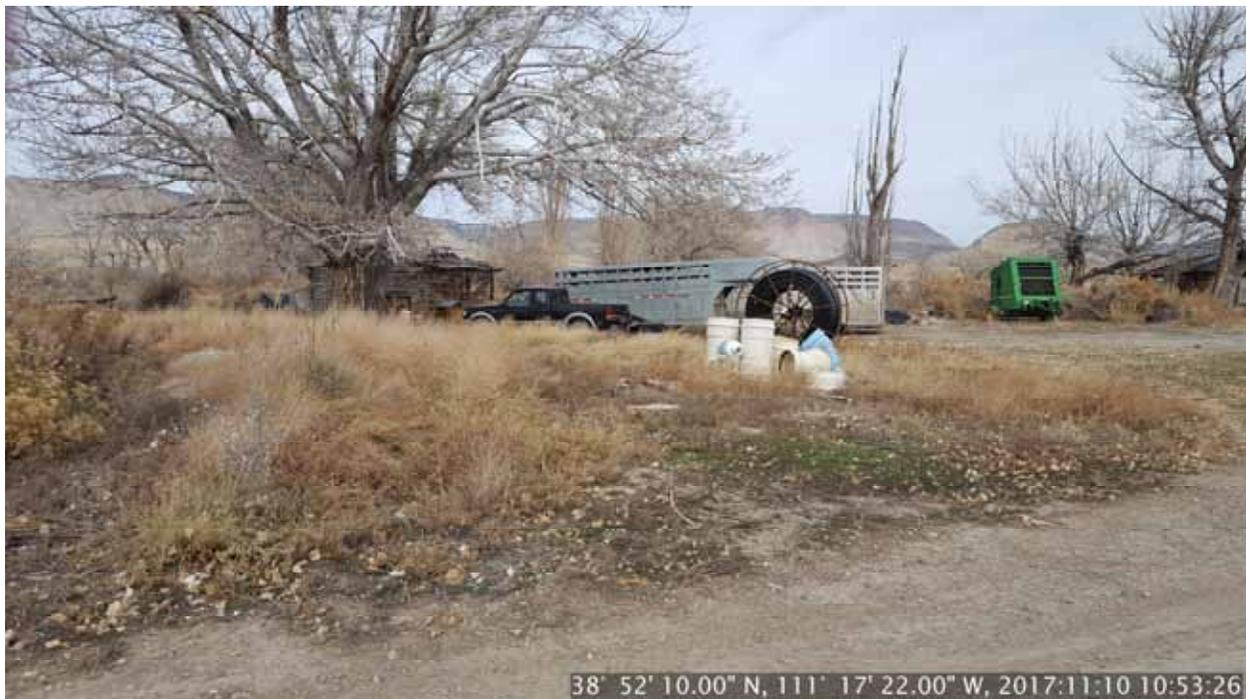
Feature 35. Ranch House and Buildings. Overview looking north.

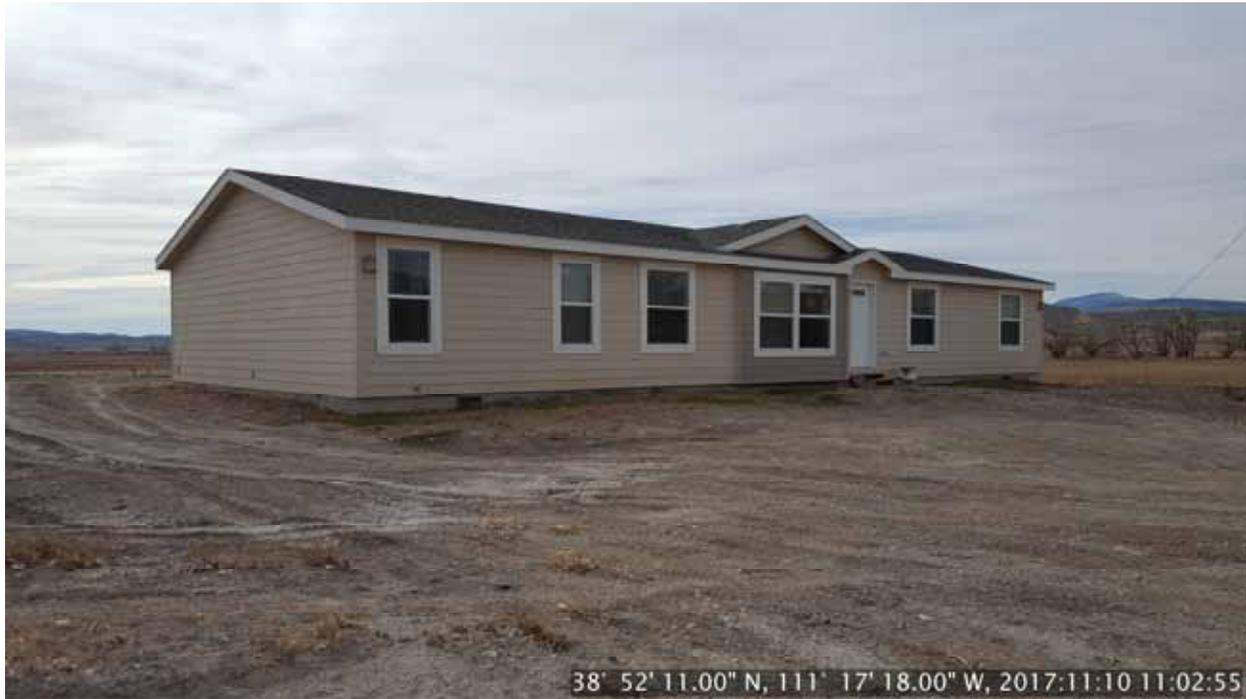
Feature 35. Ranch House and Buildings. Manufactured home looking east.

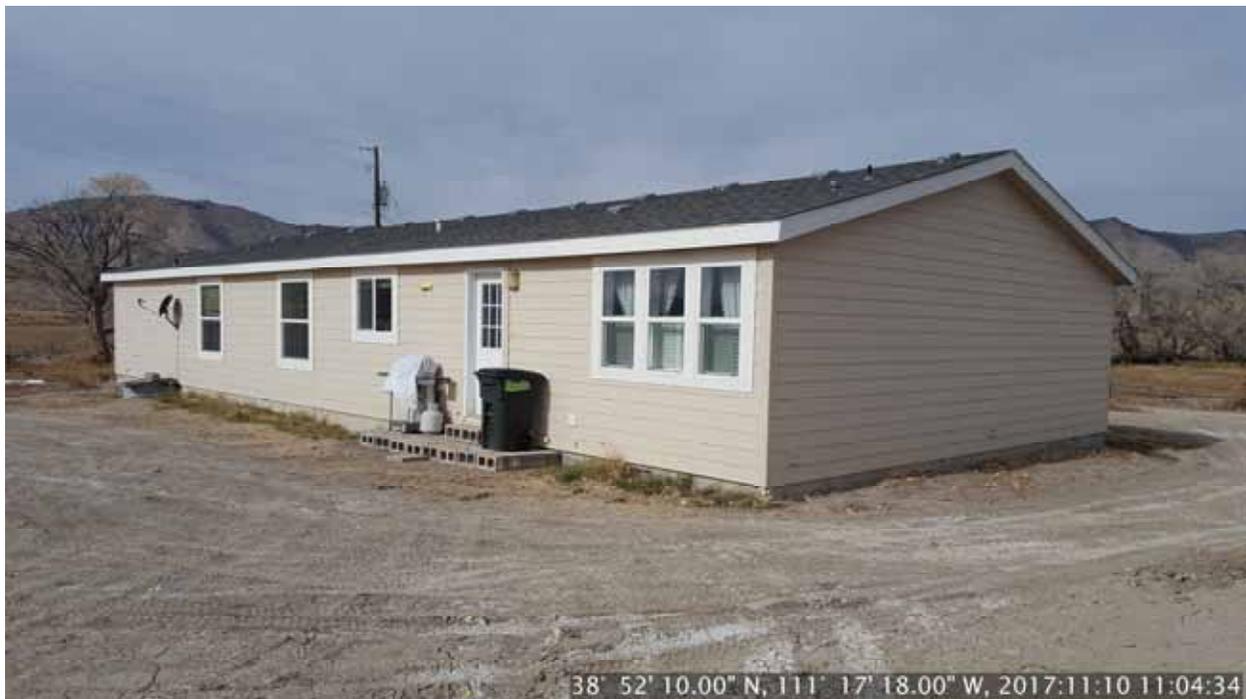
Feature 35. Ranch House and Buildings. Manufactured home looking west.

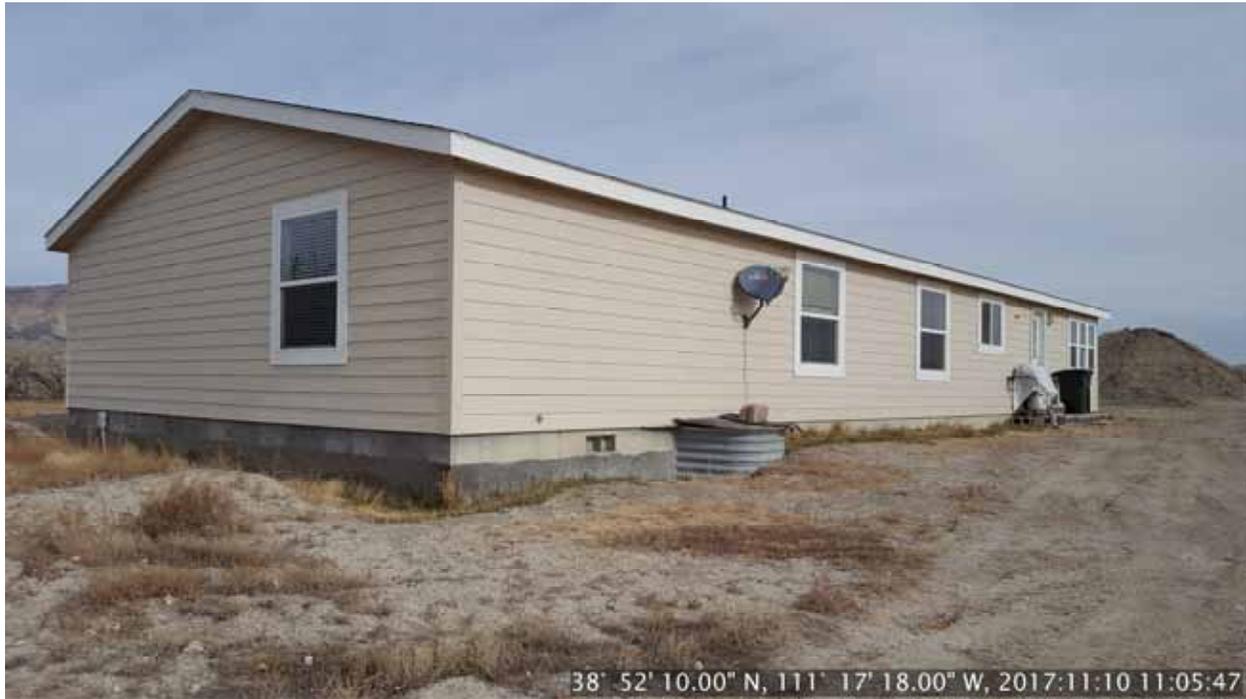
Feature 35. Ranch House and Buildings. Manufactured home. Looking north.

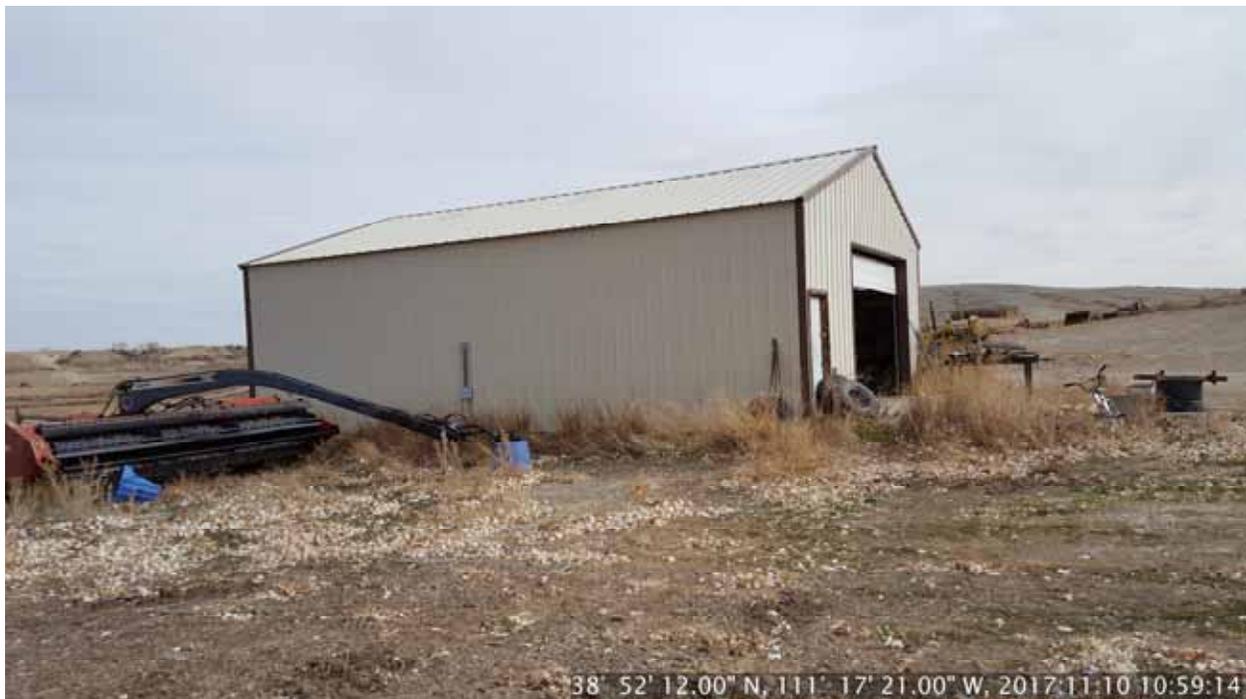
Feature 35. Ranch House and Buildings. Metal shed. Looking northeast.

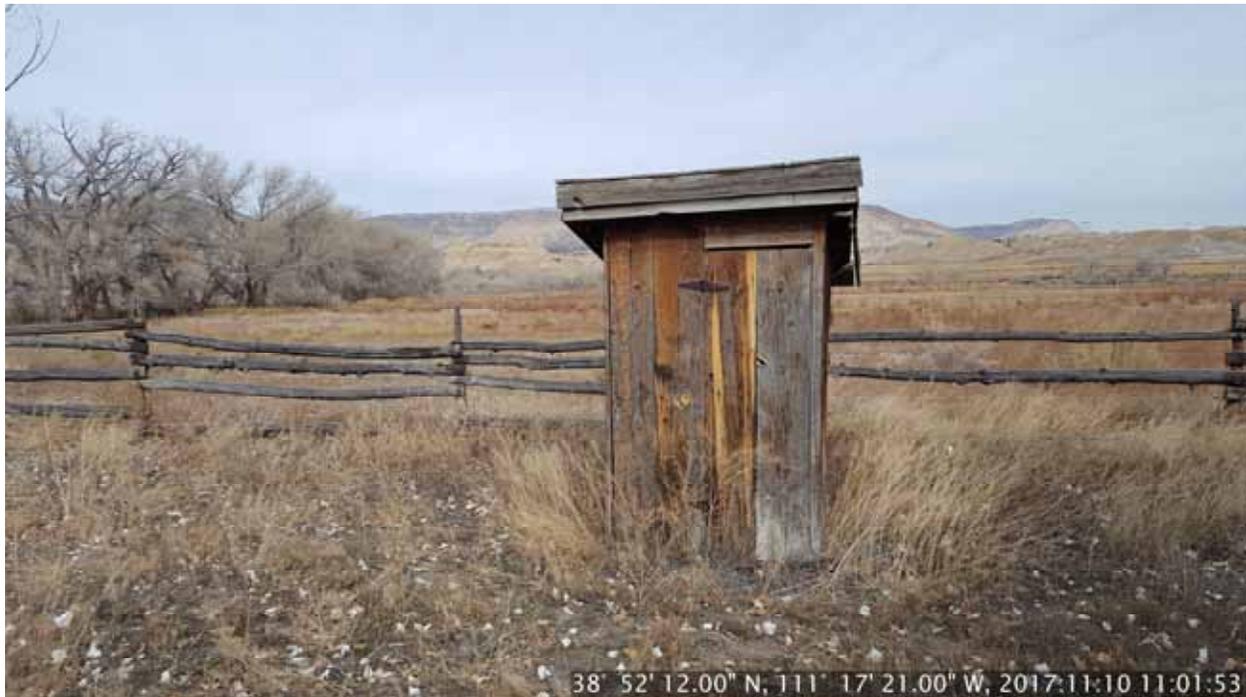
Feature 35. Ranch House and Buildings. Outhouse.

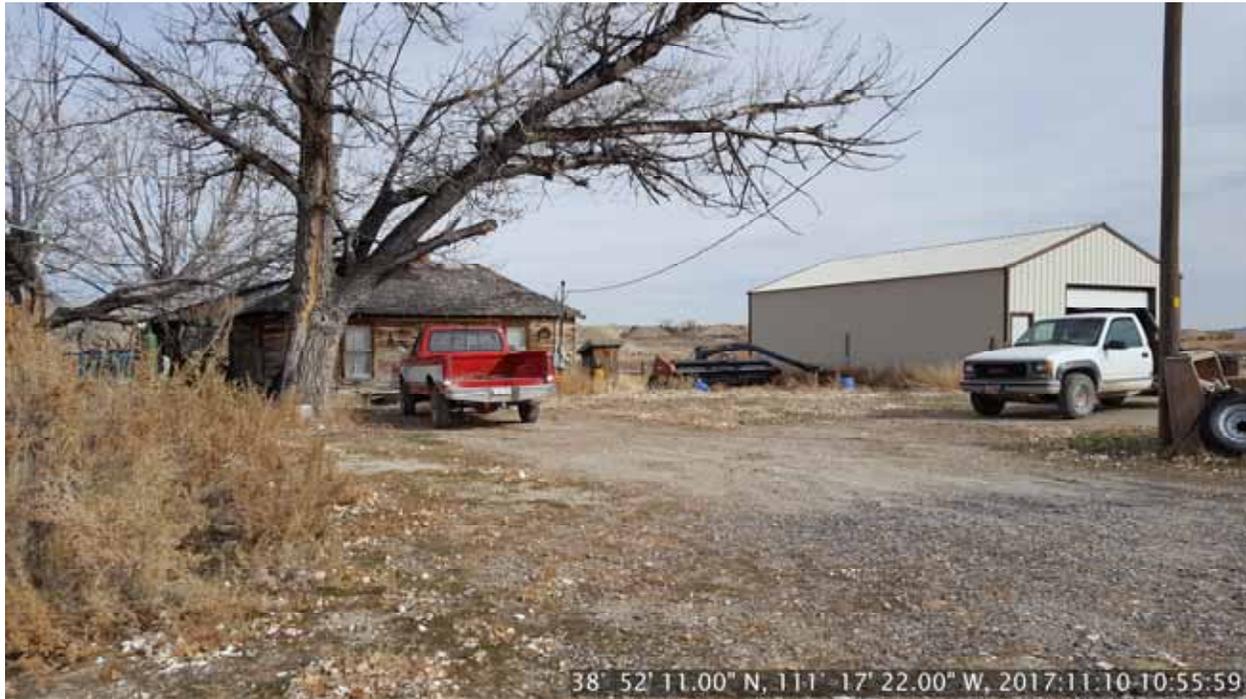
Feature 35. Ranch House and Buildings. Metal shed (right) and ranch house (left).

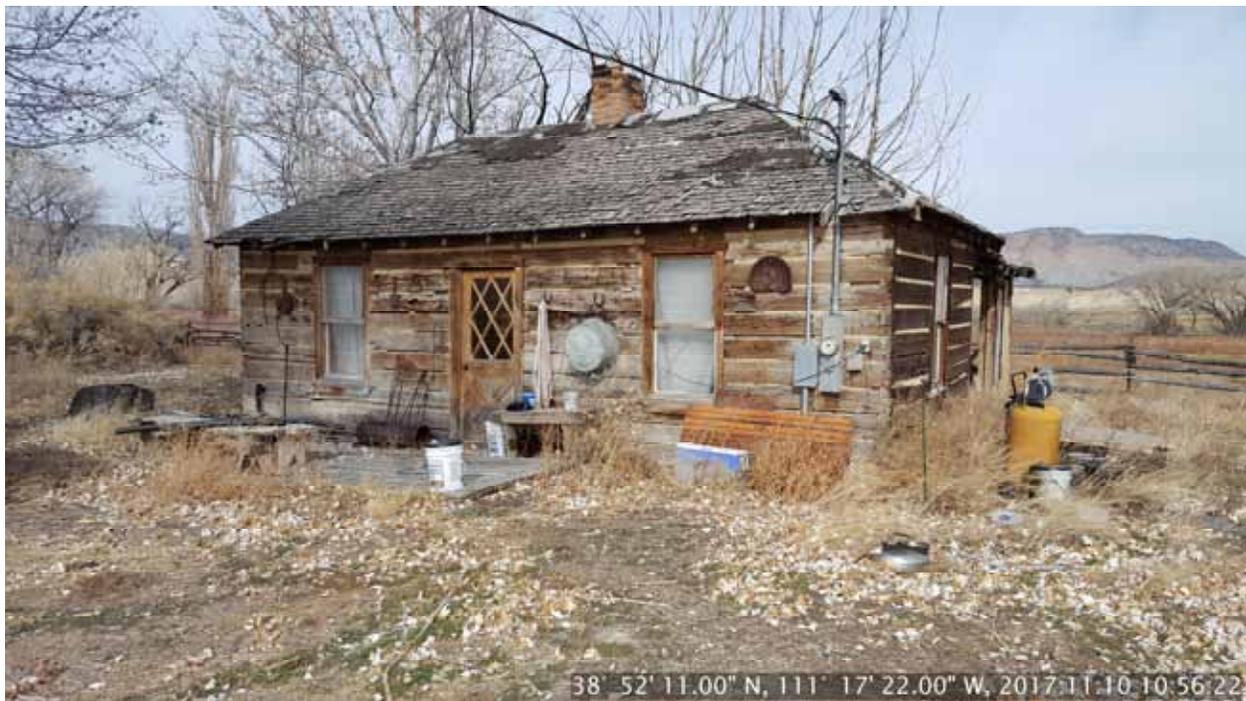
Feature 35. Ranch House and Buildings. Front view of ranch house.

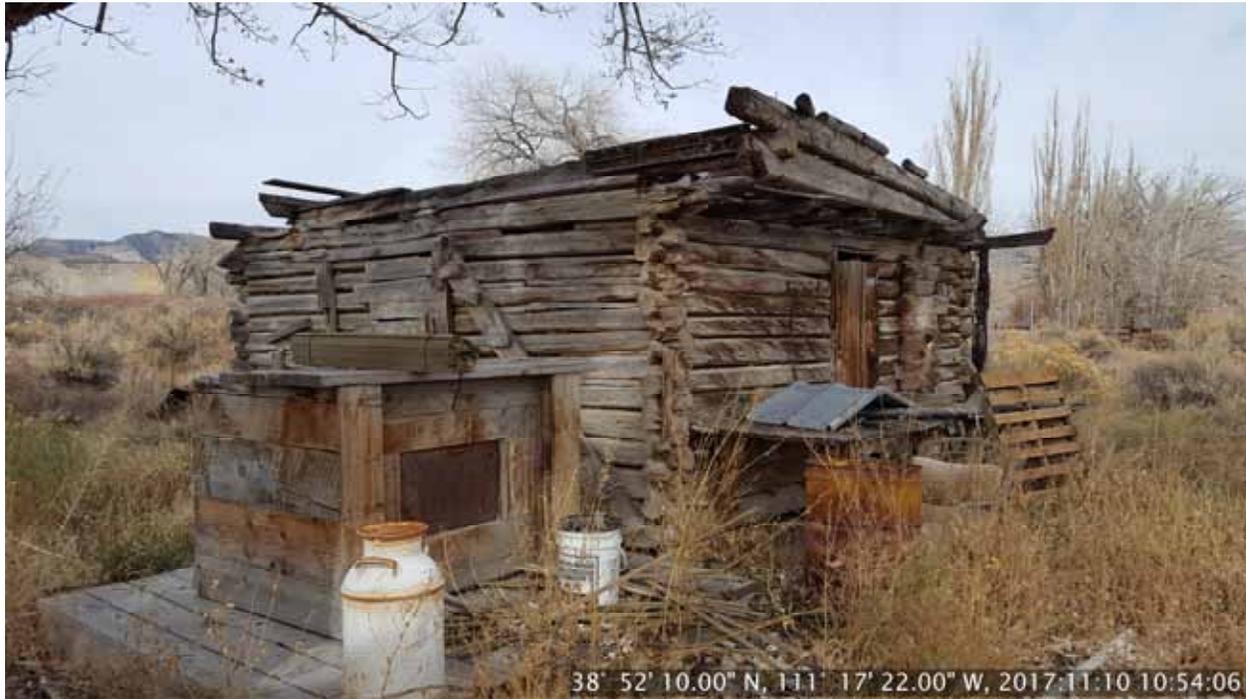
Feature 35. Ranch House and Buildings. Rear view of ranch house. Adobe walls have crumbled.

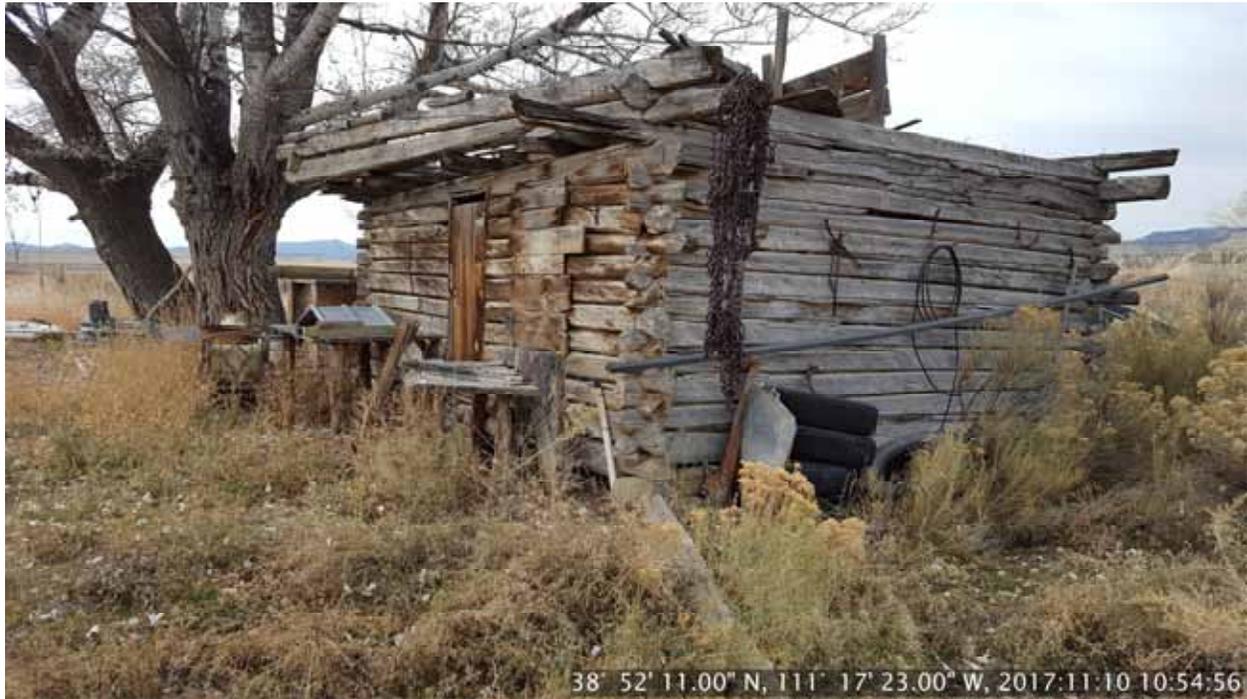
Feature 35. Ranch House and Buildings. Wood building. View of foundation.

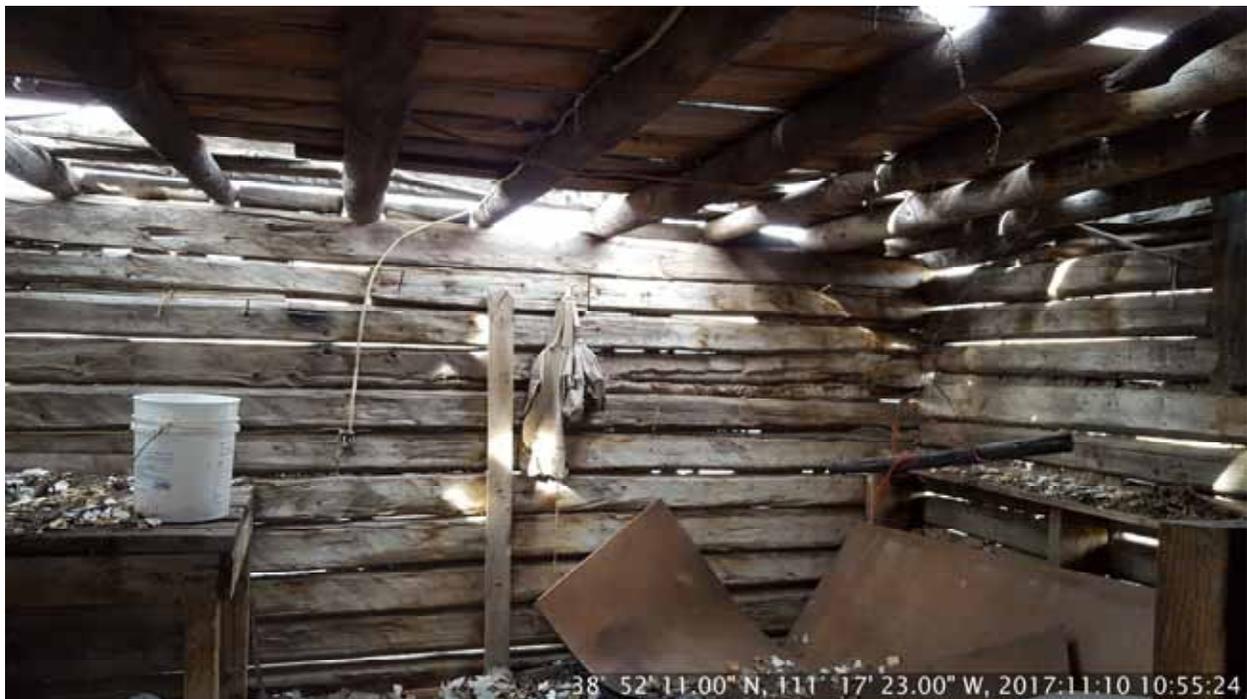
Feature 35. Ranch House and Buildings. Wood building.

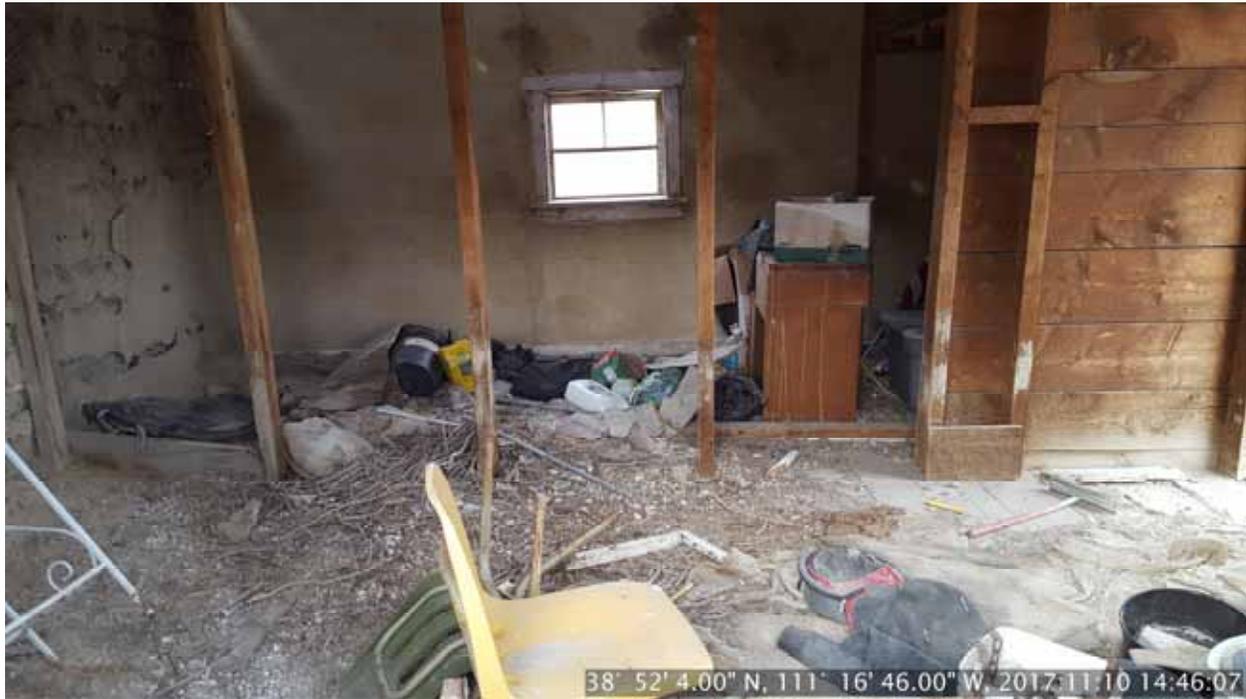
Feature 39. Log Cabins. The title and description of this feature have been updated from the Valley Engineering (1980) report. The corrals mentioned in the 1980 report have been removed. There are two log cabins at this location. The cabins are made of rough cut wood logs and are founded on wood or stacked rocks. Both cabins are in dilapidated condition.

Feature 39. Log Cabins. Cabin 1 looking south.

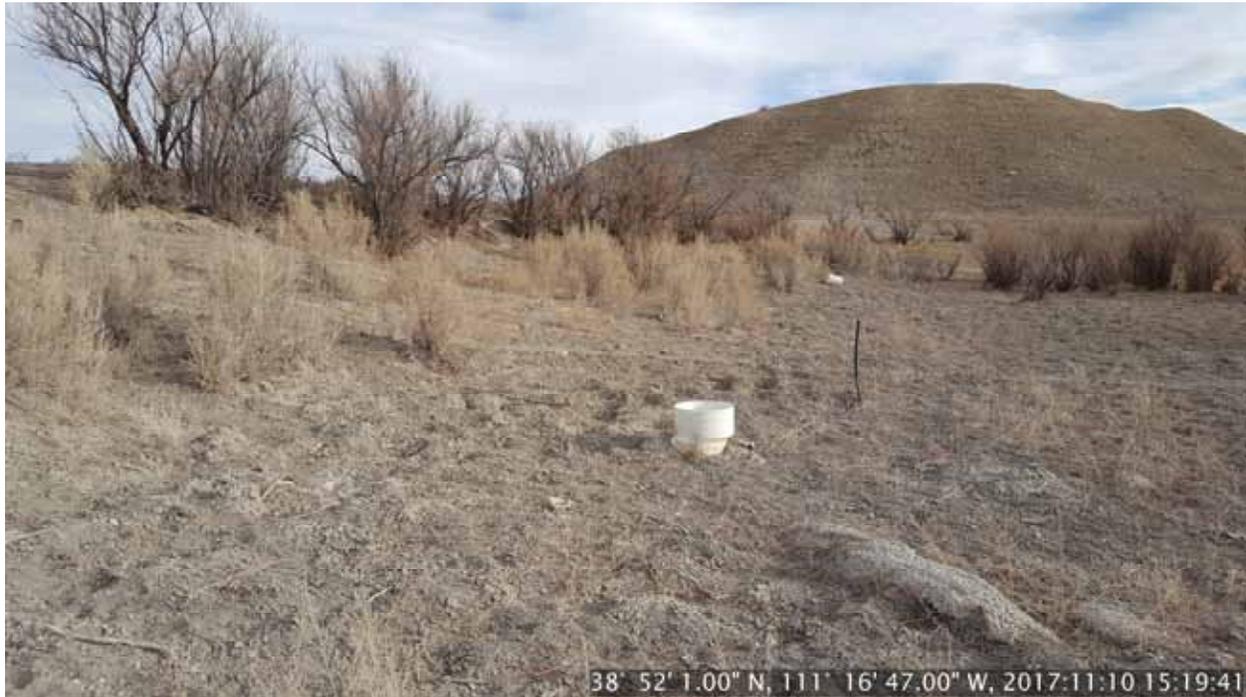
Feature 41. Pond. The description of this feature has been updated from the Valley Engineering (1980) report. The pond was constructed by installing an approximately 8 foot tall berm between two small hills. The berm is approximately 250 feet long and approximately 6 feet wide at its crest. The berm is located approximately 100 yards north of the section corner marker (Feature 40). A 25 foot long by 3 foot deep path has been worn through the western end of the berm. Water flows out of the pond via a 16" PVC riser. The pond was dry at the time of the survey.

Feature 41. Pond. Looking southwest at face of earthen dam. This dam situated between two small hills forms the north side of the pond.

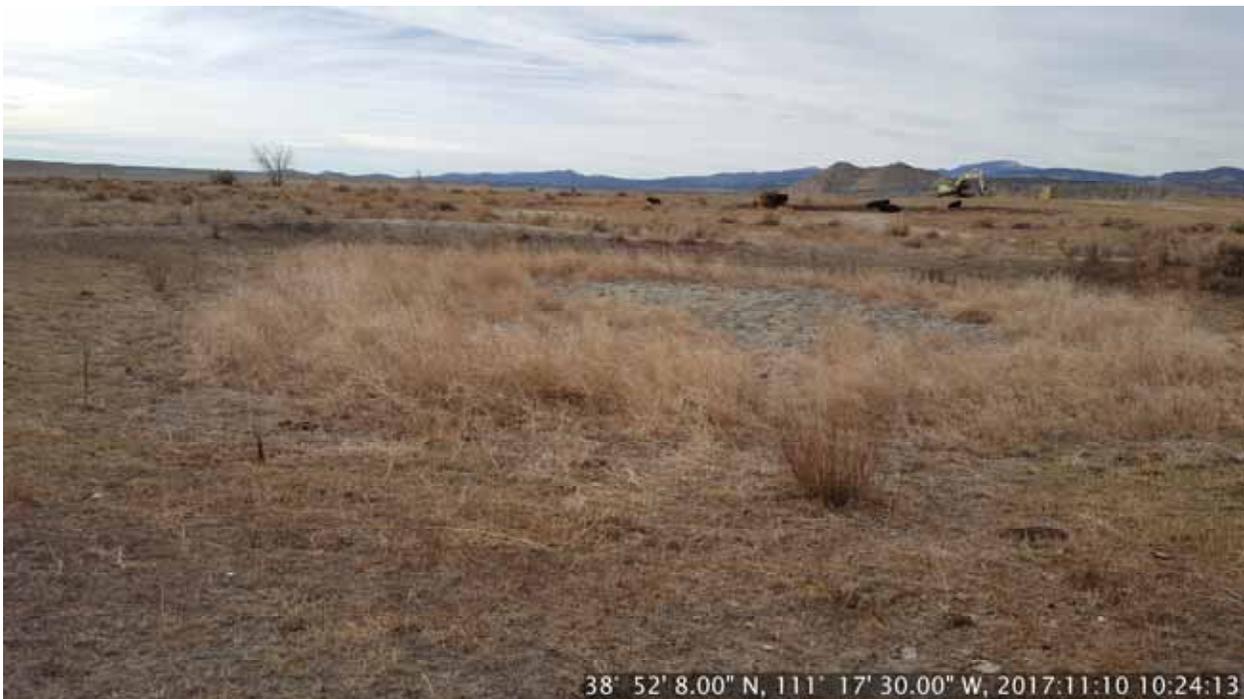
Feature 43. Corrals and Grain Silo. The description of this feature has been updated from the Valley Engineering (1980) report. This feature is located within a buffer zone, depicted on Figure 1 and Plate V-5, where subsidence is not anticipated. The corrals and feeding areas are constructed of rough cut lumber, timber posts, and railroad ties and are in good condition. The gates to the corrals are made of steel pipes and are in good condition. The galvanized steel grain silo, located approximately 180 yards west of the southwestern corner of the corrals, rests on a concrete pad and is in good condition.

Feature 43. Corrals and Grain Silo. Looking south at grain silo.

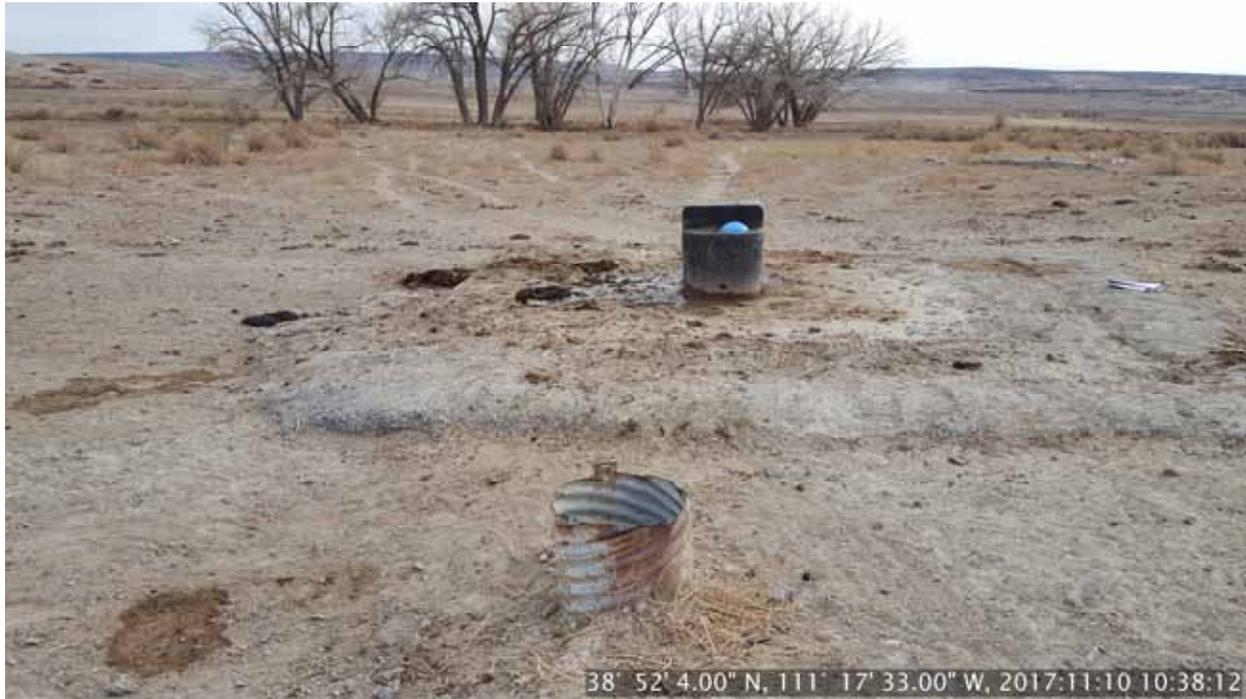
Feature 44. Pond, Livestock Waterer, and Water Line Air Vent. The title and description of this feature have been updated from the Valley Engineering (1980) report. The small pond observed in the area is still intact. However, the two corrals identified in the Valley Engineering report have been removed. The circular pond has a diameter of approximately 100 feet and is currently dry. A stock watering device (MiraFount 3465) installed on a 16 foot square unformed concrete pad is located roughly a 100 yards southwest of the pond. A 15" diameter corrugated

Feature 44. Pond, Livestock Waterer, and Water Line Air Vent. Pond.

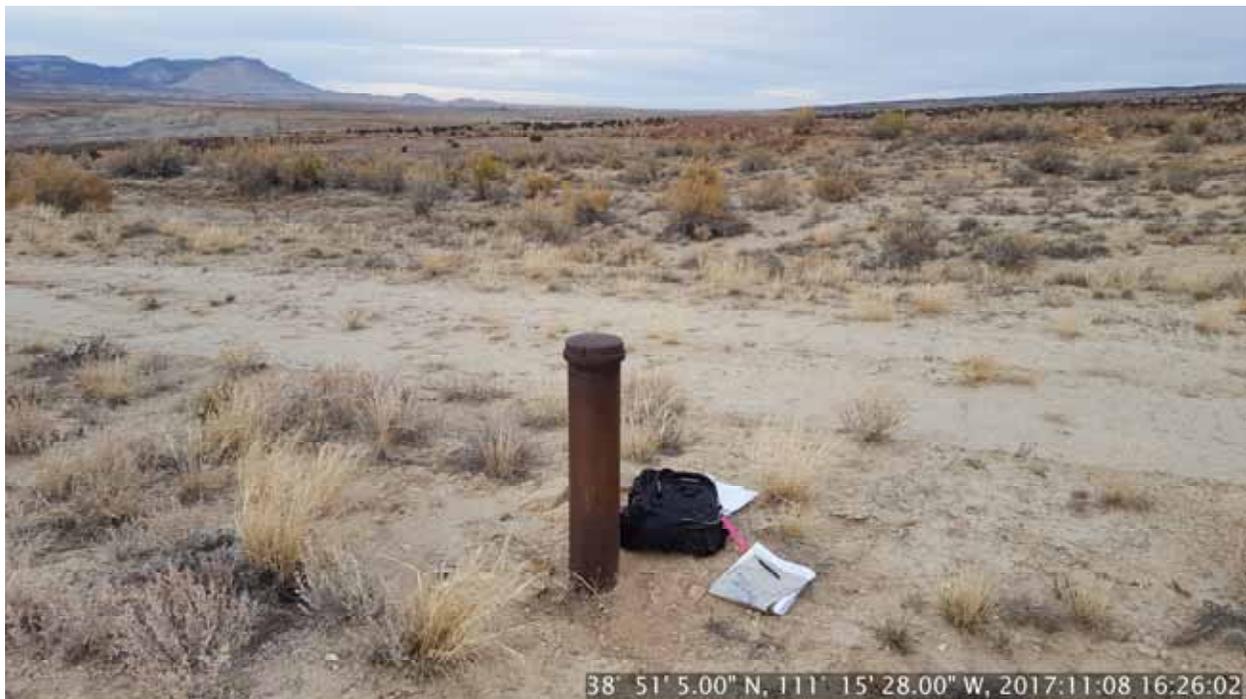
Feature 120. Steel Pipes. This feature description remains essentially the same as described in the Valley Engineering (1980) report, which states the following: “These pipes are approximately 6 inches in diameter with steel caps. The pipes extend about 2½ feet to 3 feet out of the ground. There were three pipes found in this area. The purpose of these pipes is unknown.” Two additions to the above description are added in this document: the steel caps are threaded and only two of the three pipes were found.

Feature 120. Steel Pipes. Top view of 1st pipe.

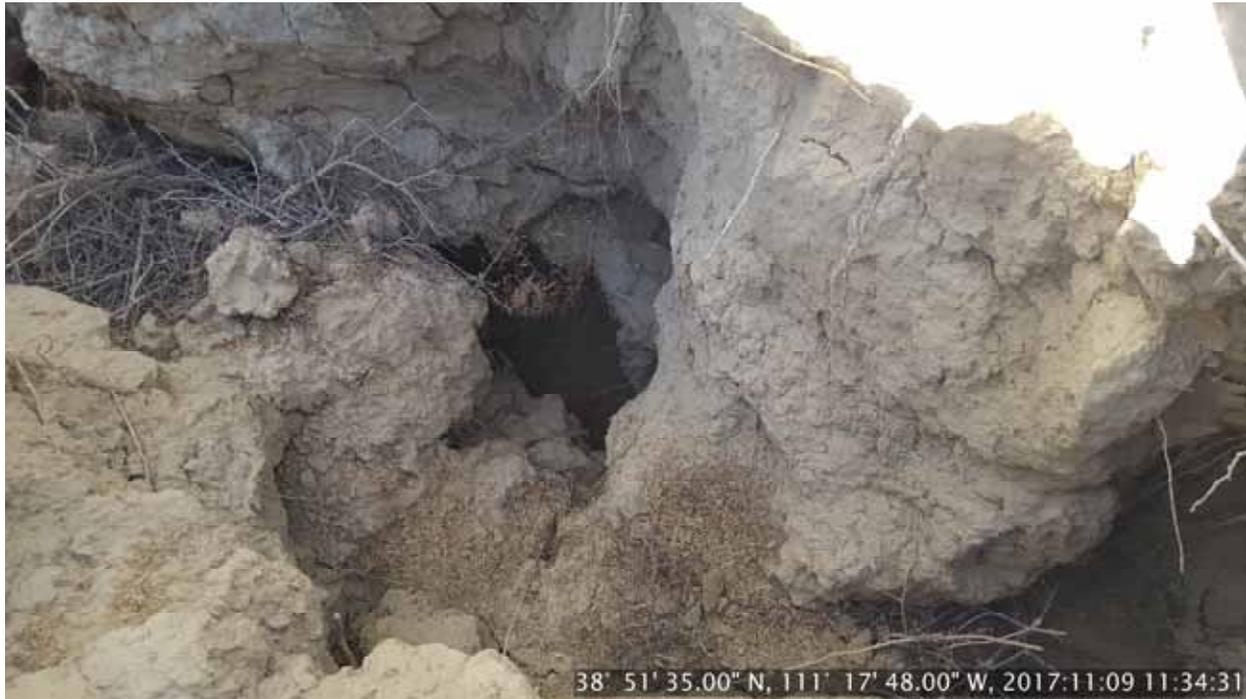
Feature 126. Sinkhole. Looking east.

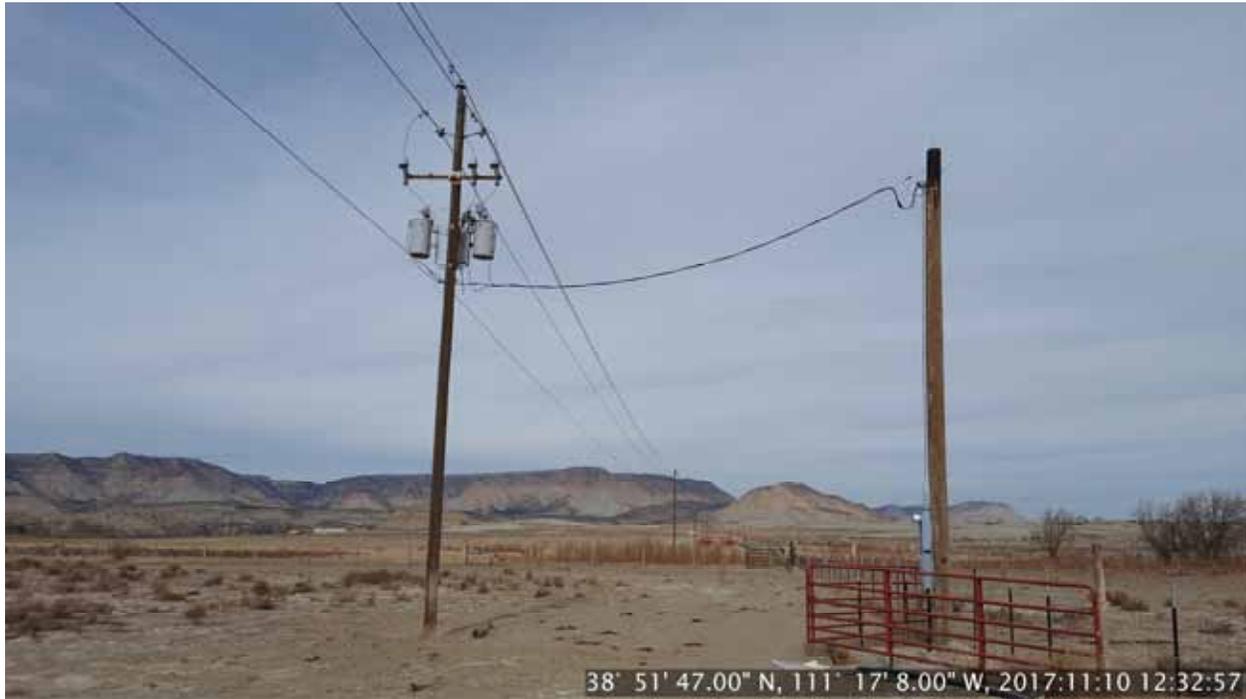
Feature 128. Water Line Air Vent. This feature was constructed after the Valley Engineering (1980) report was written. A water line air vent (Wade Rain PRVC 300) is installed on an underground water line. It is protected from livestock damage by metal tee posts and heavy gauge galvanized wire mesh. The current landowner is in the process of converting from an open ditch irrigation system to a more efficient pressurized irrigation system consisting of underground buried pipe and irrigation pivots. Newly constructed pivots, pivots under construction, miscellaneous piping and piping supplies, and evidence of recent trenching were encountered in numerous locations near this feature.

Feature 128. Water Line Air Vent.

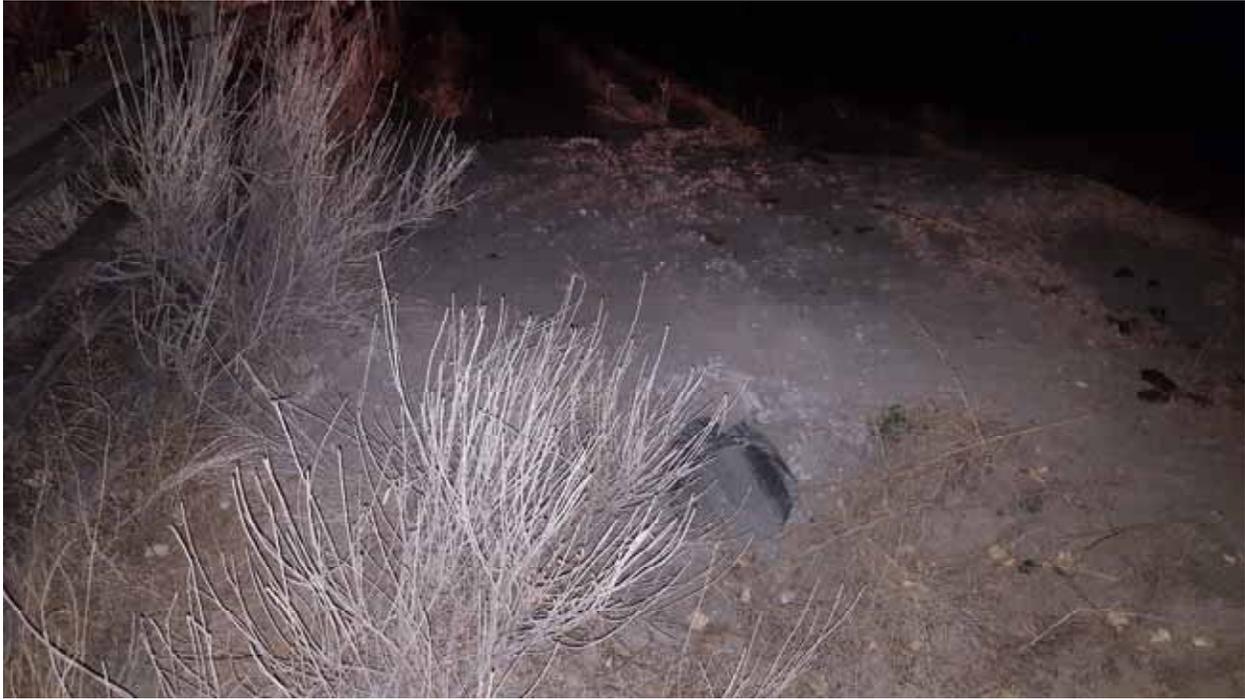
Feature 129. Underground Electrical Feed. Looking west. Disturbed soil where underground electrical line was recently installed to feed a future sprinkler pivot.
