**RE: Bronco Utah Operations LLC
Emery Mine
DOGM Permit No. C/015/0015
Emery 2 Second Left Panel Full Extraction Revision**

GEOLOGY AND SUBSIDENCE

The purpose of this report is to present baseline surface conditions prior to full extraction operations from the Emery 2 portal of the Bronco Utah Operations, LLC. (Bronco) Emery Mine, Emery County, Utah. The areas covered in this report include the following:

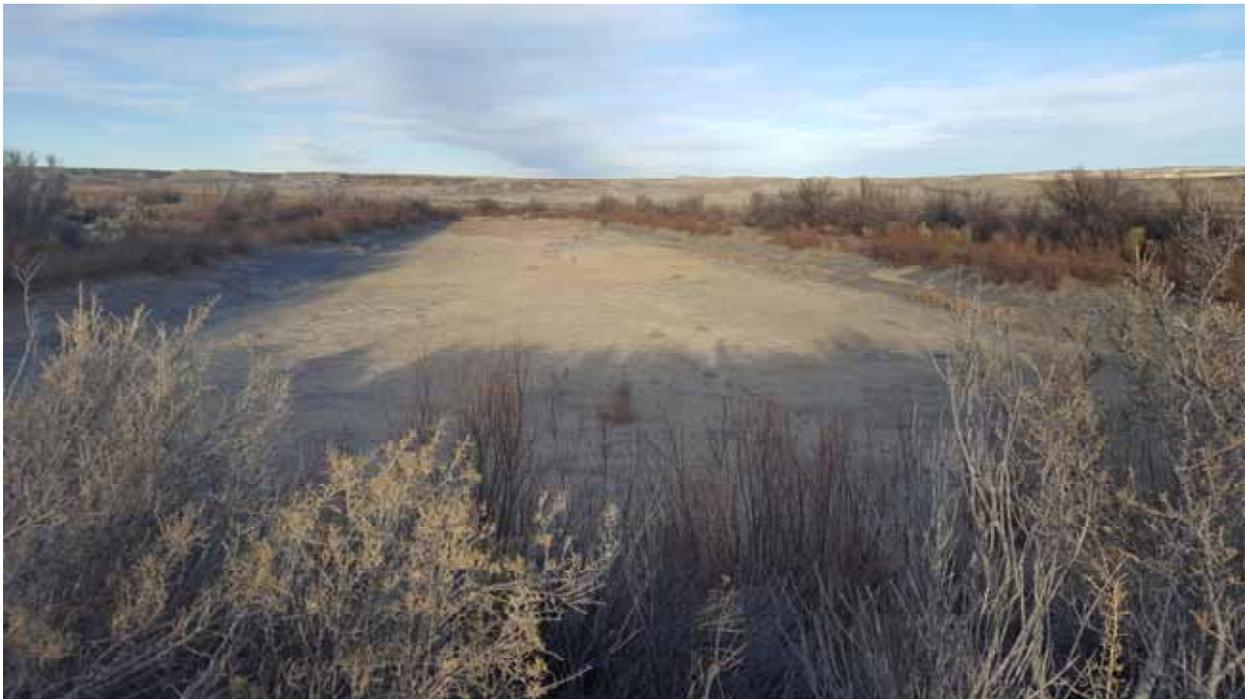
Feature 130. Irrigation Ditch Sinkhole. This feature was discovered by the current land owner, William Boyd Stansfield Jr., after the Valley Engineering (1980) report was written. The closest underground mining activity to this location, 2 West Submains, is located 2,665 feet away. At that distance, it is not possible that historic mining activity caused this feature to form. In addition, future mining activity is very unlikely to affect this feature, because it is located within a buffer zone, depicted on Figure 1 and Plate V-5, where subsidence is not anticipated. Per Mr. Stansfield, a sinkhole opened up across the ditch line in 2015 while the ditch contained flowing irrigation water. The hole measured approximately 5 feet in diameter with an unknown depth. The entire ditch (trapezoidal in shape, measuring roughly 4 feet wide at the top, 1.5 feet wide at the bed, and 2 feet tall) of flowing irrigation water disappeared into this hole and did not surface, he attempted to plug off the hole by installing up to 15 cubic yards of soil into the opening. It became saturated and disappeared into the hole. After turning water out of this ditch, he placed enough soil in the hole to fill it to the surface and installed a 16 inch diameter by 15 feet long length of HDPE piping to cross over the sinkhole. Since that time water has flowed through the 16 inch HDPE pipe, however, he has not exceeded approximately one half of the quantity of water in the ditch that was flowing on the day the sinkhole opened up.

Feature 130. Irrigation Ditch Sinkhole. Looking southeast at HDPE pipe installed over sinkhole.
