**RE: Bronco Utah Operations LLC
Emery Mine
DOG M Permit No. C/015/0015
Emery 2 Second Left Panel Full Extraction Revision Clean Copy task 5847**

The purpose of this report is to present baseline surface conditions prior to full extraction operations from the Emery 2 portal of the Bronco Utah Operations, LLC. (Bronco) Emery Mine, Emery County, Utah. The areas covered in this report include the following:

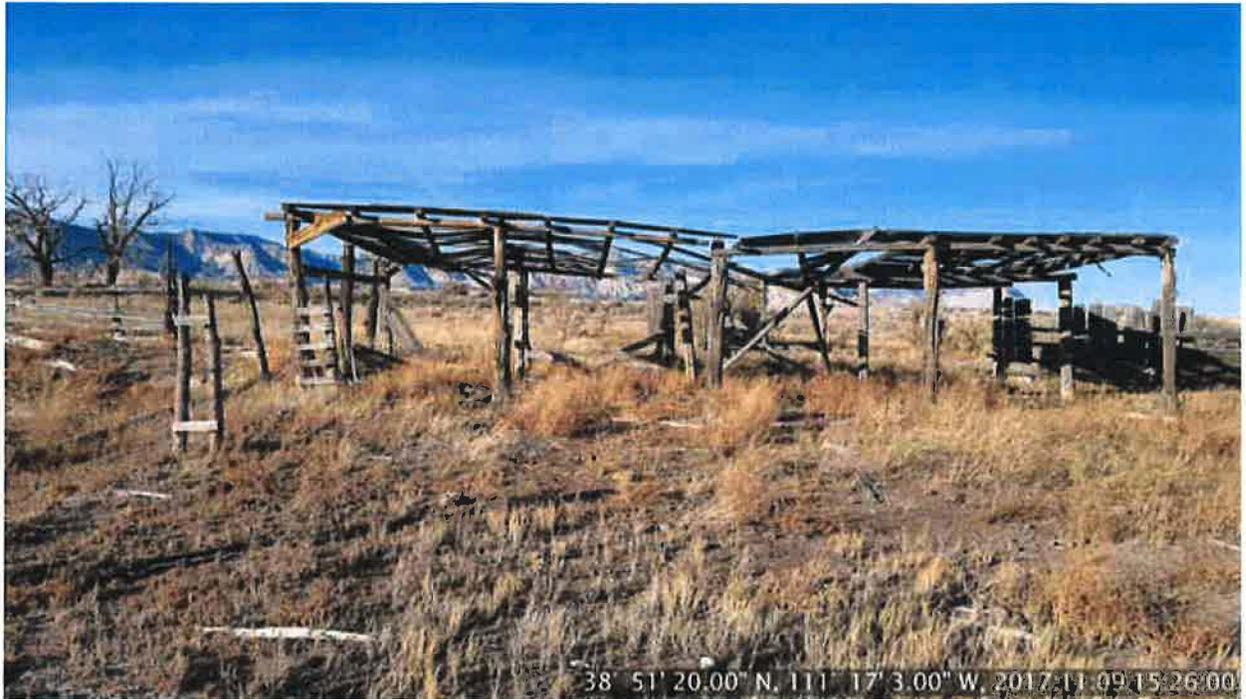
Feature 1. Ranch House, Buildings, and Corrals. Corrals.

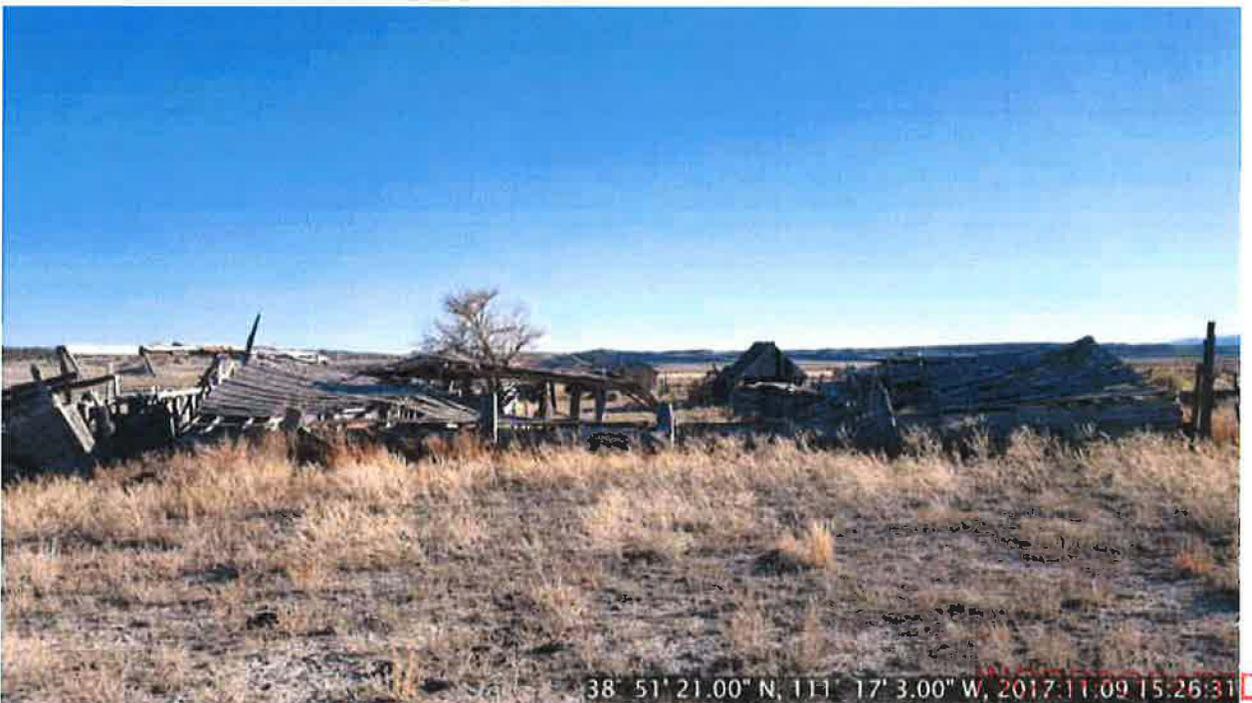
Feature 1. Ranch House, Buildings, and Corrals. Corrals.

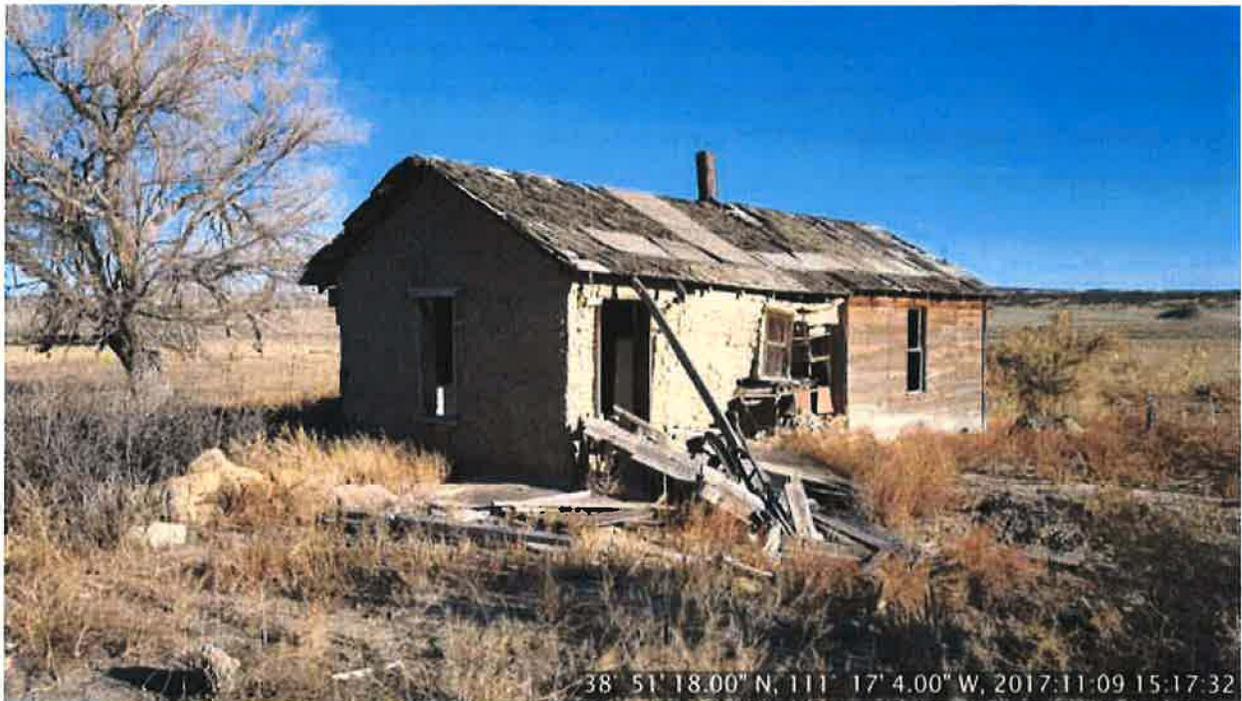
Feature 1. Ranch House, Buildings, and Corrals. Ranch House.

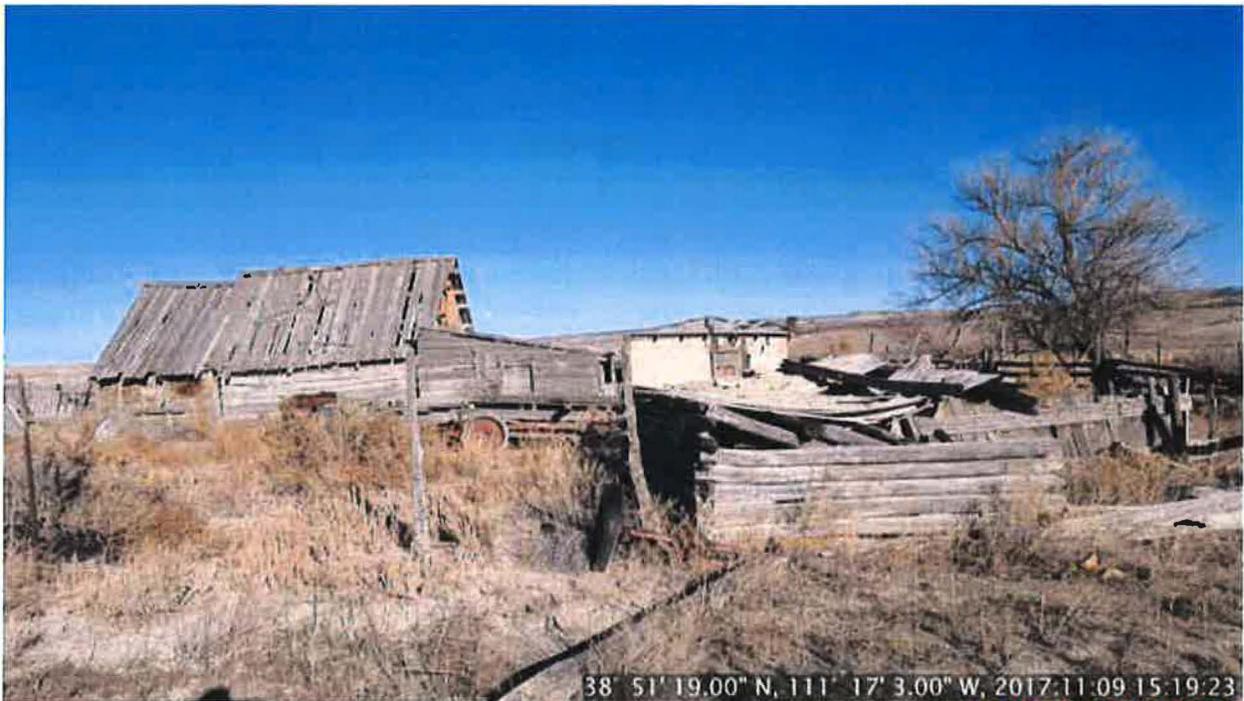
Feature 1. Ranch House, Buildings, and Corrals. Buildings.

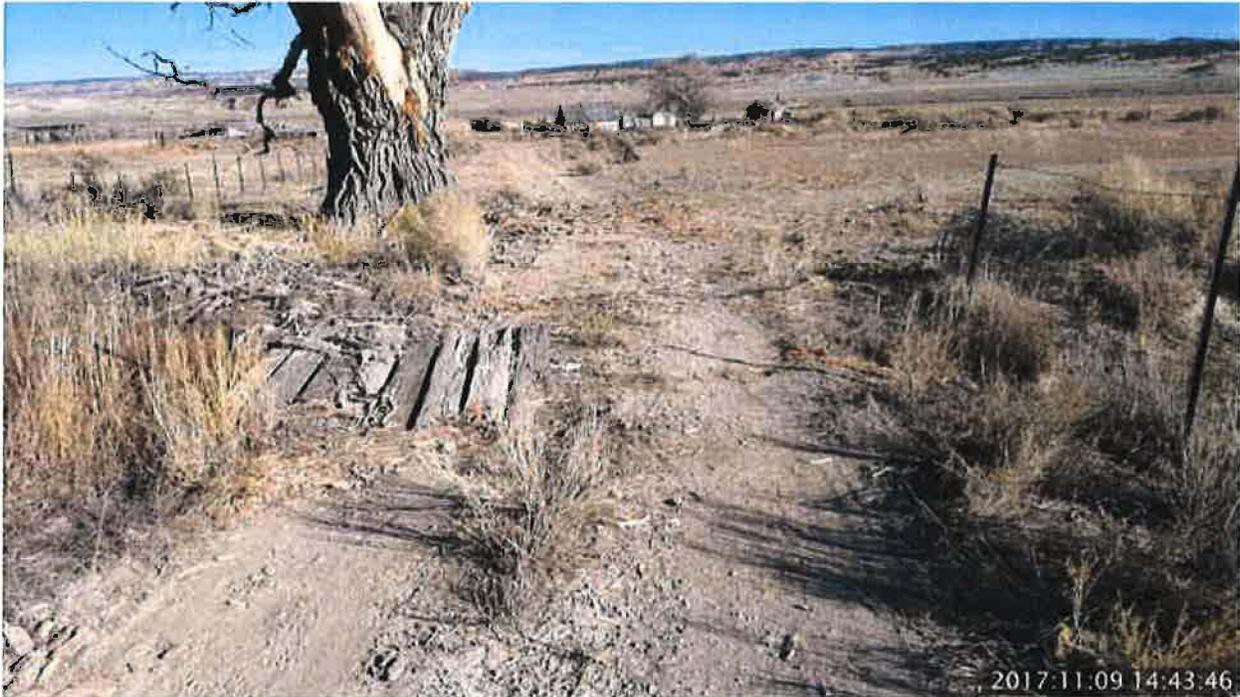
Feature 2. Irrigation Ditch and Bridge. Looking east.

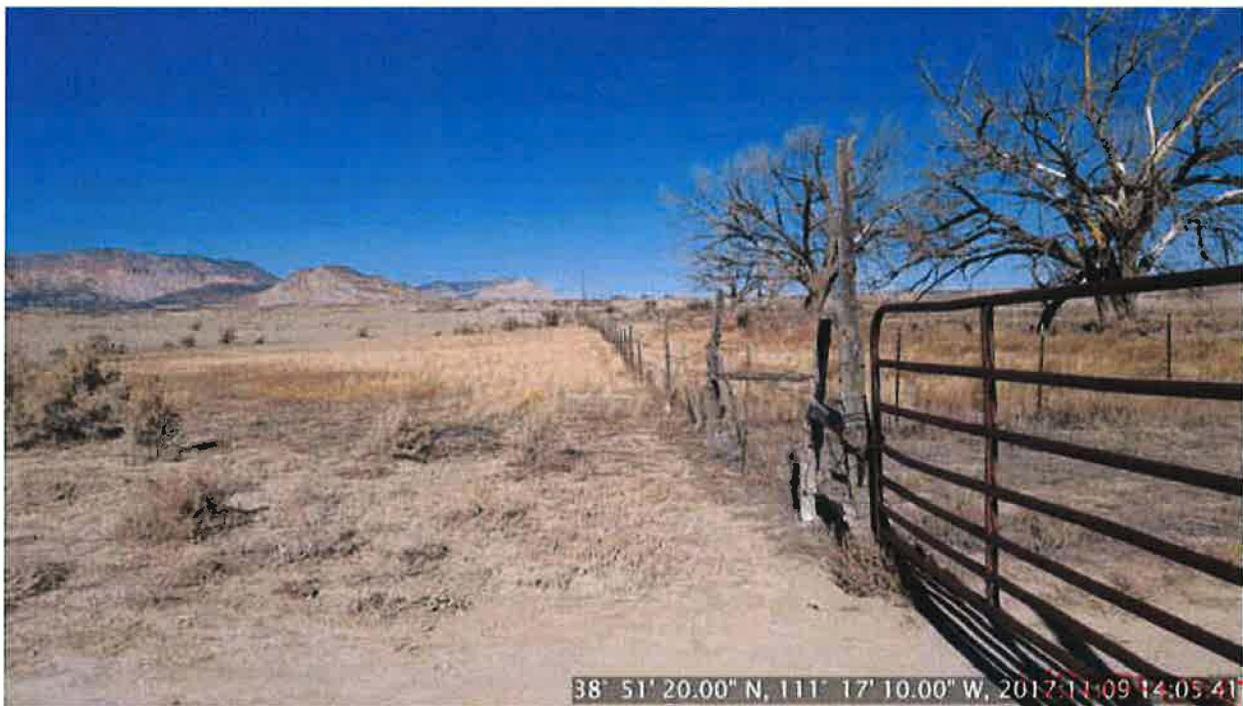
Feature 3. Ranch Fence Line. Looking north along gated entrance to Feature 1.

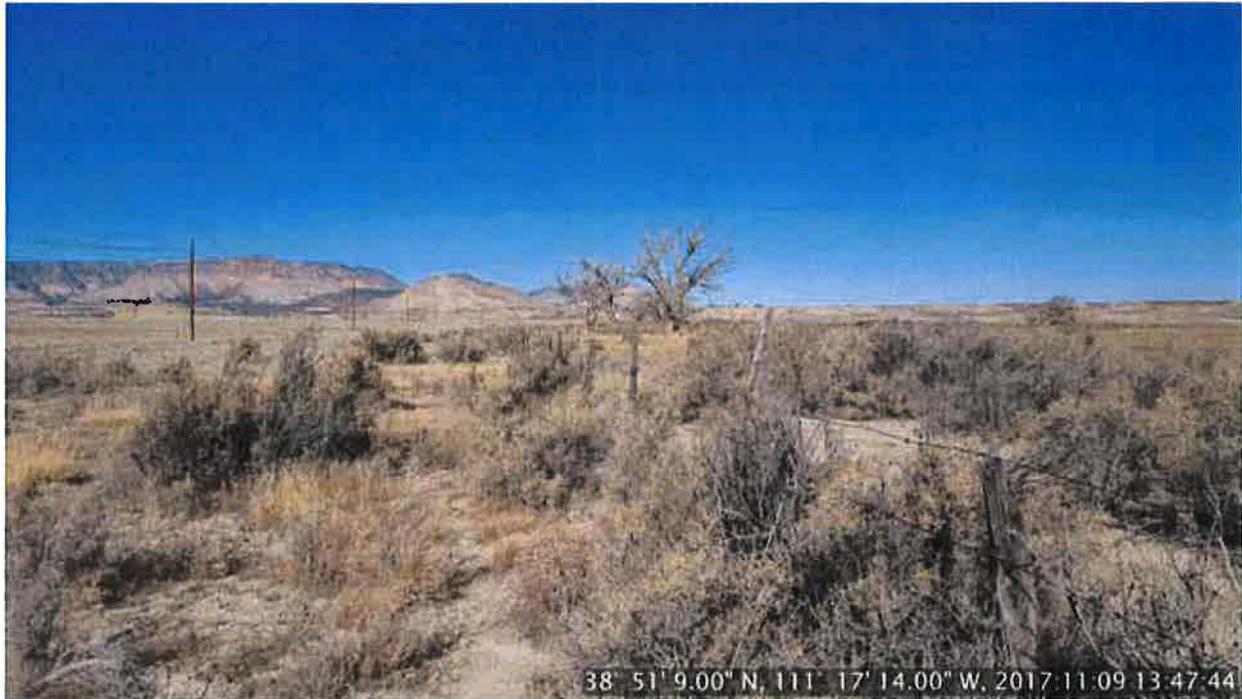
Feature 3. Ranch Fence Line. Looking north.

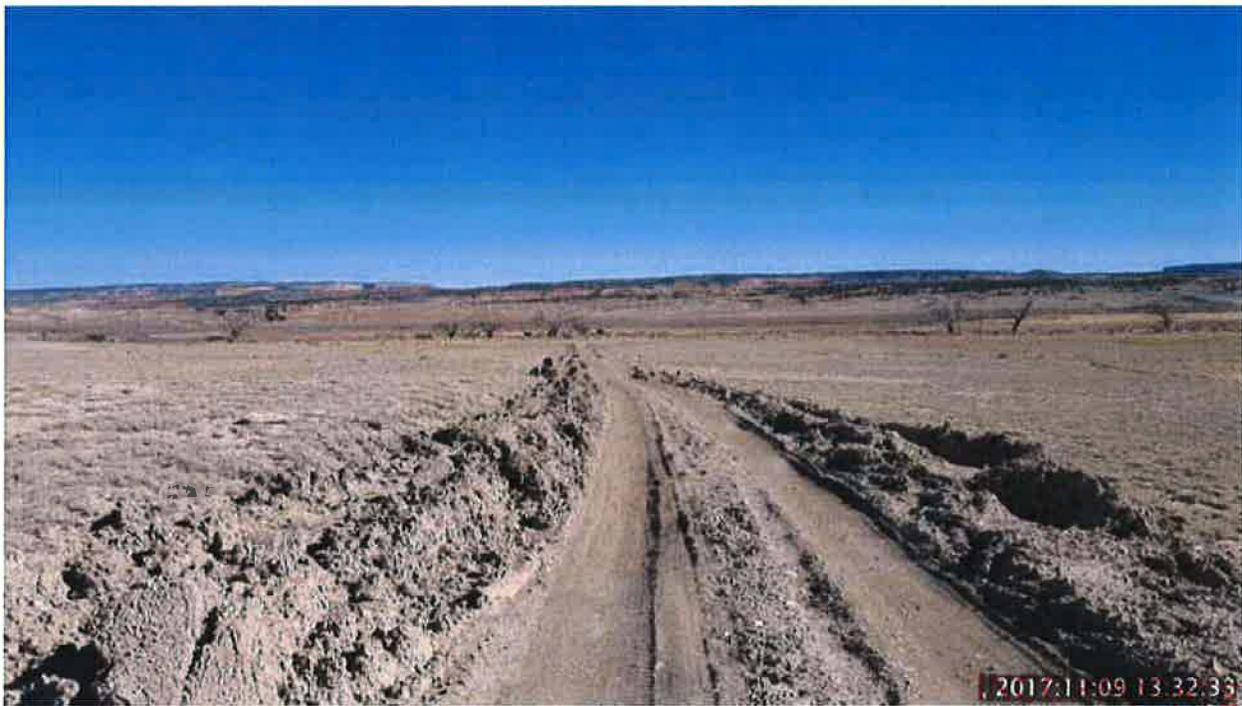
Feature 4. Ranch Access Road. Looking east.

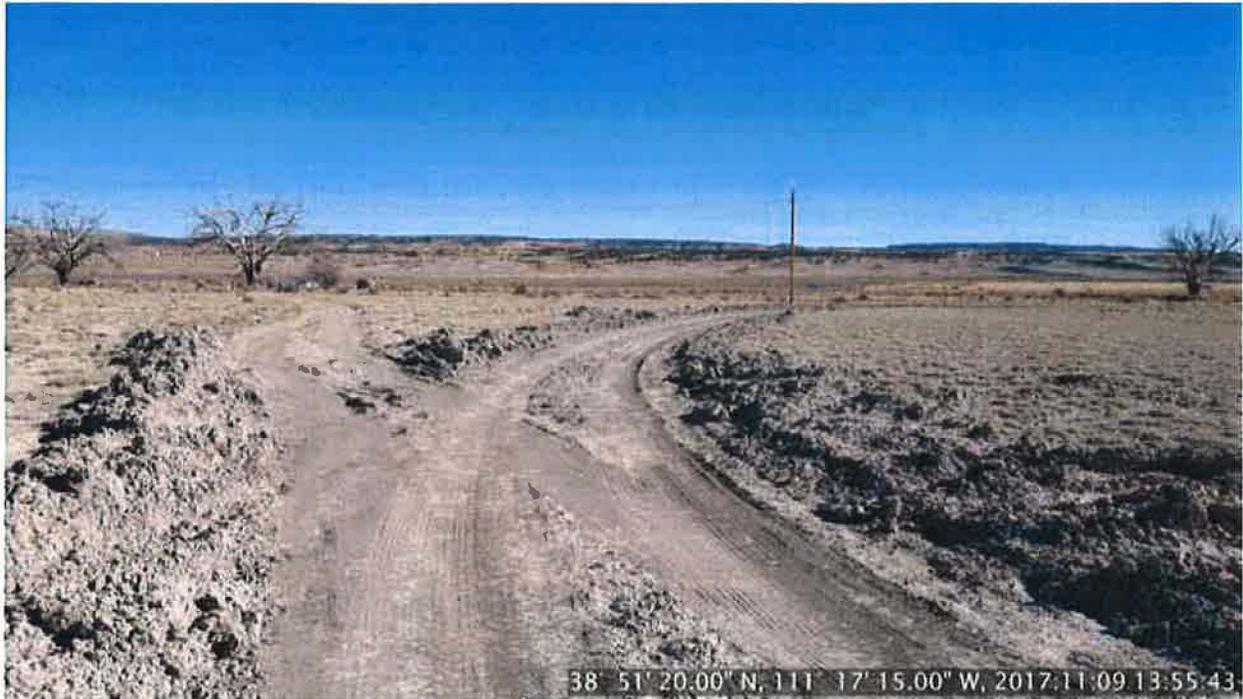
Feature 4. Ranch Access Road. Photo is taken farther east at split to Feature 11.

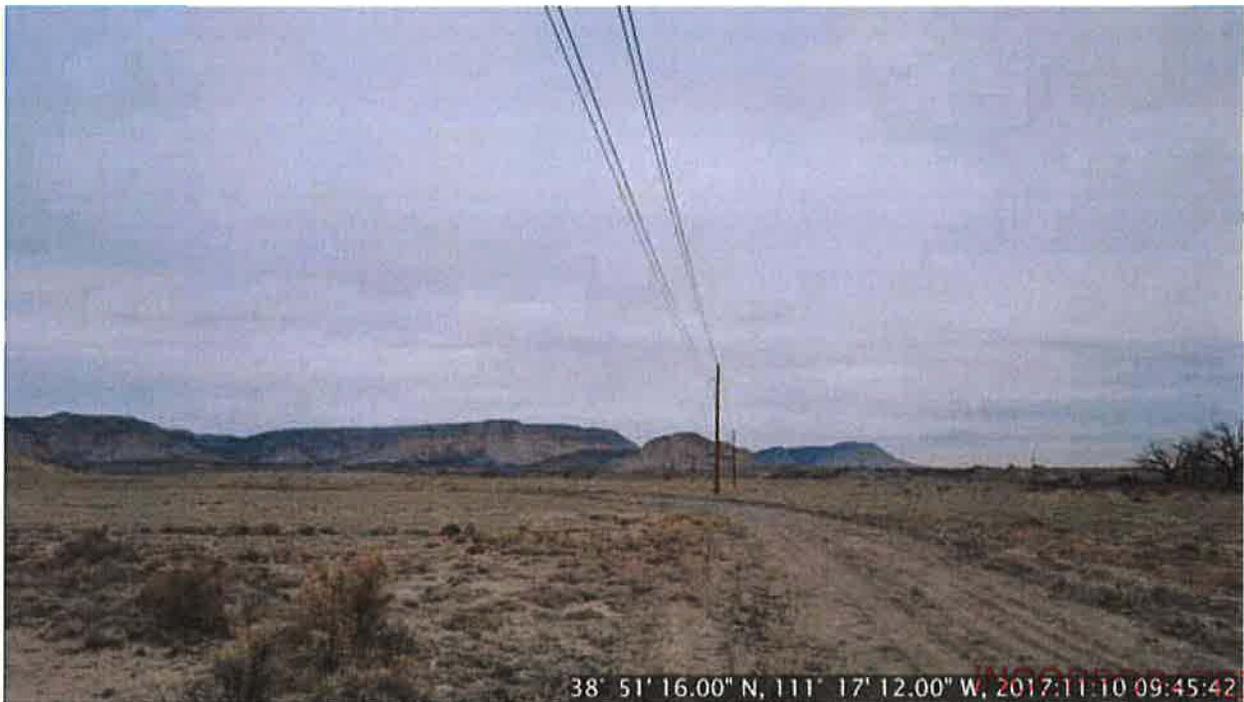
Feature 5. Utility Power Lines. Looking north.

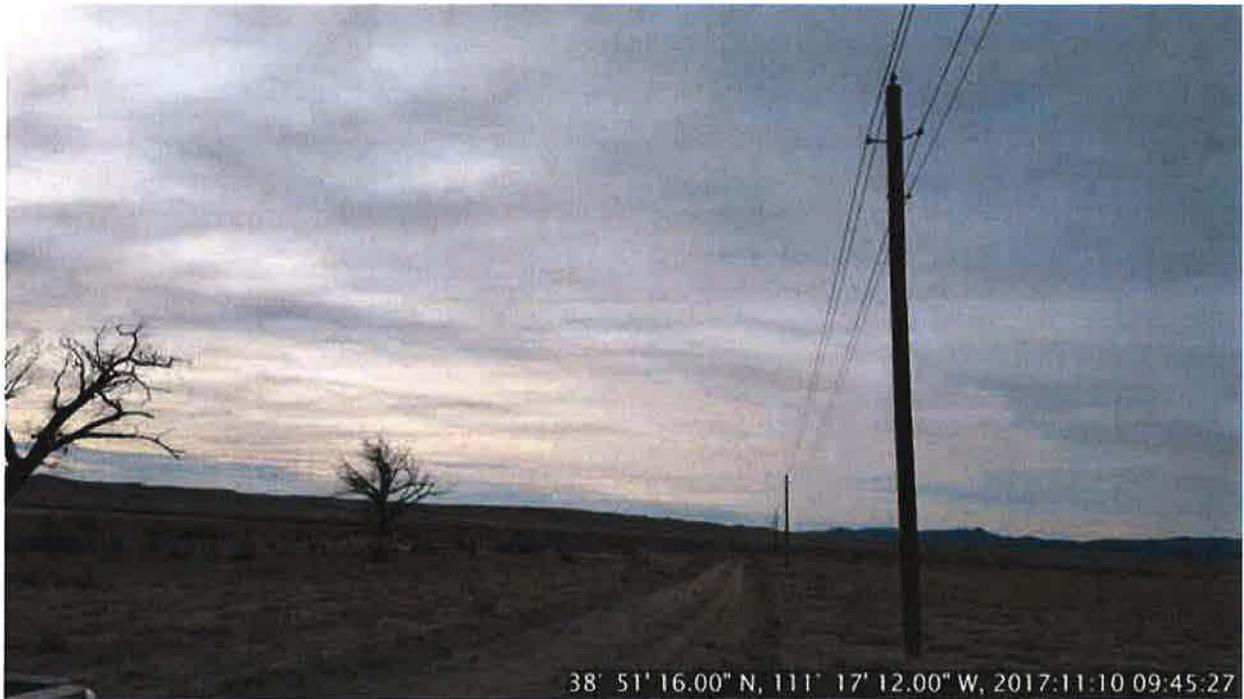
Feature 5. Utility Power Lines. Looking south.

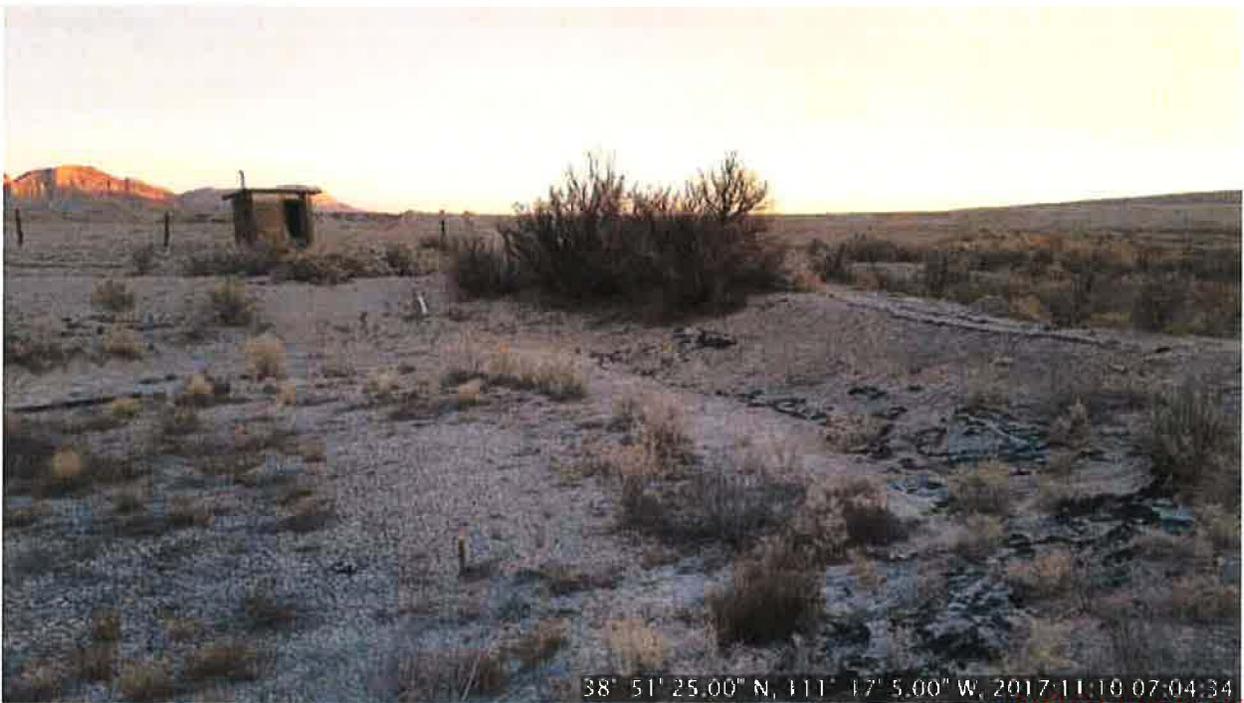
Feature 6. Pond. A well (Feature 8.) is in the background.

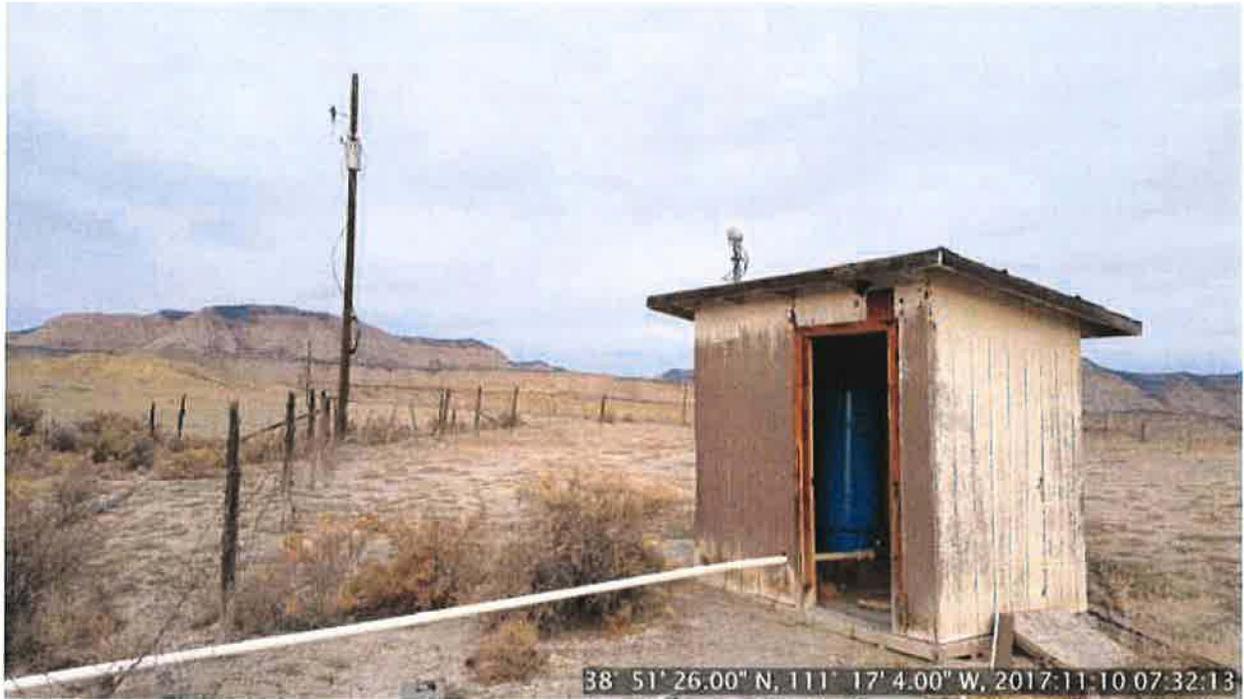
Feature 8. Well. Power line from pole to pump-house is disconnected.

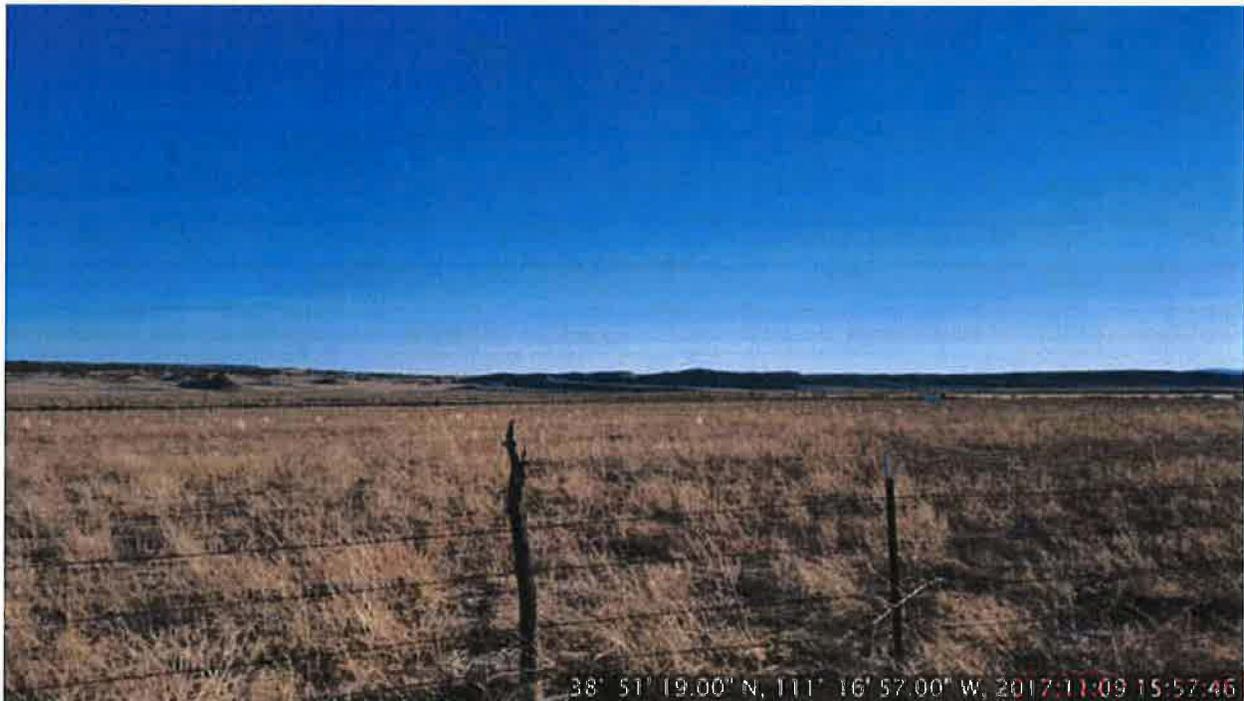
Feature 9. Farm Lands.

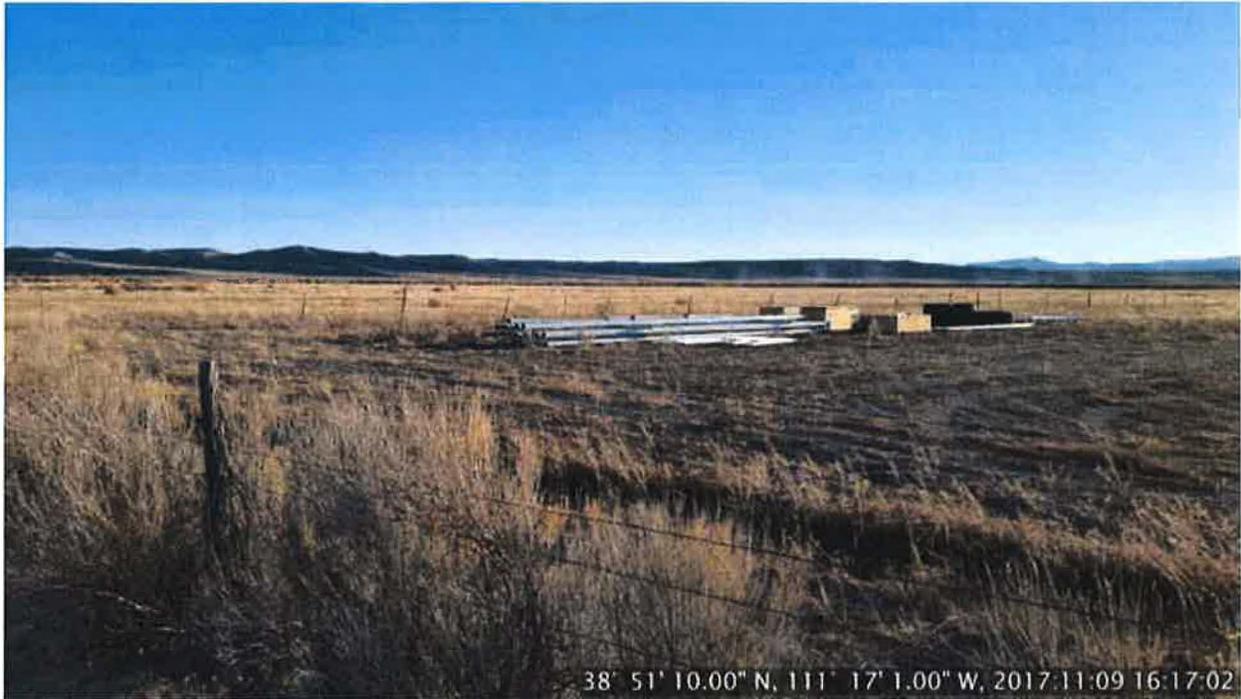
Feature 9. Farm Lands. Piping supplies for future sprinkler pivot lying on ground.

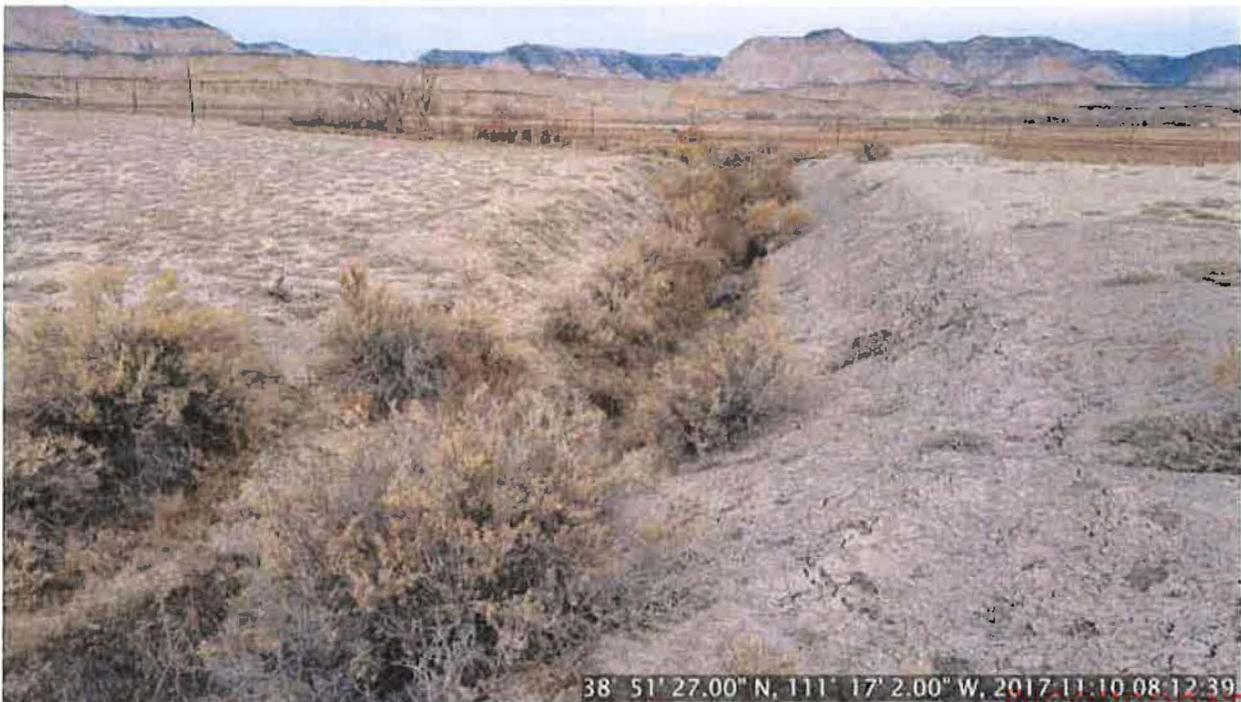
Feature 10. Irrigation Ditch. Looking west.

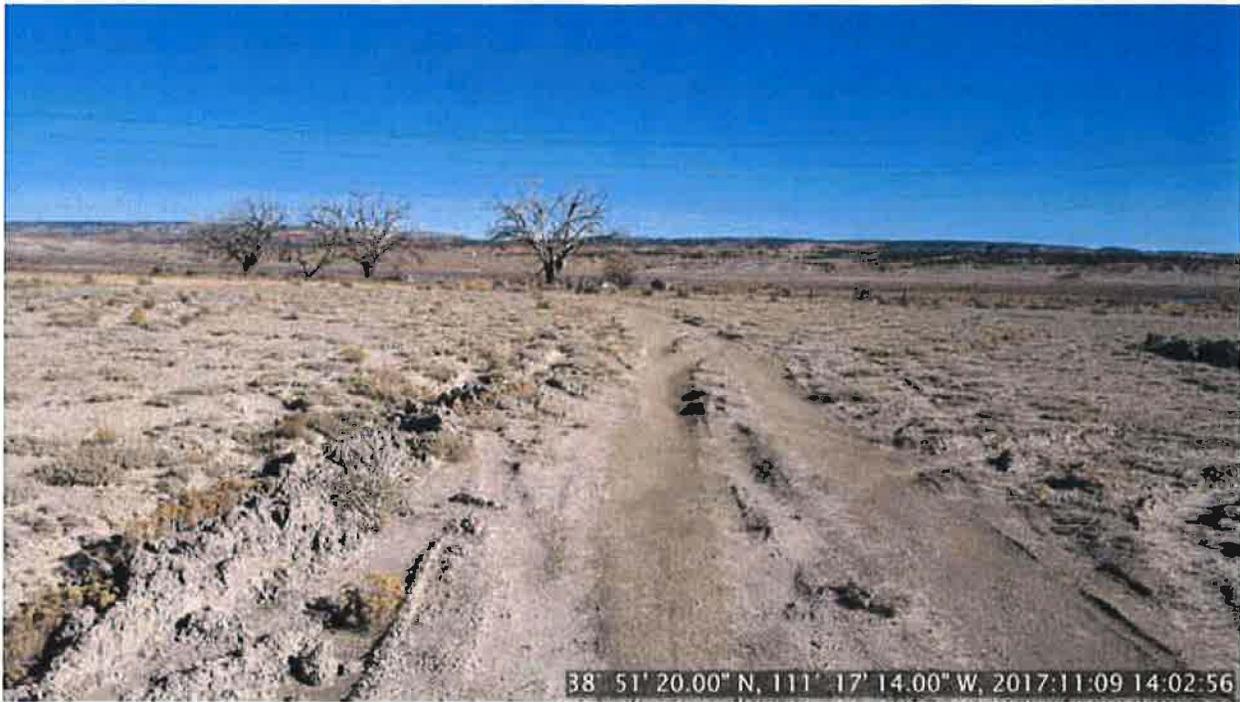
Feature 11. Unimproved Dirt Road. Looking east. This road leads to the ranch house, buildings, and corrals identified as Feature 1.

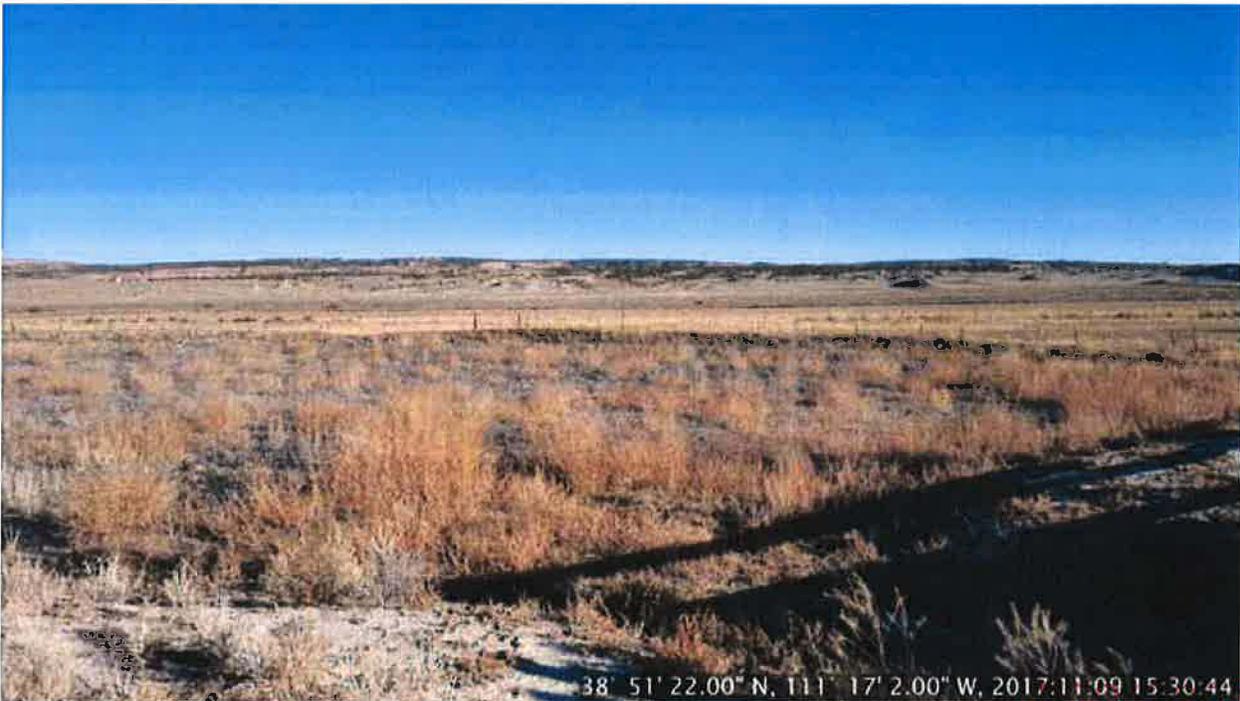
Feature 15. Pond. Breached berm in foreground.

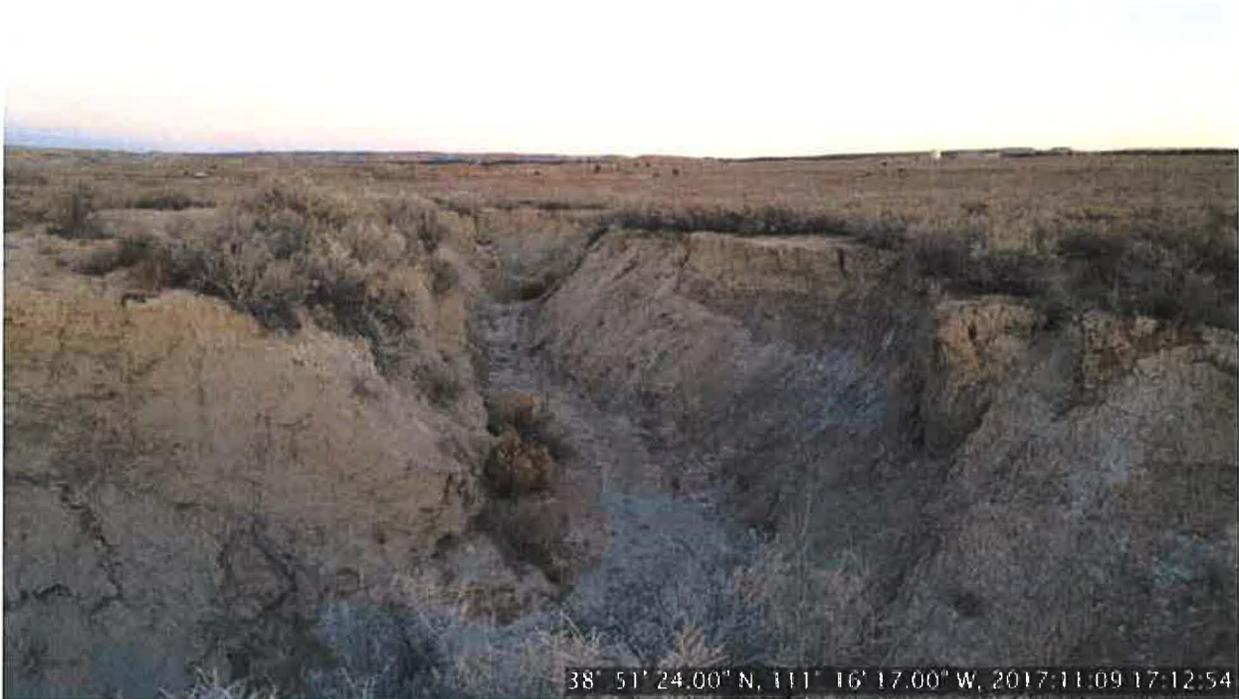
Feature 22. Dry Wash. Looking east.

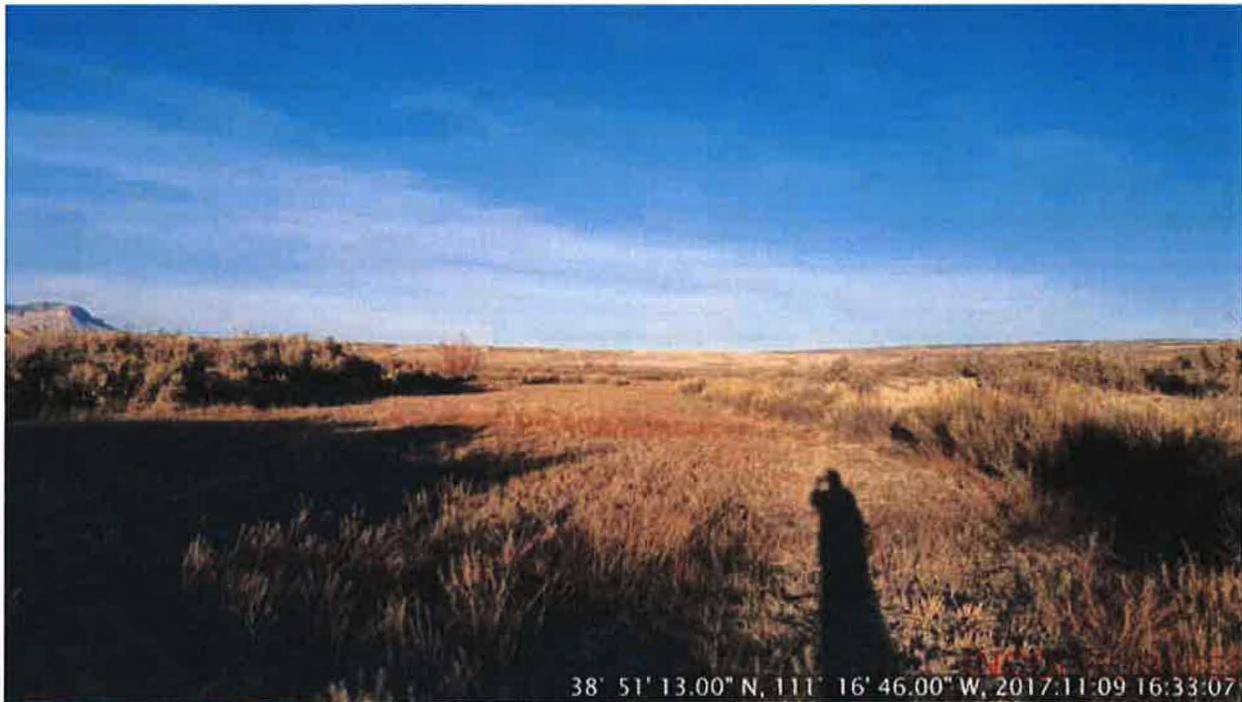
Feature 23. Grassy Area. Looking east.

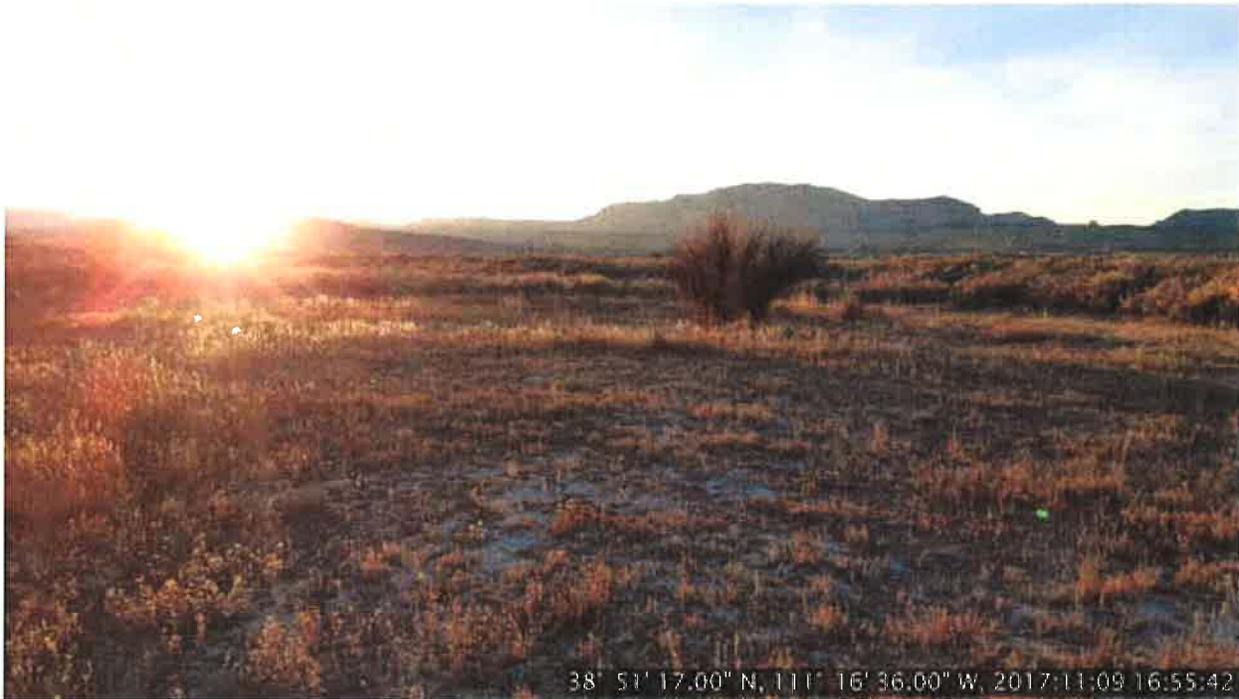
Feature 23. Grassy Area. Looking west.

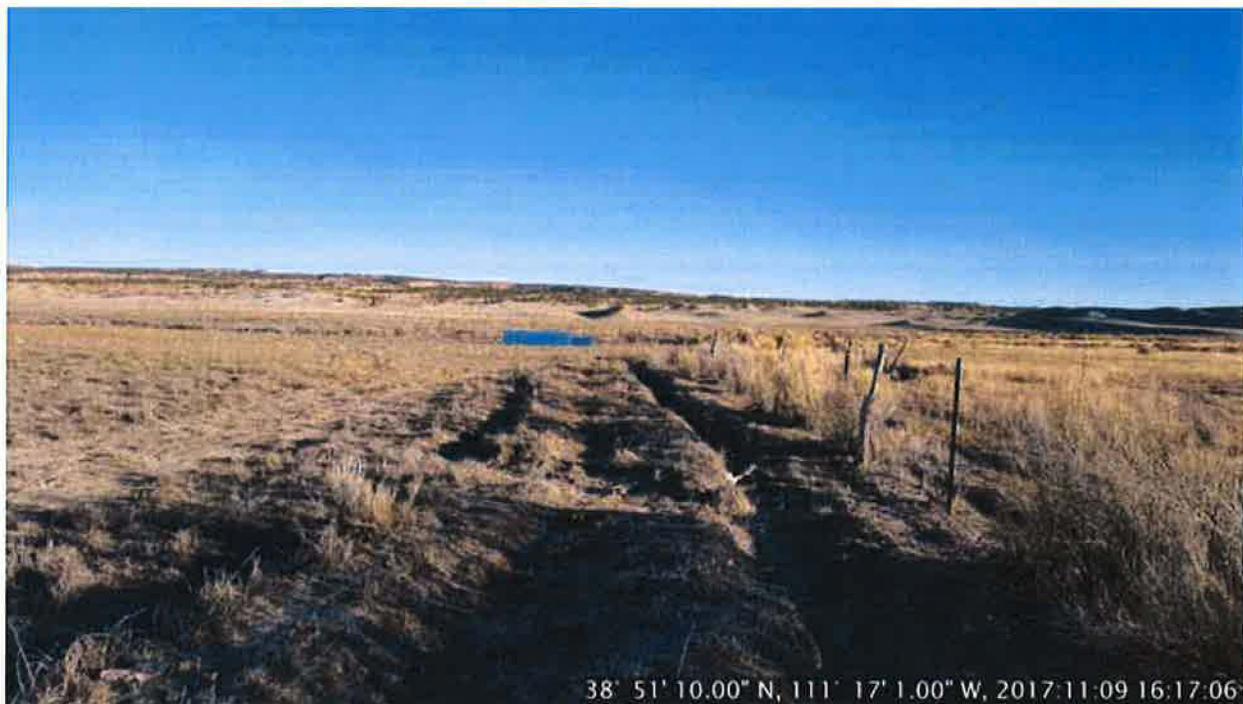
Feature 24. Irrigation Ditch Junction.

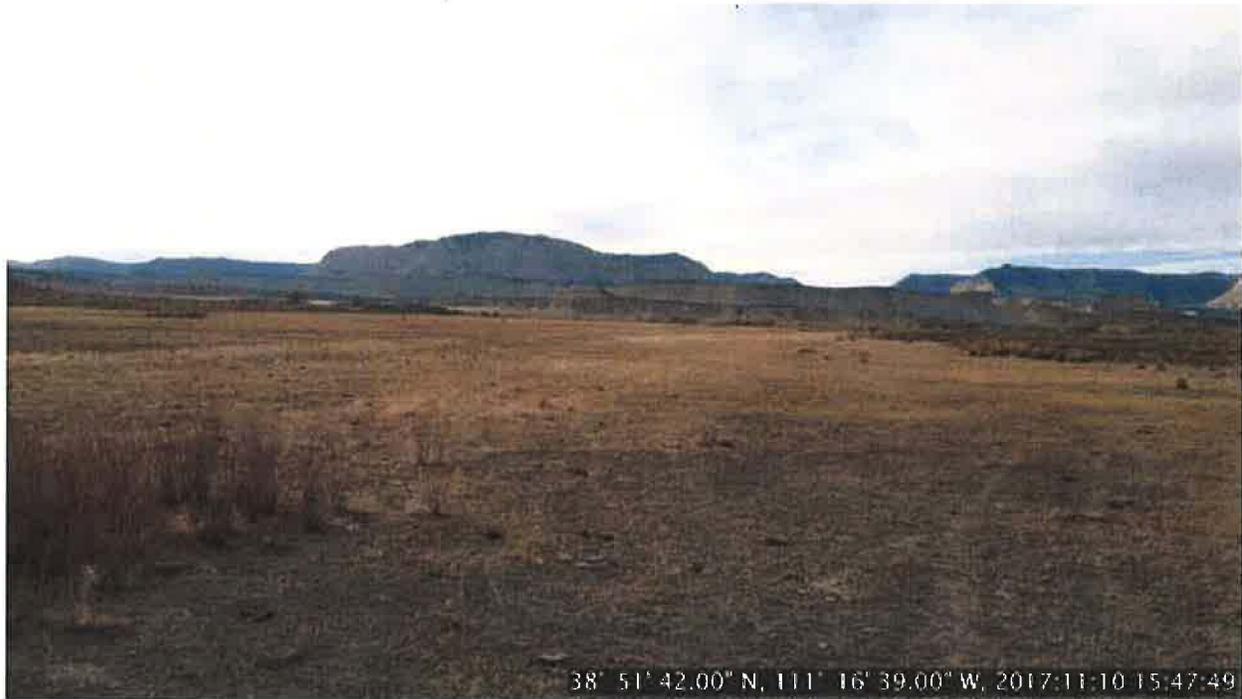
Feature 25. Grassy Area. Looking east.

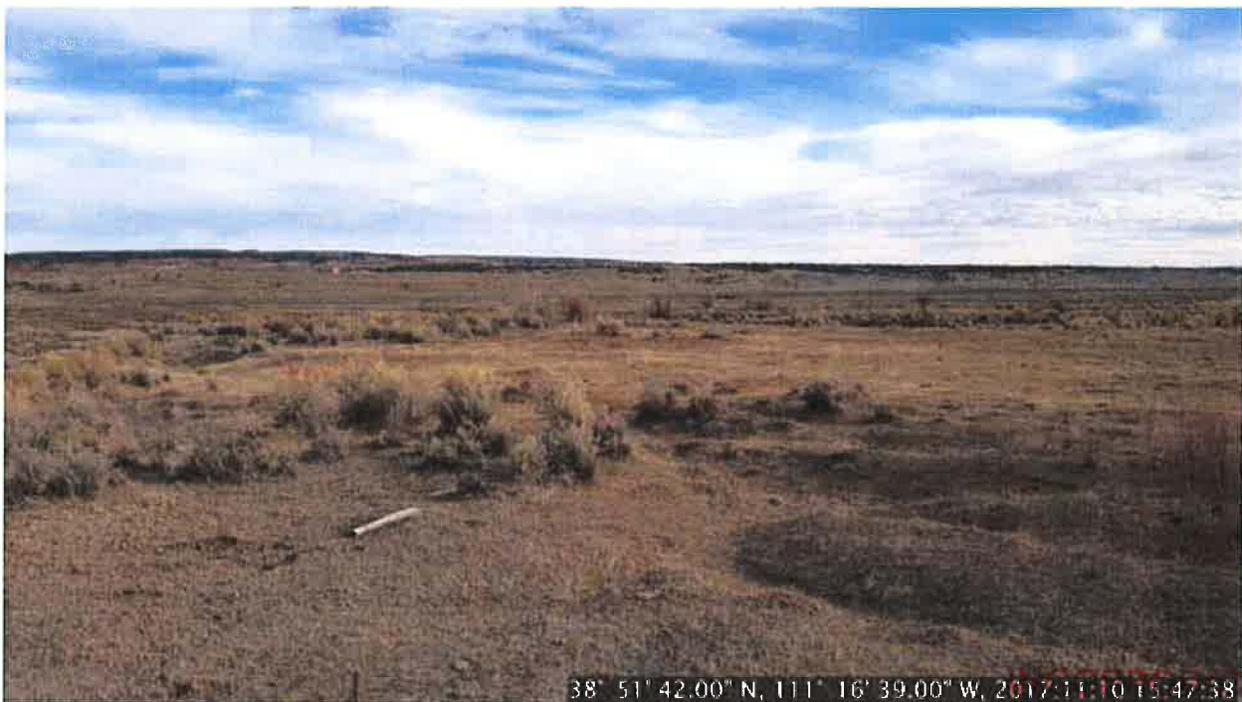
Feature 25. Grassy Area. Looking west.

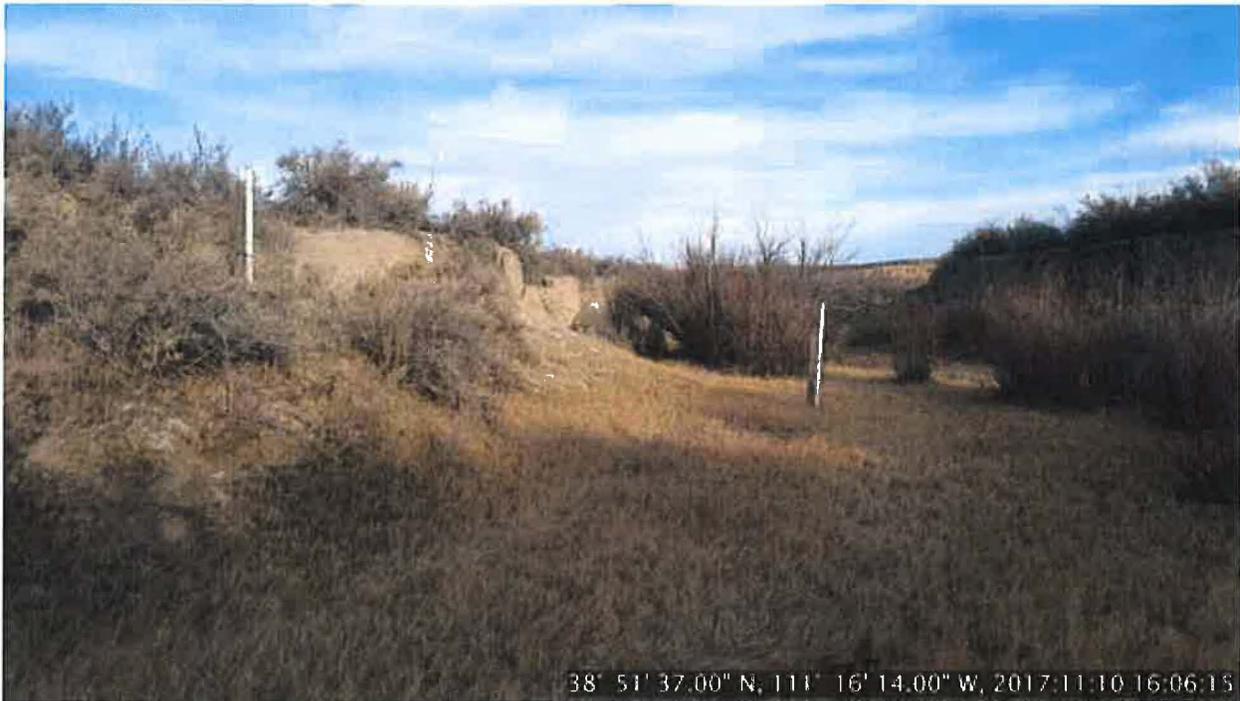
Feature 26. PVC Pipe Water Depth Gauge.

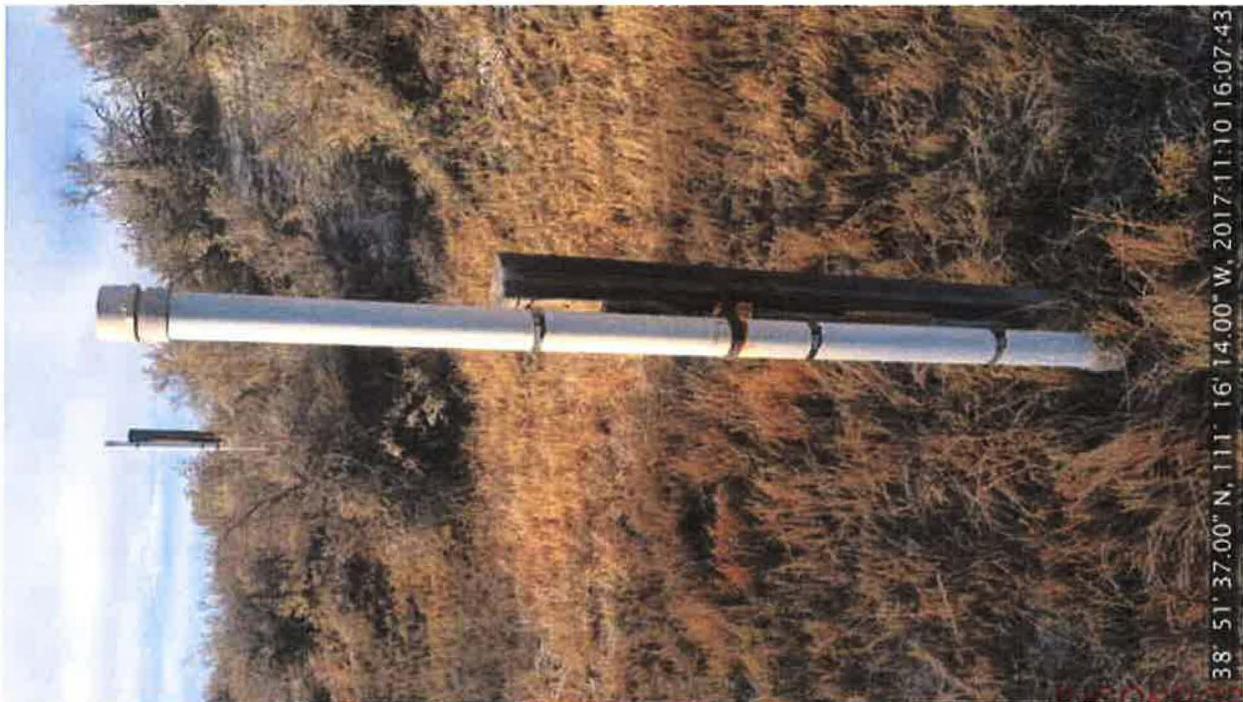
Feature 26. PVC Pipe Water Depth Gauge. *Rotate photo clockwise.*
