**RE: Bronco Utah Operations LLC
Emery Mine
DOG M Permit No. C/015/0015
Emery 2 Second Left Panel Full Extraction Revision Clean Copy task 5847**

The purpose of this report is to present baseline surface conditions prior to full extraction operations from the Emery 2 portal of the Bronco Utah Operations, LLC. (Bronco) Emery Mine, Emery County, Utah. The areas covered in this report include the following:

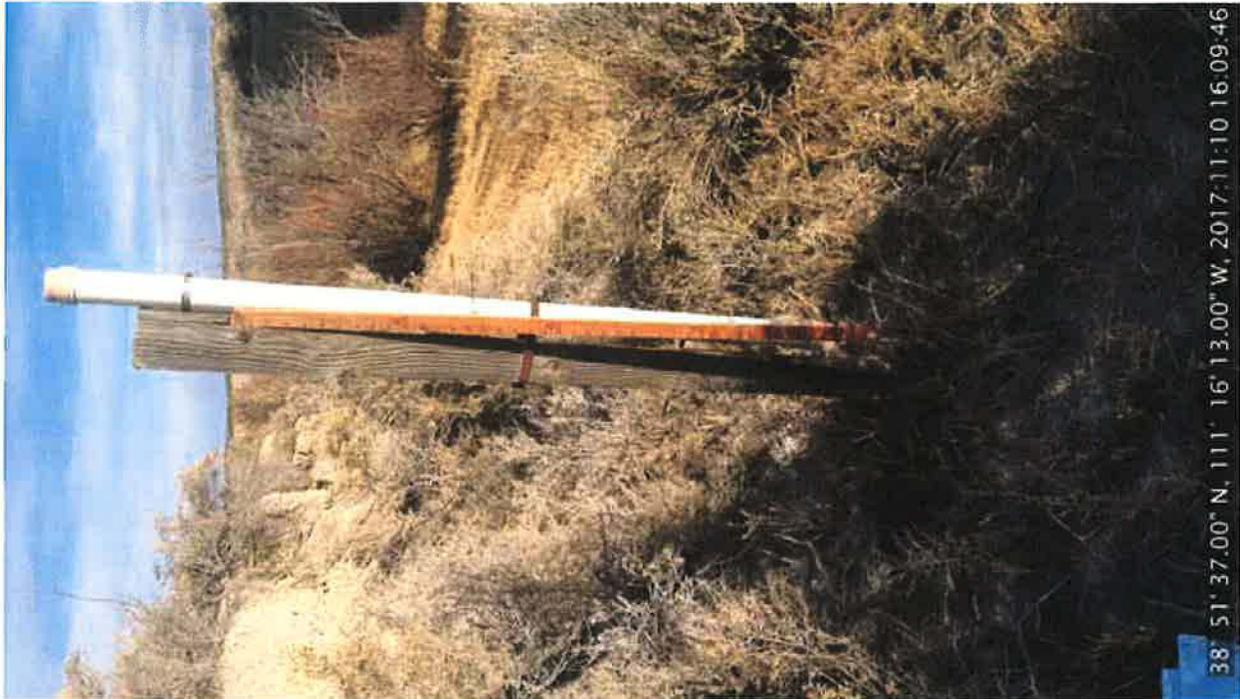
Feature 26. PVC Pipe Water Depth Gauge. *Rotate photo clockwise.* Graduated scale located in PVC tube.

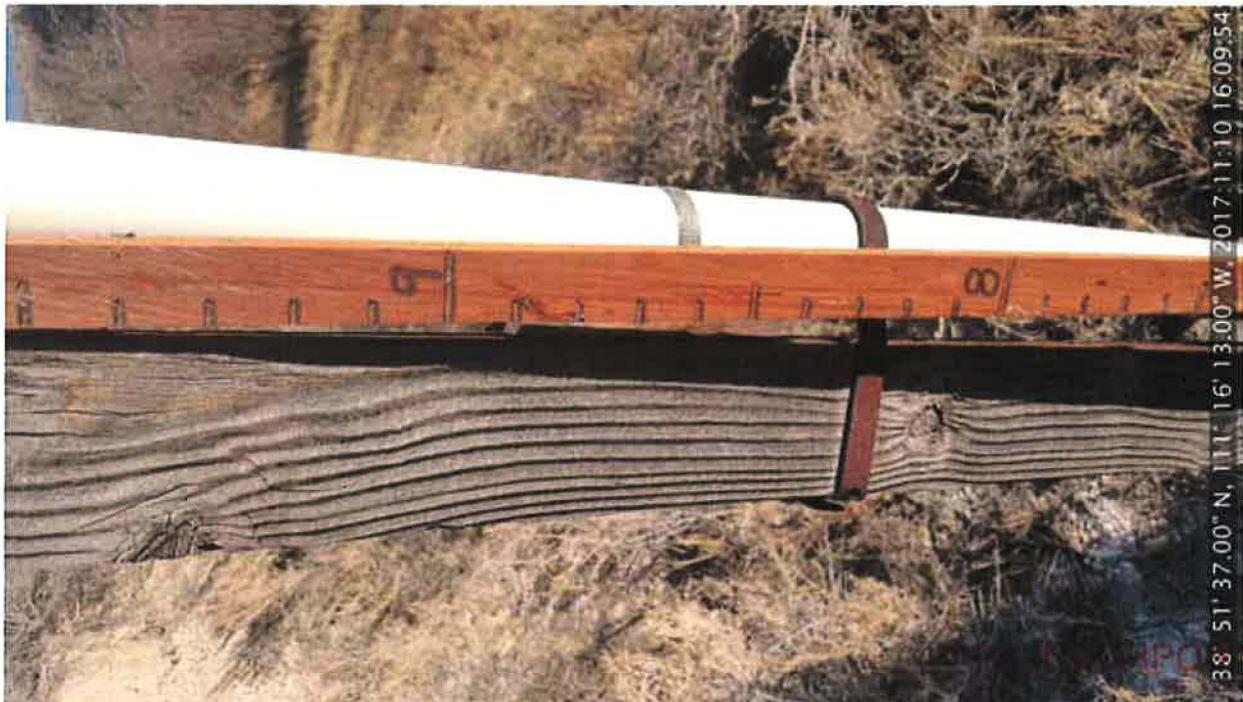
Feature 26. PVC Pipe Water Depth Gauge. *Rotate photo clockwise.* Close up photo of graduated scale. JAN 24 2019

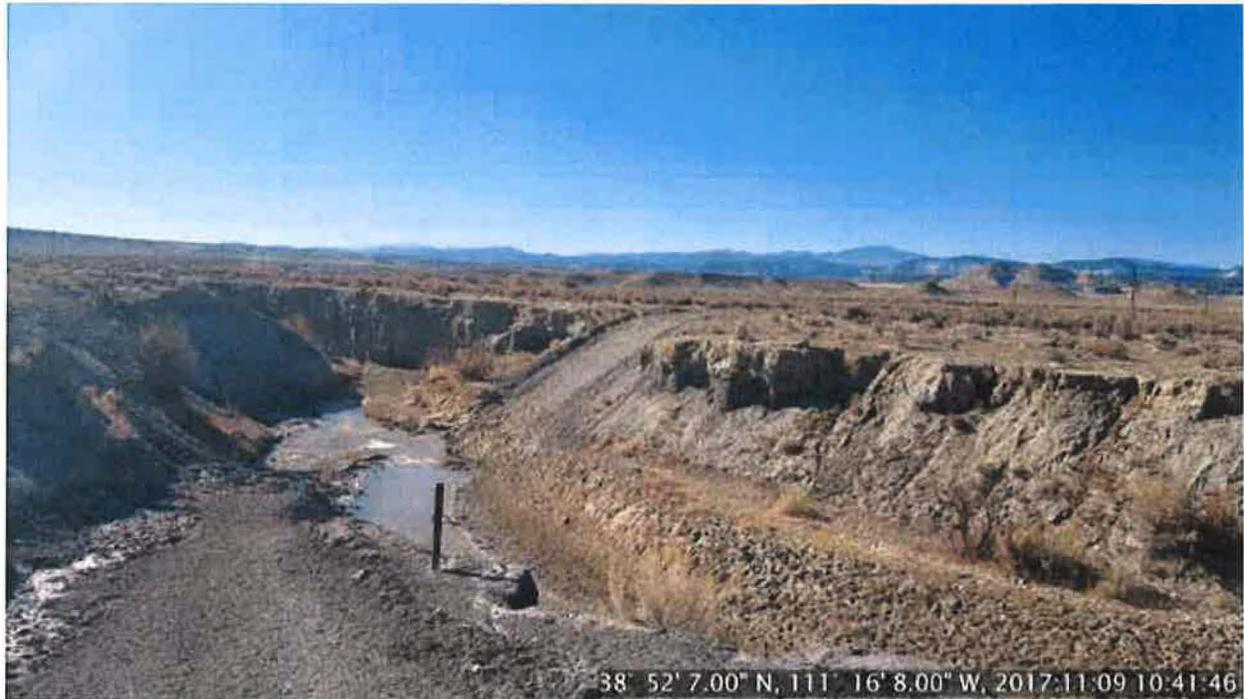
Feature 27. Area Roads. Looking south. Road is impassable and bisected by Quitcupah Creek.

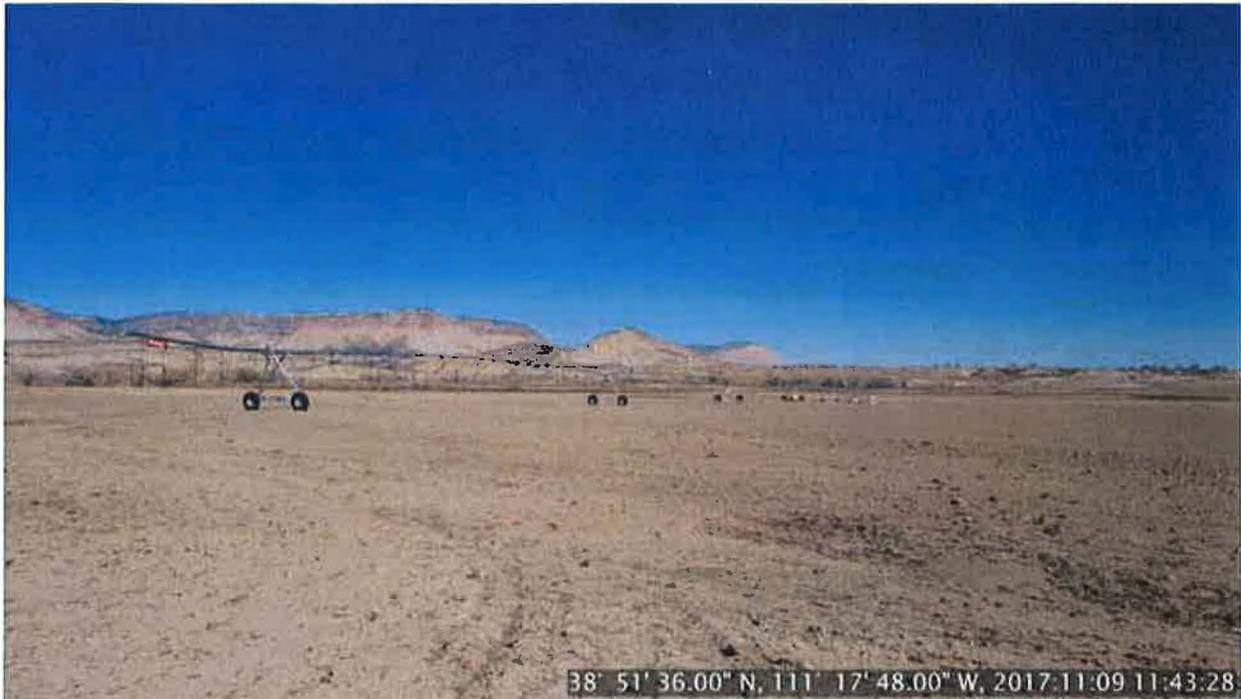
Feature 32. Irrigation Ditch and Farm Land. Ditch replaced with pivot sprinklers.

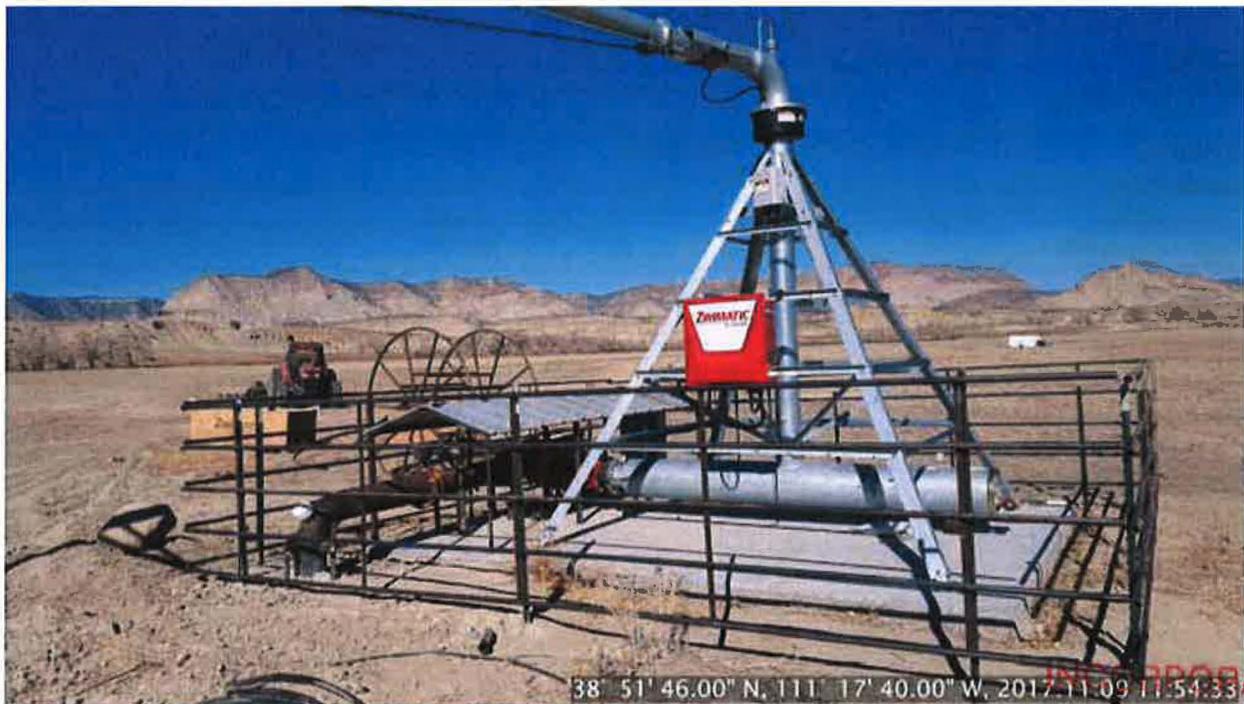
Feature 32. Irrigation Ditch and Farm Land. Foundation for pivot sprinklers.

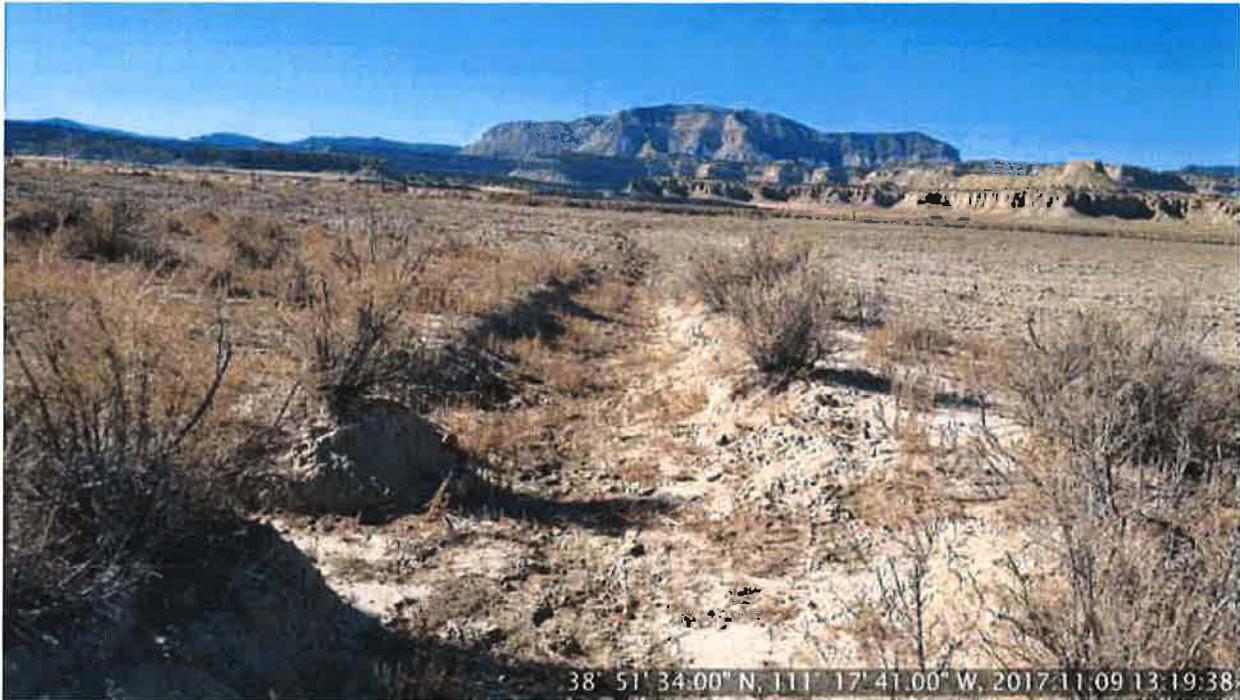
Feature 32. Irrigation Ditch and Farm Land. Southern edge of farmland. Return irrigation ditch in foreground. Field has been regraded, eliminating need for irrigation ditch, background.

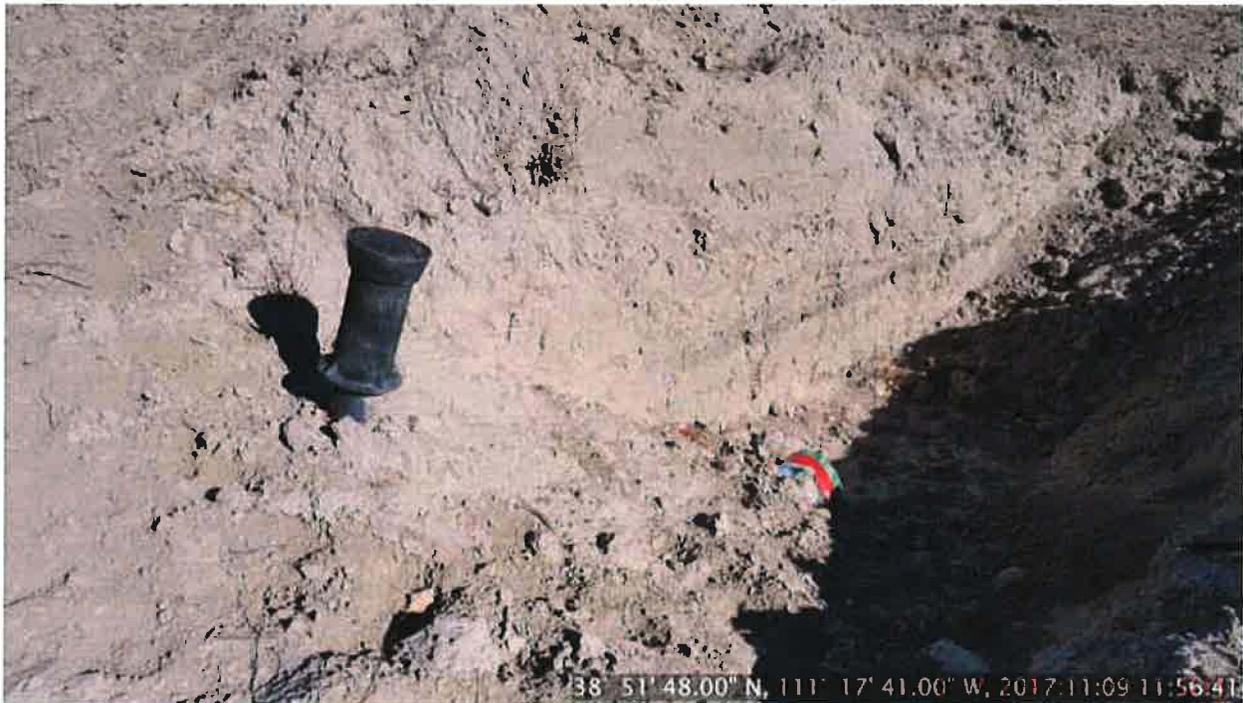
Feature 32. Irrigation Ditch and Farm Land. Underground water line feeding pivot sprinklers.

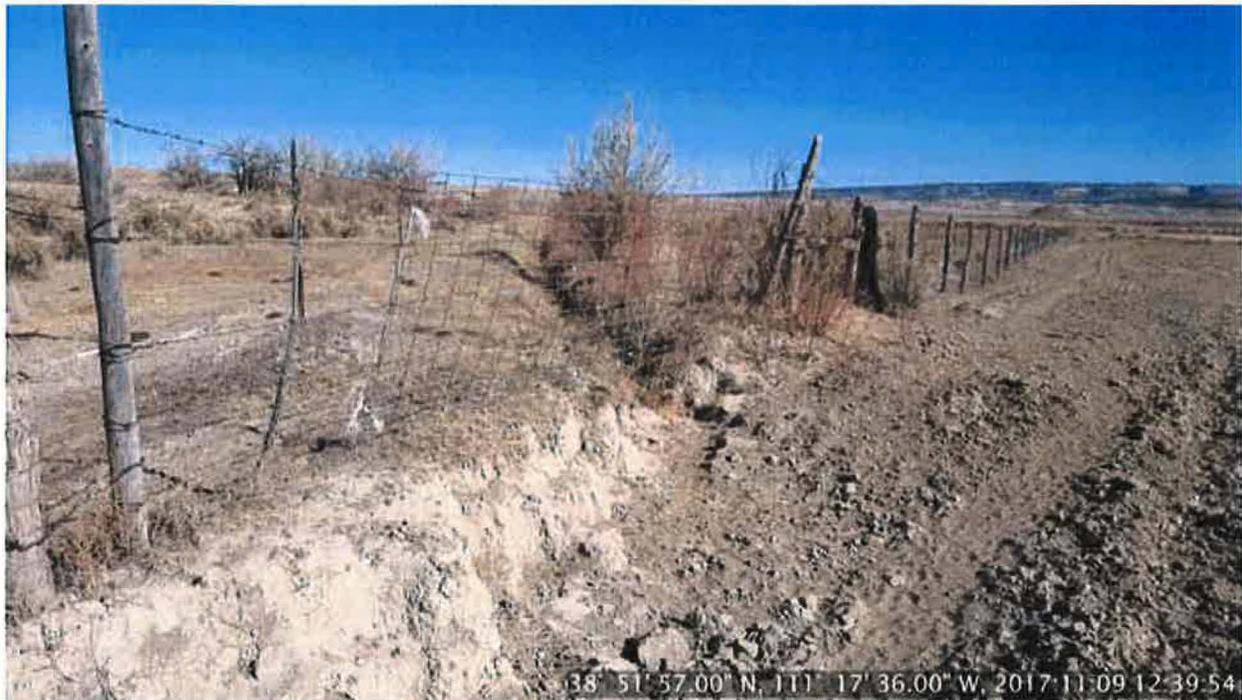
Feature 33. Irrigation Ditch. Photo taken at north end of farm land (Feature 32.). The farm land was expanded and regraded, eliminating need for irrigation ditch.

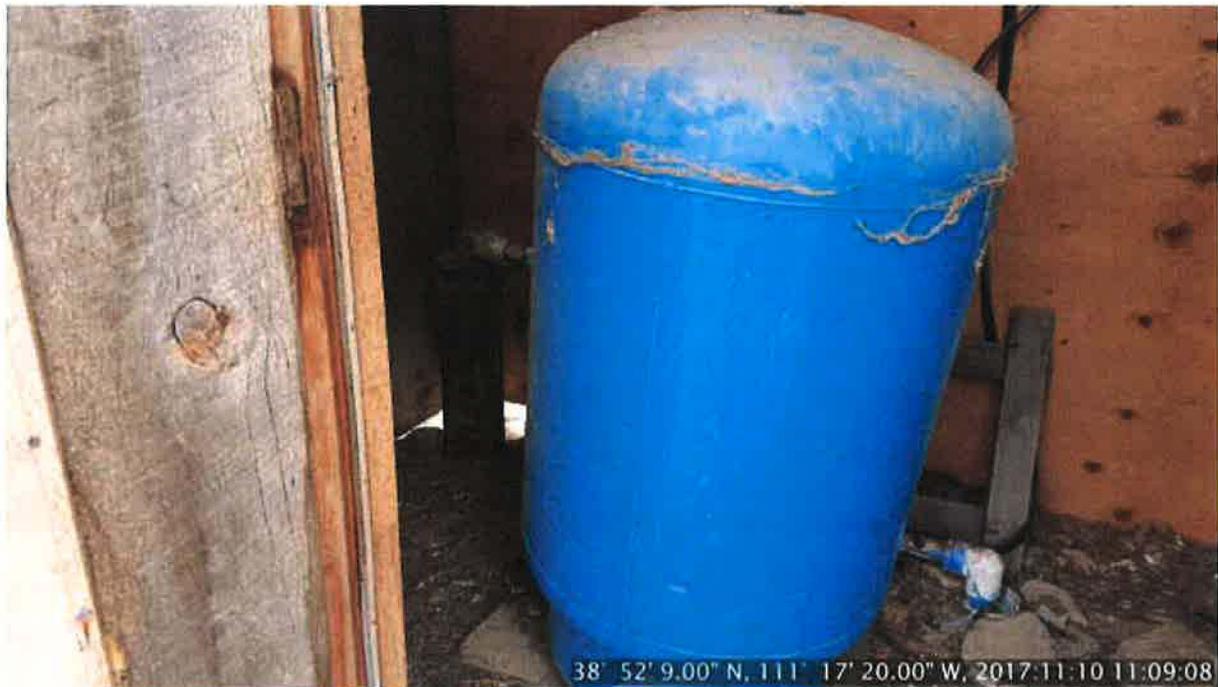
Feature 34. Culinary Well. Concrete pad surrounding wellhead is cracked and separated from rest of pad.

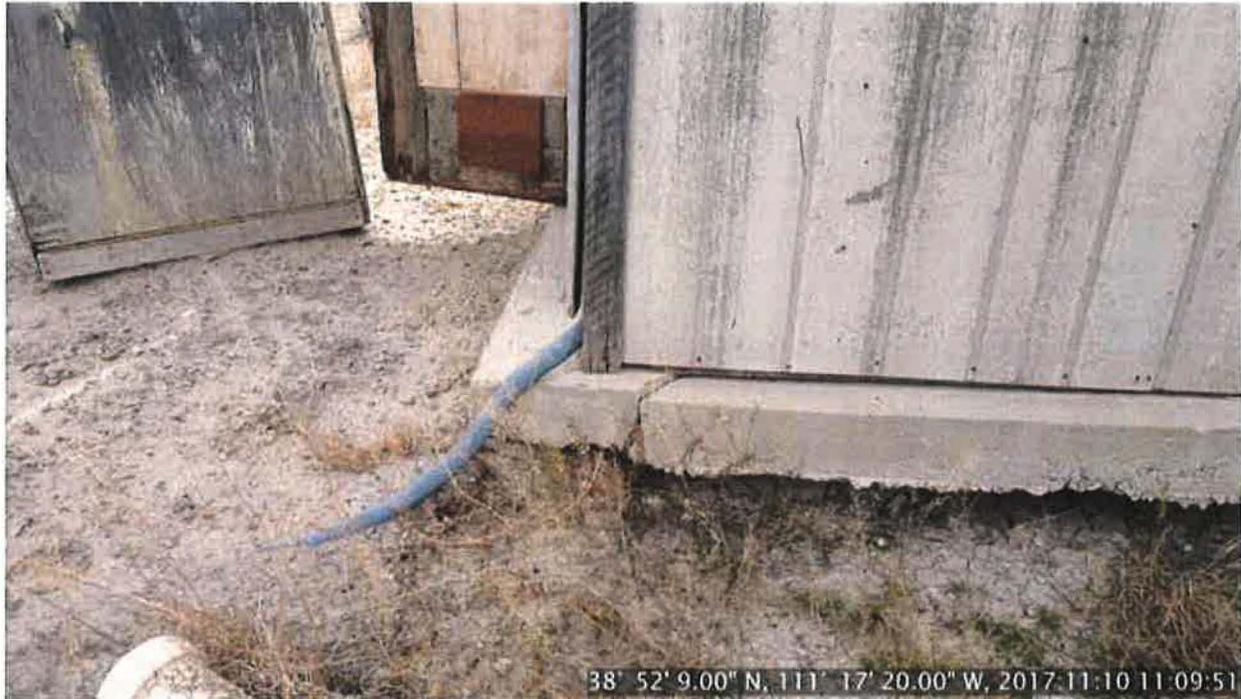
Feature 34. Culinary Well. Concrete pad near conduit is cracked and offset.

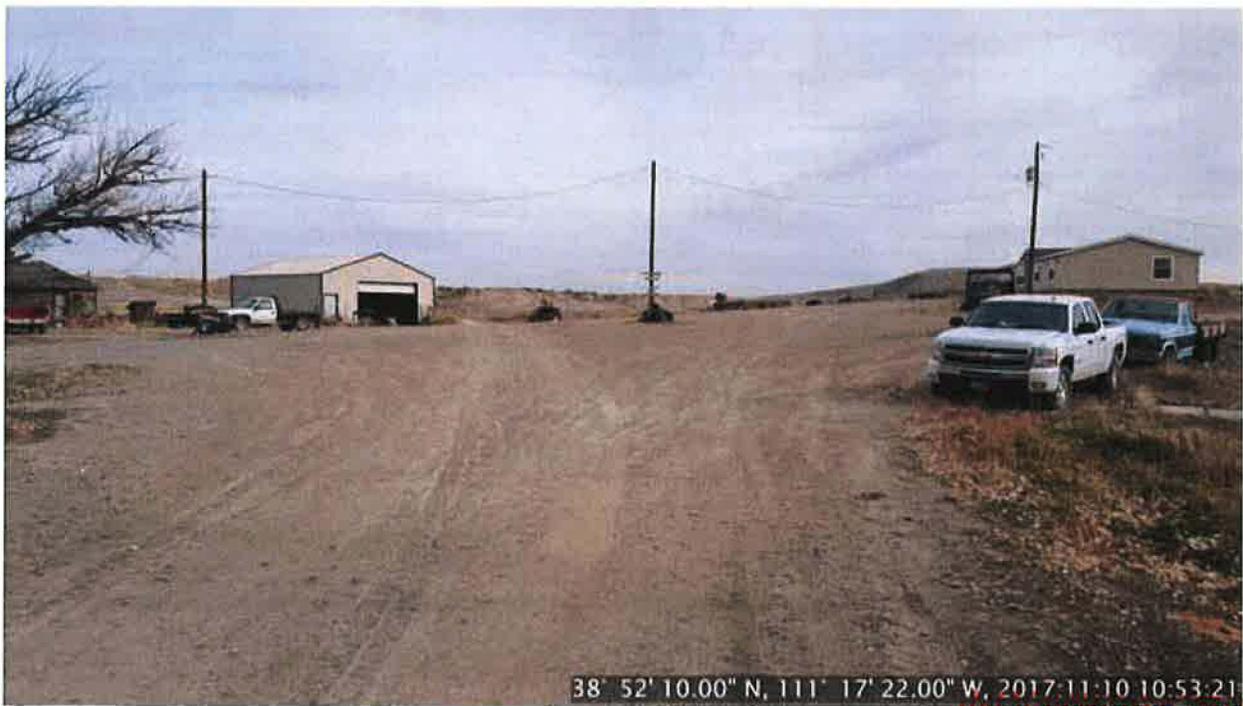
Feature 35. Ranch House and Buildings. Overview looking east.

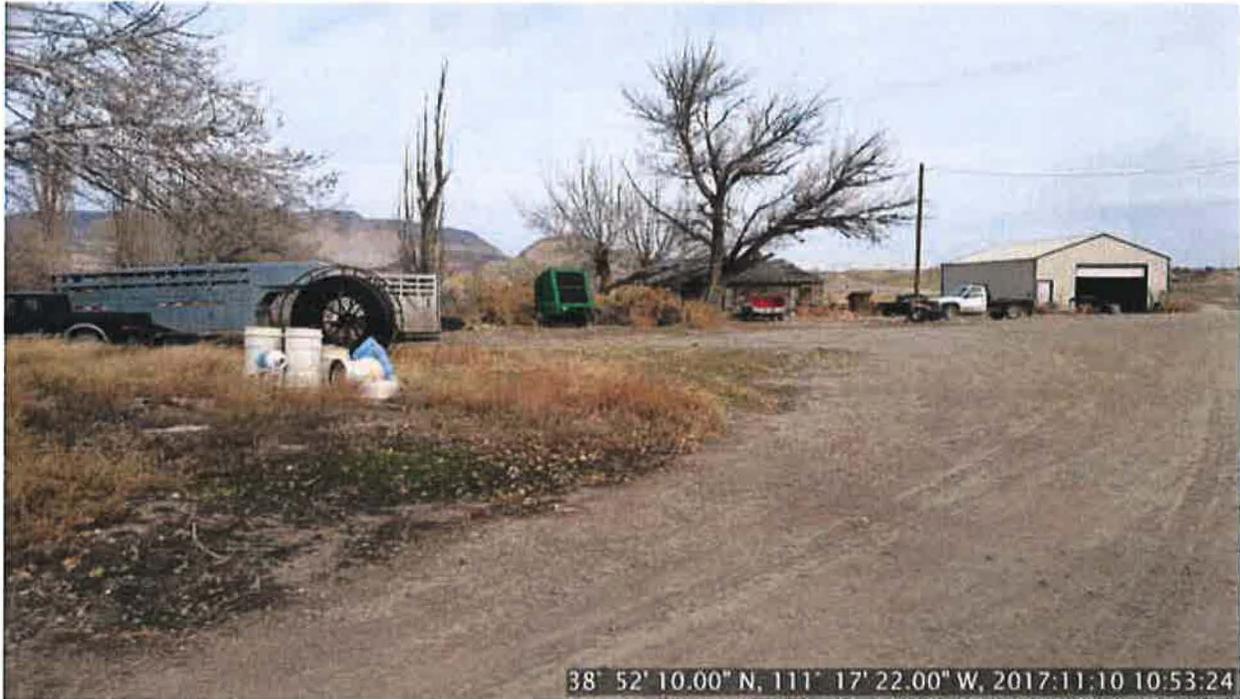
Feature 35. Ranch House and Buildings. Overview looking northeast.

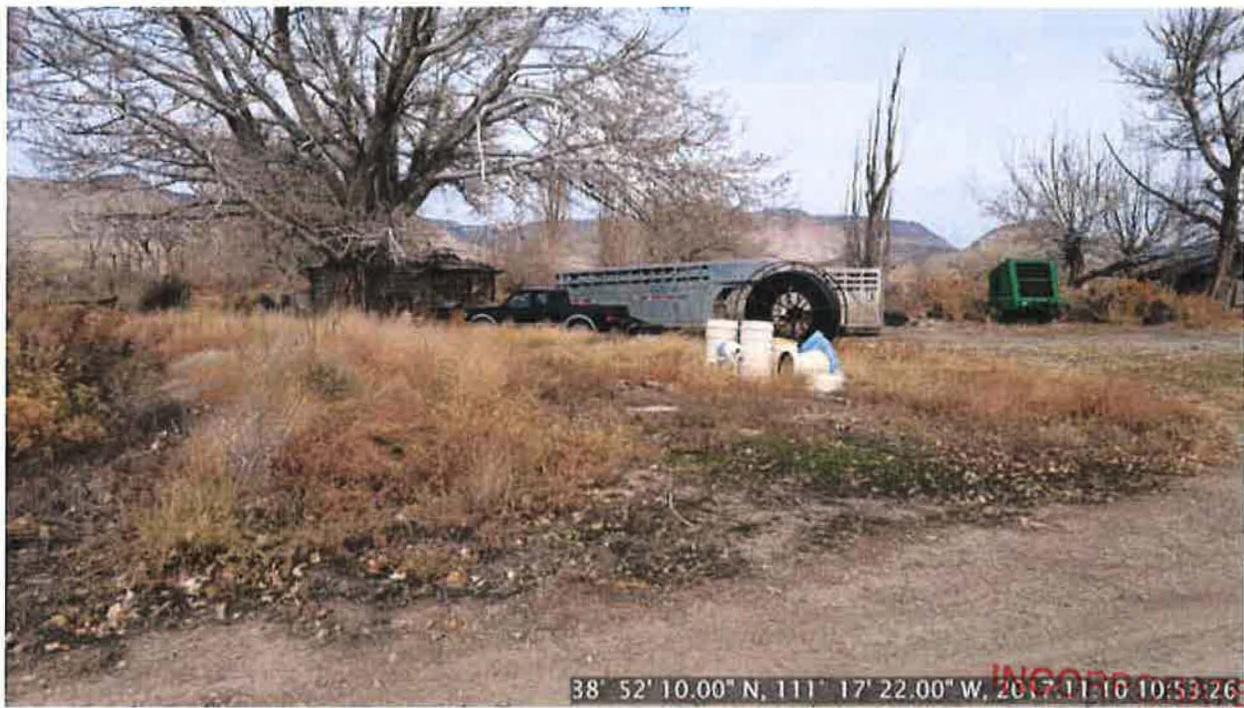
Feature 35. Ranch House and Buildings. Overview looking north.

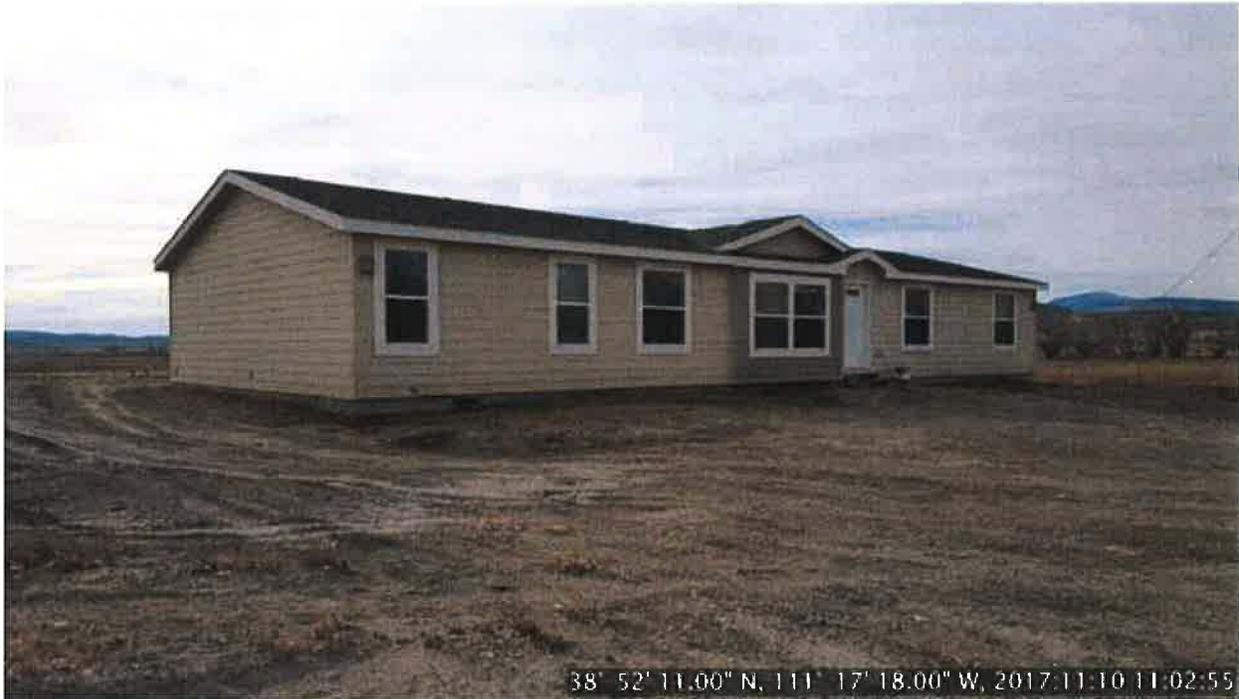
- A double wide manufactured home installed after the 1980 report. This home is installed on a concrete foundation that is intact with only two small cracks that are typical of cracks found in most residential home foundations. Overall, the home appears to be in good condition.

Feature 35. Ranch House and Buildings. Manufactured home looking east.

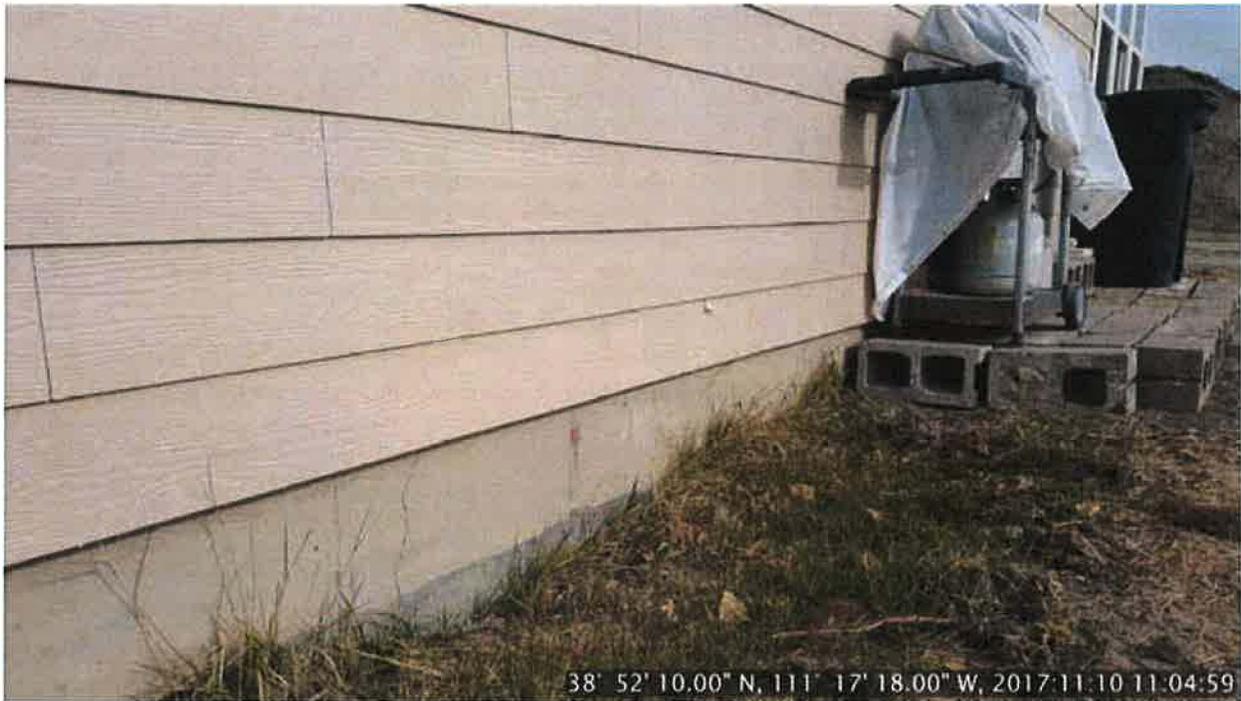
Feature 35. Ranch House and Buildings. Manufactured home. Small cracks in foundation.

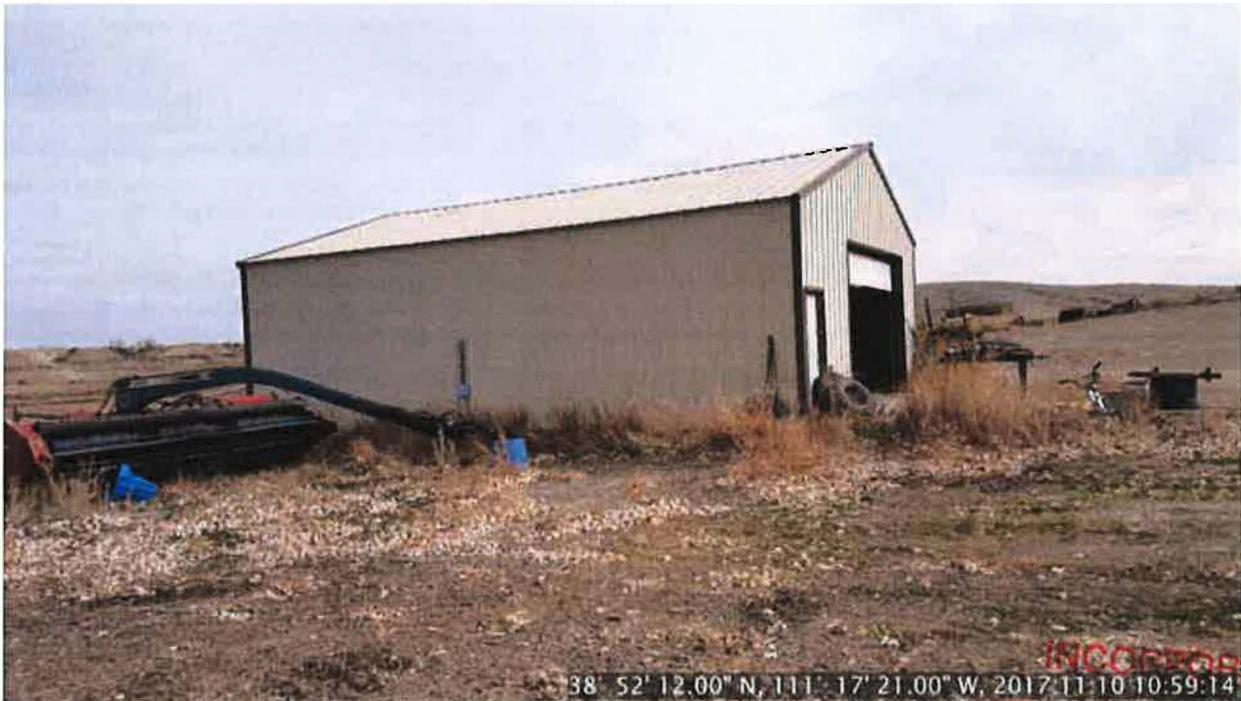
- Metal shed on a concrete slab. The metal shed is in good condition. The concrete slab is in fair condition with some cracking observed. Four elevated fuel tanks are located on the east side of the shed.

Feature 35. Ranch House and Buildings. Metal shed. Looking northeast.

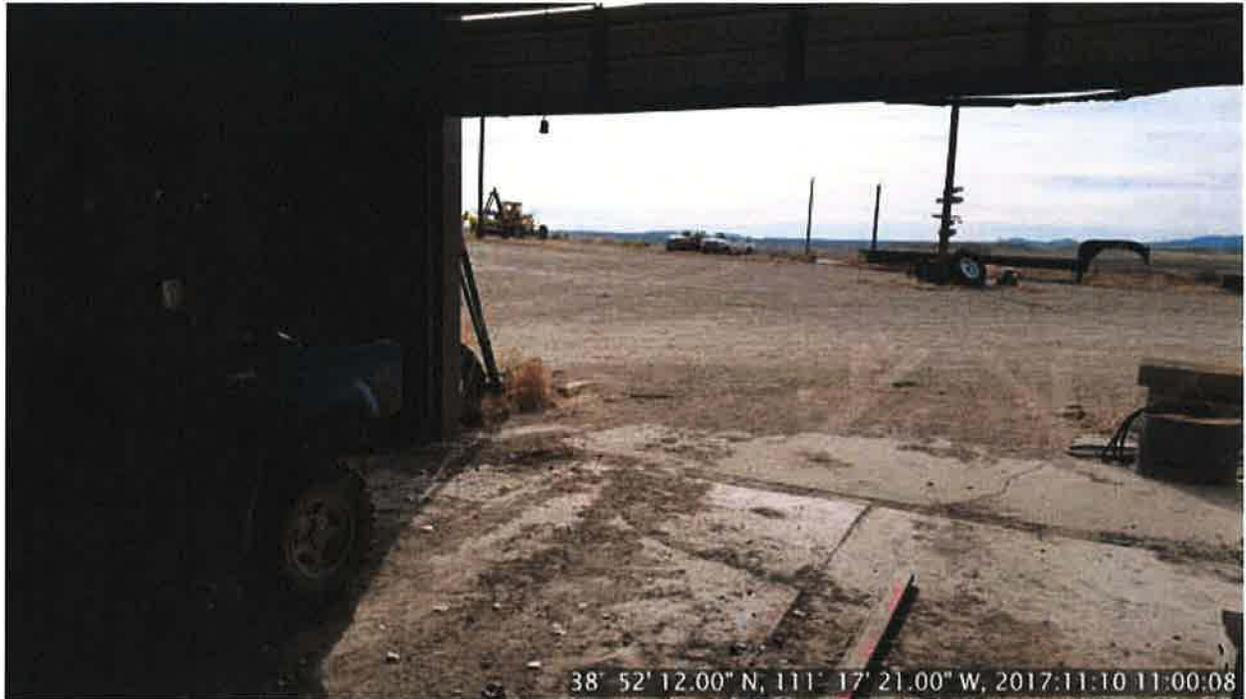
Feature 35. Ranch House and Buildings. Metal shed. Looking outside through overhead door. Cracks in concrete floor.

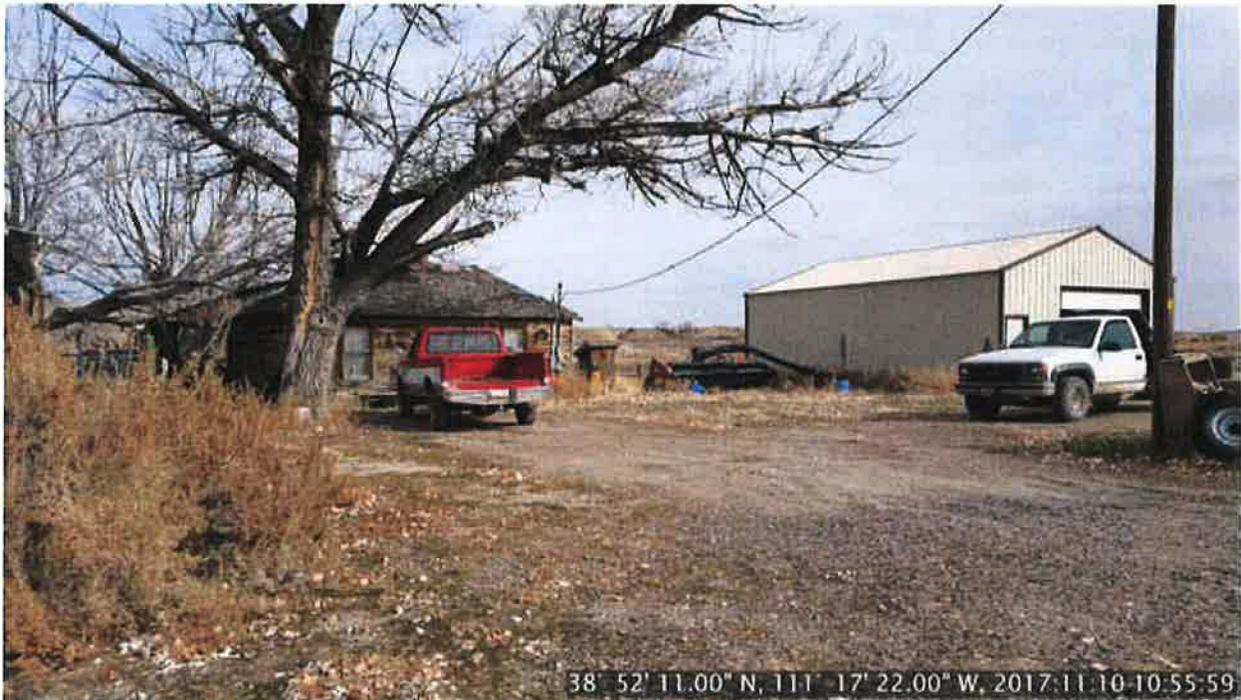
Feature 35. Ranch House and Buildings. Metal shed (right) and ranch house (left).

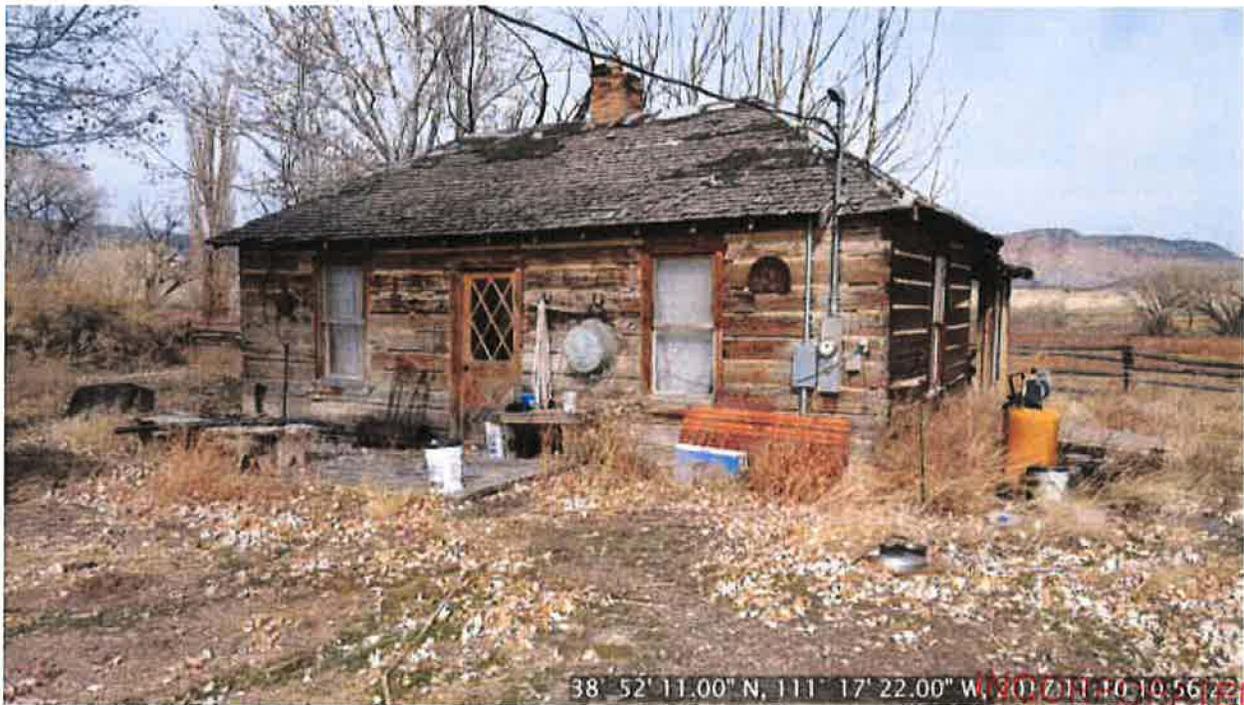
Feature 35. Ranch House and Buildings. Front view of ranch house.

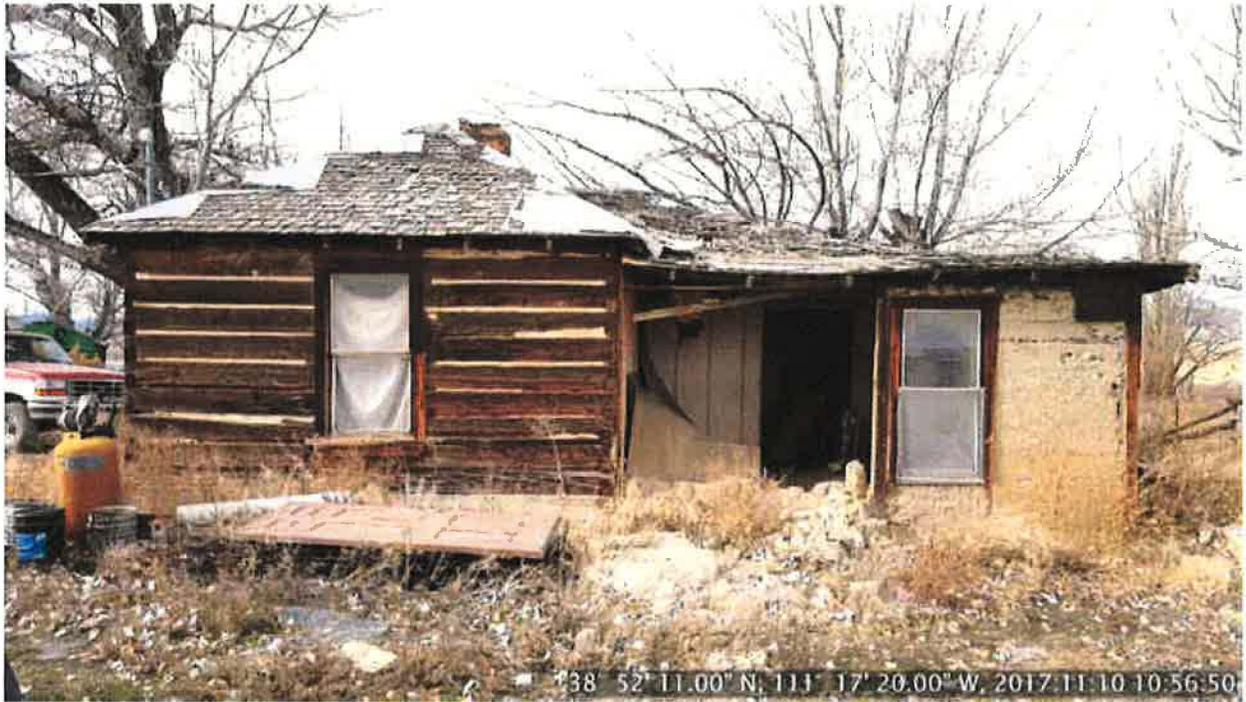
- Wood outhouse constructed of natural rough cut logs. This structure appears to be in fair condition.
- Ranch house constructed of rough sawn logs and adobe brick. The adobe walls have fallen down, exposing the north end of the house to outside elements. It is dilapidated and unlivable. A concrete structure located near the ranch house appears to be an old septic tank.

Feature 35. Ranch House and Buildings. Side view of ranch house. Adobe wall crumbled. Sagging roof.

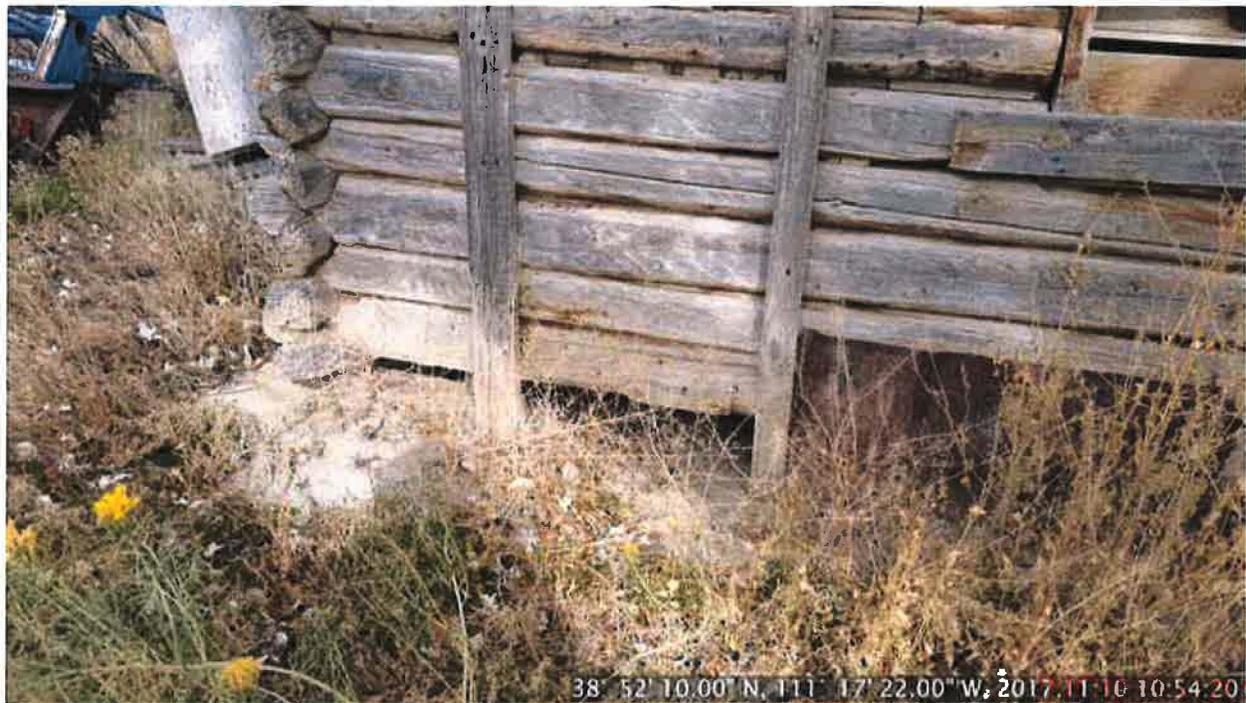
- Wood building constructed of natural rough cut logs. Intermittently placed sandstone rocks serve as a foundation for the structure. The structure is in dilapidated condition.

Feature 35. Ranch House and Buildings. Wood building. View of foundation.

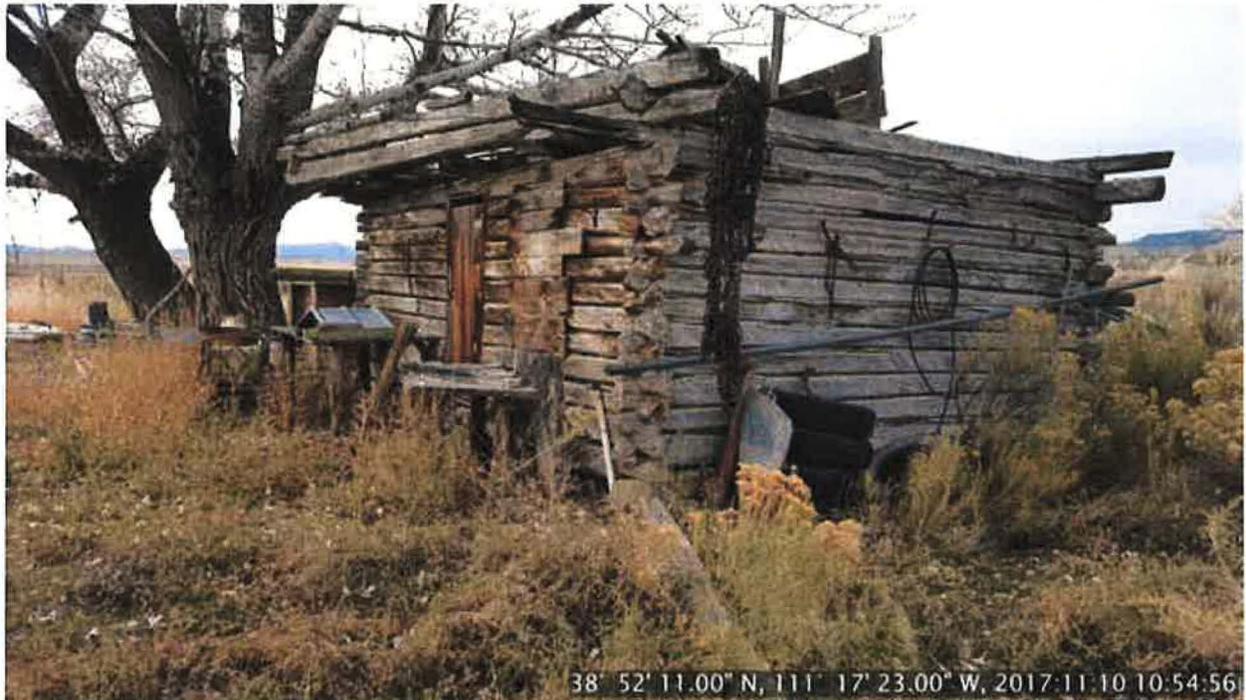
Feature 35. Ranch House and Buildings. Wood building.

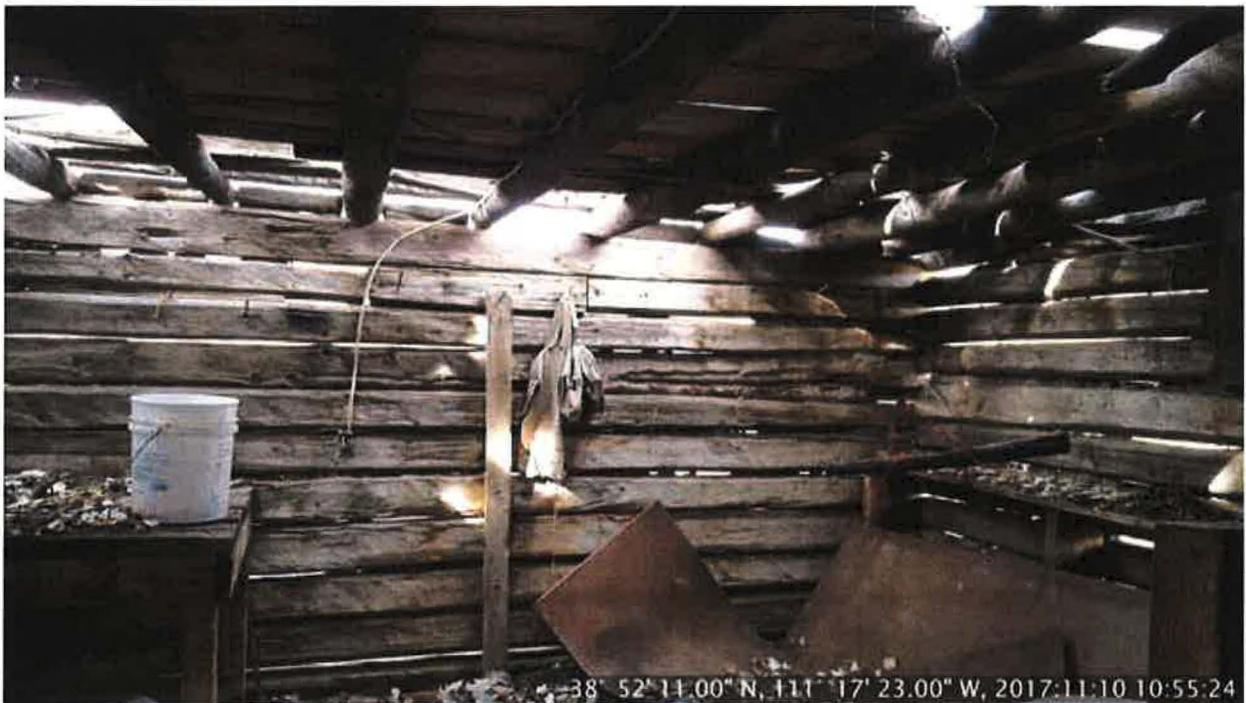
Feature 35. Ranch House and Buildings. Inside view of wood building.

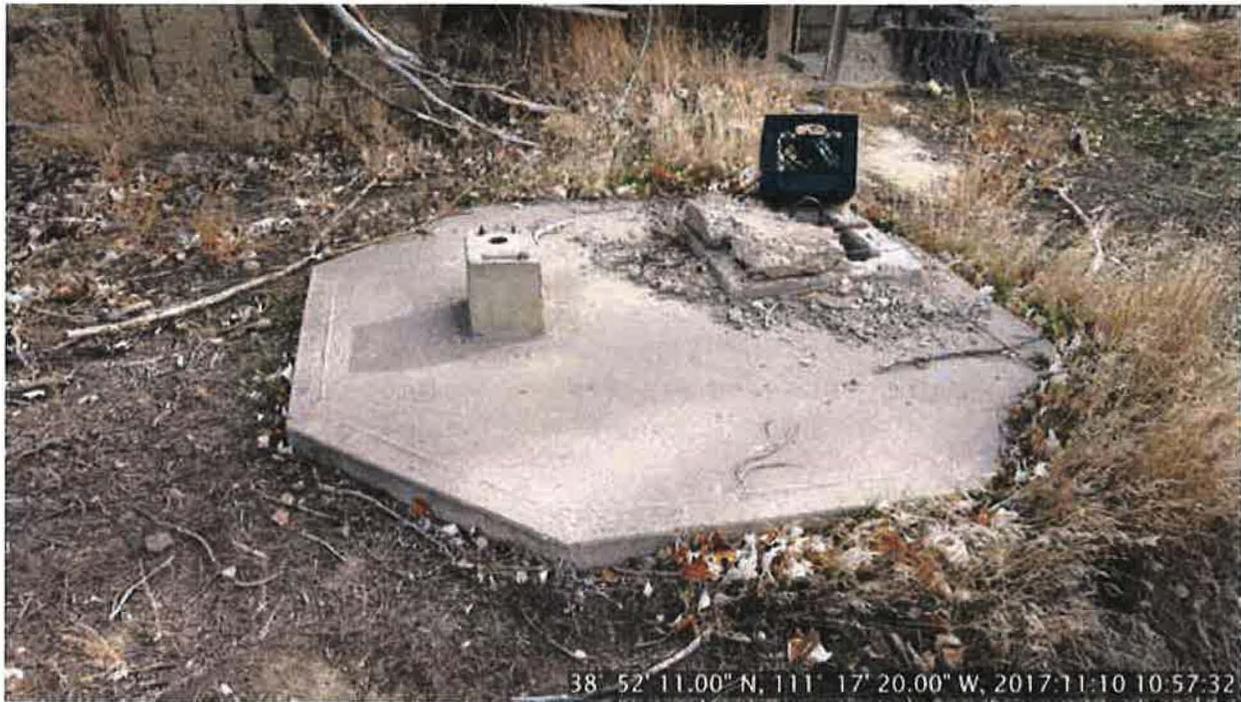
Feature 35. Ranch House and Buildings. Concrete structure. This may be an old septic tank.

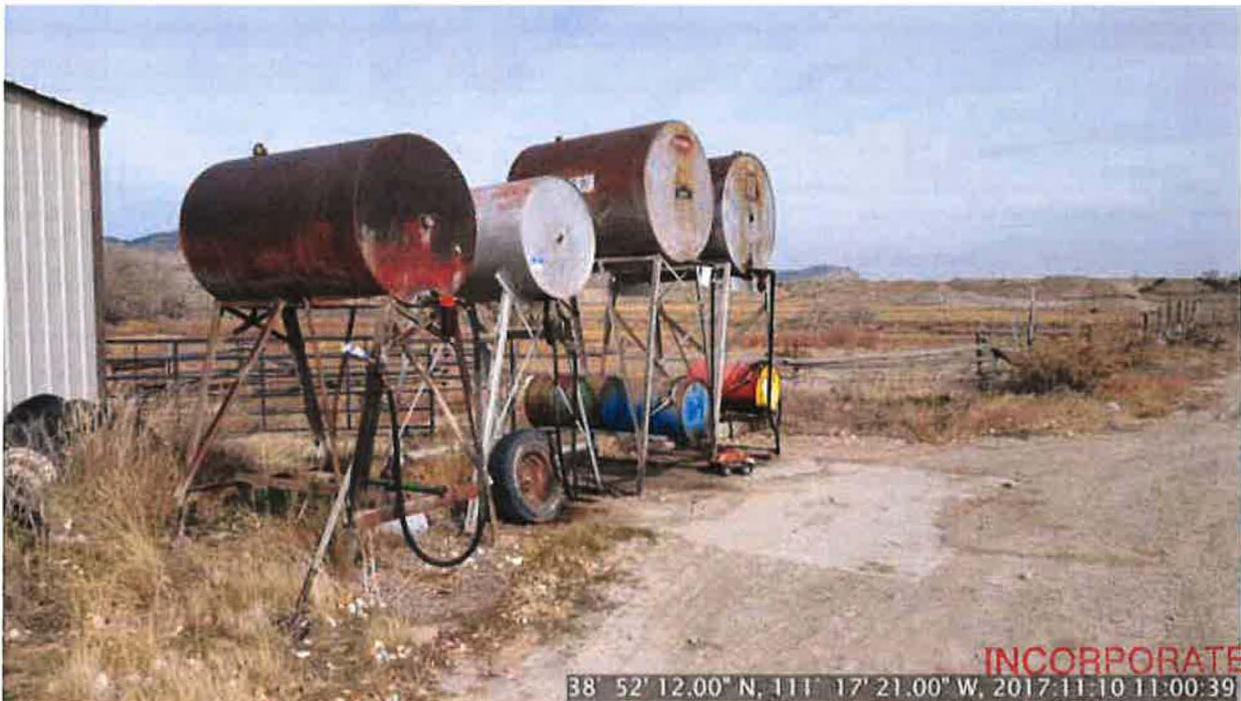
Feature 35. Ranch House and Buildings. Elevated fuel tanks located on east side of metal structure.
